KIWI INSPECTIONS LTD

## RESIDENTIAL HOUSE INSPECTION

74 Amyes Rd  
Christchurch, Canterbury Region 8042

23/10/2025

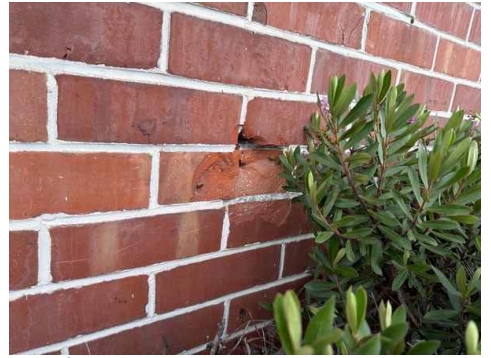
North

#### LOOSE BRICKS

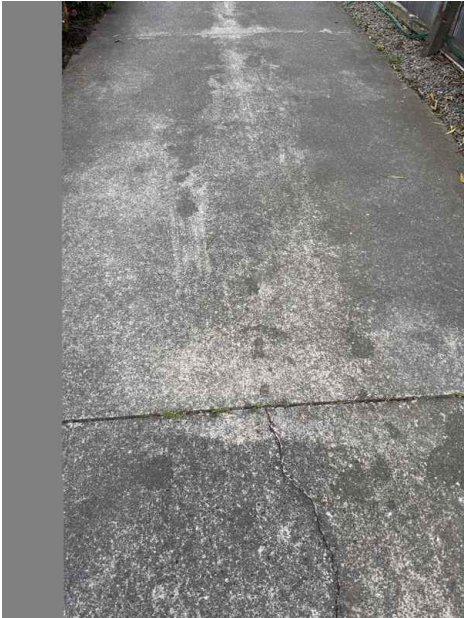
10.1.1 Driveway		
<b>CRACKING AND MOVEMENT NOTED</b>		
Cracking and movement to the driveway is noted		<div>

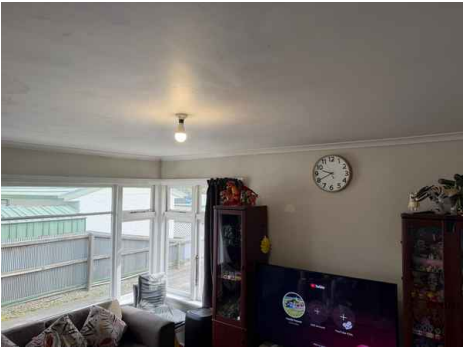
16.2.1 Exterior Joinery  
**WINDOW FUNCTIONALITY IS LIMITED**  
BEDROOM  
Adjust and maintain as required.

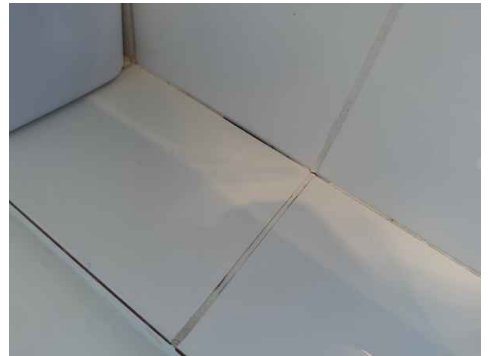
**DETERIORATION OF SILICONE SEALANT**

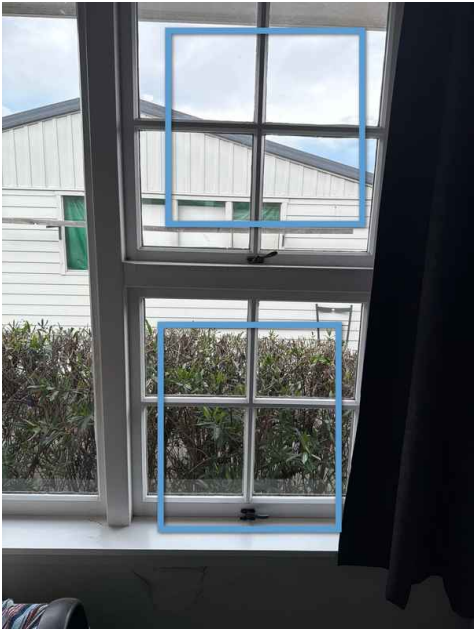
22.2.1 Exterior Joinery

**WINDOW FUNCTIONALITY IS LIMITED**

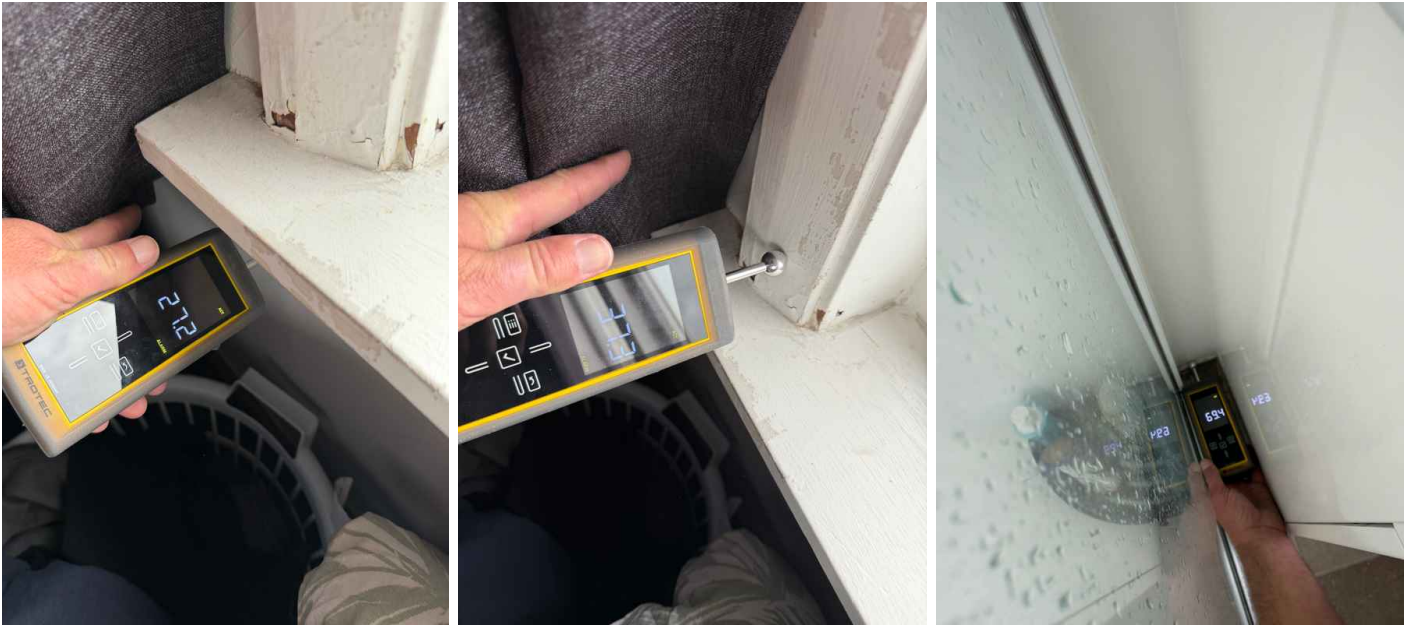
### 24.1.1 Moisture

Elevated moisture was located to the: right hand side of the shower enclosure, remedial work required.

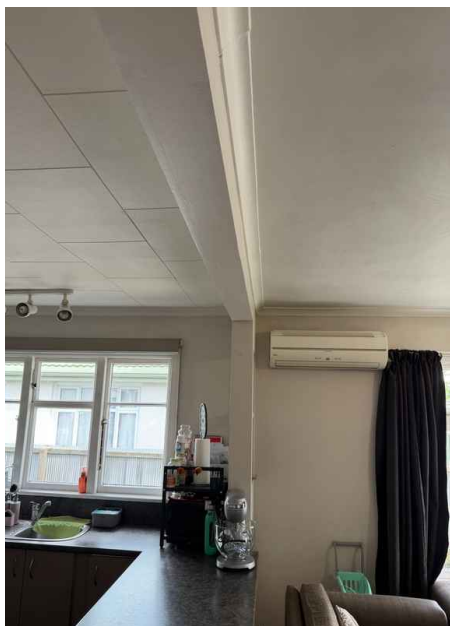
Alterations to the original building have been observed, it is recommended that council records are checked to ensure council approval and compliance has been achieved.
