BUILDING INSPECTION REPORT

RED LBP PRE-PURCHASE REPORT

PRE-PURCHASE BUILDING REPORT

Property Address	49B Inwoods Road, Parklands, Christchurch 8083
Client	Tanglewood Developments Ltd
Date of Inspection	24th November 2025
Time	9:00 am
Inspector	Jamie Chapman National Certificate in Carpentry
LBP Number	BP137228
People Present	Inspector
House Occupied	Staged

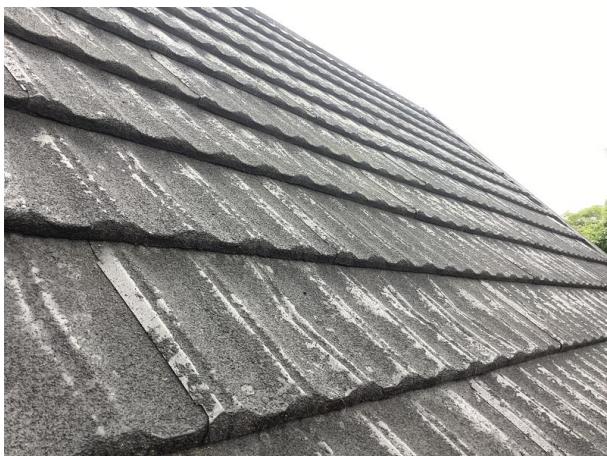
Photo 3

Painted decramastic coated metal tiles are located over the dwelling.

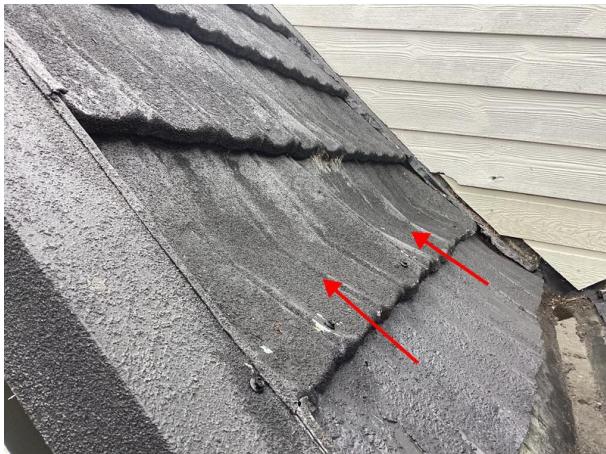
Photo 4

A few dented metal tiles were noticed above the entrance area.

Due to the age of the roof system and the dented metal tiles noticed in a few locations, ongoing monitoring and repairs/maintenance will likely be required. Some signs of maintenance and repairs were visible at the time of the inspection, with the roof system appearing to be recently repainted, and screw fixings visible in a couple of areas. Regularly inspect for surface deterioration and leaks to maintain its condition.

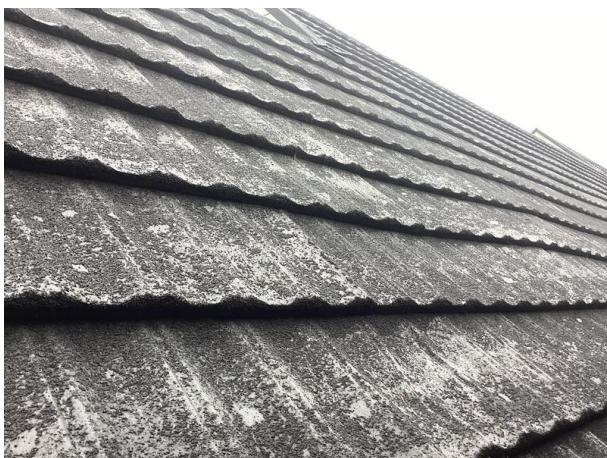
Photo 8

View of the painted decramastic coated metal tiled roof viewed from the east side roof elevation.

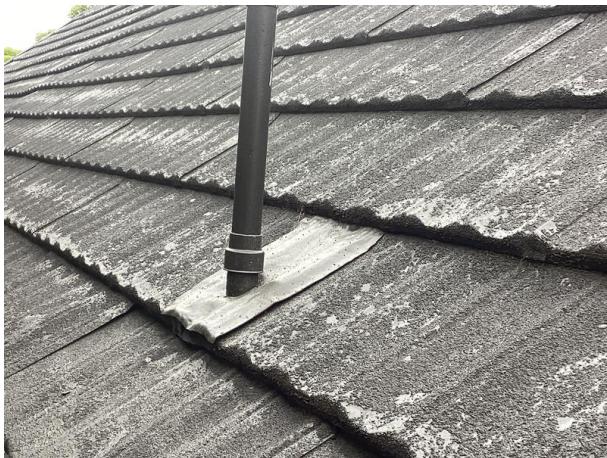
Photo 14

Roof penetrations are located on the east side of the roof system.

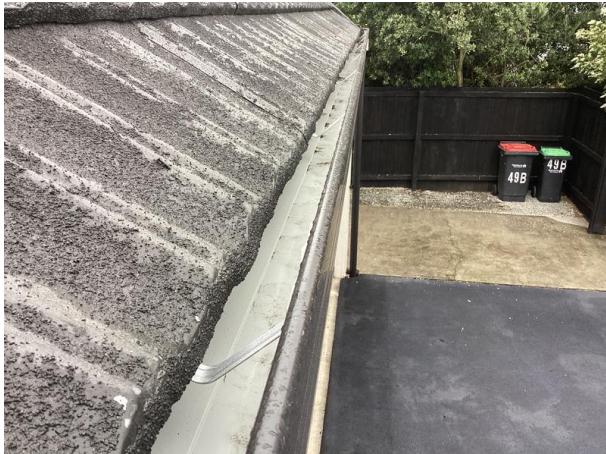
Photo 15

The metal gutter system was clean and clear at the time of the inspection.

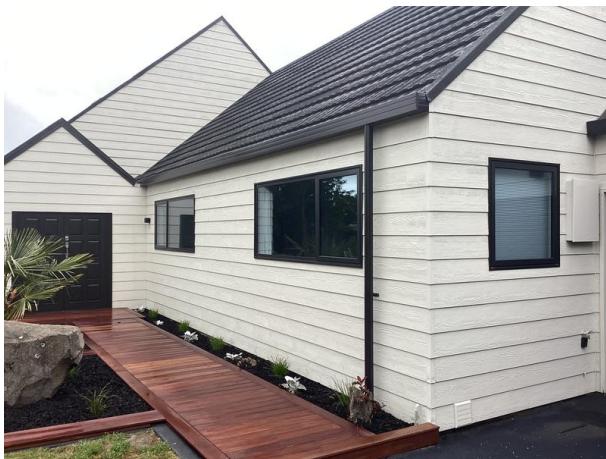
Photo 16

Fibre cement weatherboards are located on the South and West side of the dwelling.

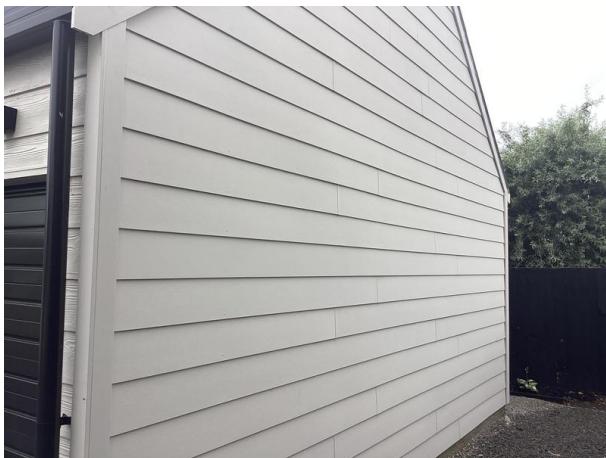
Photo 17

The South side fibre cement boards appear to have been replaced.

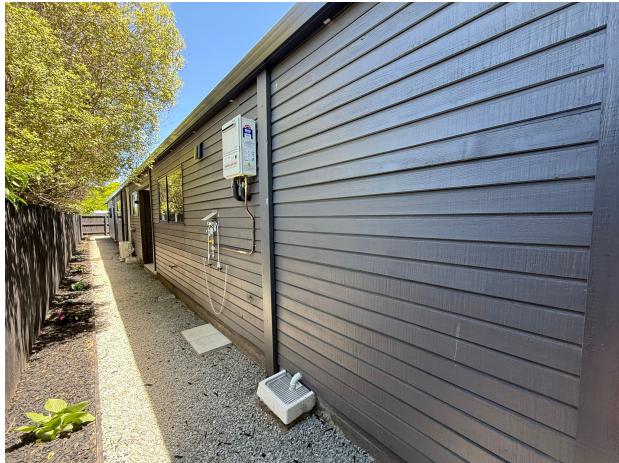
Photo 22

Horizontal timber weatherboards are located around the rest of the dwelling.

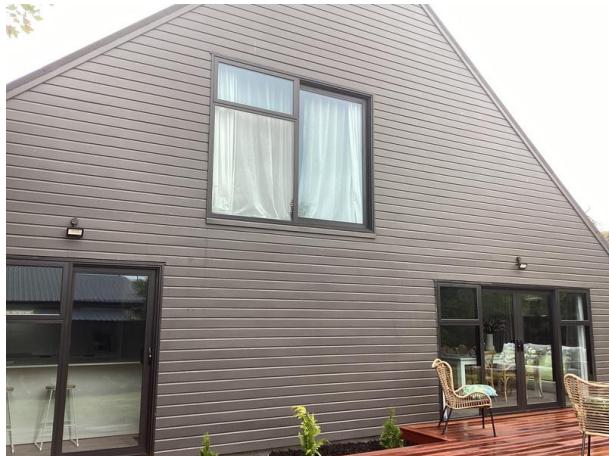
Photo 23

The North side timber weatherboards appear to have been recently replaced.

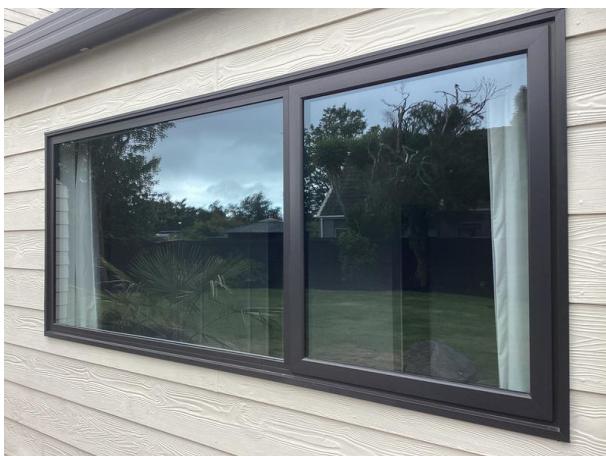
Photo 29

Double glazed aluminium windows are located around the dwelling.

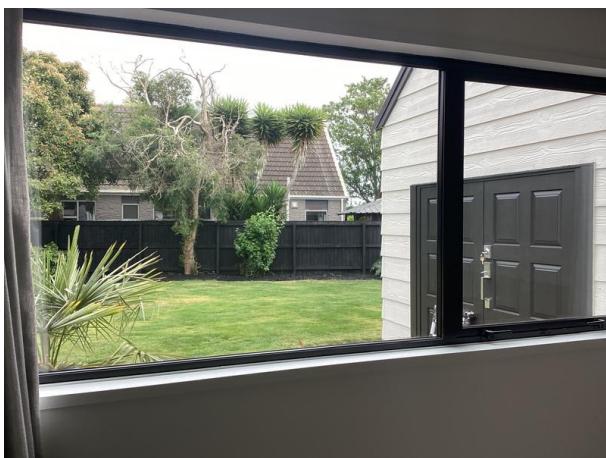
Photo 31

Aluminium windows viewed from inside the dwelling.

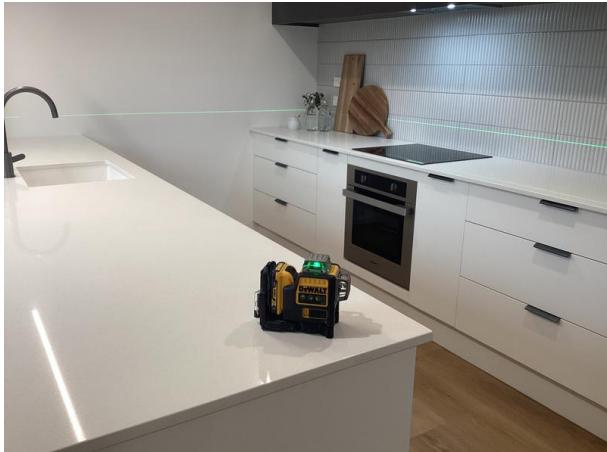
Photo 34

The kitchen bench tops were also checked and were level.

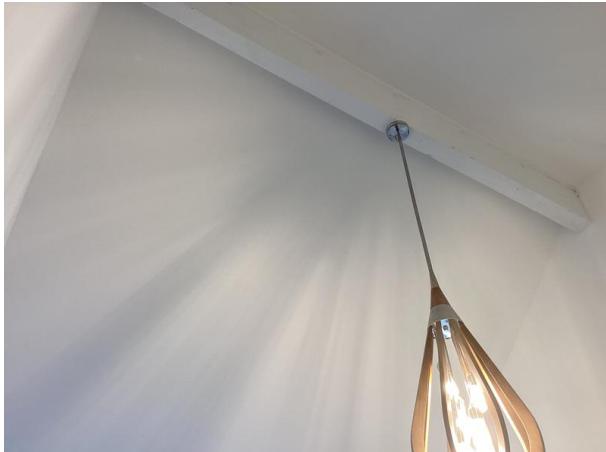
Photo 35

Some of the dwelling has a skillion roof. There is no access manhole to view the condition behind these areas.

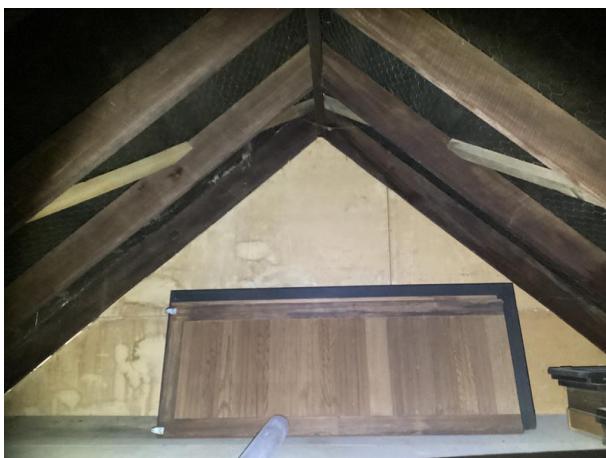
Photo 36

View of the garage roof space area.

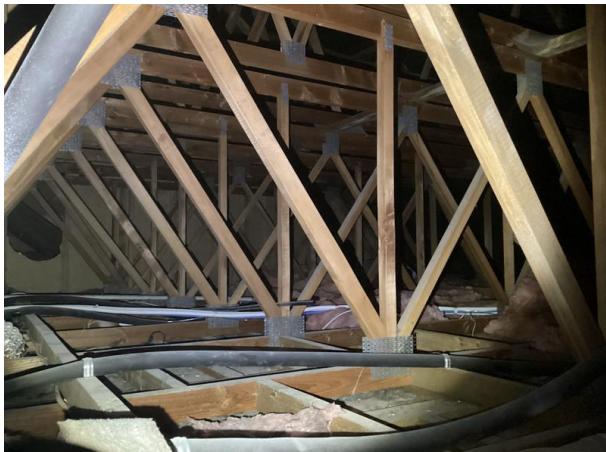
Photo 38

View of the main roof space area with manufactured timber trusses supporting the roof system.

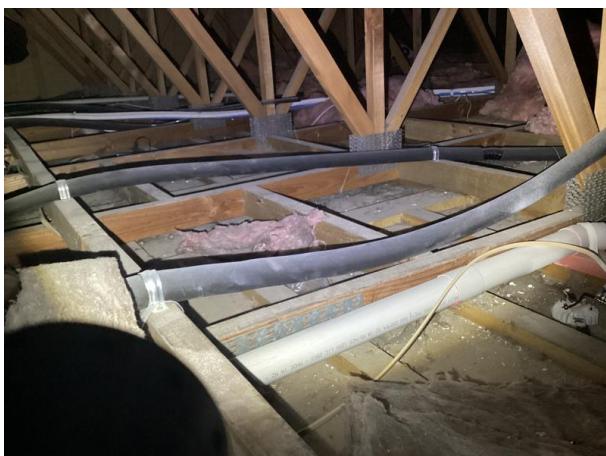
Photo 39

Thickness of insulation visible - None. Areas missing insulation.

Future maintenance would include installing a consistent layer of insulation in the roof space.

Fill areas not covered and add another layer over the top to increase R value.

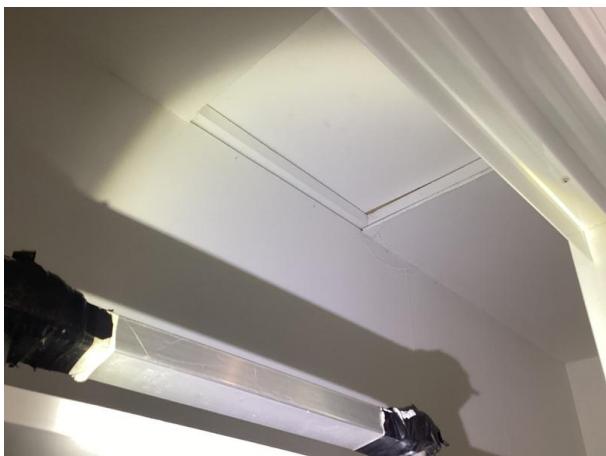
Photo 40

There was limited access into the main roof space area due to the location of the manhole.

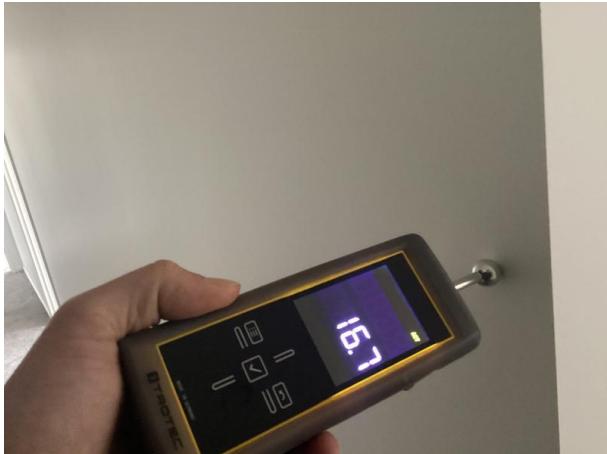
Photo 41

Example of a base reading that was taken on an internal wall. This was the average moisture reading during this inspection.

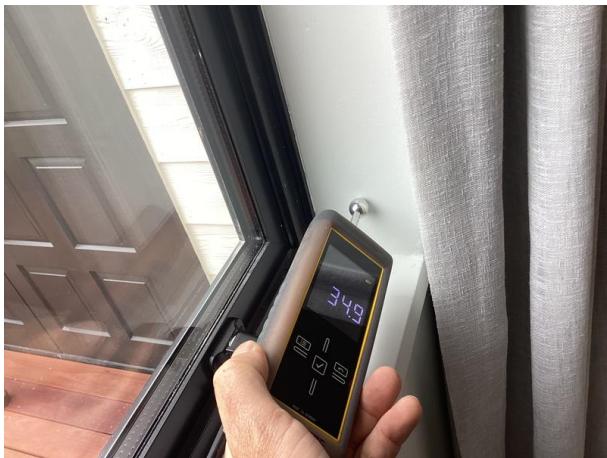
Photo 43

Moisture testing was done around the external window joinery.

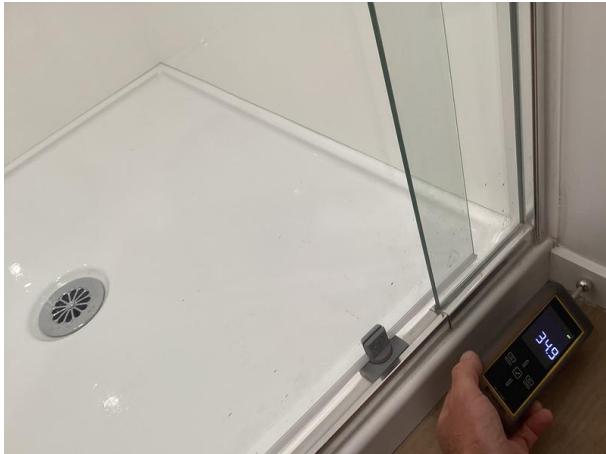
Photo 44

Moisture testing was done around plumbing and wet areas.

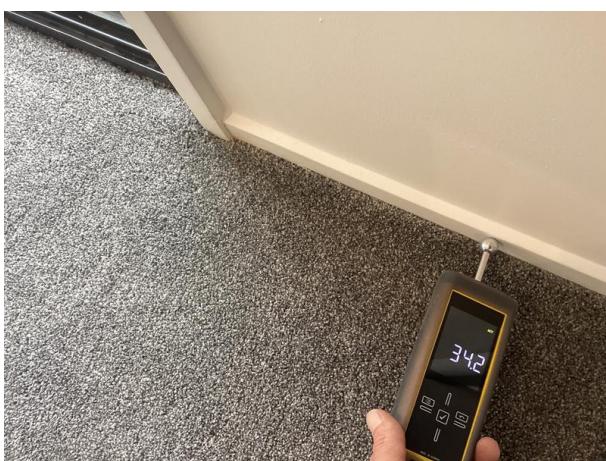
Photo 51

Example of a dry/normal moisture reading detected away from the previous photos.

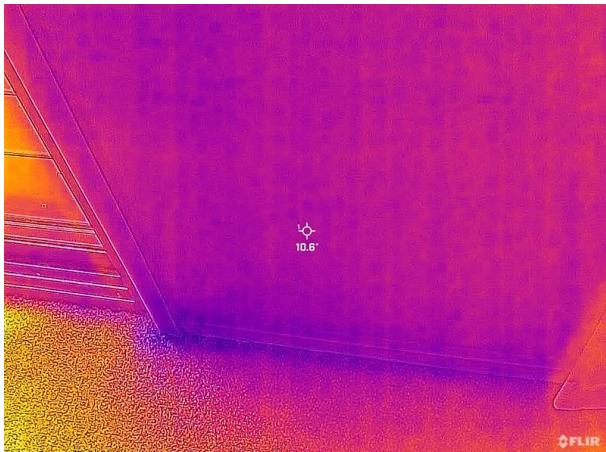
Photo 53

As detailed in the photos below, indications of elevated moisture were detected on the north side of the dining room beside the external sliding door. The FLIR thermal imaging camera was then used, with no significant thermal abnormalities discovered during the inspection. When viewing the other side the timber weatherboards appear to have recently been replaced. However, there were gaps noticed between the timber weatherboards and window joinery. It is unknown if the moisture readings detected are historic or a current issue. Further information or investigation is recommended into this area.

The FLIR thermal imaging camera was then used around this area with no significant thermal abnormalities discovered during the inspection.

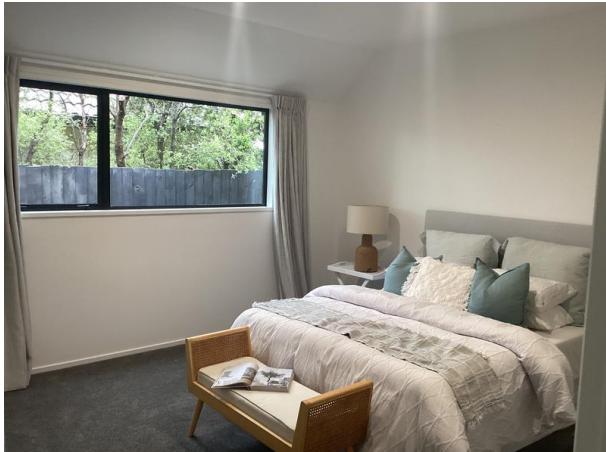
Photo 62
Bedroom 3.

Ceiling linings - Plasterboard - Paint finished.
Ceiling wall junction - Square stopped.
Wall linings - Plasterboard - Paint finished.
Exterior joinery - Aluminium - Double-glazed - Standard glass - Painted timber reveals.
Internal doors - Hollow core.
Floor coverings - Carpet.
Cupboards - Double - Doors - Panel.

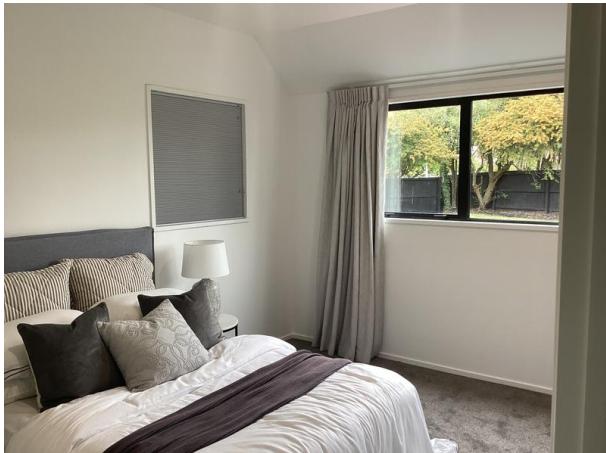
Photo 63
Bedroom 4.

Ceiling linings - Plasterboard - Paint finished.
Ceiling wall junction - Square stopped.
Wall linings - Plasterboard - Paint finished.
Exterior joinery - Aluminium - Double-glazed - Standard glass - Painted timber reveals.
Internal doors - Hollow core.
Floor coverings - Carpet.
Cupboards - Quad - Doors - Panel.

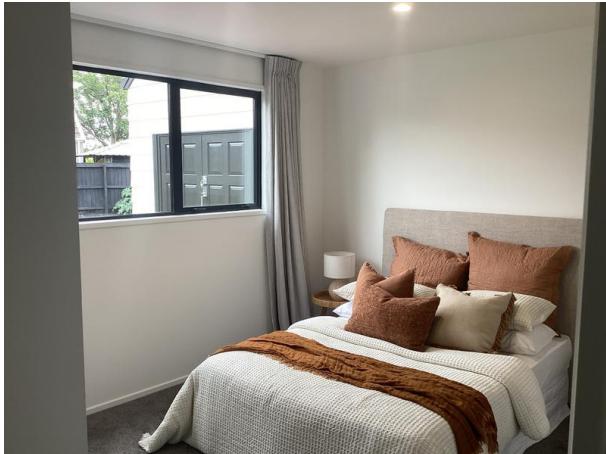
Photo 64
Bedroom 5.

Ceiling linings - Plasterboard - Paint finished.
Ceiling wall junction - Square stopped.
Wall linings - Plasterboard - Paint finished.
Exterior joinery - Aluminium - Double-glazed - Standard glass - Painted timber reveals.
Internal doors - Hollow core.
Floor coverings - Carpet.
Cupboards - Double - Doors - Panel.

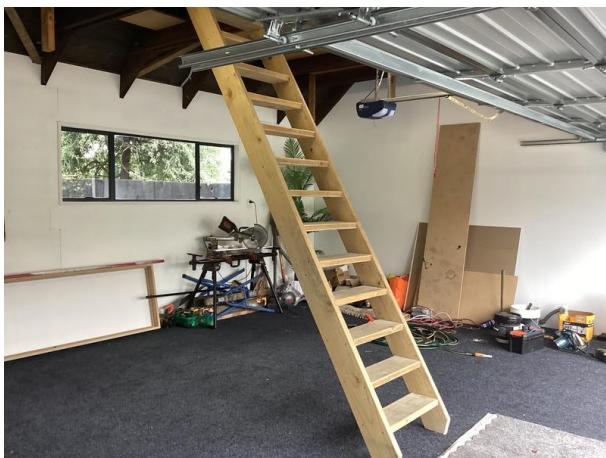
Photo 65
Garage.

Wall defects - Cosmetic issues.

Garage door - Sectional - Double and Single - Aluminium - Automatic opener functional - Yes.

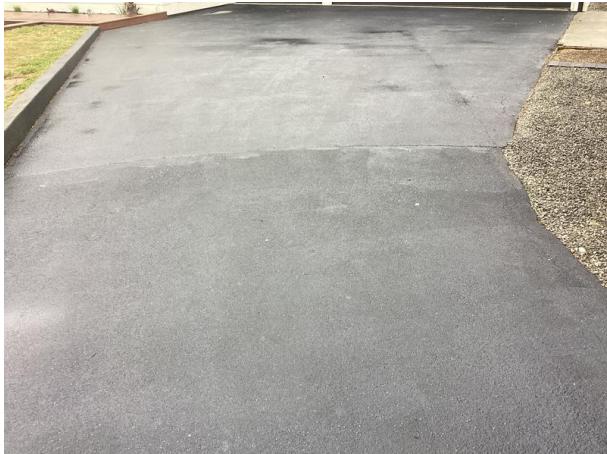
Photo 67

Asphalt driveway, no significant issues.

General upkeep and maintenance of driveway by cleaning and keeping free of debris.

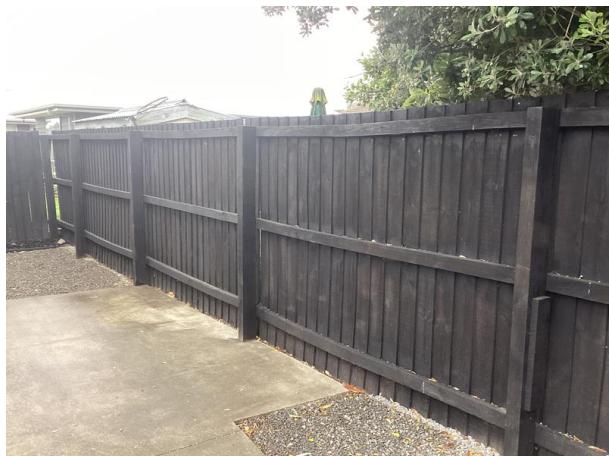
Photo 68

The timber fences are mostly in a condition expected for age.

A few broken and loose timber palings were noticed.

General upkeep and maintenance.

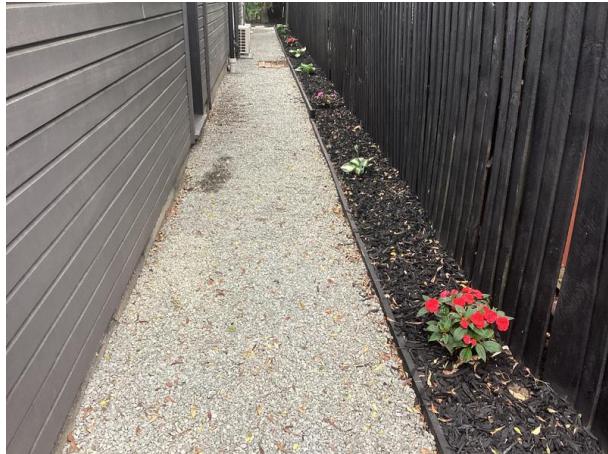
Photo 70

Stone paths, no significant issues.

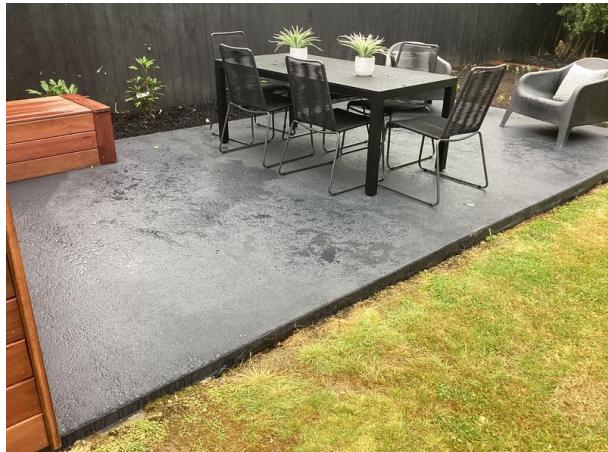
Photo 71

North side concrete patio, no significant issues.

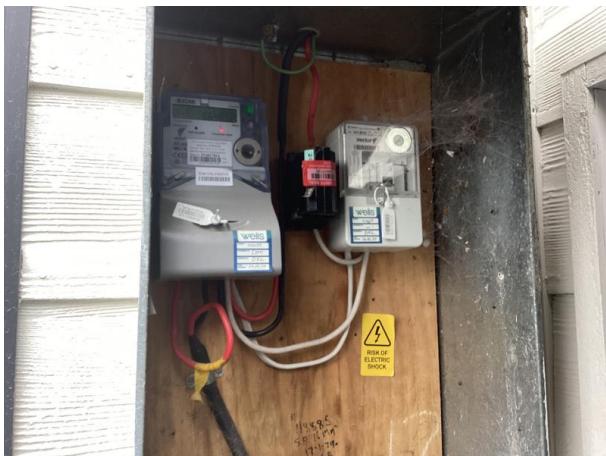
Photo 74

Meter box located on the west side of the dwelling.

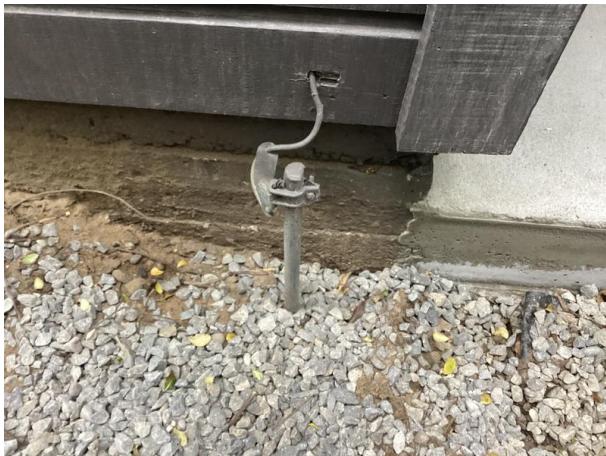
Photo 75

Earth connection located on the east side of the dwelling.

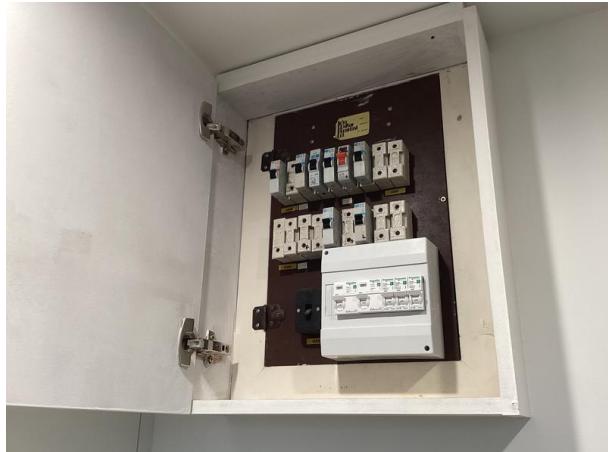
Photo 76

Switchboard located in the laundry.

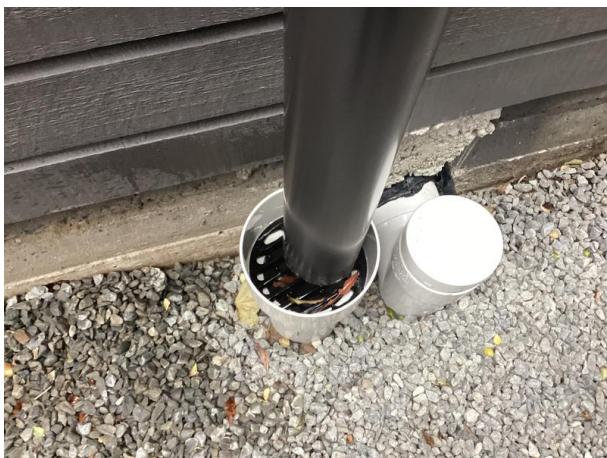
Photo 77

Stormwater risers are located around the dwelling.

Maintain a clear area around drainage systems by ensuring vegetation and soil are kept away. This helps to prevent blockages, maintain proper water flow, and reduce the risk of water pooling or drainage failure. Regularly inspect and remove any overgrowth or debris that may obstruct the drainage.

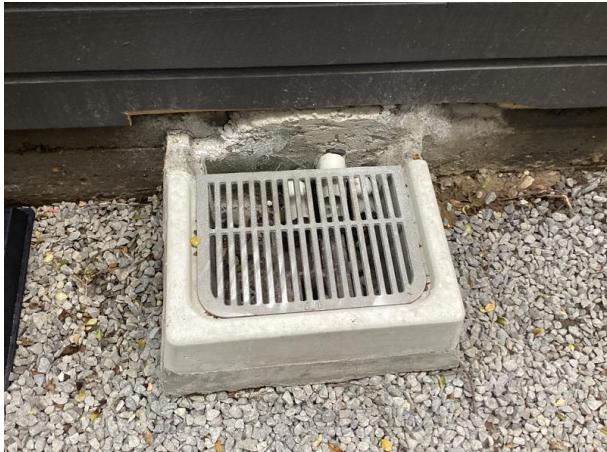
Photo 78
East side gully trap.

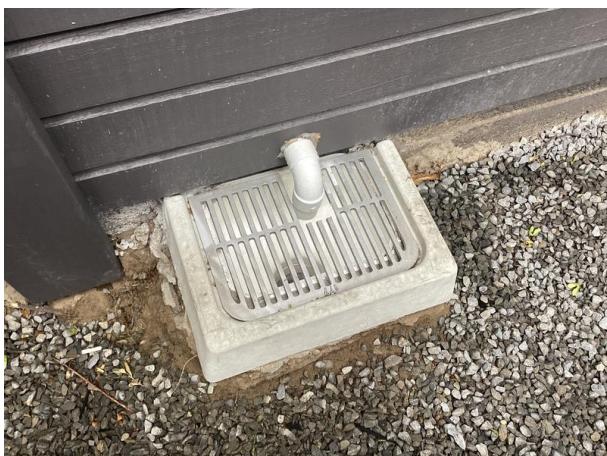
Photo 79
East side gully trap.

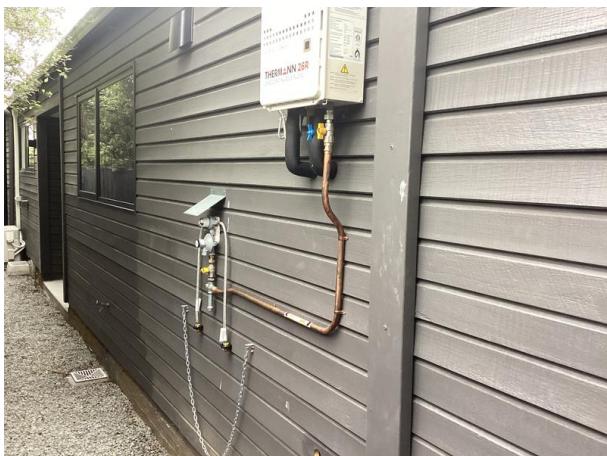
Any visible defects - No gas bottles were installed during the inspection to test any hot water around the dwelling. It is recommended to have gas bottles installed to test the hot water before settlement.

Photo 80
Gas bottle station and hot water Califont located on the east side of the dwelling.

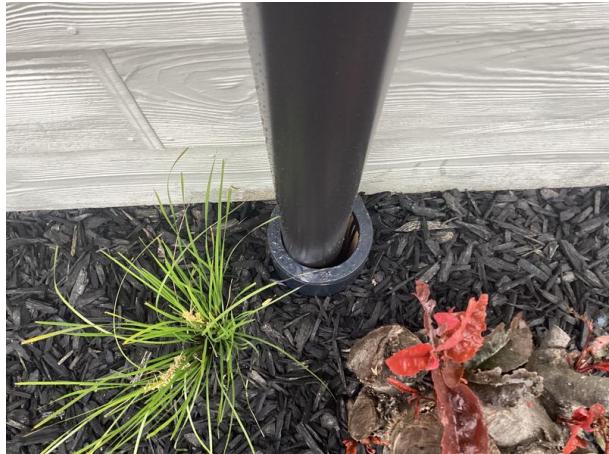
Photo 81
South side stormwater riser.

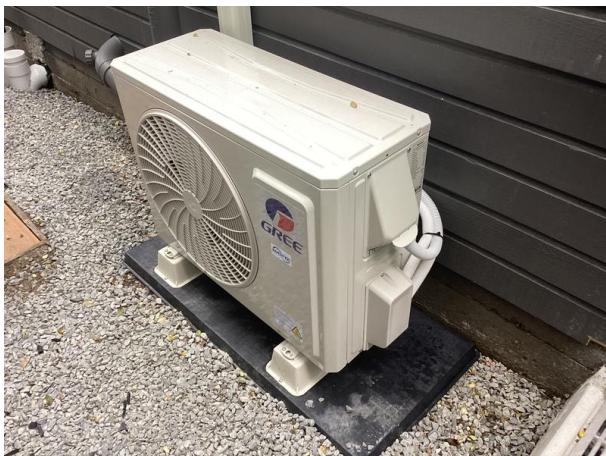
Photo 82
External Gree heatpump system.

Follow the manufacturer's recommended servicing schedule to ensure the equipment operates efficiently and maintains optimal performance.

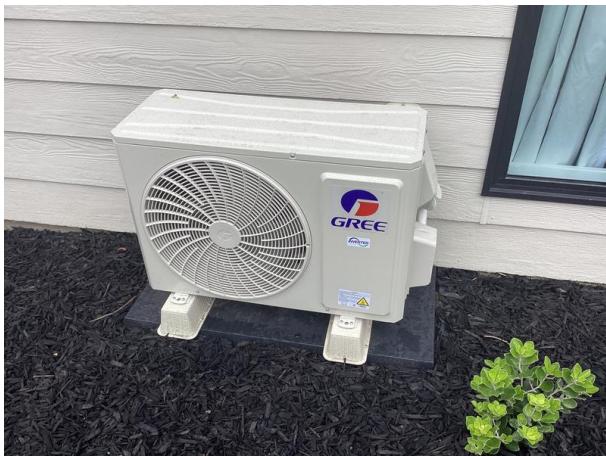
Photo 83
External Gree heatpump system.

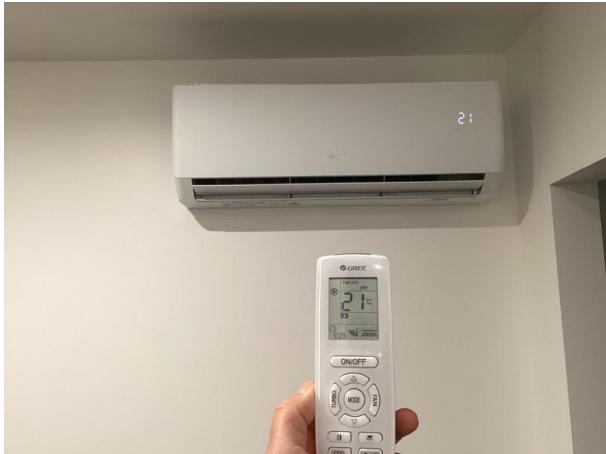
Photo 84

Gree heat pump located in the hallway.

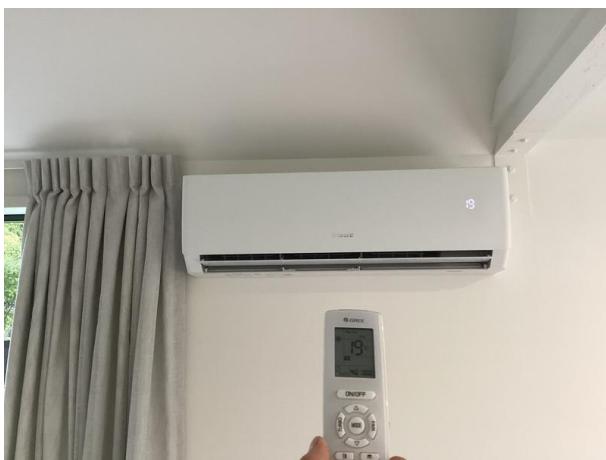
Photo 85

Gree heat pump located in the living room.

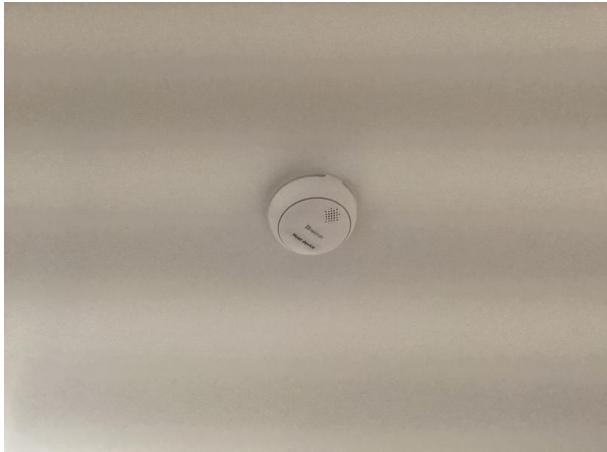
Photo 86

Smoke alarms have been installed around the dwelling.

Regular checks to ensure smoke detectors are functional.

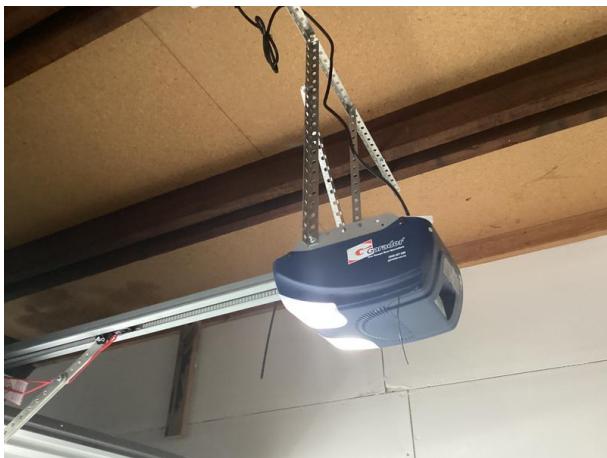
Photo 87

Automatic garage door openers.
