PROJECT SUMMARY

Site Address 19 Belfield Street, Dallington, Christchurch 8061

Project No. 25288

REPAIR DESIGN FOR EXISTING RESIDENTIAL DWELLING

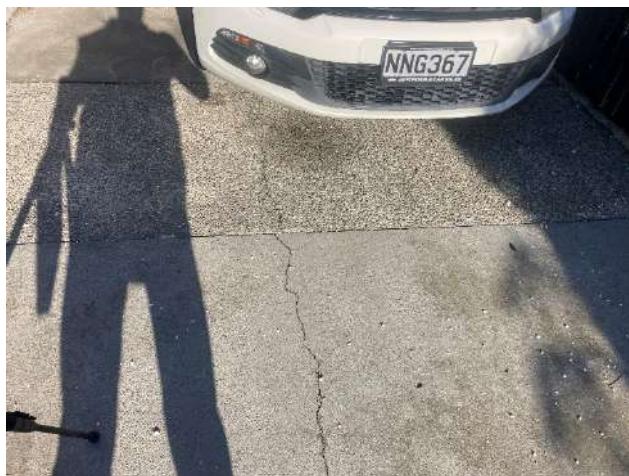
- The window outside of the lounge was measured to be plumb.
- The driveway had cracks along its length. There was no significant damage or cracking at the interface between the house cladding and the driveway.

- Cracking to the plaster was noted at the interface with the concrete patio. A timber board was also showing signs of rot.
- No damage to the concrete patio was noted on this elevation.

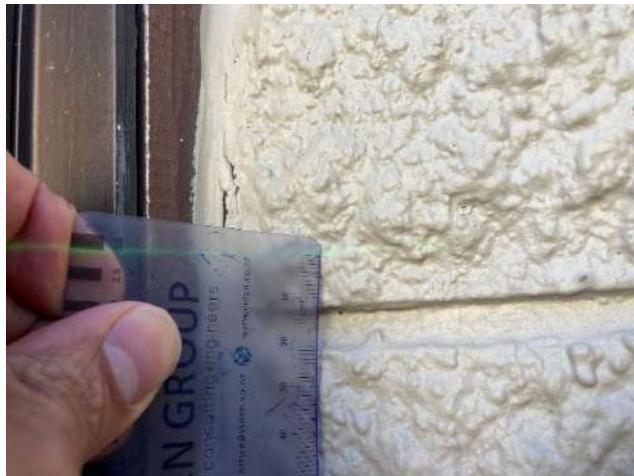
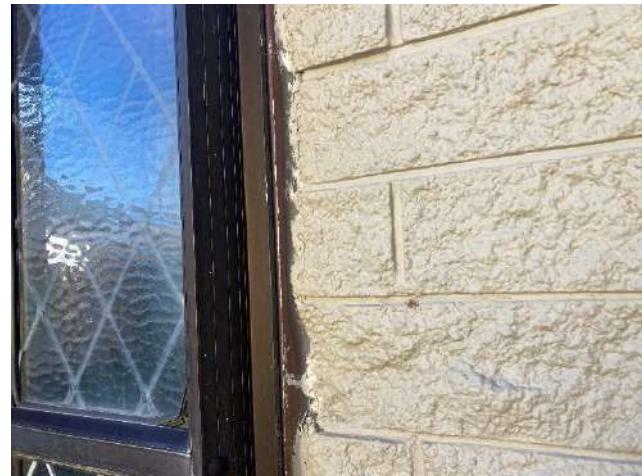
- No damage or separation was noted to the concrete steps outside of the sunroom.
- The brick veneer outside of the dining area was sloping 12mm down towards the north. A silicone type product had been applied between the brick and the

window frame that appeared recent.

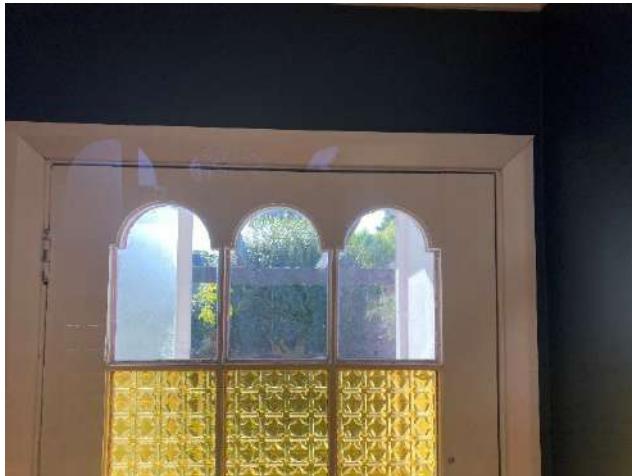
- There were reasonably consistent gaps around the entry door. However, it appeared that the striker plate had been adjusted or replaced.

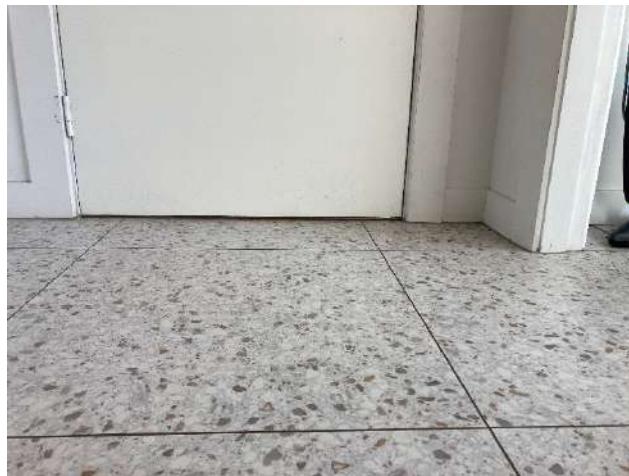
- The windows operated freely, with no issues noted.
- New benches and joinery had been installed following the earthquakes. The tiles were measured to be level. The homeowner stated that they had to leave uneven finishes around the ceiling as it was uneven at the time of the renovations.
- The door had a tapering gap at the bottom. The door generally opened and closed.

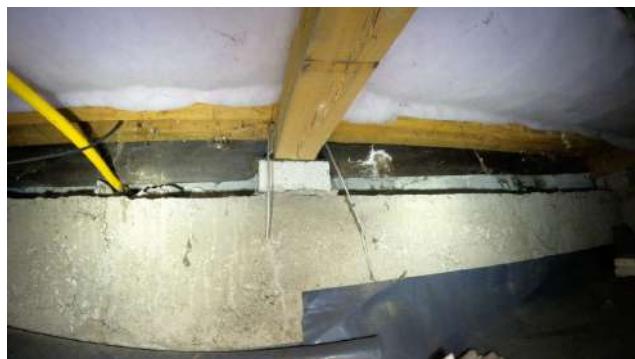
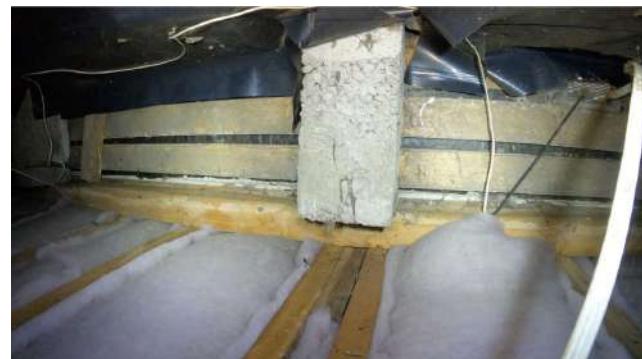
- The condition of the subfloor members appears reasonable for a building of this age. The perimeter foundation generally appears to have been constructed from concrete with rounded stone aggregates, which can be typical for a dwelling of this era. In general, the inside face of the concrete was relatively well compacted, although there were some areas of 'boney' concrete where the aggregates were more prominent. The timber subfloor is generally supported by timber bearers sitting directly on the perimeter foundation and concrete piles.

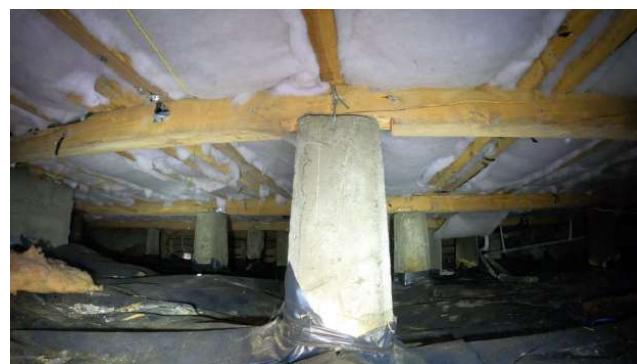
- Notching of a bearer under the lounge area was noted. No packing of the piles was recorded.

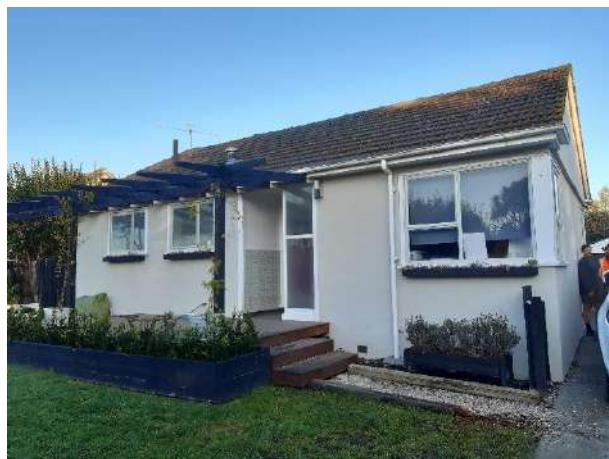
Front of dwelling

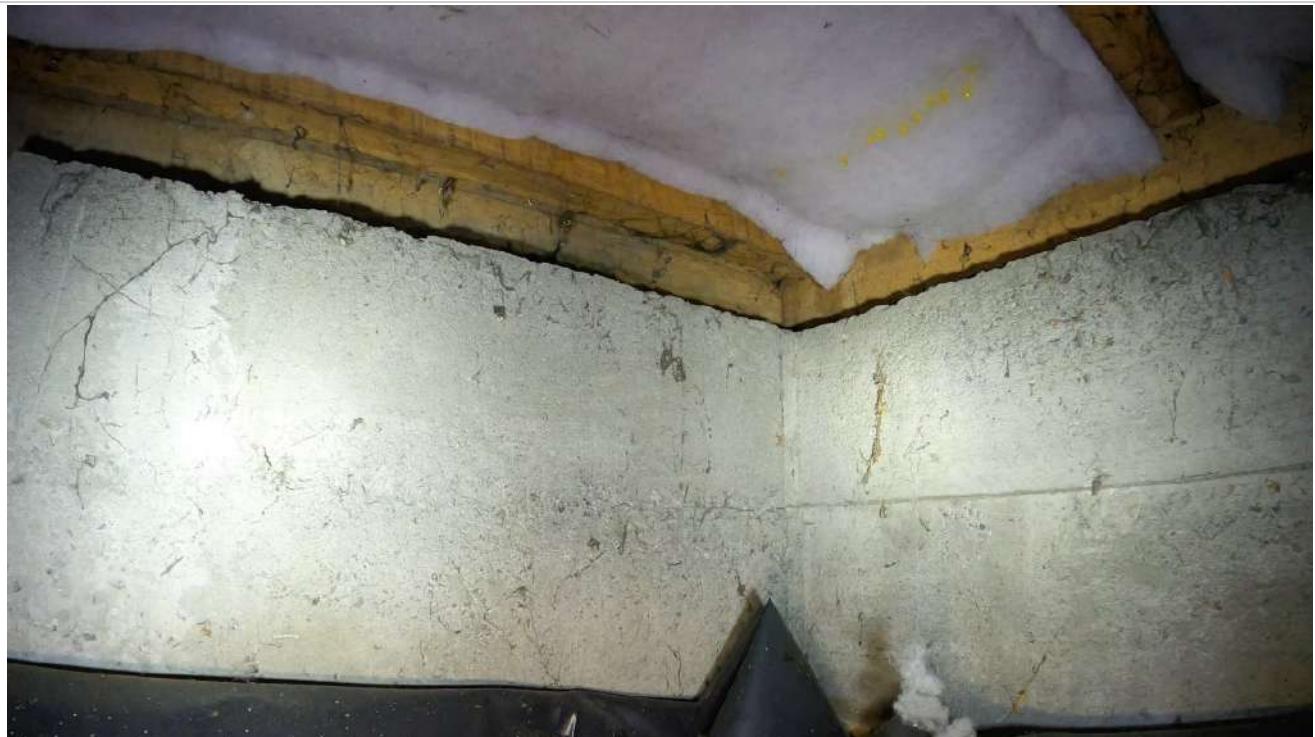
3: The home has cast in place concrete piles around the outside. Here the home has been extended.

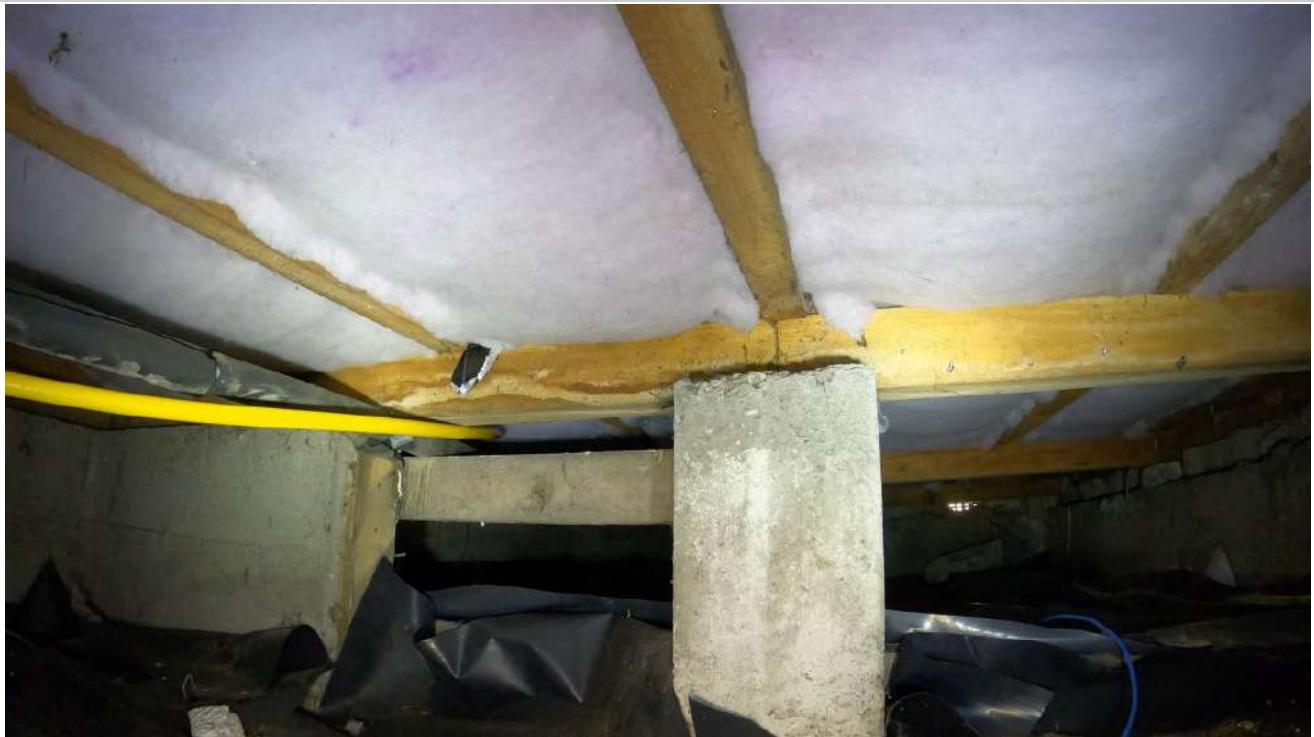
4: View of foundation join.

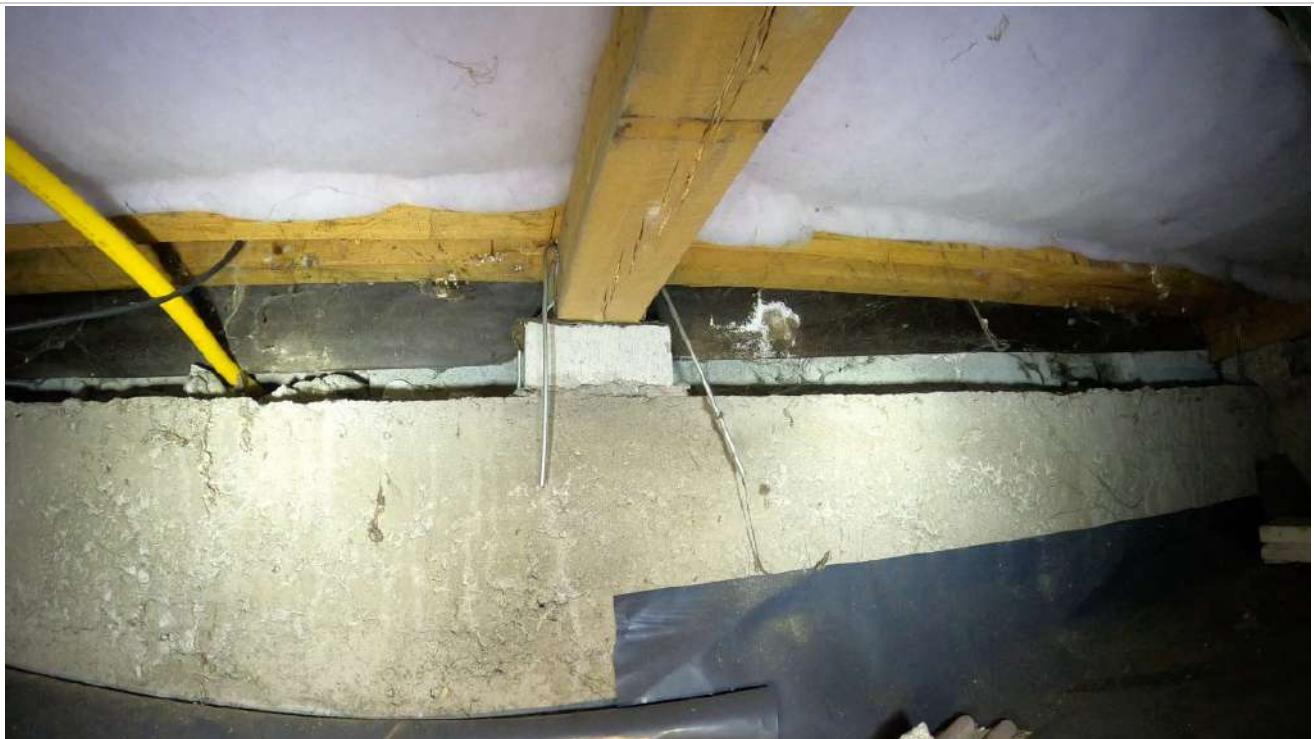
6: Precast concrete pile with connection.

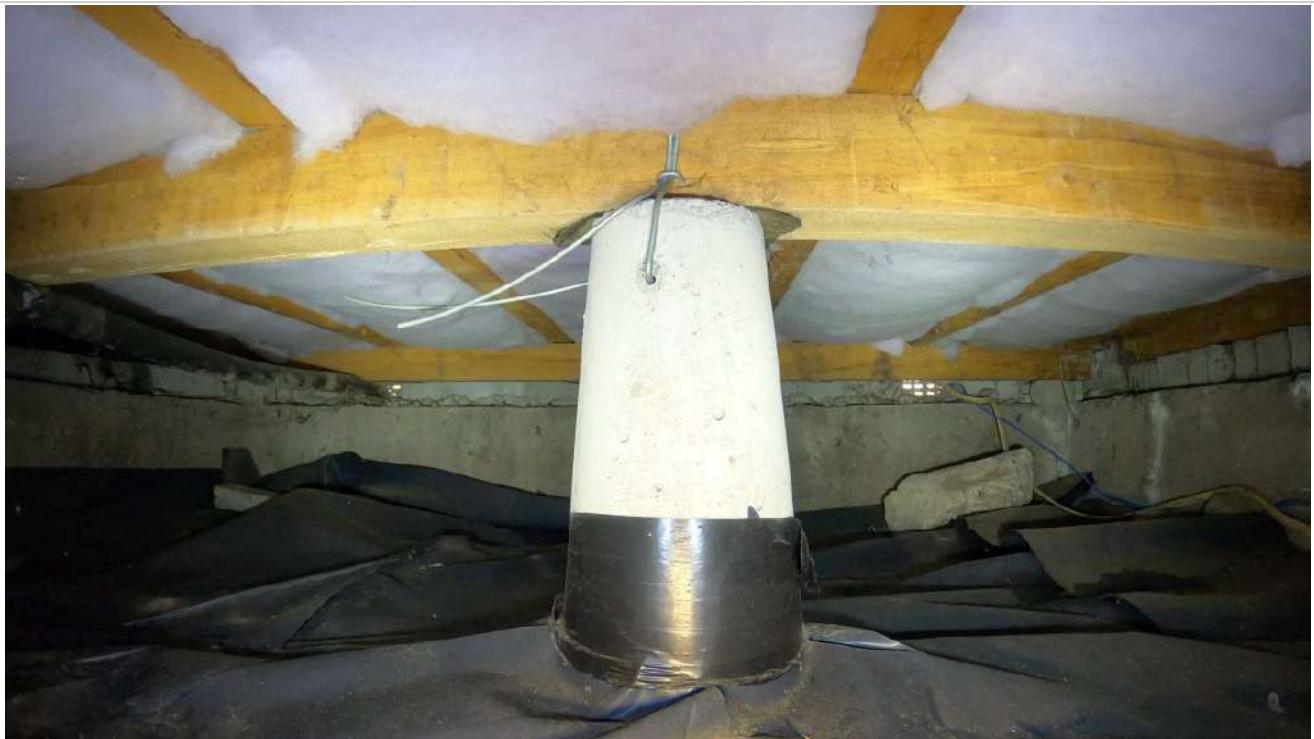
7: View of bearer meeting ring foundation.

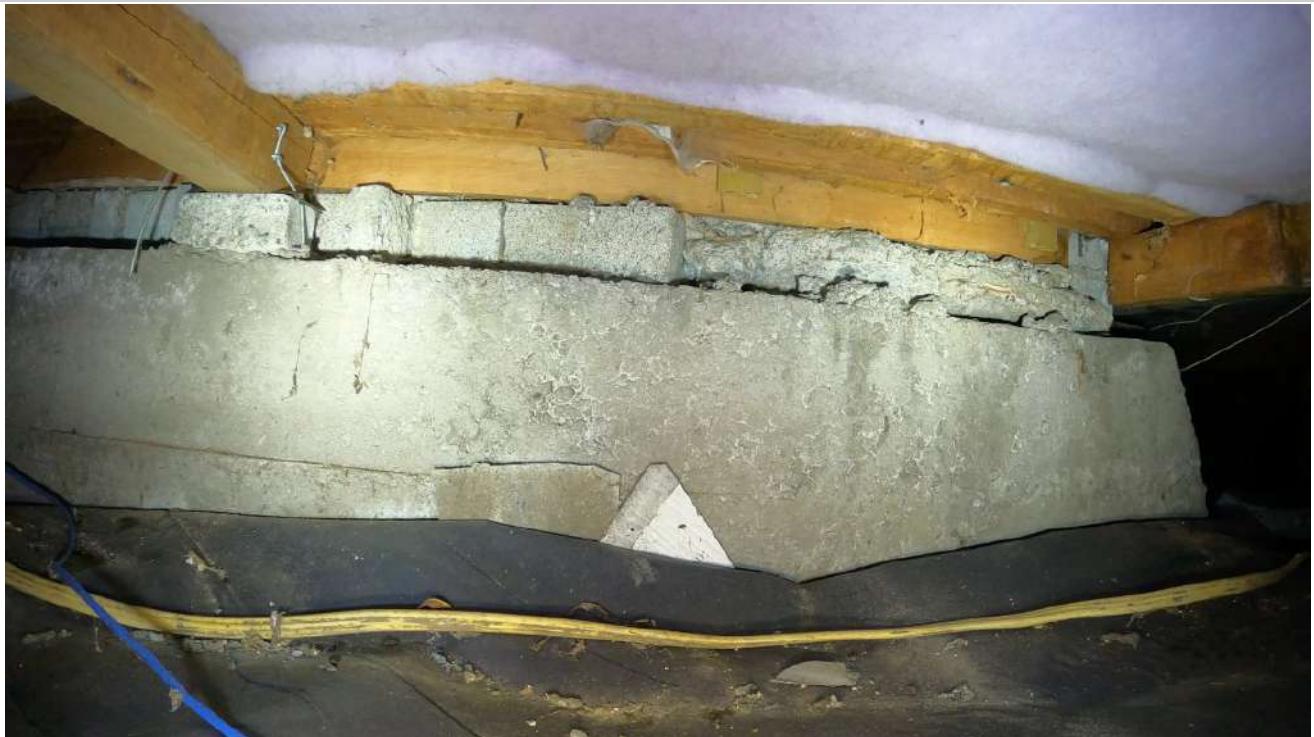
8: View of ring foundation. There are some non-compliant issues with the wiring seen in this home. They could also be a significant hazard to anybody operating under the floor. This relates specifically to unclipped wires. An electrical inspector could be consulted regarding this. The communication cable has also not been laid in a compliant manner and would easily be damaged by people accessing the subfloor.

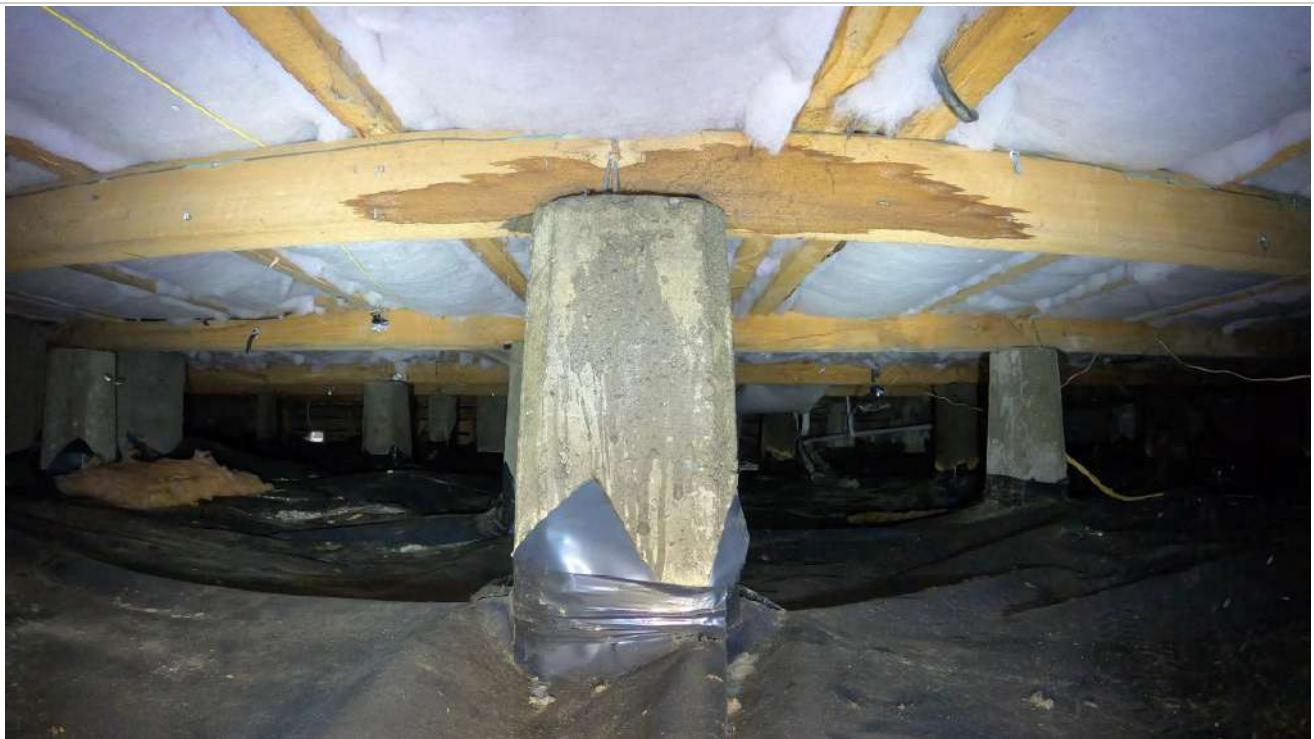
29: Precast concrete pile with connection. The ground must be fairly damp in this area and the water is making its way up the pile into the bearer.

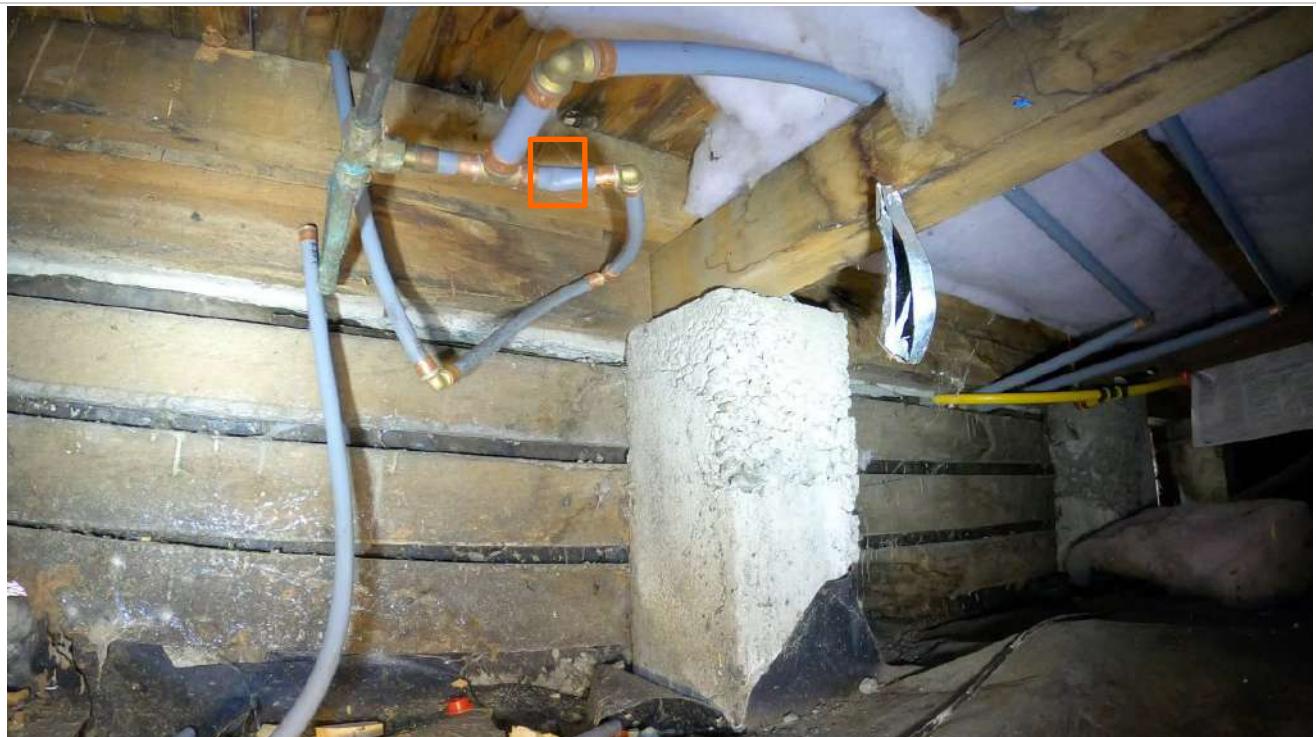
41: These pipes are under stress and bending significantly.

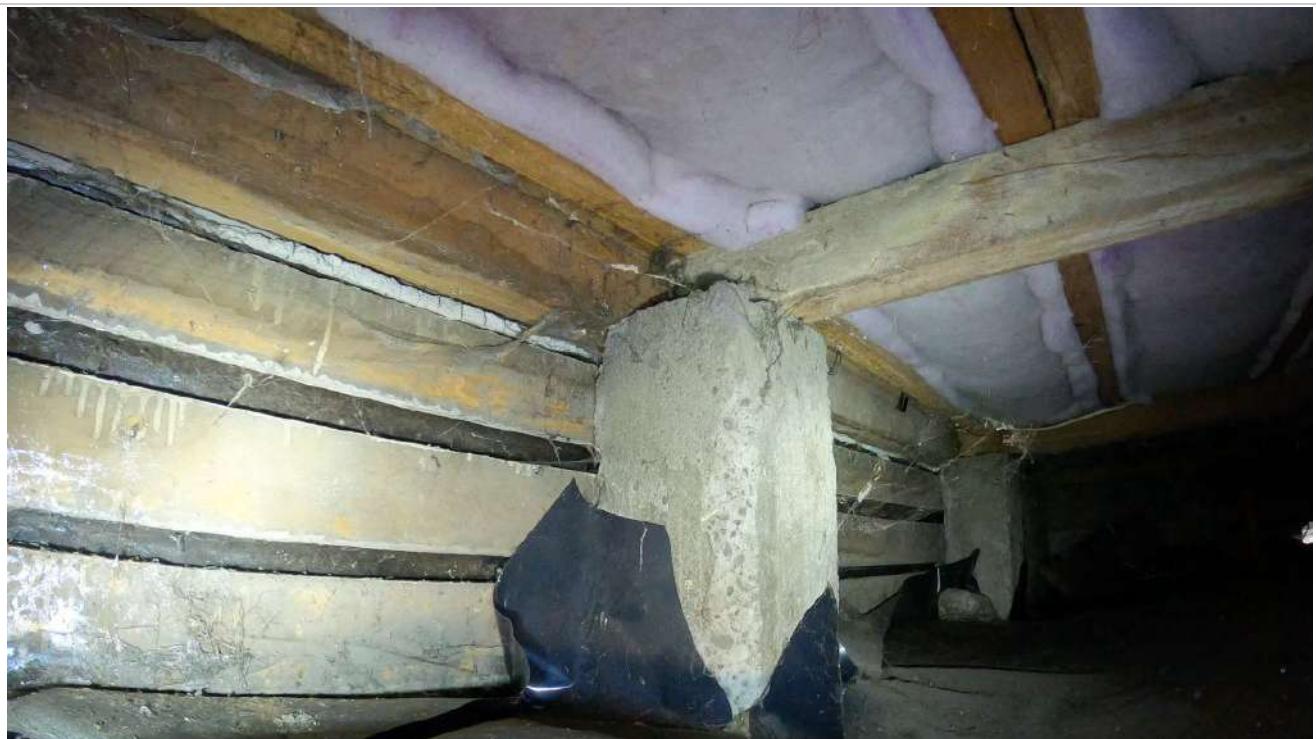
52: Cast in place concrete pile.

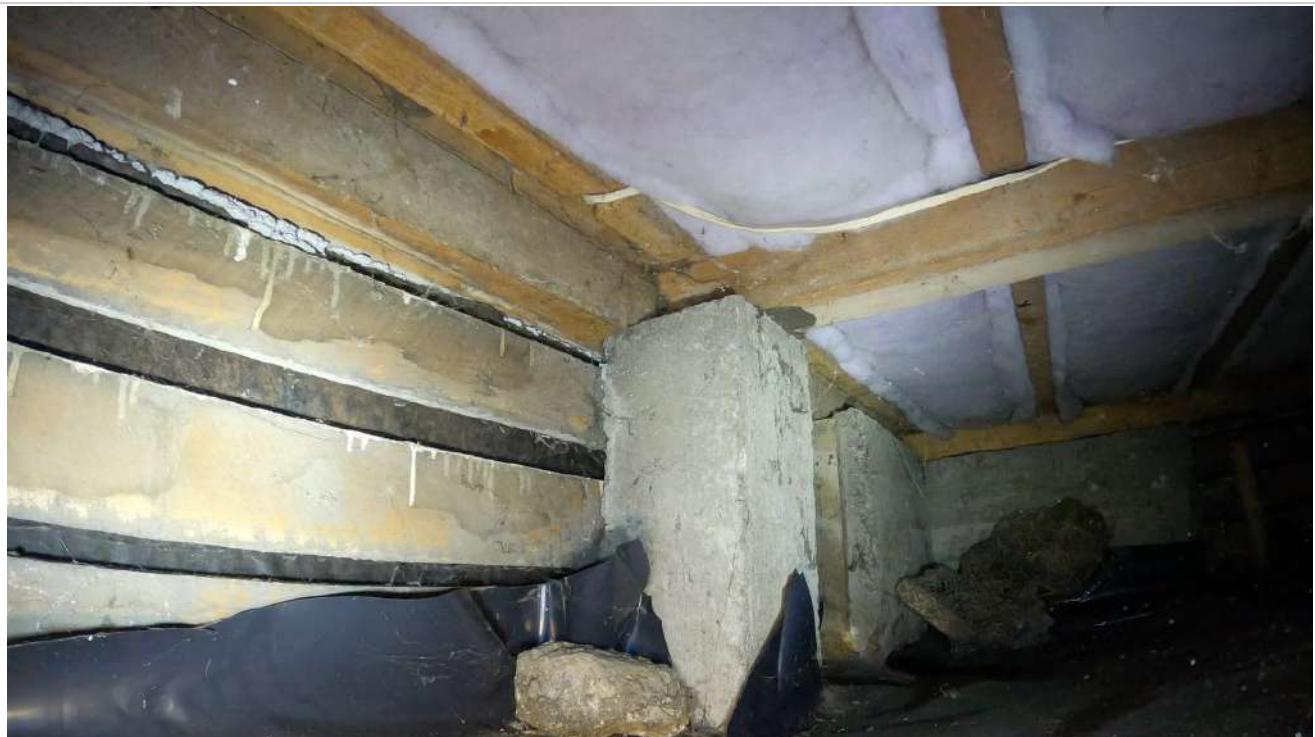
53: Cast in place concrete pile.

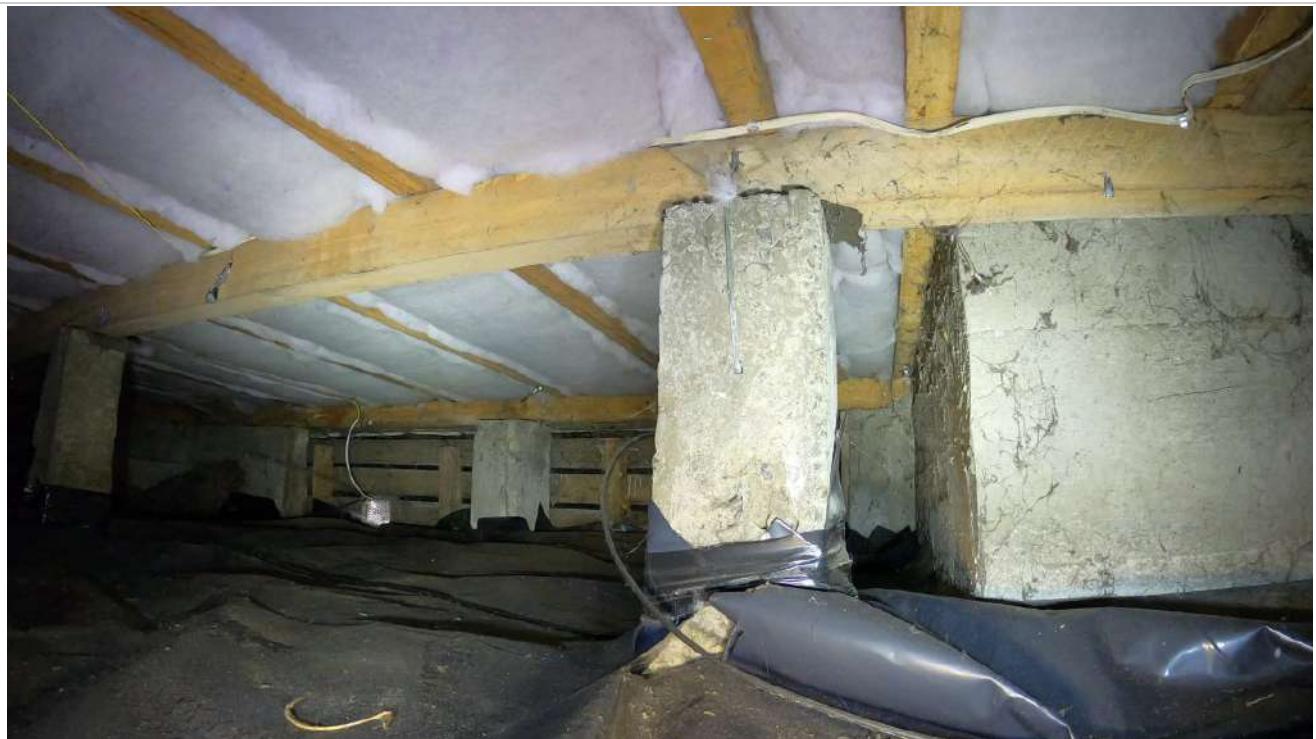
55: Precast concrete pile with connection.

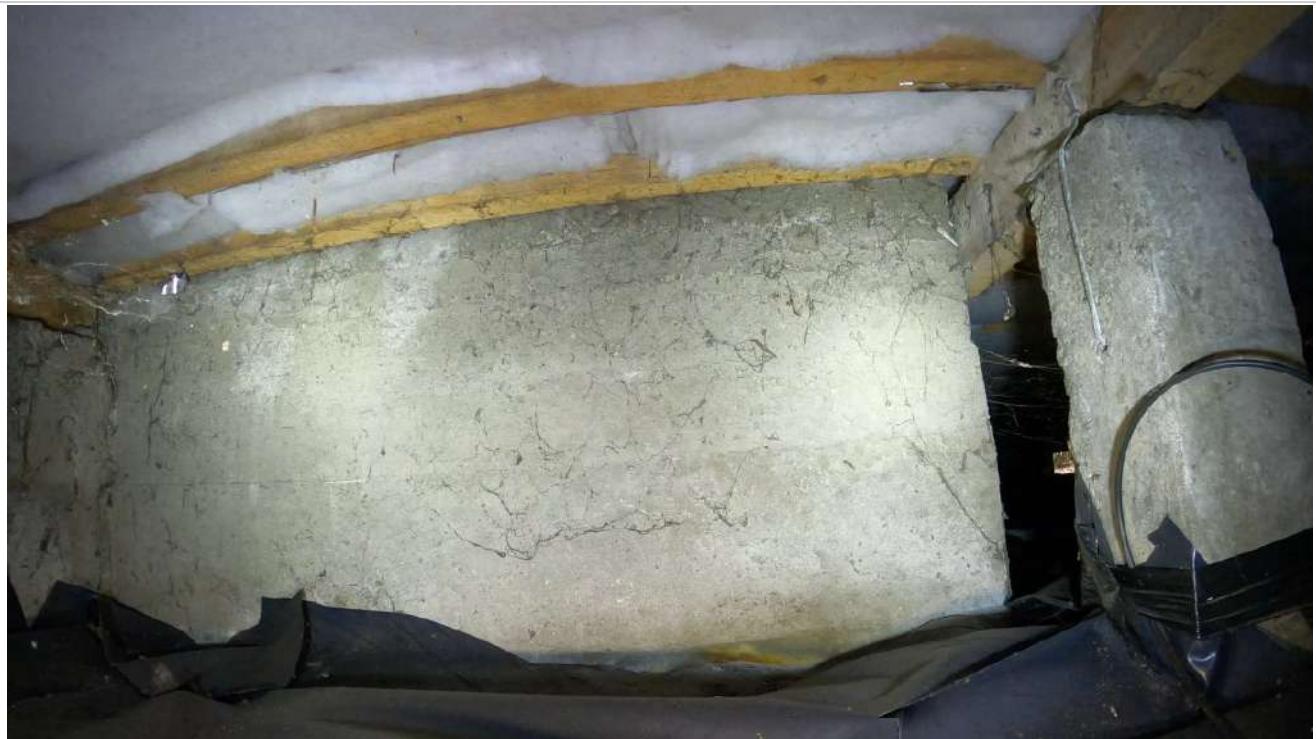
56: View of concrete base.

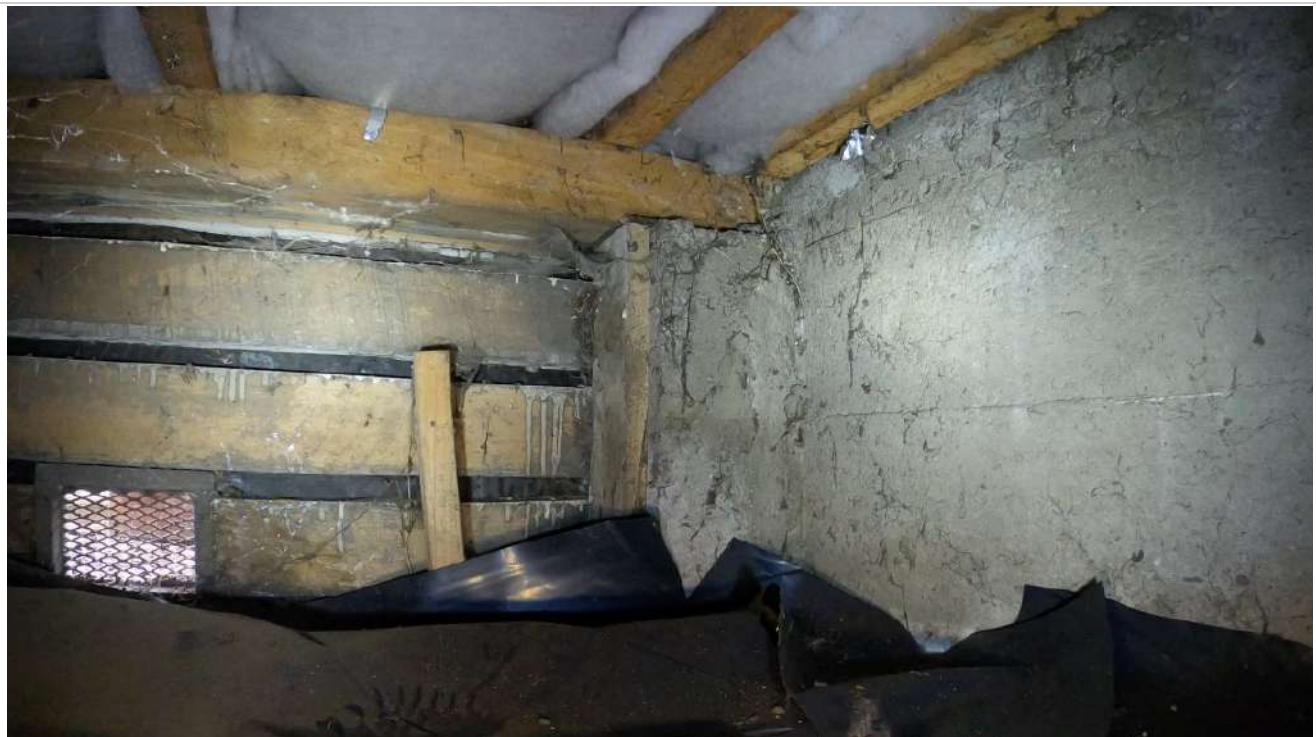
57: View of concrete base.

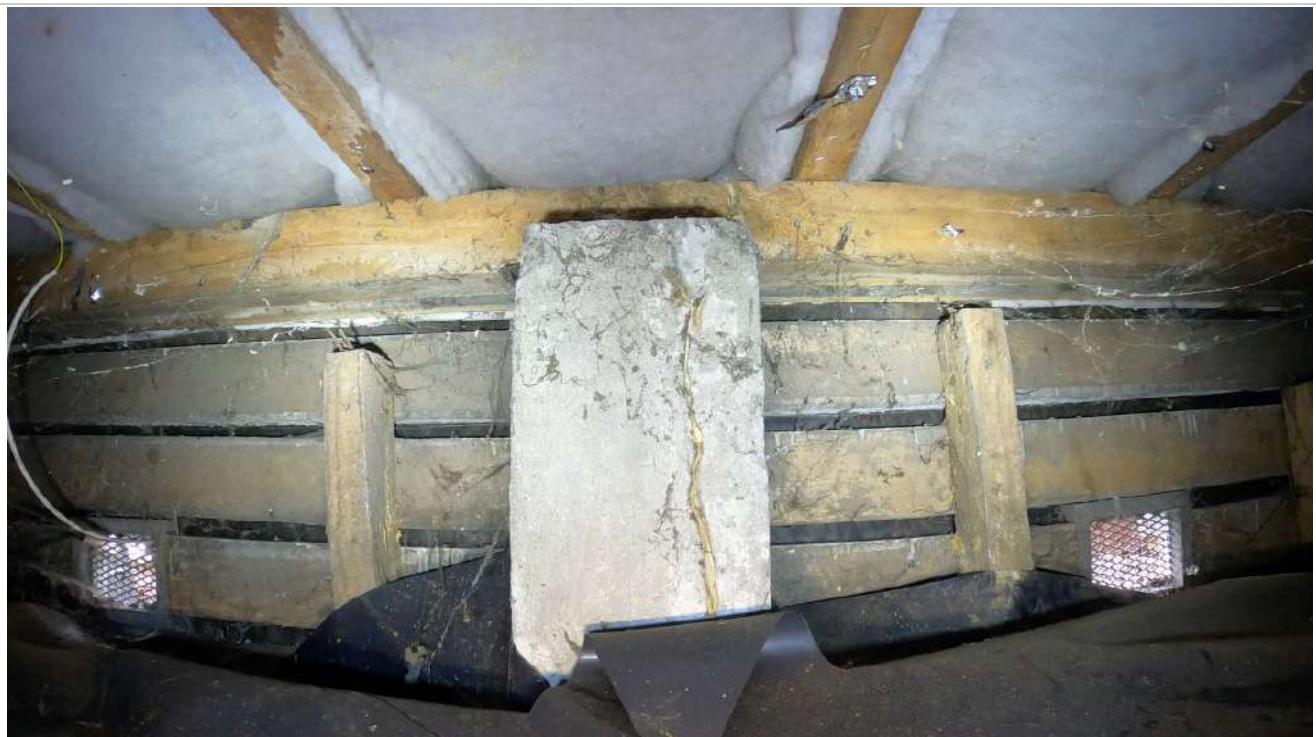
58: Cast in place concrete pile.

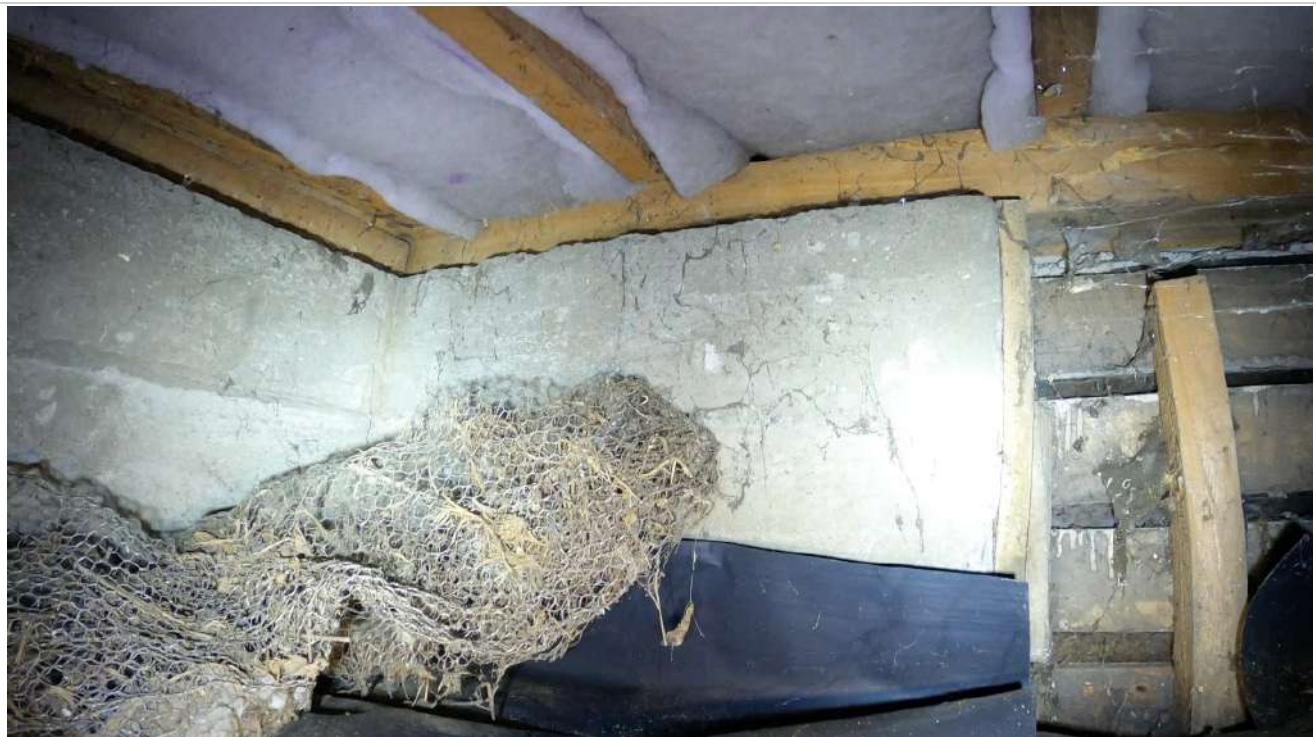
59: View of foundation.

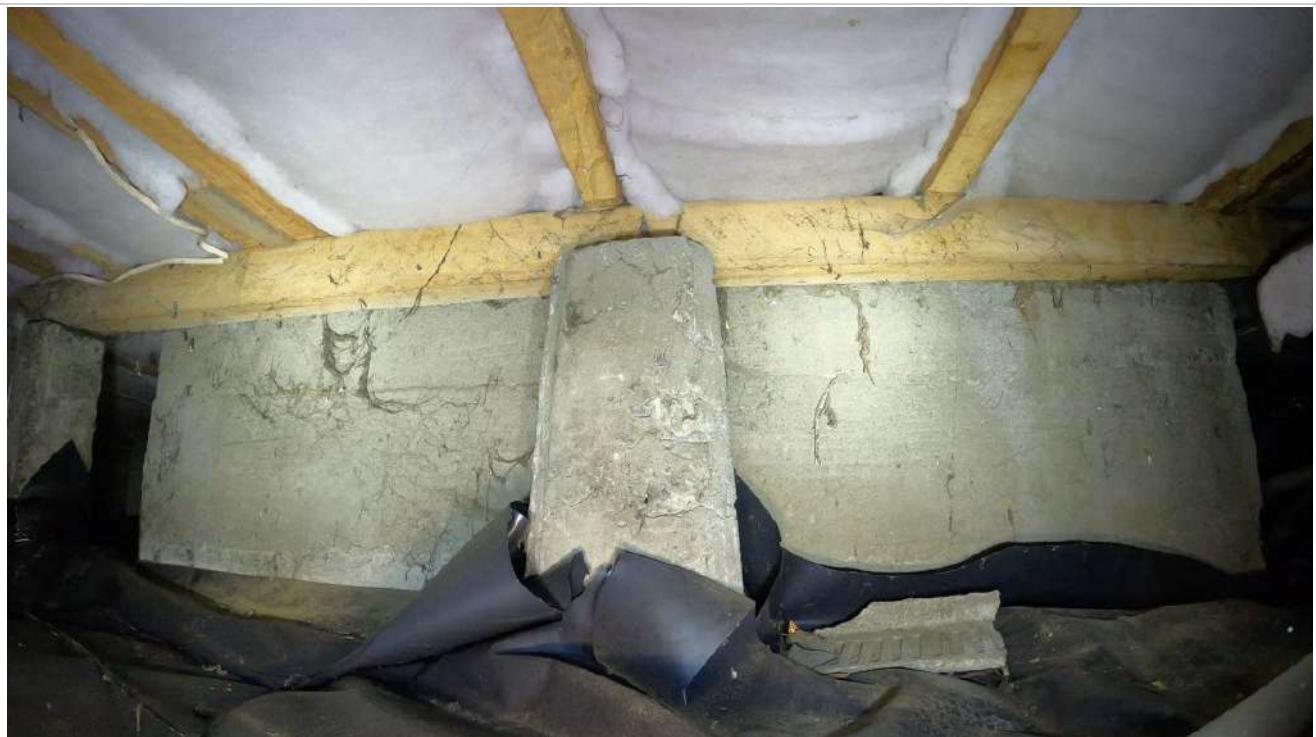
60: Precast concrete pile with connection.

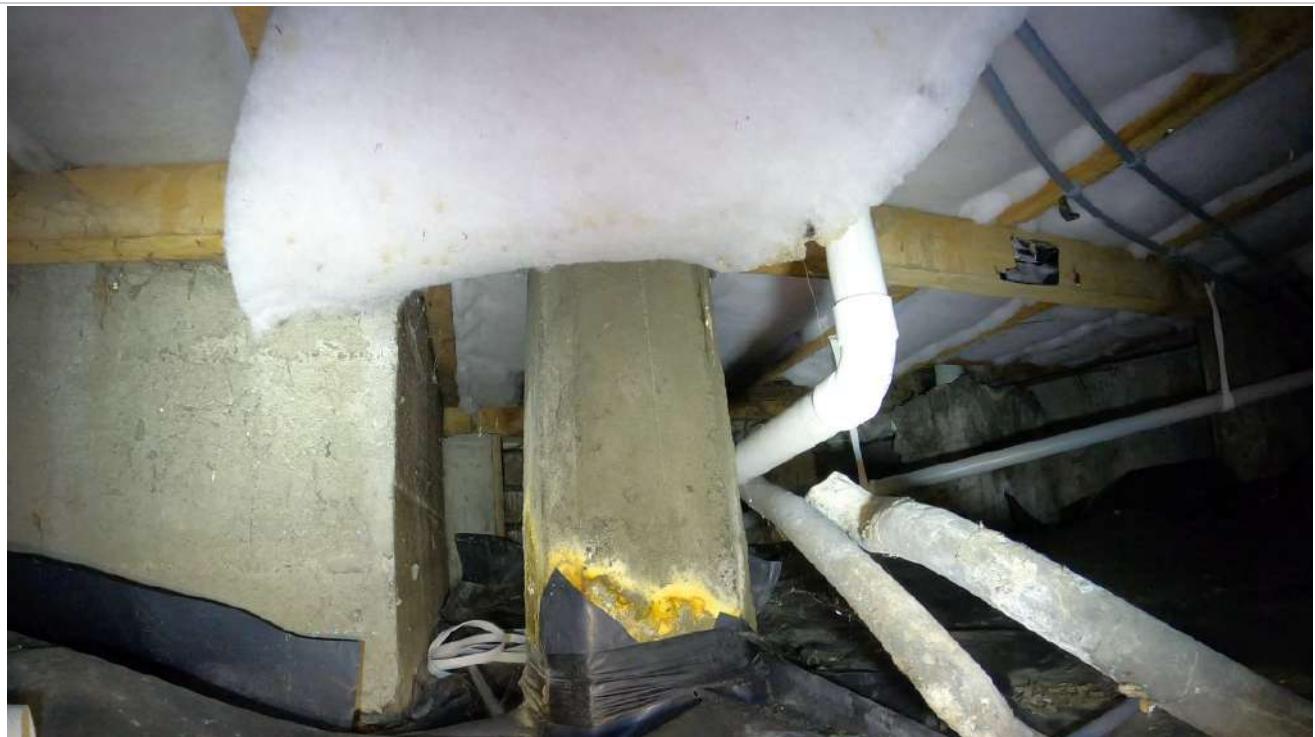
61: Precast concrete pile.

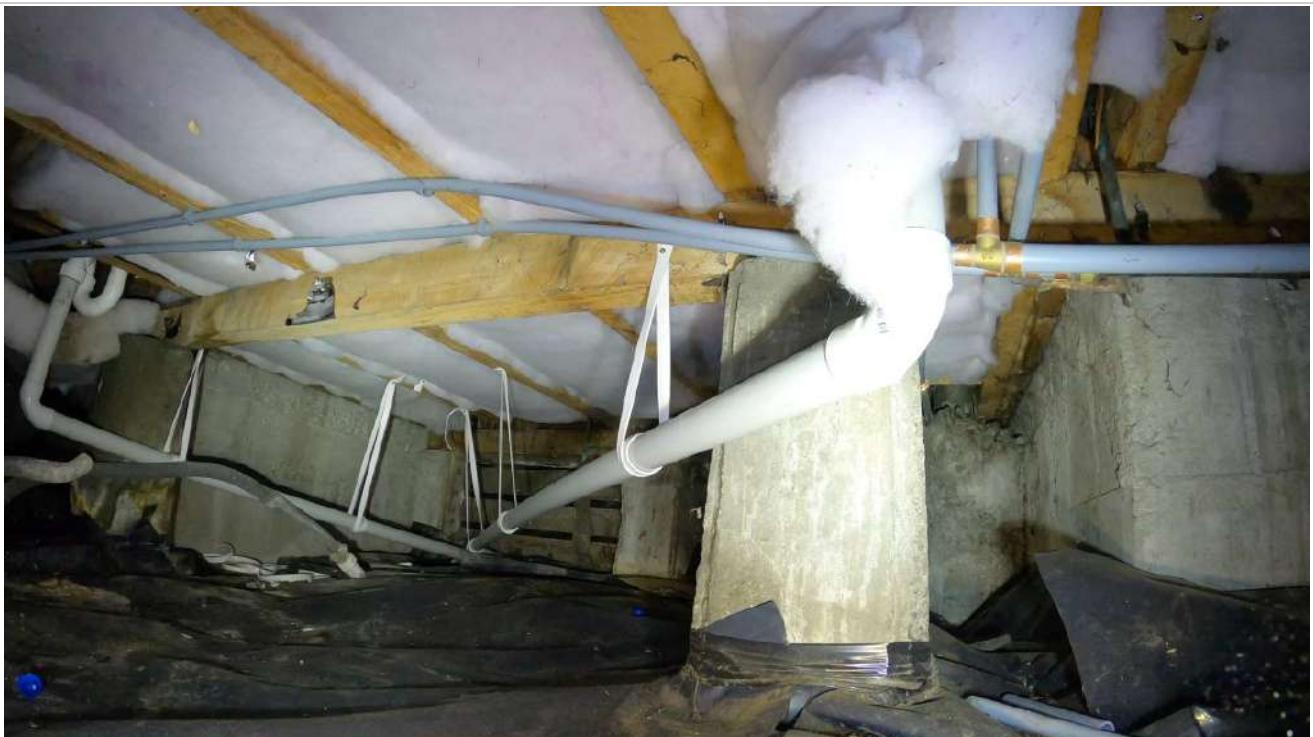
63: Precast concrete pile.

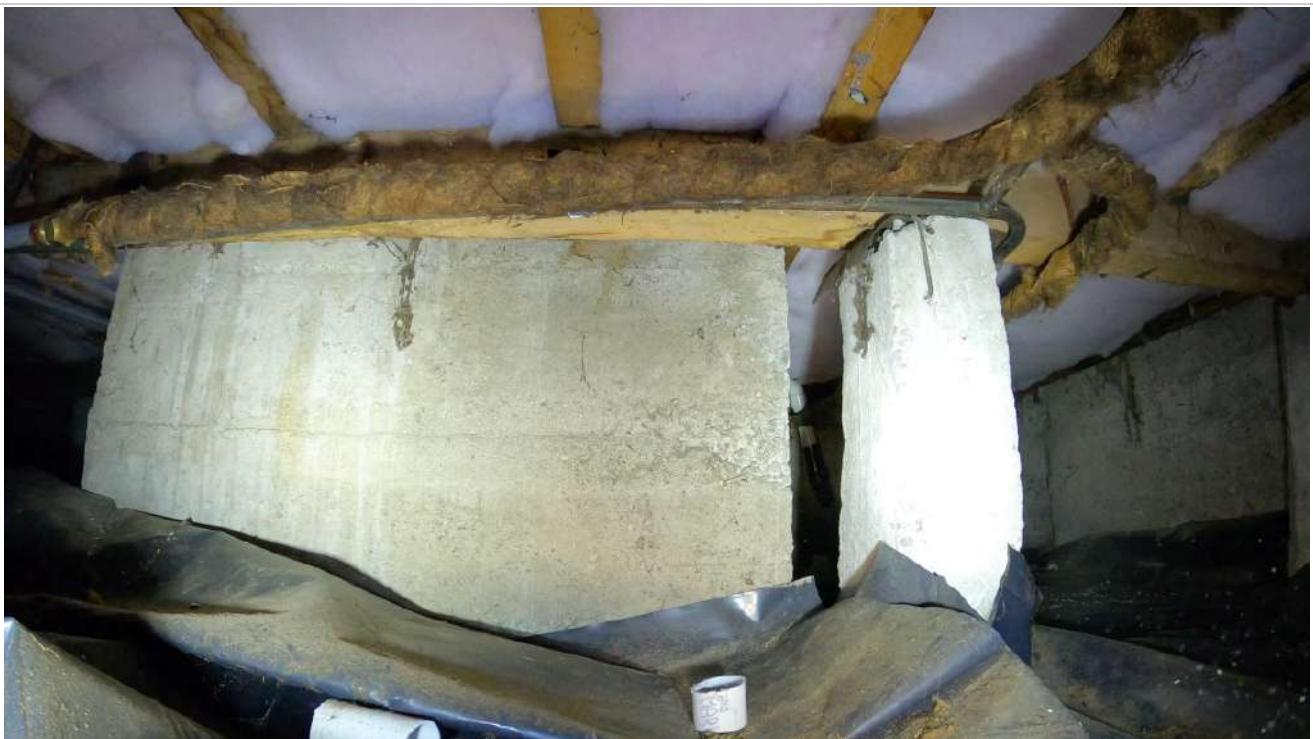
64: Precast concrete pile and concrete base.

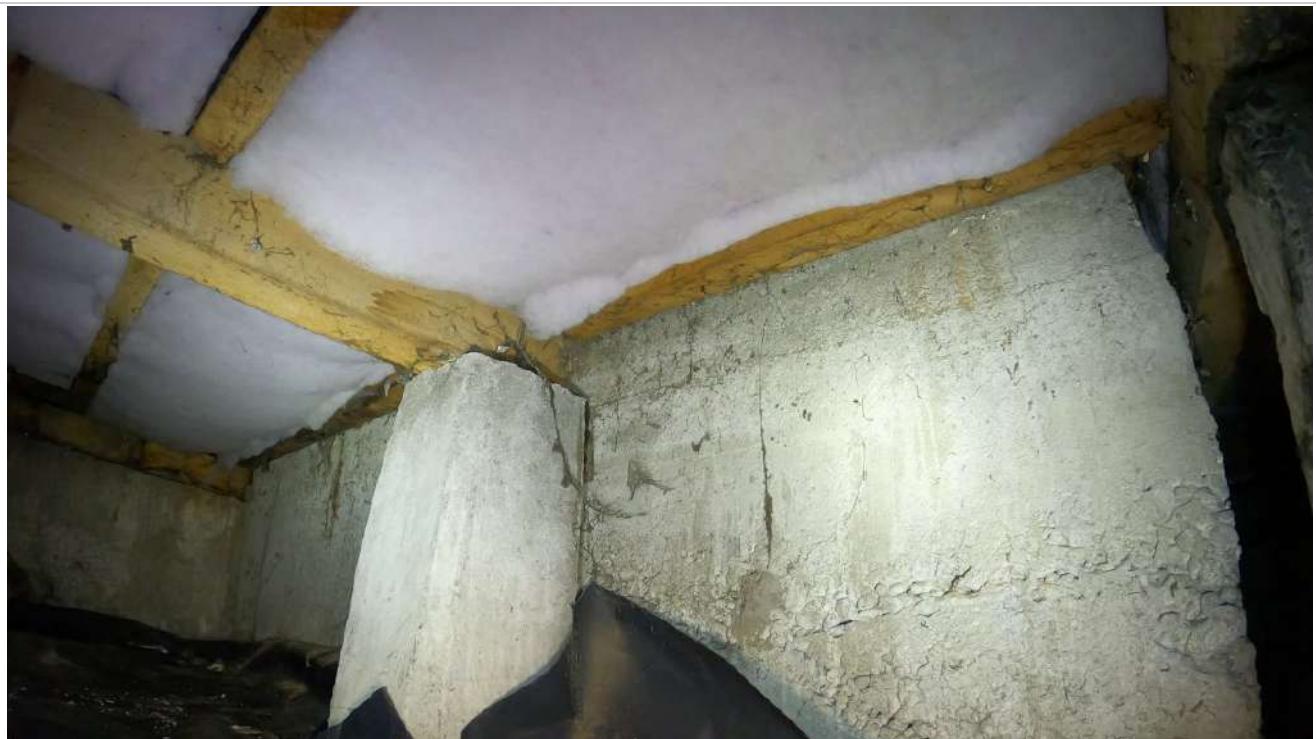
65: Precast concrete pile and concrete base.

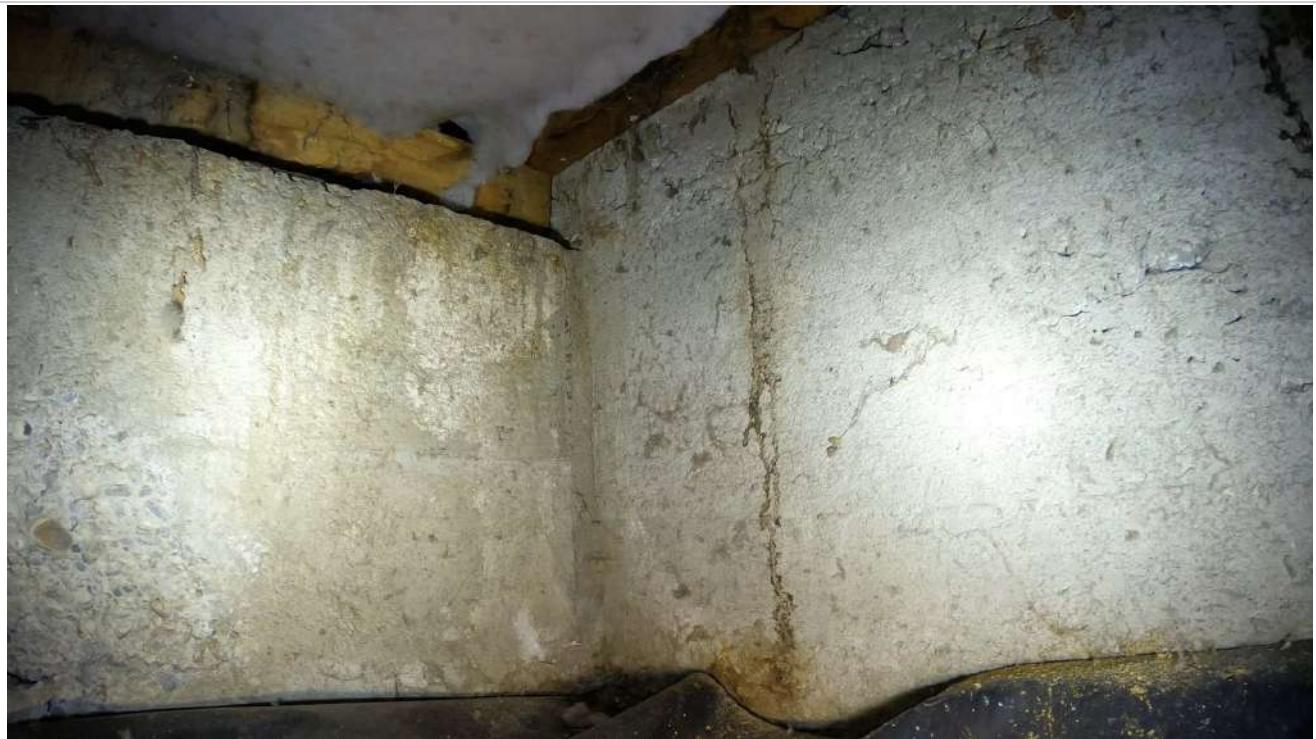
66: View of foundation with concrete base to the right.
