PROJECT SUMMARY

Site Address 19 Belfield Street, Dallington, Christchurch 8061

Project No. 25288

REPAIR DESIGN FOR EXISTING RESIDENTIAL DWELLING

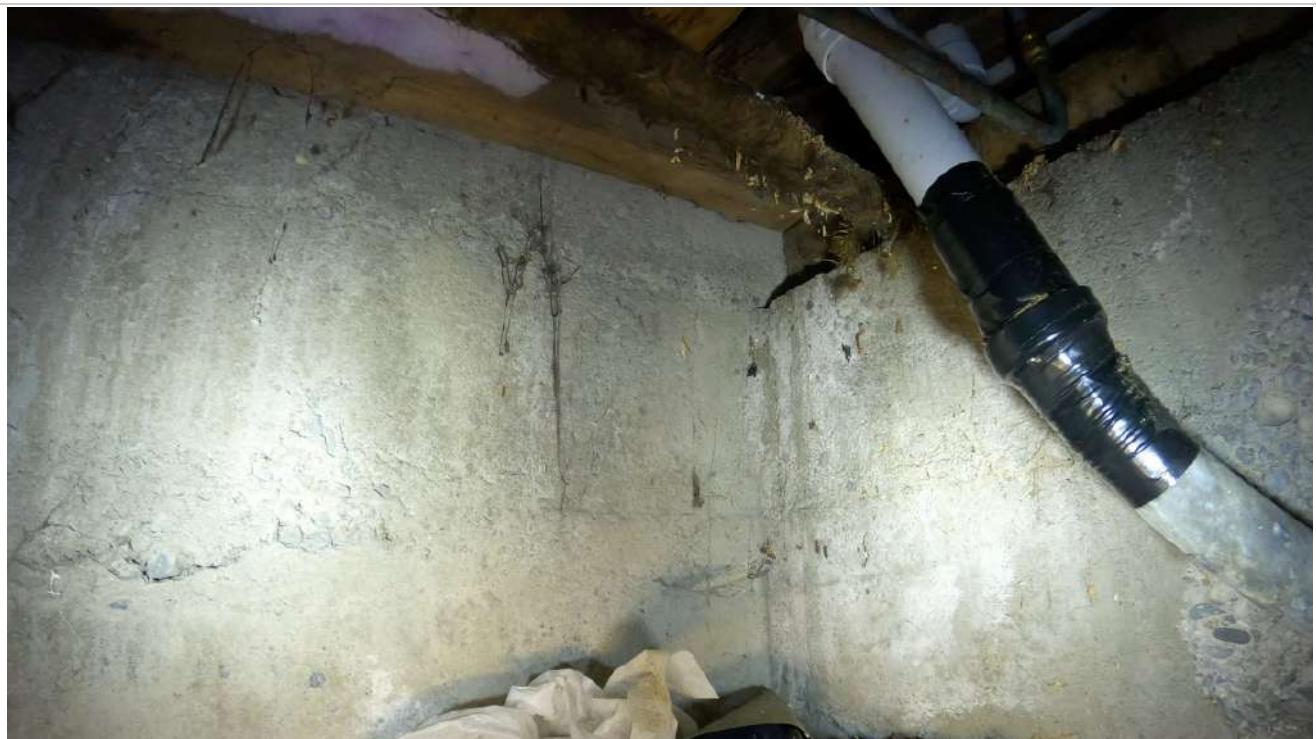
68: View of foundation with concrete base to the left.

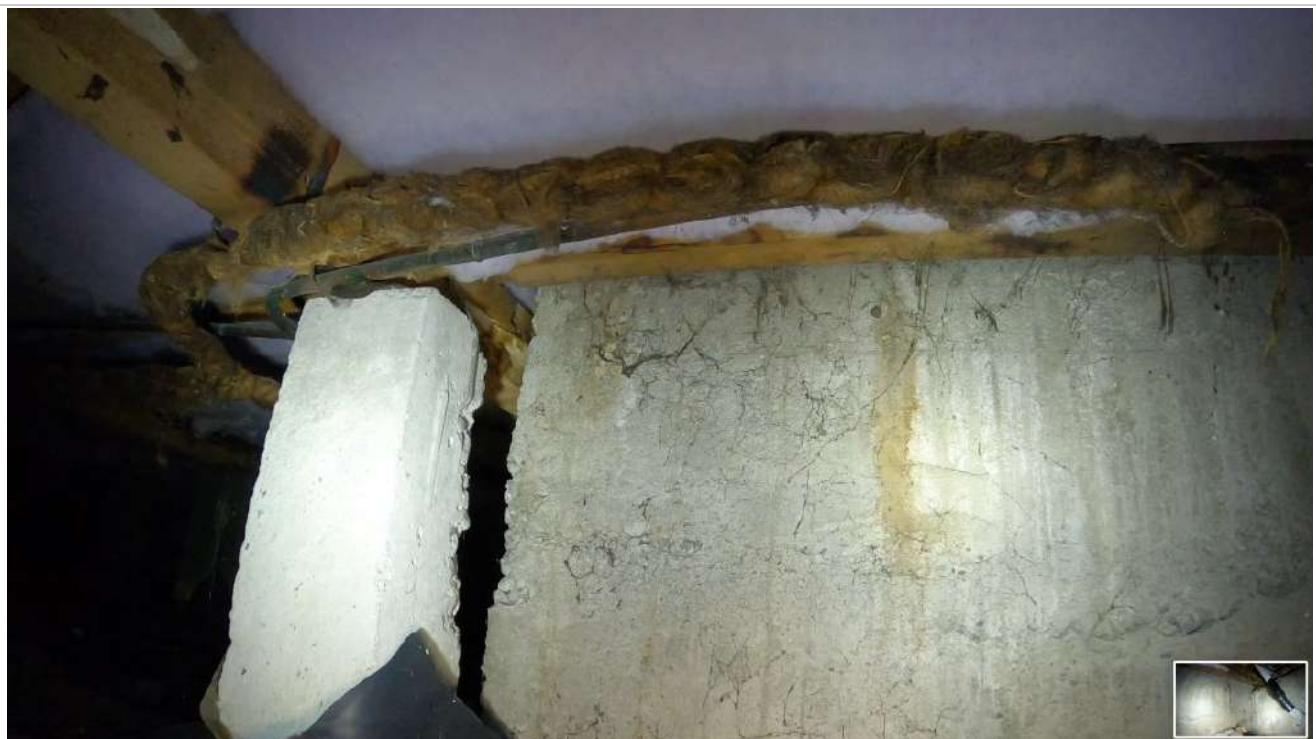
69: View of concrete base.

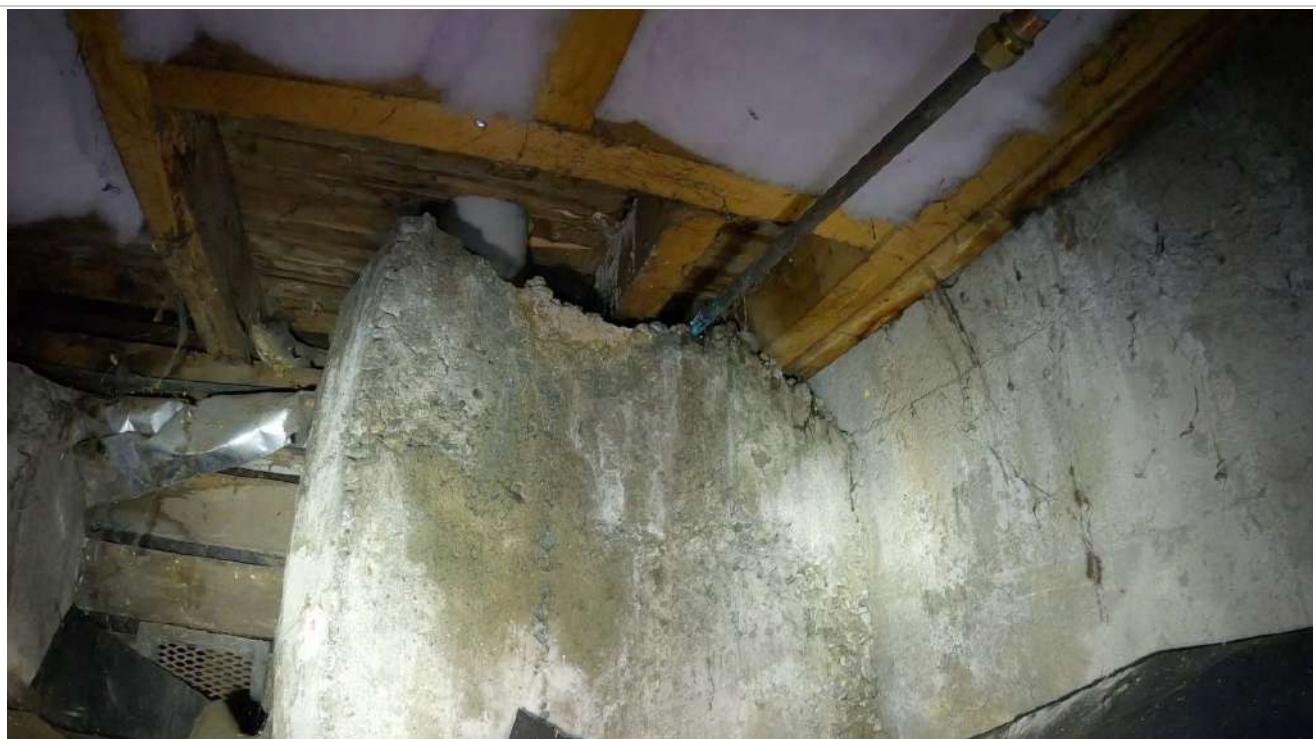
70: View of toilet stump.

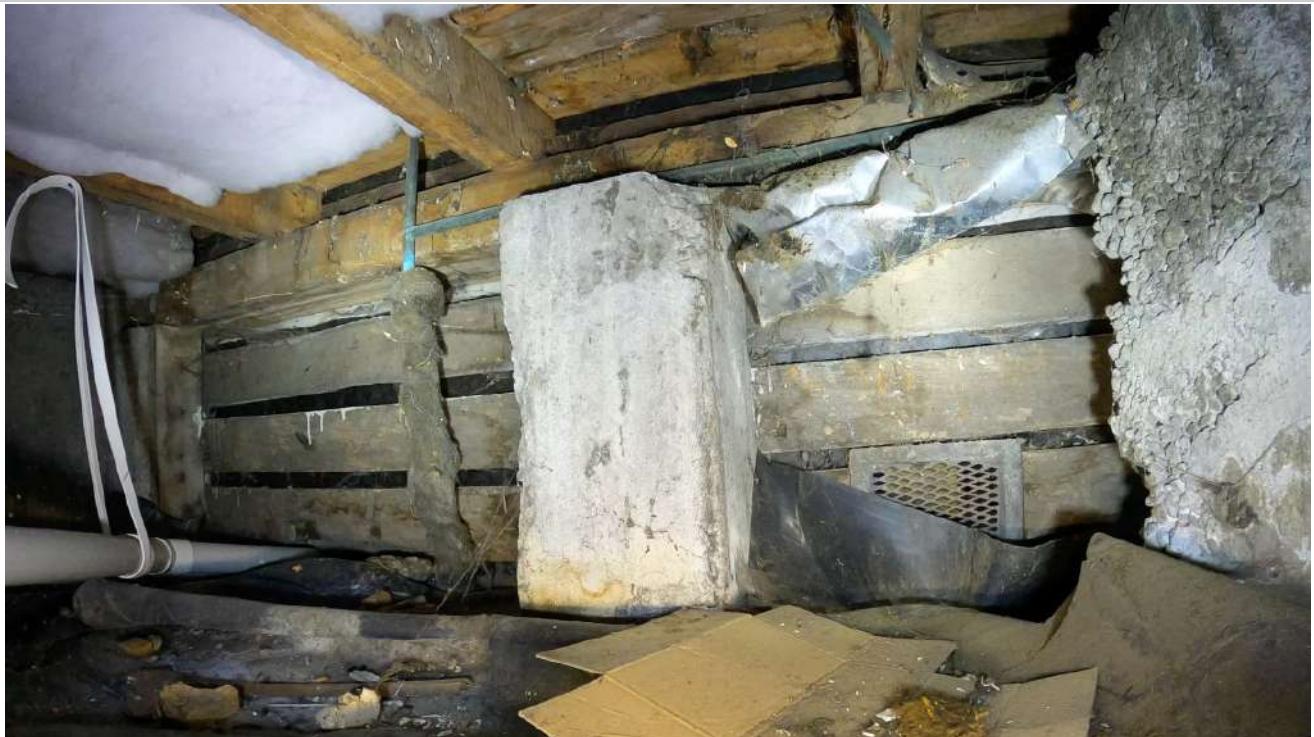
71: Cast in place concrete pile.

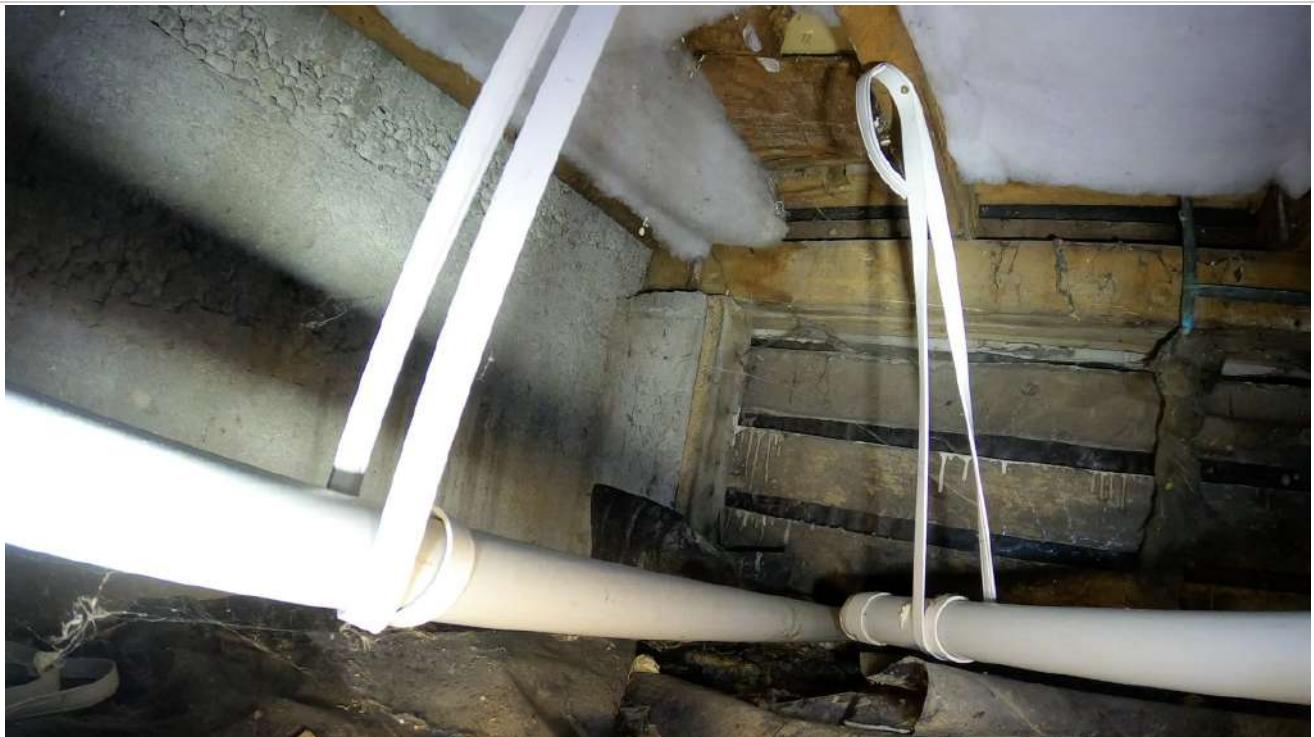
72: View of concrete base.
