Independent Builders Report

Total Home Inspection Services Porirua City Ltd

Wed 17 Dec 2025

**12 Charlotte Way, Raumati South, Paraparaumu, 5032,
New Zealand**

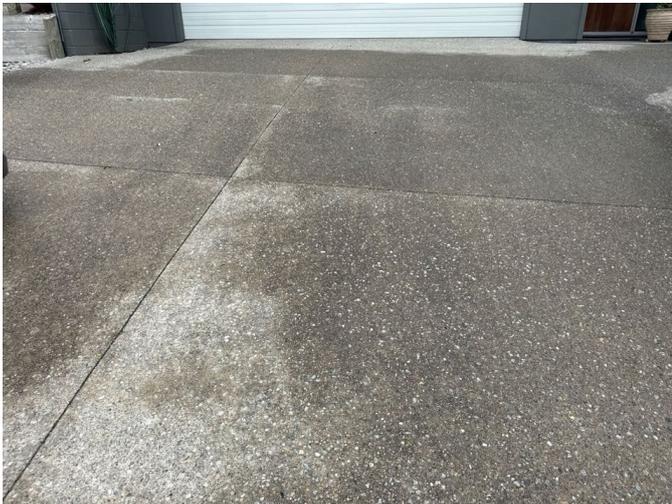
The driveway is well formed and slopes away from the garage. The surface condition of the driveway is good

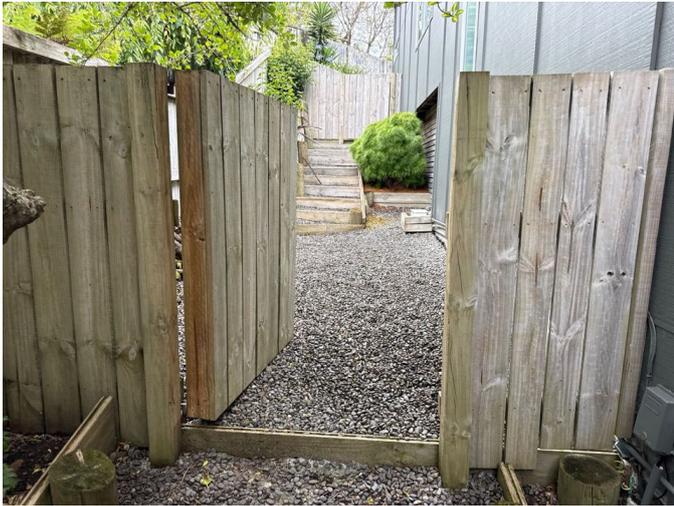
The gates around the perimeter are functional

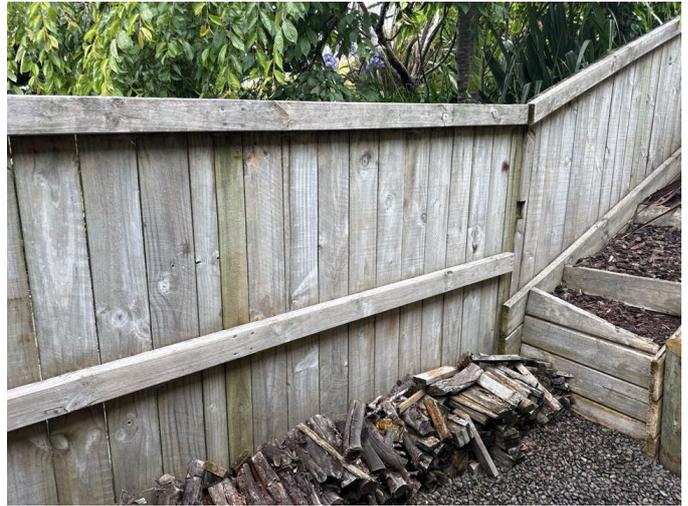
The perimeter fencing is solid and intact.

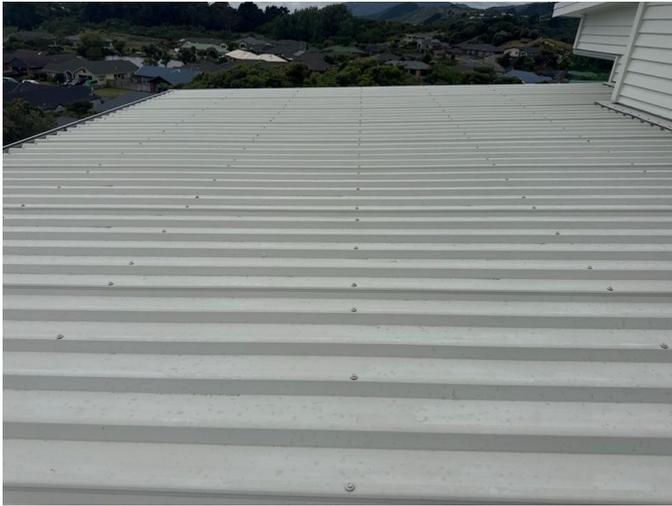
A once or twice yearly wash will help maintain the roofs surface condition and prevent premature deterioration

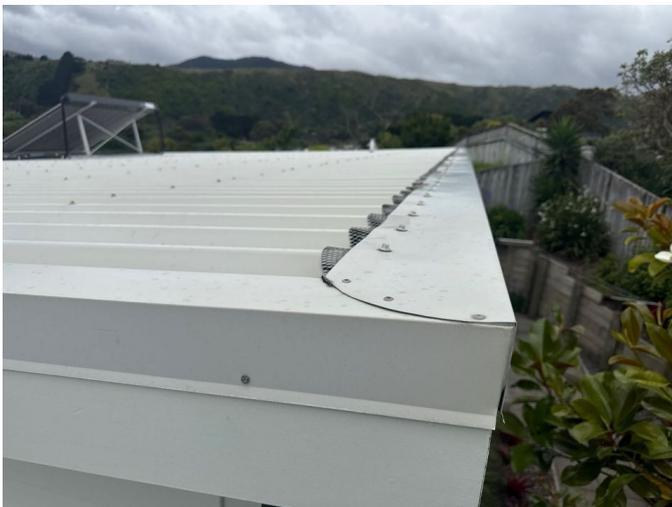
The roof flashings appear to be secure, intact and are effective. No sign of failure could be found beneath where accessible to view.

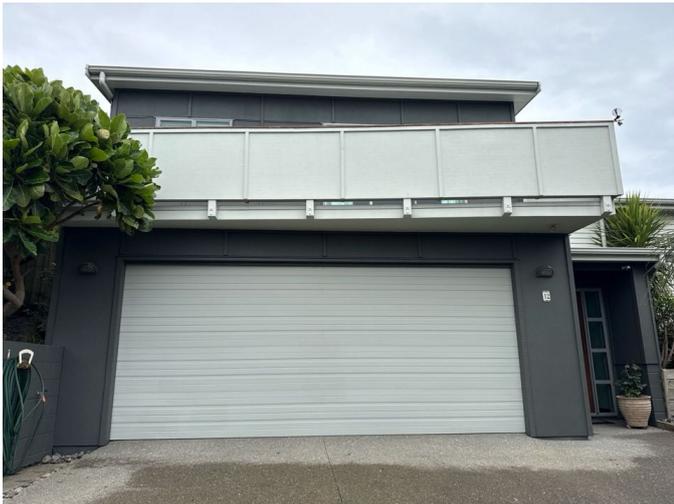
The front faces to the Northeast

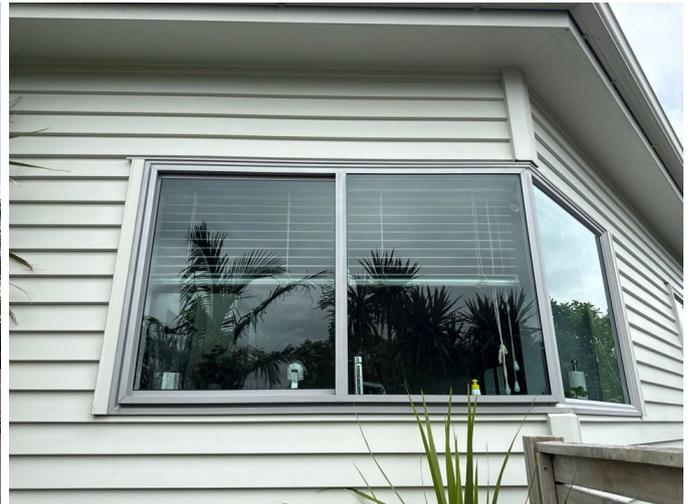
The typical double and single glazed aluminium window detail consists of a head flashing, timber facings and scribes.

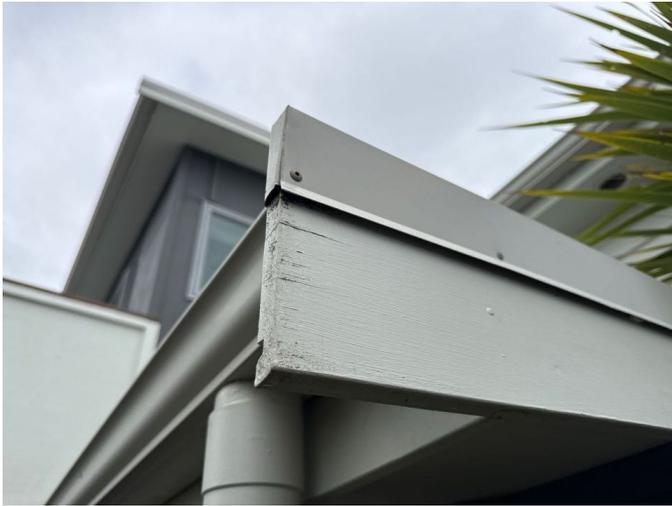
The base of the timber barge boards is often the first area to deteriorate and must be kept well sealed with paint. A paint upgrade will be required within the next 1-2 years.

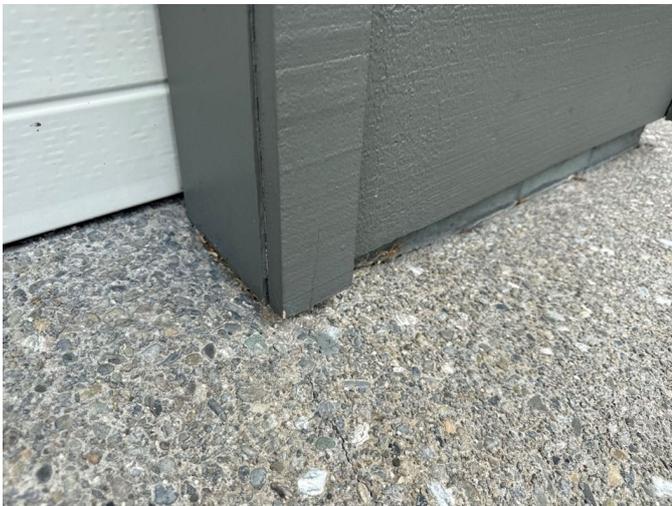
Example. Timber in close contact with the ground is at risk of premature deterioration and must be kept thoroughly sealed. Well maintained current condition noted.

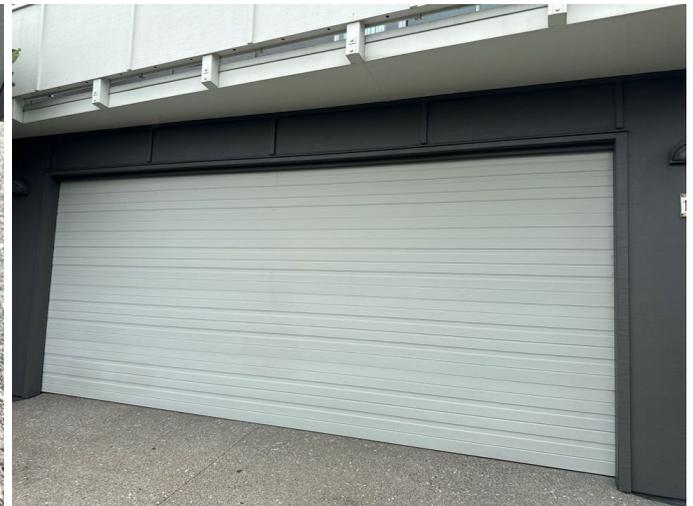
The surface condition of the garage door is good

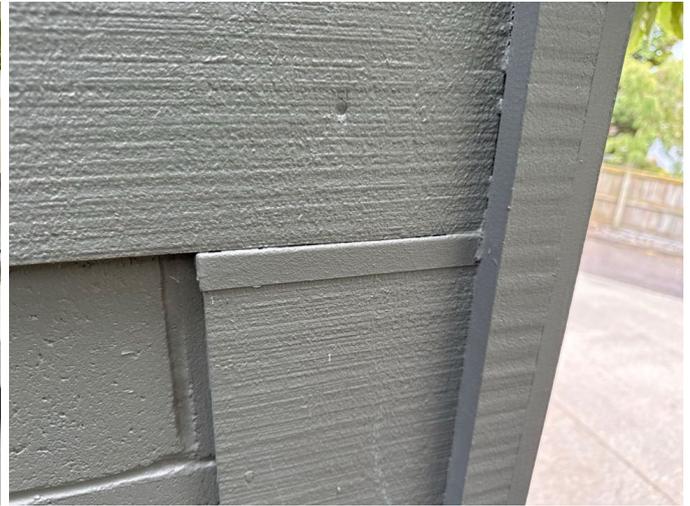
Flashings installed at the cladding junctions prevent the risk of water ingress issues

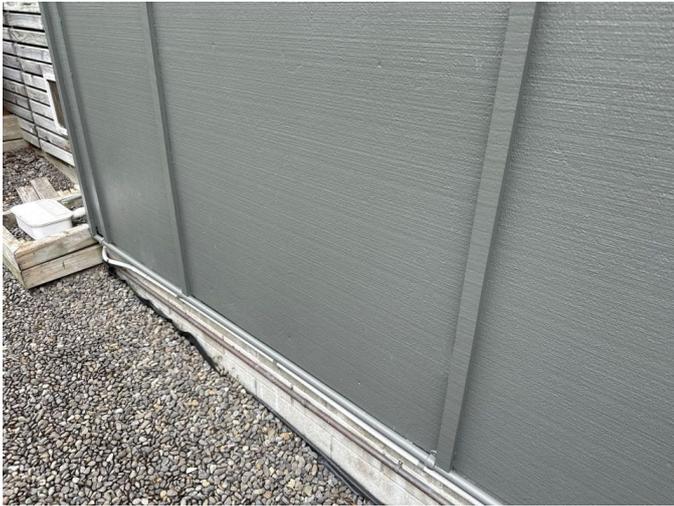
The timber battens are well sealed and secure

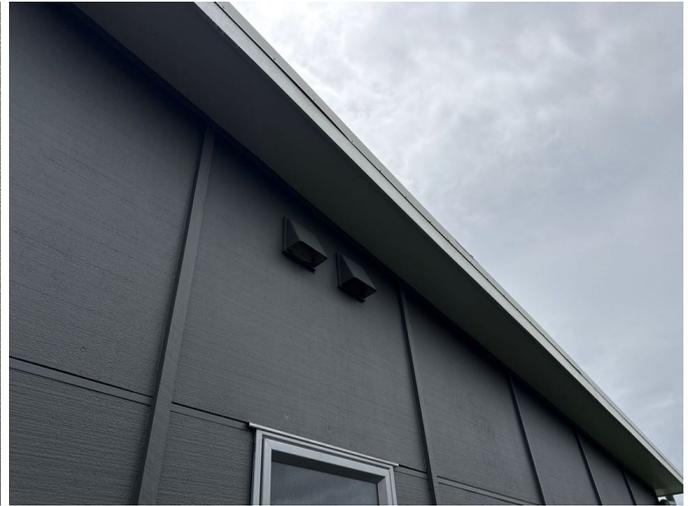
Extraction vents exit through the walls. Cladding penetrations in general are a weather tightness risk area. Penetrations such as taps, screw fixings, gas or water pipes etc. A good seal must be maintained around all cladding penetrations over time to prevent issues. No evidence of failure could be found.

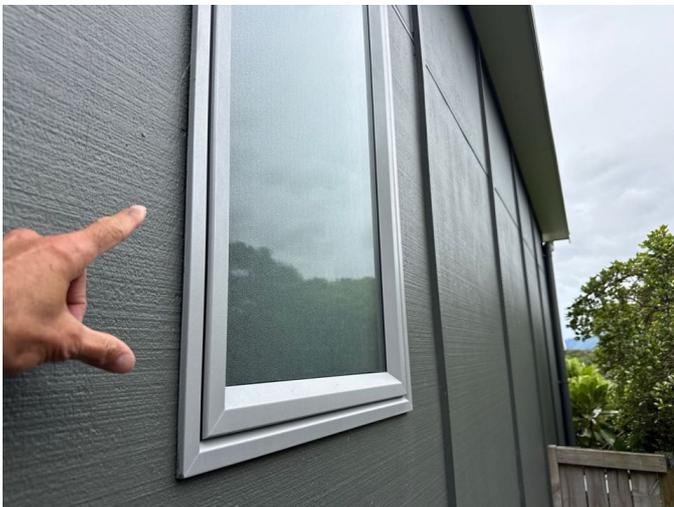
T.H.I.S could not confirm the presence of the rubber backing foam behind the face fitted windows. As a preventative measure, any gaps around the aluminium joinery should be sealed.

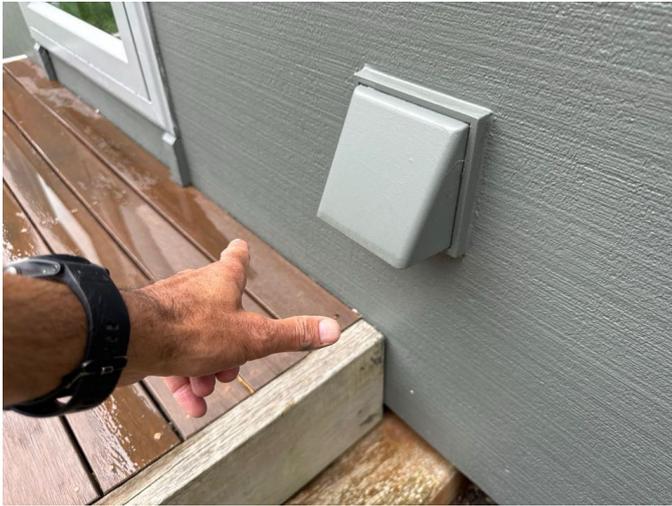
There should be a 12mm gap between the decks and the cladding to prevent the risk of rot damage. Engaging a builder to create gaps will reduce this risk (recommended by T.H.I.S). Note there was no current damage sighted.

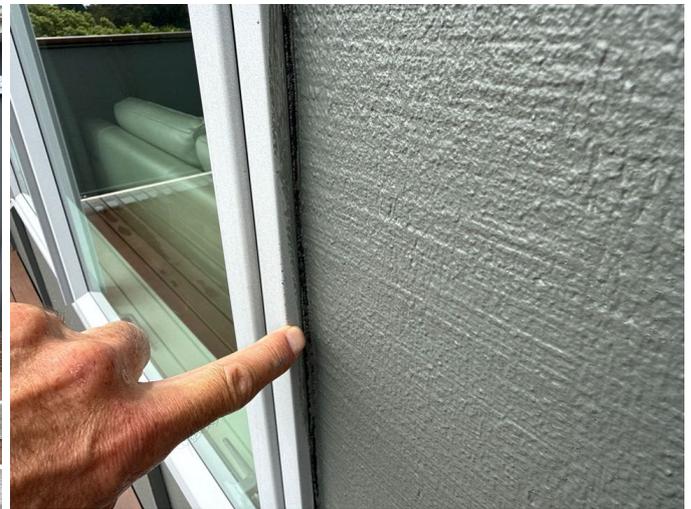
Rubber backing foam can be seen behind some windows

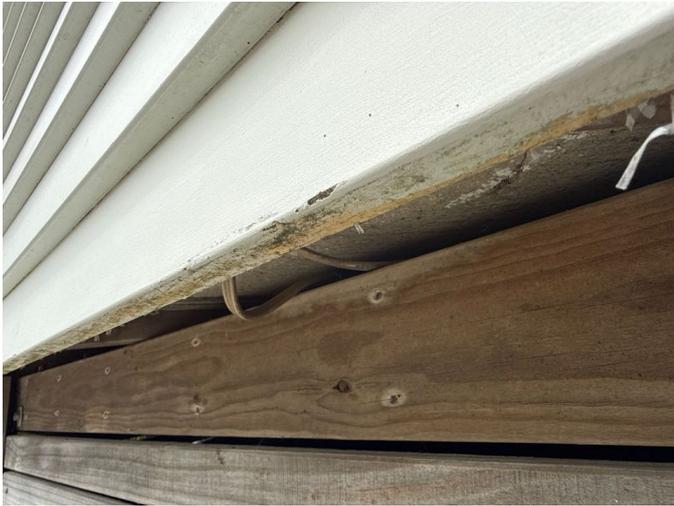
It is important to ensure that the base of the cladding, box corners, scribes etc is as well sealed as the face of the cladding. A paint upgrade is required where insufficiently painted.

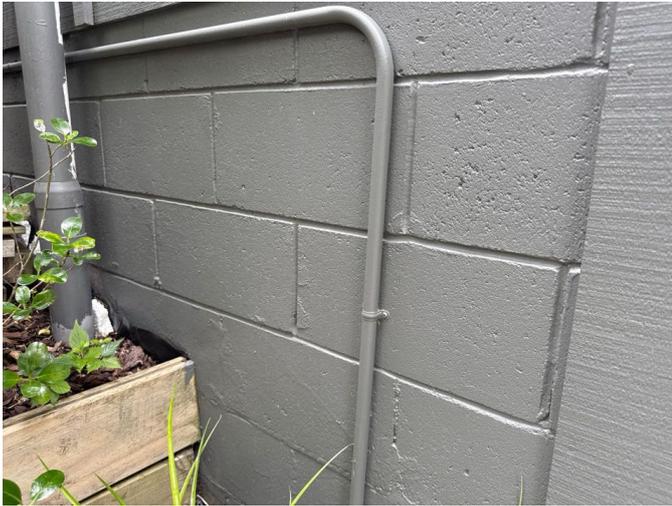
The concrete block ring foundation is in a typical condition for the age. There was no sign of cracking or significant stress.

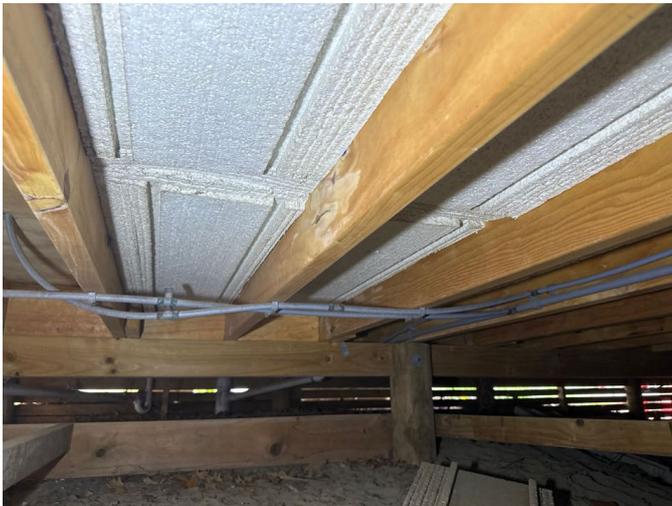
Polyester insulation is installed in the sub floor. There was no labelling present to indicate the R-Value of the material.

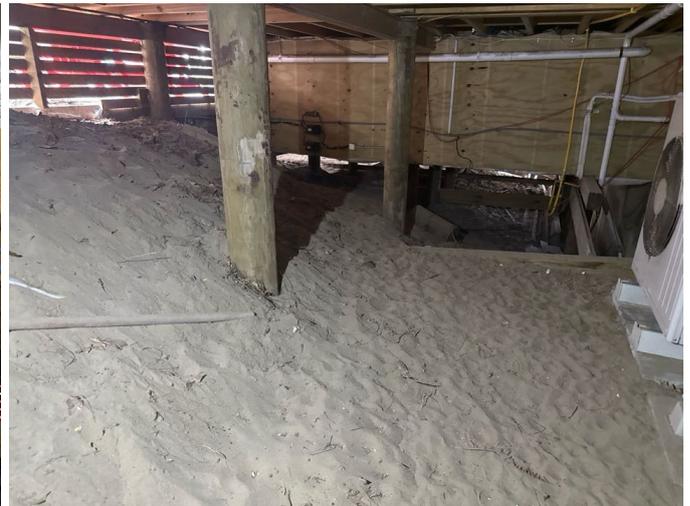
Good ventilation to the sub floor. There was no evidence of water runoff issues.

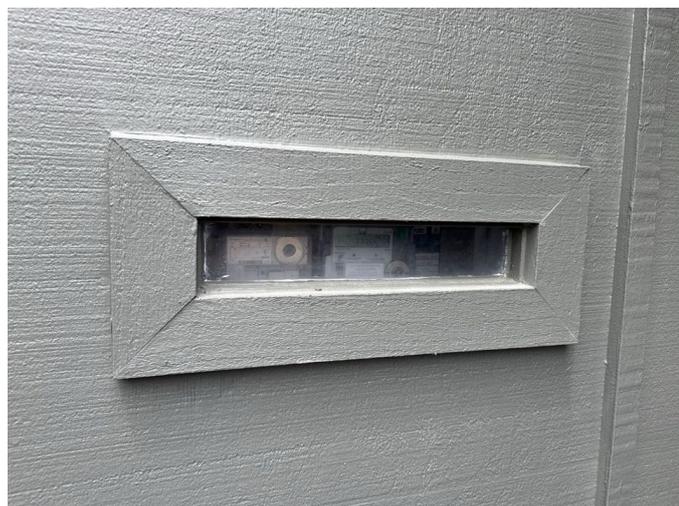
The meter board is effectively sealed at the time of inspection. The outer box should have a head flashing installed to move water away from the top. Elevated risk of moisture ingress here, ideally a head flashing should be installed. Smart meter installed, no obvious concerns sighted.

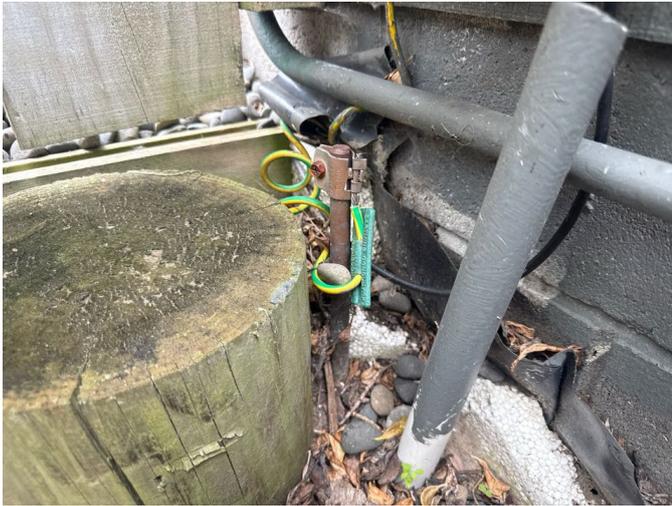
Southeast side.

The electrical earth rod provides a safe path for fault currents to dissipate into the ground, helping protect people and equipment from electric shock and reducing the risk of damage during faults or lightning strikes.

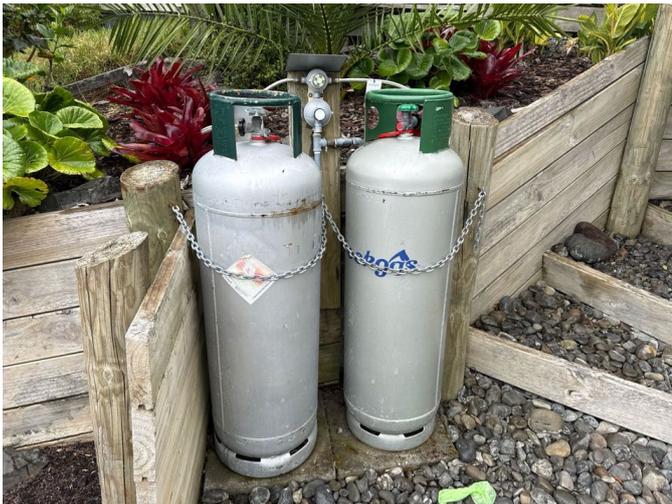
The gas system is not tested as part of this inspection. T.H.I.S recommends that gas appliances are serviced regularly to ensure correct combustion, maintaining optimum efficiency and correct performance of safety devices prior to use.

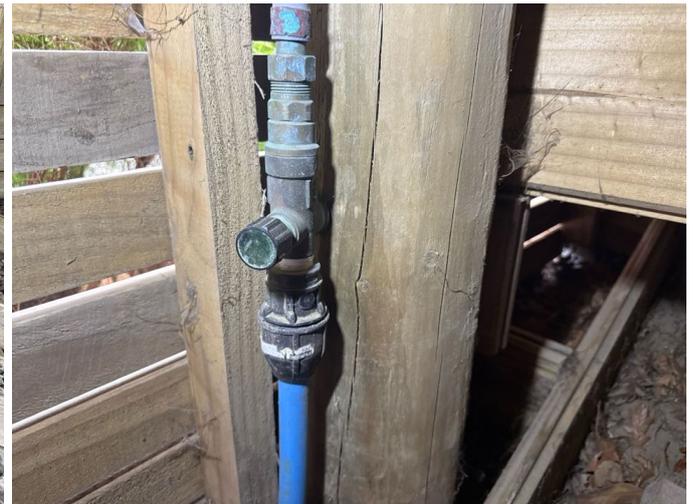
There is a water main isolation valve in the sub floor on the southeast side

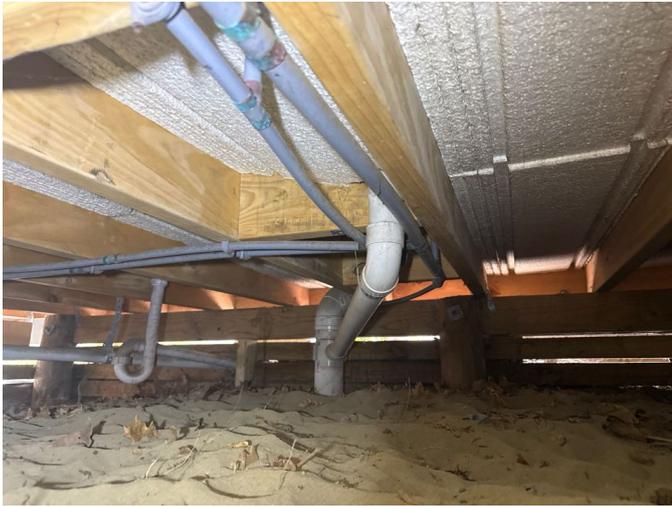
Example. There was no sign of current leaks under the plumbed areas.

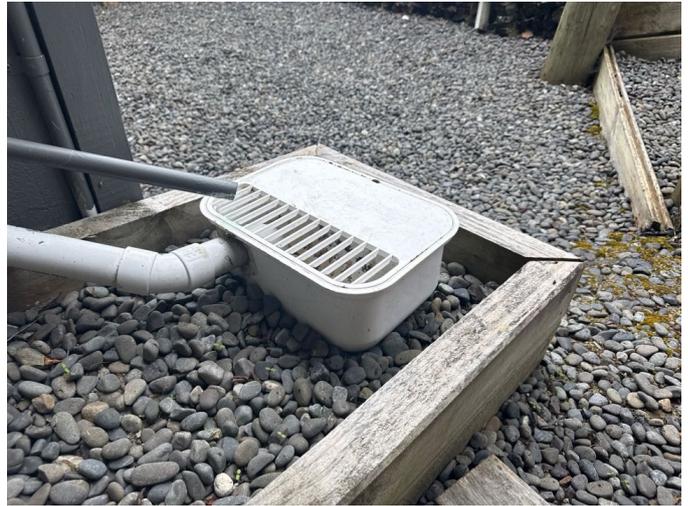
The overflow relief gully is an external outlet for waste in case of internal blockages. No sign of recent overflows. Good height noted.

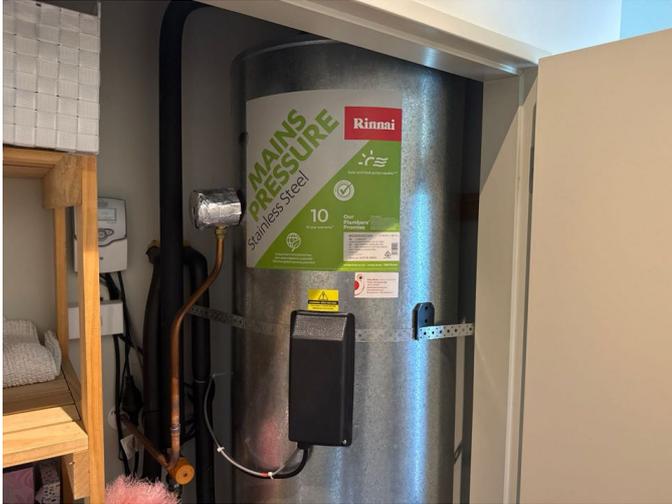
Hallway cupboard.

Rinnai 300L Mains Pressure Electric Hot Water Cylinder. Seismic restraints installed.

The pressure-reducing valve that is located at the top of the mains pressure hot water cylinder should be tested every 6 months or in accordance with the manufacturer's instructions to make sure that it is in working order.

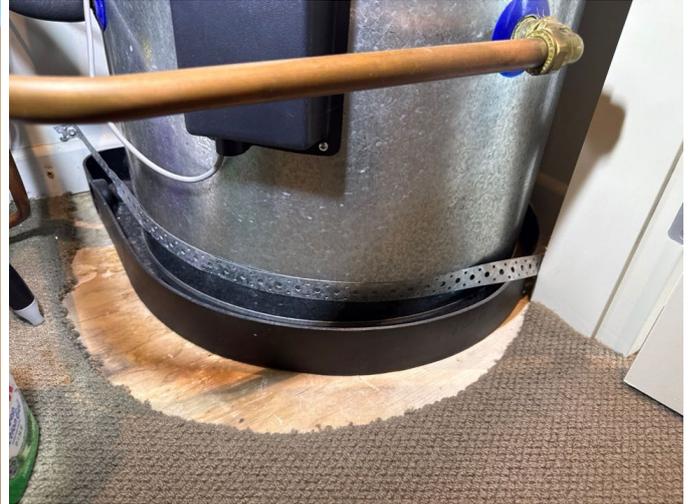
No sign of leaks around the base of the cylinder. The cylinder is placed in a safe tray with a drainage outlet as required.

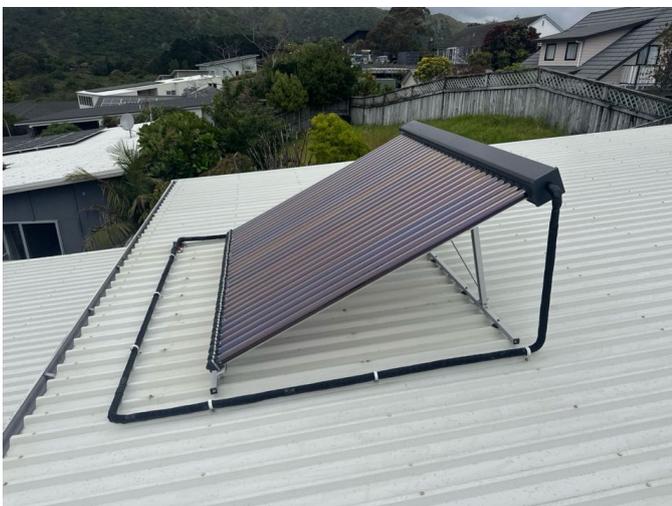
Solar water heating tubes to the roof. Outside the scope of this inspection.

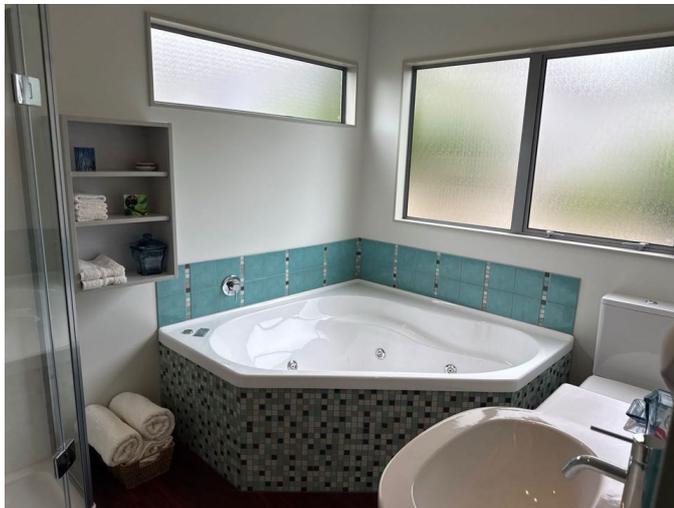
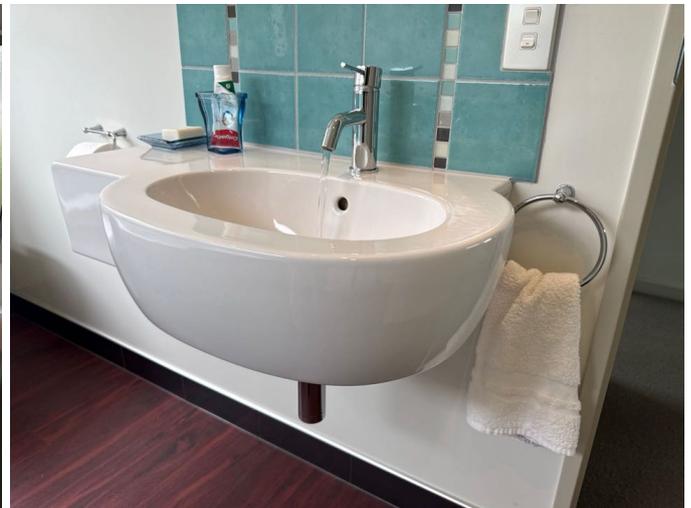
The rear edge of the sink is well sealed. The tap is functioning well. No concerns with the water feeds or waste under the vanity

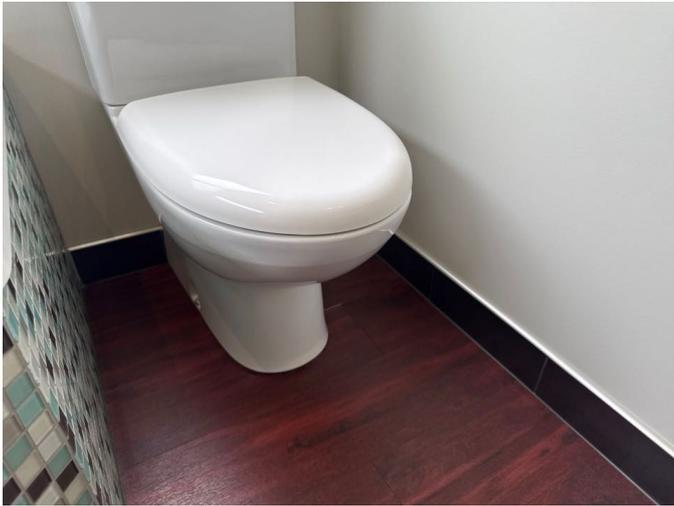
The base of the toilet is well sealed and secure. The toilet is in a functioning condition.

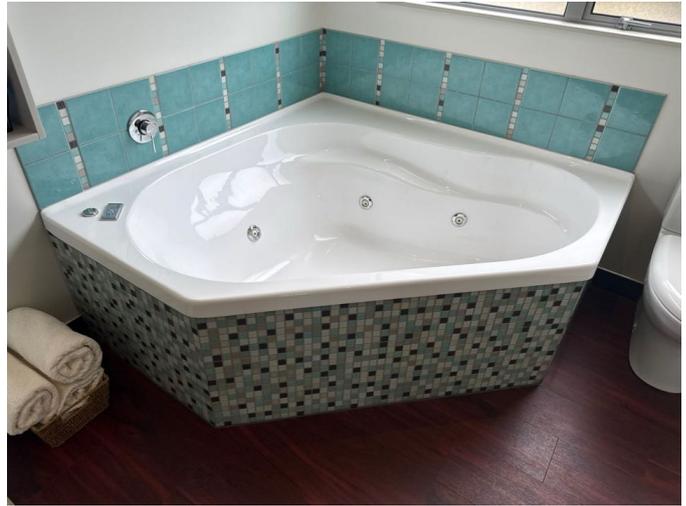
The perimeter of the bath is well sealed. The tap is functioning well.

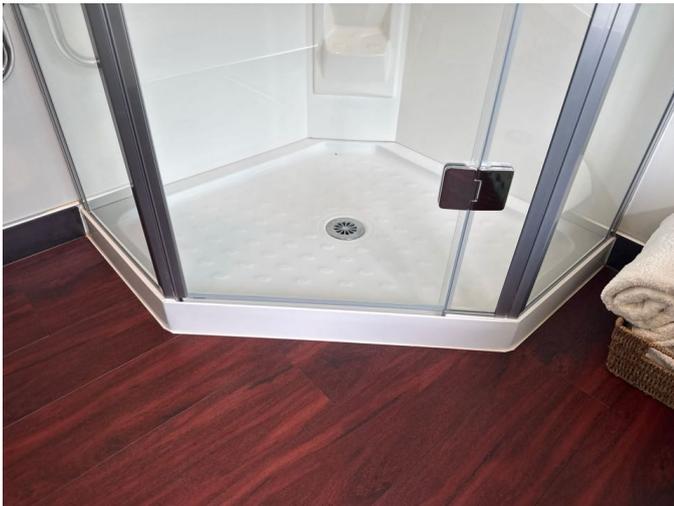
The base of the shower is well sealed to the timber flooring

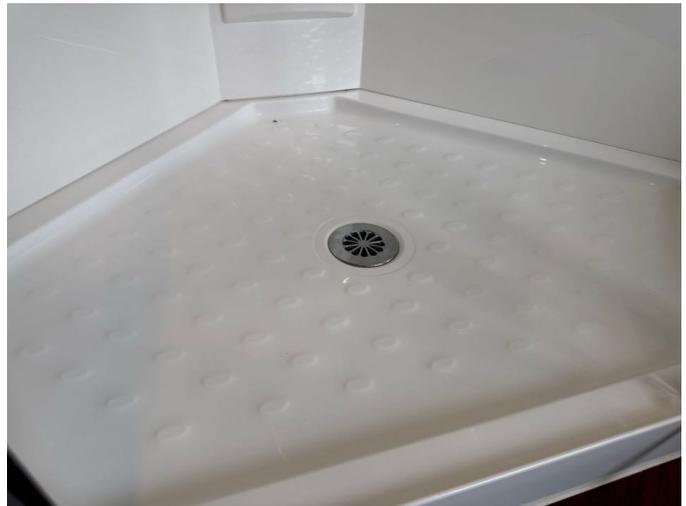
There was no evidence of damage to the shower base at the time of the inspection

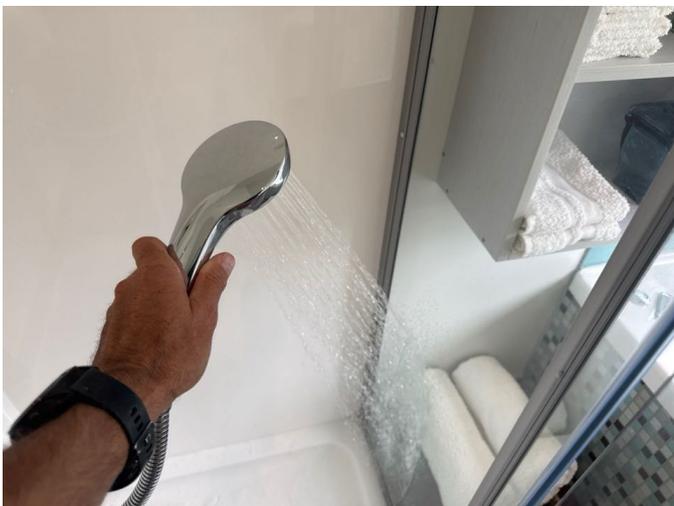
Good water pressure noted. No sign of current leaks from the shower frame during water testing.

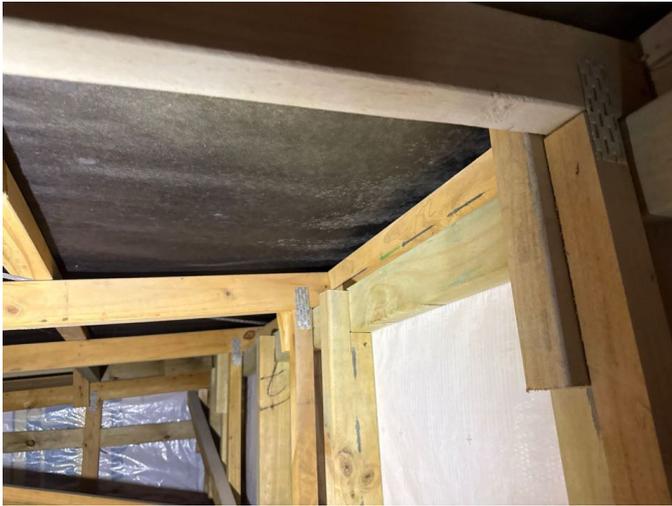
There was no evidence of current or past moisture ingress issues under the roof framing or linings (where accessible) at the time of inspection. The roof framing structure appears to be solid.

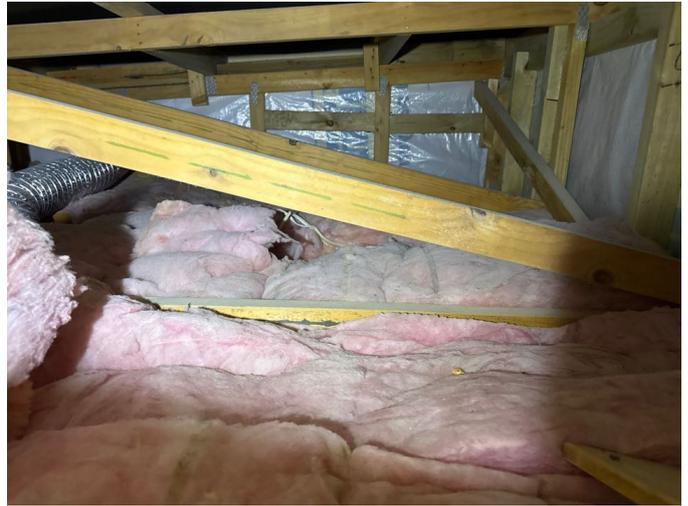
Average level of insulation in place. There was no labelling present to indicate the R-Value of the material.

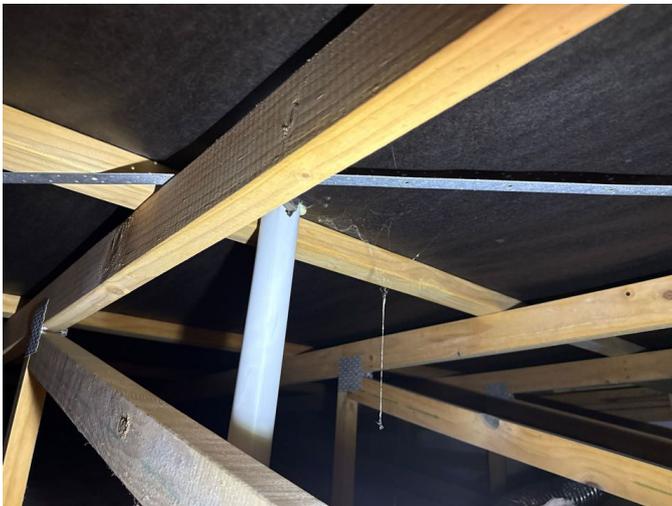
The roof penetrations were effectively sealed at the time of the inspection.

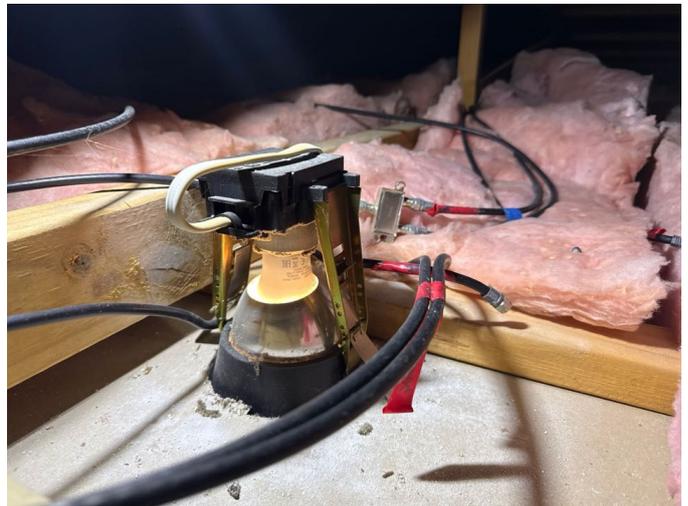
Where there are older types of recessed downlights, insulation must be kept 200mm away or 100 mm with a fixed guard to prevent the lights, ceiling materials or insulation from overheating. Recessed downlights labelled "CA80" or "CA90" can have insulation abutted against them. BRANZ recommends replacing older downlights with surface-mounted lights or with IC or IC-F recessed downlights that can have insulation placed over them. The owner disclosed that most of the bulbs have been replaced with LED.

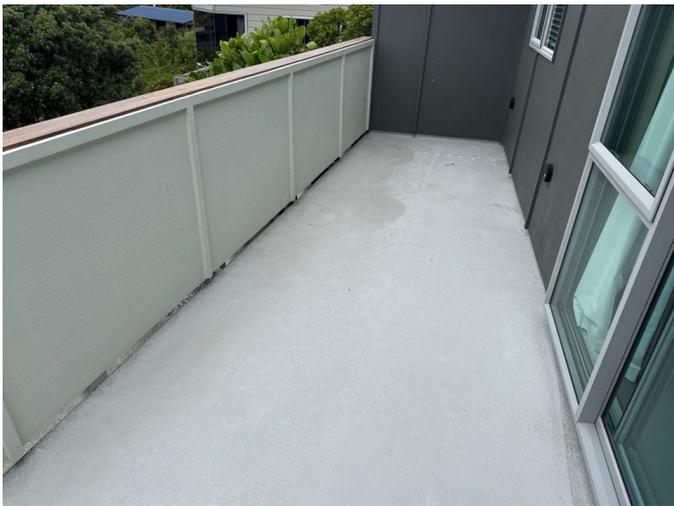
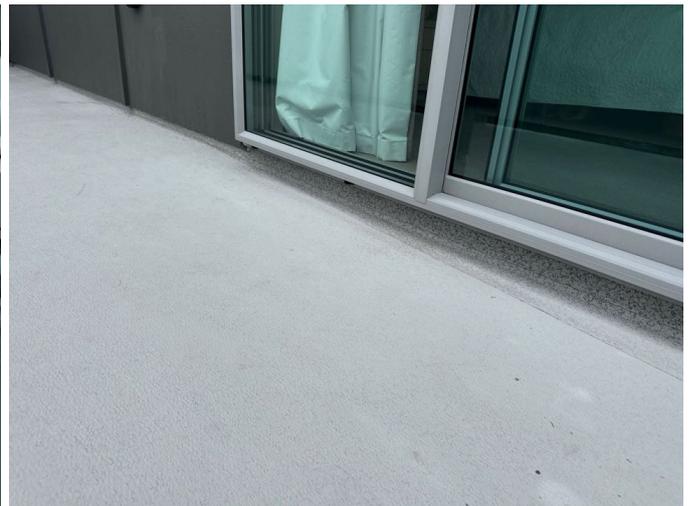
The membrane extends under the cladding. T.H.I.S is unable to view or comment on how far the laps extends. The lap is effective and there was no evidence of failure found internally. Good clearance between the internal floor and the deck surface. Good fall away from the house noted.

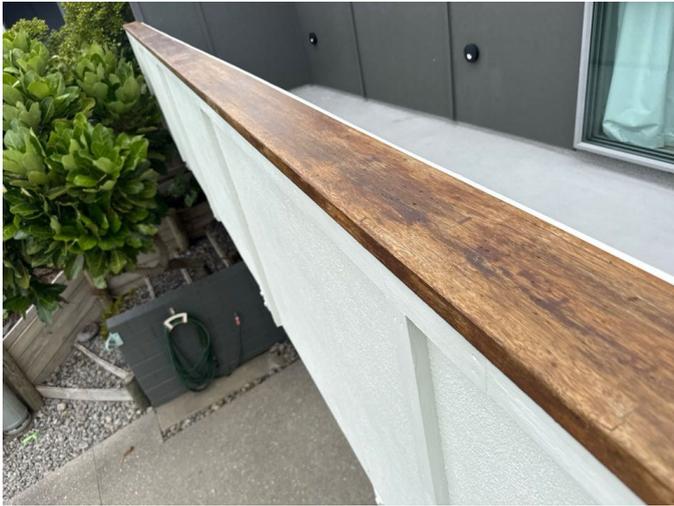
The balustrade is solid and connected sufficiently at the base

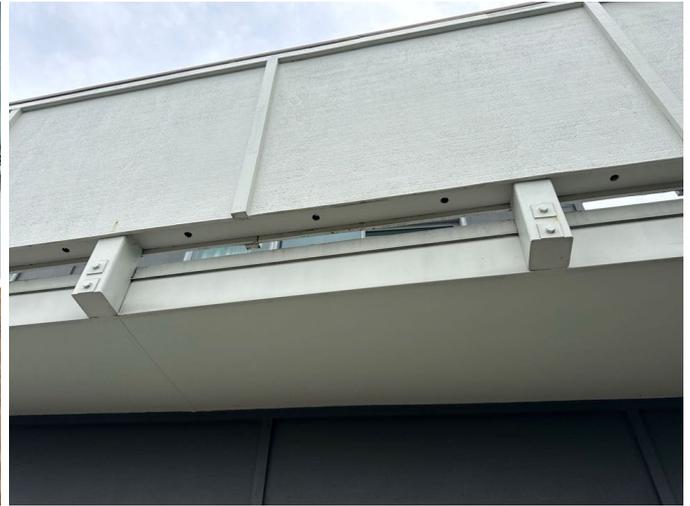
There are holes under the balustrade so that if any water happens to enter the area it will be able to escape.

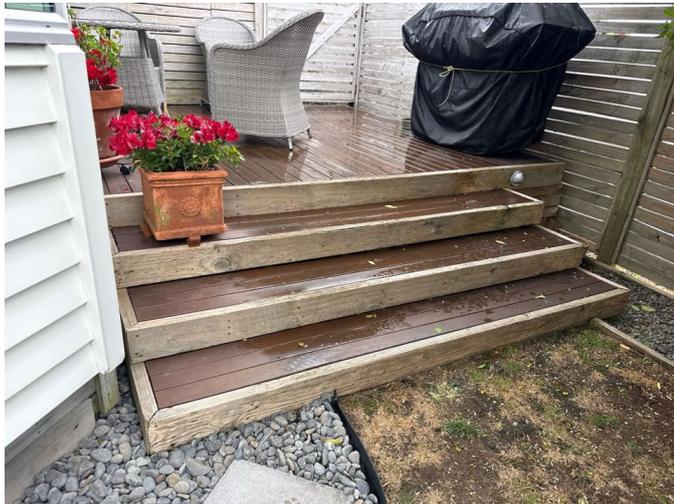
The timber decking is in good condition

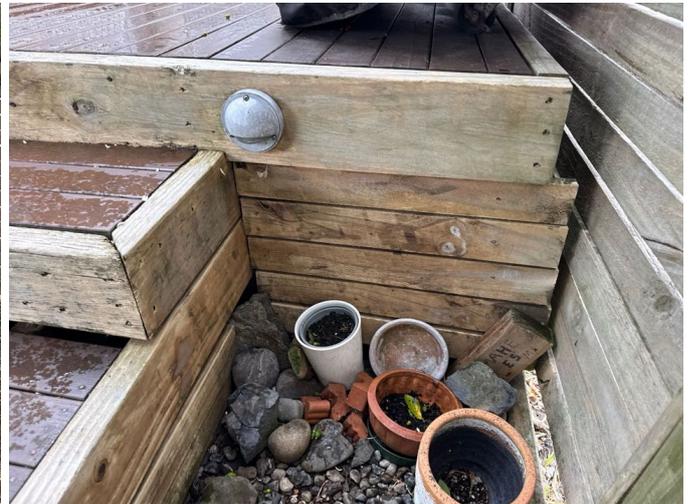
There is no access beneath therefore the main structure could not be inspected

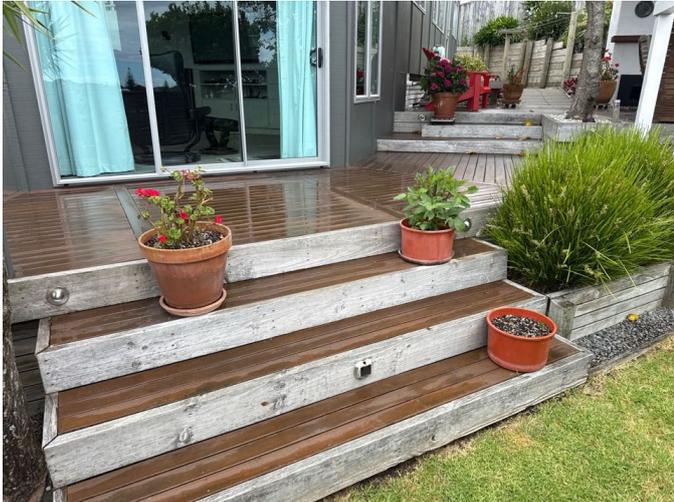
There is a risk of premature deterioration at the deck/cladding junction where the gap is less than the recommended. The gaps should be regularly cleared of debris to prevent the risk of damage. No current damage sighted.

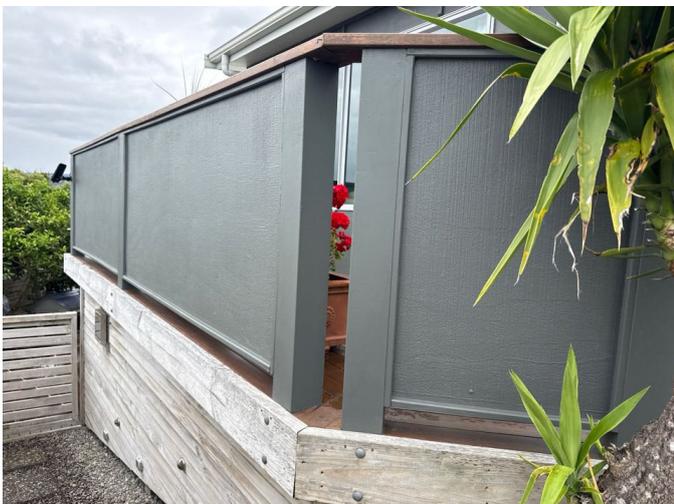
The balustrade is solid and connected sufficiently at the base

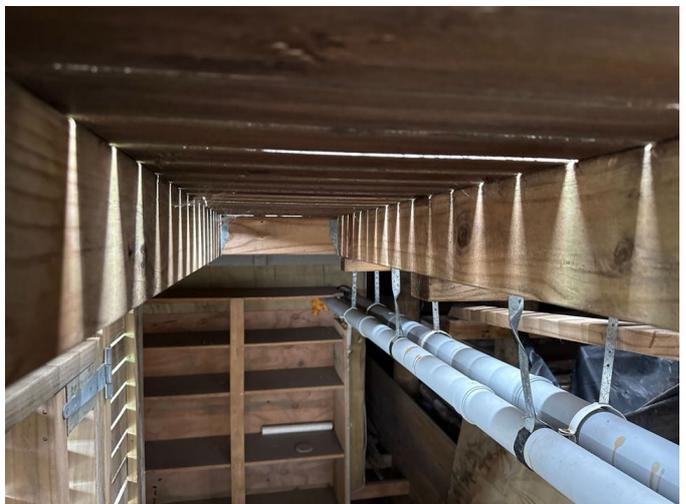
No concerns with the framing structure. Solid and well connected.

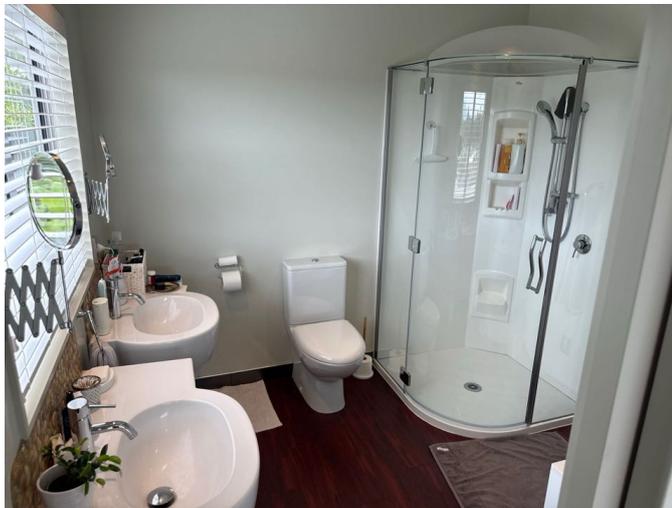
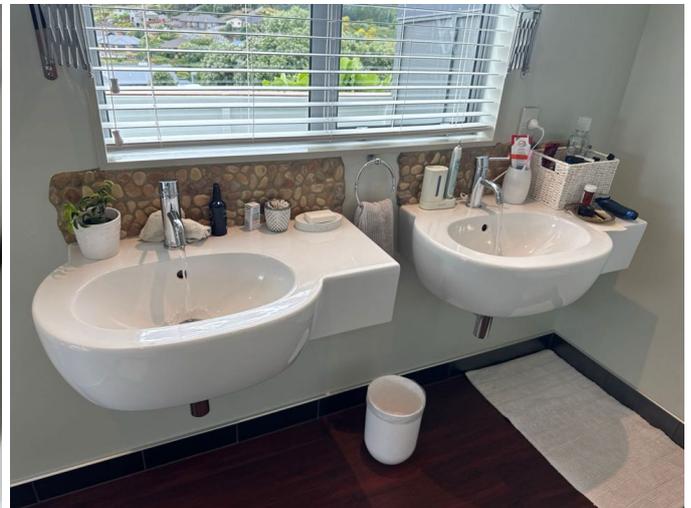
The rear edge of the sinks is well sealed. The taps are functioning well. No concerns with the water feeds or waste under the vanity

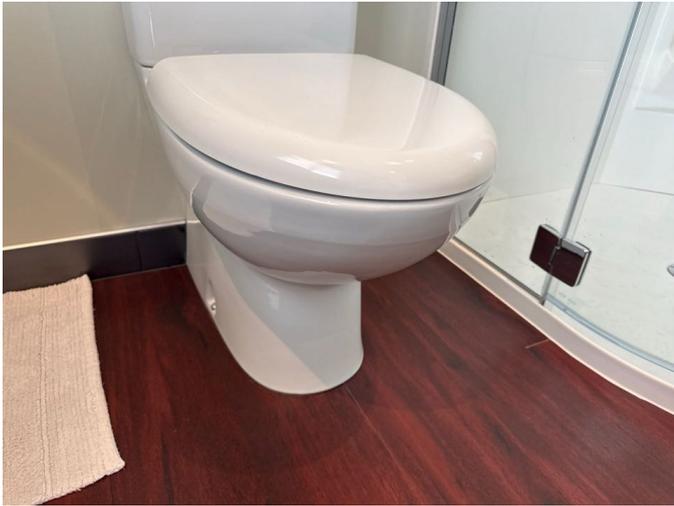
The base of the toilet is well sealed and secure. The toilet is in a functioning condition.

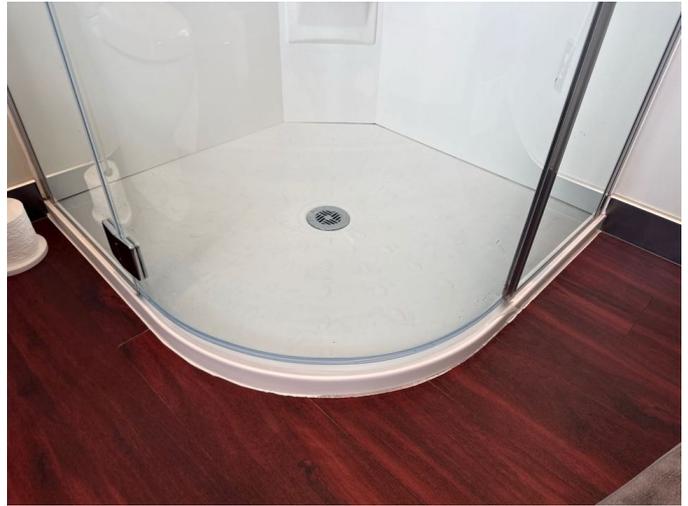
The base of the shower is well sealed. There was no evidence of damage to the shower base at the time of the inspection.

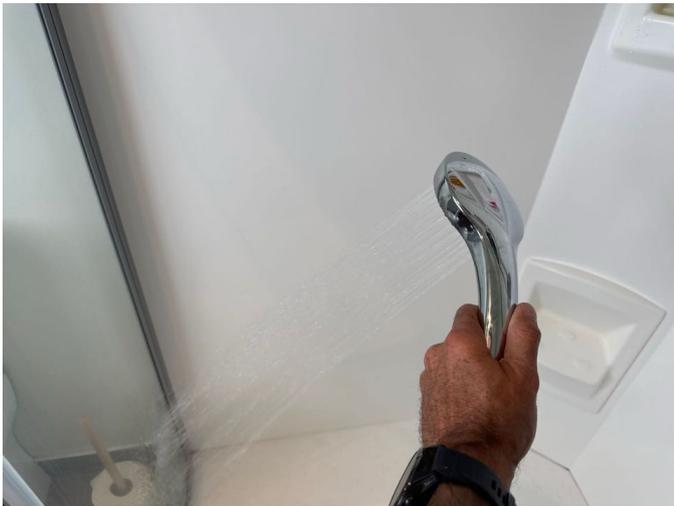
Good water pressure noted. No sign of current leaks from the shower frame during water testing.

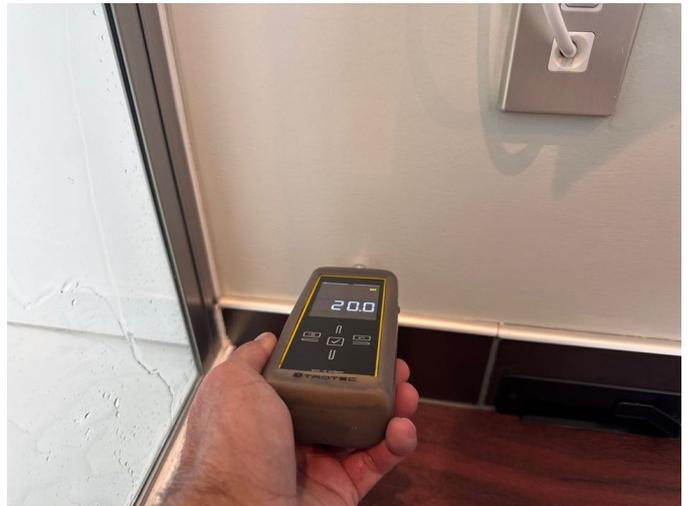
The common fail areas of the shower and plumbed areas were checked for elevated moisture. Moisture levels were within the normal range.

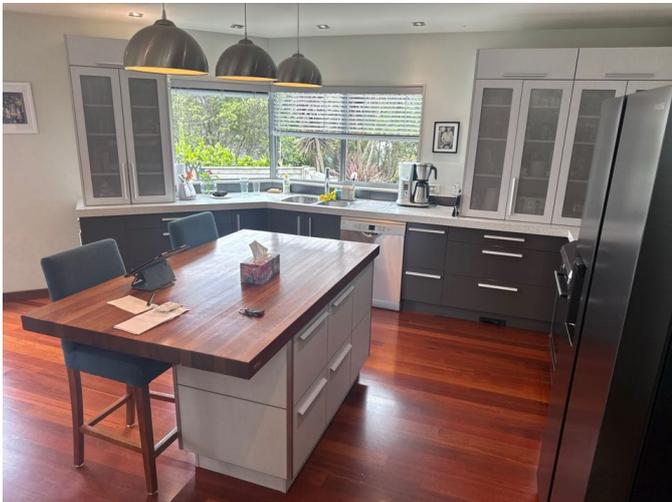
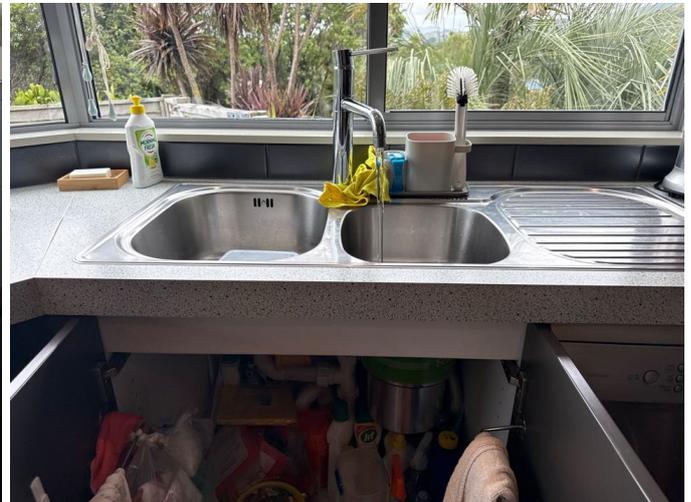
The rear edge of the bench top is well sealed. No concerns with the water feeds or waste pipes under the sink.

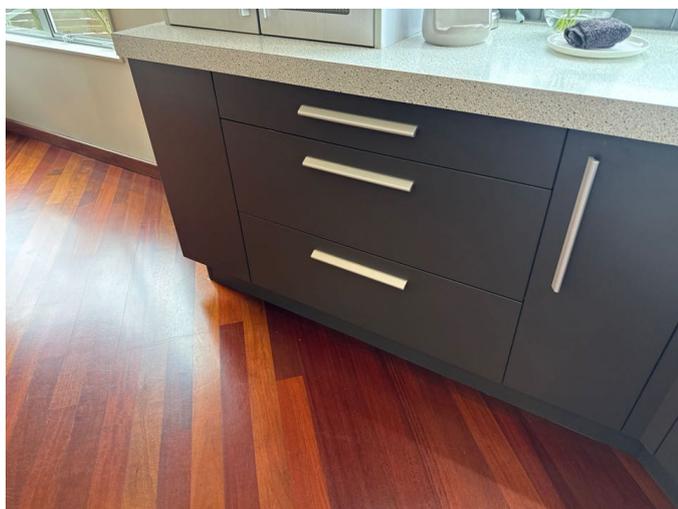
The kitchen cabinetry and timber floor are in good condition

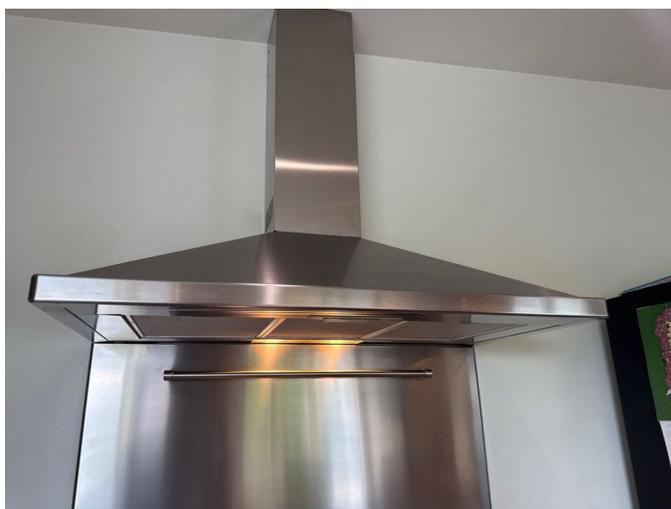
The range hood extraction unit is functioning

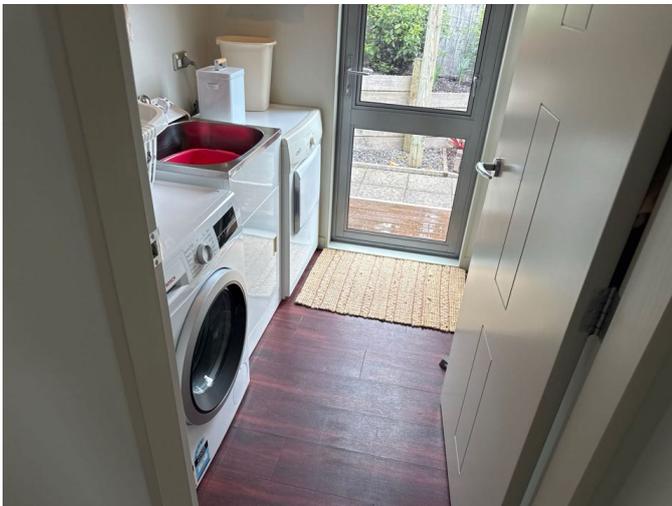
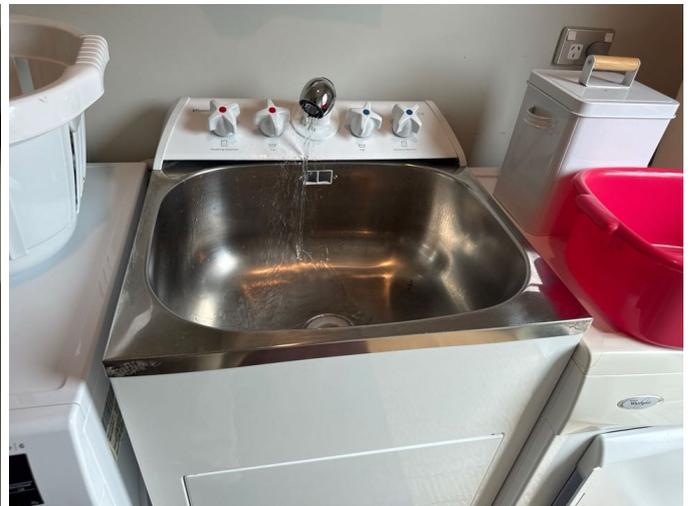
The tub is in an average condition and is functional
