Independent Builders Report

Total Home Inspection Services Porirua City Ltd

Wed 17 Dec 2025

**12 Charlotte Way, Raumati South, Paraparaumu, 5032,
New Zealand**

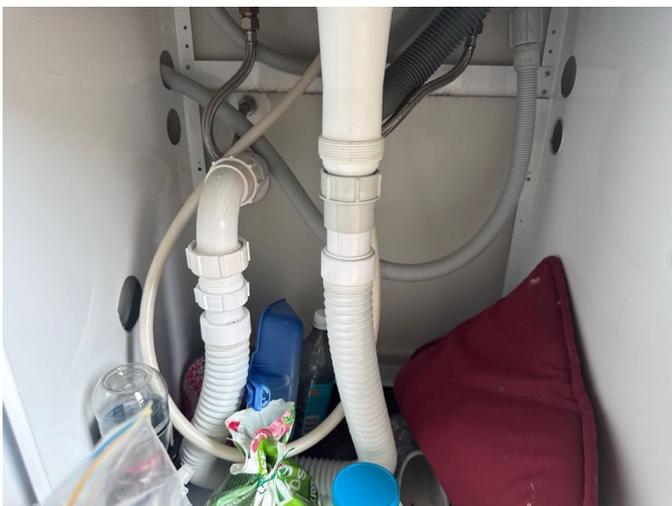
No concerns with the waste or water feeds beneath the tub

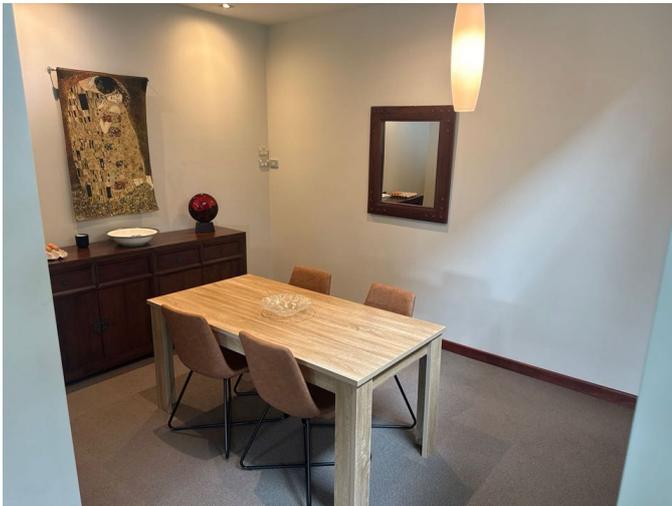
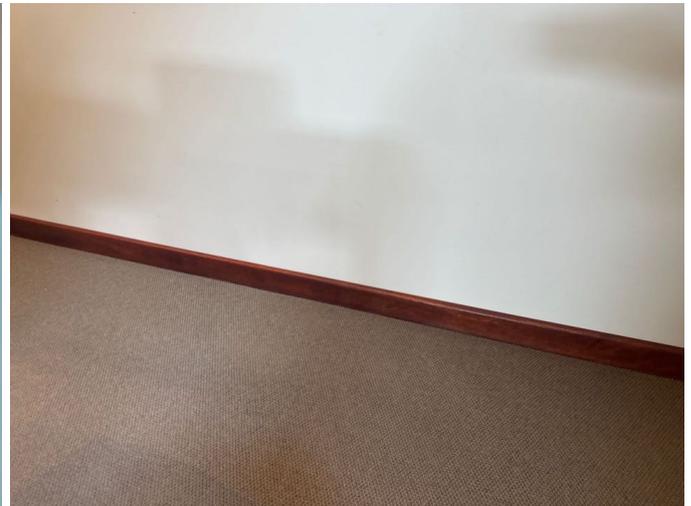
The wall and ceiling linings and carpet are in good condition

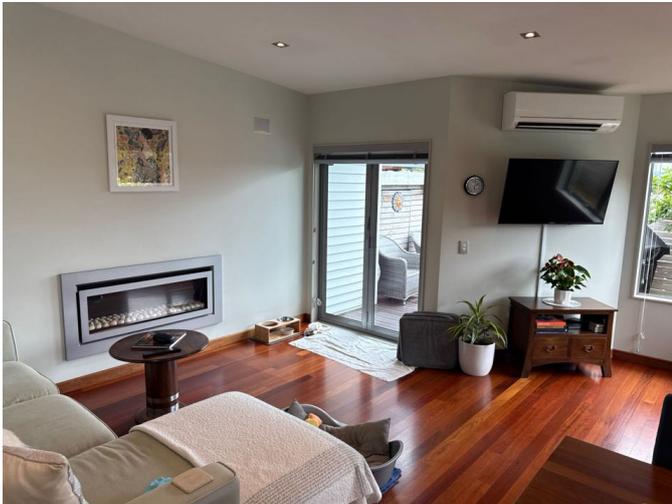
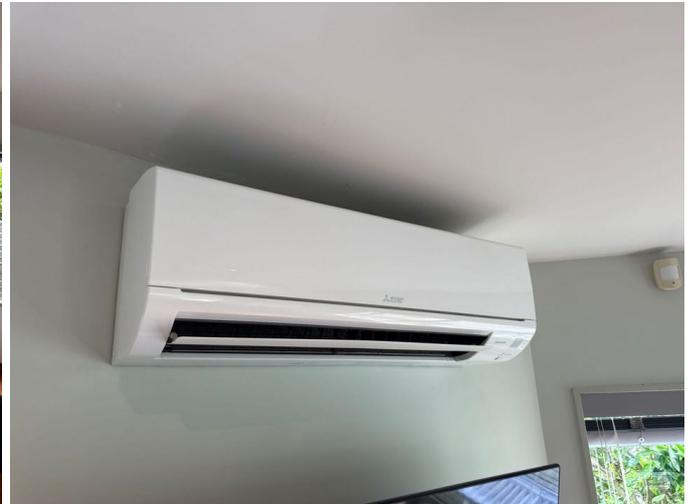
Heat pump installed, untested.
Heat pumps require regular servicing to be efficient.
The manufacturers instructions should be checked and understood with regards to future servicing requirements.

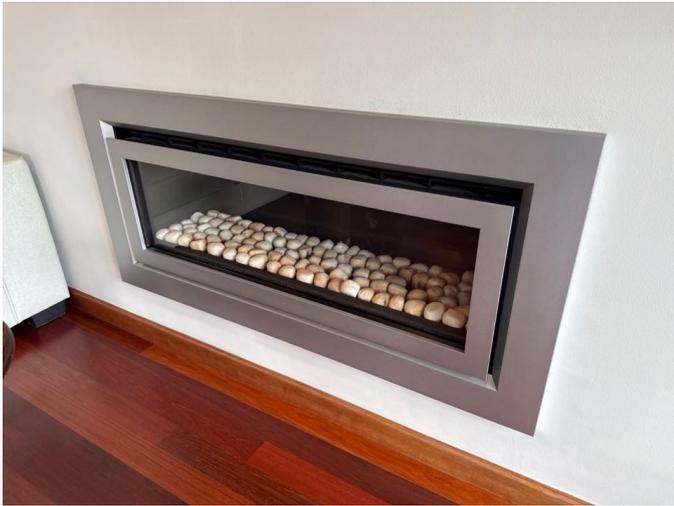
The heating appliances are not tested as part of the inspection process. Gas appliances require regular servicing to be efficient and should be checked and serviced by an industry professional prior to the first use.

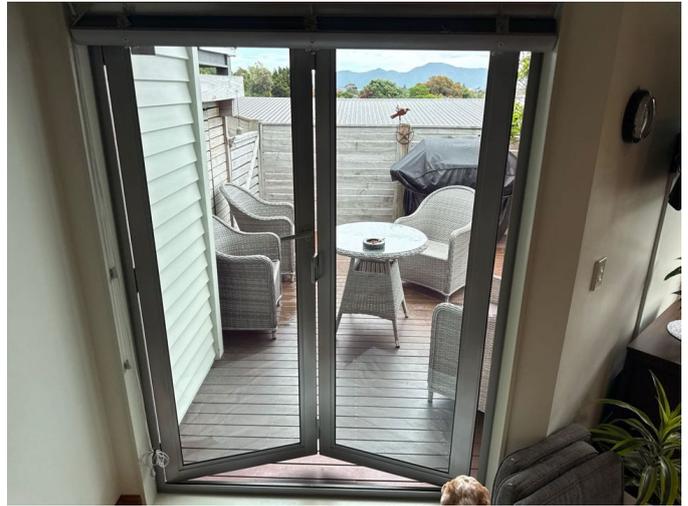
The bifold door and window are functioning

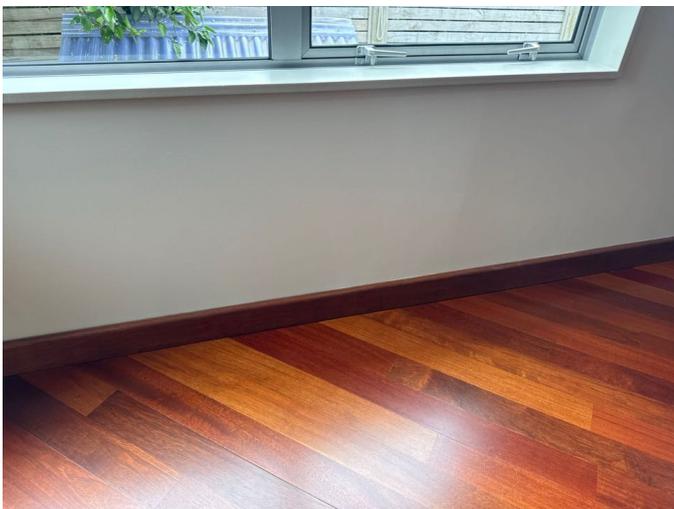
The wall and ceiling linings and timber flooring are in good condition

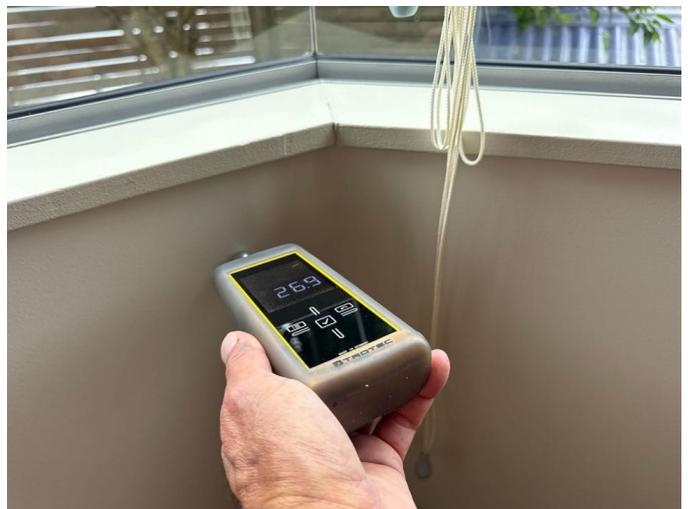
Moisture levels to the external walls were within the normal range at the time of inspection

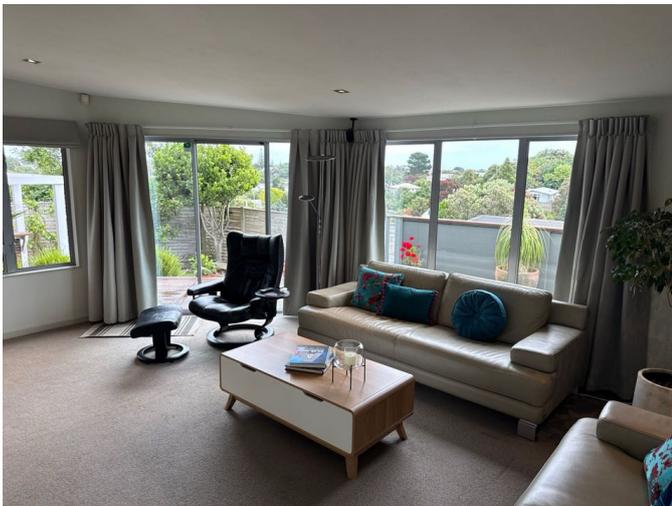
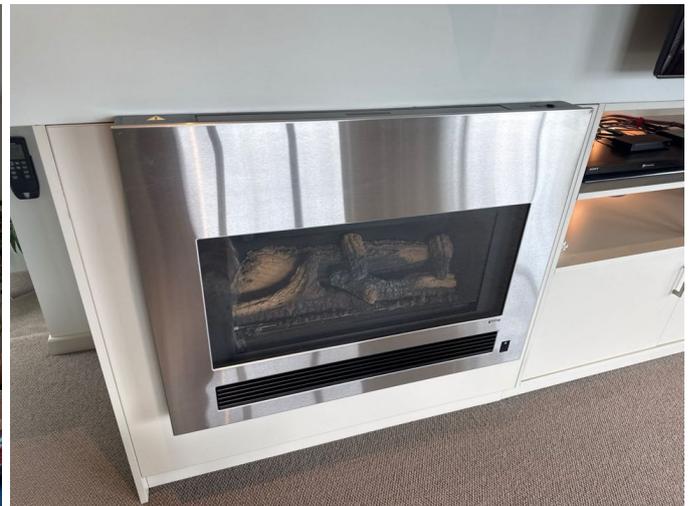
Gas fireplace installed. Untested.

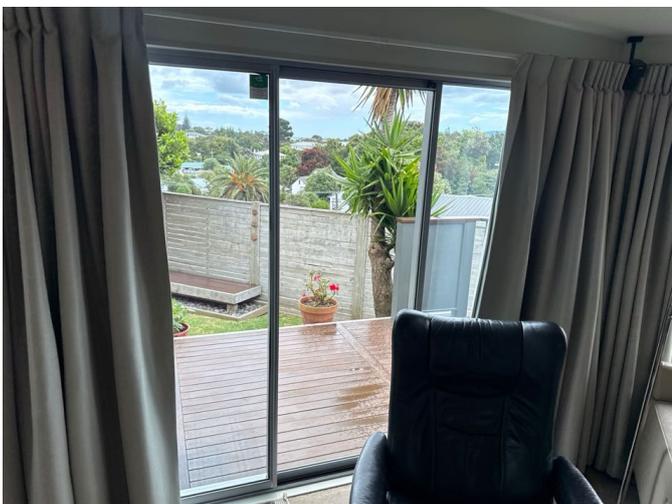
The sliding door and windows are functional

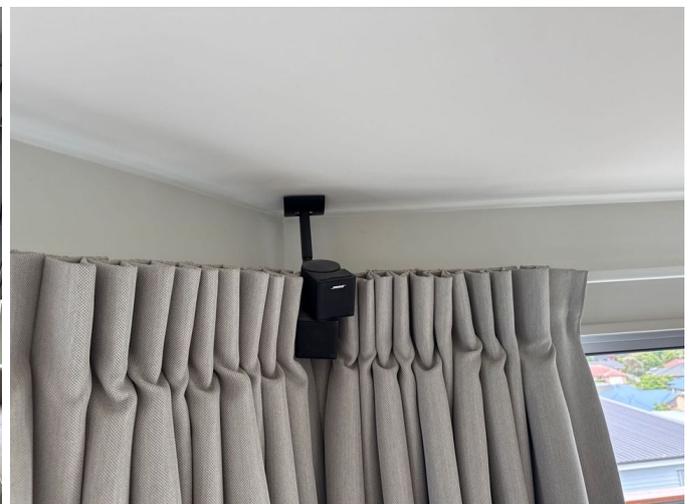
The integrated speaker system was not checked as part of the inspection process

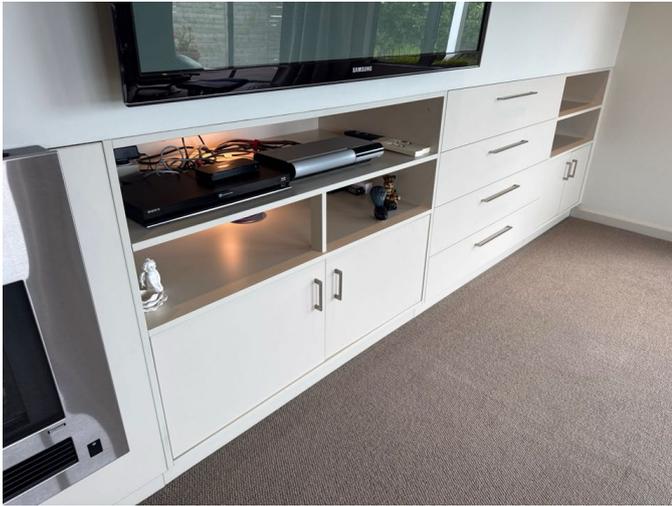
Built in cabinetry noted

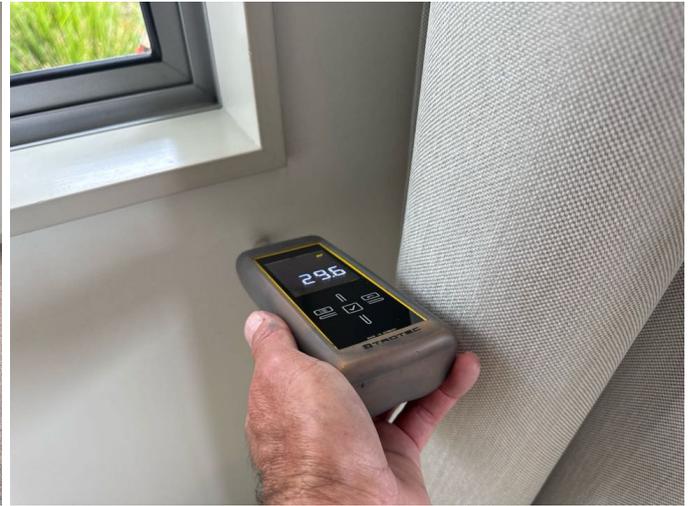
Moisture levels to the external walls were within the normal range at the time of inspection

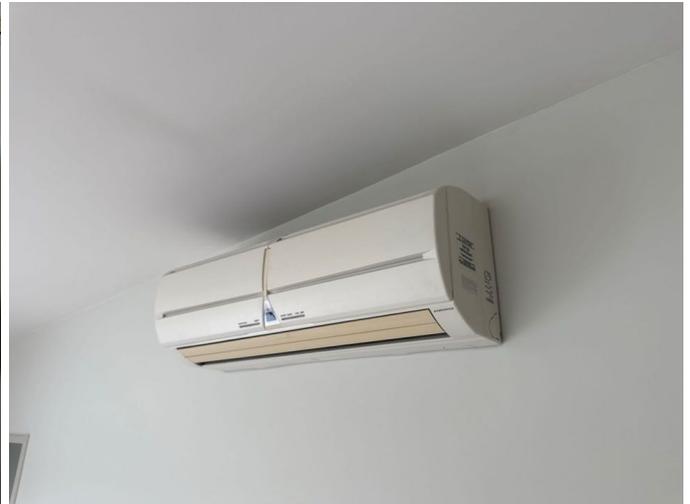
Heatpump installed. Untested.

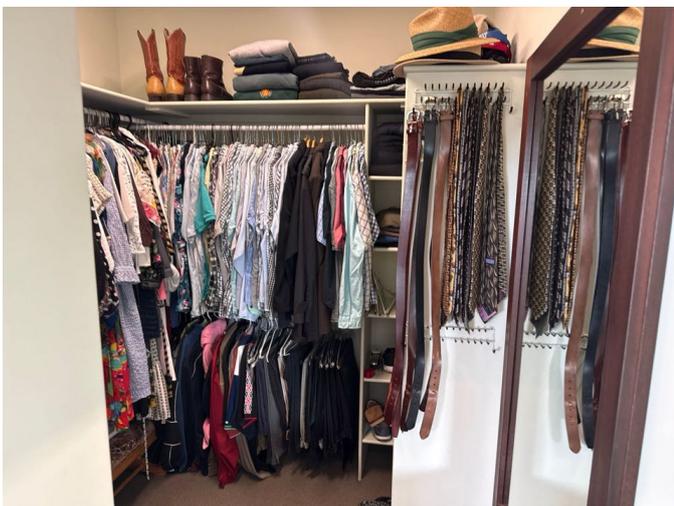
The walk in wardrobe has a storage system in place which is secure and in good condition

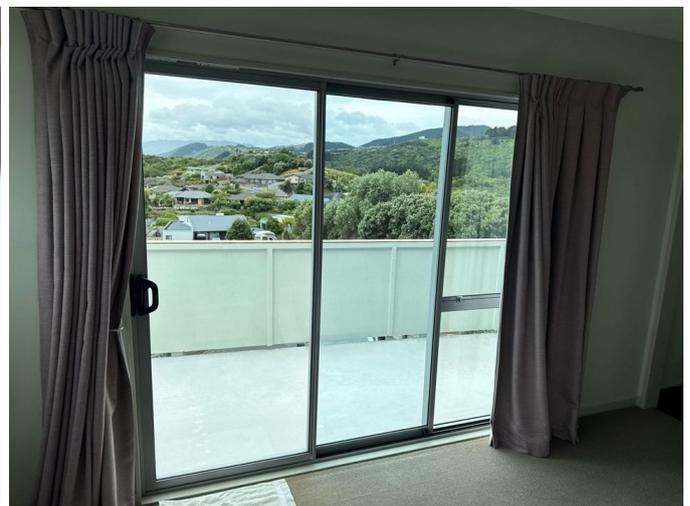
The sliding door is functional

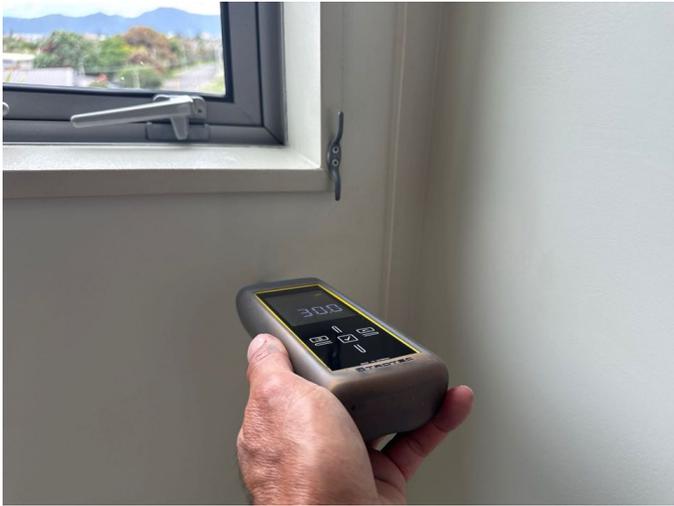
Moisture levels to the external walls were within the normal range at the time of inspection

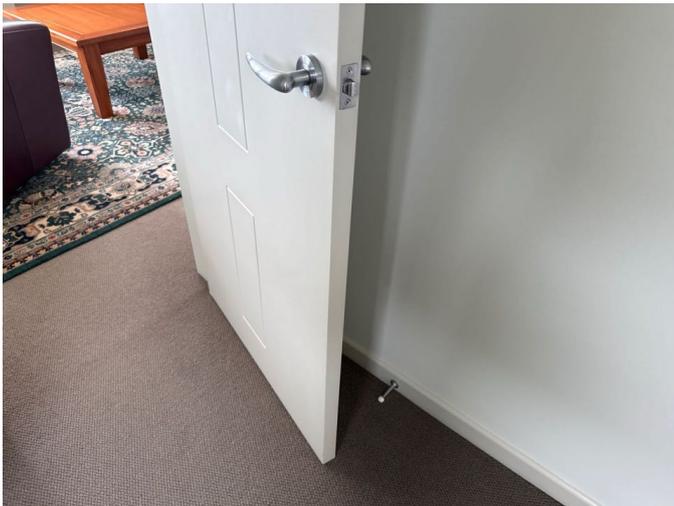
The internal doors are functioning well. Door stops installed behind the doors.

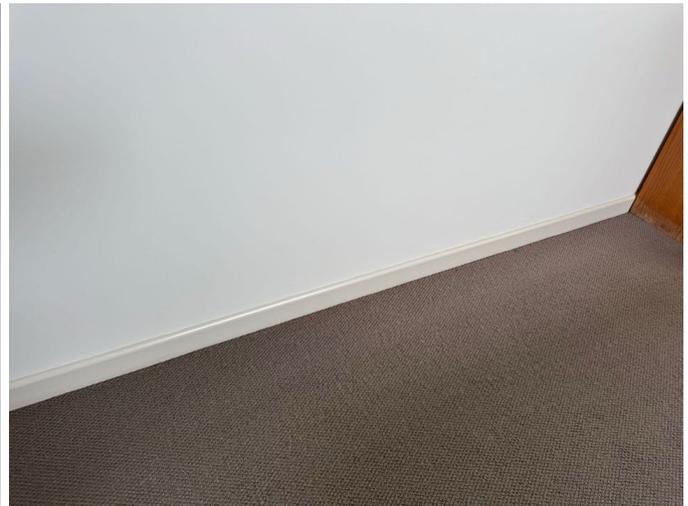
The wall and ceiling linings and carpet are in good condition

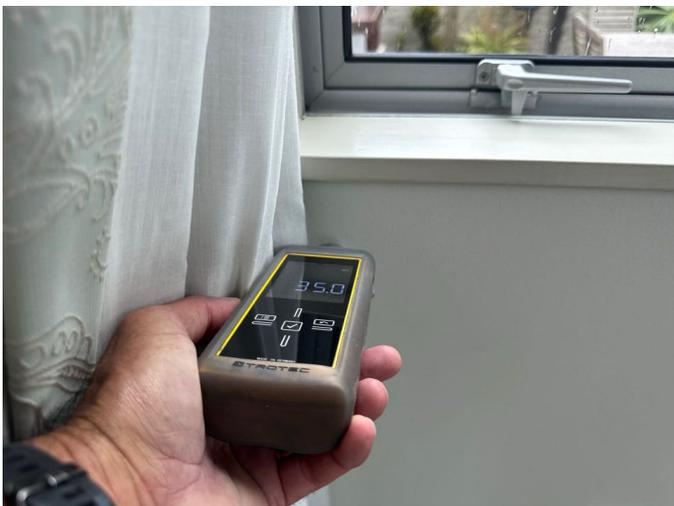
Moisture levels to the external walls were within the normal range at the time of inspection

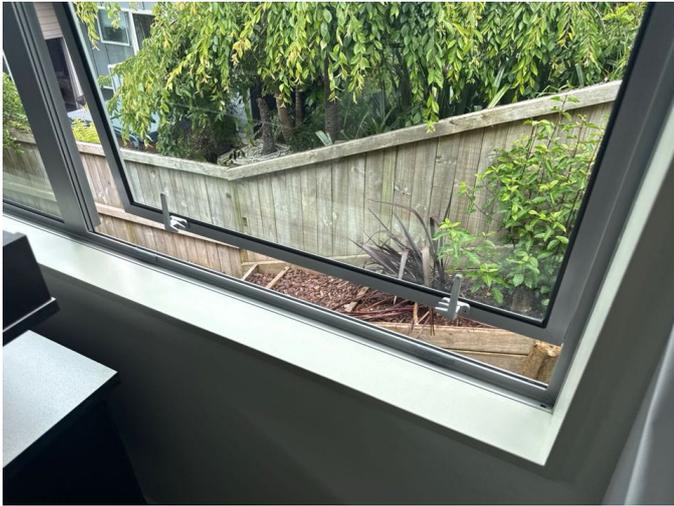
The windows are functioning well

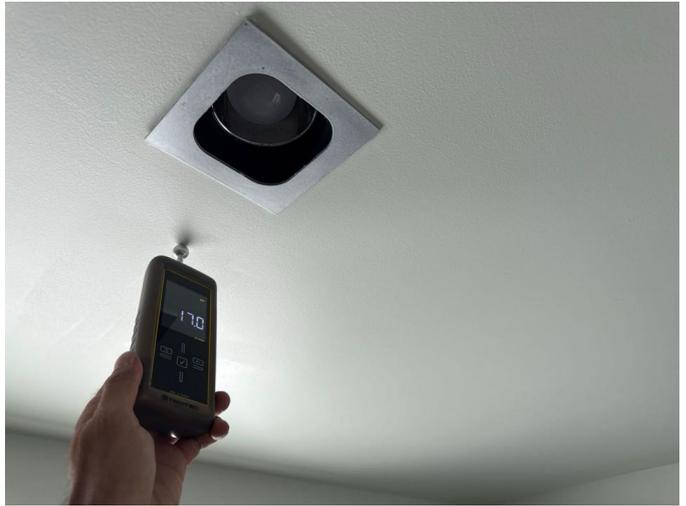
The moisture levels to the ceiling were within the normal range.

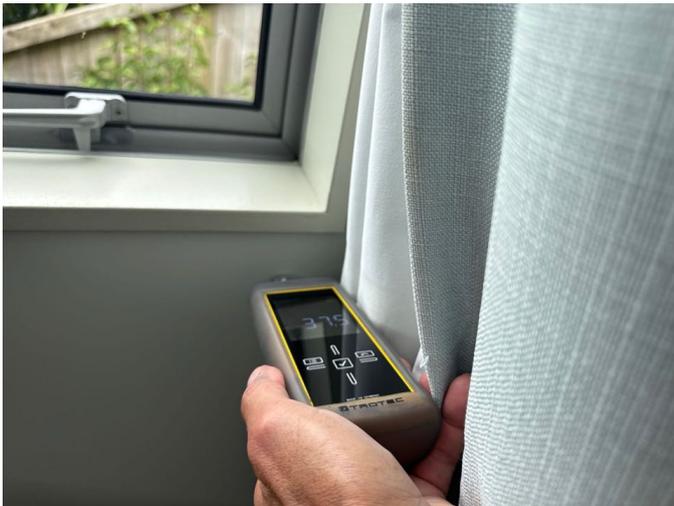
Moisture levels to the external walls were within the normal range at the time of inspection

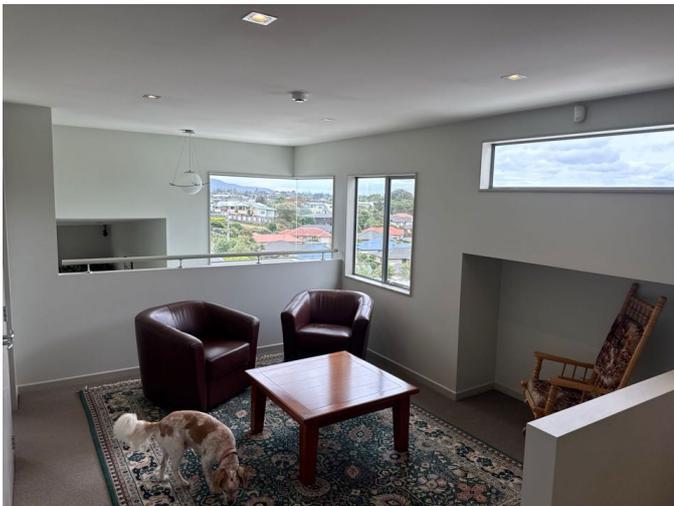
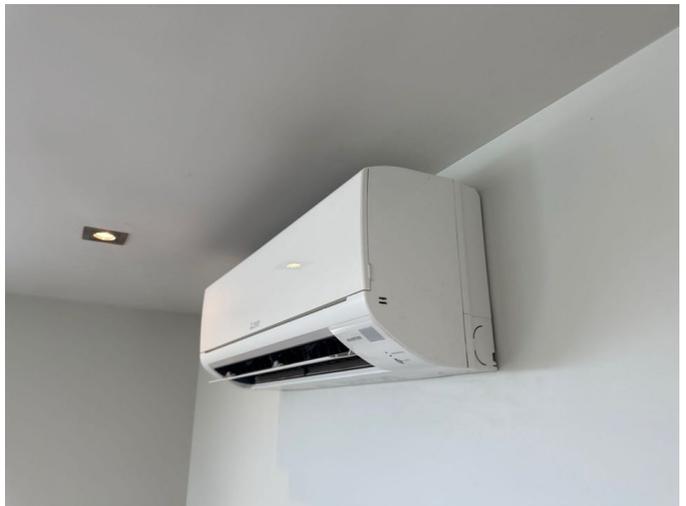
Heatpump installed. Untested.

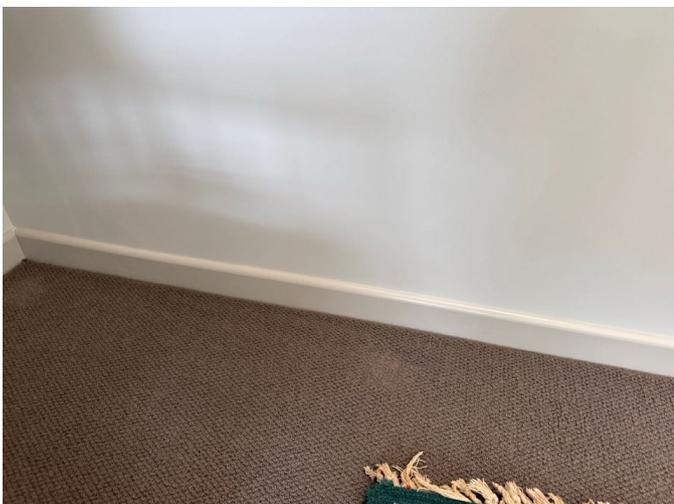
The carpet and wall linings are tidy

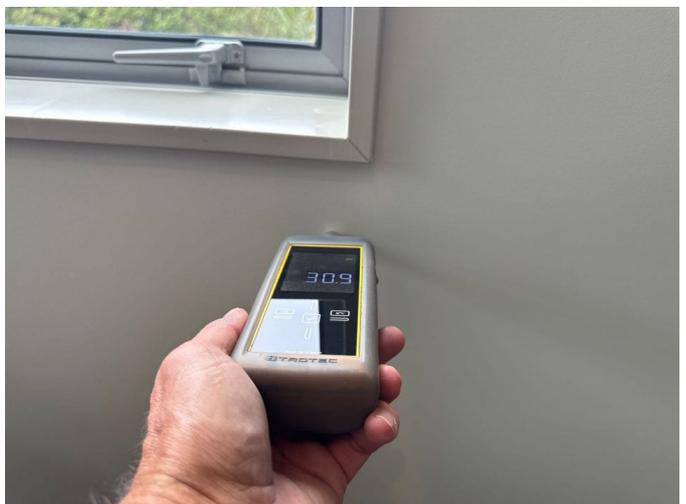
Moisture levels to the external walls were within the normal range at the time of inspection

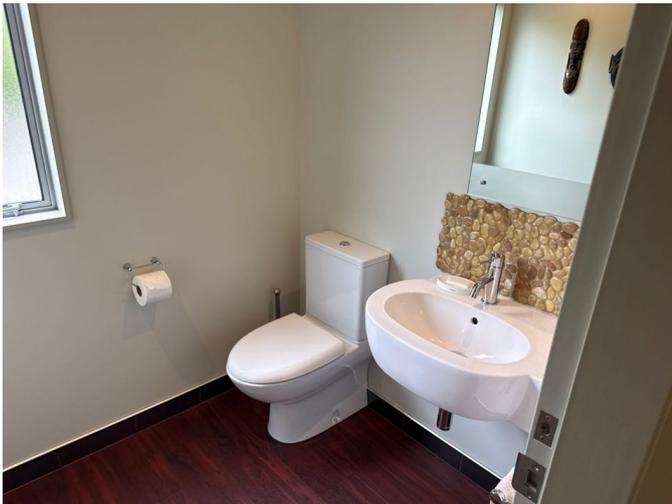
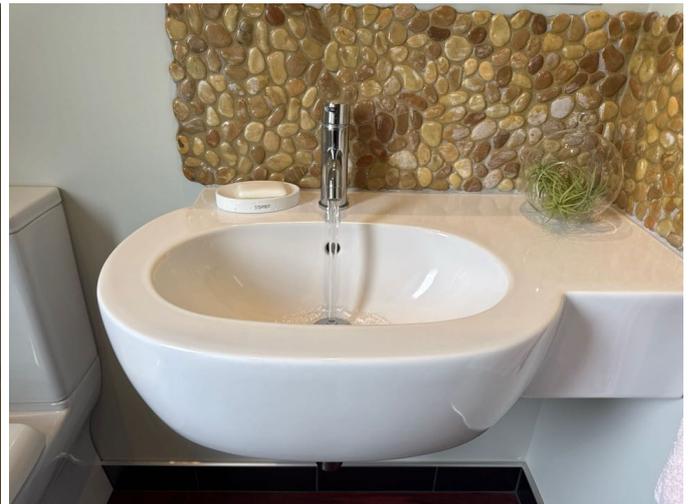
The sink is well sealed to the wall. The tap is functioning well. No visible concerns with the water feeds or waste beneath the sink.

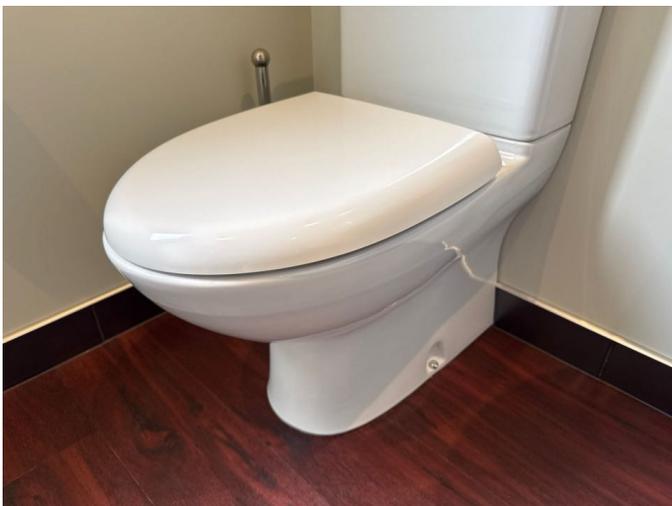
The base of the toilet is well sealed and is secure. The toilet is in a functioning condition.

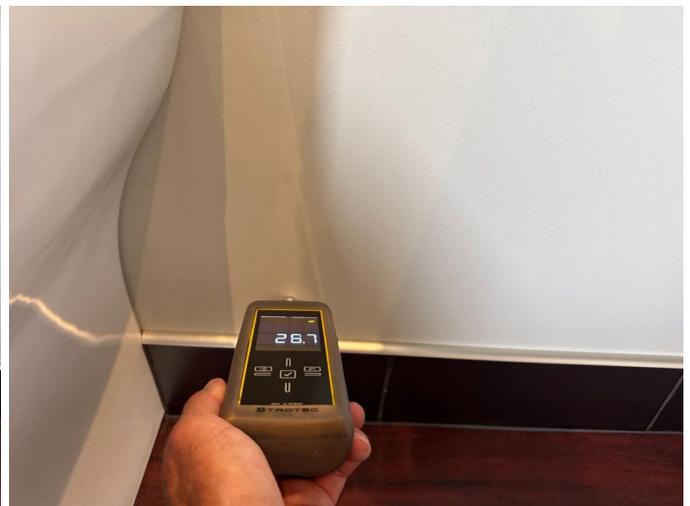
Moisture levels behind the toilet were within the normal range at the time of inspection

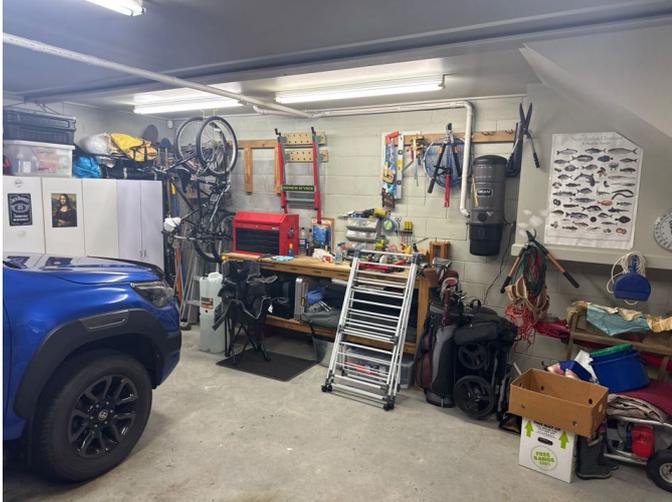
Not all areas of the garage could be fully inspected due to the presence of stored items. A full inspection is recommended once cleared. This applies to all concealed locations throughout the house.

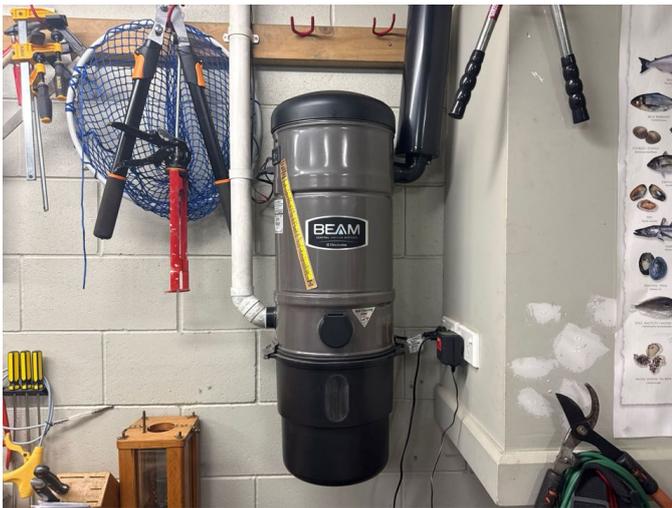
The central vacuum system is located in the garage. Untested.

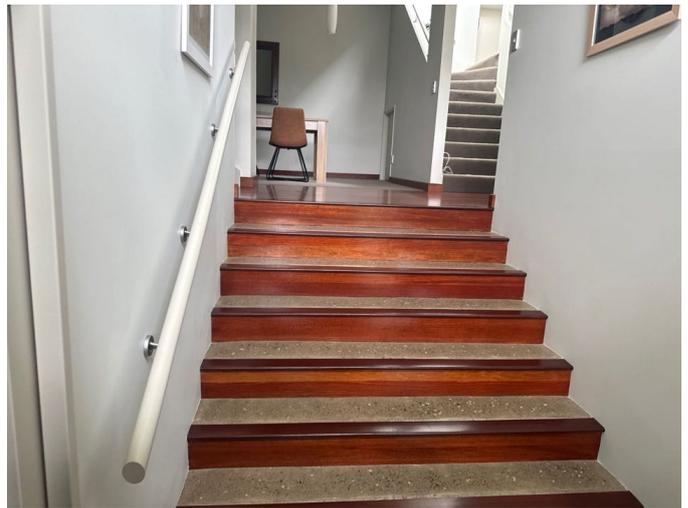
The timber stairs and handrail are solid and secure
