Independent Builders Report

Total Home Inspection Services Porirua City Ltd

Wed 28 Jan 2026

5 Miro Rd, Raumati South, Paraparaumu, 5032, New Zealand

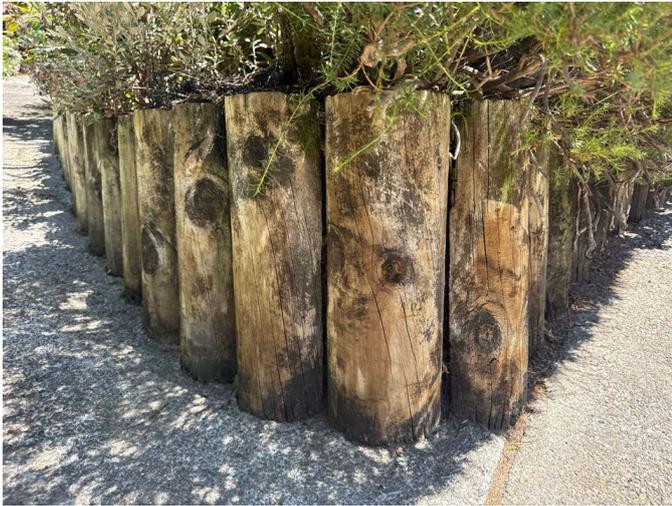
The condition of the retaining walls is consistent with the age of the property. The retaining walls will require ongoing monitoring. No signs of significant damage or movement at the time of inspection.

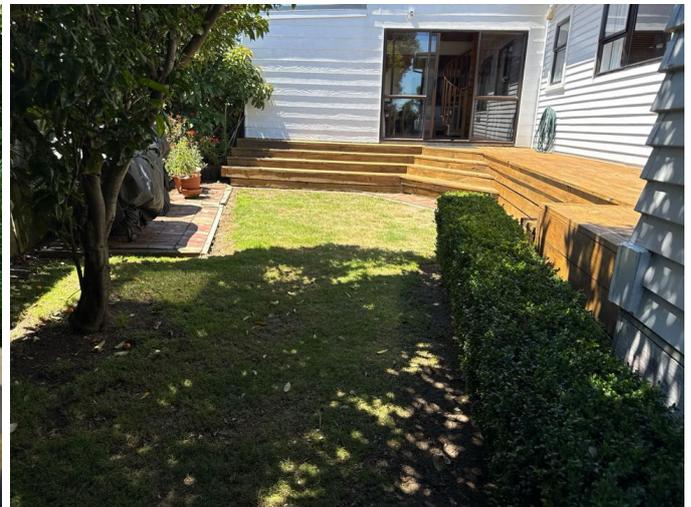
The section is tidy

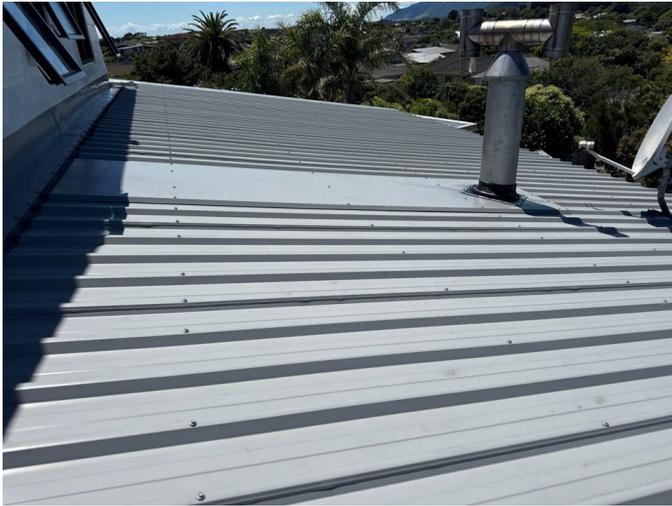
A once or twice yearly soft wash will help maintain the roofs surface condition and prevent premature deterioration

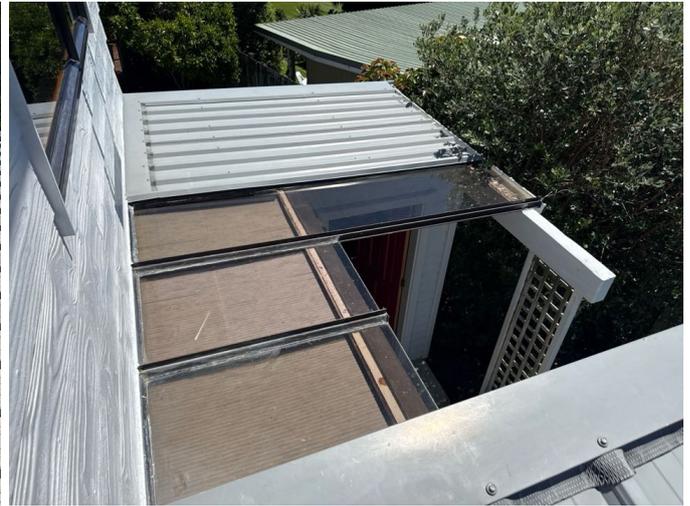
Sealant to the glass roof by the north entrance will need to be monitored over time

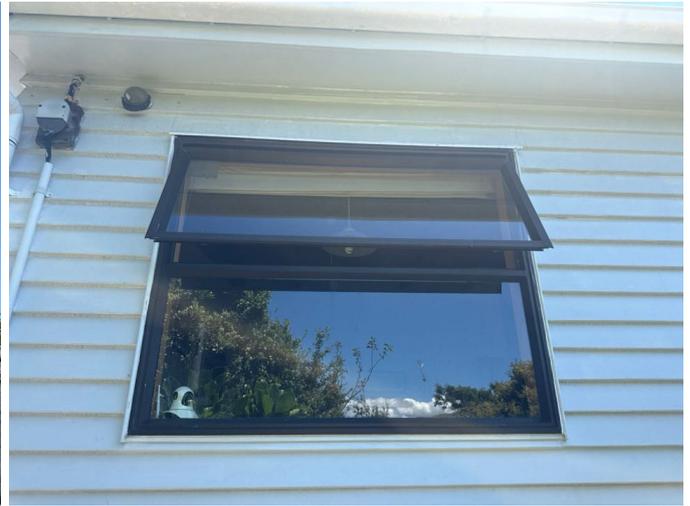
The typical single glazed aluminium window detail consists of a head flashing and timber scribes.

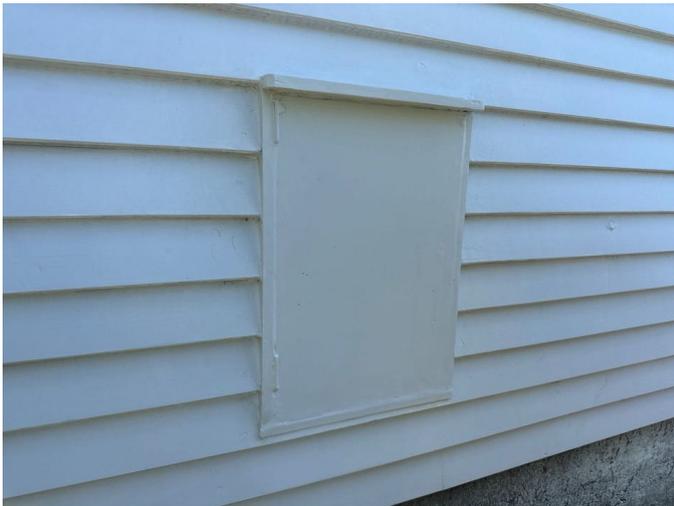
The old door has been sealed and is no longer useable

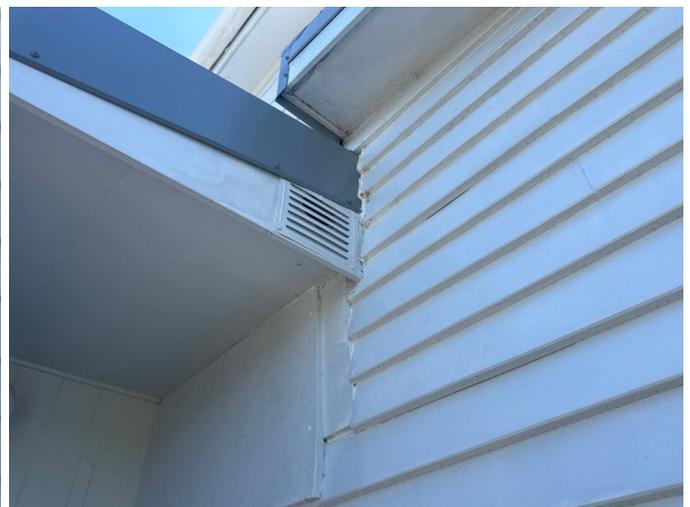
Extraction vents exit through the walls and soffits

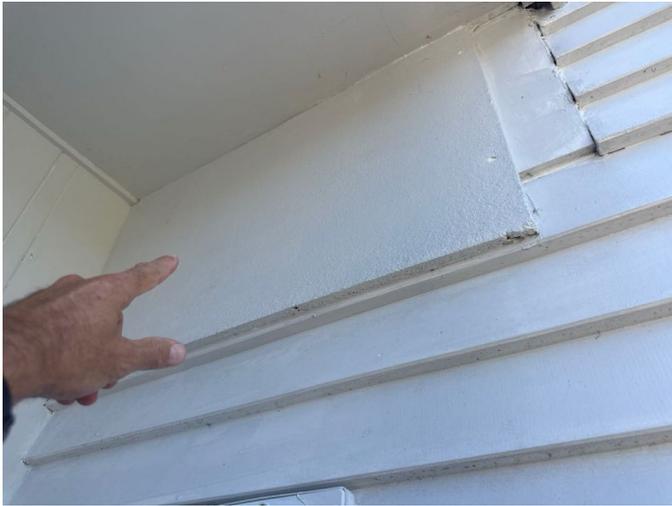
The particle board is not suited to outdoor use like this and will deteriorate if it is not kept well sealed. Effectively sealed at the time of the inspection.

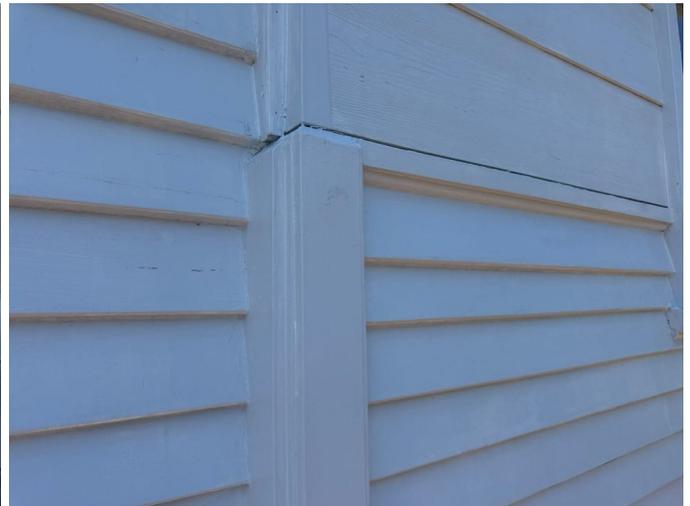
Cladding junctions such as this appear to be effectively sealed

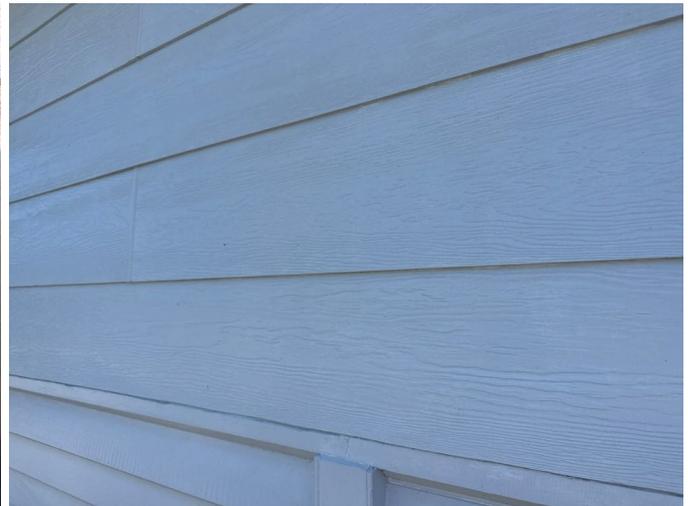
Due to the age of the home, some of the materials installed may contain elements of Asbestos. Please note this is safe in an inert state and must be kept well sealed. If any work is to be completed in areas that likely contain Asbestos then there are certain health and safety precautions that should be followed.

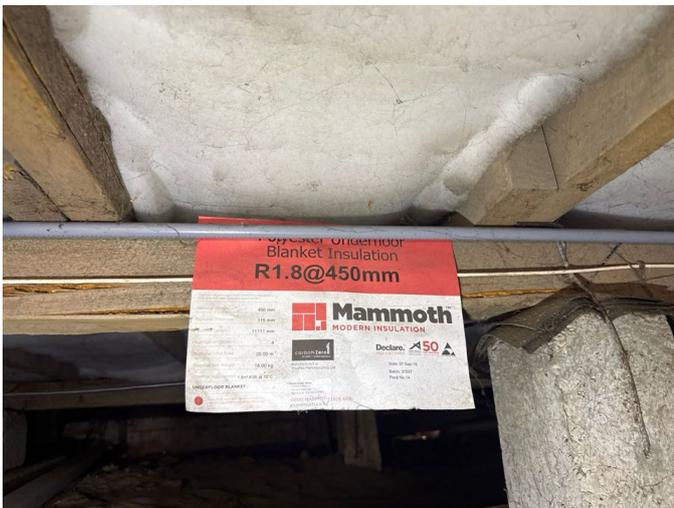
Polyester insulation is installed in the sub floor. The thermal resistance rating or R-Value is the measure used most commonly in the building and construction industry to determine a material's ability to resist the transfer of heat. The higher the R-Value the better thermal resistance the product will provide.

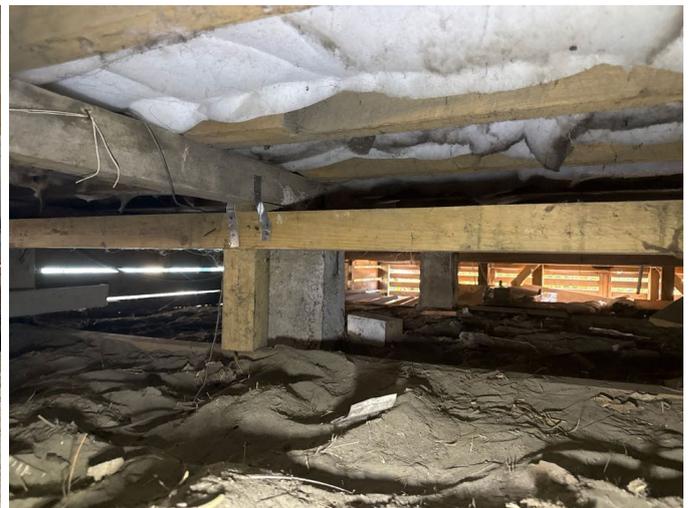
The timber supports which have been added are solid and secure

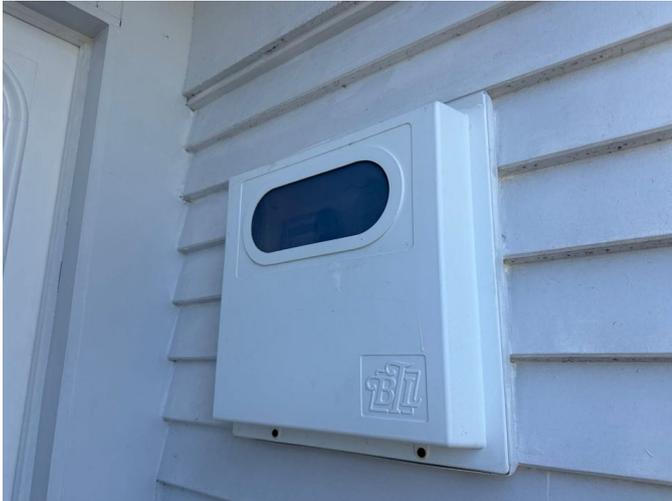
The meter board is well sealed and protected under the entrance soffit

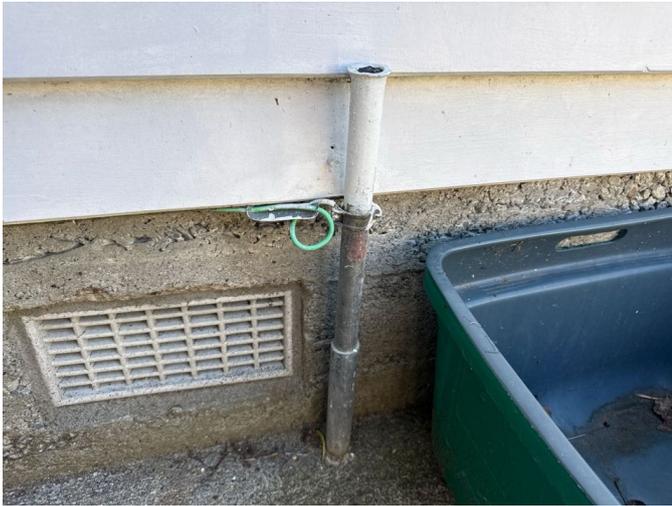
The electrical earth rod provides a safe path for fault currents to dissipate into the ground, helping protect people and equipment from electric shock and reducing the risk of damage during faults or lightning strikes. An earth loop test should be considered to determine the earth's effectiveness.

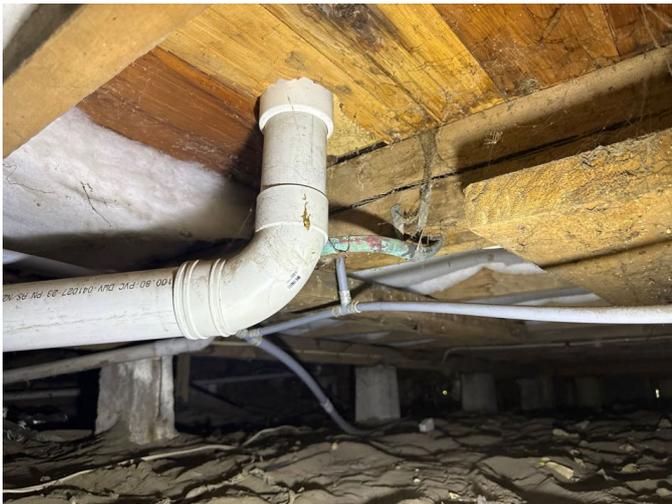
There was no evidence of current leaks under the plumbed areas

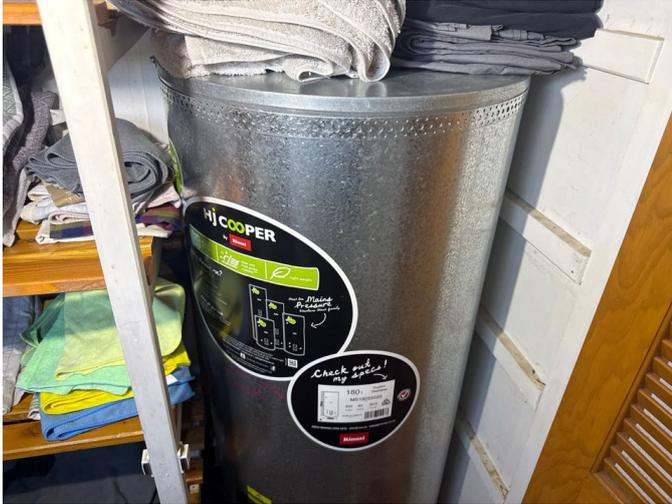
Hallway cupboard.
Rinnai 180L Mains Pressure Electric Hot Water Cylinder. Seismic restraints installed.
The pressure-reducing valve that is located at the side of the mains pressure hot water cylinder should be tested every 6 months or in accordance with the manufacturer's instructions to make sure that it is in working order.

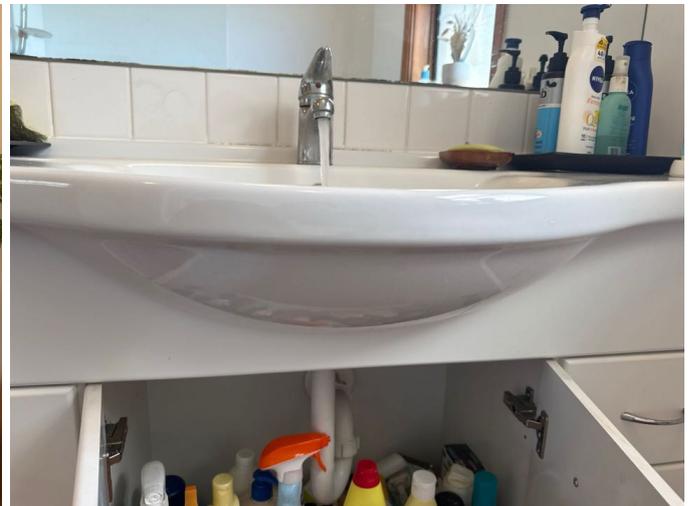
The rear edge of the vanity is well sealed. The tap is functioning well. No concerns with the water feeds or waste under the vanity

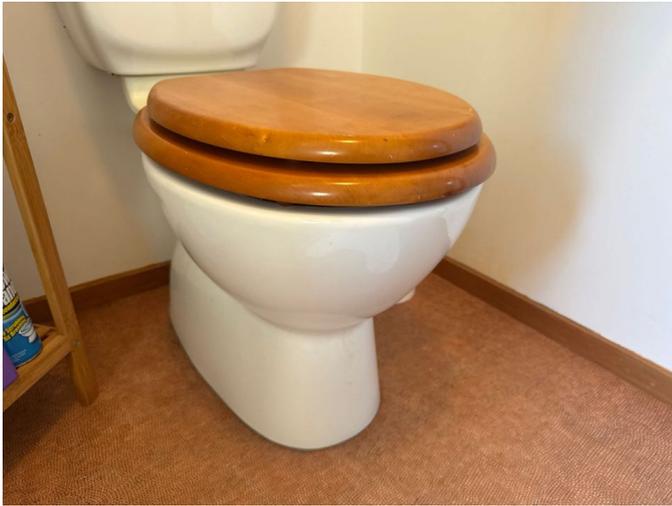
The base of the toilet is well sealed and secure. The toilet is in a functioning condition.

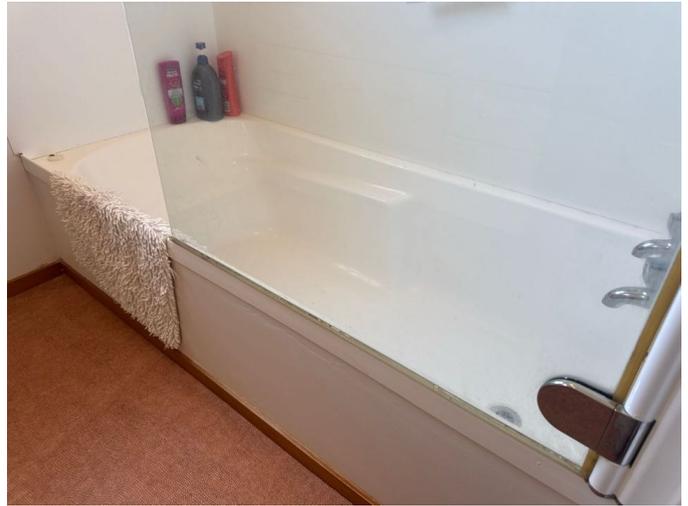
The perimeter of the bath is well sealed. The taps are functioning well.

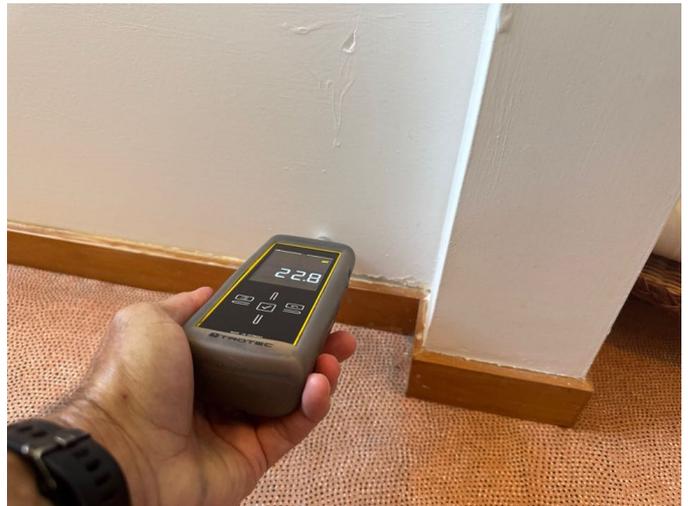
The common fail areas of the shower and plumbed areas were checked for elevated moisture. Moisture levels were within the normal range.

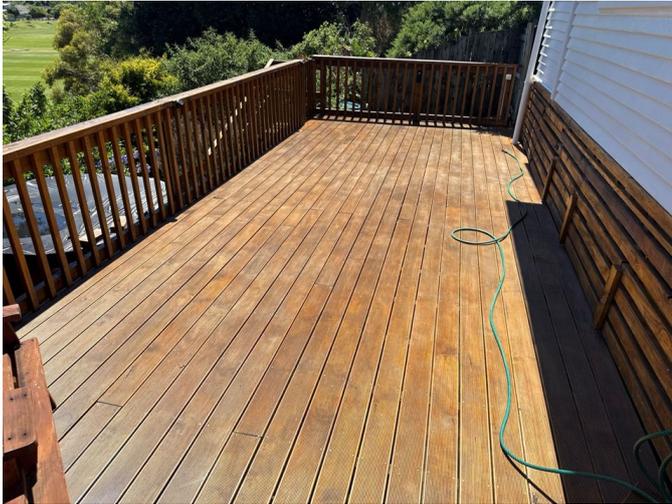
The decking is in good condition

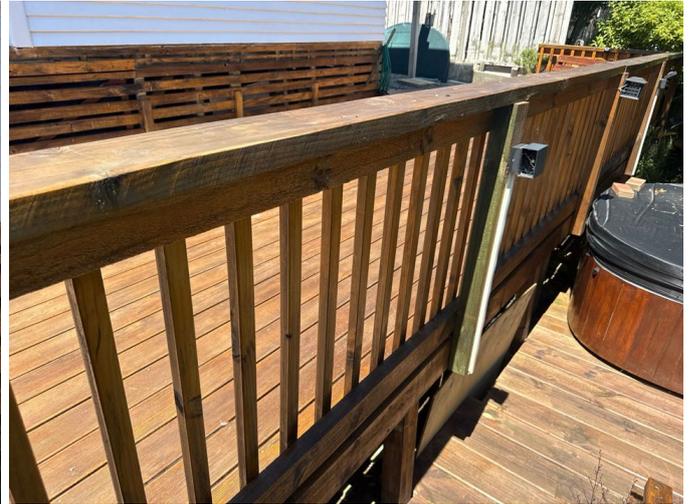
The balustrade is solid and connected sufficiently at the base

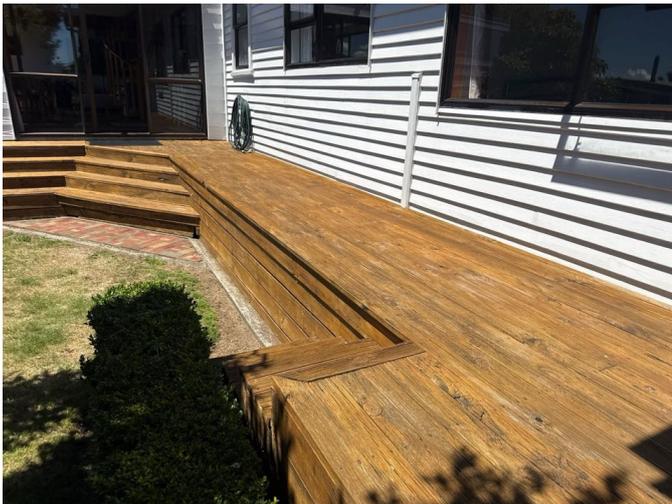
The decking has some age related wear but no significant damage. The main deck struts could not be fully accessed or inspected due to the lack of space.

The deck has been directly fixed through the cladding which was common at the time of construction. There is a risk that the timber will eventually rot out therefore ongoing monitoring will be required. If installed now there would need to be a clearance gap of approximately 12mm to allow water to escape. No current concerns found.

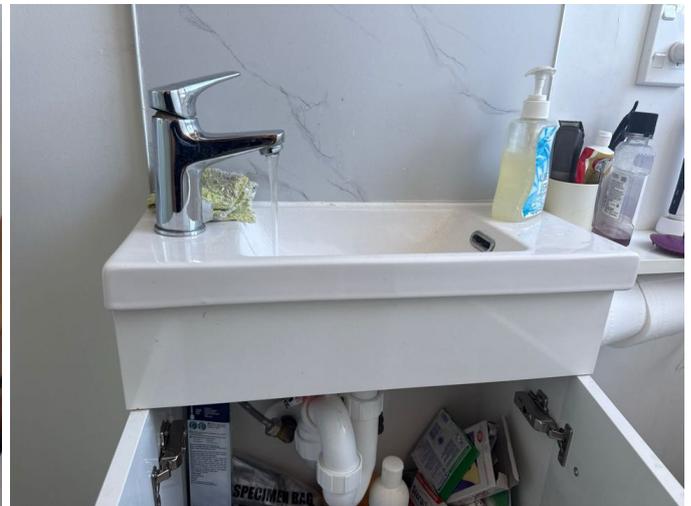
The rear edge of the vanity is well sealed. The tap is functioning well. No concerns with the water feeds or waste under the vanity

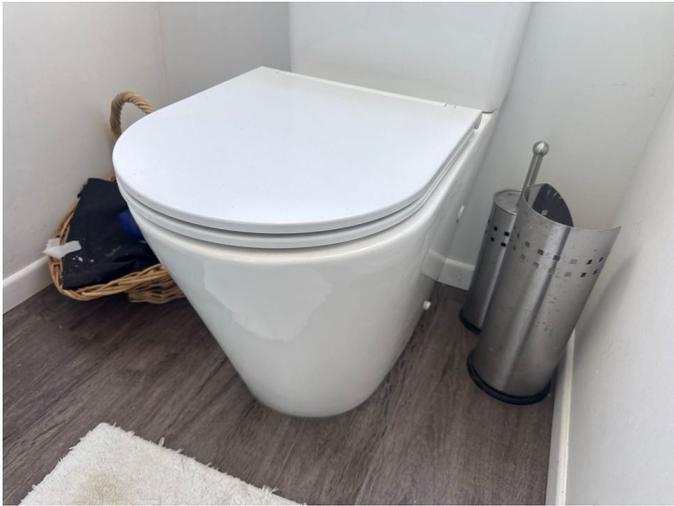
The base of the toilet is well sealed and secure. The toilet is in a functioning condition.

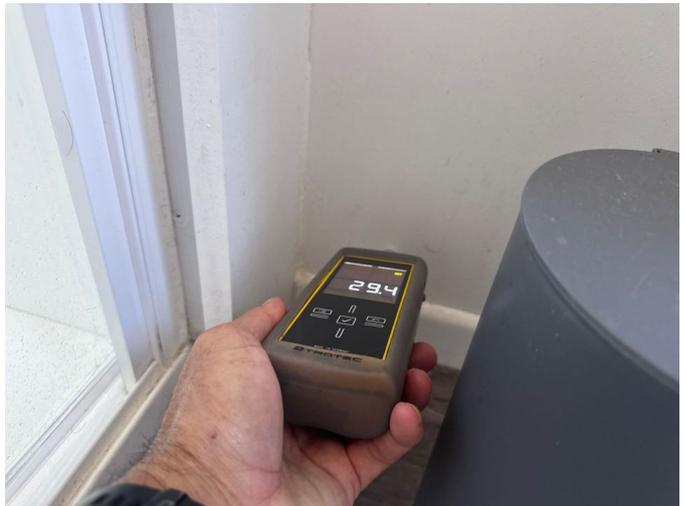
The common fail areas of the shower and plumbed areas were checked for elevated moisture. Moisture levels were within the normal range.

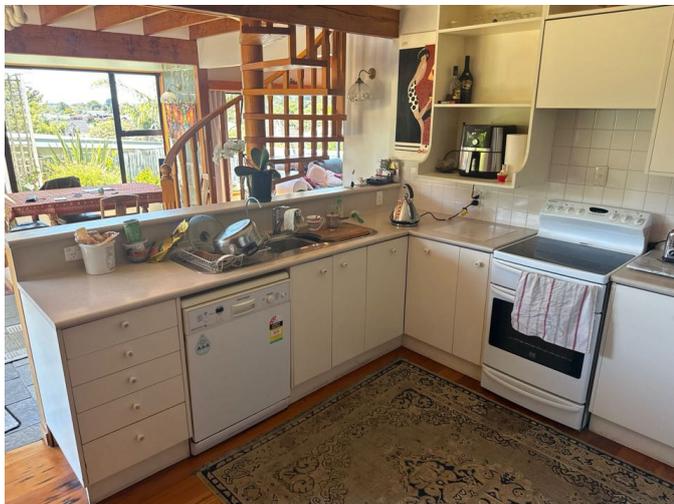
The rear edge of the bench top is well sealed. The taps are functional. No concerns with the water feeds or waste pipes under the sink. Water filtration system installed. Regular servicing recommended to ensure a clean water supply is maintained.

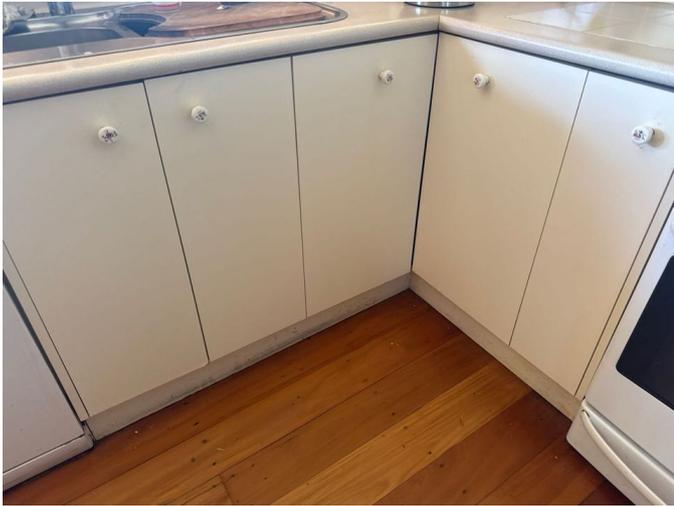
The kitchen cabinetry and timber floor are in a tidy condition

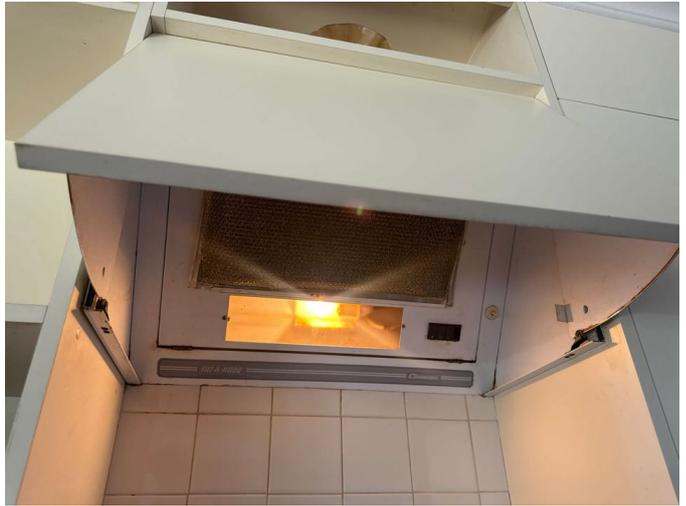
The range hood extraction unit is functioning

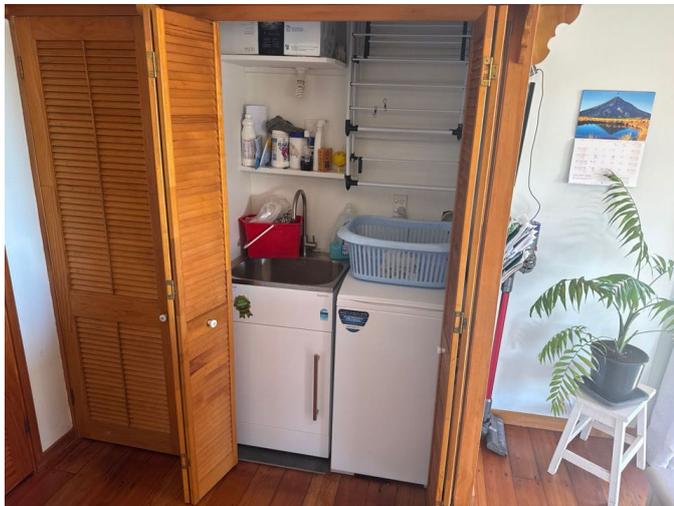
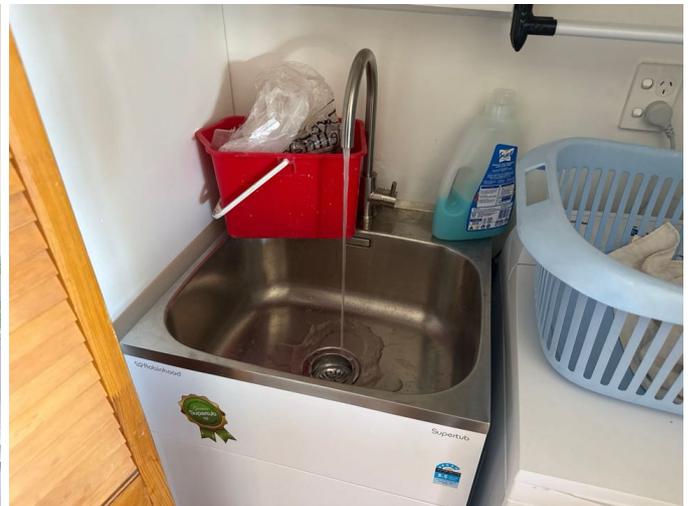
The tub is visibly in good condition and is functional

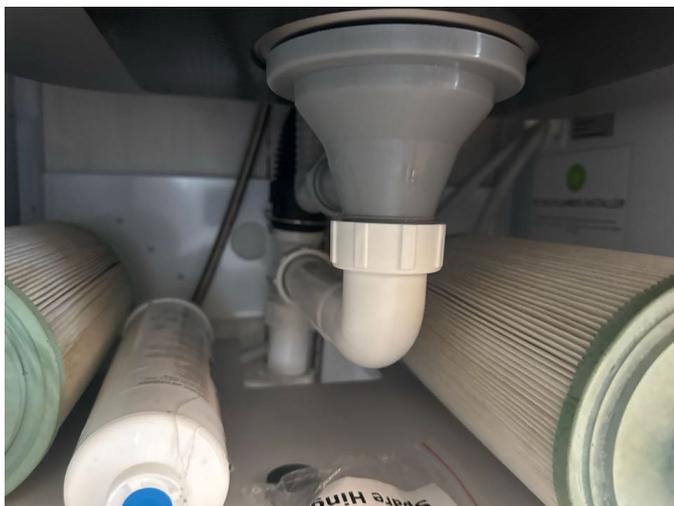
No concerns with the waste or water feeds beneath the tub

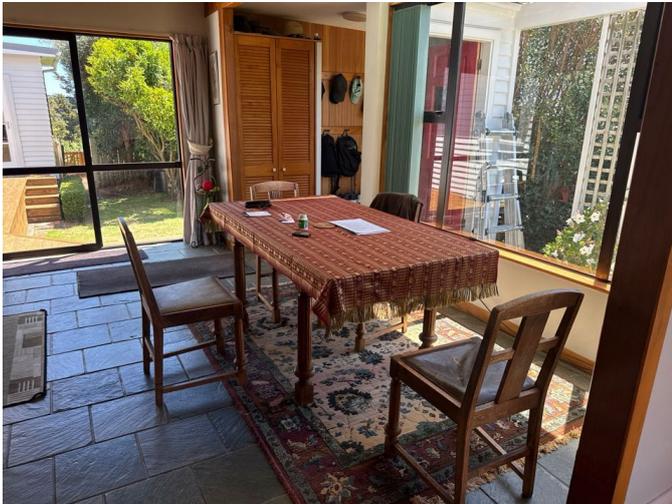
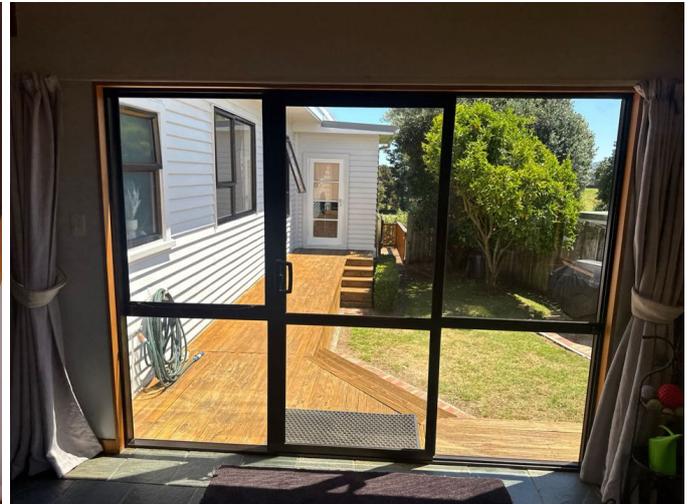
The sliding door and windows are functional

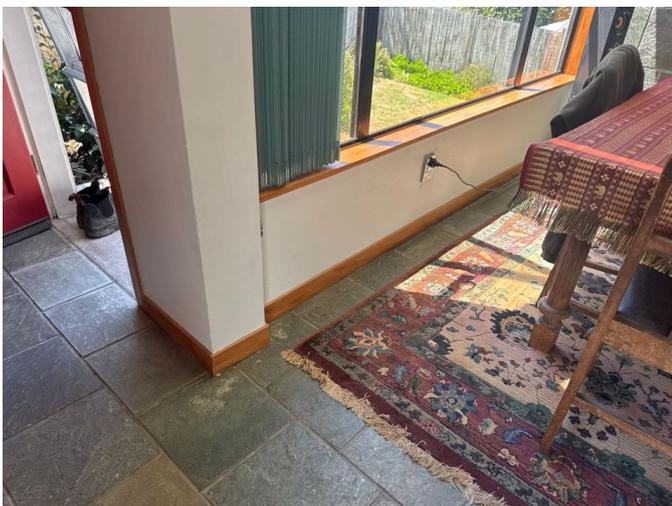
The wall and ceiling linings and tiles are in a tidy condition

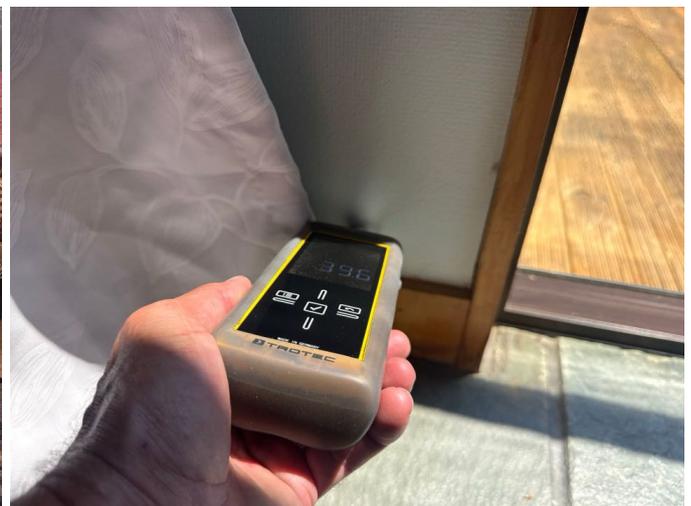
Moisture levels to the external walls were within the normal range at the time of inspection

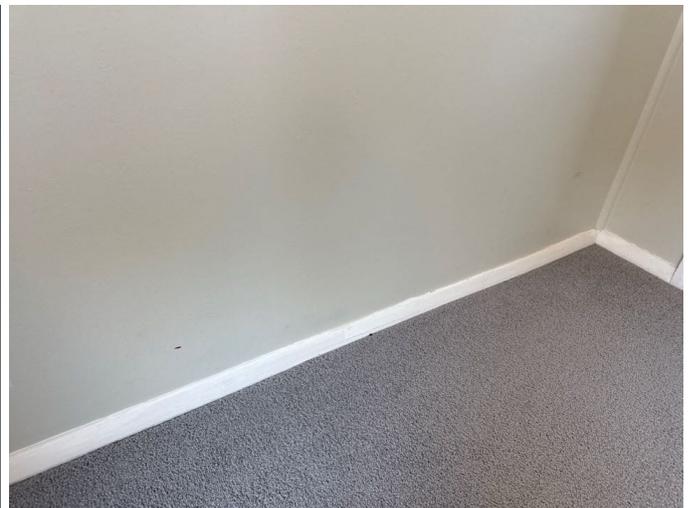
The wall and ceiling linings and carpet are in good condition

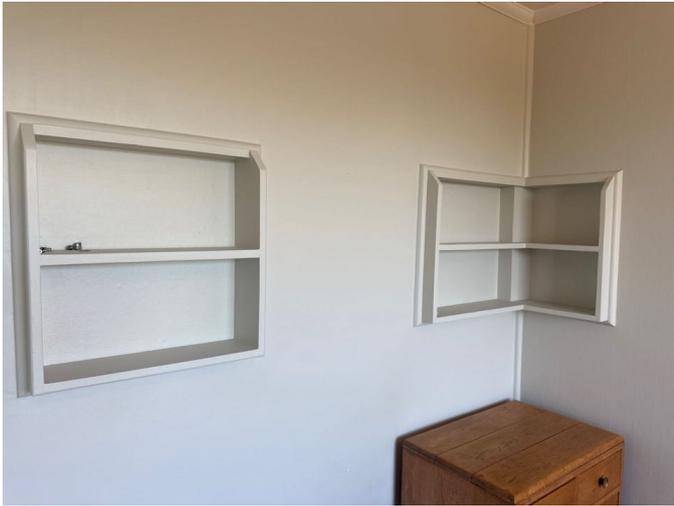
Built in shelving noted

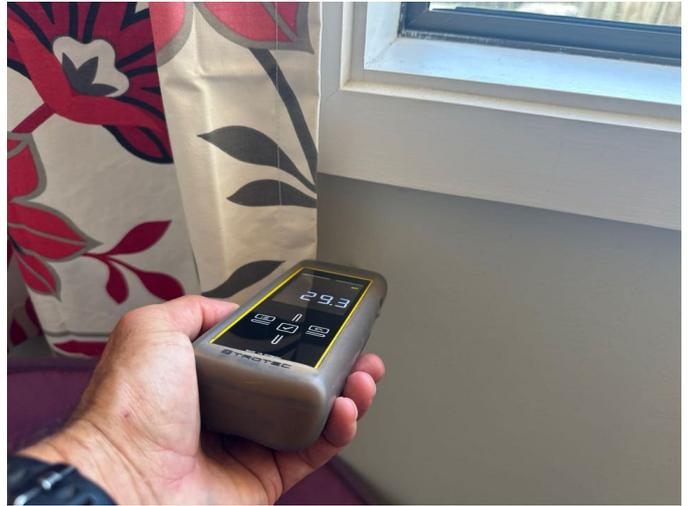
Moisture levels to the external walls were within the normal range at the time of inspection

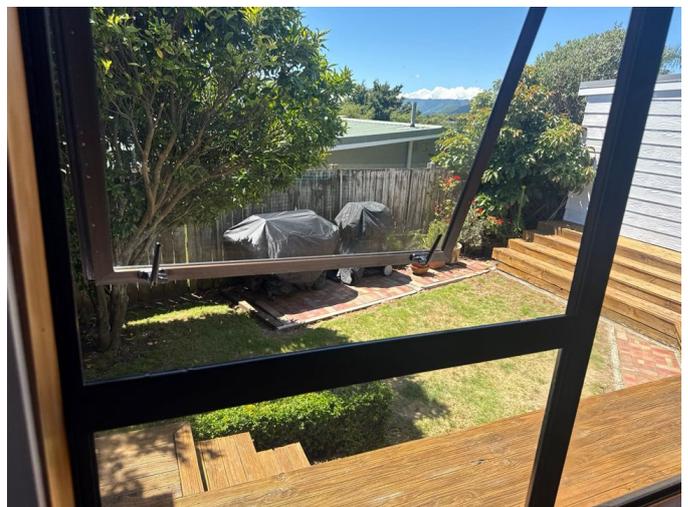
The windows are functional

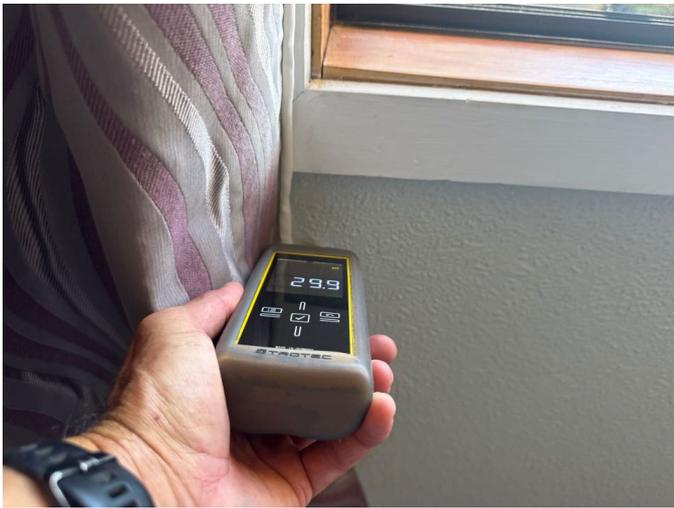
Moisture levels to the external walls were within the normal range at the time of inspection

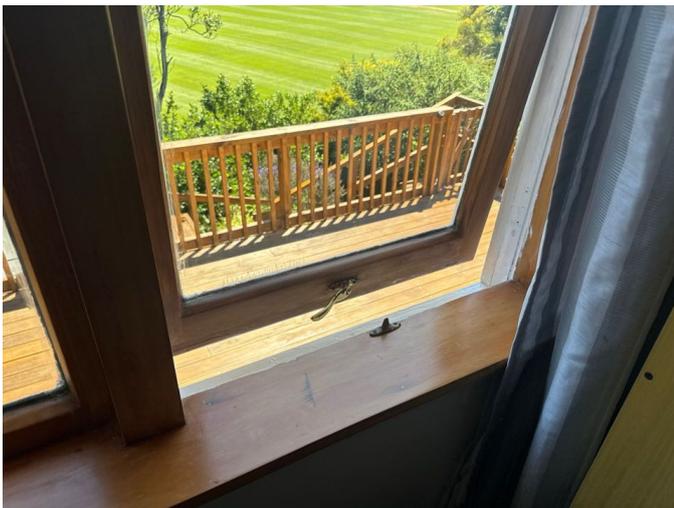
The timber windows are functioning well

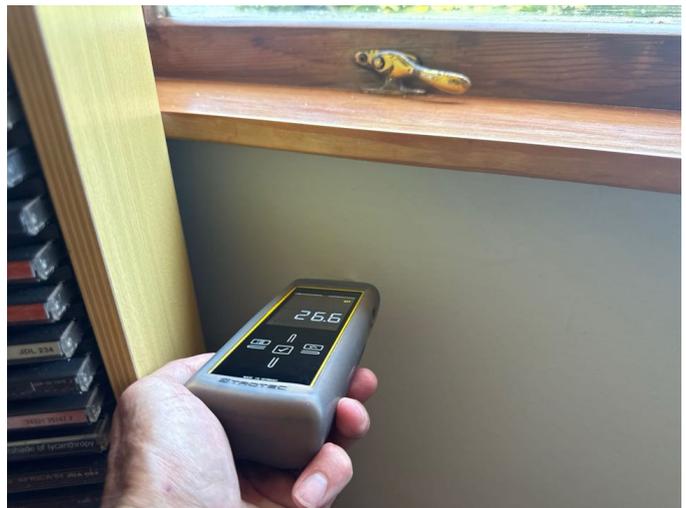
Moisture levels to the external walls were within the normal range at the time of inspection

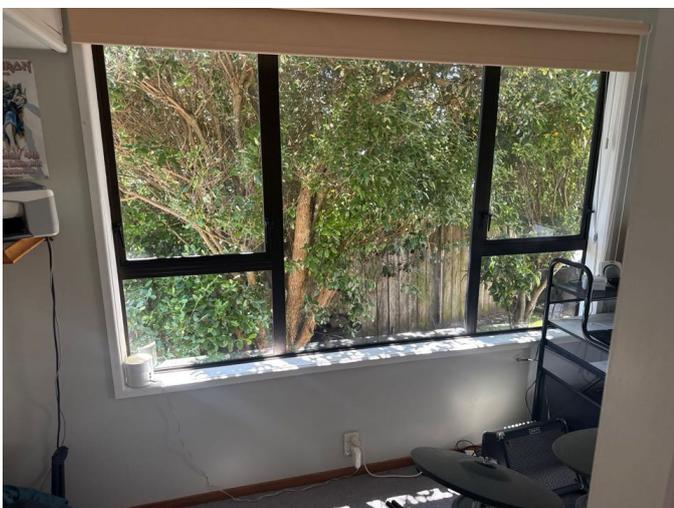
The room off bedroom 3 is tidy. There were no concerns found.

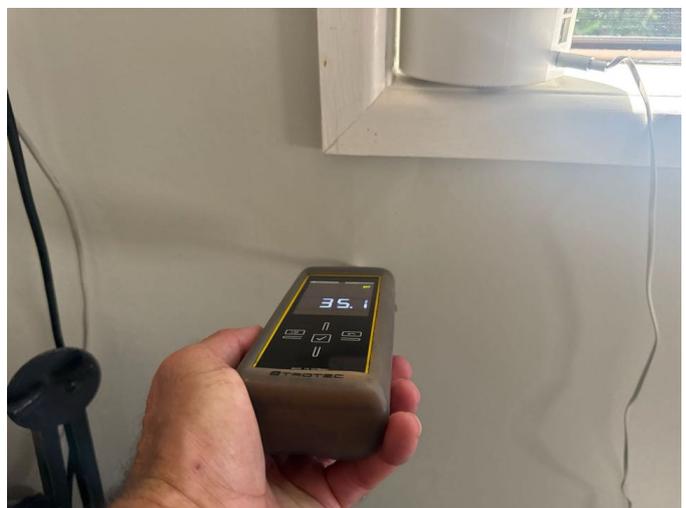
Moisture levels to the external walls were within the normal range at the time of inspection

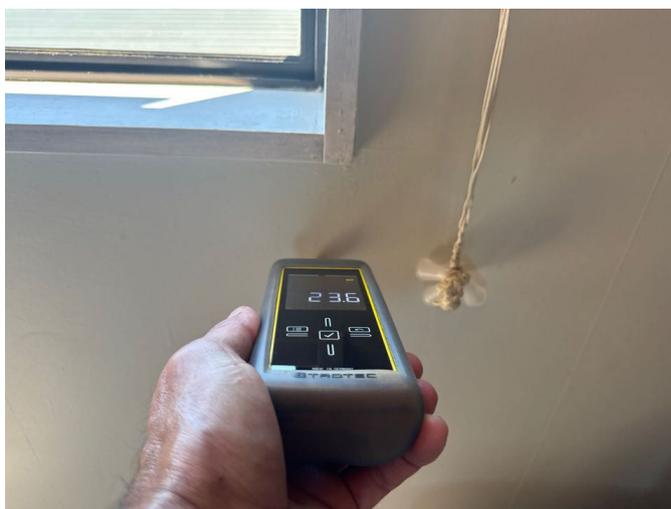
Moisture levels to the external walls were within the normal range at the time of inspection

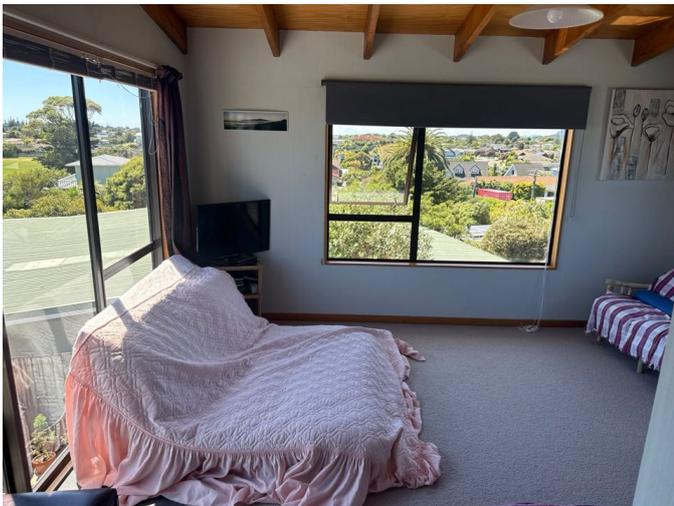
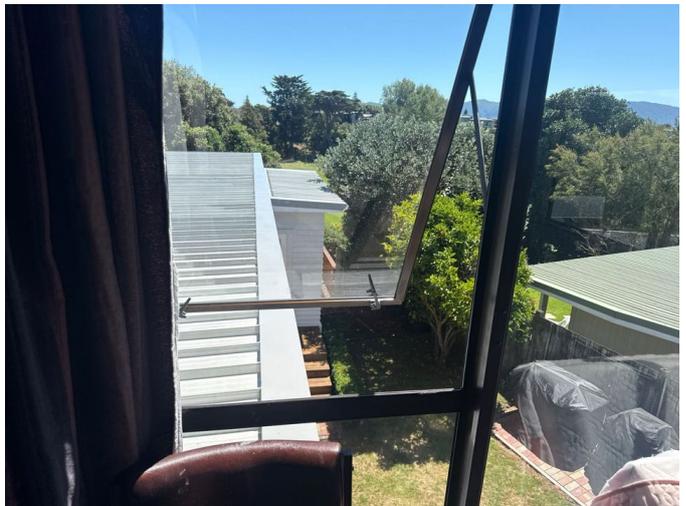
The windows are functional

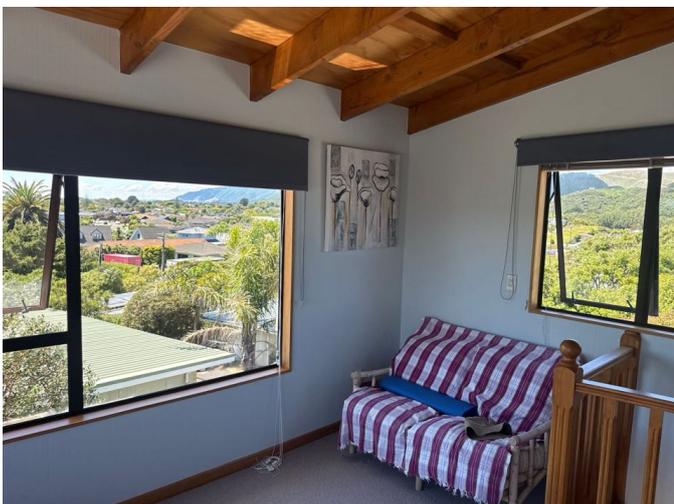
The wall and ceiling linings and carpet are in a tidy condition

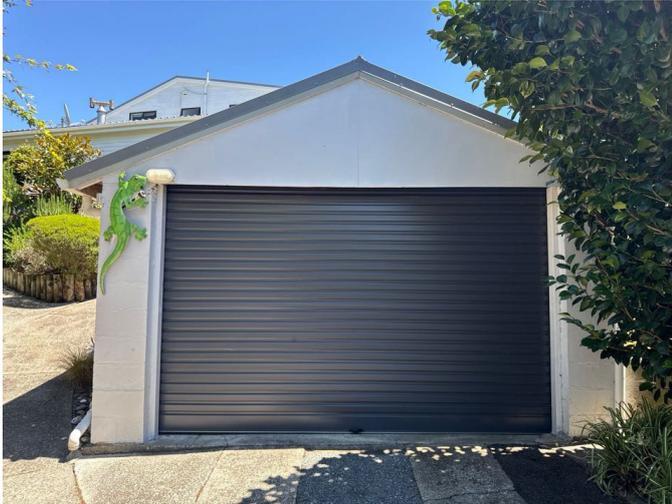
The surface condition of the garage door is good

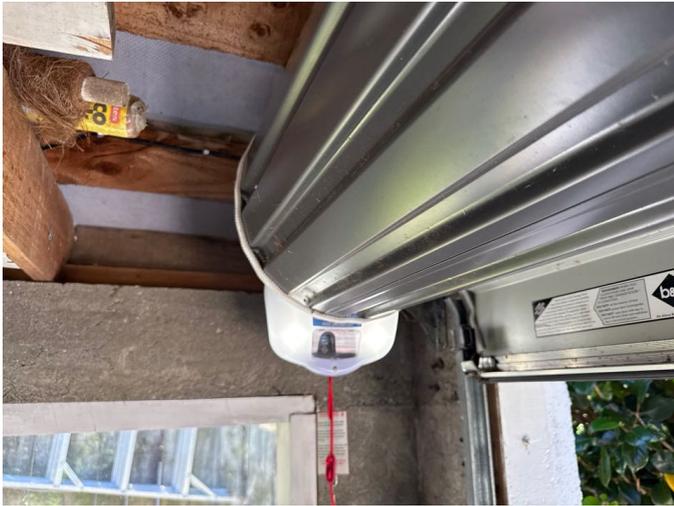
The electric garage door is functioning

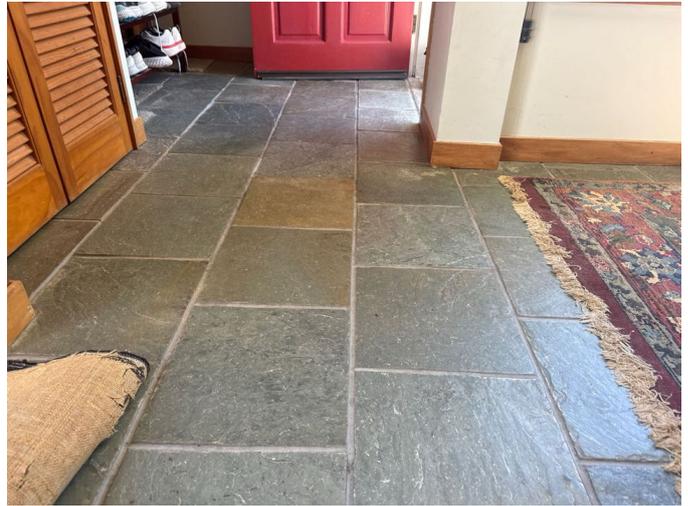
The tiles to the entrance are intact and are well adhered to the floor

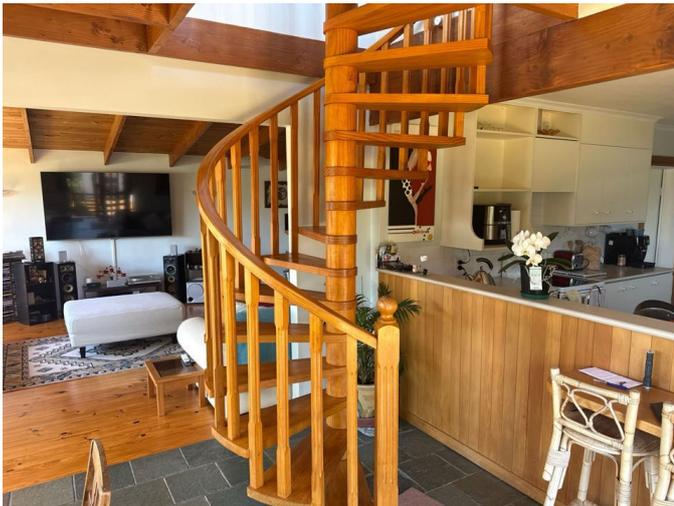
The spiral staircase is solid and secure

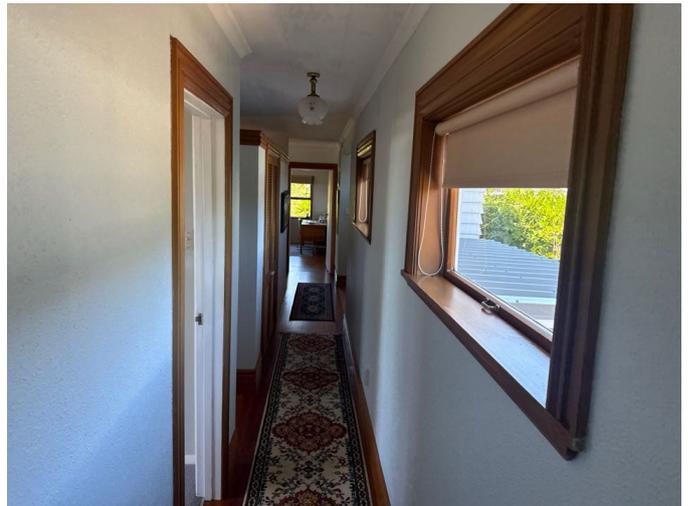
The hallway is tidy

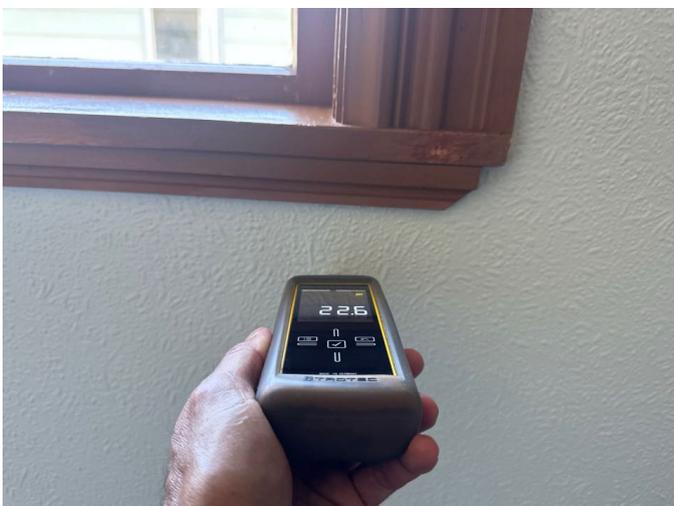
The moisture levels beneath the hallway windows were in the normal range
