BUILDING INSPECTION REPORT

26 Jan 2026 / 26 Taumutu St

Pre-Purchase/Sale Visual Non-Invasive Property Inspection

Eye Spy Property Inspections
Pre sale building report
26 Taumutu St, Southbridge

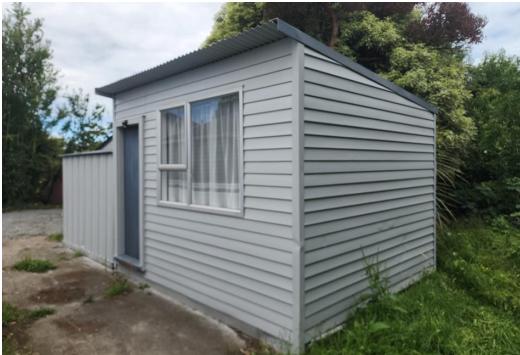
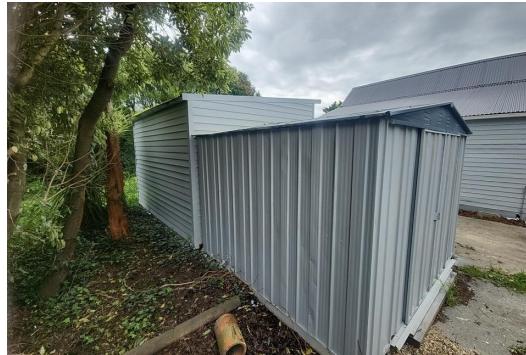
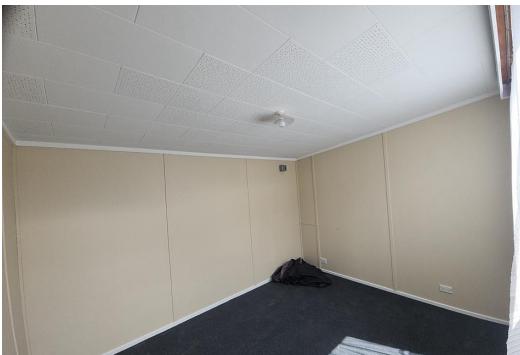
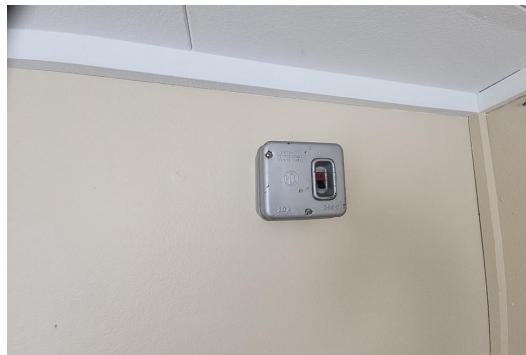
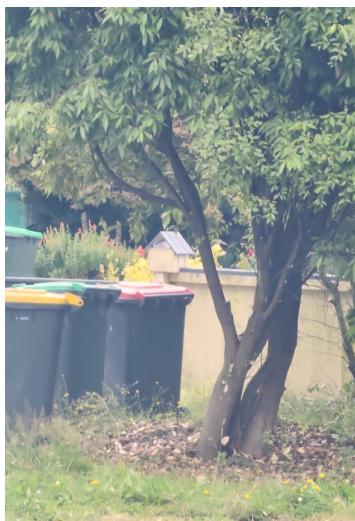
Detached studio with attached garden shed is constructed of timber frame with corrugated iron roof with
Private & confidential

steel cladding on a timber floor structure appears in average condition typical for age

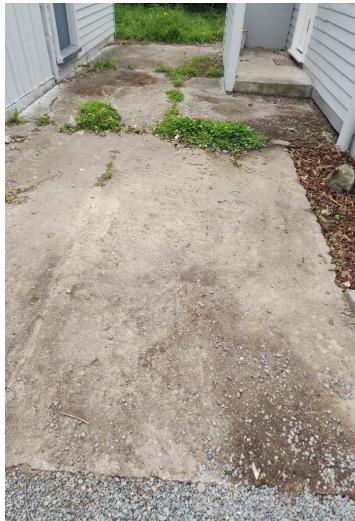
Photo 21

Relatively new timber decks appear in sound usable condition.
Older concrete appears in average but usable condition with cracking and movement typical for age

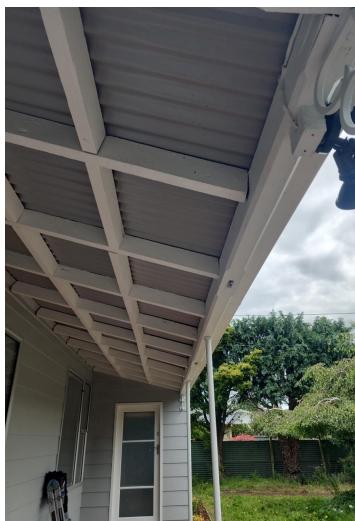
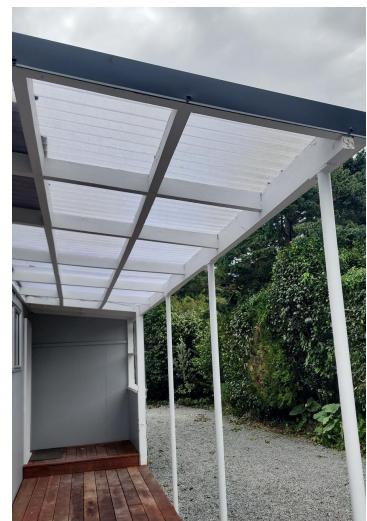
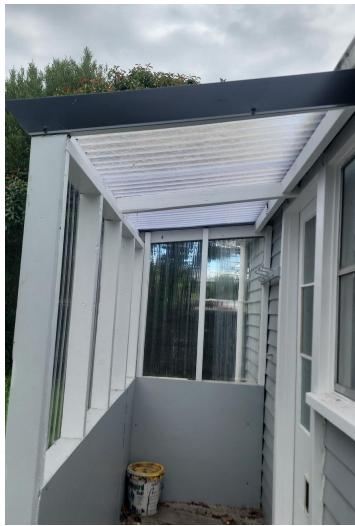
Attached varandas appear generally sound typical for age

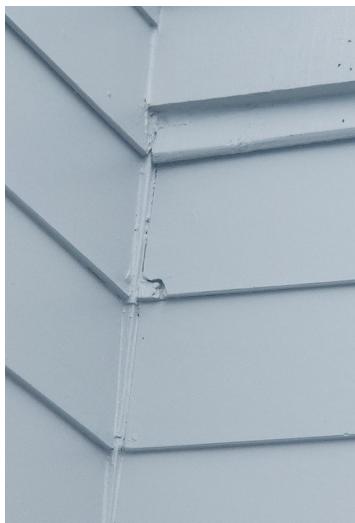
Photo 34

Painted fibrecement weatherboard appears generally sound with wear and tear typical for age

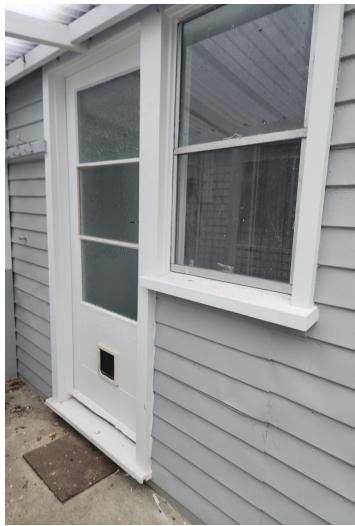
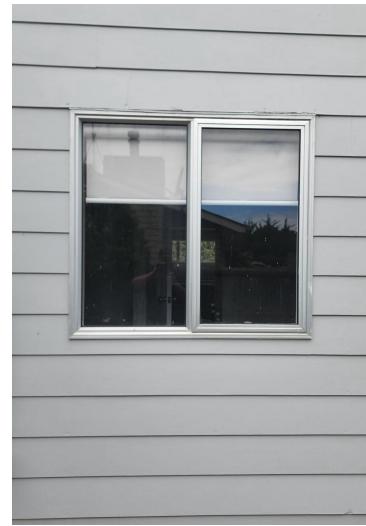
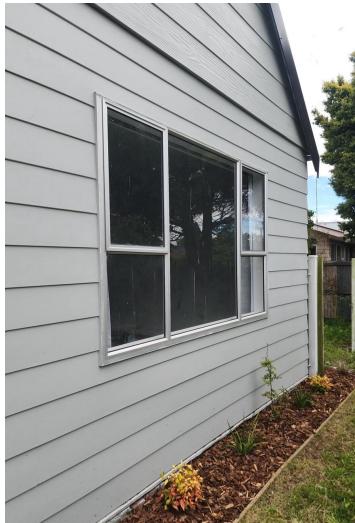
Painted timber single glazed appear typical for age.

Aluminium single glazed appear typical for age

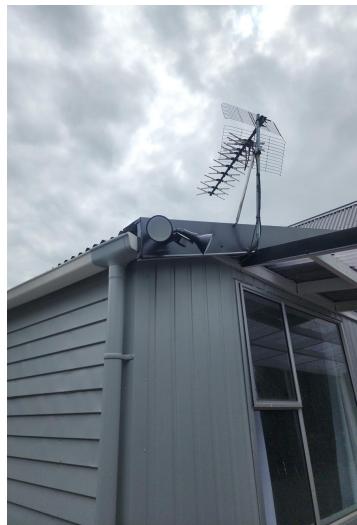
Painted timber fascia.
Only small or no soffits

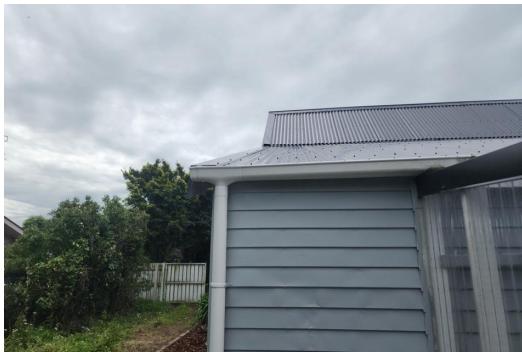
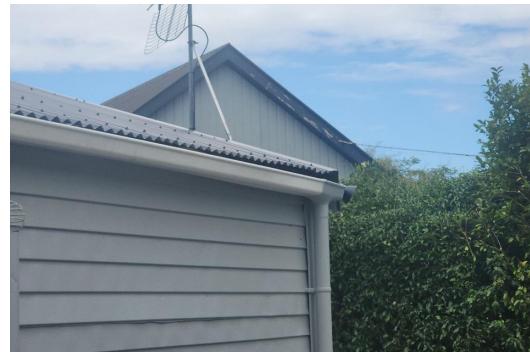
PVC spouting and downpipes

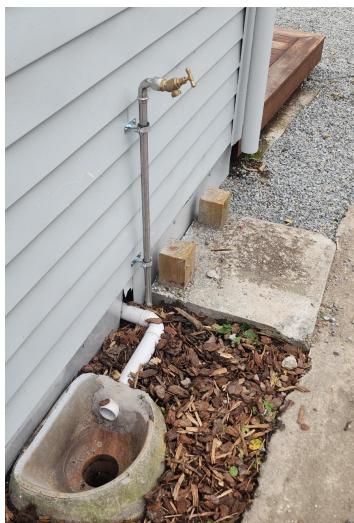
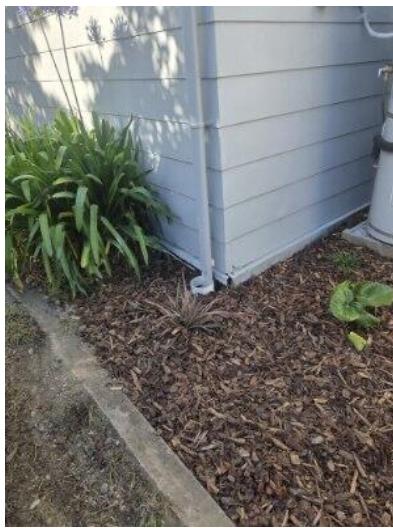
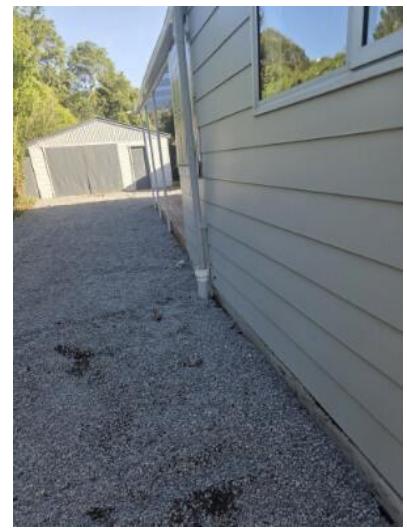
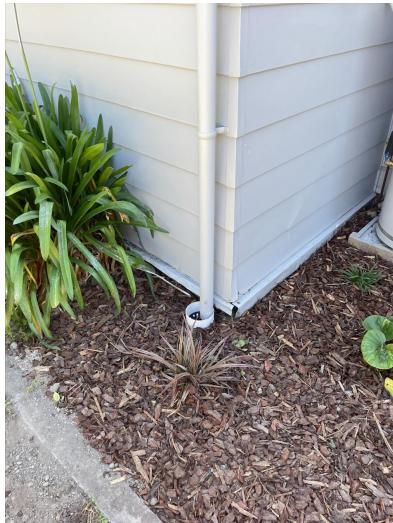
Downpipes fall to clay storm water risers. Some fall to ground.
Gully traps clear

No guarantees can be given regarding the integrity of the underground pipes (if any) due to seismic or historical damage and/or blockage.
Due to the seismic events, it is advisable to have the underground drains CCTV inspected.

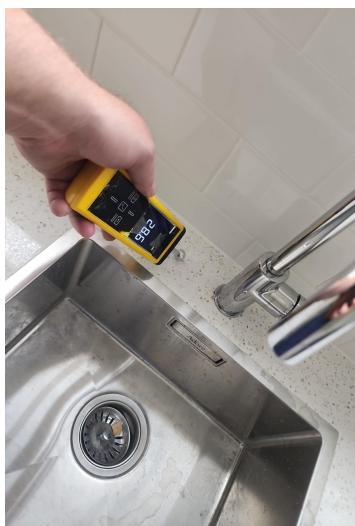
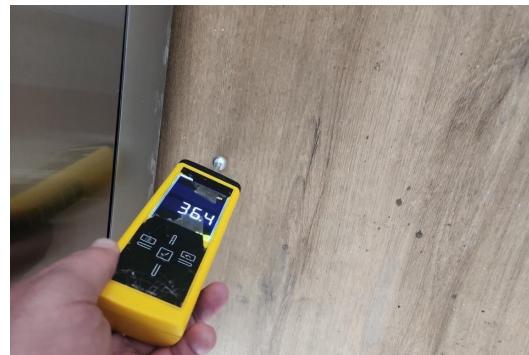
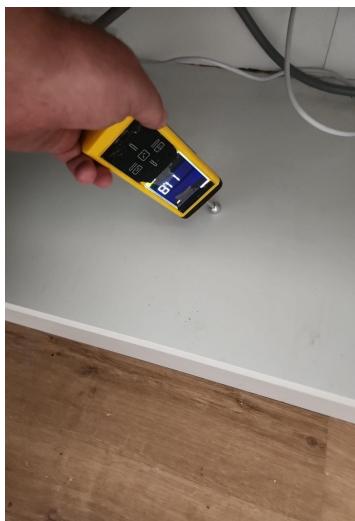
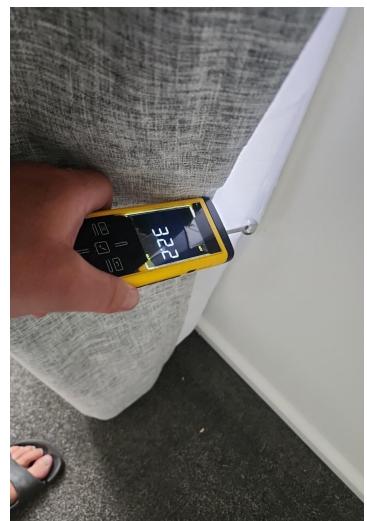
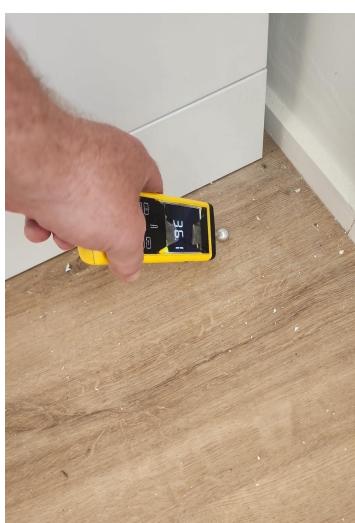
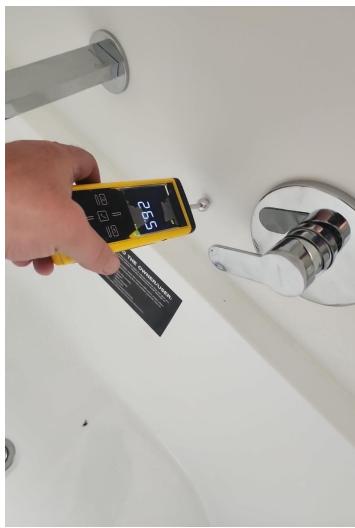
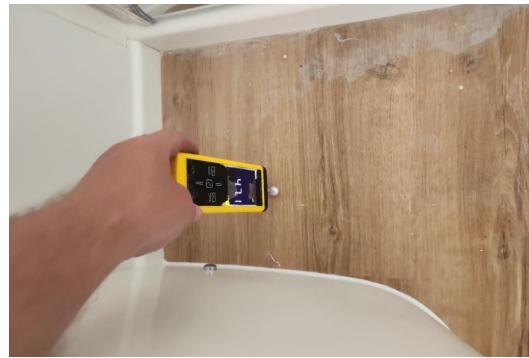
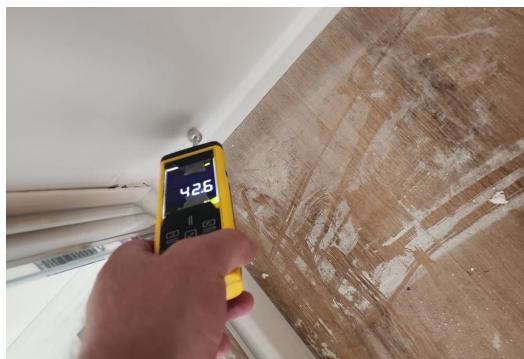
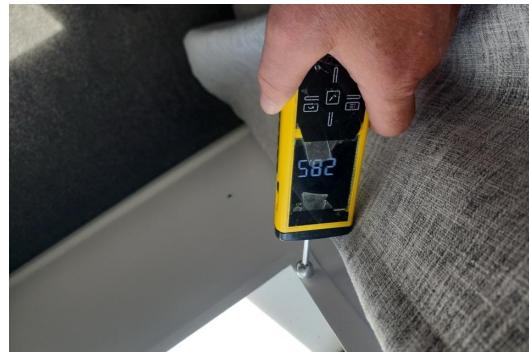
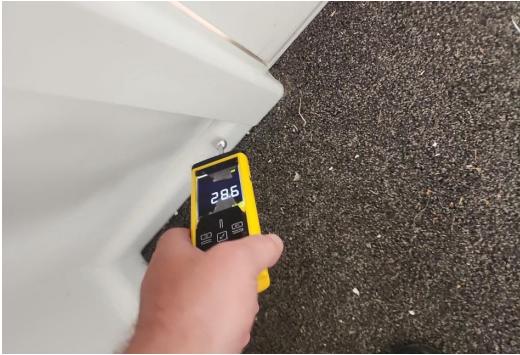
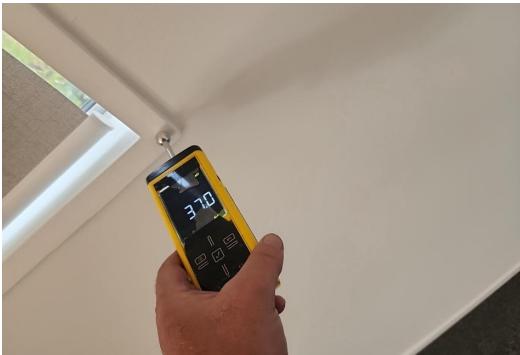
Tested low at time of the time of the inspection

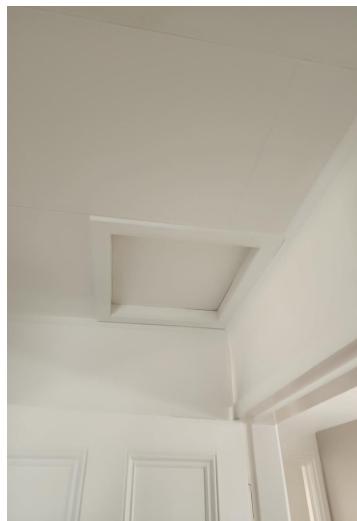
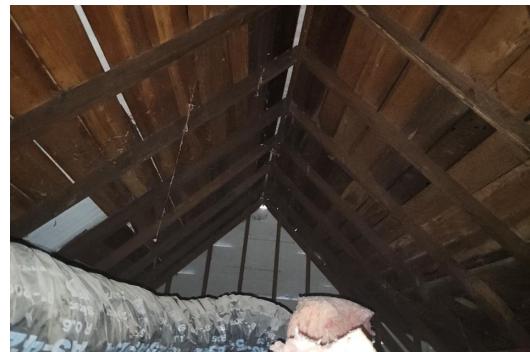
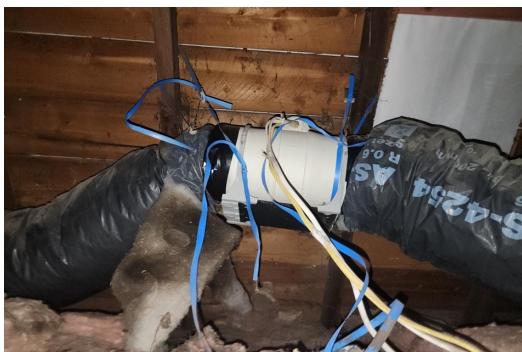
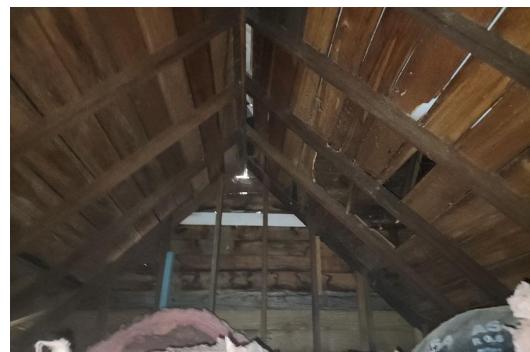
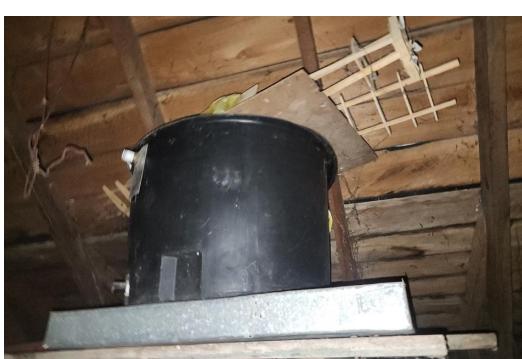
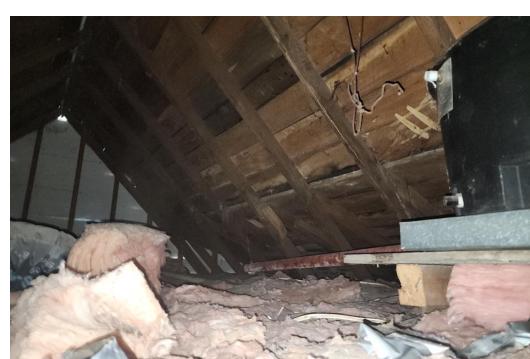
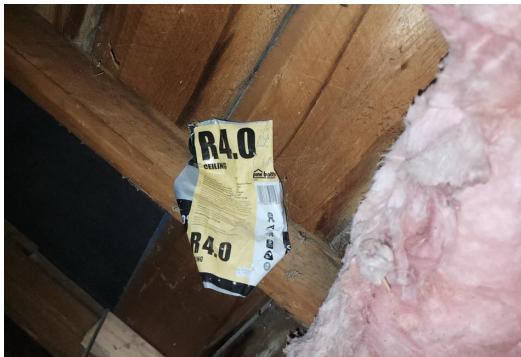
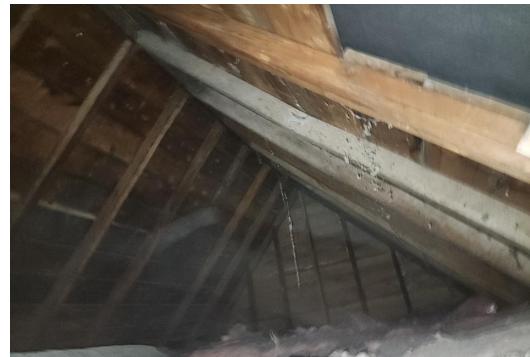
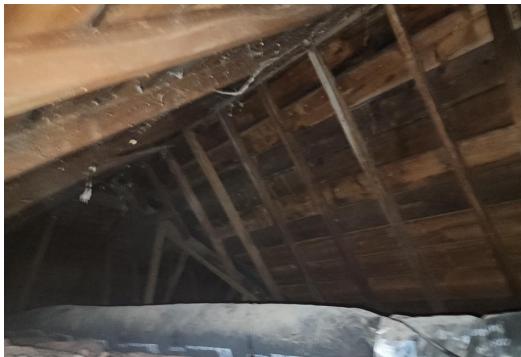
This is a pitched roof with corrugated iron over building paper over timber sarking over timber rafters and joists appears typical for age.

Insulation is fibreglass batts approximately 200mm thick between joists

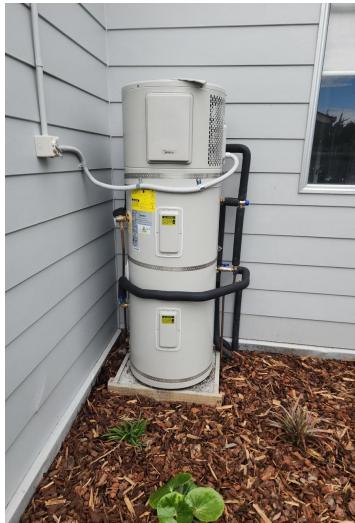
Photo 88

External mains pressure cylinder

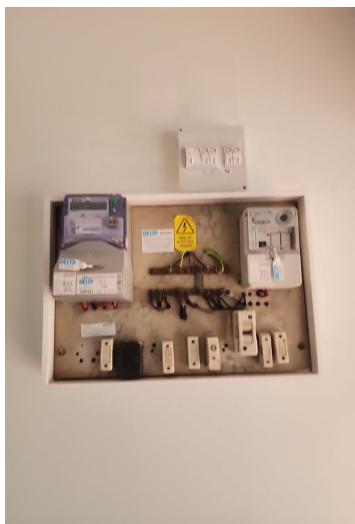
Photo 89

Switchboard in bedroom has fuses and mini circuit breakers. Power was on at time of the inspection

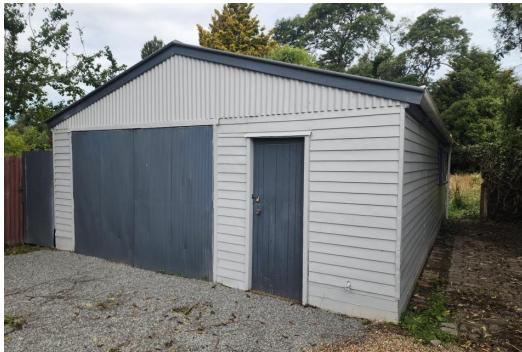
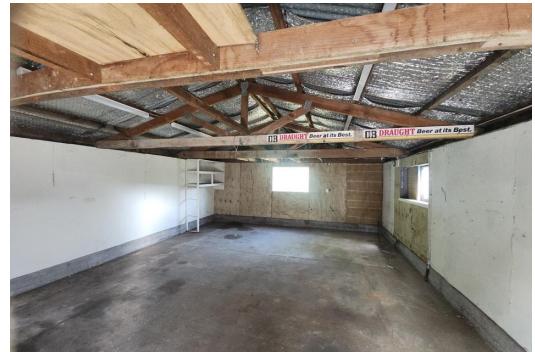
Detached double garage

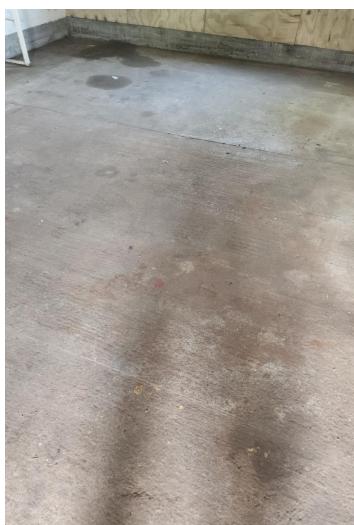
Photo 93

Concrete

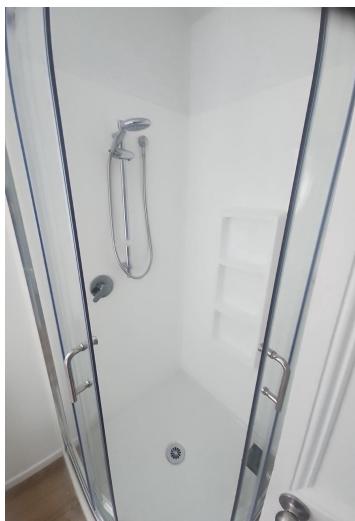
Photo 132

Plumbing Fittings appear in sound usable condition with good hot water pressure

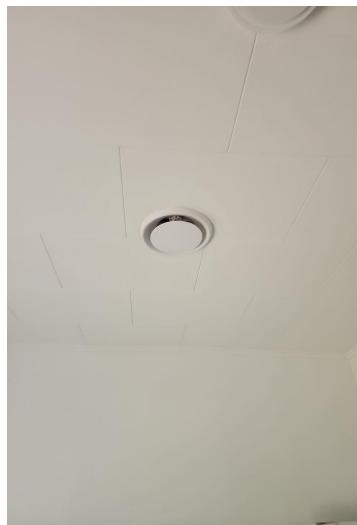
Photo 142

Heatpump vent in ceiling untested

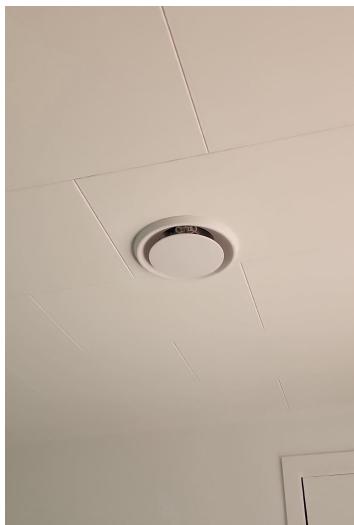
Photo 153

Heatpump vent in ceiling untested
