Independent Builders Report

Total Home Inspection Services Porirua City Ltd

Thu 15 Jan 2026

5 Puriri Rd, Waikanae, Kāpiti, 5036, New Zealand

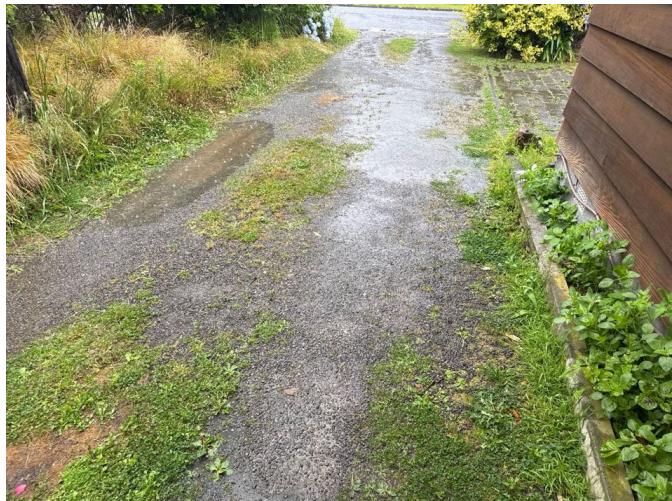
The unsealed driveway has some low points which hold water but is generally tidy and functional

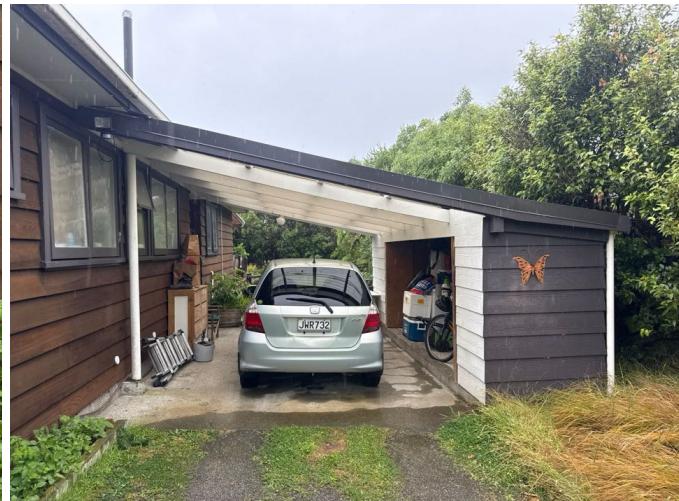
The carport structure is solid and secure

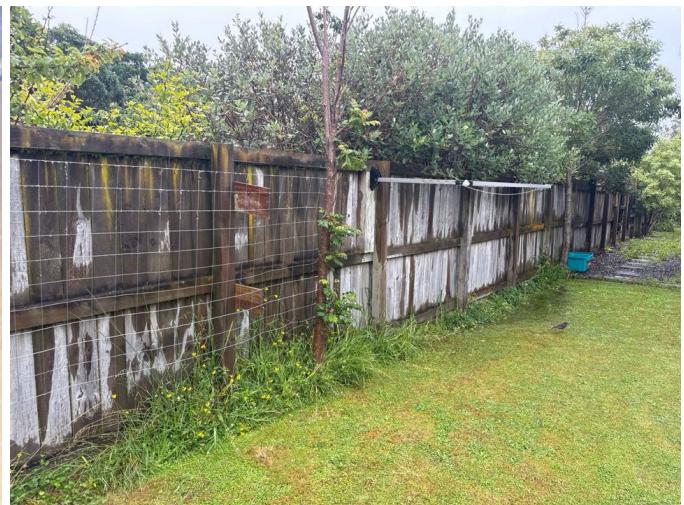
The perimeter fencing is solid and intact.

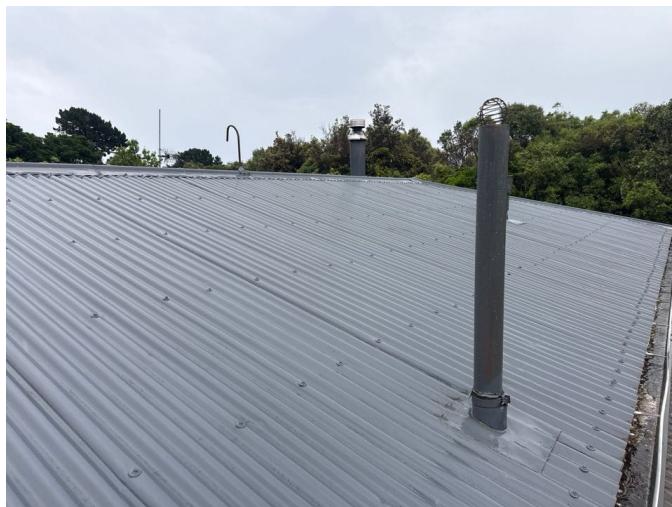
A once or twice yearly wash will help maintain the roofs surface condition and prevent premature deterioration

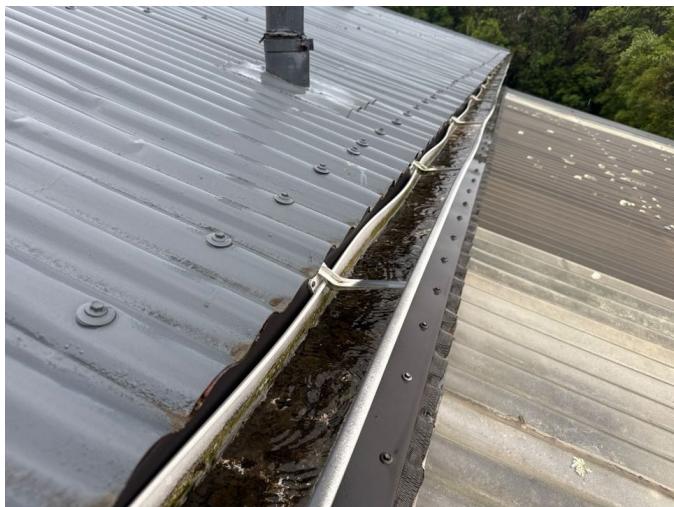
The spouting is in need of a clean out which will help prevent the risk of blockages.

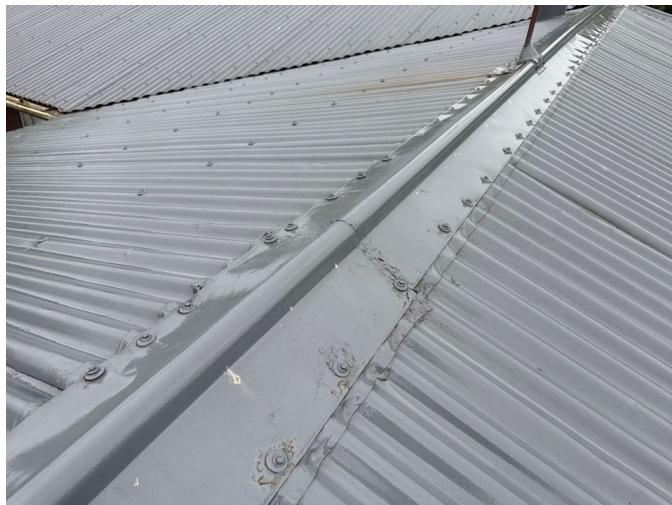
The roof flashings appear to be secure, intact and are effective. No sign of failure could be found beneath where accessible to view.

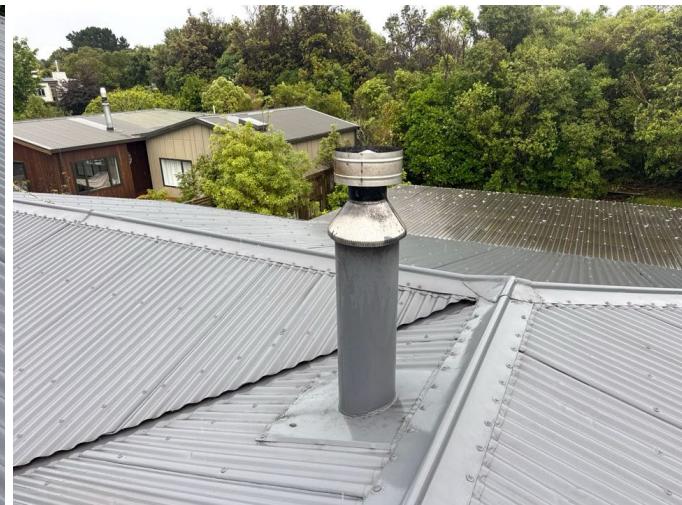
The main steel flue is in good condition and is effectively flashed

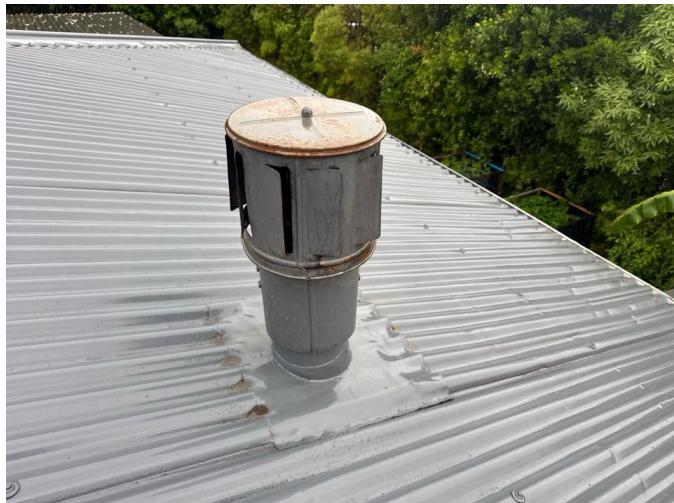
If installed now, all roof penetrations greater than 85mm would need to have a soaker flashing installed beneath the boot flashing, extending to the ridge. Having a flashing installed is an optional weather tightness improvement.

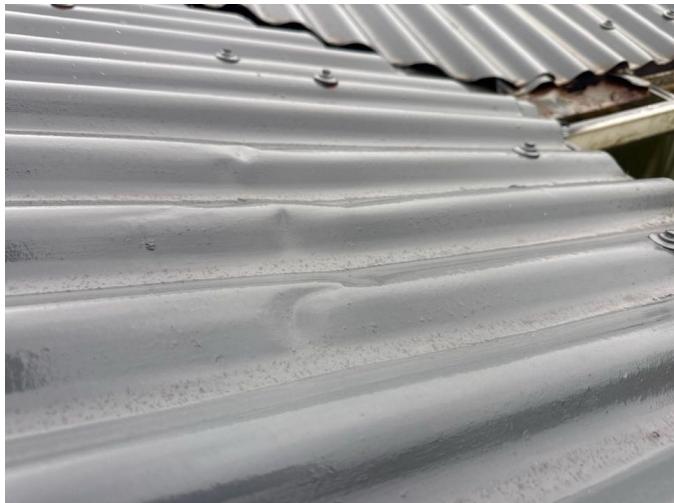
Example. Dents to various locations. The dents are not affecting the performance of the roof but should not be walked on to prevent further damage.

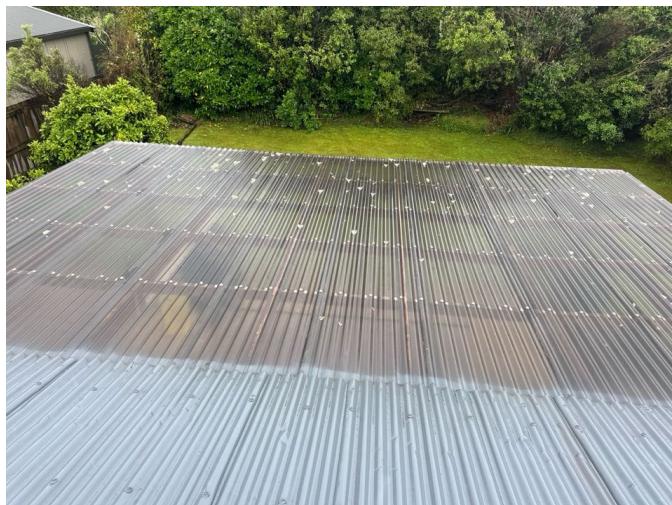
The plastic deck roof is intact and secure

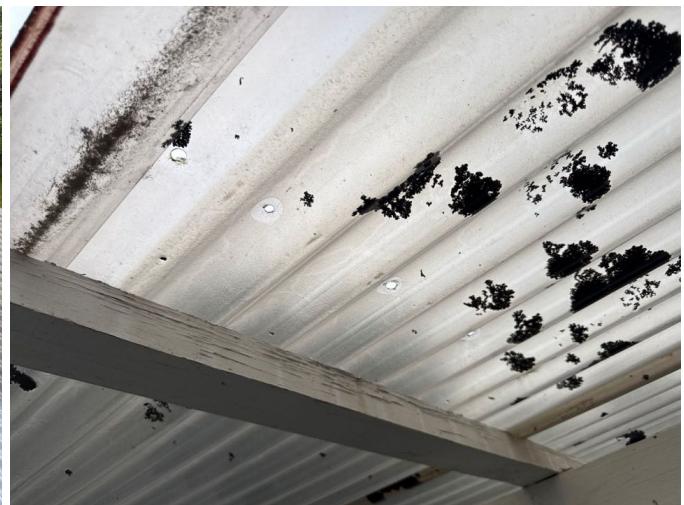
The plastic carport roof has holes from old fixing points

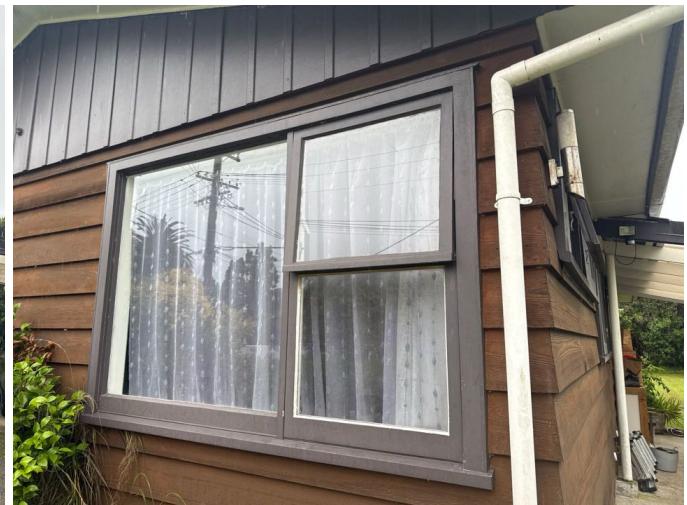
The typical single glazed timber window detail consists of a head flashing, timber scribes and sill.

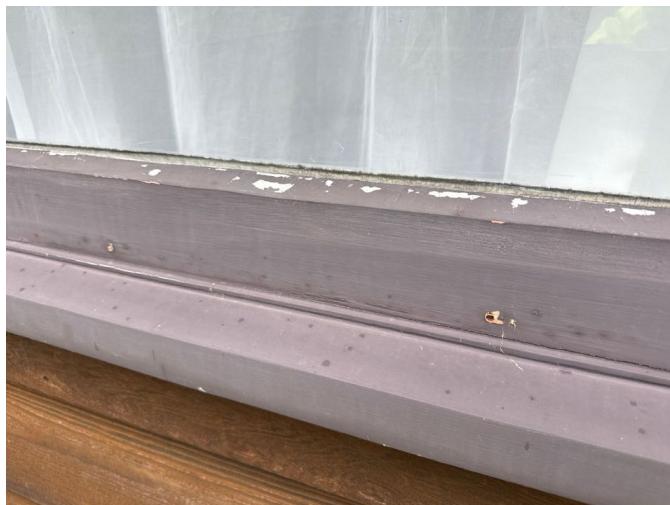
The timber windows and doors require a paint upgrade where surface wear is present.

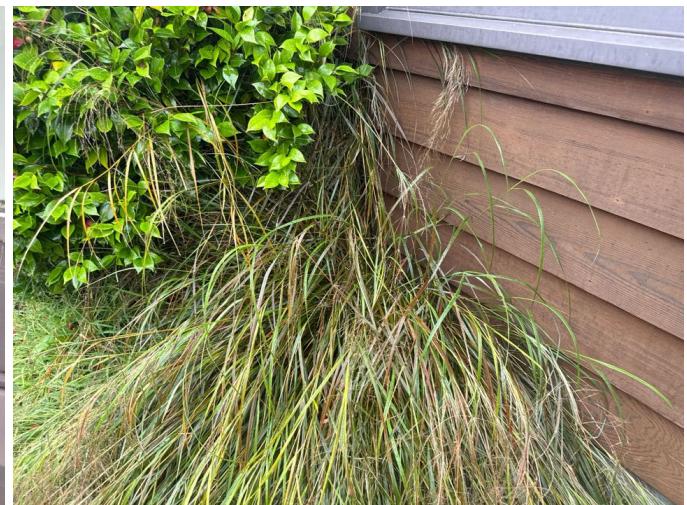
Plants in close contact with the cladding should be trimmed back to prevent the risk of premature deterioration

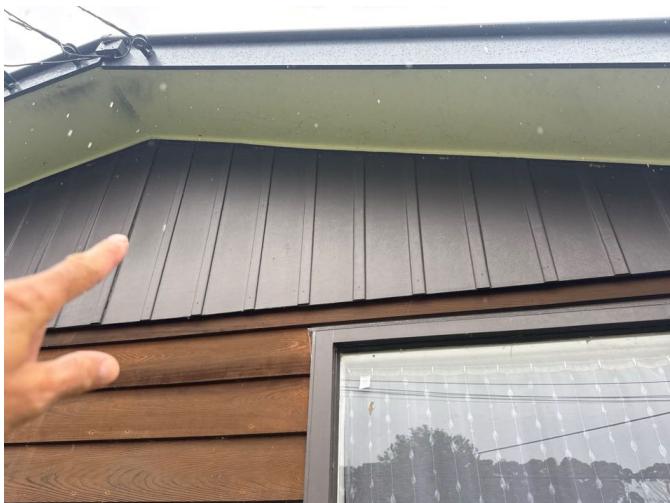
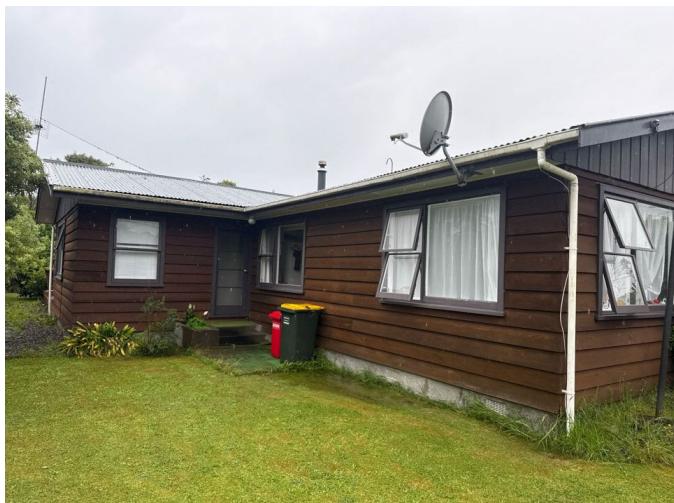
Due to the age of the home, some of the materials installed may contain elements of Asbestos. Please note this is safe in an inert state and must be kept well sealed. If any work is to be completed in areas that likely contain Asbestos then there are certain health and safety precautions that should be followed. Good paint quality noted.

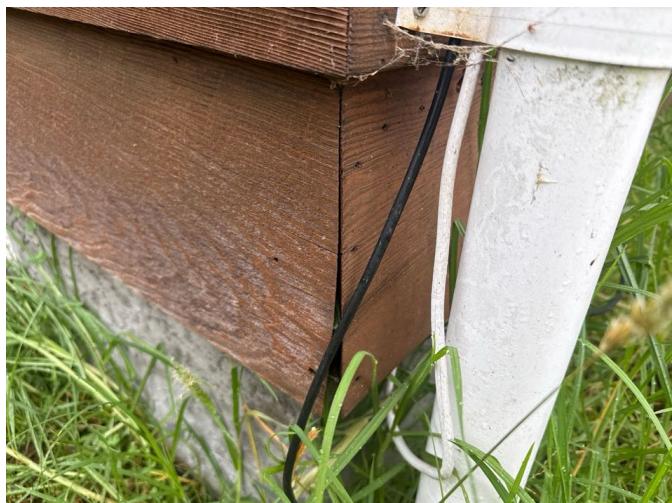
The mitred corners should be kept thoroughly sealed to prevent the risk of rot damage. Thorough sealing improvements are required in some areas. Installing corner soakers or box corners is an optional improvement for the future.

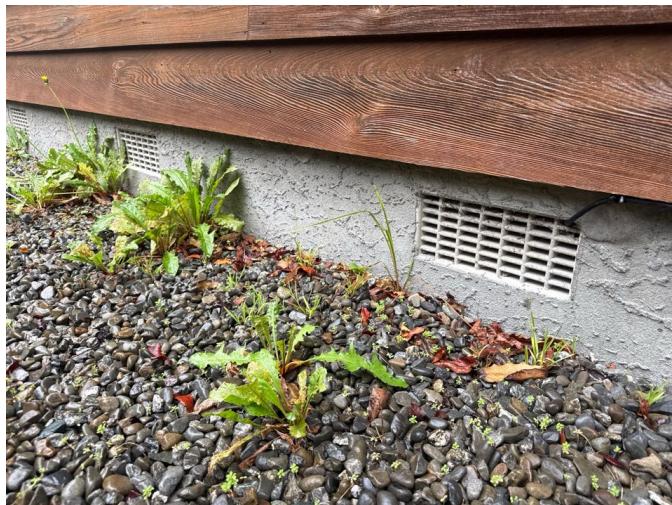
Good ground clearance around the perimeter. The current building code requires a 150mm clearance between the internal floor height and the sealed ground and 225mm to unsealed ground.

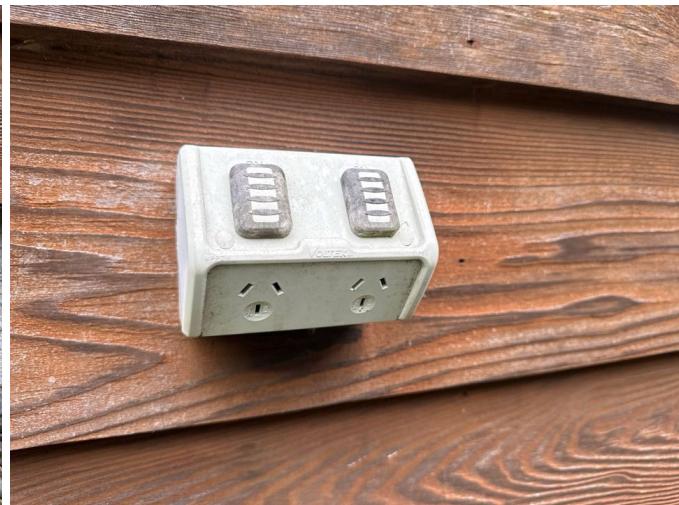
External power point noted. Untested.

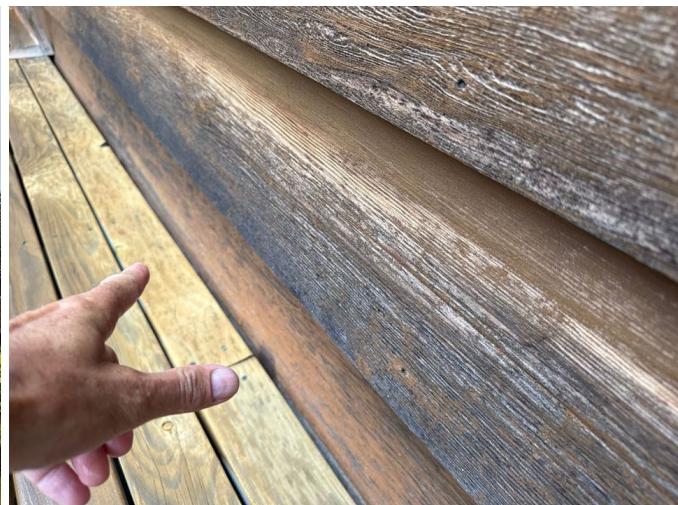
Good clearance between the deck and the weatherboards. This detail allows water to drain away.

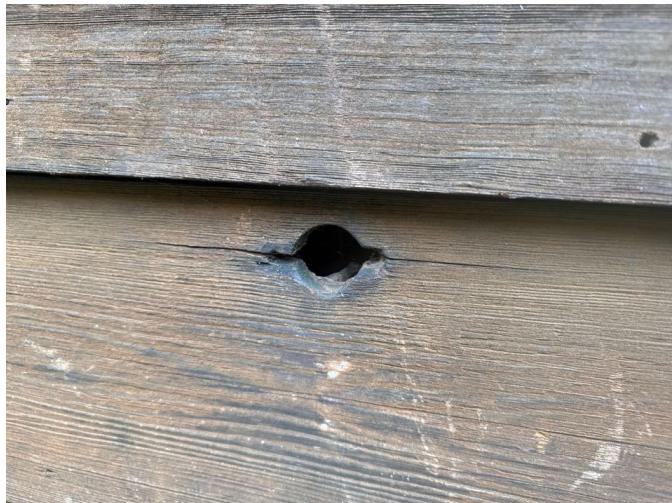
The hole in the cladding should be waterproofed

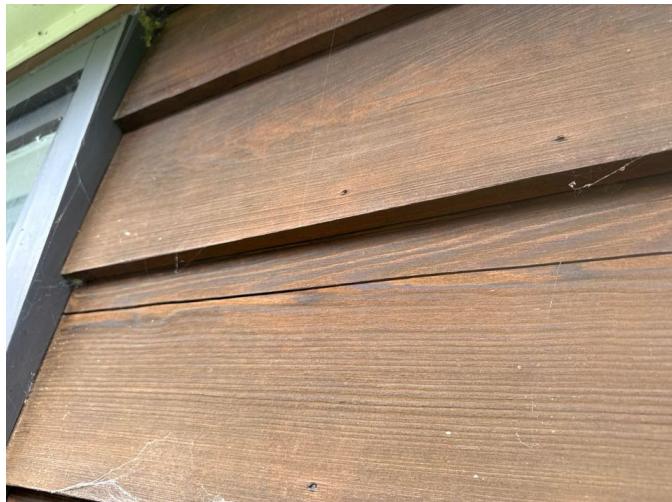
Example. Any cracks such as this should be thoroughly sealed or the boards replaced.

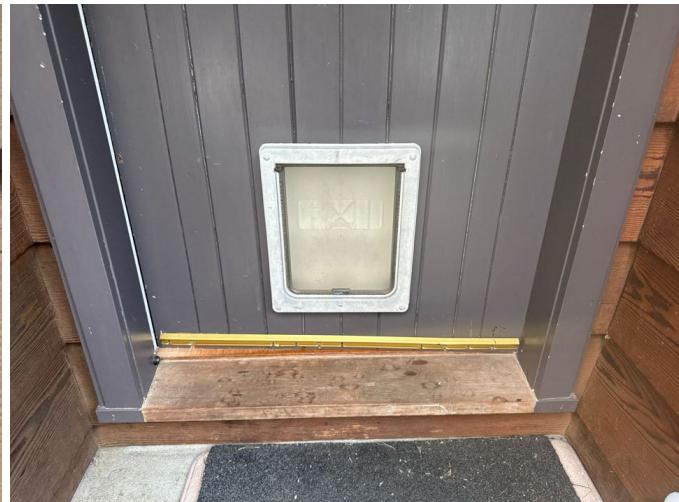
Cat door installed

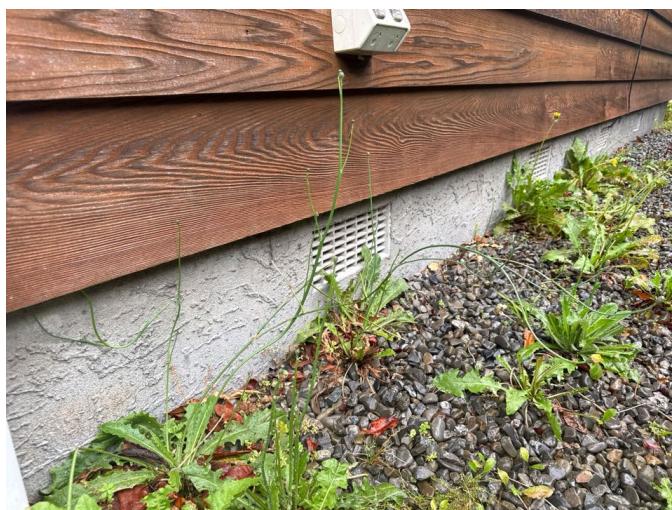
The concrete ring foundation is in a typical condition for the age. No sign of cracking or significant stress.

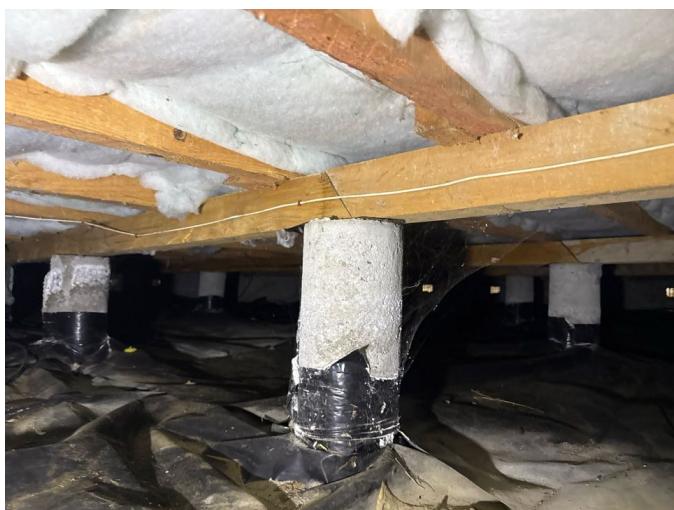
The concrete piles are solid at the time of inspection. Galvanised wire connects the bearers to the piles and anchors the structure to the ground.

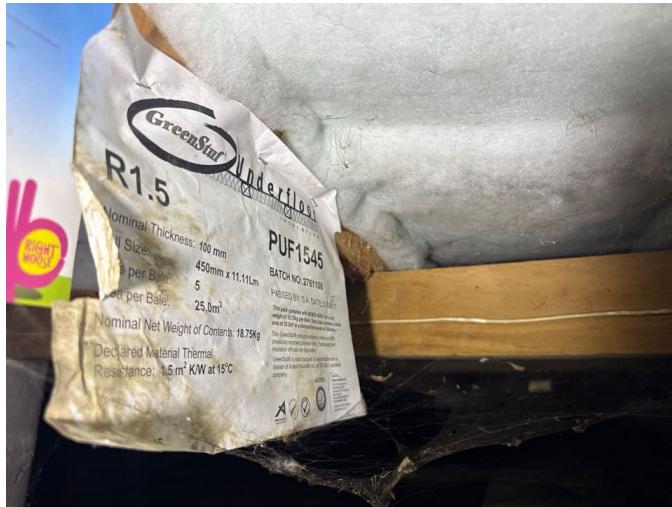
Polyester insulation installed in the sub floor. The thermal resistance rating or R-Value is the measure used most commonly in the building and construction industry to determine a material's ability to resist the transfer of heat. The higher the R-Value the better thermal resistance the product will provide.s

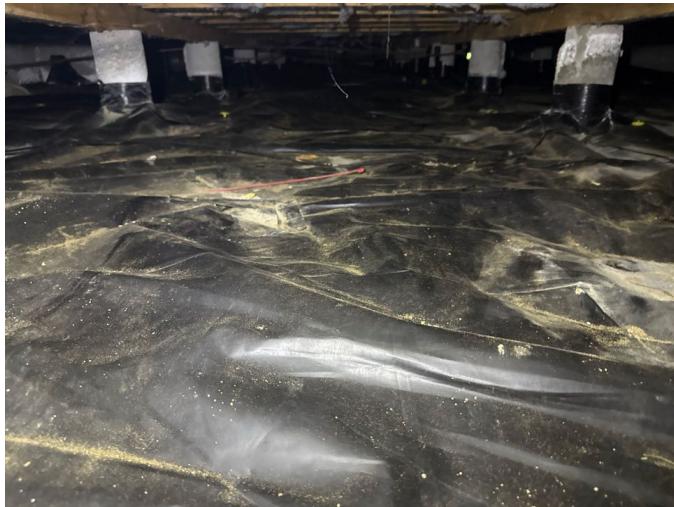
A ground moisture barrier is installed to limit moisture rising from the ground into the subfloor space. This helps reduce dampness, mould growth, timber decay, and corrosion of fixings, and can improve the overall durability of the structure and indoor air quality of the home.

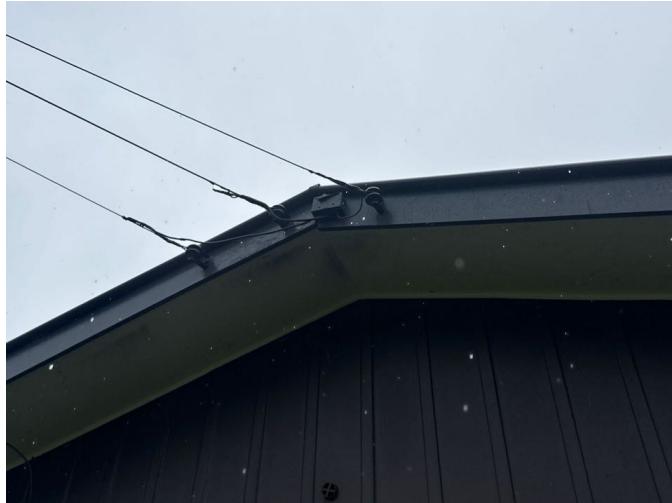
Connections to the house are in good condition. Purchasers should consider an electrical condition assessment (by a registered electrician) as part of your due diligence to rule out potential issues.

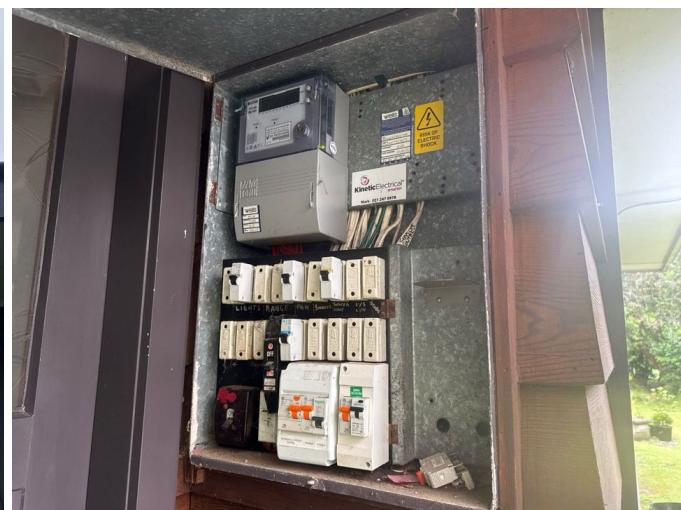
A visual inspection of the electrical system did not show any evidence of electrical overload to switches or power points. Cover plate(s) were not removed and the wiring behind the distribution board not inspected. This is beyond our scope of expertise. Please note. The assessor is not a registered electrician; no electrical safety tests or electrical component tests were undertaken. Power points, lights and switch testing therefore does not form part of this report.

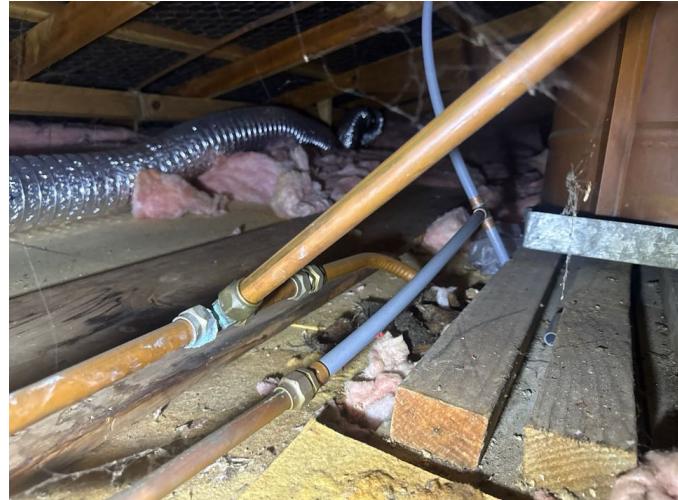
Only Buteline and Copper pipes sighted during the inspection.

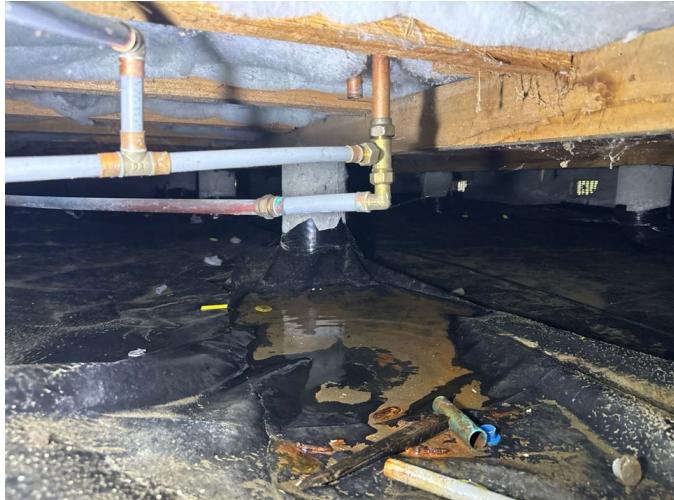
The hot water cylinder drain is distributing water onto the ground moisture barrier. A plumber should be engaged to extend the pipe to an approved drainage outlet. Excess water in sub floors can cause premature deterioration to building materials and unhealthy conditions such as fungal growth if left.

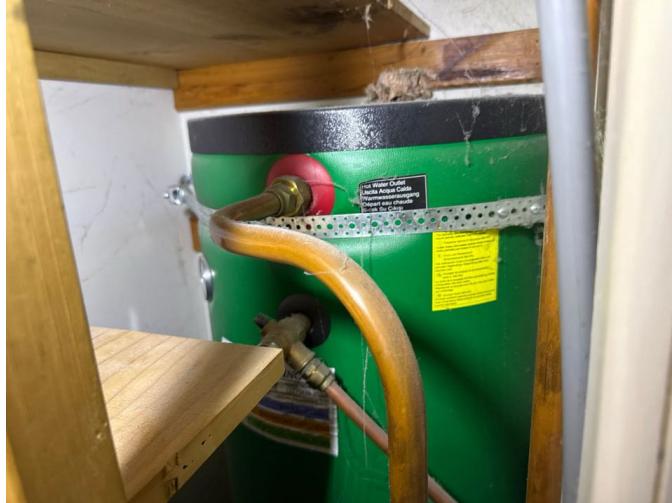
Hallway cupboard.

(Approximate) 180L Mains Pressure Electric Hot Water Cylinder. Seismic restraints should be installed. The pressure-reducing valve that is located at the side of the mains pressure hot water cylinder should be tested every 6 months or in accordance with the manufacturer's instructions to make sure that it is in working order.

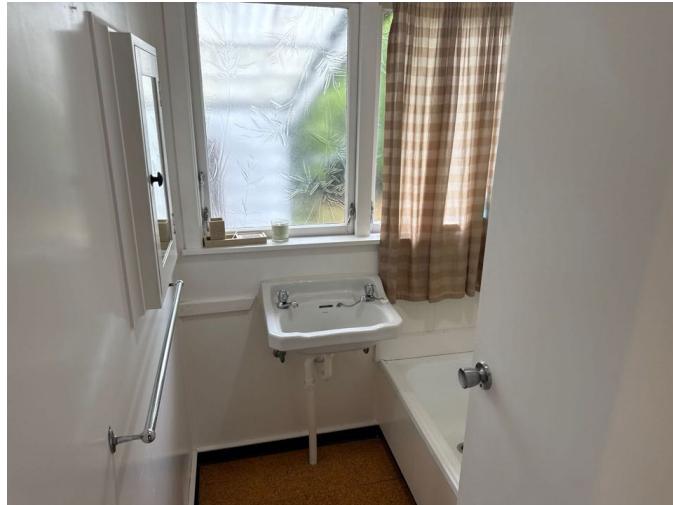
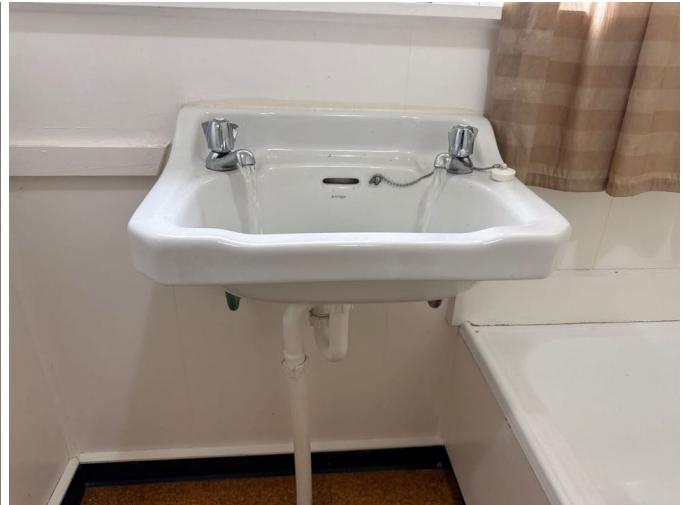
The rear edge of the sink is well sealed. The taps are functioning well. No concerns with the water feeds or waste under the vanity

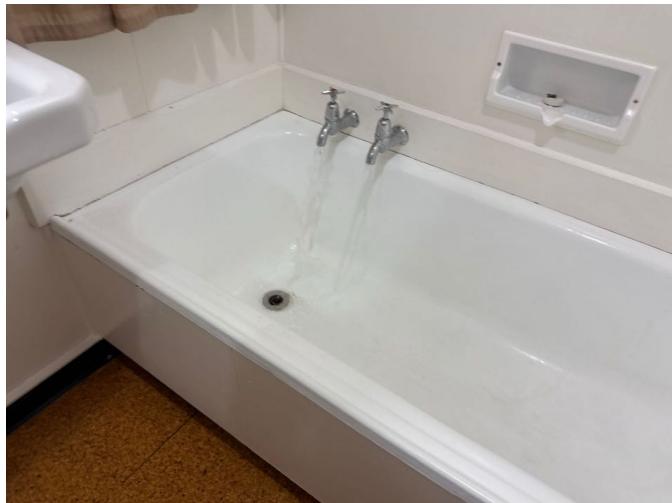
The perimeter of the bath is sufficiently sealed. The taps are functioning well.

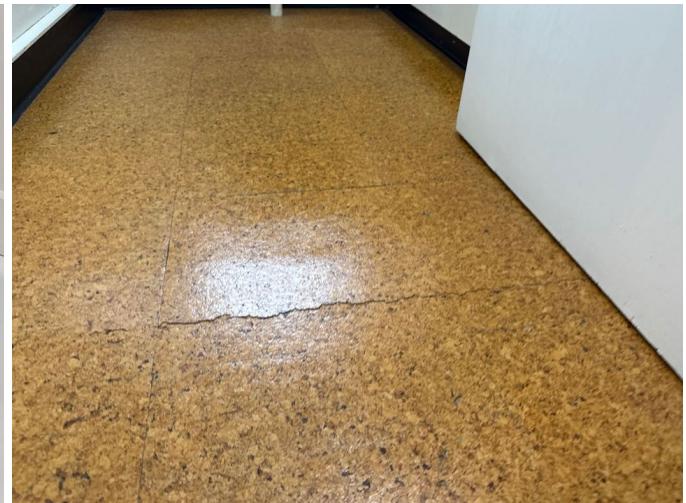
Wear to the cork flooring will need to be monitored

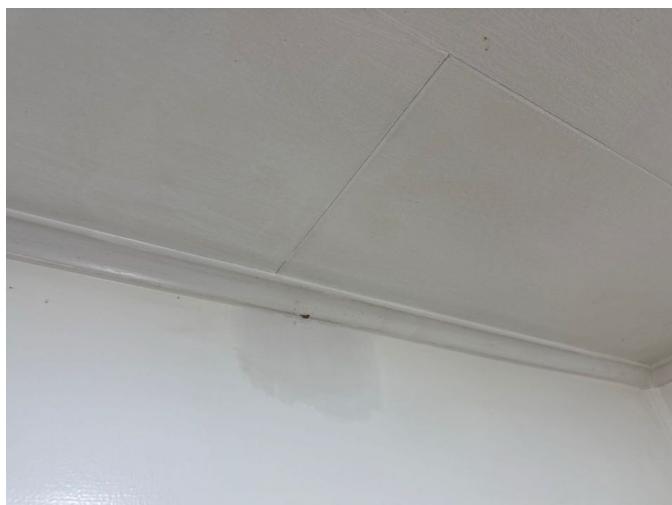
Cosmetic noted. A paint upgrade will be required in the short term.

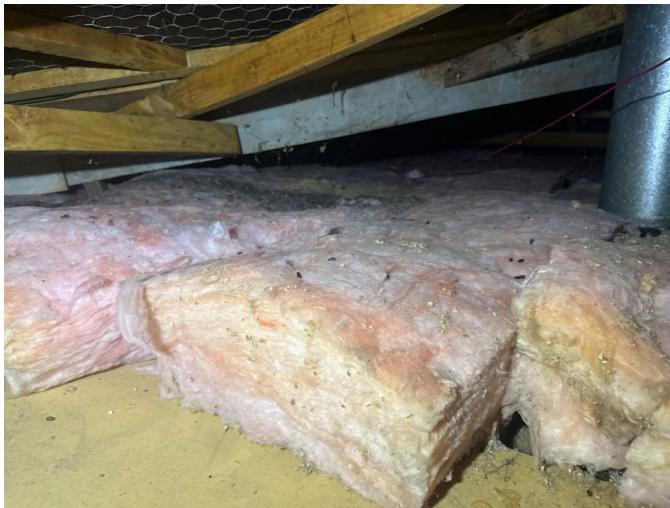
Average level of insulation installed at most locations

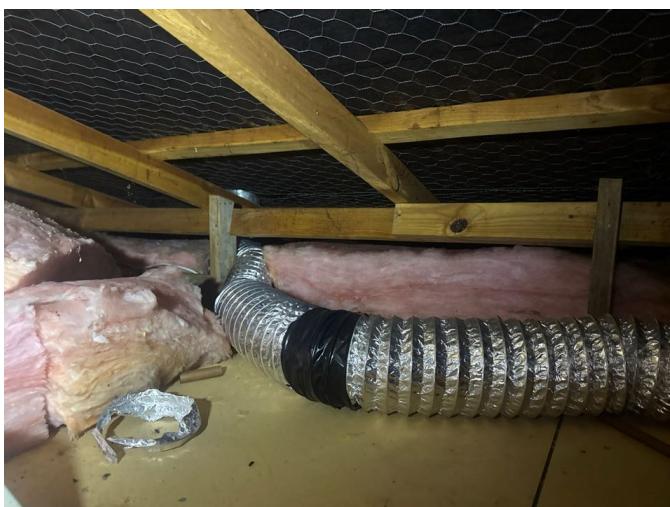
Extraction units vent to the exterior

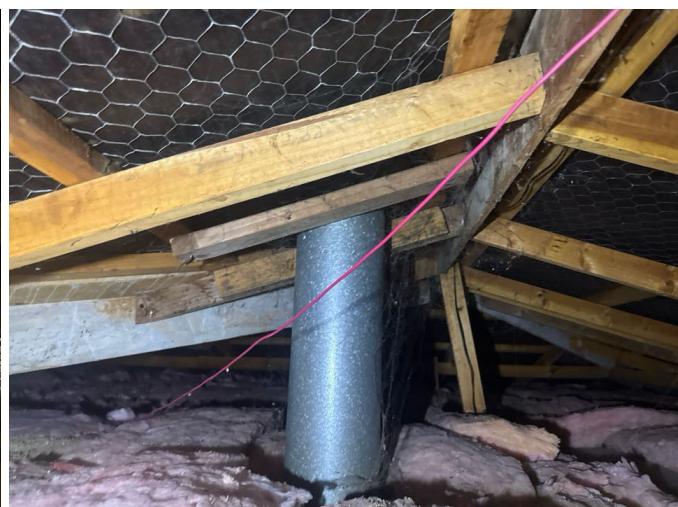
The roof penetrations appear to be effectively sealed

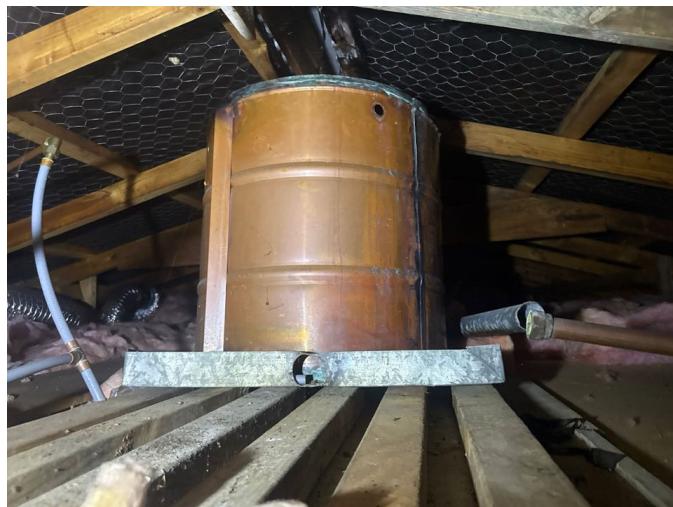
The old copper header tank is still present in the ceiling cavity but is not a concern as it is.

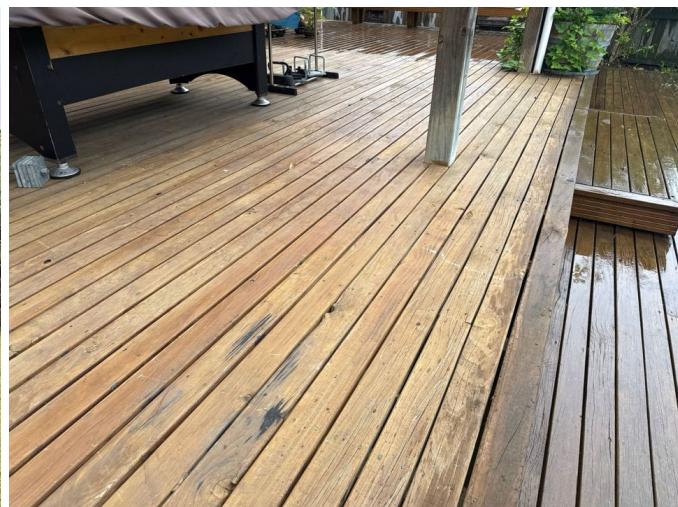
The timber decking is in good condition

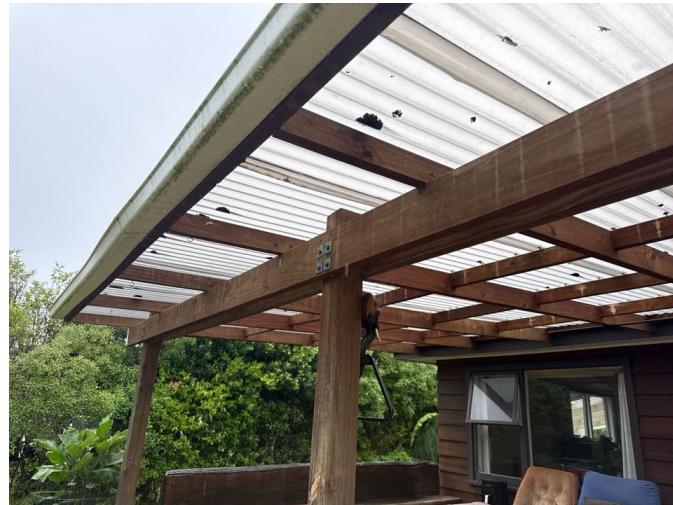
The roof structure is solid and is well connected

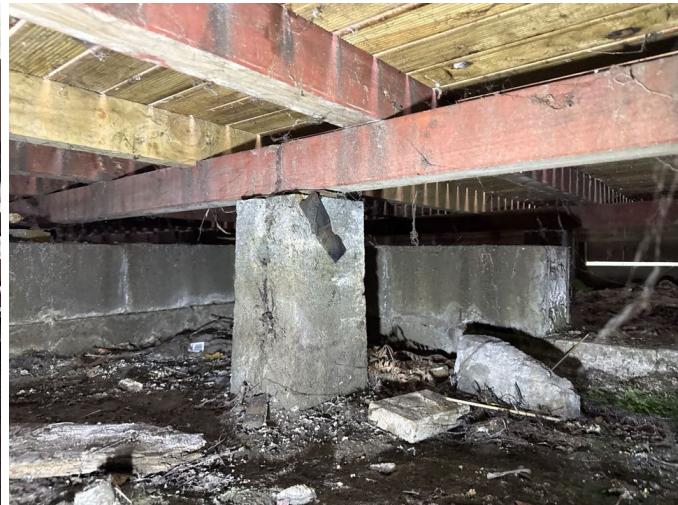
No concerns with the framing structure. Solid and well connected.

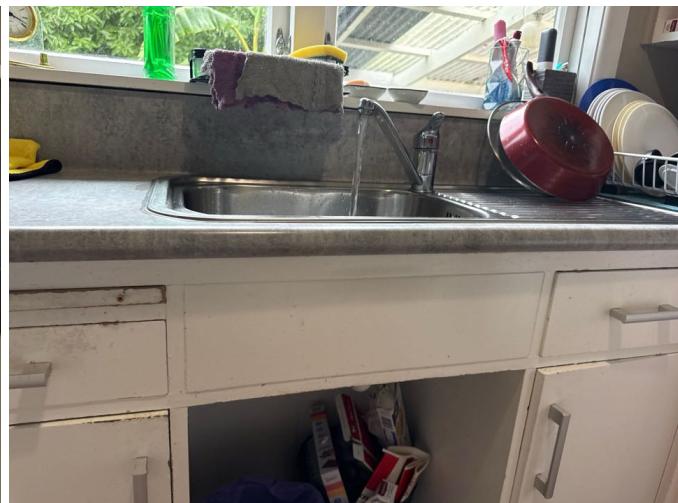
The rear edge of the bench top is well sealed. The tap is functioning. No concerns with the water feeds or waste pipes under the sink.

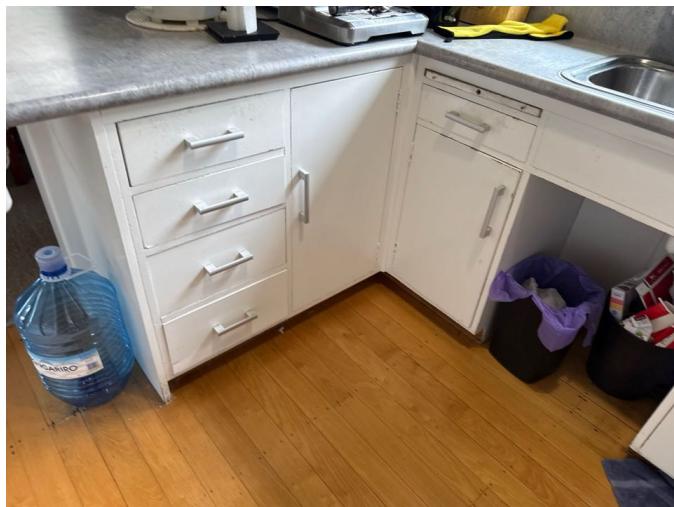
The kitchen cabinetry and timber floor are in a tidy condition

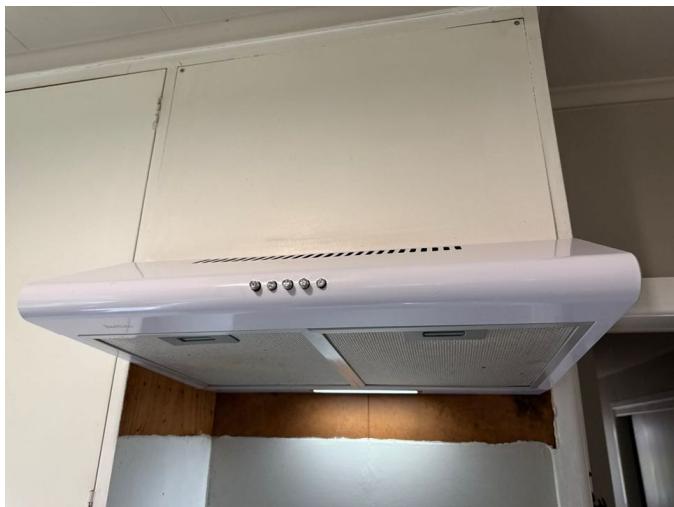
The range hood extraction unit is functioning

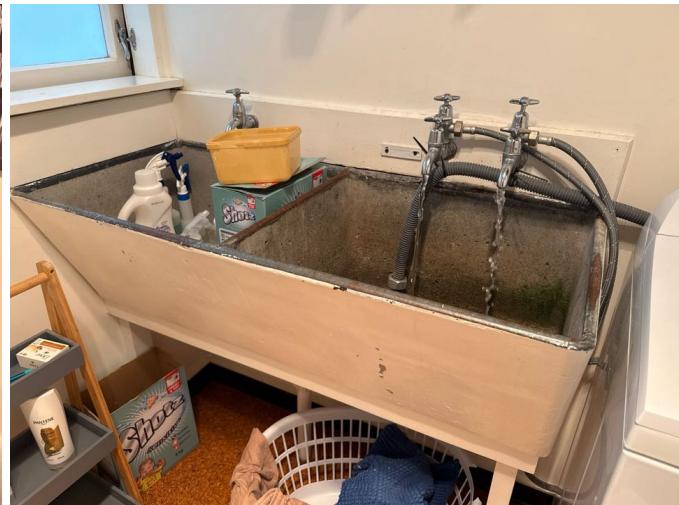
The old concrete tub is aging but functional

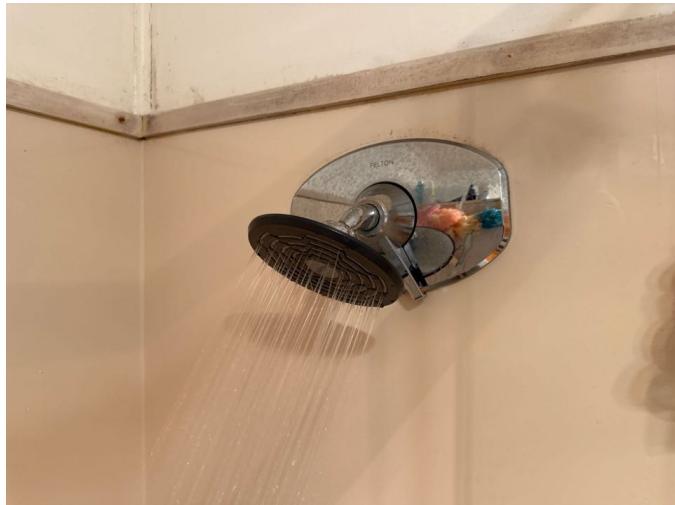
Average water pressure to the shower

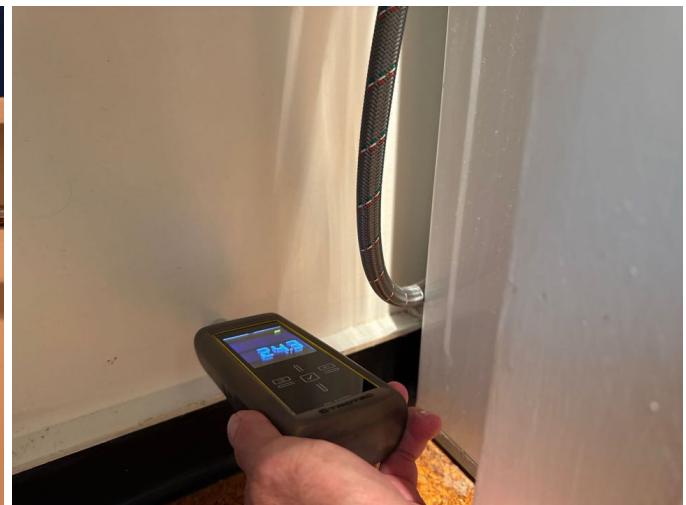
The moisture levels by the washing machine were within the normal range

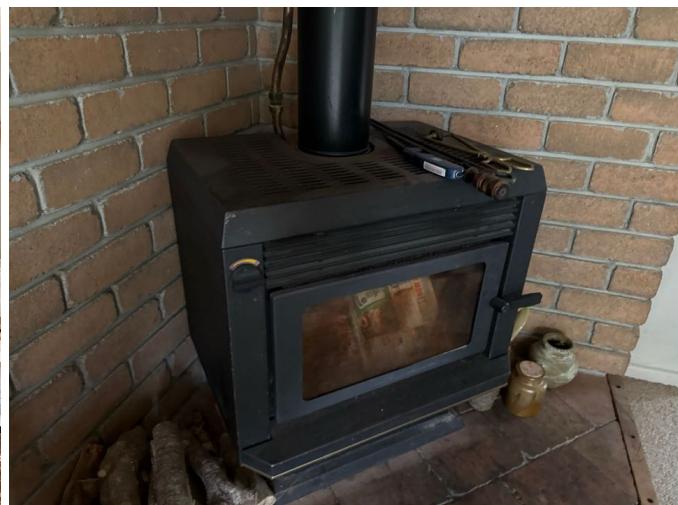
The fireplace and chimney were not checked as part of the inspection process. All fireplace manufacturers stipulate an annual service and insurance companies require evidence of due care and maintenance in the event of a claim. Purchasers should check when the fireplace was last serviced prior to the first use and have a service completed if necessary. The chimney was not checked as part of this inspection process.

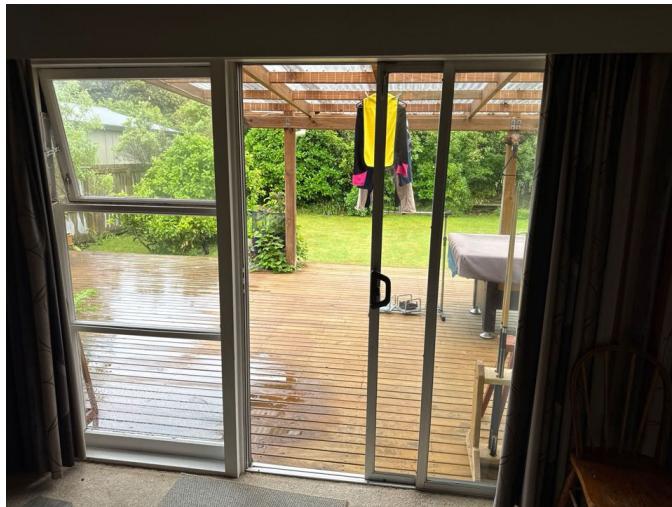
The sliding door is functioning it may benefit from a service

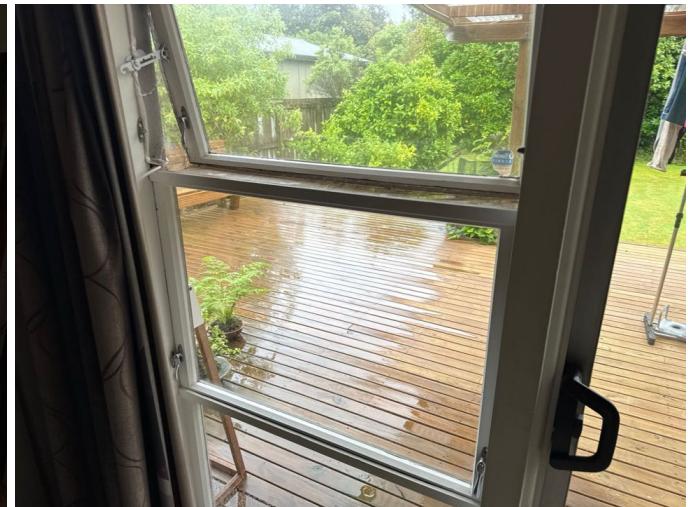
The windows are functional

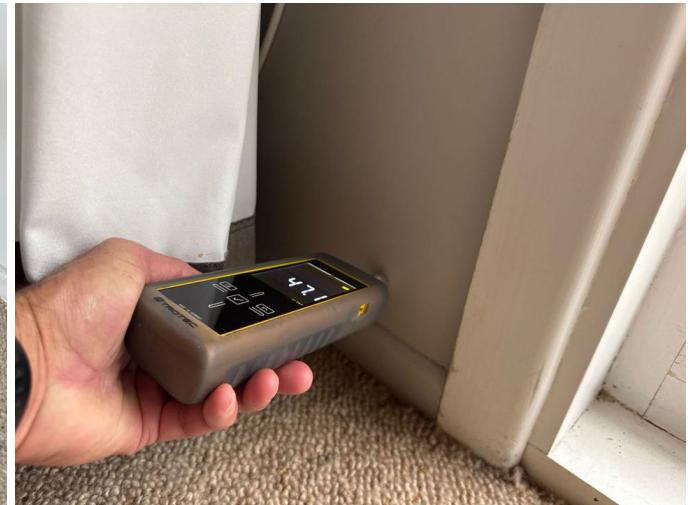
The moisture levels to the external walls were within the normal range

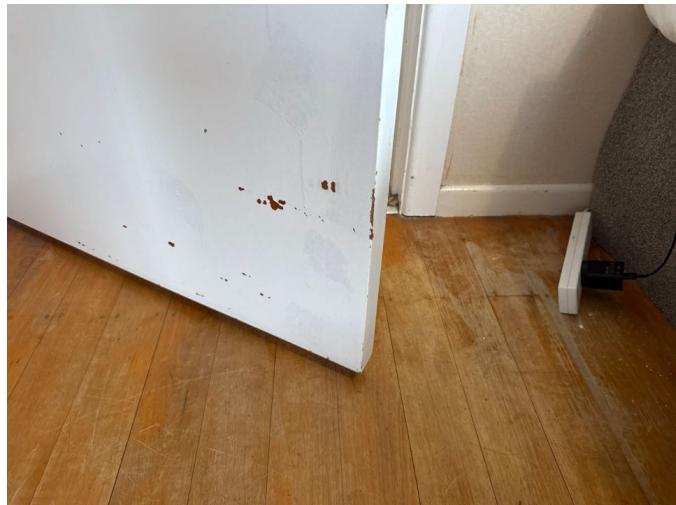
Bedroom 1

Example. Minor cosmetic defects noted.

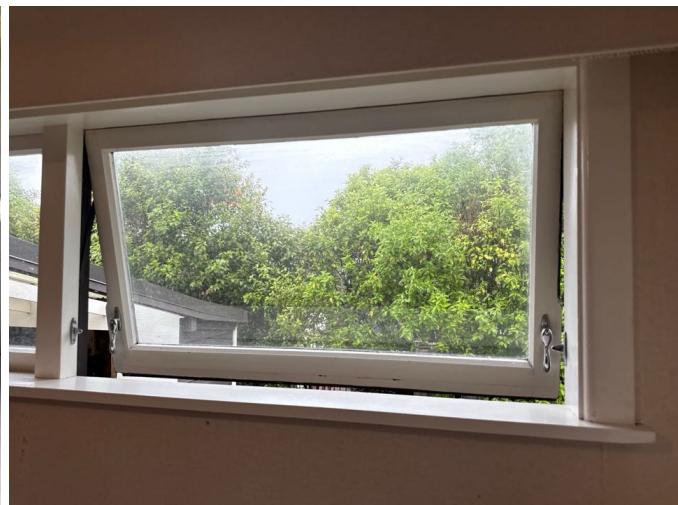
The windows are functional

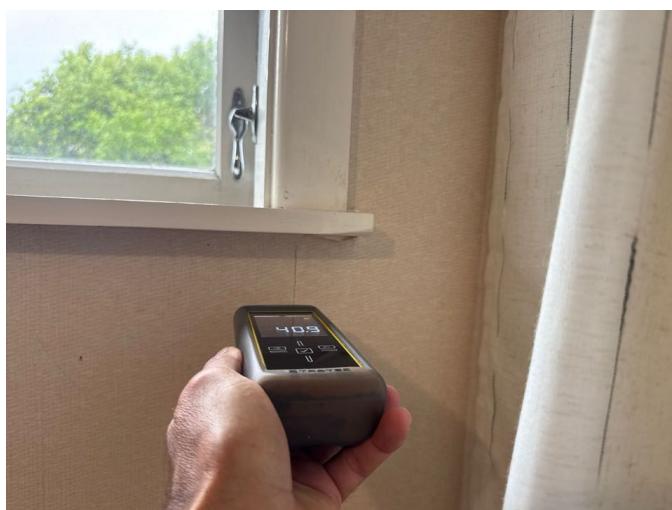
The moisture levels to the external walls were within the normal range

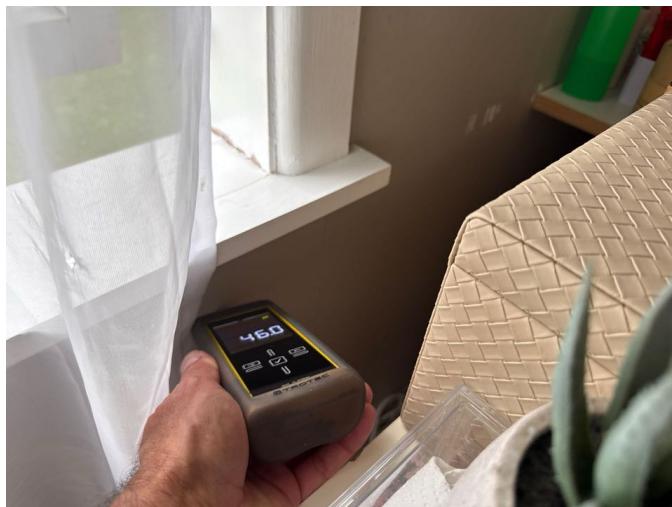
Bedroom 2

The moisture levels to the external walls were within the normal range

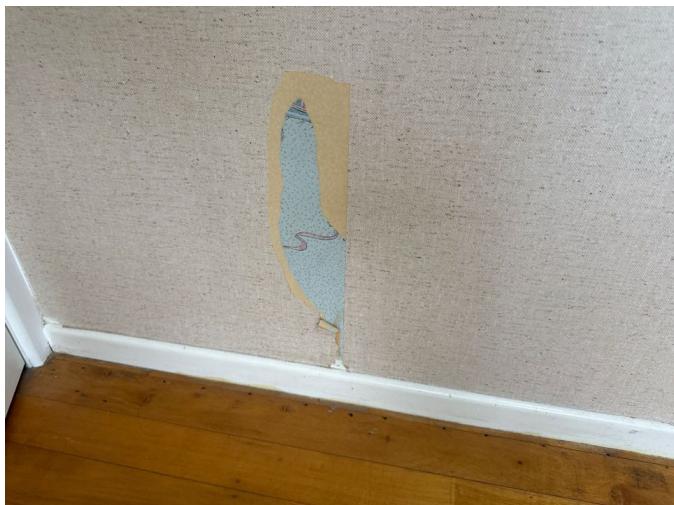
Wear and tear to the wallpaper in areas

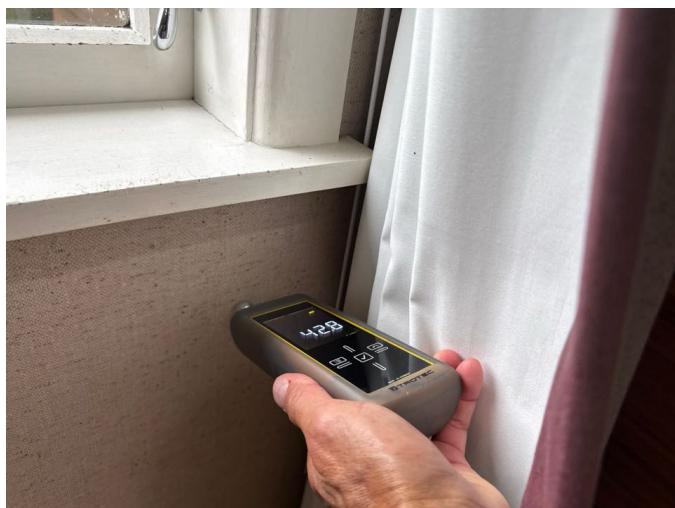
The moisture levels to the external walls were within the normal range

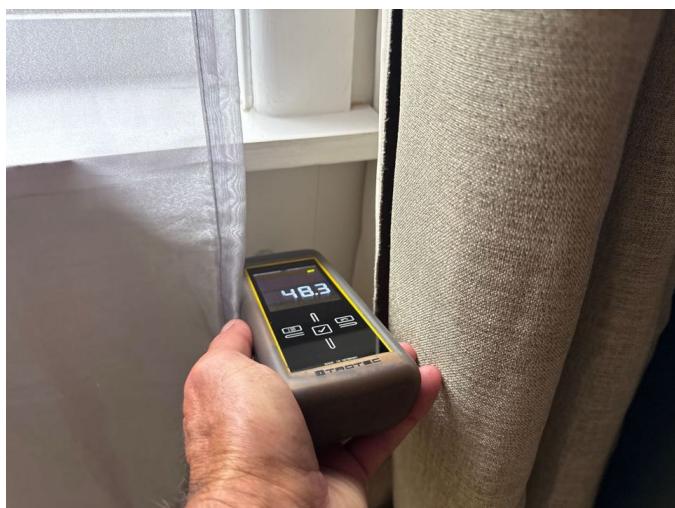
The moisture levels to the external walls were within the normal range

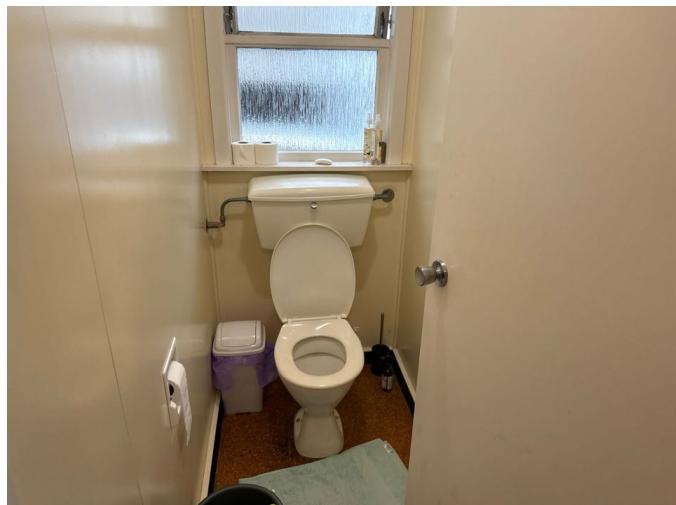
The toilet is secure and in a functioning condition.
