Independent Builders Report

Total Home Inspection Services Porirua City Ltd

Thu 15 Jan 2026

5 Puriri Rd, Waikanae, Kāpiti, 5036, New Zealand

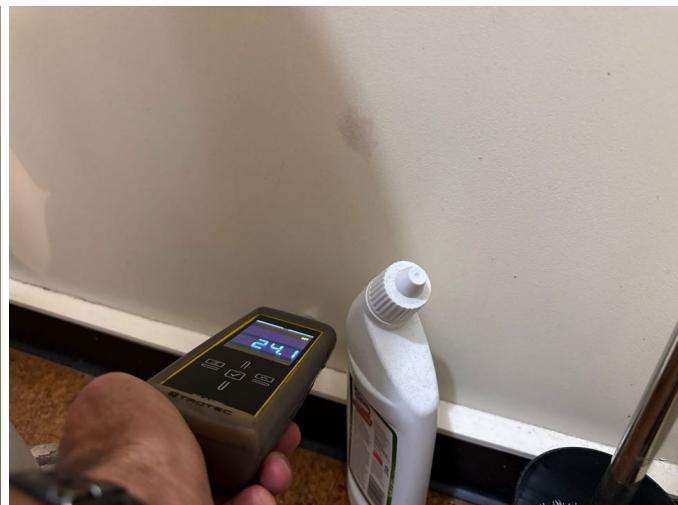
The toilet is secure and in a functioning condition.

Moisture levels behind the toilet were within the normal range at the time of inspection

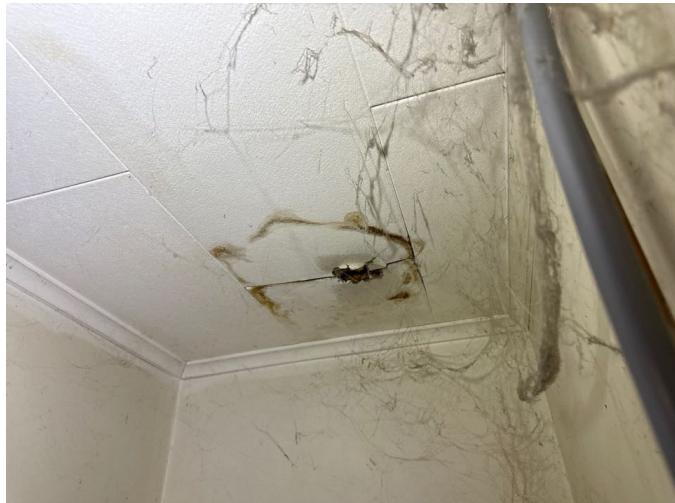
Historic moisture damage above the hot water cylinder is cosmetic only

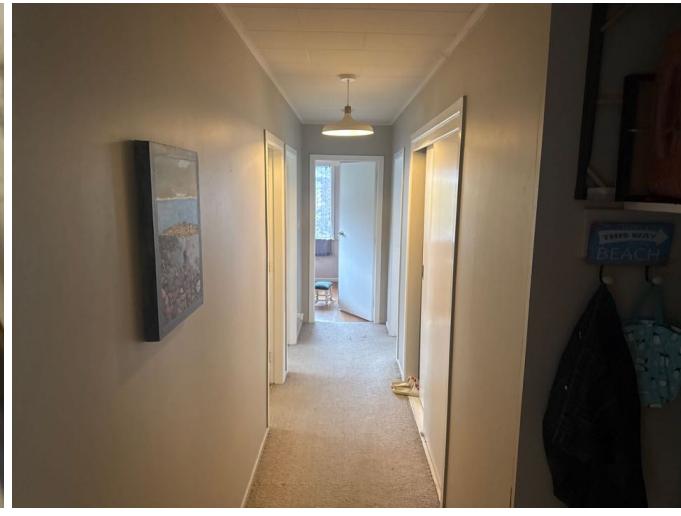
The hallway is generally tidy
