Independent Builders Report

Total Home Inspection Services Porirua City Ltd

Thu 29 Jan 2026

76 Kotare St, Waikanae, Kāpiti, 5036, New Zealand

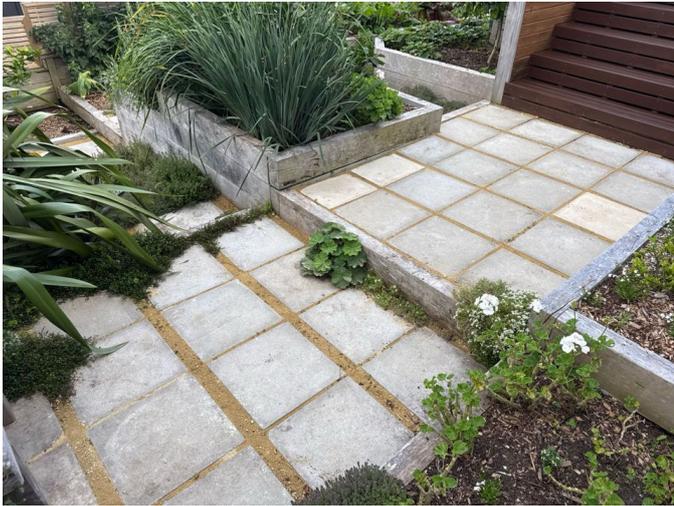
The paved paths are tidy

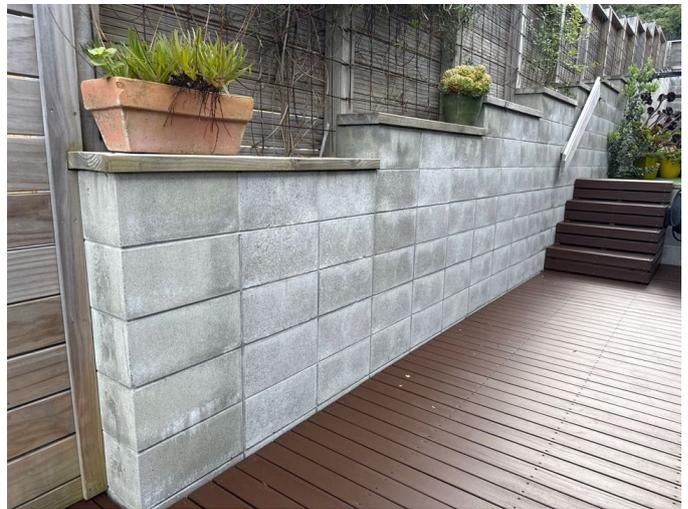
The concrete block walls are solid

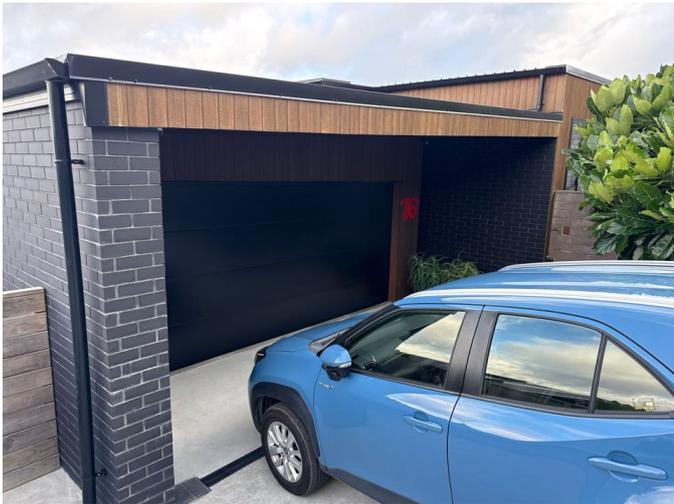
The front faces to the Southeast

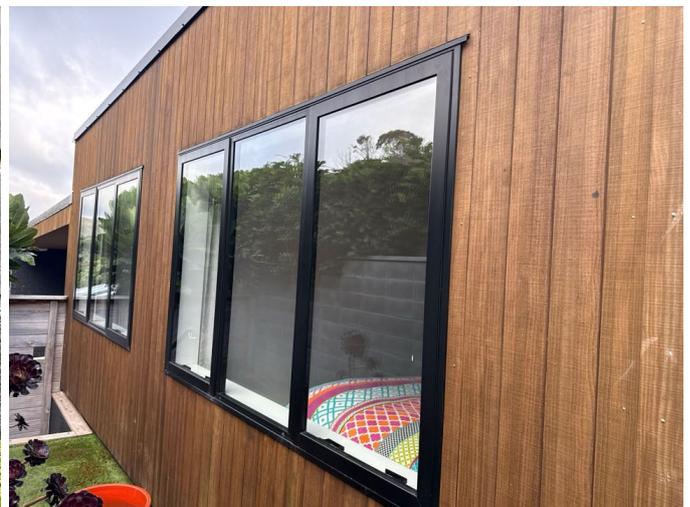
The typical double glazed aluminium window/door is face fitted with a head flashing

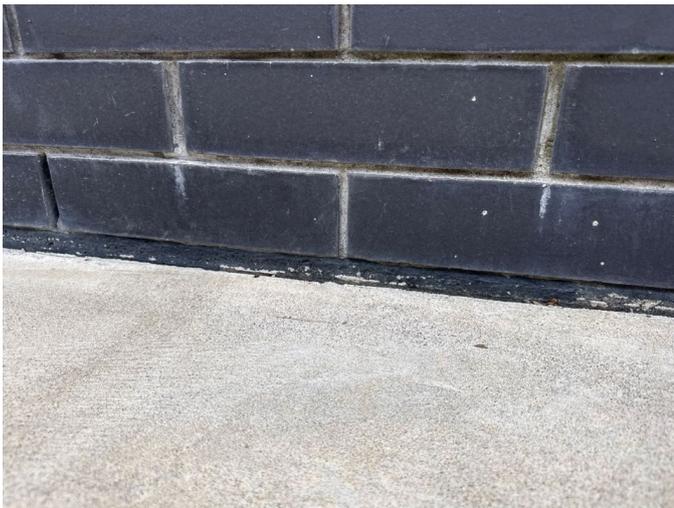
The current Acceptable Solution requirement of the Building Code requires that a concrete floor to ground dimension with brick veneer be 150 mm to unpaved and 100 mm to paved surfaces and cladding other than brick veneer be 225 mm to unpaved and 150 mm to paved surfaces. This dwelling generally satisfies this requirement.

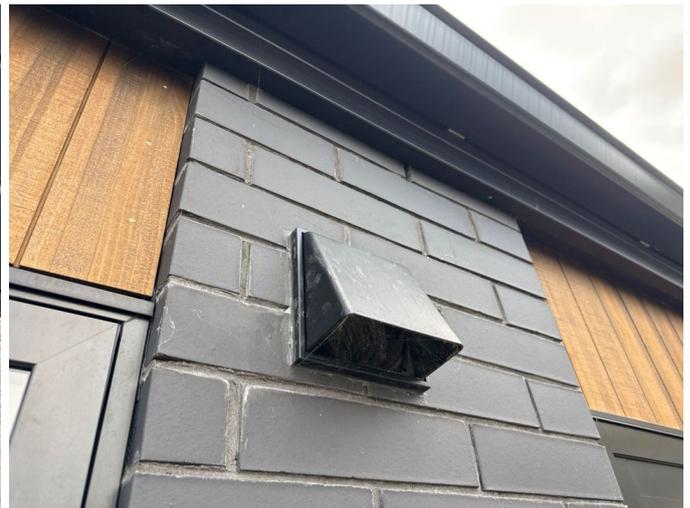
Extraction vents exit through the walls

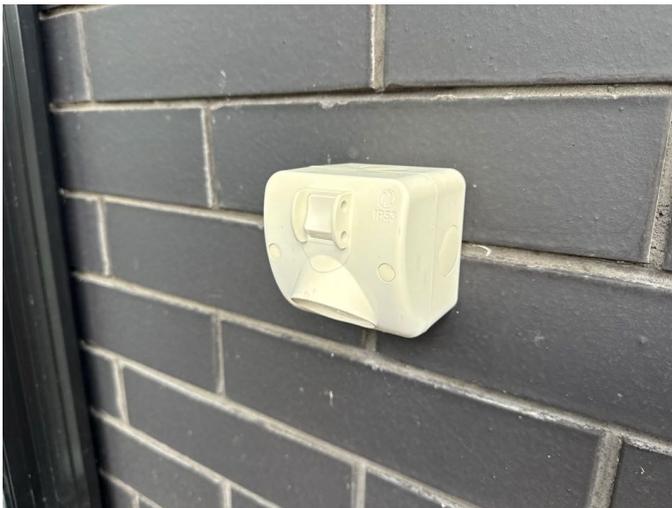
External power point noted

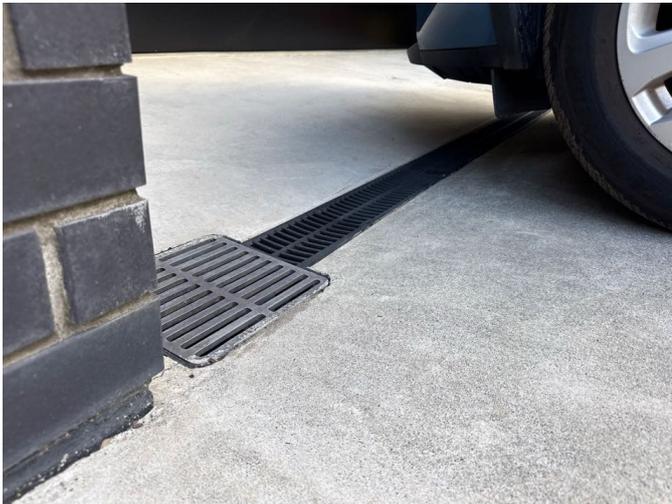
Channel drain and sump to the driveway. There was no sign of current blockages or recent overflows. The effectiveness of the drains will need to be monitored over time.

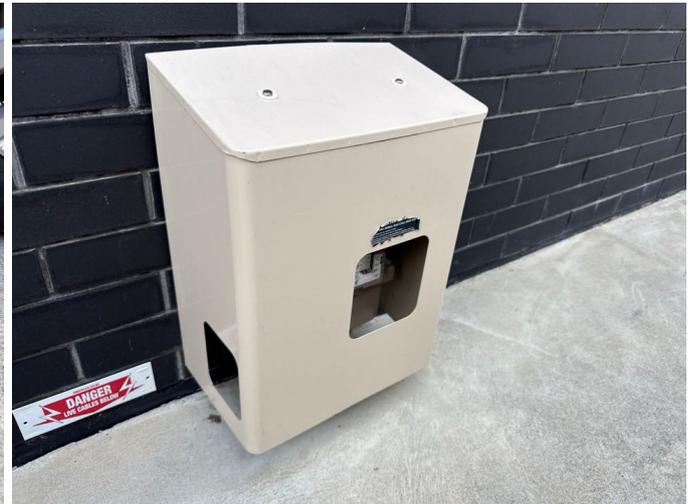
The gas system is not tested as part of this inspection. T.H.I.S recommends that gas appliances are serviced regularly to ensure correct combustion, maintaining optimum efficiency and correct performance of safety devices prior to use.

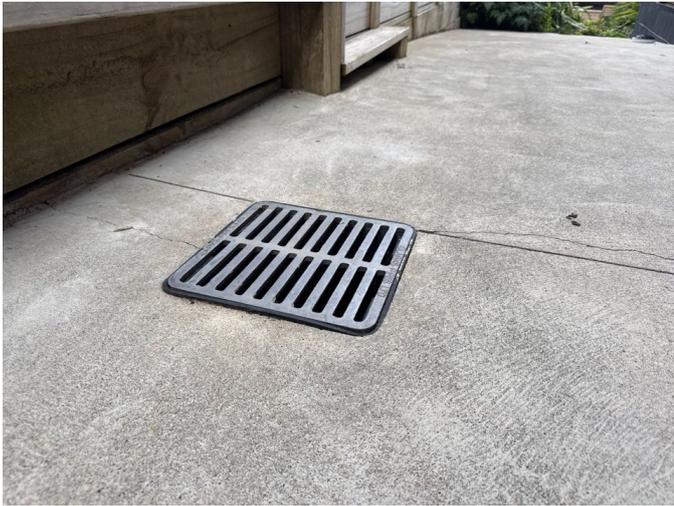
Surface drain to the Southwest path

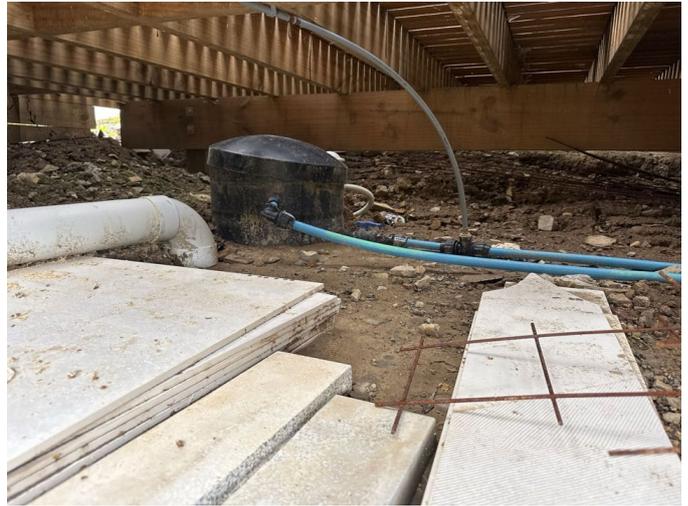
The tank and water pump under the deck uses stormwater for the toilets and external tap. Outside the scope of this inspection.

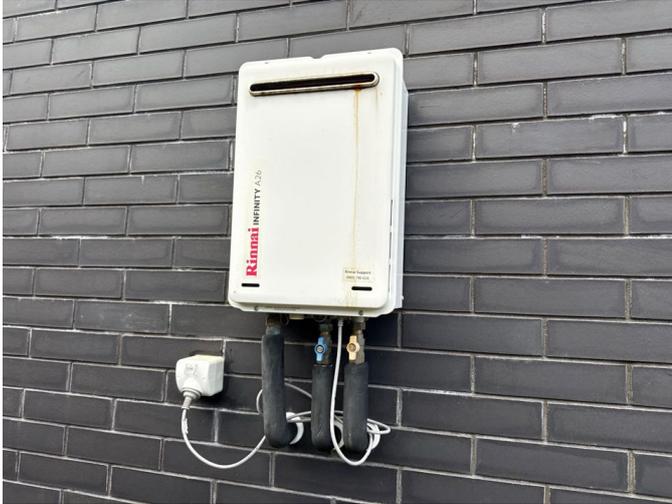
Northeast side.

For reliable operation Rinnai INFINITY water heaters in residential applications should be serviced every two years. Servicing and repair should only be carried out by authorised personnel. No visible signs of issues that may affect the performance of the gas water heater.

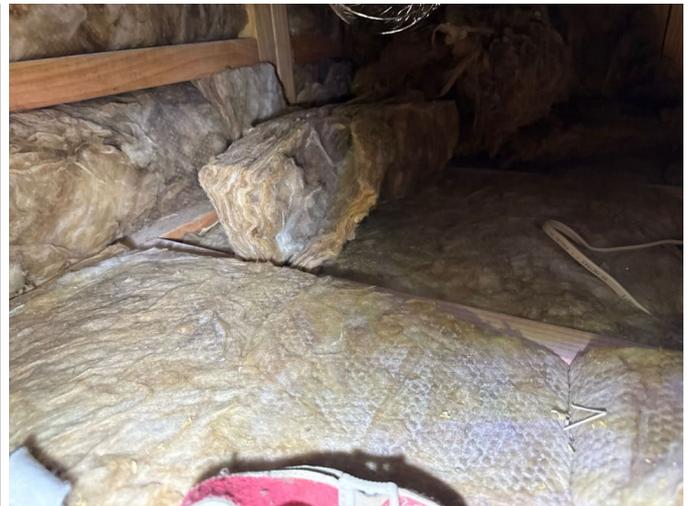
Average level of insulation installed. There was no labelling present to indicate the R-Value of the material.

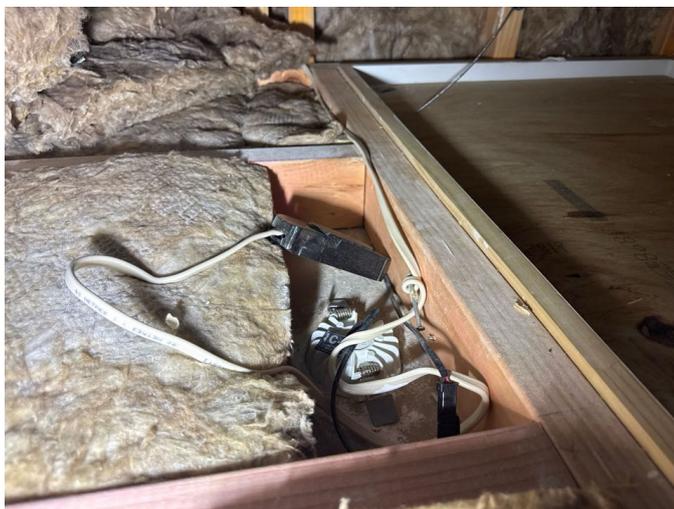
Modern downlights (labelled IC) installed which are safe to have insulation placed over them.

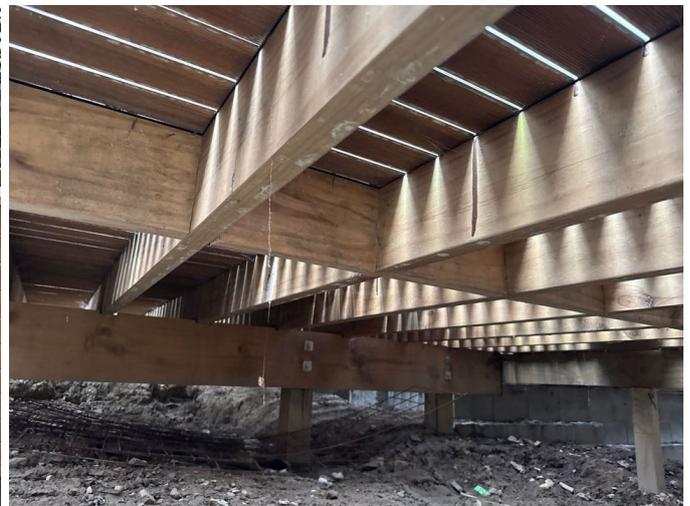
No concerns with the main structure. Solid and well connected.

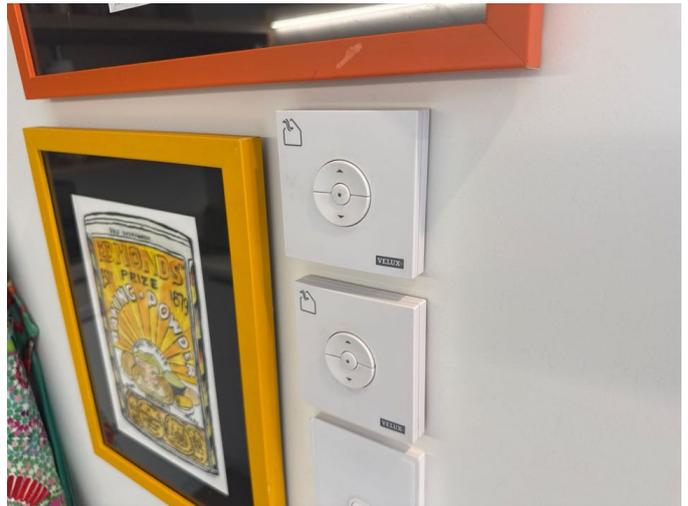
The motorised skylights were not tested as part of the inspection process

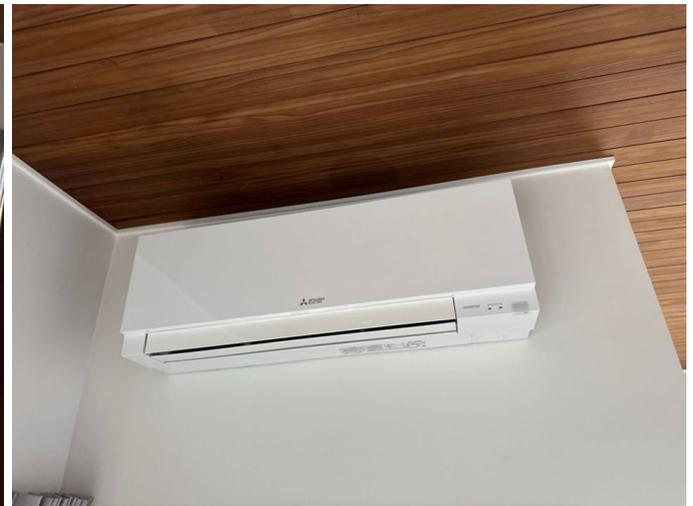
Heat pump installed, untested.
Heat pumps require regular servicing to be efficient.
The manufacturers instructions should be checked and understood with regards to future servicing requirements.

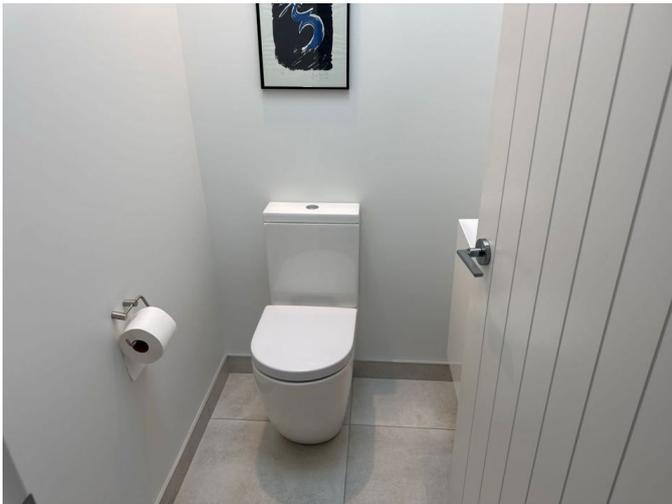
The base of the toilet is well sealed and is secure. The toilet is in a functioning condition.

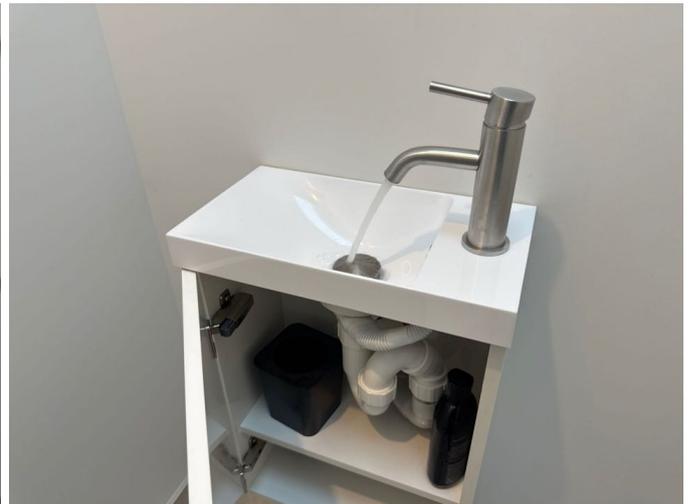
The sink is well sealed to the wall. The tap is functioning well. No visible concerns with the water feeds or waste beneath the sink.

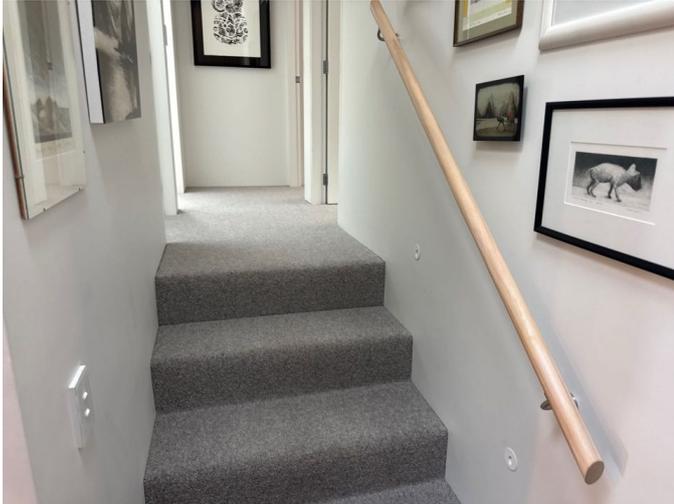
The timber stairs and handrail are solid and secure

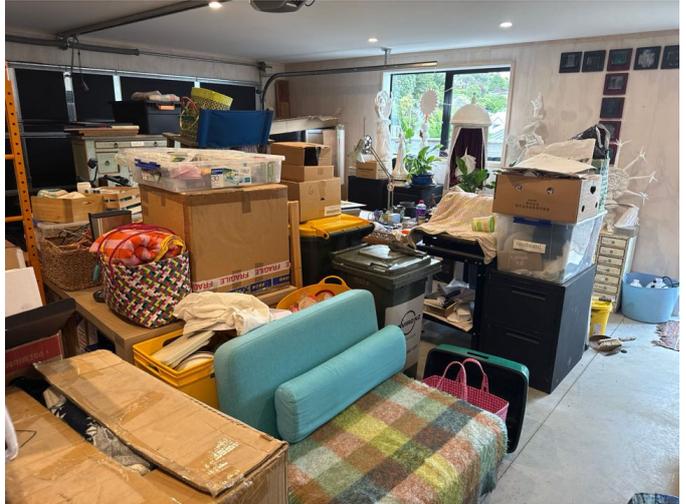
Not all areas of the garage could be fully inspected due to the presence of stored items. A full inspection is recommended once cleared. This applies to all concealed locations throughout the house.

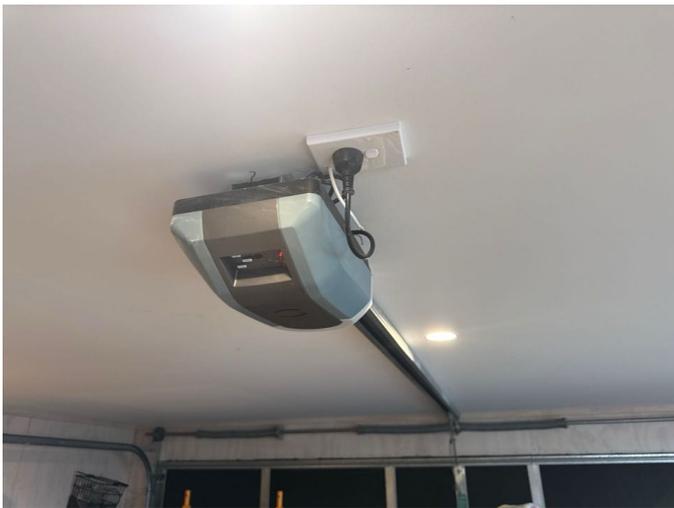
The electric garage door is functioning

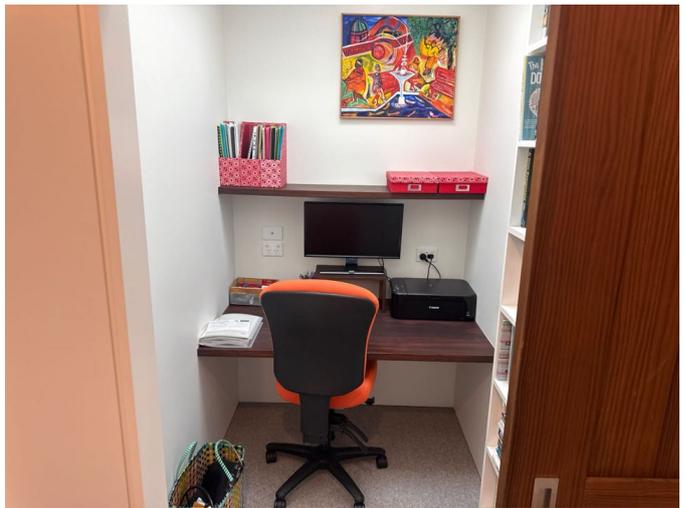
The small office space is tidy
