BUILDING INSPECTION REPORT

RED LBP PRE-PURCHASE REPORT

PRE-PURCHASE BUILDING REPORT

Property Address	7/24 Whitmore Street, Edgeware, Christchurch 8013
Client	Jonathan Booth & Aurora Lin
Date of Inspection	7th February 2026
Time	8:00 am
Inspector	Jamie Chapman National Certificate in Carpentry
LBP Number	BP137228
People Present	Inspector
House Occupied	No

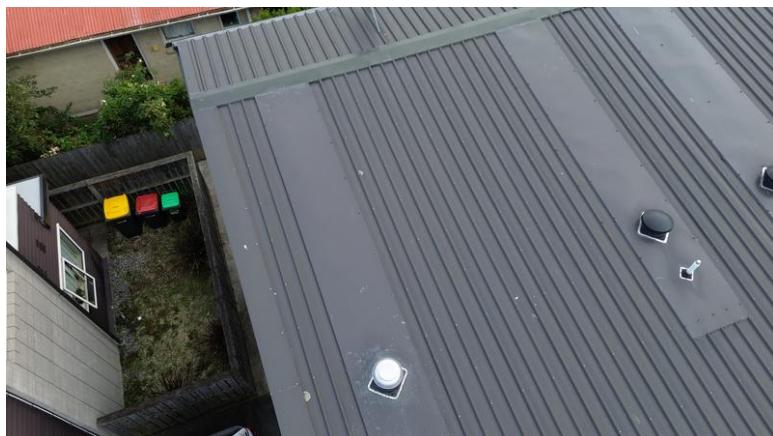
Photo 3

The second story roof system was viewed via a drone.

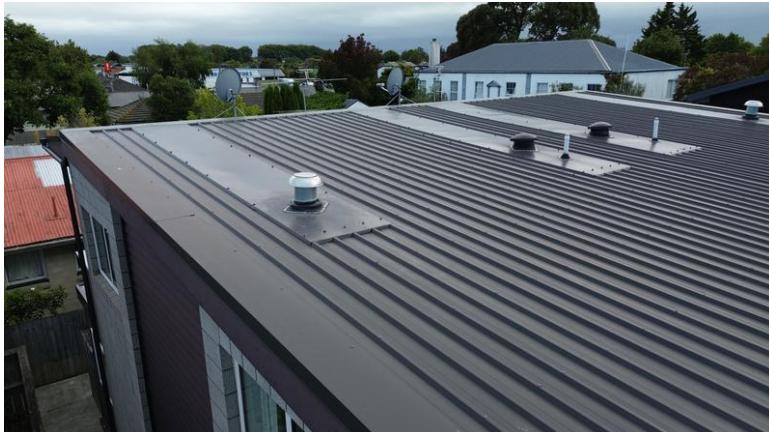
Photo 4

A long run profiled metal roof with screw fixings is located over the dwelling.

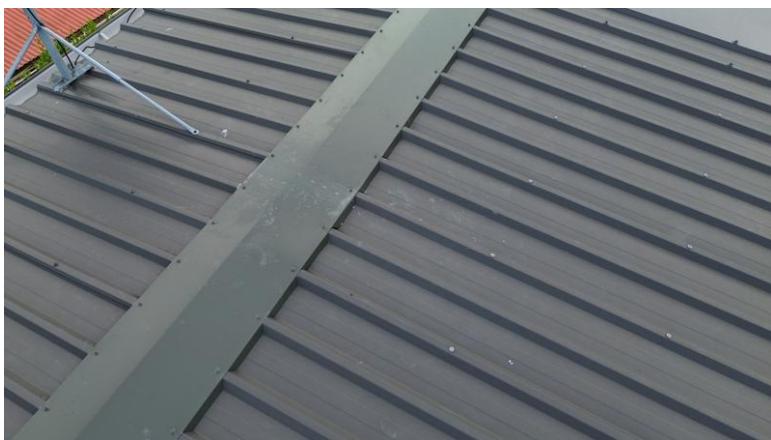
Photo 7

Metal ridge capping located on the high point of the roof.

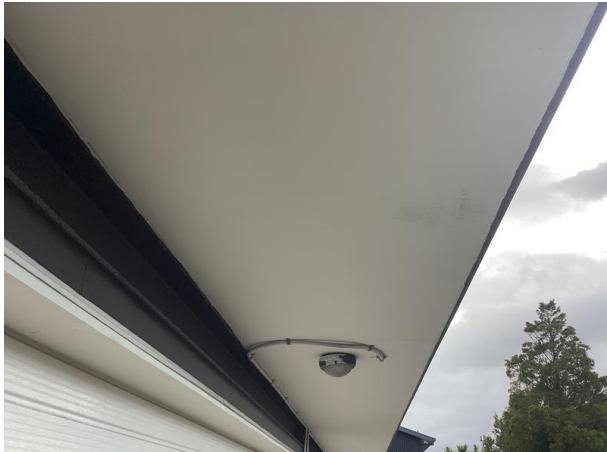
Photo 9

Painted fibre cement soffits located around some of the dwelling.

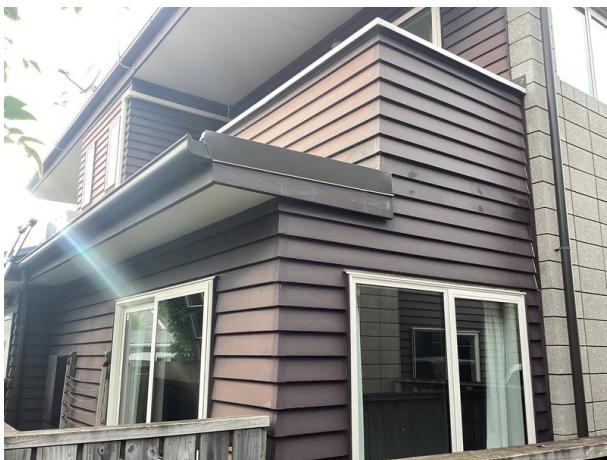
Photo 11

Horizontal fibre cement weatherboards are located around some of the dwelling.

It is recommended to regularly maintain the painted surfaces, in accordance with the manufacturer's recommendations for the specific cladding type, is essential to preserving weathertightness. Proper upkeep helps protect the cladding from environmental exposure, prevents deterioration, and ensures the building's exterior remains effective at repelling moisture.

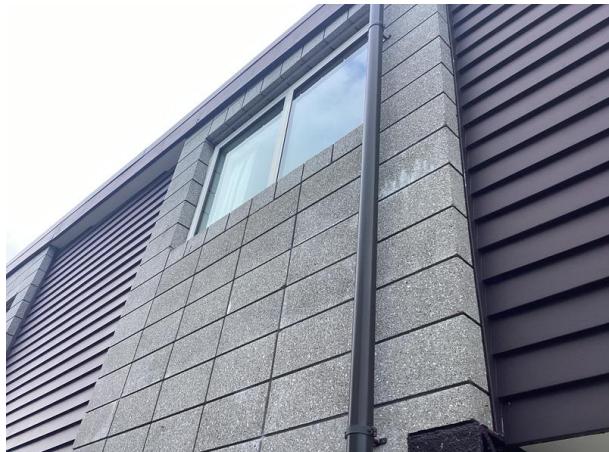
Photo 17

Masonry blocks are also located around some of the dwelling. No significant visible issues during the inspection.

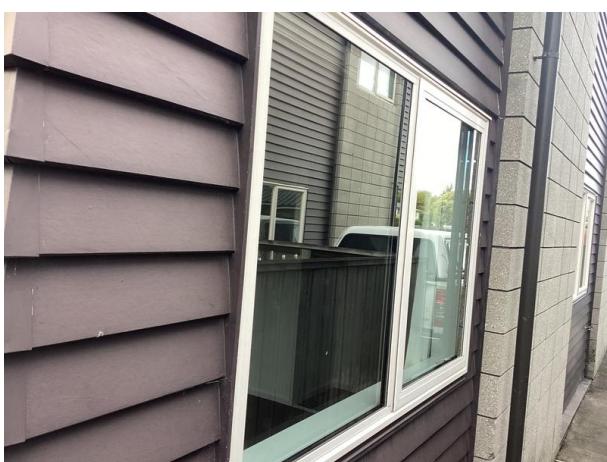
Photo 18

Double glazed aluminium windows are located around the unit.

Keep up regular maintenance. It is recommended to seal the ends of the head flashing to weatherboard junctions.

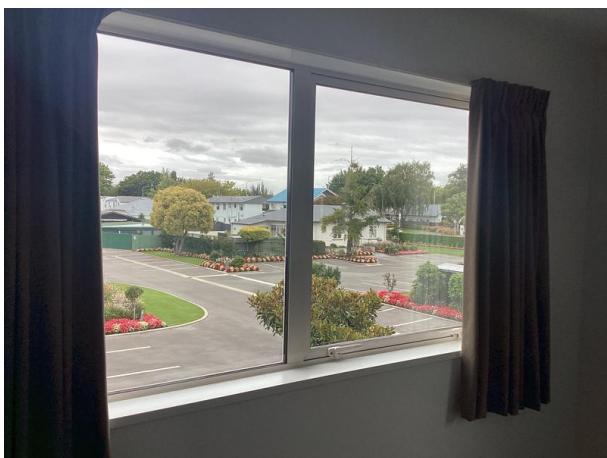
Photo 21

Aluminium windows viewed from inside the dwelling. No significant issues during the inspection.

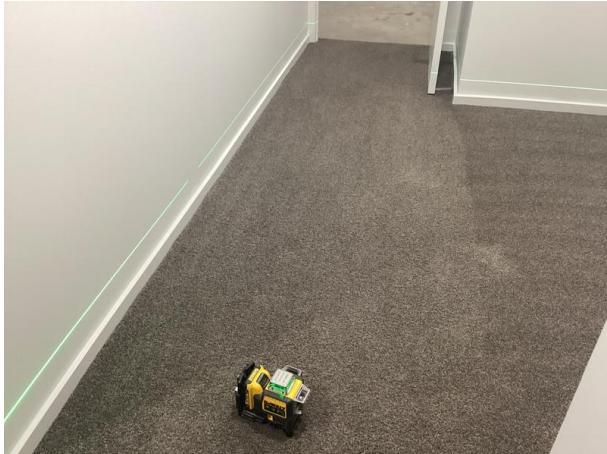
Photo 23

The floor levels were spot checked around the dwelling using a self levelling laser.

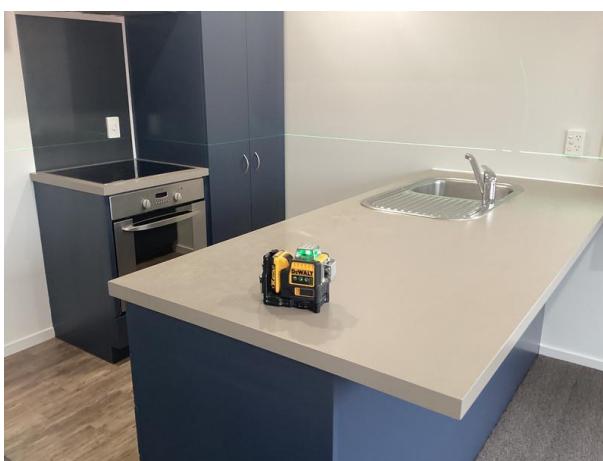
Photo 25

The kitchen bench tops were also checked and were level.

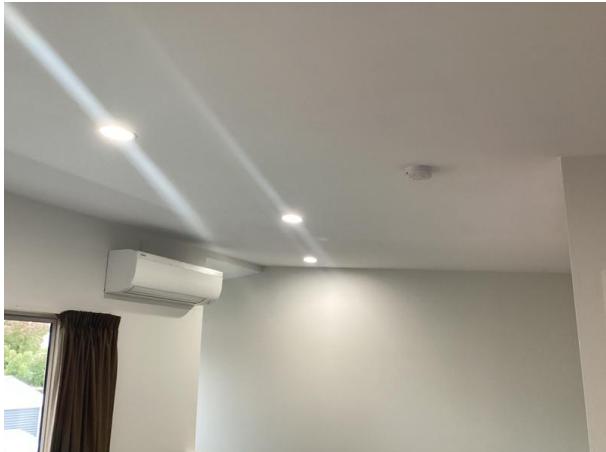
Photo 26

The condition of the roof framing is unknown.

There is no roof space to view due to this roof system being a skillion construction.

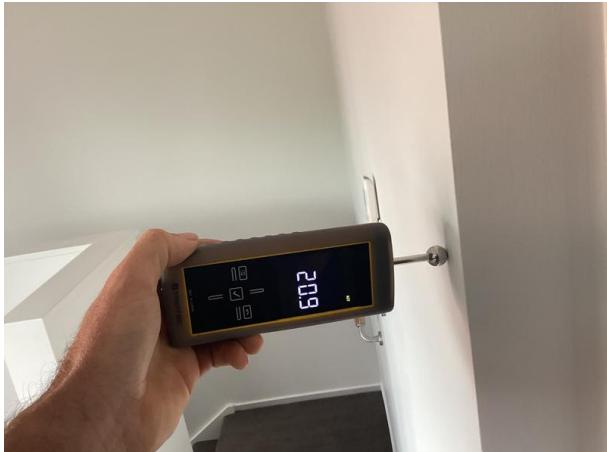
Photo 27

Example of a base reading that was taken on an internal wall. This was the average moisture reading for this dwelling during the inspection.

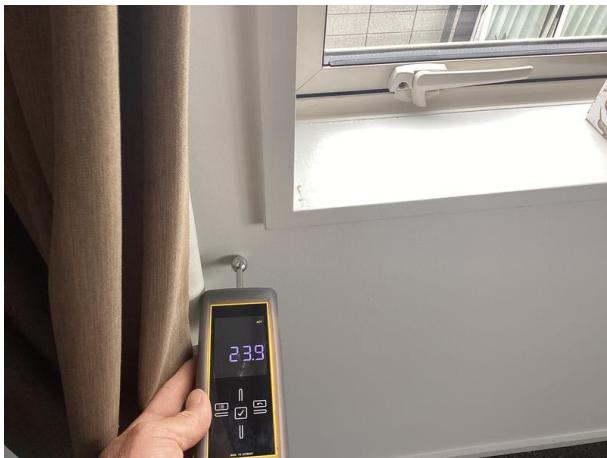
Photo 29

Moisture testing was done around the external window joinery.

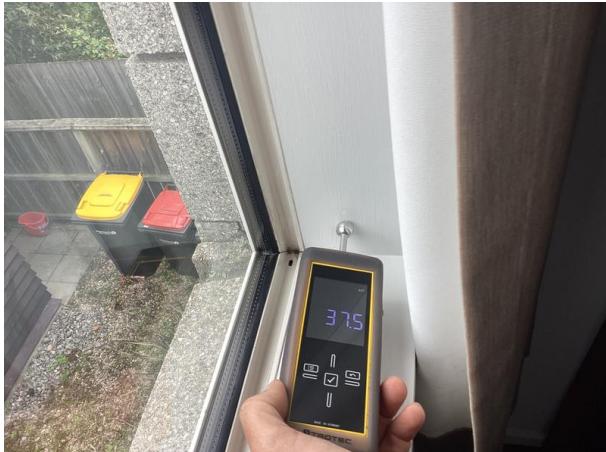
Photo 30

Example of moisture testing being carried out around the external window joinery.

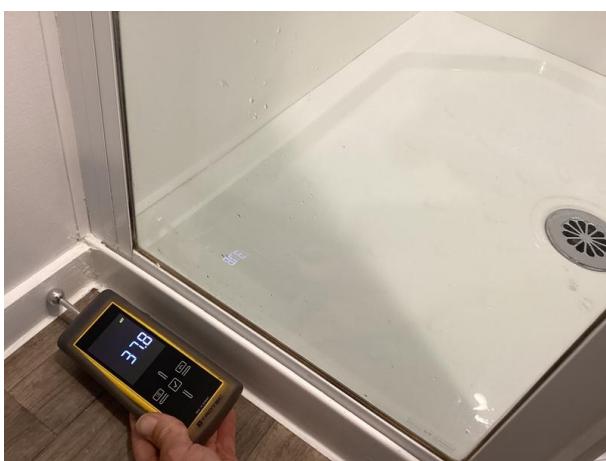
Photo 31

Moisture testing done around wet areas.

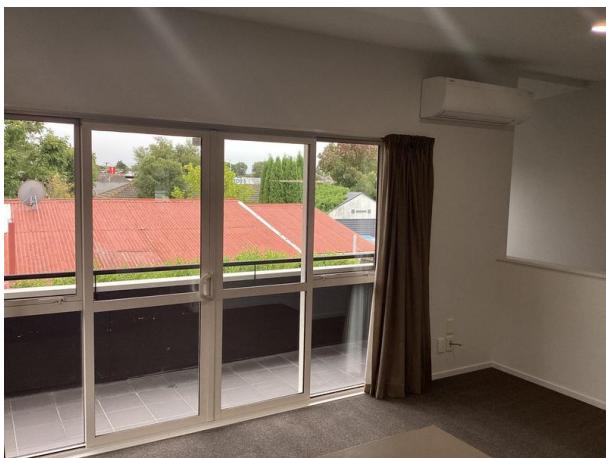
Photo 45

Living room.

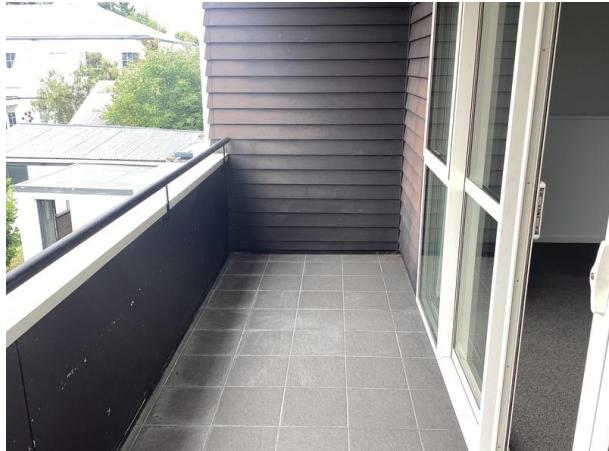
Photo 50

Balcony located off the living room.

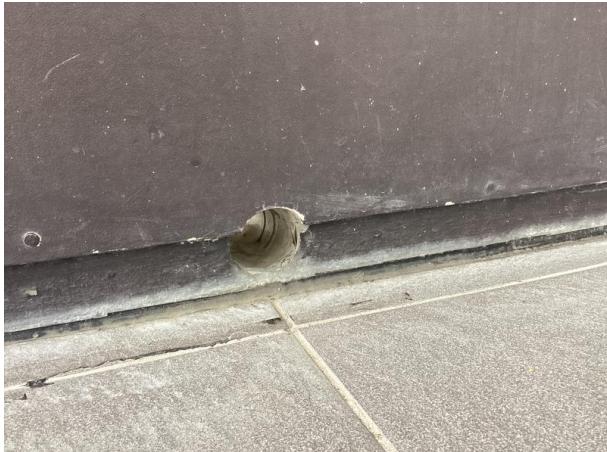
Photo 52

An overflow pipe was installed to this balcony.

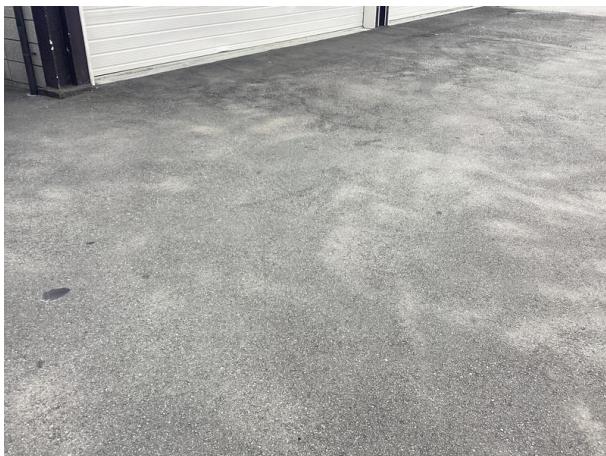
Photo 53

Asphalt driveway, no significant issues.

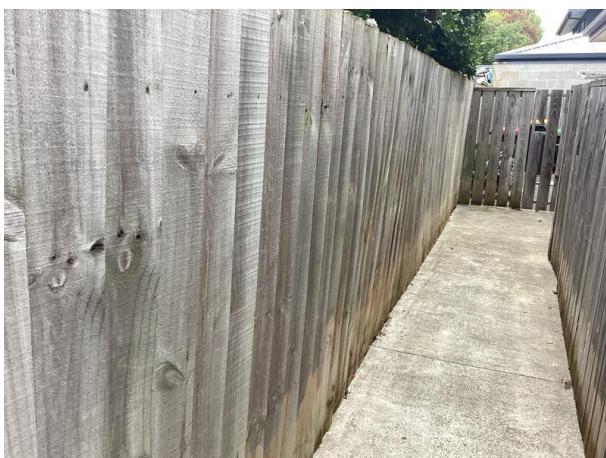
Photo 54

Timber fences, in a condition expected for age.

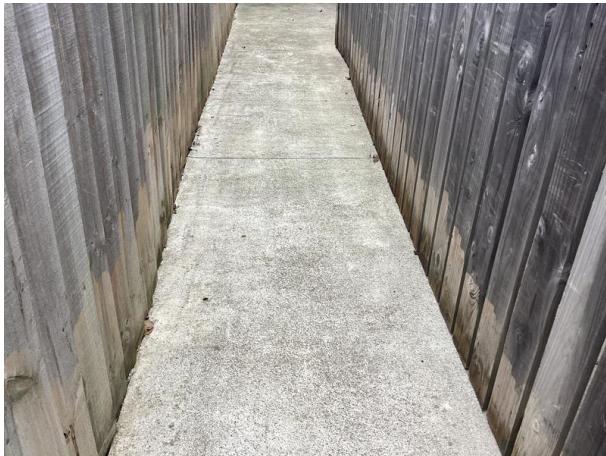
Photo 55

Concrete paths, no significant issues.

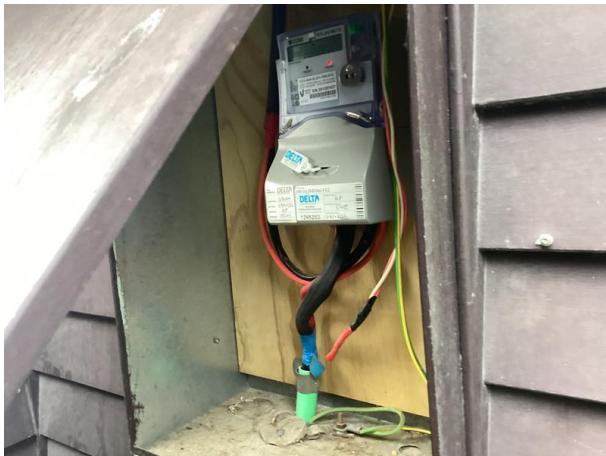
Photo 58

Meter box located on the north side of the dwelling.

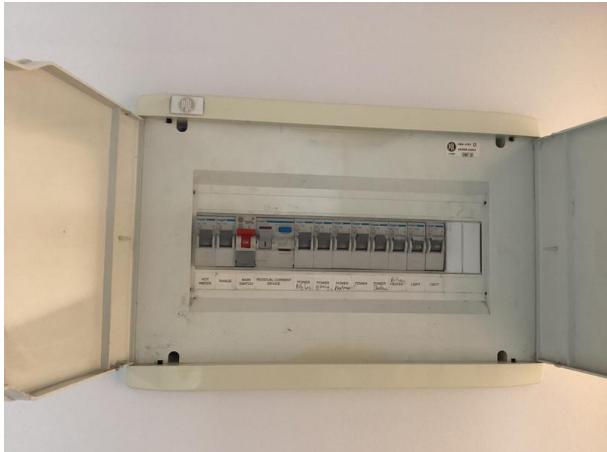
Photo 59

Switchboard located in the living area.

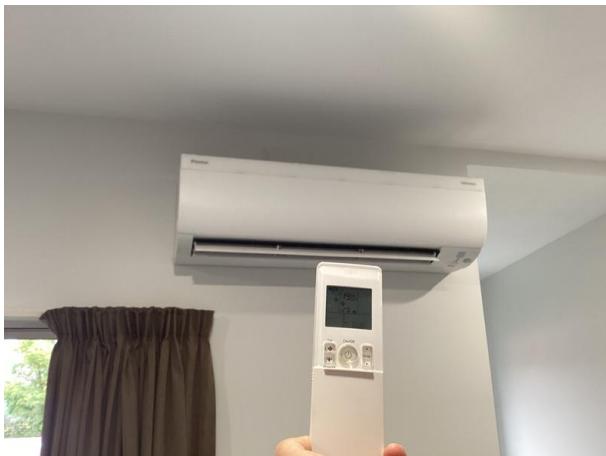
Photo 65
Daikin heat pump located in the living room.

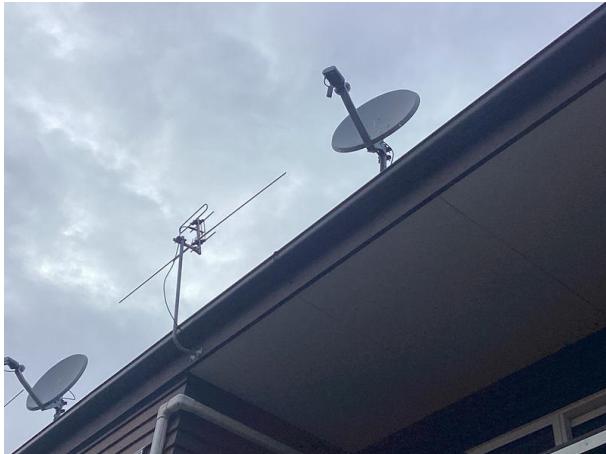
Photo 66

Satellite aerial and antenna located on the roof system.

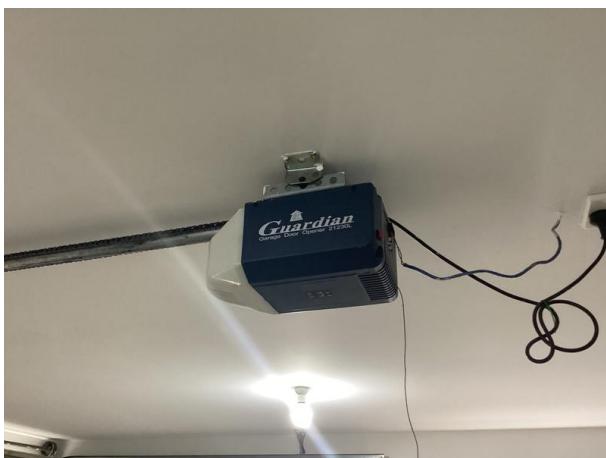
Photo 67

Automatic garage door opener.

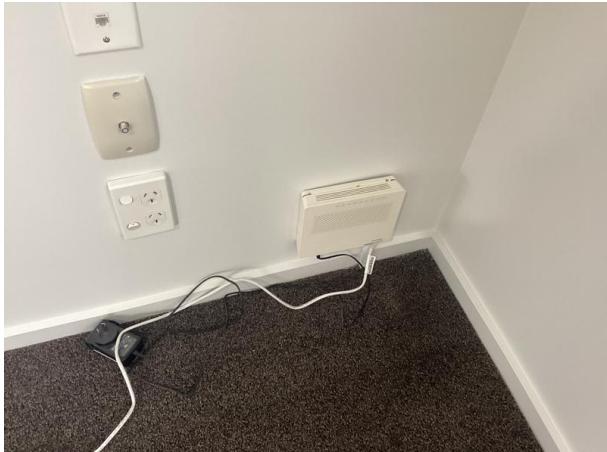
Photo 69

Communications hub located in the upstairs bedroom.
