BUILDING INSPECTION REPORT

RED LBP PRE-PURCHASE REPORT

PRE-PURCHASE

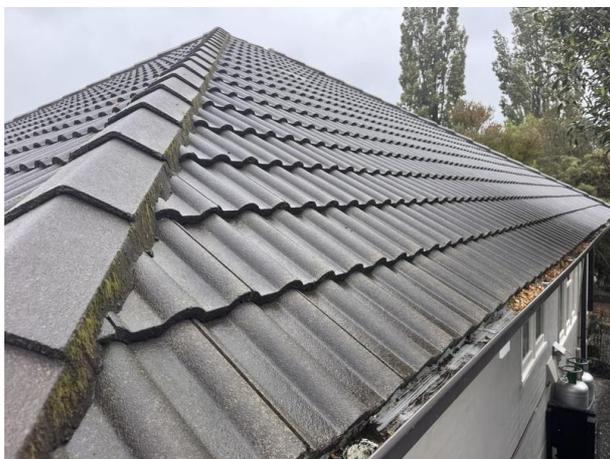
Photo 3

Masonry tile hip roof. East elevation.

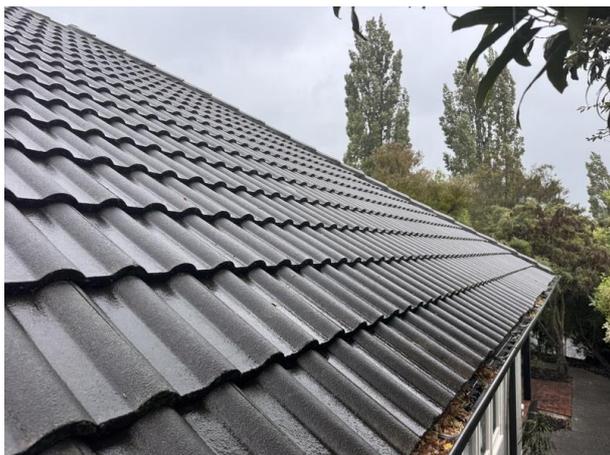
Photo 4
Masonry tile roof east elevation.

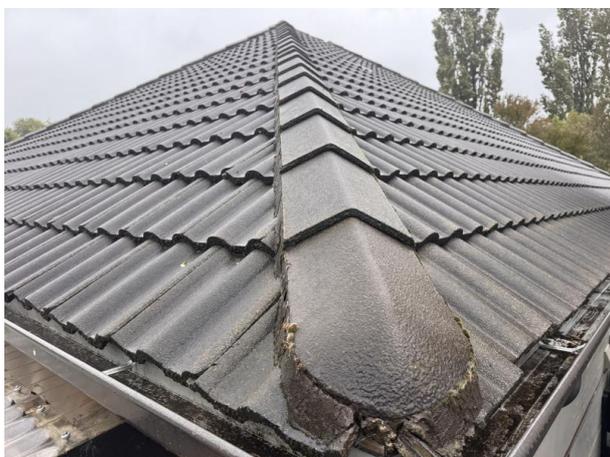
Photo 5
Masonry tile hip roof.

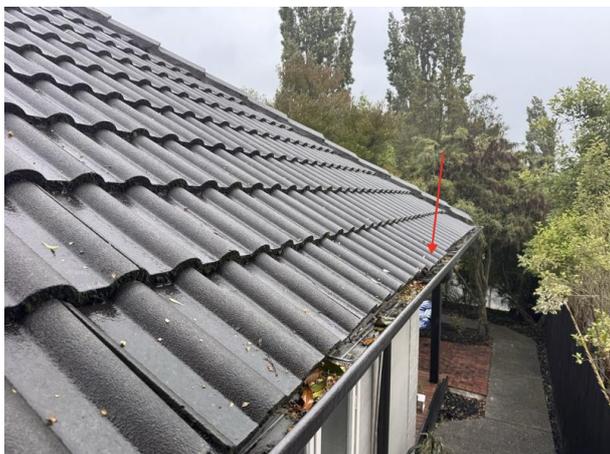
Tile alignment - Slipped tiles observed.

Photo 6
Slipped tiles visible on the east elevation.

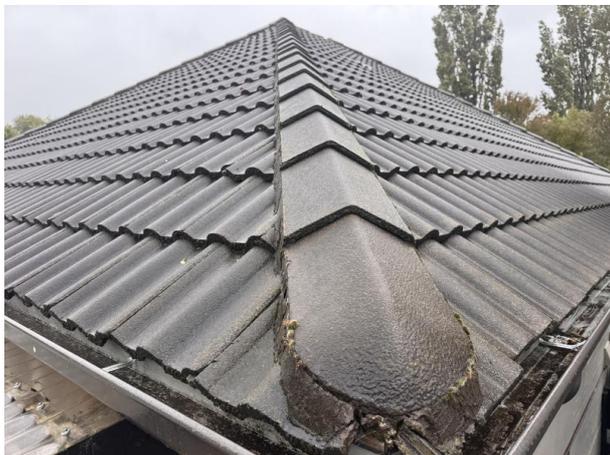
Photo 9
Masonry tile hip cap flashings.

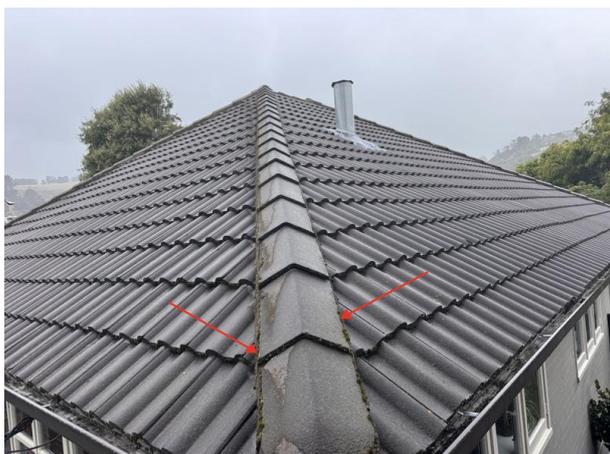
Condition - Moss and lichen

Photo 10
Moss growth visible on the north westbound corner hip.

The roof displayed visible signs of moss growth in certain areas, and it is advised to address this issue as part of regular maintenance. Failure to do so could cause deterioration of the coating.

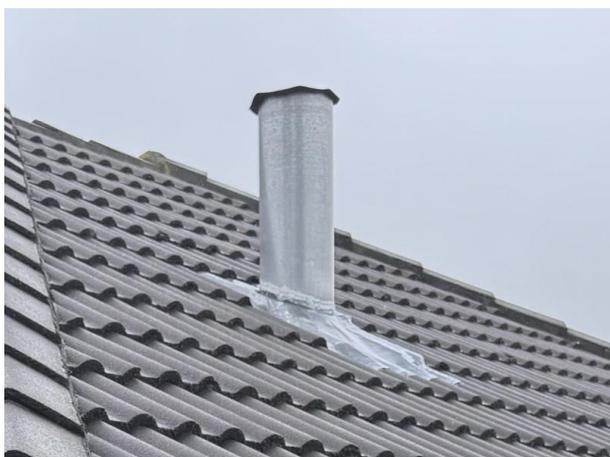
Photo 11
Decommissioned fire flue roof penetration on the west elevation with a lead base flashing.

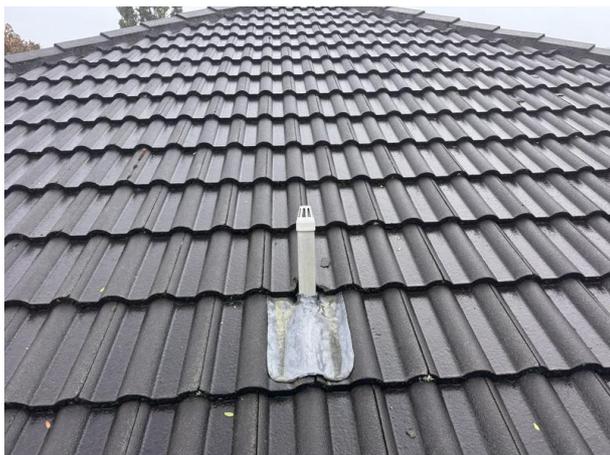
Photo 12

Terminal vent pipe roof penetration on the east elevation with a lead base flashing.

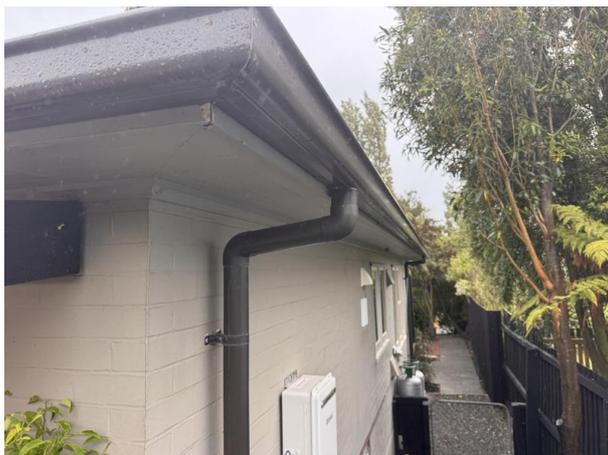
Photo 13
Profiled metal roof edge gutter and downpipes attached to timber fascia with painted to soffit lining.

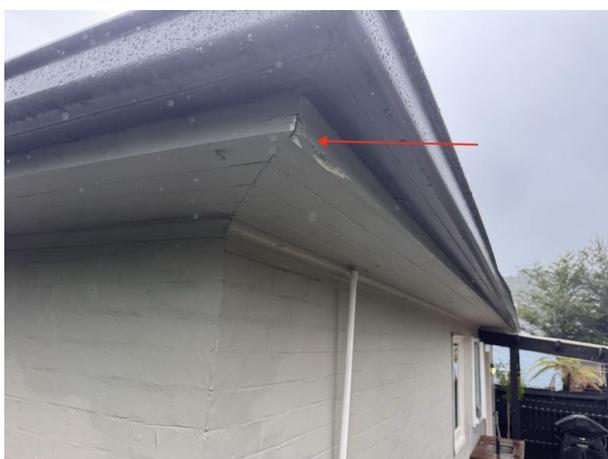
Damage and Rot - Areas requiring maintenance.

Photo 14
Timber fascia splitting visible on the south west corner.

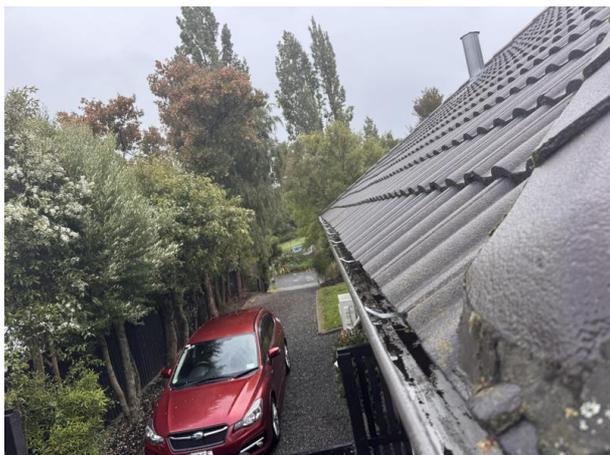
Photo 16
Profiled metal roof edge gutter on the west elevation. Clear at the time of inspection.

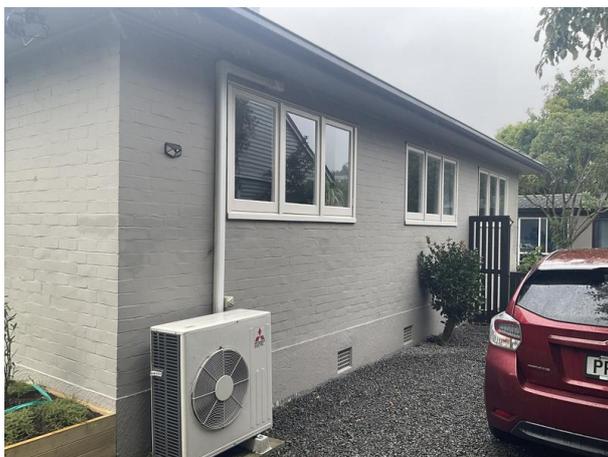
Photo 19

Brick veneer cladding with a painted finish.

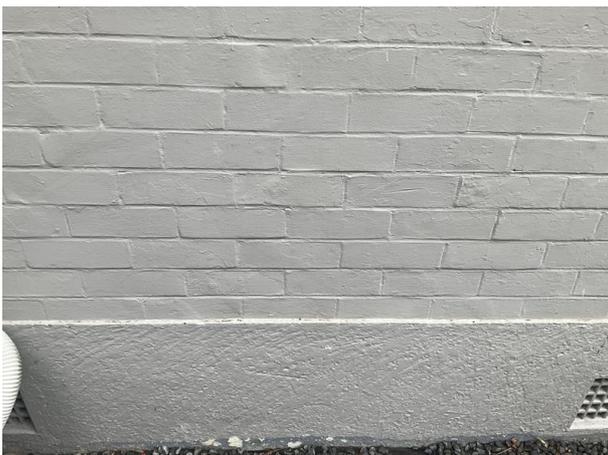
Early detail books from the 1970s showed suspended timber floors with brick veneer cavities left open to the subfloor. This allowed moist air to move up the cavity into the roof space, often causing significant moisture issues. During renovations, the cavity should be sealed from both the subfloor and roof space, as also required in SNZ HB 4236:2002, section 9.2.6(f).

Photo 20
No external weep holes on the bottom course as the brick cavity is open to the subfloor.

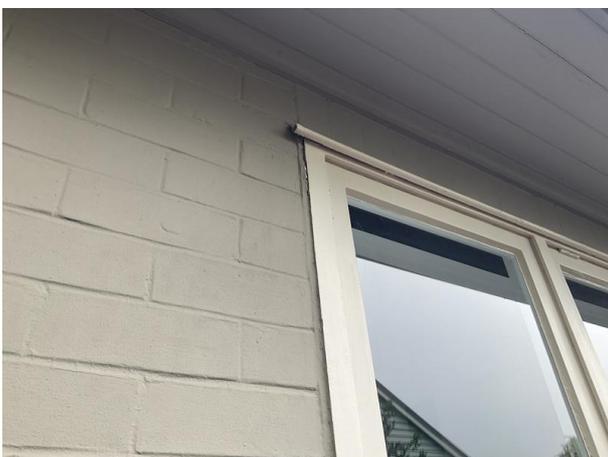
Photo 21
Timber joinery side sealed to the cladding and head flashings installed.

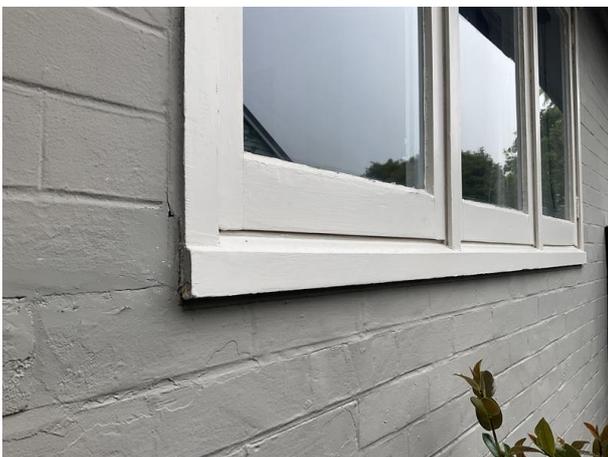
Photo 22
Timber window sills installed with suitable run off angle.

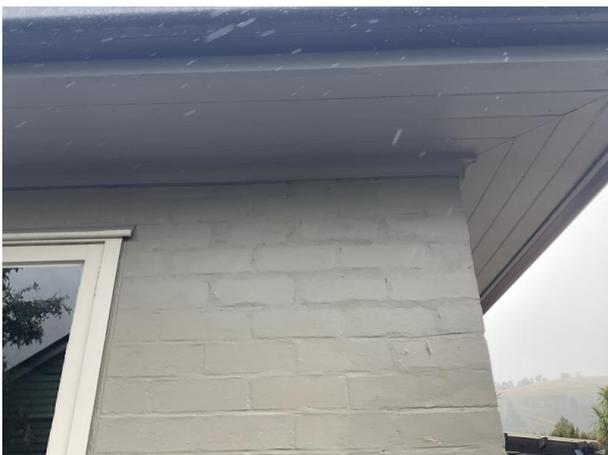
Photo 23

No top coarse external vent holes visible, as the brick cavity is open to the roof space.

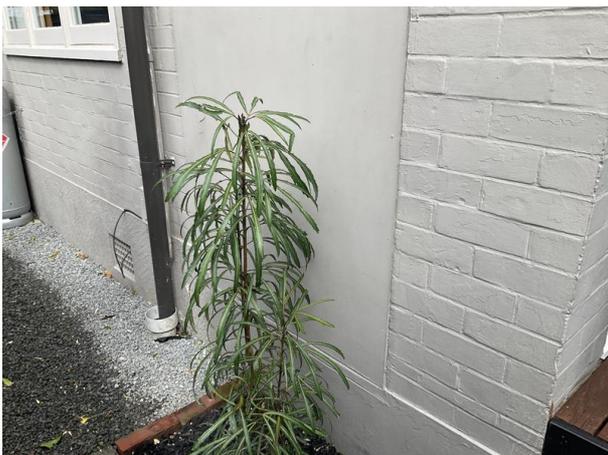
Photo 26
Second area filled in with a fibrous cement sheet cladding on the north east corner.

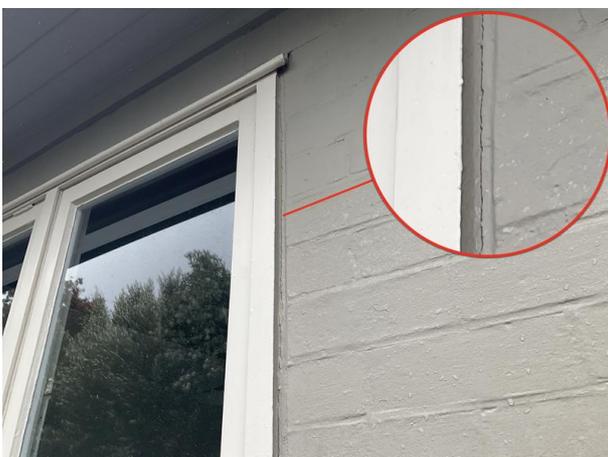
Photo 27
Visible gap on the west elevation window side seal.

Any incomplete or damaged exterior side seals at the cladding to the exterior joinery units need to be repaired to stop water ingress.

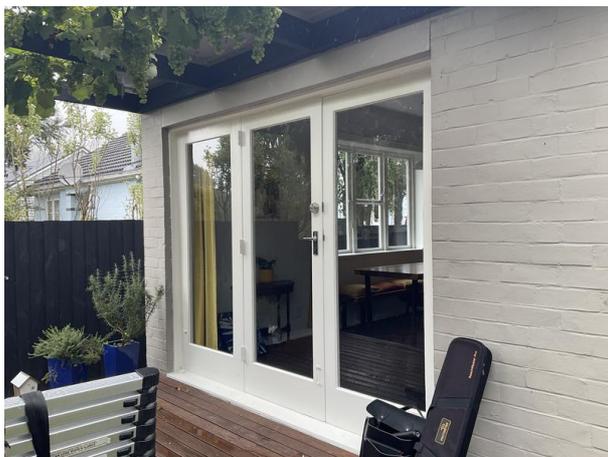
Photo 29

Single glazed timber joinery. French door access to the dining room.

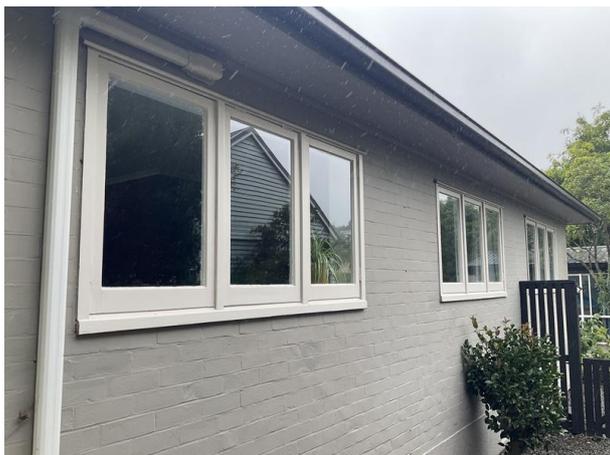
Photo 30
Single glazed timber joinery.

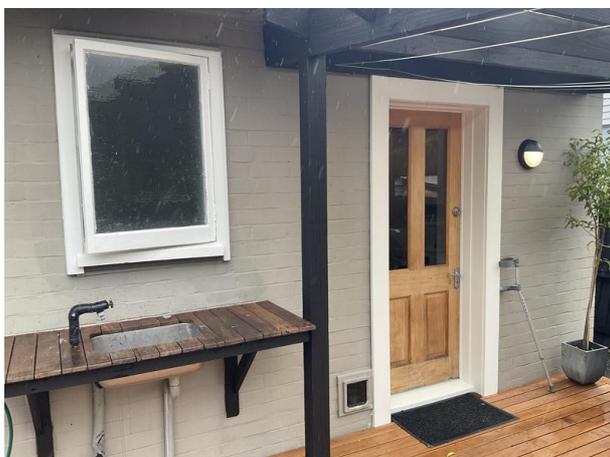
Photo 31
Single glazed timber back door.

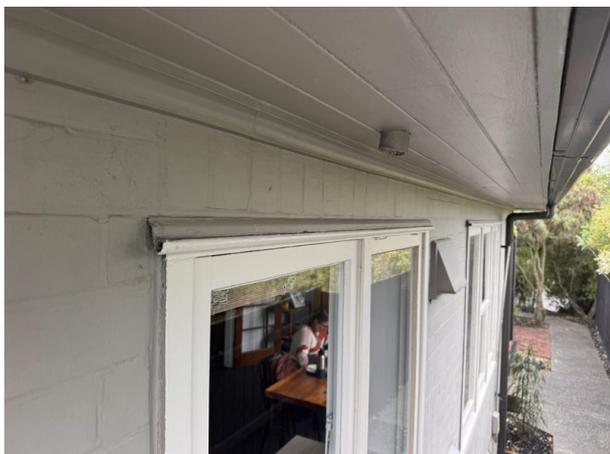
Photo 35
Profiled metal head flashings.

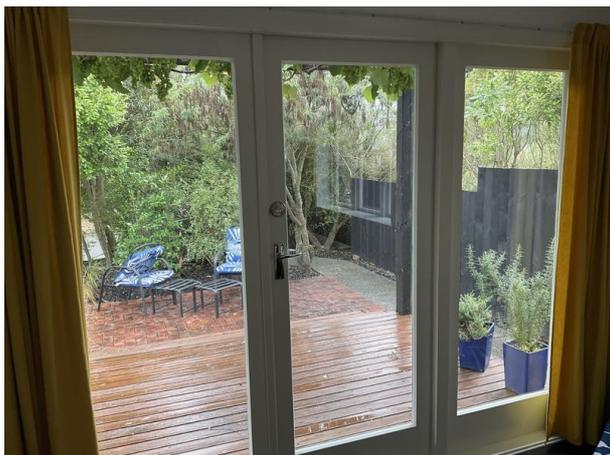
Photo 36
All accessible windows and doors tested for function.

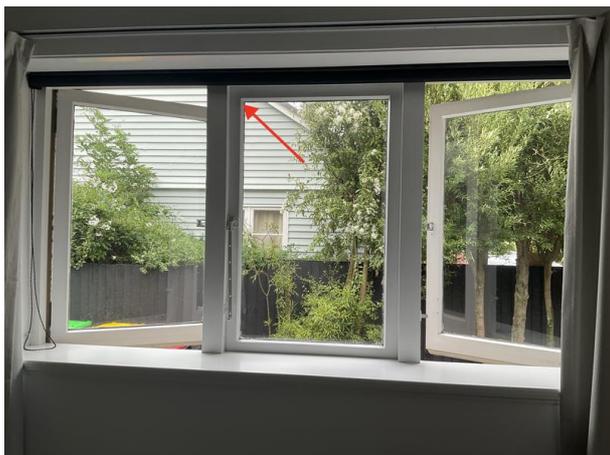
Photo 39
The middle window in bedroom two requires some adjustment to regain function.

Some repairs required to the opening sashes of the windows in order to restore functionality and to reduce draughts.

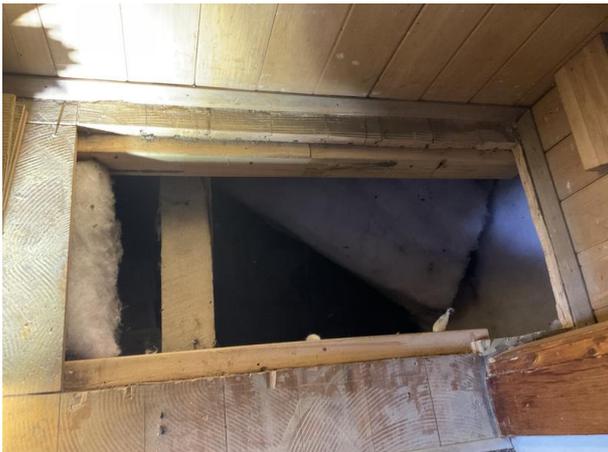
Photo 42
Subfloor access located in the bedroom one cupboard.

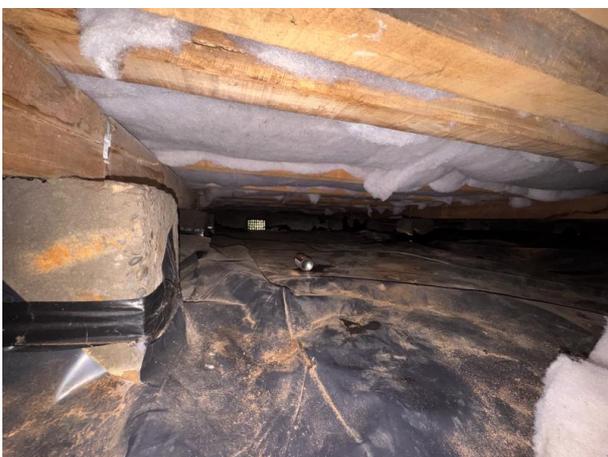
Photo 43
Suspended timber floor supported by a concrete perimeter ring foundation and precast concrete piles.

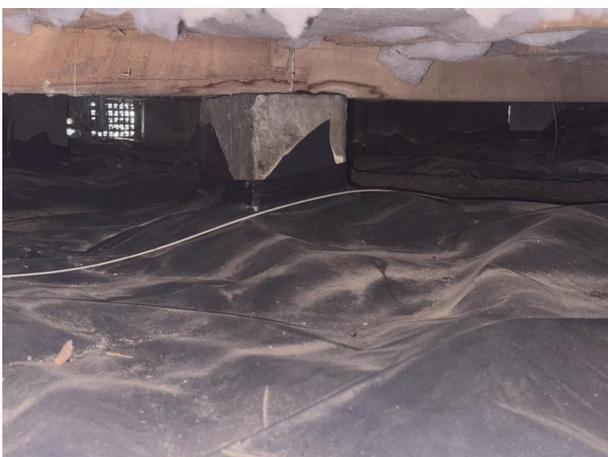
Photo 46
Polythene ground moisture barrier installed, and polyester insulation.

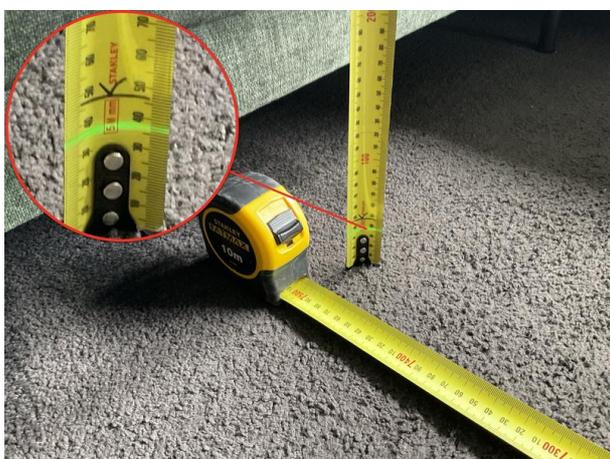
The overall level difference measured in the sampled areas was approximately 10mm. This assessment is limited to a visual, non-invasive spot-check and is not a full floor-level survey or certification of compliance.

Photo 49
10mm deviation over 7.5m from the dining
room into the living room.

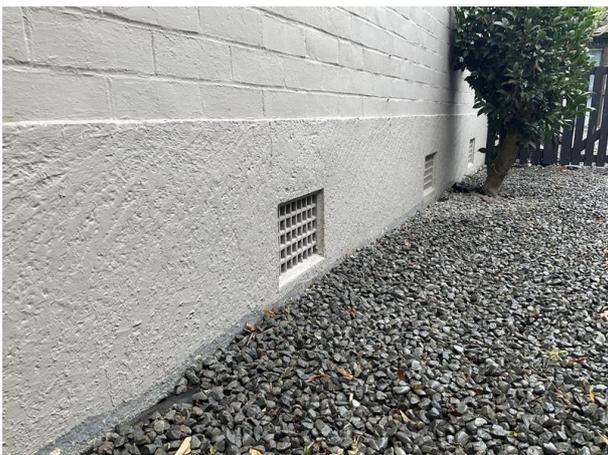
Photo 51
Concrete perimeter ring foundation.

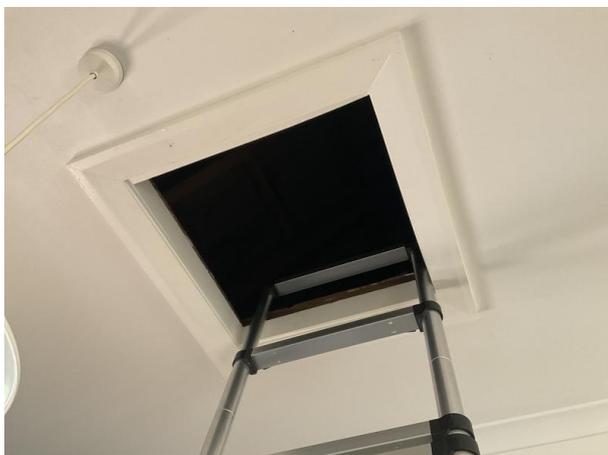
Photo 53

Roof space access located in the laundry kitchen area.

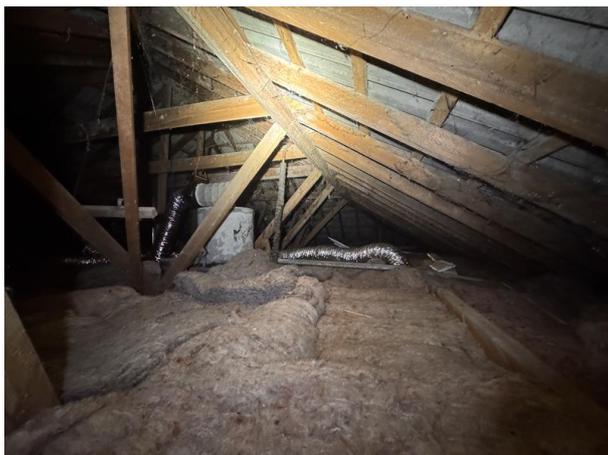
Photo 54
Pitched timber roof frame supporting the masonry tile roof.

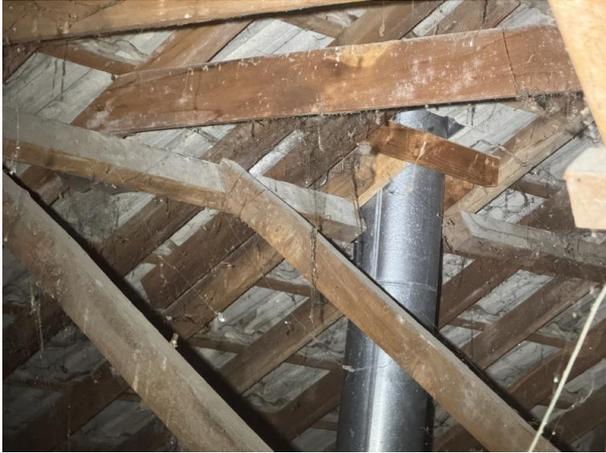
Photo 57
Decommissioned fire flue roof
penetration.

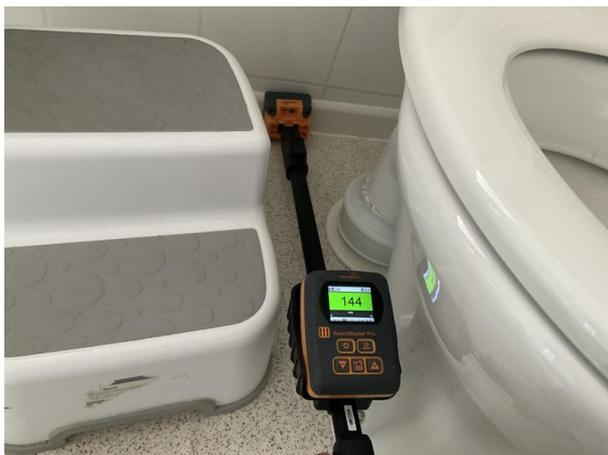
Photo 60

Moisture reading taken from behind the toilet. No indications of elevated moisture found at the time of inspection.

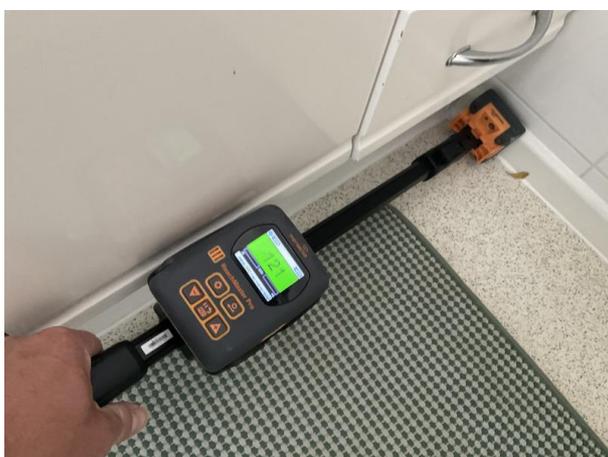
Photo 61

Moisture taken from under bathroom vanity. No indications of elevated moisture found at the time of inspection.

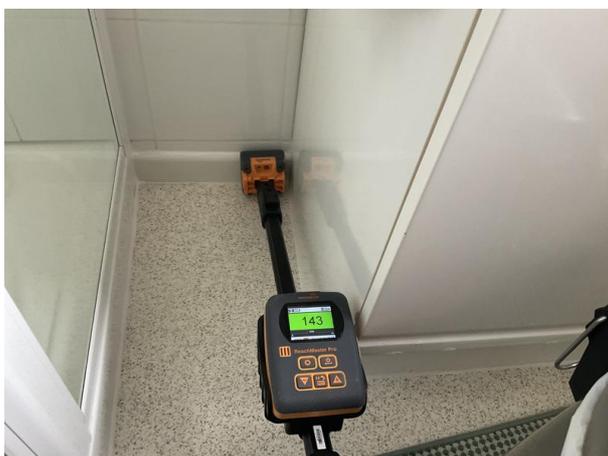
Photo 62

Moisture taken from under the bathroom vanity. No indications of elevated moisture found at the time of inspection.

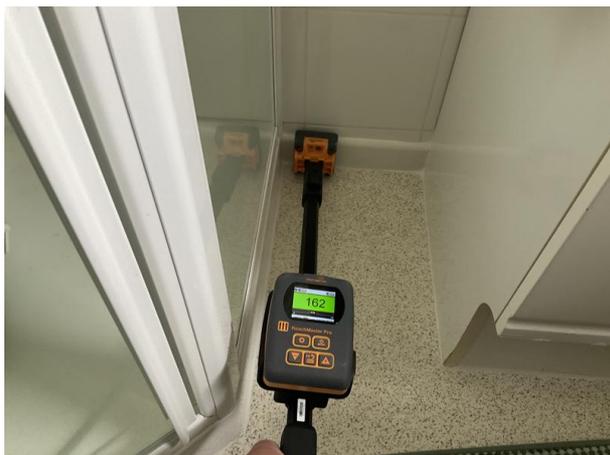
Photo 63
Moisture taken from under the shower corner. No indications of elevated moisture found at the time of inspection.

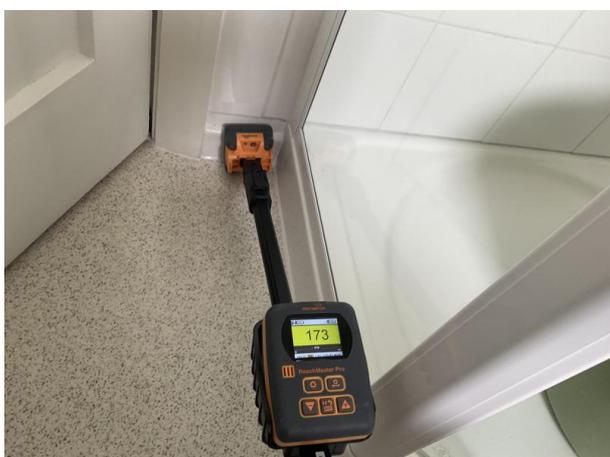
Photo 64
Moisture taken from shower corner. No indications of elevated moisture found at the time of inspection.

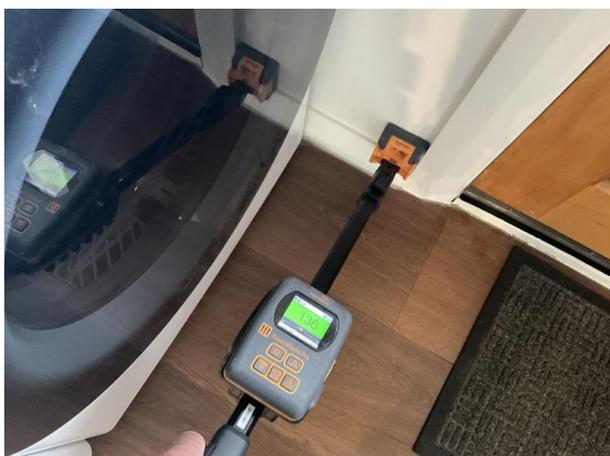
Photo 65
Moisture taken from the back entrance. No indications of elevated moisture found at the time of inspection.

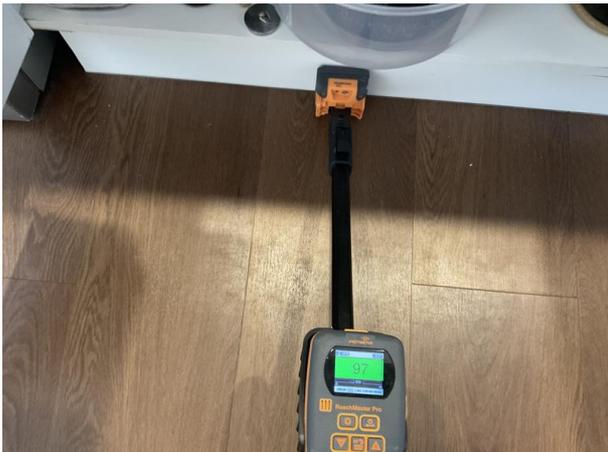
Photo 66

Moisture taken from the kitchen base cabinet. No indications of elevated moisture found at the time of inspection.

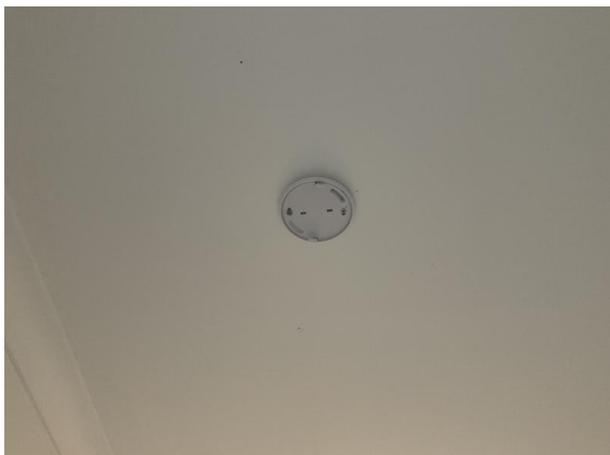
Photo 70
Smoke detector not in place at the time of inspection.

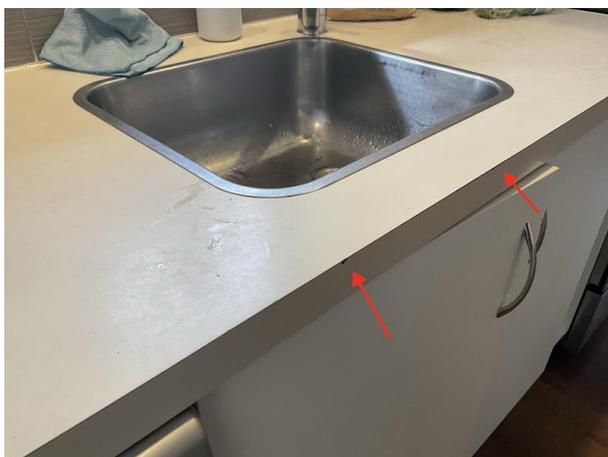
Photo 78
Benchtop ware and tear visible.

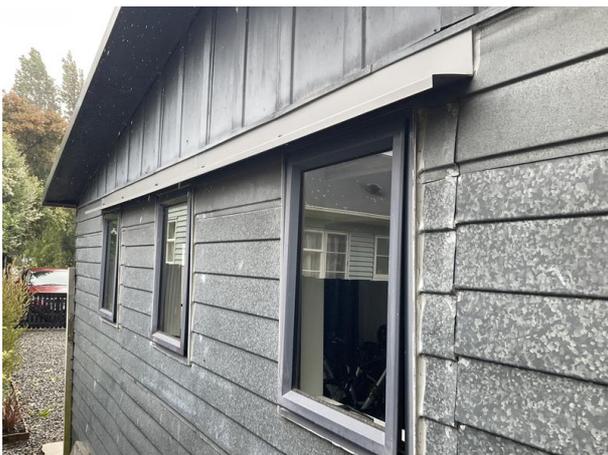
Photo 82
Profiled metal weatherboard cladding on
the east, west elevations.

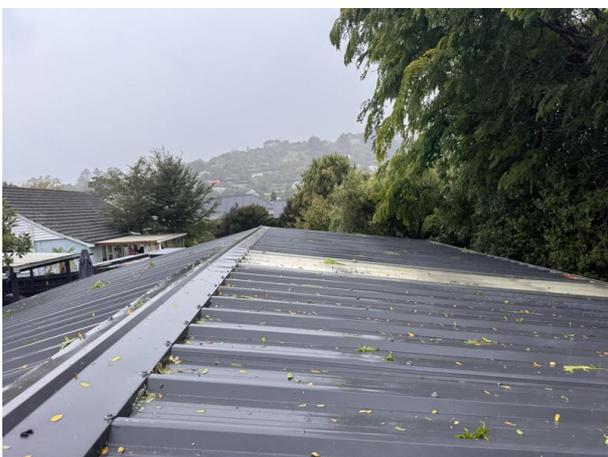
Photo 86
Profiled metal and polycarbonate roof on the studio.

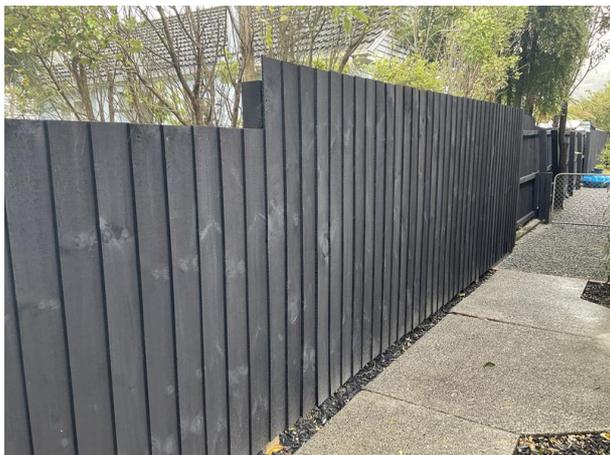
Photo 88
Timber paling East boundary fence.

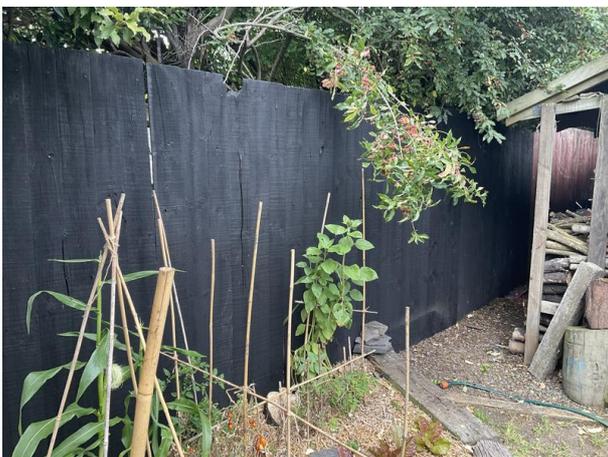
Photo 92
Timber paling south boundary fence.

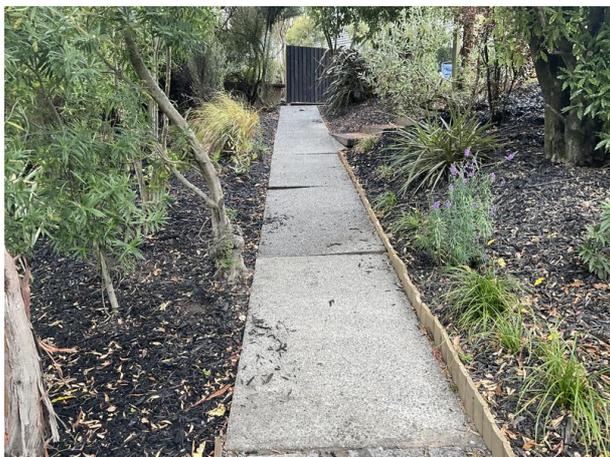
Photo 94
Plain concrete path on the north side of the dwelling.

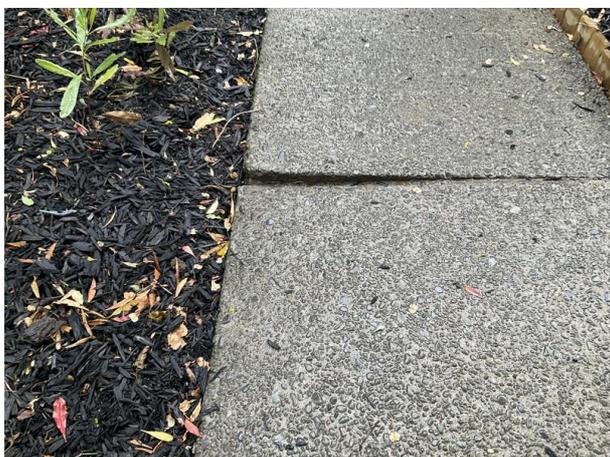
Photo 95
Some displacement visible on the concrete path.

General upkeep and maintenance.
Clean down to remove moss and reduce slip hazard as part of regular maintenance.

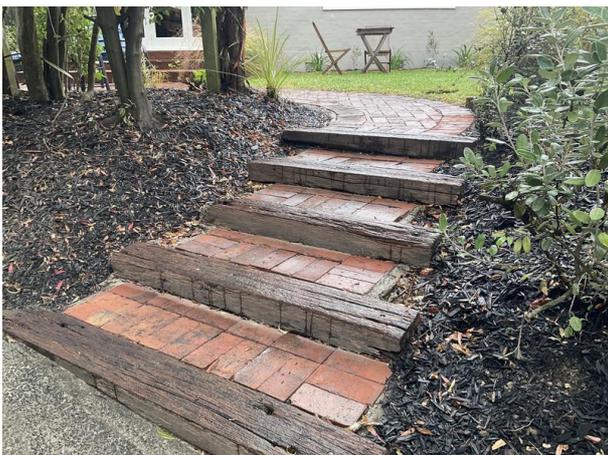
Photo 96
Clay brick path access to the dining deck.

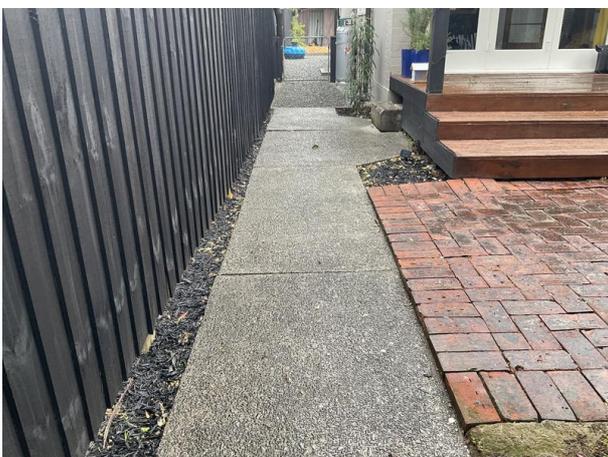
Photo 97
Plain concrete path on the east side of the dwelling

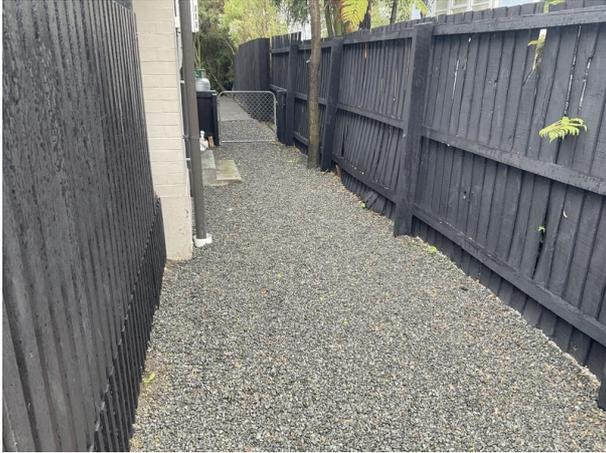
Photo 99
Shingle path on the east side of the dwelling.

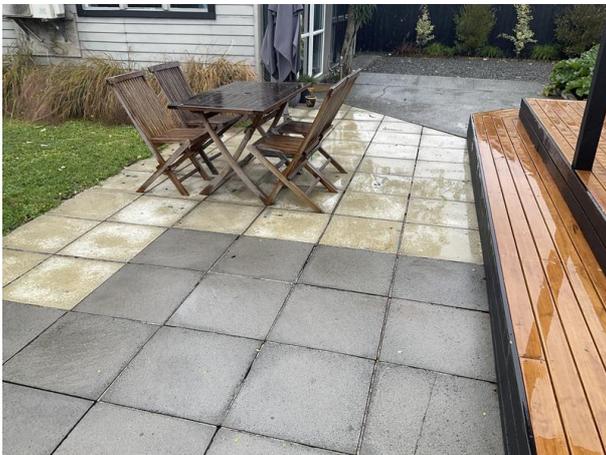
Photo 100
Concrete paver patio area on the south side of the dwelling.

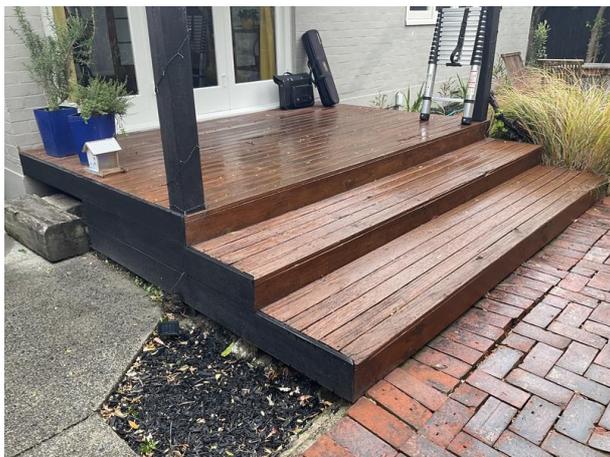
Located on the north of the home, accessed from the dining room.
Timber deck over timber substrate with nail fixings.
Connected to dwelling - Yes.
Condition of visible timbers - Some timbers are splitting from the ends.
Defects - Refer to photos.
Attached pergola without roofing of timber construction.

Photo 101
Timber deck on the north elevation with access to the dining area.

Clean down to remove slip hazard and keep free of debris.

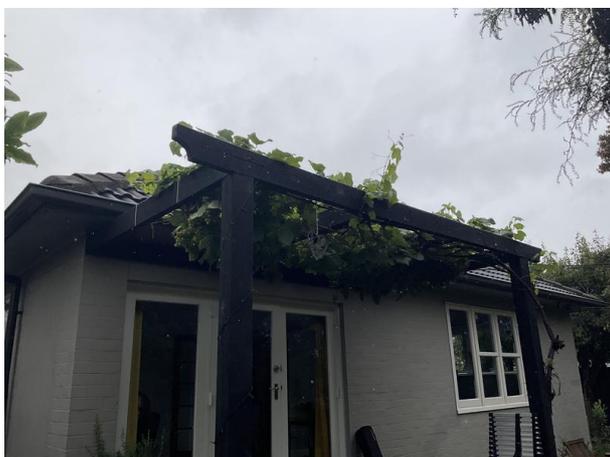
Photo 102
Attached timber Pagola frame installed over the north elevation deck.

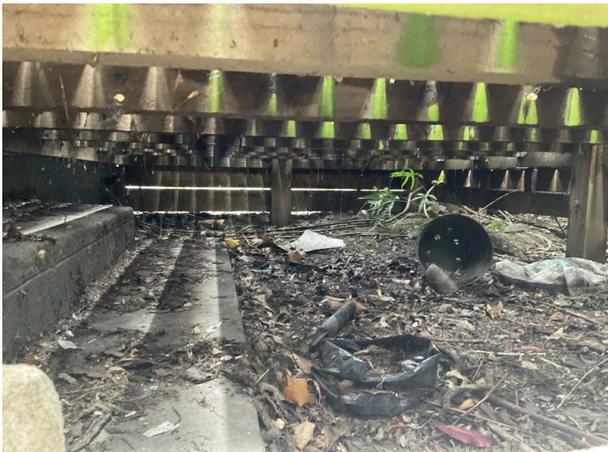
Photo 103
Under side of the north elevation deck frame.

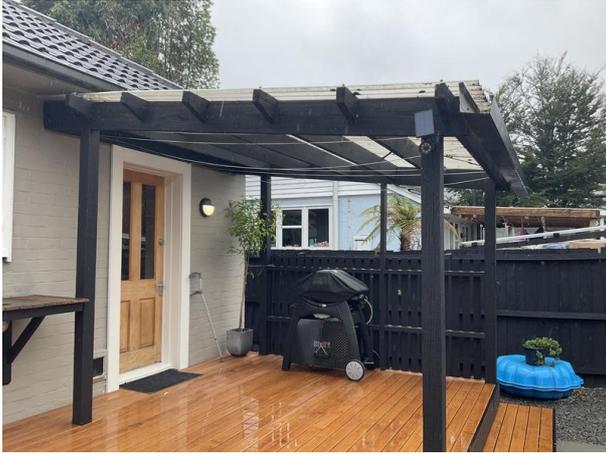
Photo 106
Attached timber Pagola frame with
polycarbonate roofing.

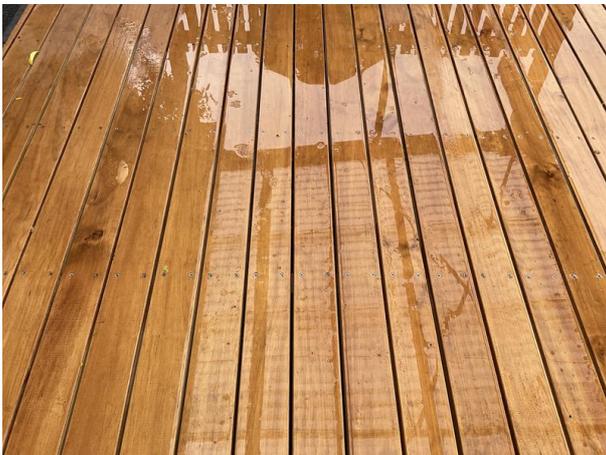
Photo 107
Screw fixings used.

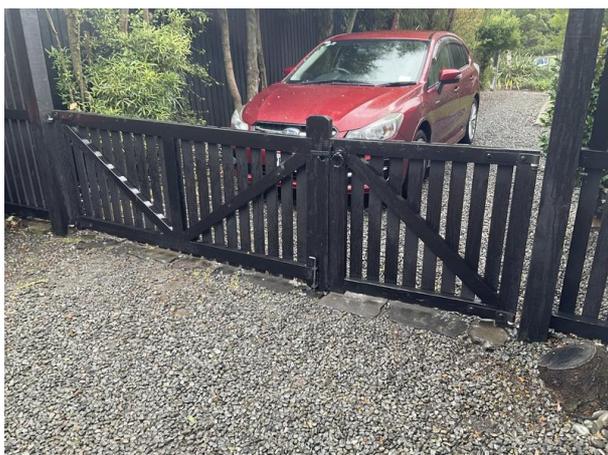
Photo 109
Driveway gate.

It is recommended to apply regular lubrication to the hinges and latch to maintain full function.

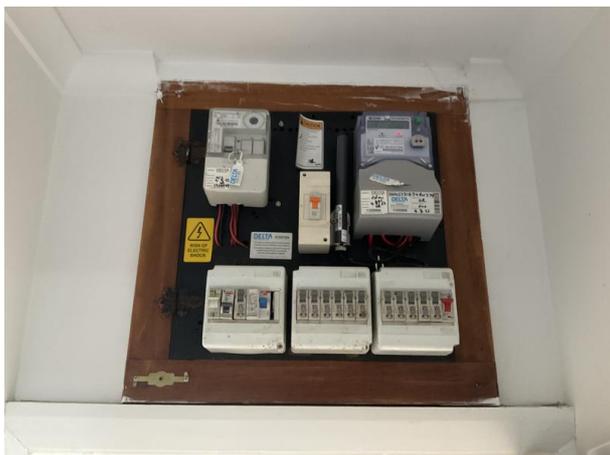
Advisory sticker on board stating the board is an asbestos-containing material.

Photo 110
Power meter and distribution board located in the hallway.

It is recommended to have a registered electrician advise on the electrical system.

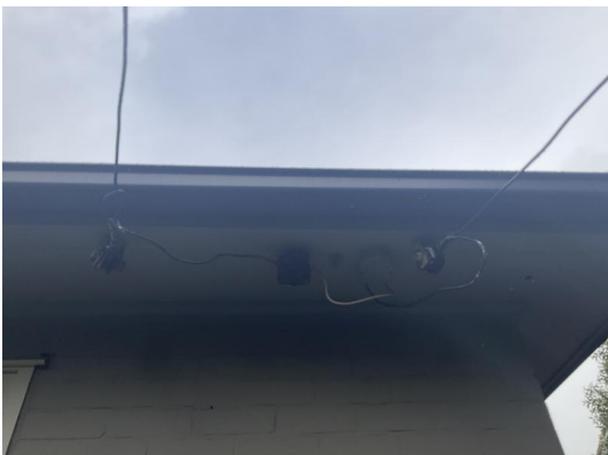
Photo 112
Overhead power supply.

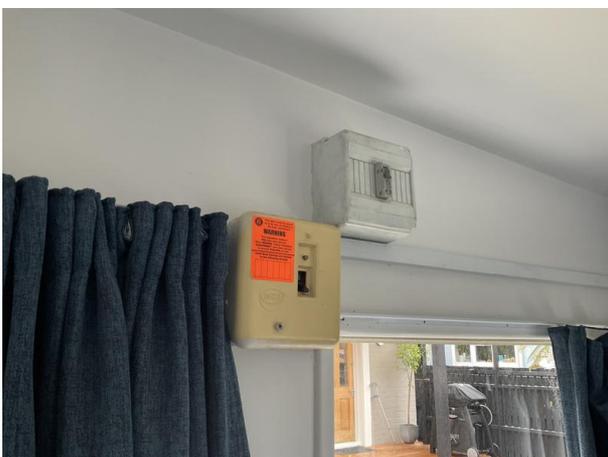
Photo 113
Sub power board located in the studio outbuilding.

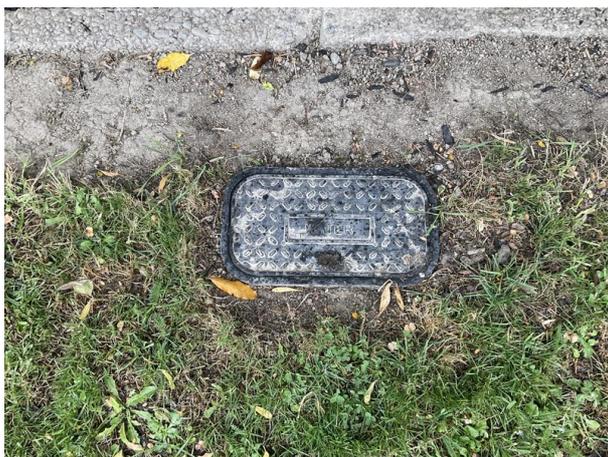
Photo 114

Water meter located in the front grass verge.

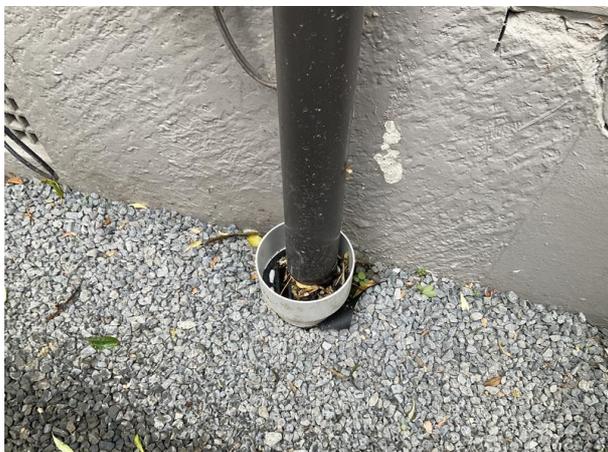
Photo 115

PVC stormwater rises.

Maintain a clear area around drainage systems by ensuring vegetation and soil are kept away. This helps to prevent blockages, maintain proper water flow, and reduce the risk of water pooling or drainage failure. Regularly inspect and remove any overgrowth or debris that may obstruct the drainage.

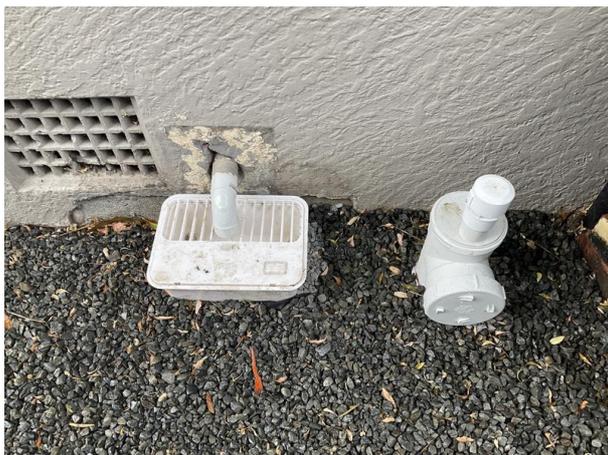
Photo 116
PVC terminal pipe and gully traps.

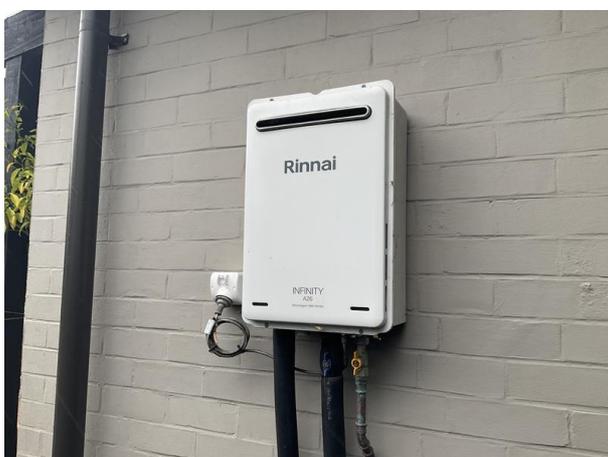
Photo 117
Gas califont hot water heater located on the east elevation.

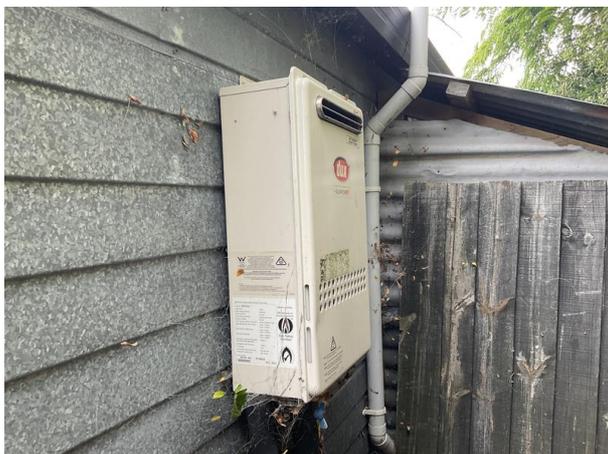
Photo 118
Gas califont hot water heater located on south wall of the studio outbuilding.

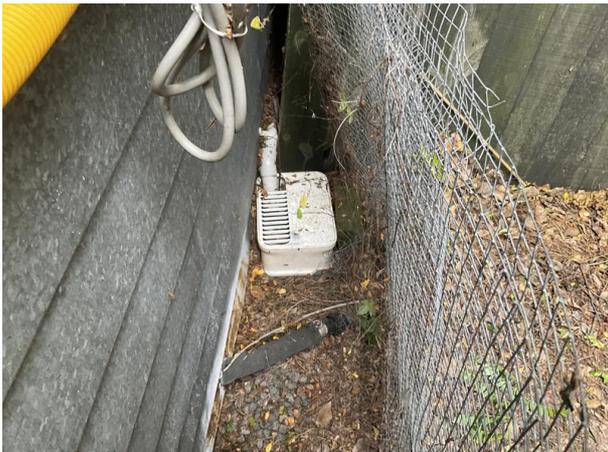
Photo 119
PVC gully trap installed on the south wall
of the studio.

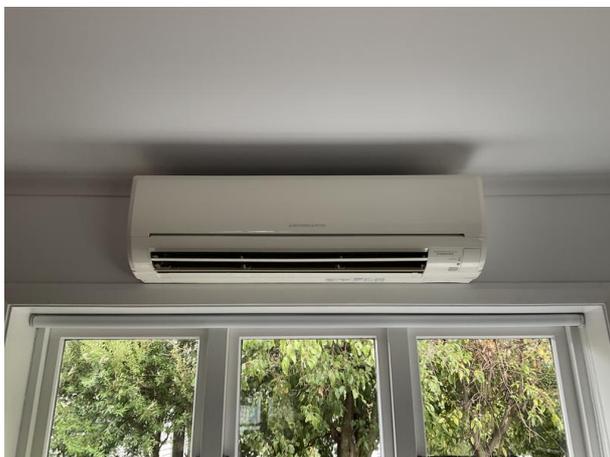
Photo 121

Mitsubishi high wall heat pump installed in the living room.

Follow the manufacturer's recommended servicing schedule to ensure the equipment operates efficiently and maintains optimal performance. Adhering to these guidelines helps identify and address potential issues early, reducing the risk of costly repairs and ensuring compliance with warranty requirements.

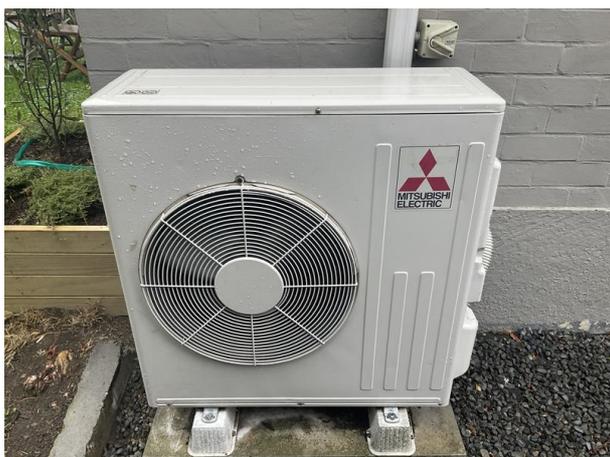
Photo 122

Mitsubishi heat pump inverter located on the west elevation

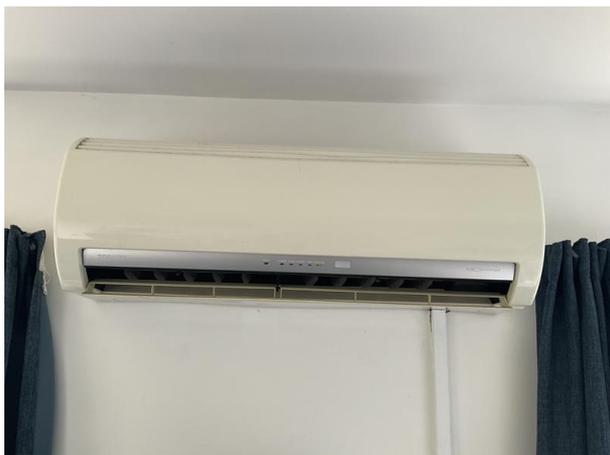
Photo 123
Toshiba high heat pump installed in the studio outbuilding.

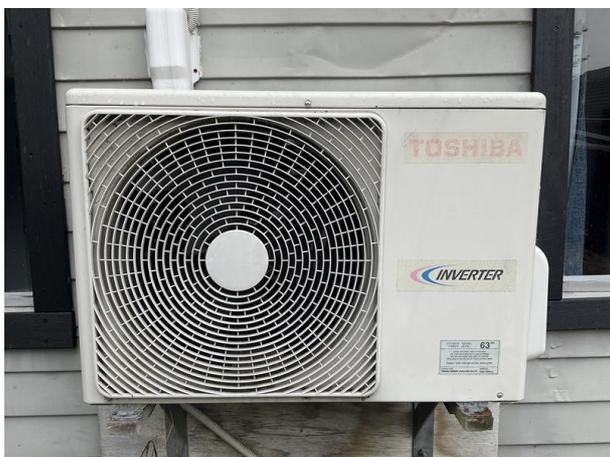
Photo 124
Toshiba heat pump inverter located on the east elevation of the studio.

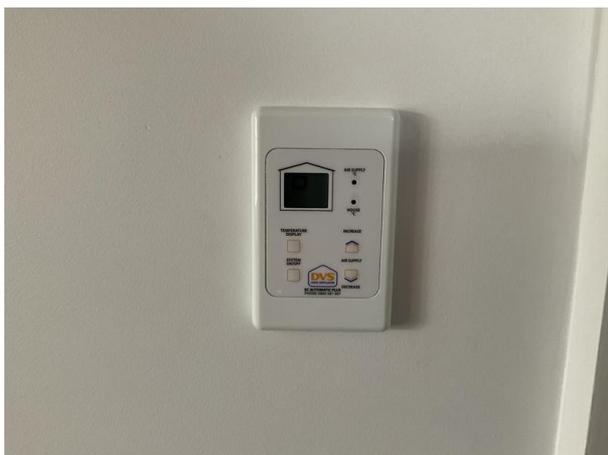
Photo 125
DVS ventilation system installed.

Ventilation system filters should be inspected annually and replaced periodically or as required by the manufacturer.

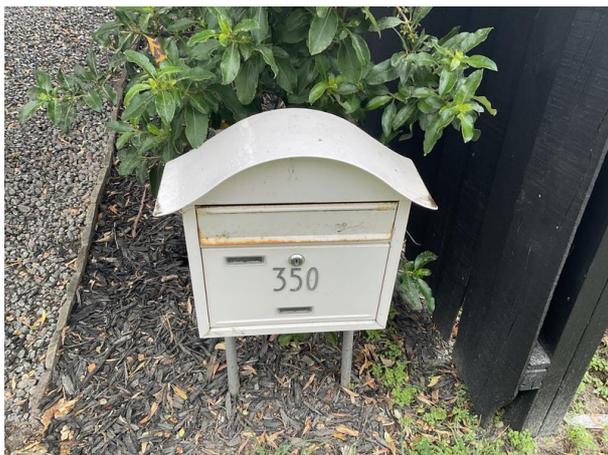
Photo 126
Letterbox

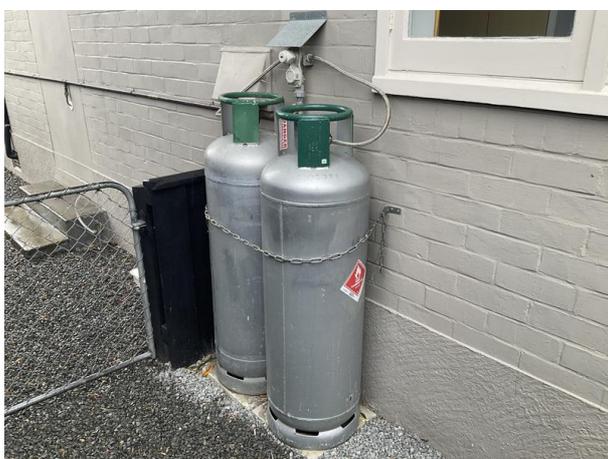
Photo 127
Gas bottle station located on the east elevation

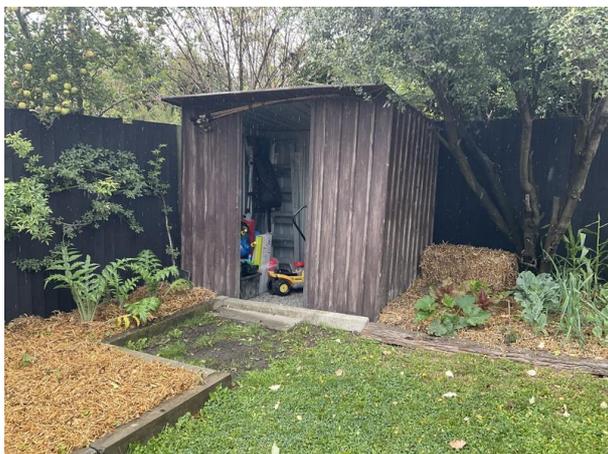
Photo 128
Garden shed located in the south east corner

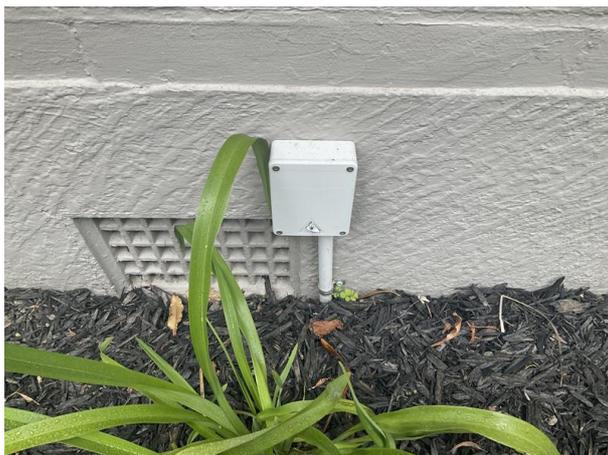
Photo 129
Fibre installed
