BUILDING INSPECTION REPORT

RED LBP PRE-PURCHASE REPORT

PRE-PURCHASE

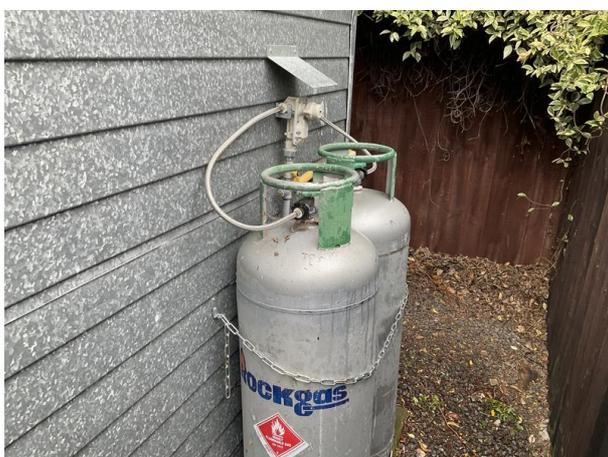
Photo 130
Gas bottle station located on the west elevation of the studio outbuilding.

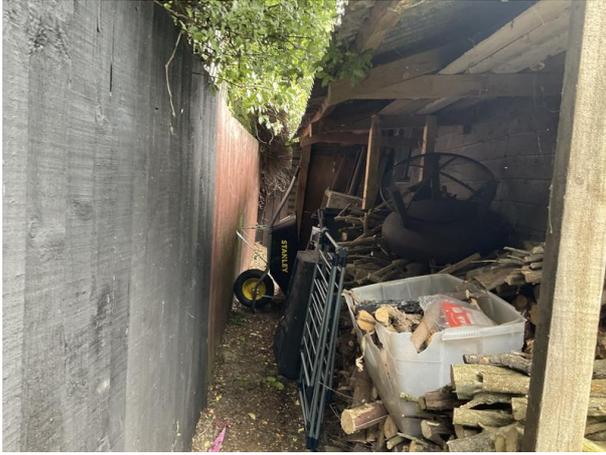
Photo 132
Storage shelter on the south side of the studio.
