# 5b Madeley Place, Mount Pleasant.

## **Structural Assessment & Building Report Property File Document Summary**

## **5b Madeley Road, Mount Pleasant, Christchurch**

RedFox Structural and Seismic Engineers have been engaged by Blackmilk Interiors NZ Ltd to provide a structural inspection report for the property at the above mentioned address.

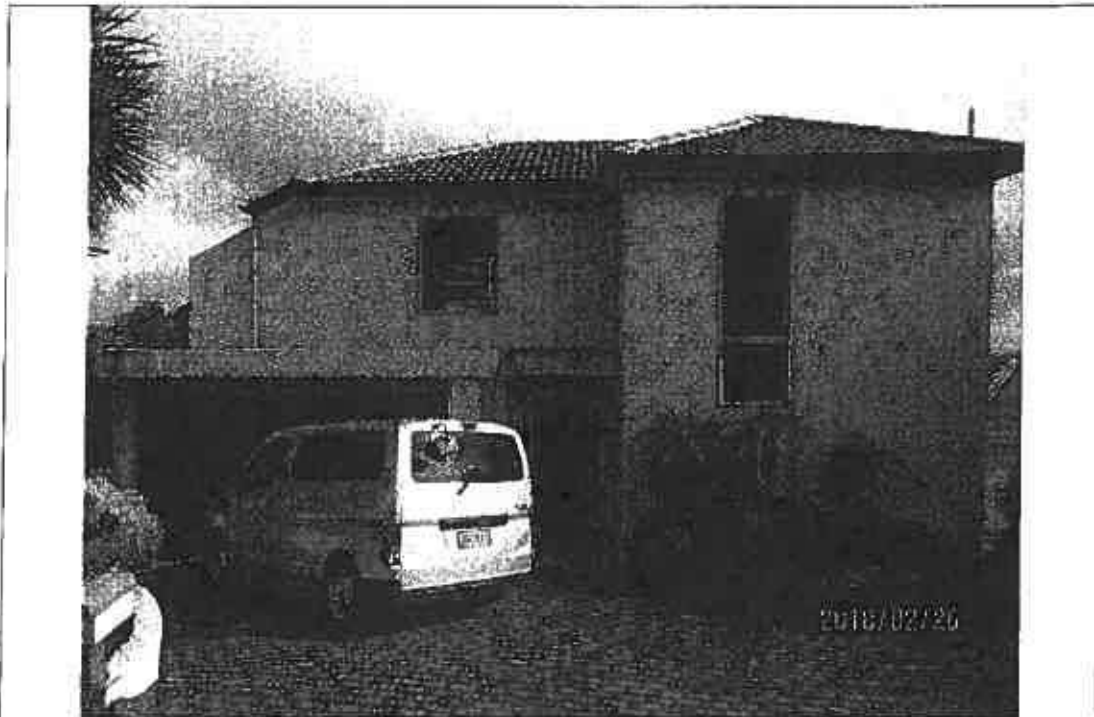
Photograph taken from the driveway looking at the front of the house

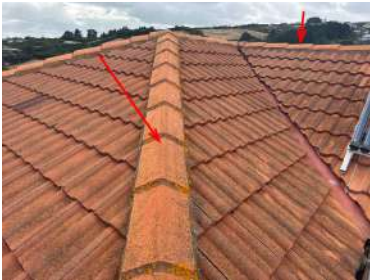
Concrete tile roof with hip and ridge cappings

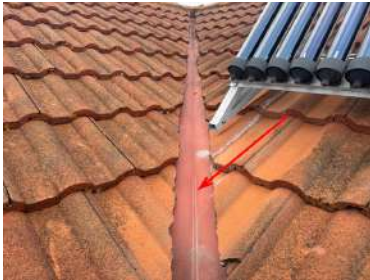
Valley flashing

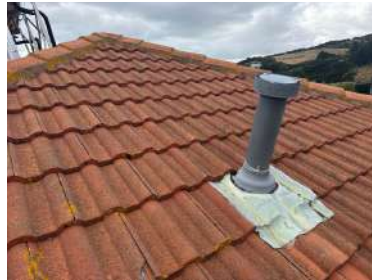
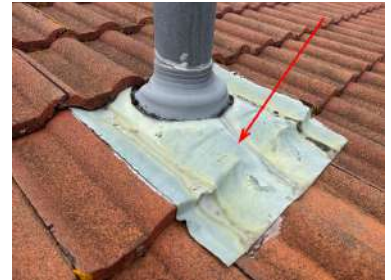
Chimney penetration flashing

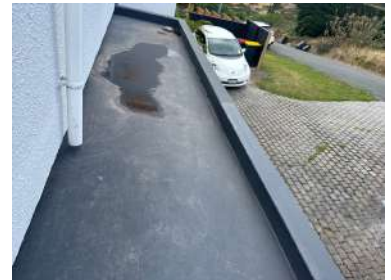
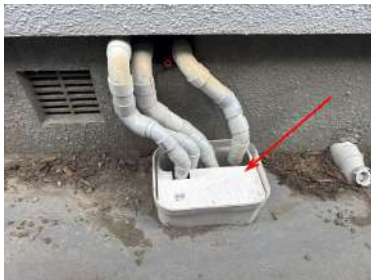
Gully trap

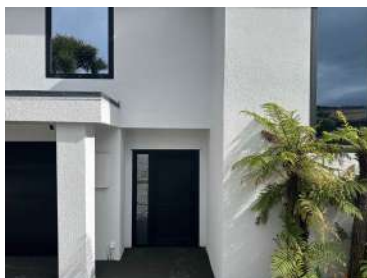
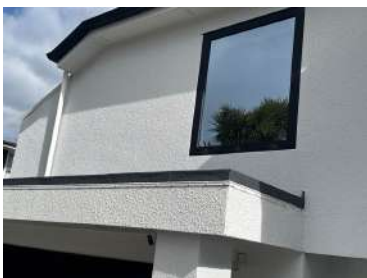
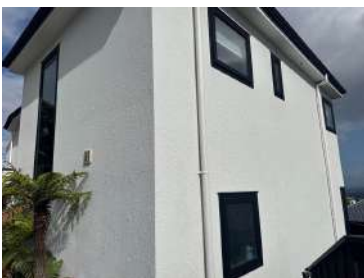
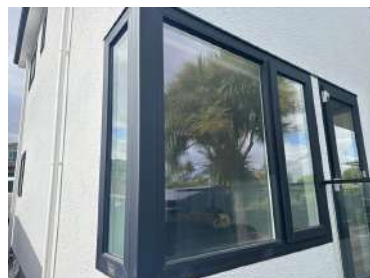
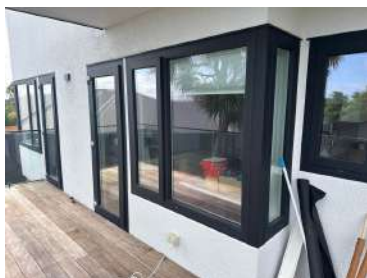
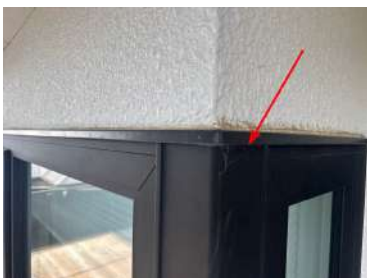
Window head flashings

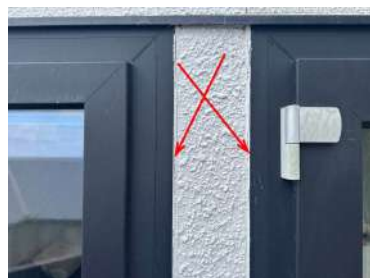
Window silicon seals

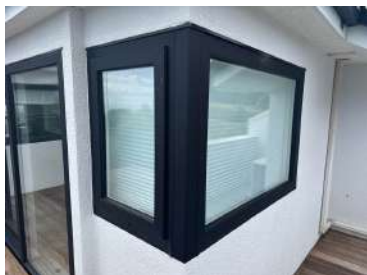
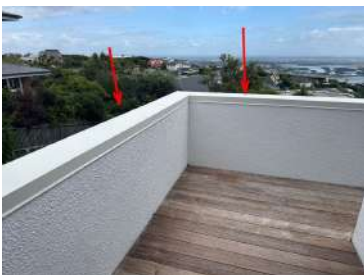
Parapet flashings

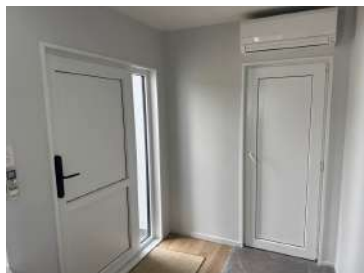
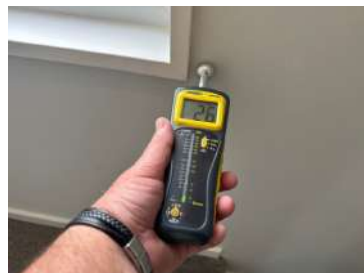
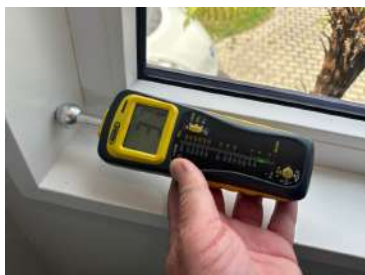
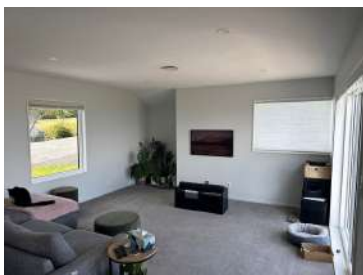
### Interior Spaces

| Comments | <p>Hallways, Stairwell &amp; Living Areas</p> <p>The downstairs hallway and front door area are in excellent condition. The stairwell is also in excellent condition and appears structurally stable. The stairwell window was moisture tested, with no issues detected.</p> <p>The upstairs living and dining areas are in excellent condition overall. Carpets throughout these areas are in good condition, and ceilings present well with no defects noted. Ranch sliders, windows, and internal doors were operated at the time of inspection and are opening and closing properly.</p> <p>Moisture testing was carried out in typical risk areas, with readings below 15; the green light indicates dry conditions. No moisture-related or other issues were observed throughout these areas.</p> <p>Risk: Low</p> |

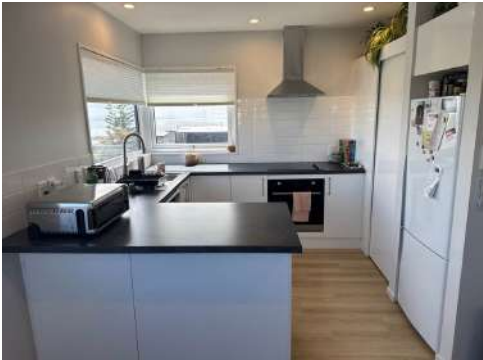
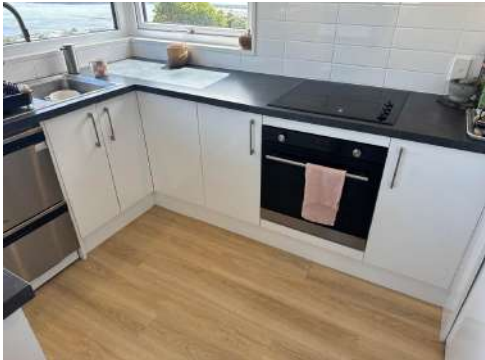
Kitchen

| Comments | <p>The kitchen is in excellent condition overall. Cabinetry, benchtops, and wall and ceiling surfaces present very well, with no visible defects noted at the time of inspection. All doors and drawers appear to be functioning as intended. Plumbing fixtures and tapware were checked and are in good working order, with no leaks observed beneath the sink.</p> <p>Moisture testing was carried out in typical risk areas, with readings below 15; the green light indicates dry conditions. No moisture-related issues were detected.</p> <p>Risk: Low</p> |

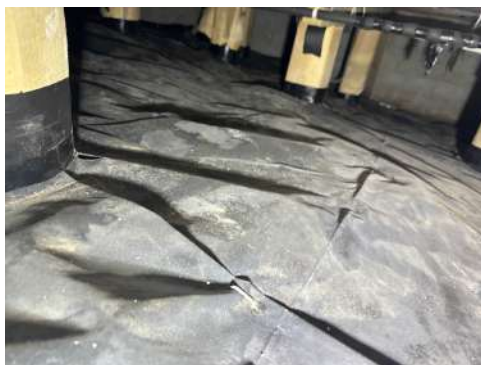
### Insulation

| Comments | <p>Earthwool ceiling insulation batts were observed installed within the roof space. The insulation is in good condition, providing good coverage and effective thermal protection at the time of inspection. No signs of displacement, damage, or deterioration were noted. The roof framing structure observed appears stable, with no issues identified. No other concerns were observed throughout the accessible roof space.</p> <p>Polyester underfloor insulation is installed beneath the timber floor and appears to be in good condition and correctly installed. A ground moisture barrier is also in place, correctly installed, and in good condition. The underfloor area appeared dry and clean at the time of inspection.</p> <p>Risk: Low</p> |

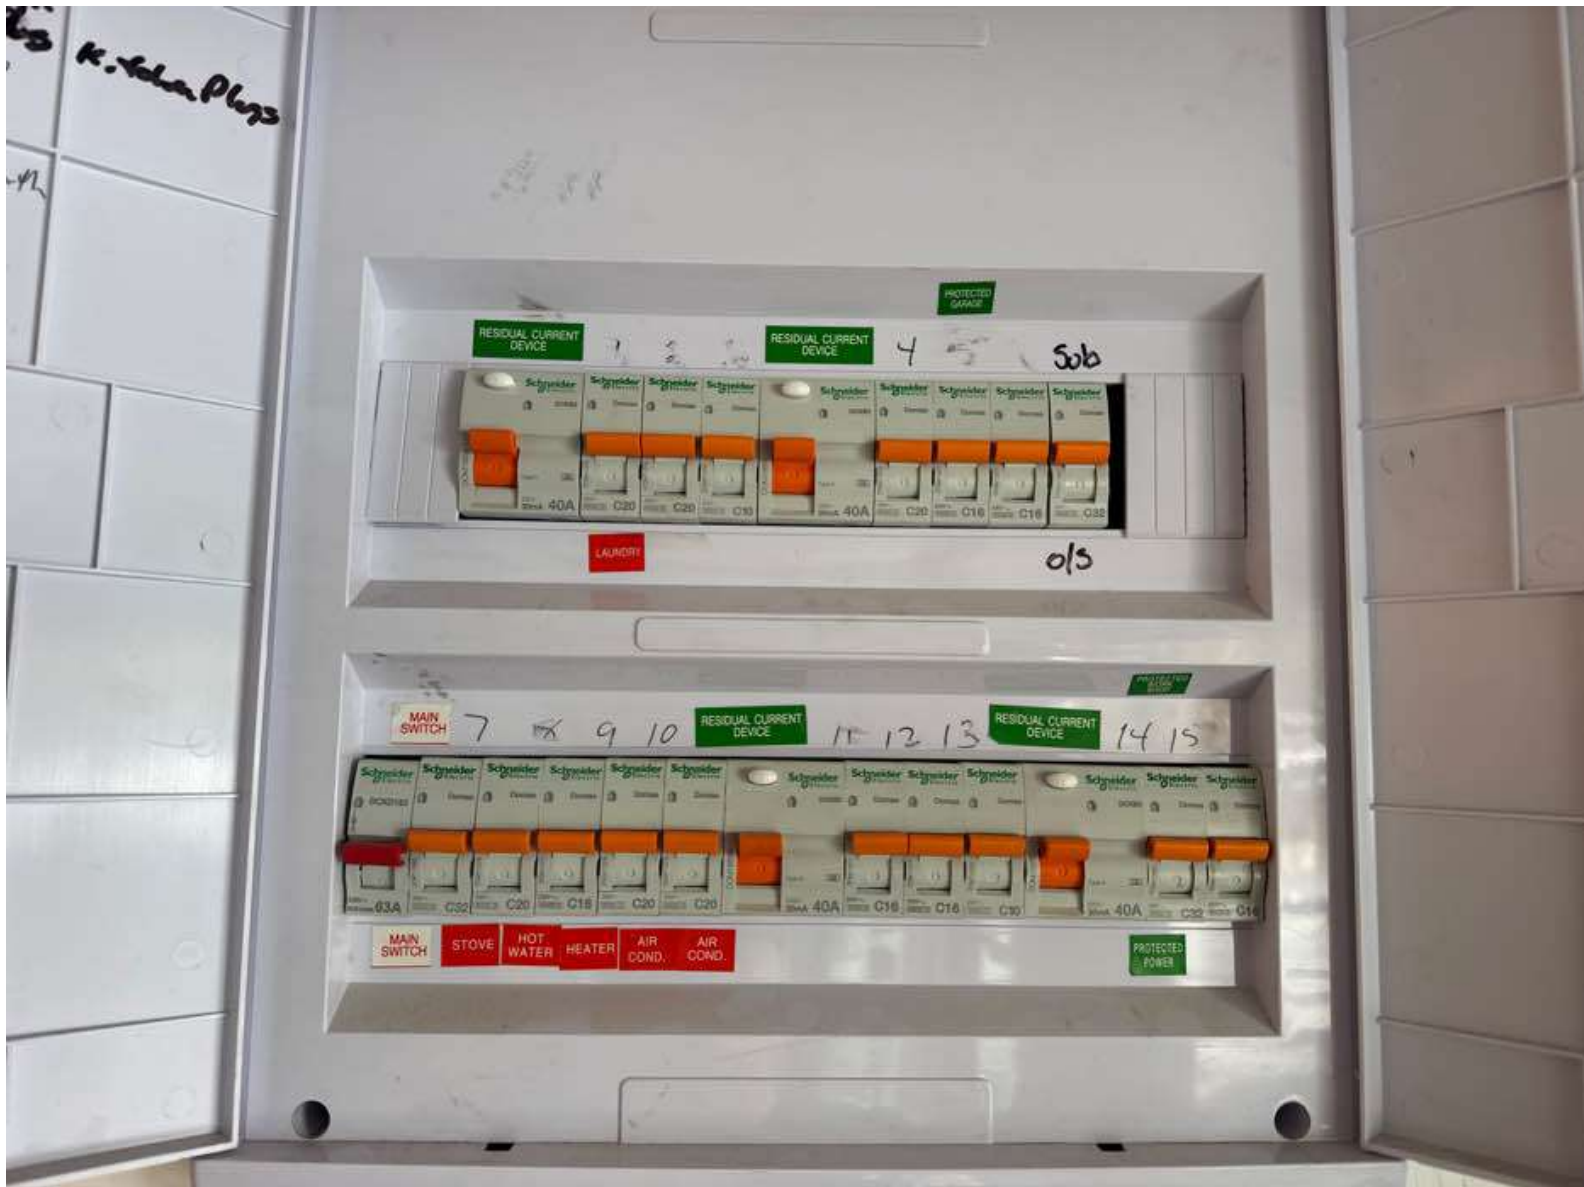
Electrical

| Comments | <p>The main switchboard is located in the garage and appears to be in very good condition. It appears to have been updated in recent years, with no visible defects noted at the time of inspection. Power sockets, light switches, and light fittings throughout the house were checked and all appear to be in very good condition and operational.</p> <p>This assessment is based on a visual inspection only, and no internal wiring was accessed.</p> <p>Risk: Low</p> |

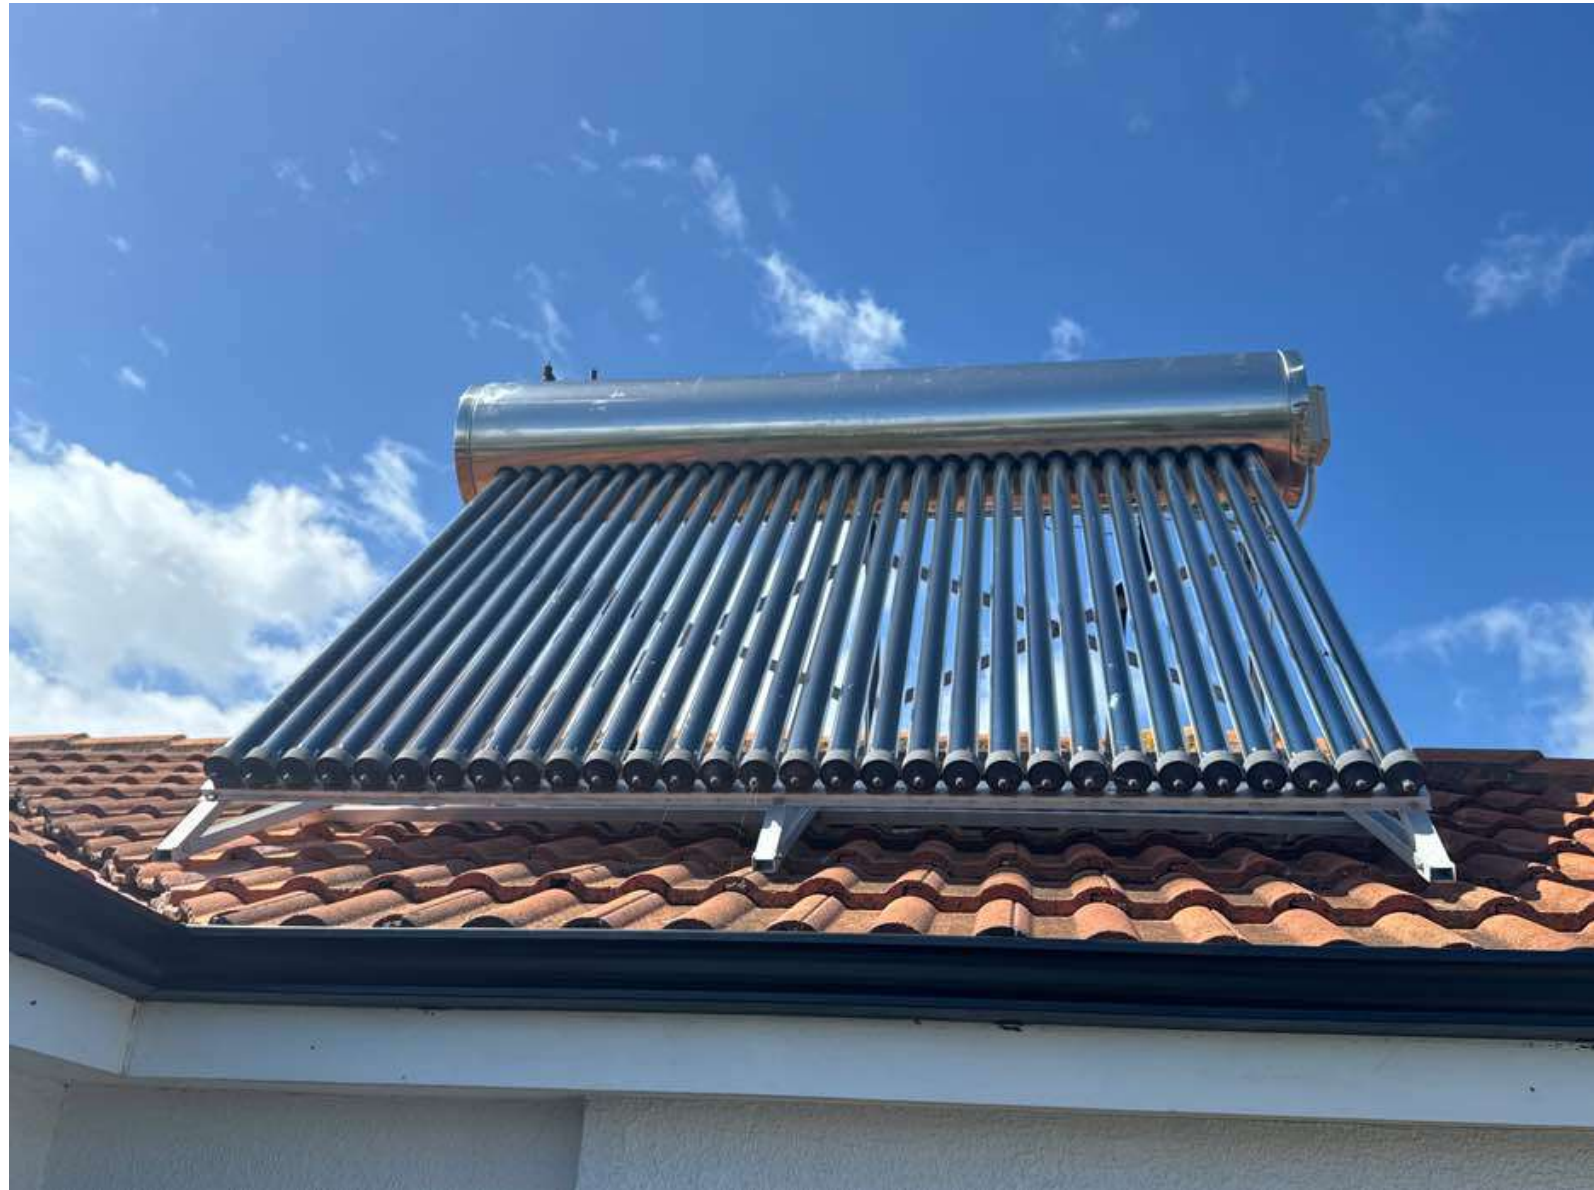
| Comments | <p>Solar Hot Water System (Roof-Mounted)</p> <p>A roof-mounted solar hot water system is installed, consisting of evacuated tube collectors connected to a storage cylinder. The collectors appear securely fixed to the concrete tile roof, with no visible damage noted to the tubes at the time of inspection. The mounting frame appears stable and appropriately positioned.</p> <p>No obvious defects were observed from a visual inspection. Roof penetrations associated with the system appear tidy and weather-tight. Due to system complexity, internal components, pipework performance, and operational efficiency were not tested as part of this inspection.</p> <p>Risk: Low</p> |
