BUILDING INSPECTION REPORT

RED LBP PRE-PURCHASE REPORT

Property Address	19 Tirangi Street, Hei Hei, Christchurch 8042
Client	[REDACTED]
Date of Inspection	2nd February 2026
Time	8:30 am
Inspector	Jamie Chapman National Certificate in Carpentry
LBP Number	BP137228
People Present	Owner
House Occupied	Yes

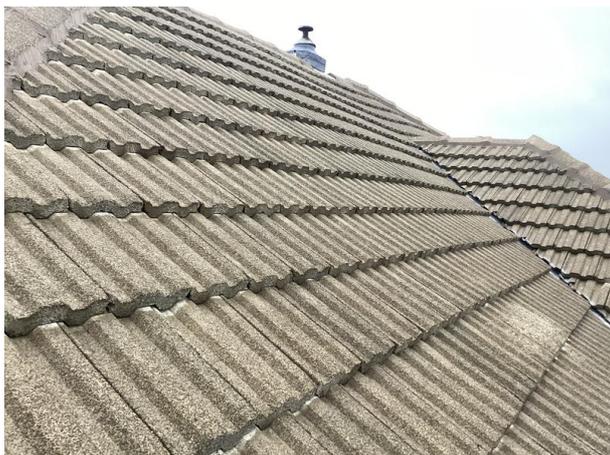
Photo 3

Masonry tiles are located around the dwelling.

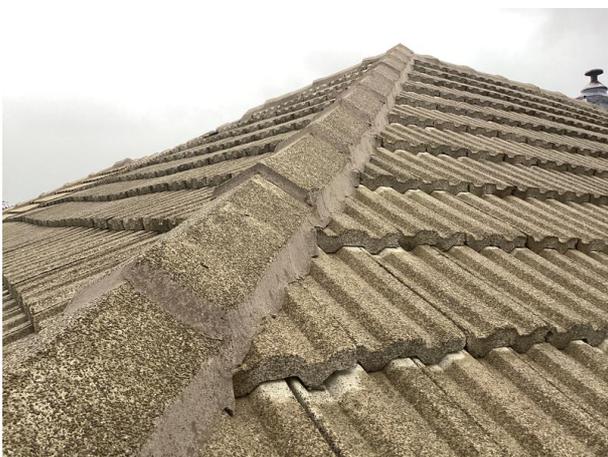
Photo 9

Masonry tiled hips and ridges are located around the roof system.

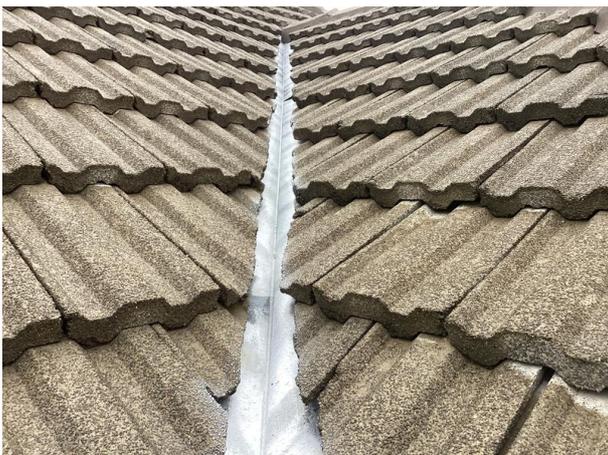
Photo 10
Metal valleys located around the roof system.

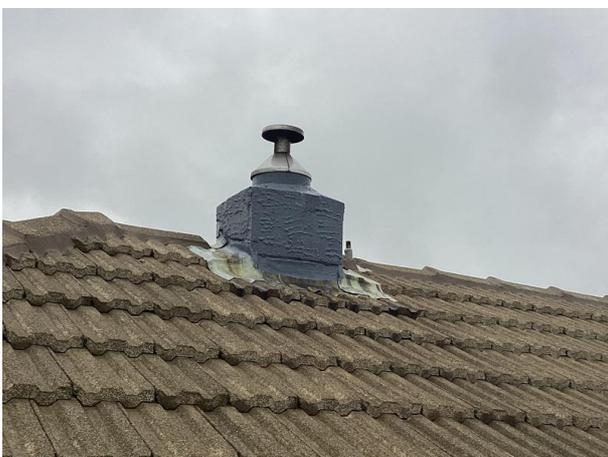
Photo 11
Chimney penetration with lead flashings.

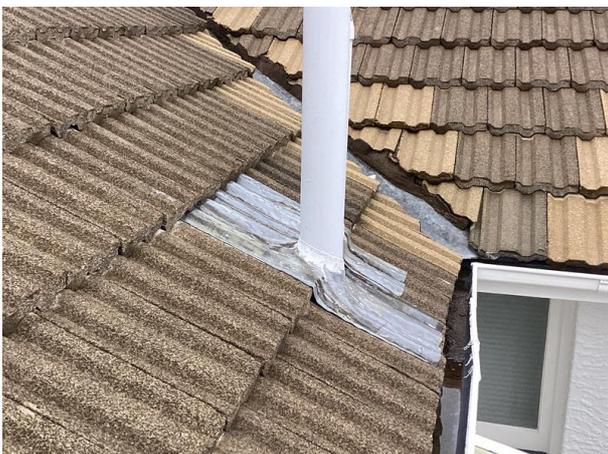
Photo 12
Southside vent penetration with lead flashing.

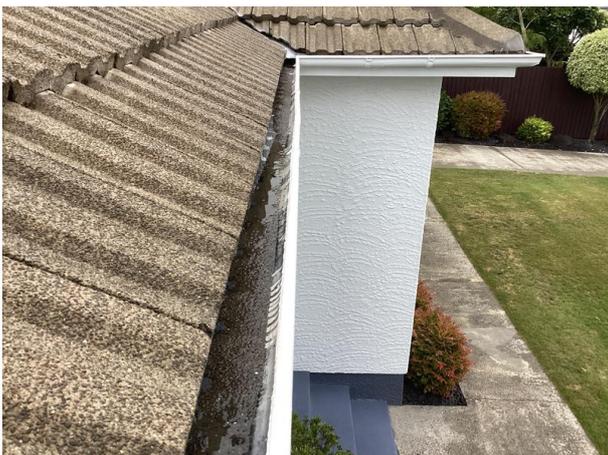
Photo 13
The metal gutter system was clean and clear at the time of the inspection.

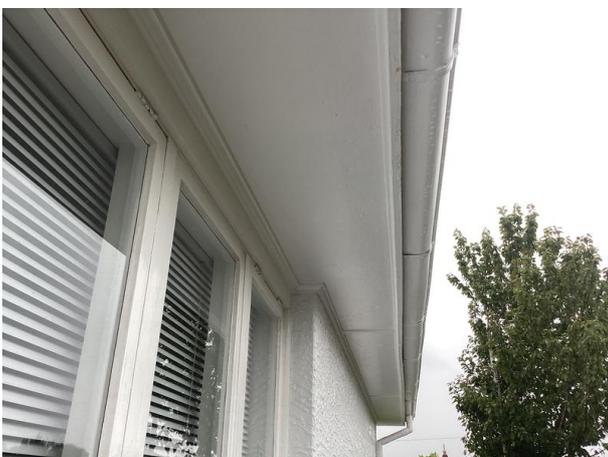
Photo 14
Painted fibre cement soffits located around the dwelling.

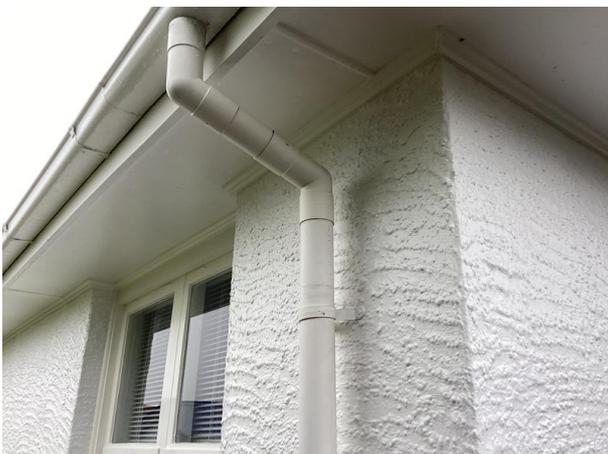
Photo 15
PVC downpipes installed around the dwelling.

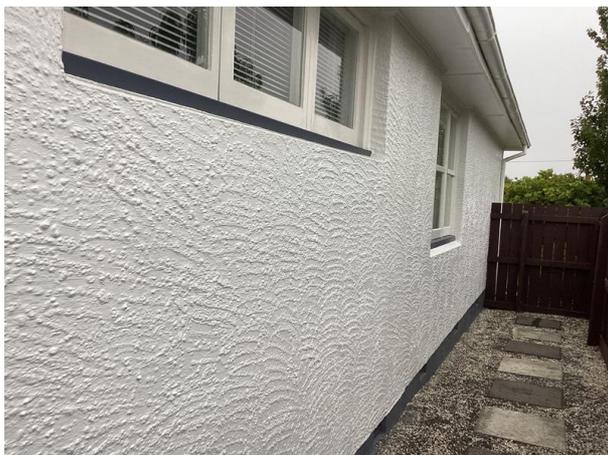
Photo 16

Stucco plaster over a masonry substrate is located around the dwelling.

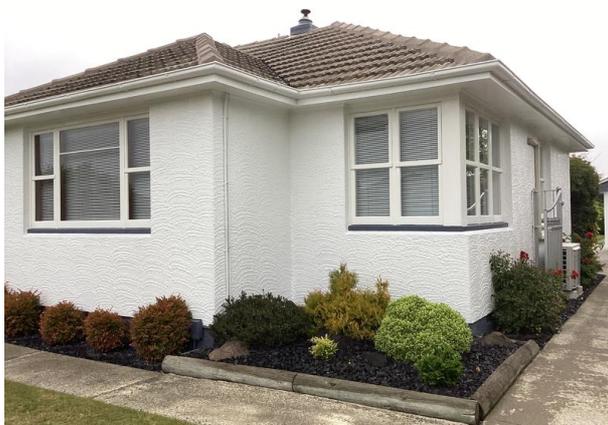
Photo 17

No significant defects identified with the stucco plaster at the time of the inspection.

Keep up regular maintenance and repainting/sealing.

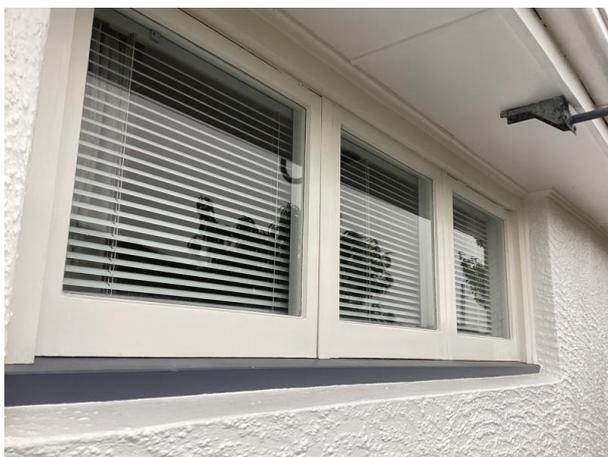
Photo 18

Single glazed timber windows are located around the dwelling.

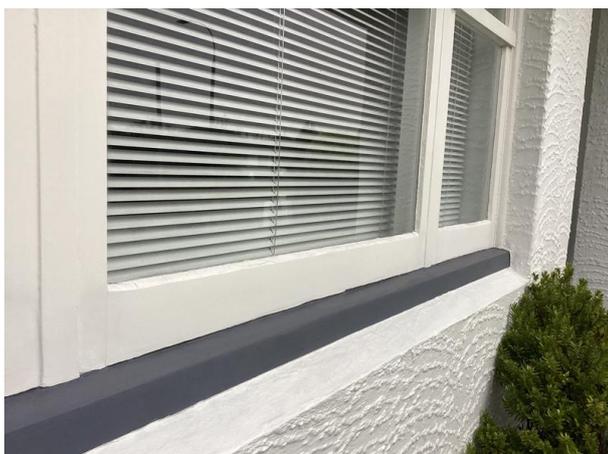
Photo 19

No significant issues identified with the timber windows on the exterior of the dwelling.

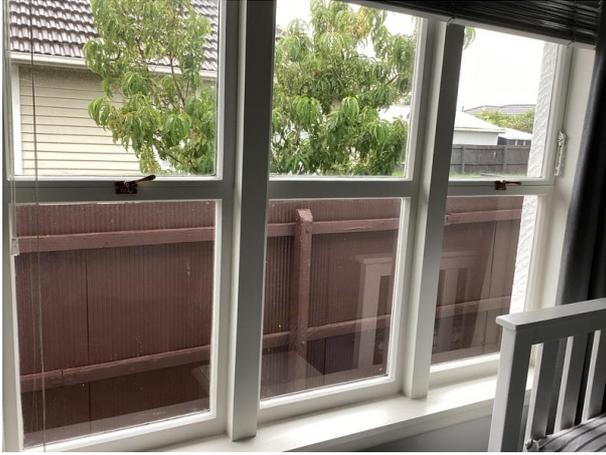
Photo 20

No significant issues with the timber windows viewed from inside the dwelling.

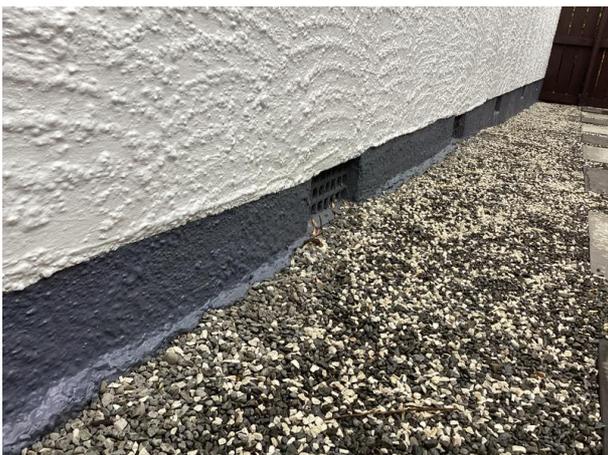
Photo 21
A concrete ring foundation with vent holes is located around the dwelling.

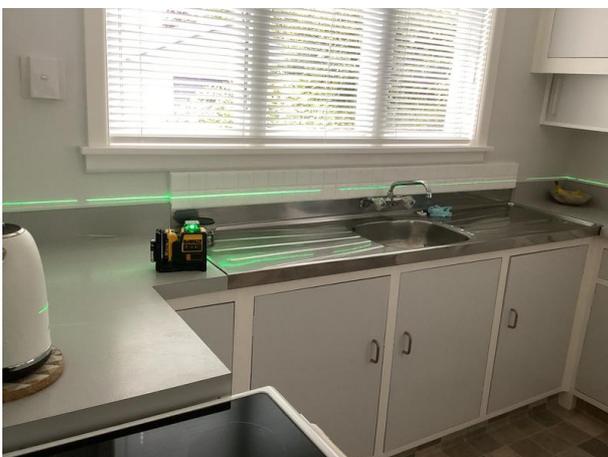
Photo 25

The kitchen Benchtops were also checked and were level.

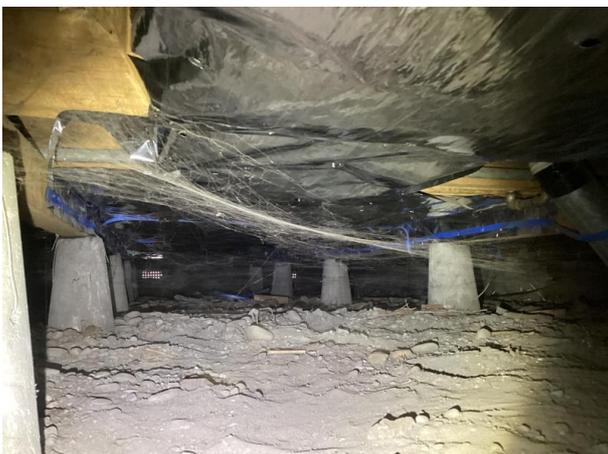
Photo 26

View of inside the subfloor.

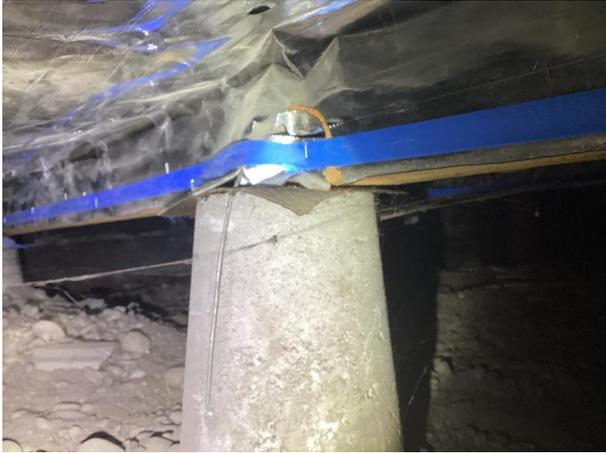
Photo 27
Tie wire connections were visible between the concrete piles and timber bearers.

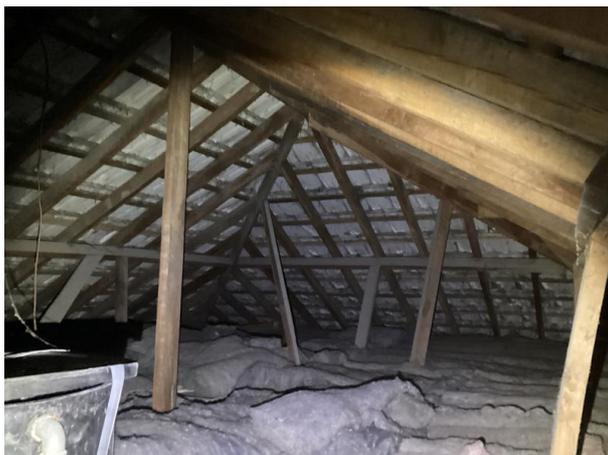
Photo 32
View of inside the roof space.

Regular maintenance of the property should include periodic visual inspections of the roof space through the manhole. These checks are essential to identify potential issues such as water leaks, signs of pest infestation, or other structural concerns. Conducting these inspections can help detect problems early, allowing for timely repairs and preventing more significant damage or costly remedial work in the future.

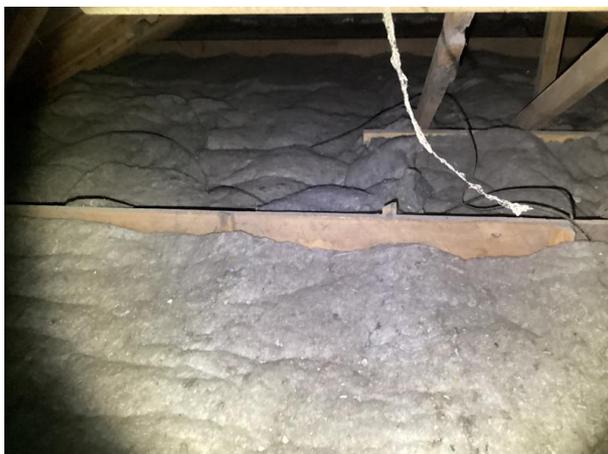
Photo 34
Acceptable coverage of insulation where visible.

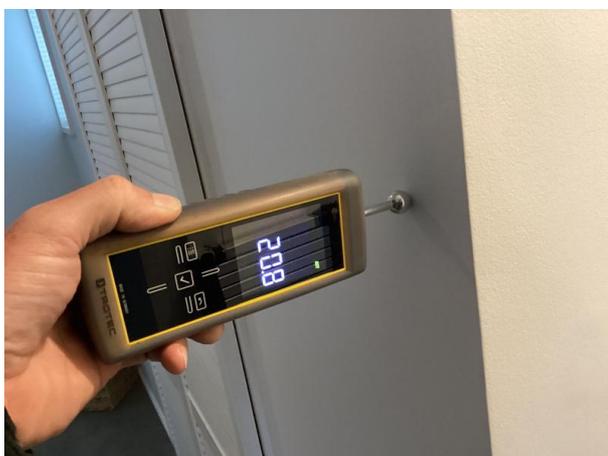
Photo 37

Example of a base reading that was taken on an internal wall. This was the average moisture reading for this dwelling during the inspection.

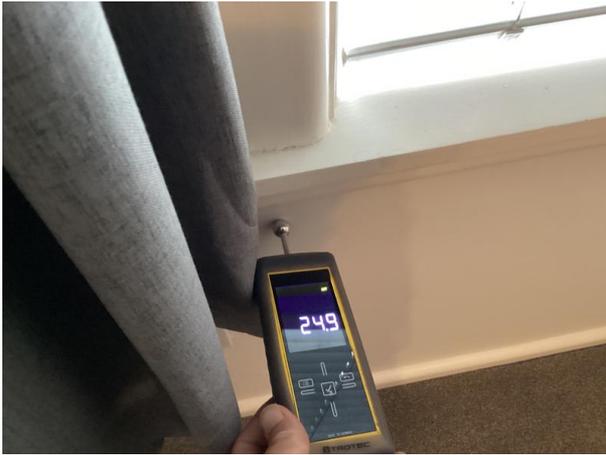
Photo 39
Moisture testing was done around the external window joinery.

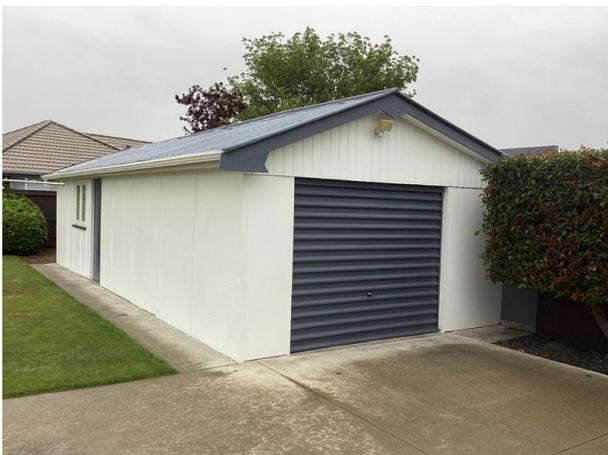
Photo 51
Garage.

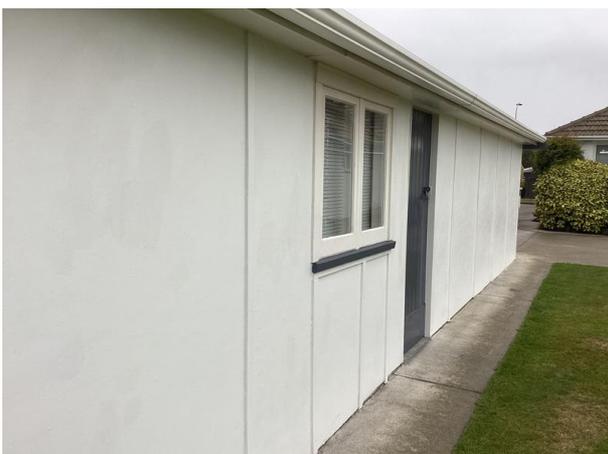
Photo 52
No significant issues with the fibre cement sheeting on the garage.

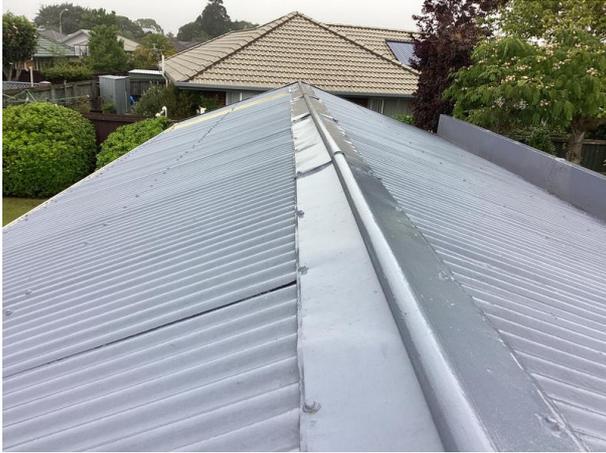
Photo 53
Profiled metal roof located over the garage.

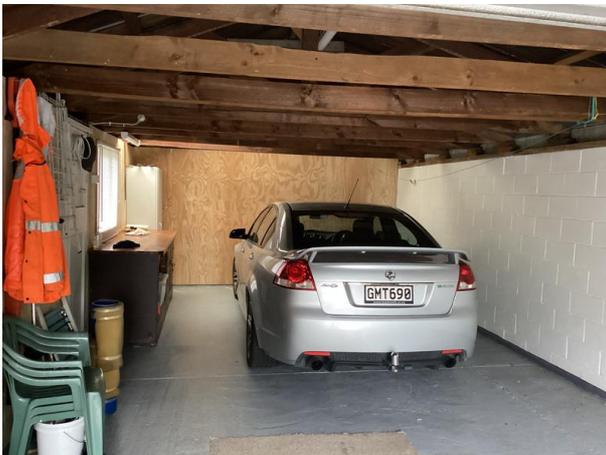
Photo 54
View of inside the garage.

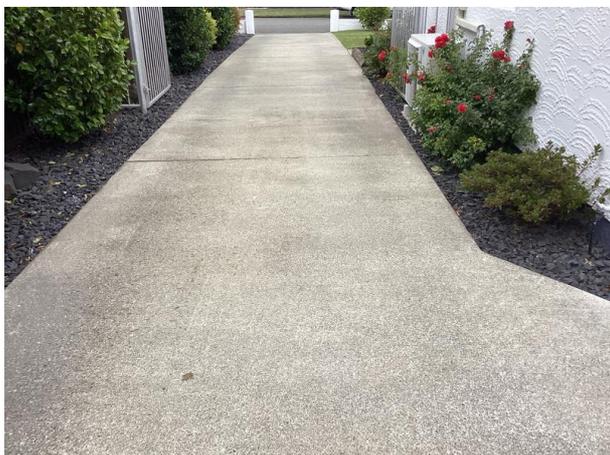
Plain concrete.
Saw cuts - Yes.
Cracking - None visible.

Photo 55
Concrete driveway, no significant issues.

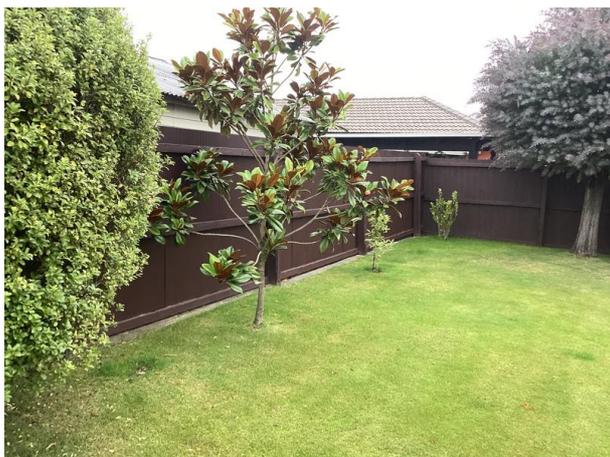
Painted timber palings and profiled metal fixed to timber rails with concrete and timber posts.
Condition of cladding - No visible issues.
Alignment - No visible issues.
Post and rail condition - No visible issues.
Average height - 1.8 metres.

Photo 56
No significant issues with the boundary fences.

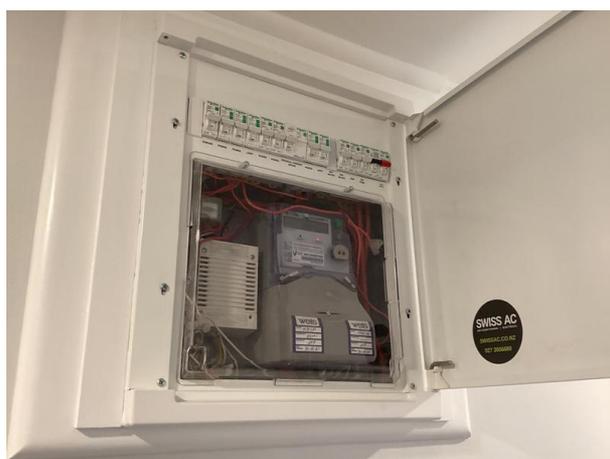
Photo 59

Switchboard and meter box located in the hallway.

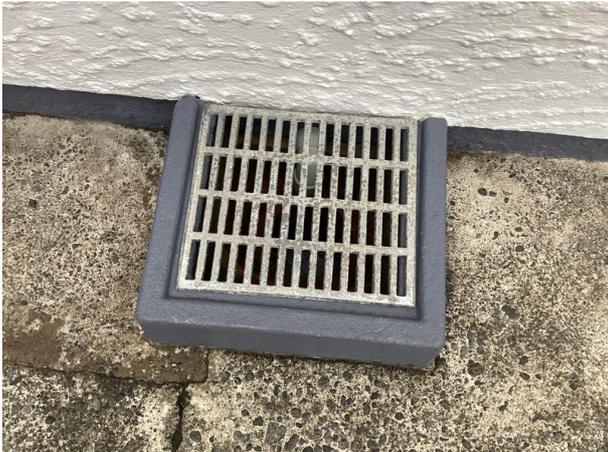
Photo 62
South side gully trap.

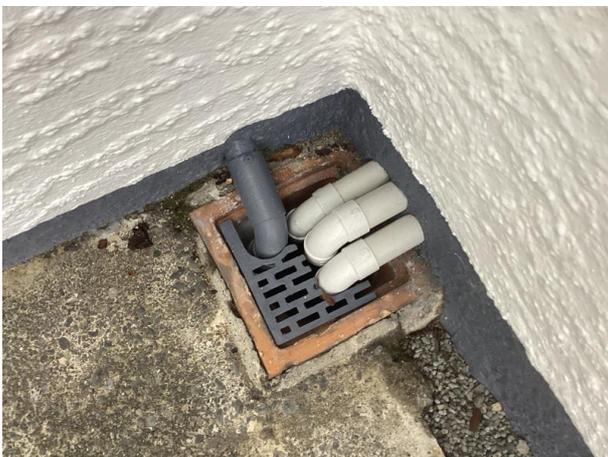
Photo 63
South side gully trap.

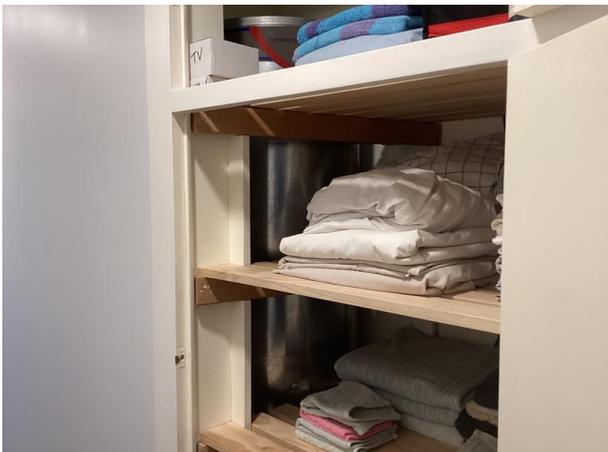
Photo 64
Hot water cylinder viewed from the hallway cupboard.

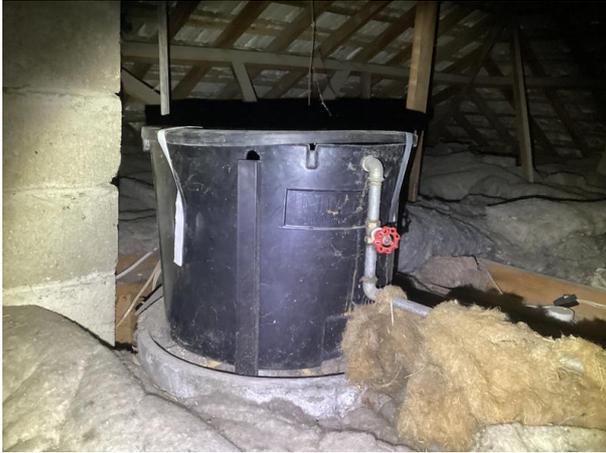
Photo 65
Header tank located in the roof space.

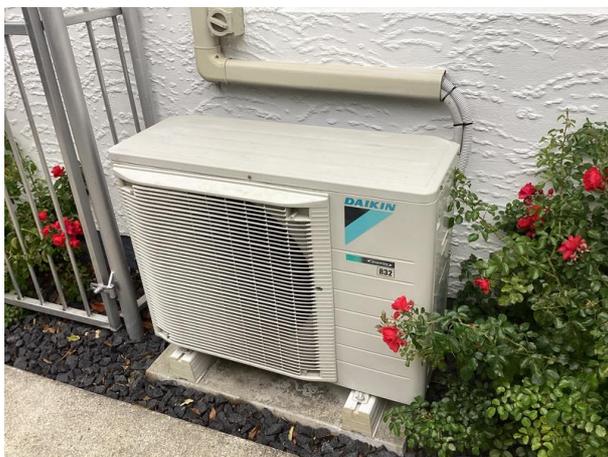
Photo 66
External Daikin heat pump system.

Follow the manufacturer's recommended servicing schedule to ensure the equipment operates efficiently and maintains optimal performance. Adhering to these guidelines helps identify and address potential issues early, reducing the risk of costly repairs and ensuring compliance with warranty requirements.

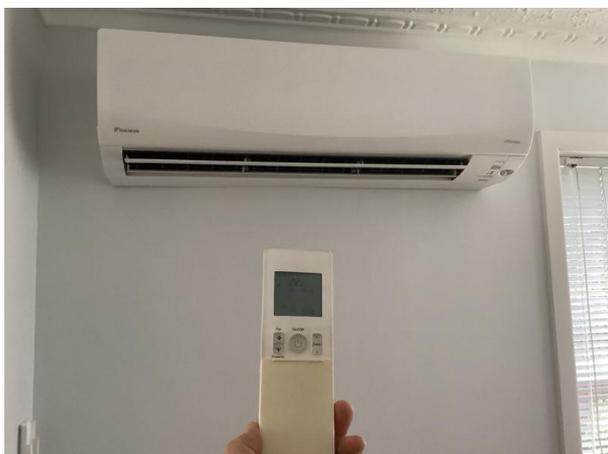
Photo 67
Daikin heat pump located in the dining room.

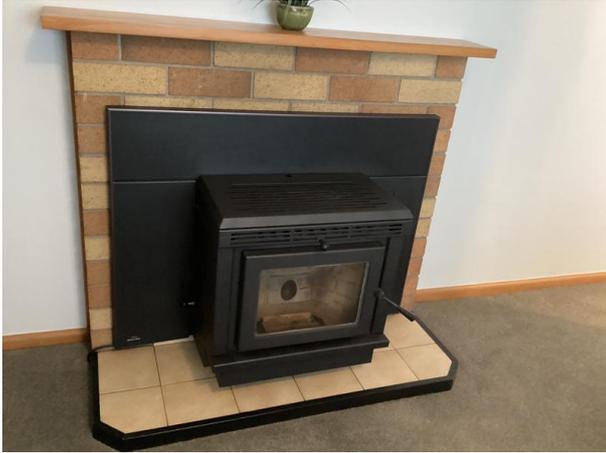
Photo 68
Pallet fire located in the living room.

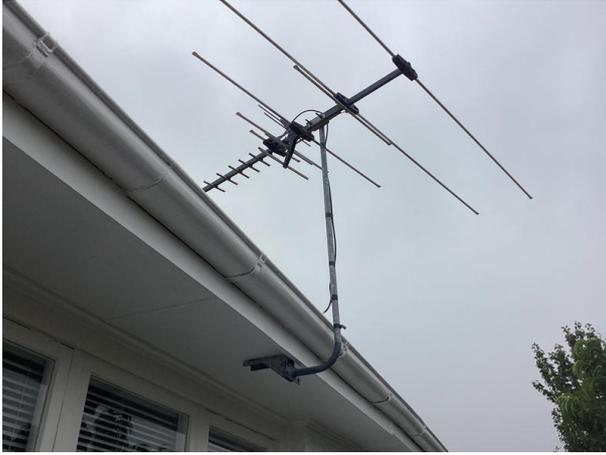
Photo 69
Antenna located on the roof system.

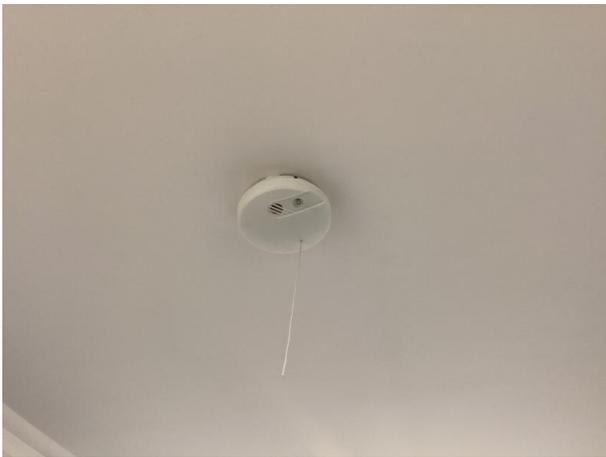
Photo 70
Smoke alarm located in the hallway.

Regular checks to ensure smoke detectors are functional.
