# Independent Builders Report

Total Home Inspection Services Porirua City Ltd

Tue 24 Feb 2026

**87 The Esplanade, Raumati South, Paraparaumu, 5032,  
New Zealand**

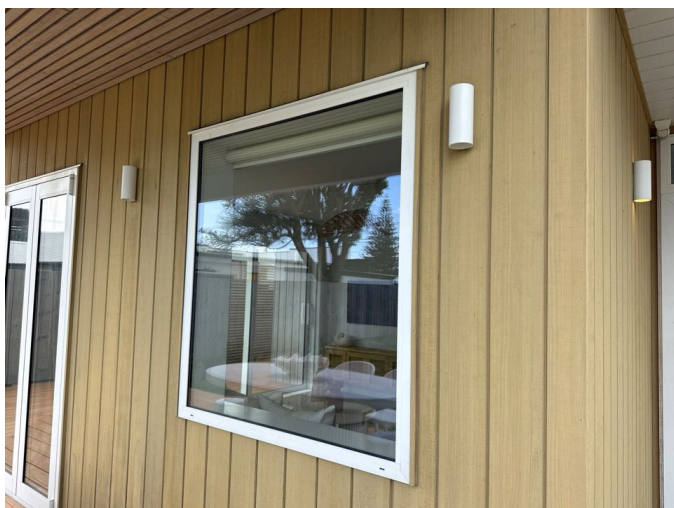
The typical double glazed aluminium window is face fitted with a head flashing and timber bead at the sides.

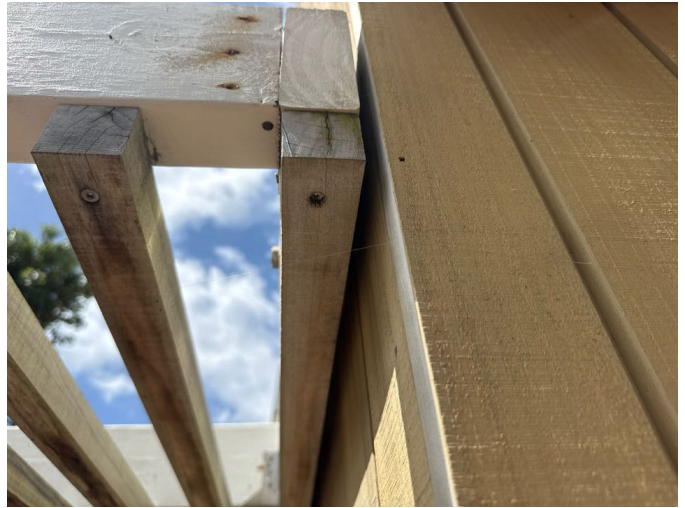
There is a good clearance between the pergola and the cladding which will allow drainage. The council file would need to be checked to determine the fixing/waterproofing detail.

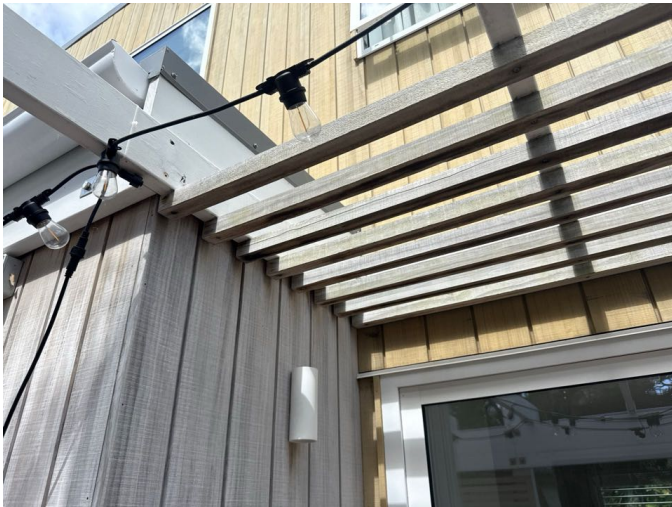
Note the 2 different Abodo finish types which require specific maintenance.

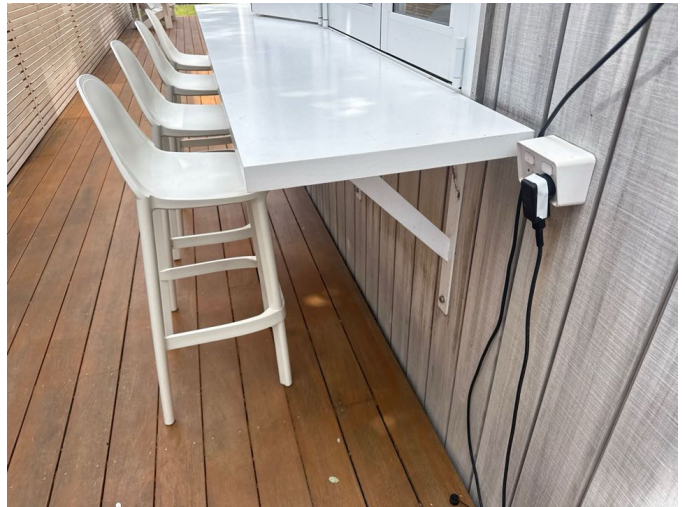
The bench is secure

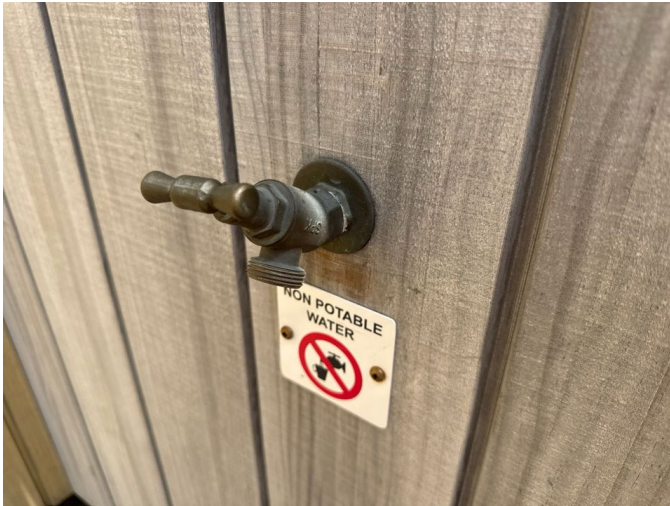
Cladding penetrations in general are a weather tightness risk area. Penetrations such as taps, screw fixings, gas or water pipes etc. Low risk with the cavity system and modern flashing detailing. No evidence of failure could be found.

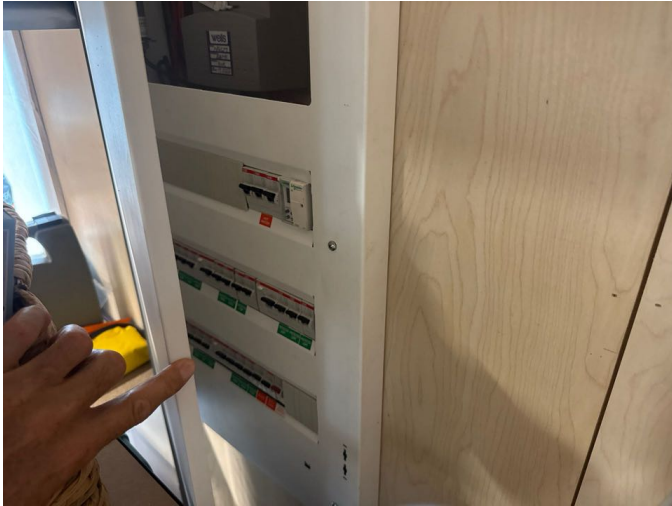
A visual inspection of the electrical system did not show any evidence of electrical overload to switches or power points. Cover plate(s) were not removed and the wiring behind the distribution board not inspected. This is beyond our scope of expertise. Please note. The assessor is not a registered electrician; no electrical safety tests or electrical component tests were undertaken. Power points, lights and switch testing therefore does not form part of this report.

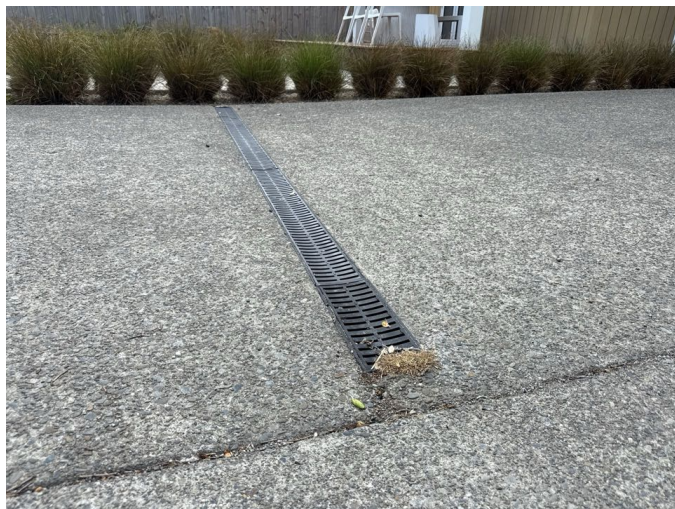
Channel drain to the driveway. There was no sign of current blockages or recent overflows. The effectiveness of the drains will need to be monitored over time.

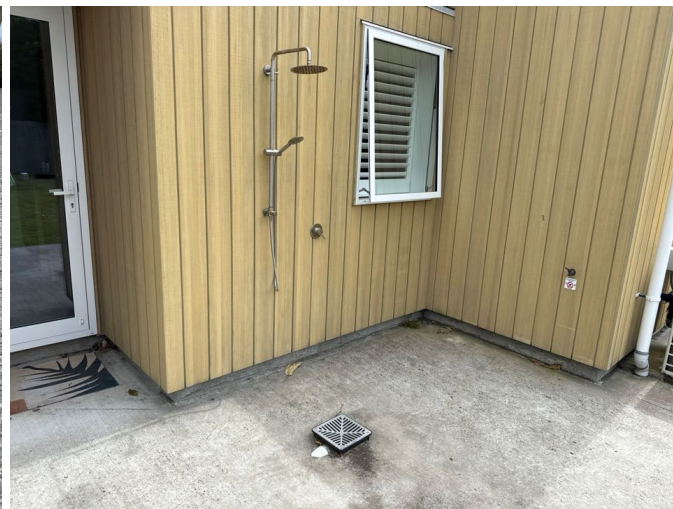
The drain was finished higher than the concrete path at the rear. The owners had intended on installing pavers at this location which would have finished flush with the drain (this is an option for the future). The outdoor shower is functional.

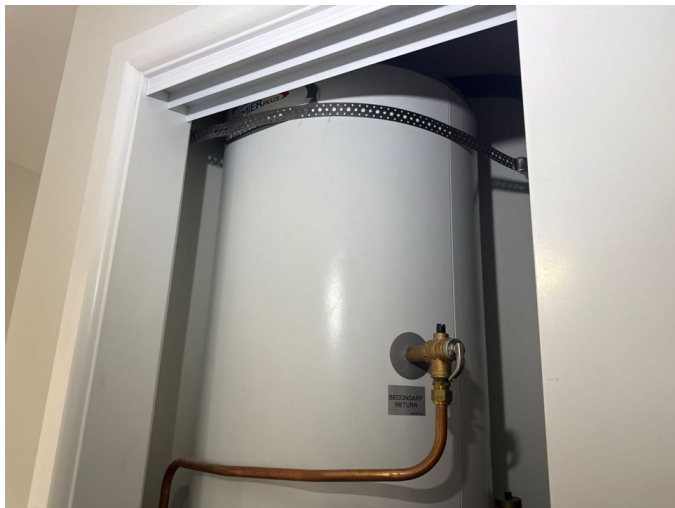
Hallway cupboard.

Baxi 300L Mains Pressure Electric Heatpump Hot Water Cylinder. Seismic restraints installed.

The pressure-reducing valve that is located at the side of the mains pressure hot water cylinder should be tested every 6 months or in accordance with the manufacturer's instructions to make sure that it is in working order.

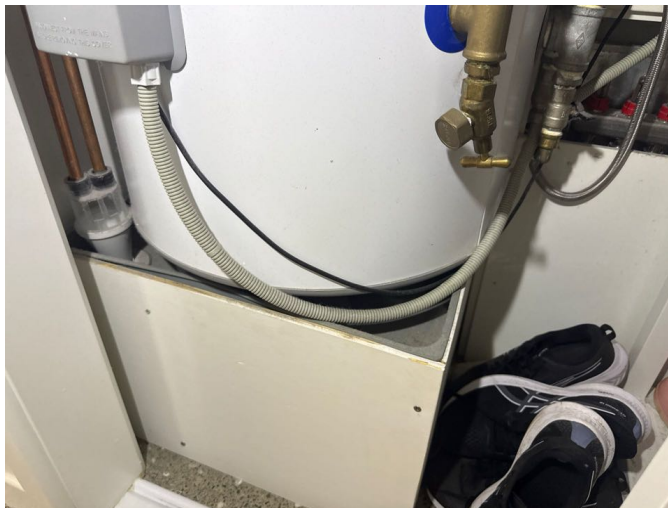
No sign of leaks around the base of the cylinder. The cylinder is placed in a safe tray with a drainage outlet as required.

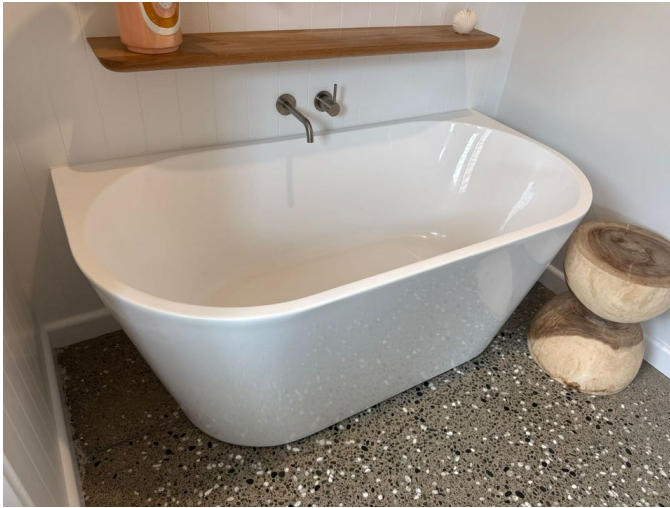
The back of the bath is well sealed. The tap is functioning well.

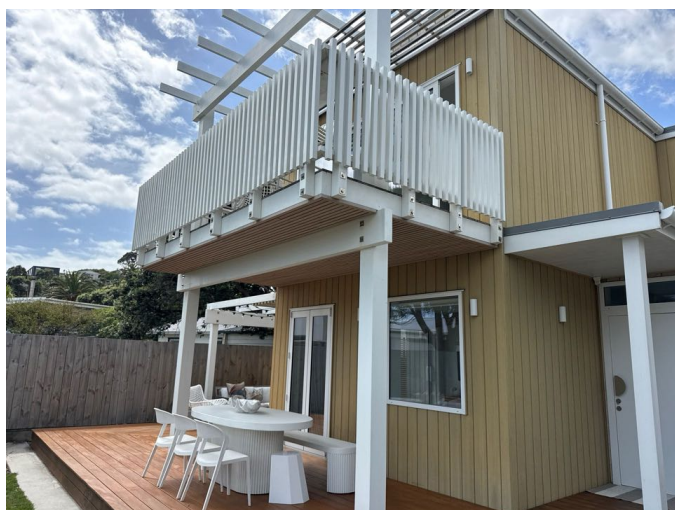
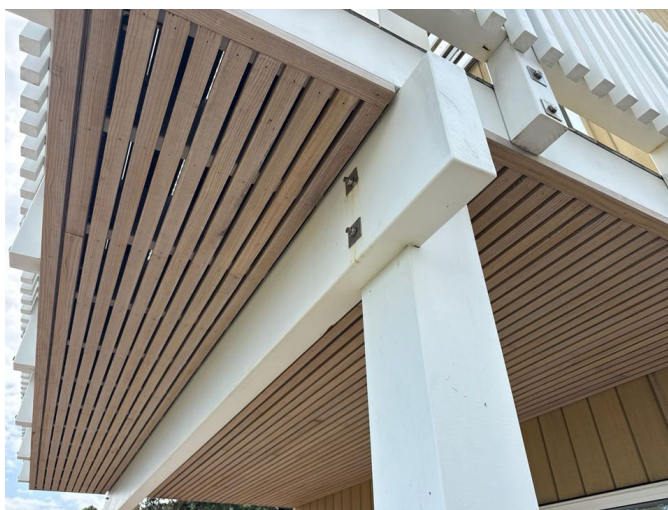
No concerns with the framing structure. The deck is solid and is well connected.

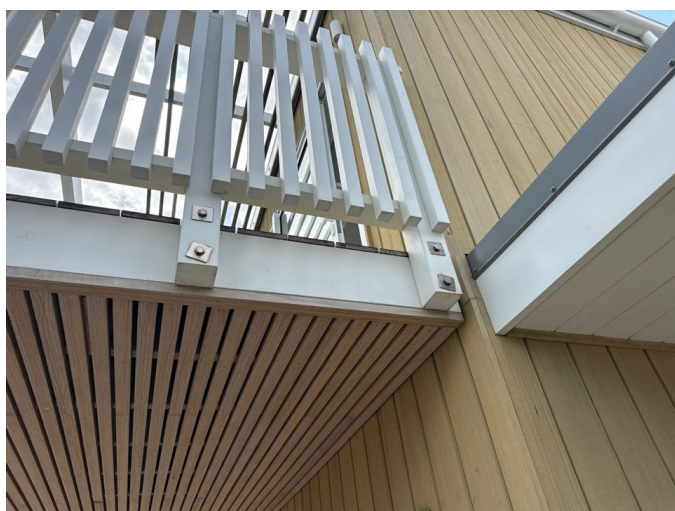
The balustrade is connected sufficiently at the base

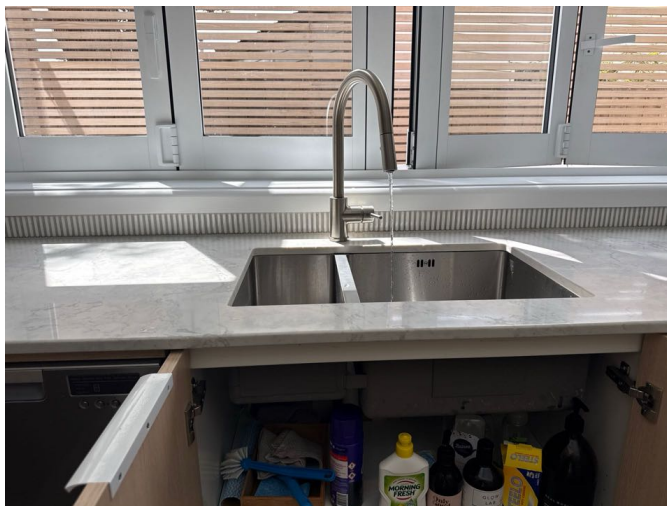
The rear edge of the bench top is well sealed. The tap is functioning well. No concerns with the water feeds or waste pipes under the sink.

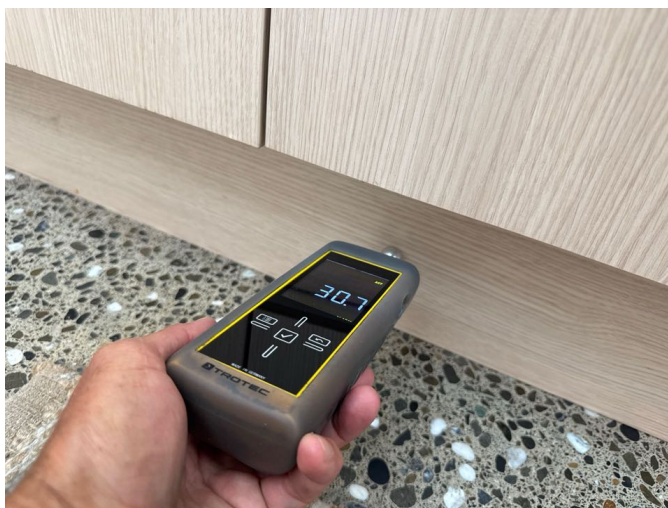
Moisture levels in the kitchen were within the normal range

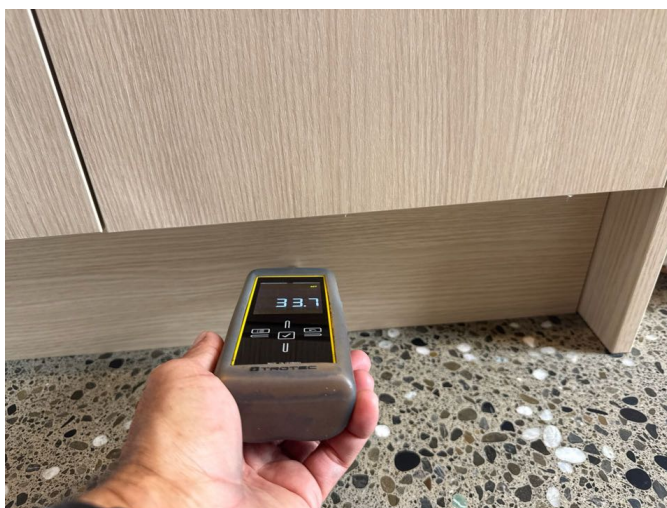
Moisture levels in the laundry were within the normal range at the time of inspection.

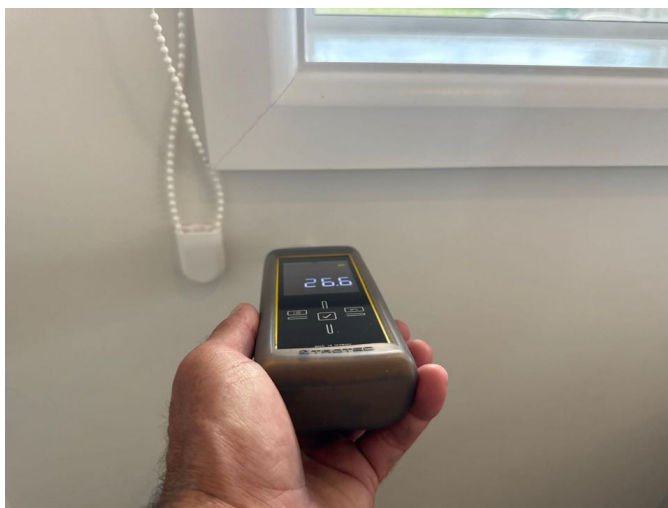
Moisture levels to the external walls were within the normal range at the time of inspection

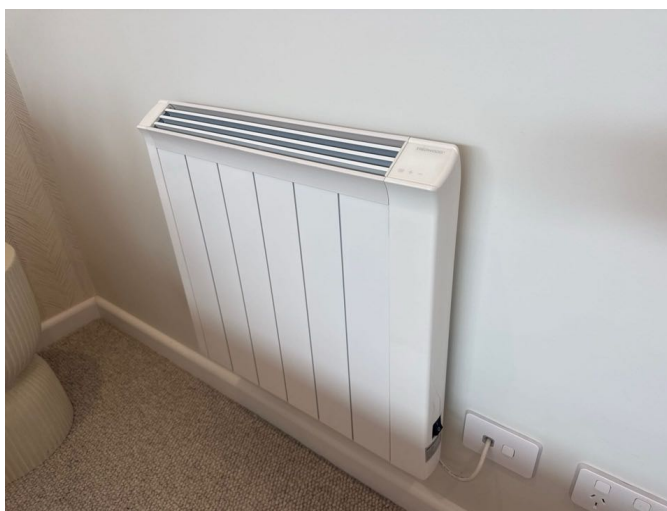
The heating appliances are not tested as part of the inspection process.

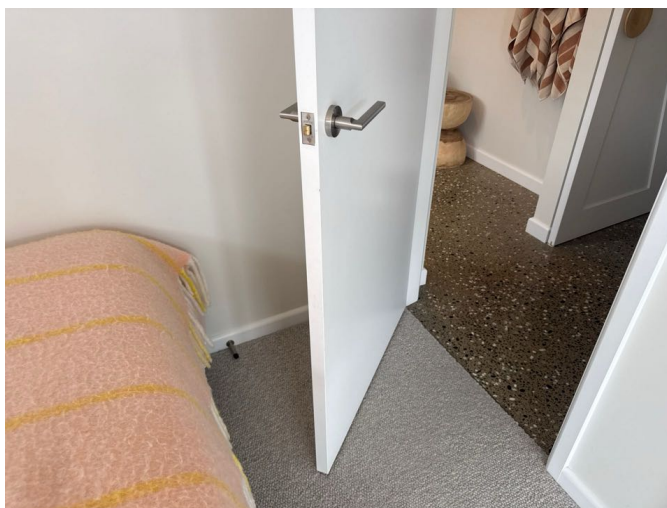
The internal doors are functioning well. Door stops installed behind the doors.

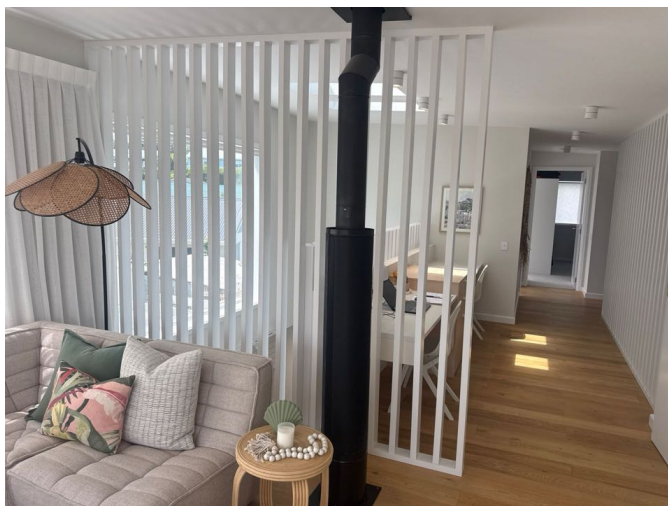
The no longer required flue passes through this room

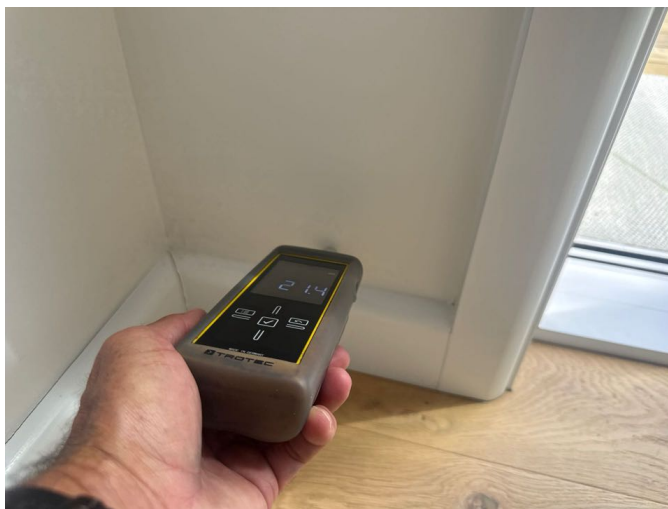
Moisture levels to the external walls were within the normal range at the time of inspection

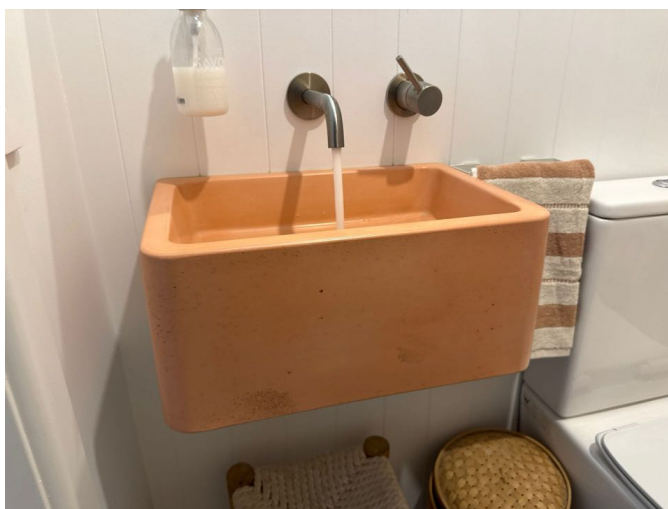
The sink is well sealed to the wall. The tap is functioning well. No visible concerns with the water feeds or waste beneath the sink.

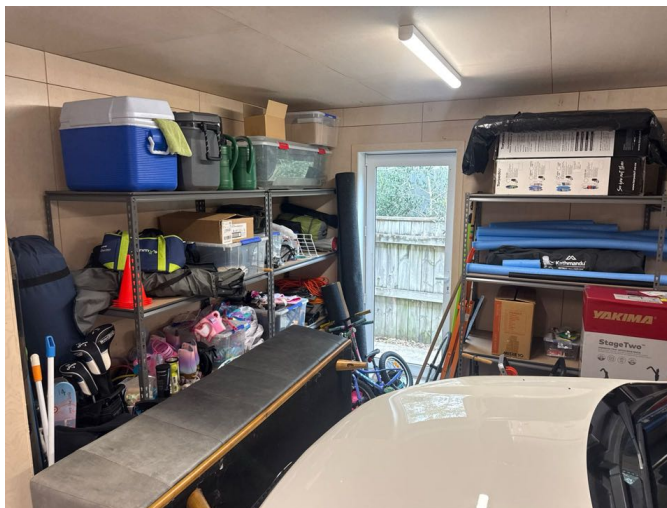
Not all areas of the garage could be fully inspected due to the presence of stored items. A full inspection is recommended once cleared. This applies to all concealed locations throughout the house.

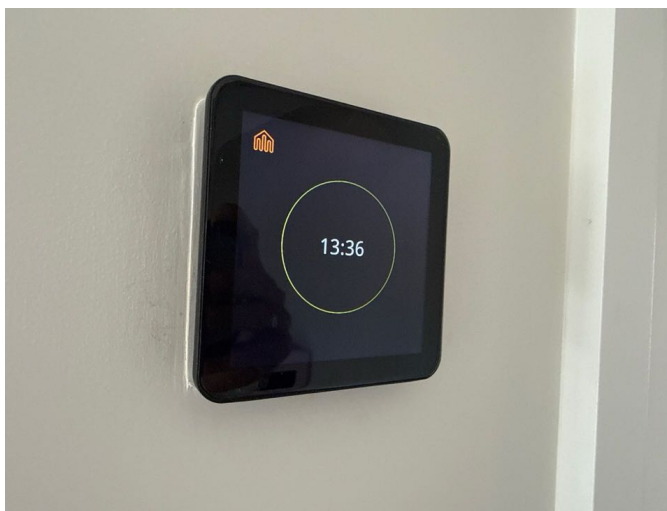
The control panel for the hydronic in floor heating system is located by the kitchen. Untested.
