Under floor Inspections

Report prepared for: Claire Holmes

Property address: 41 Mackenzie Avenue, Woolston

Date: 14 February 2023

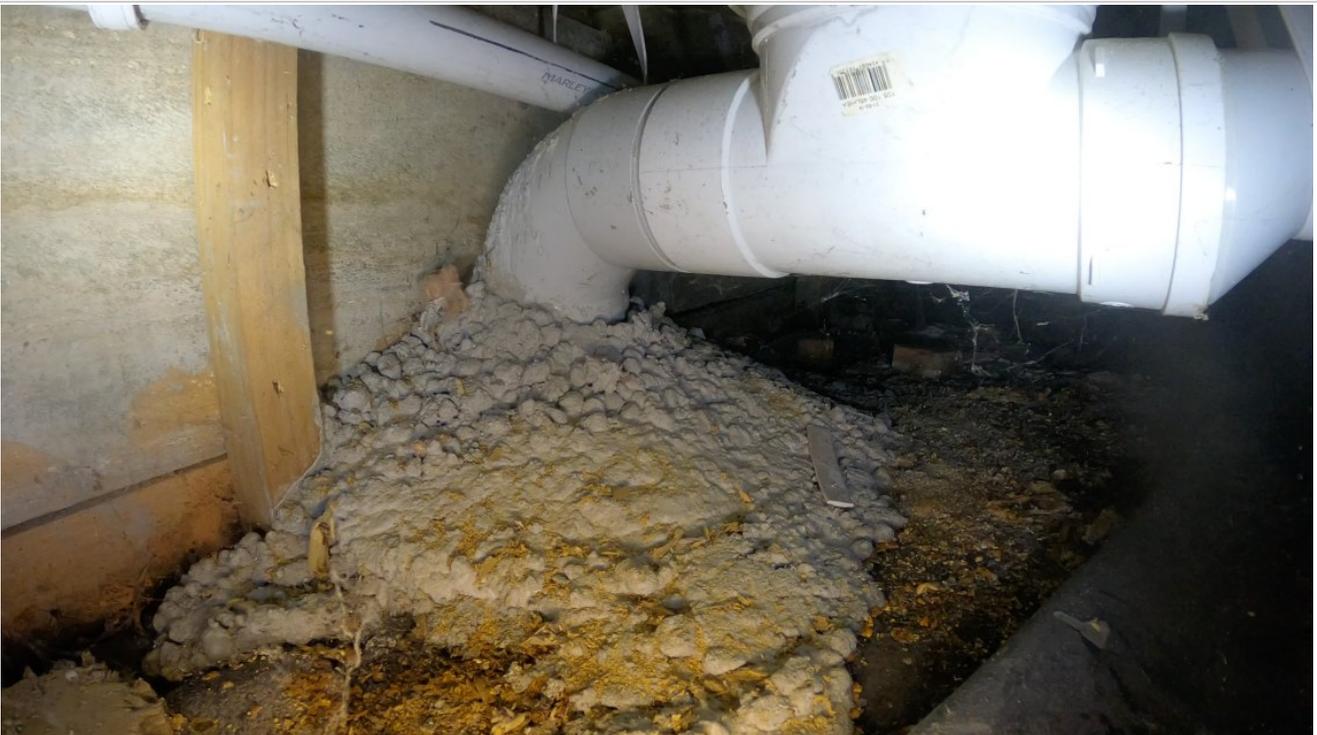
8: View of toilet connection.

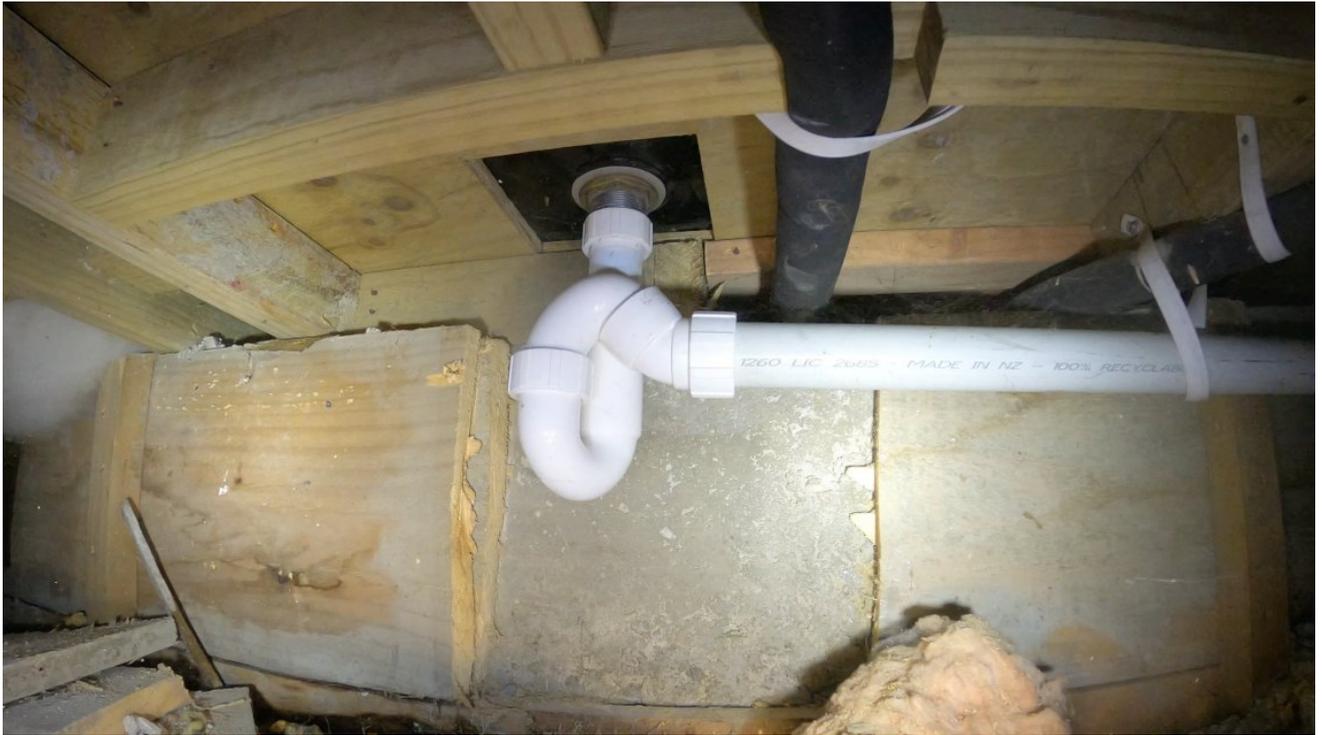
9: Here we can see a section of the new concrete which appears fine.

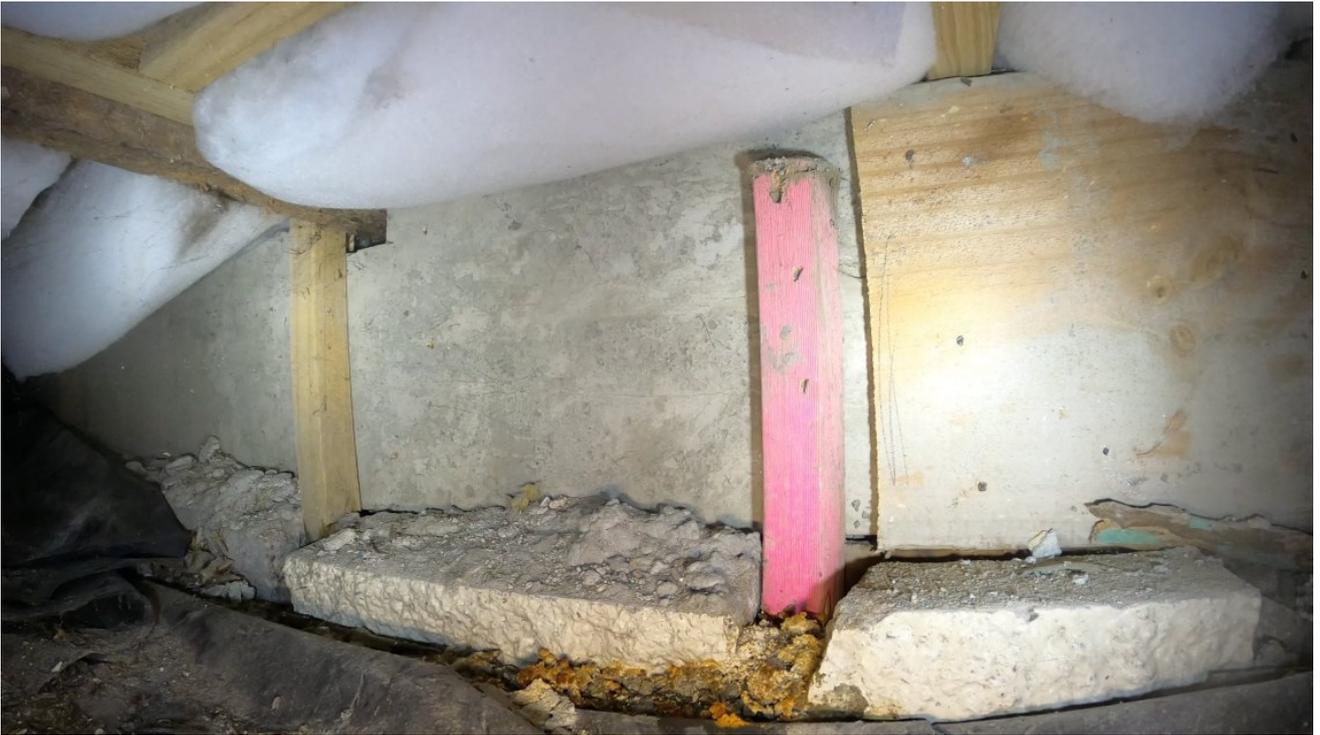
11: View of boxing.

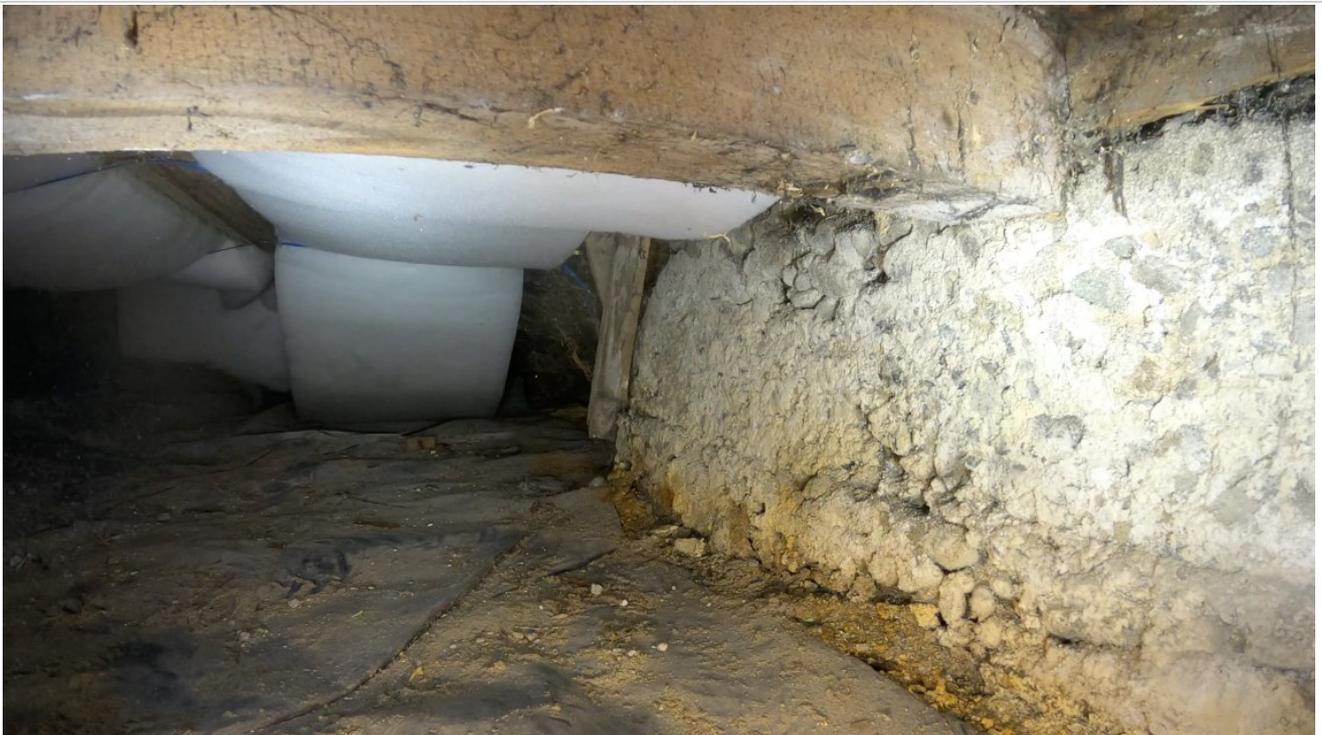
14: View of bearer meeting chimney breast.

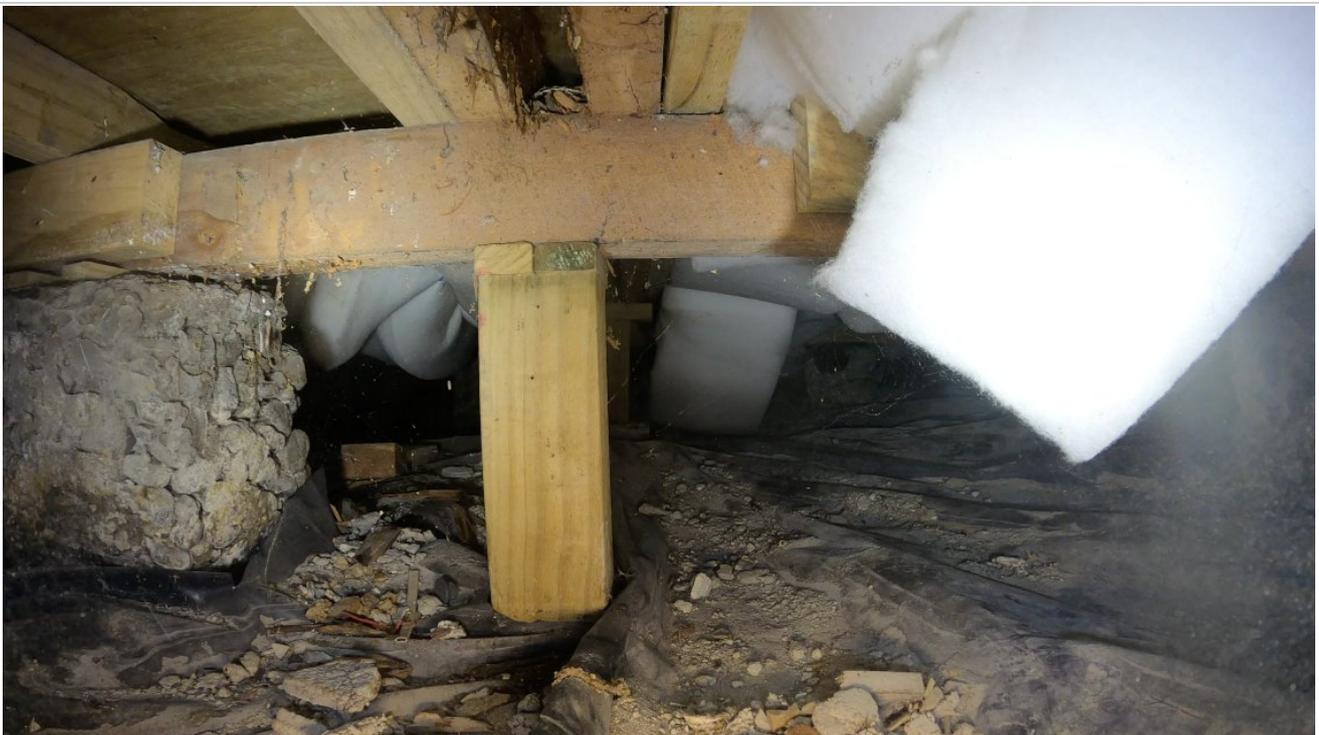
16: Right across the subfloor we see the use of these props. They are not concreted into the ground and are definitely not piles. This is very poor workmanship.

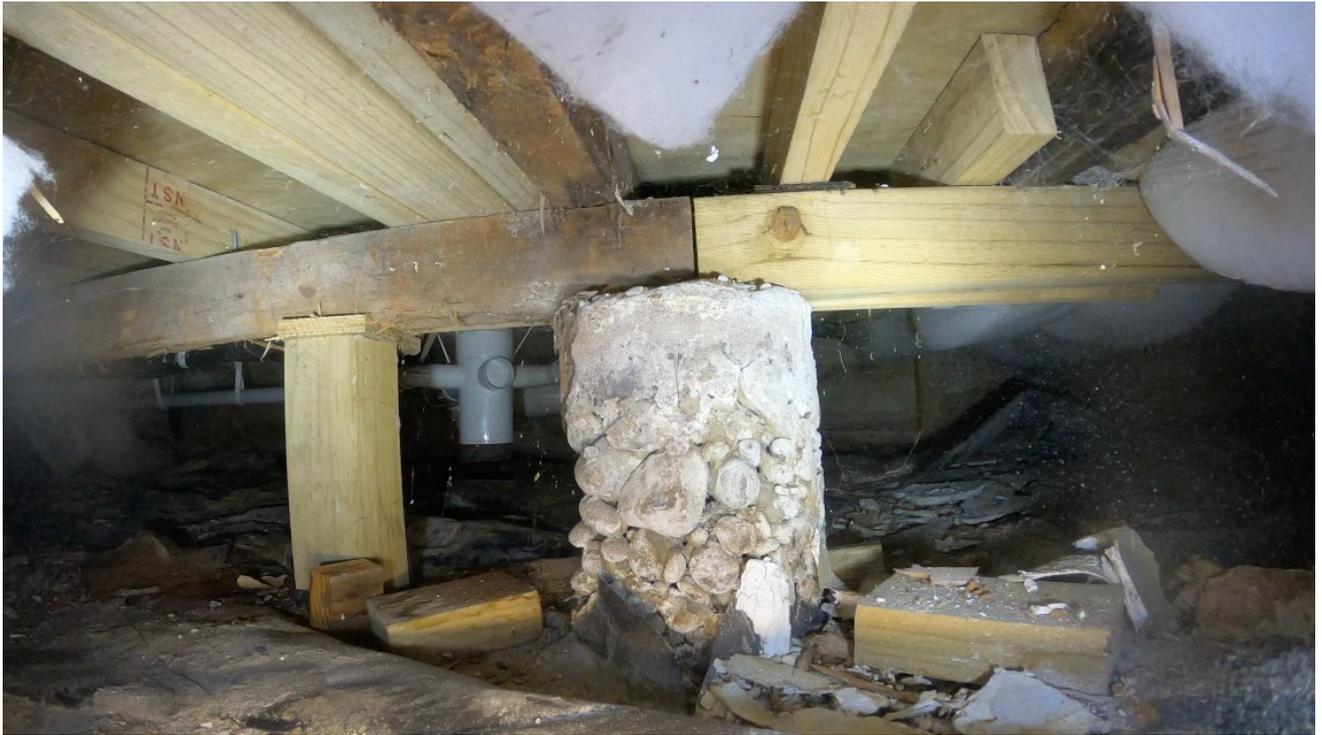
19: There is a new bearer to the right.

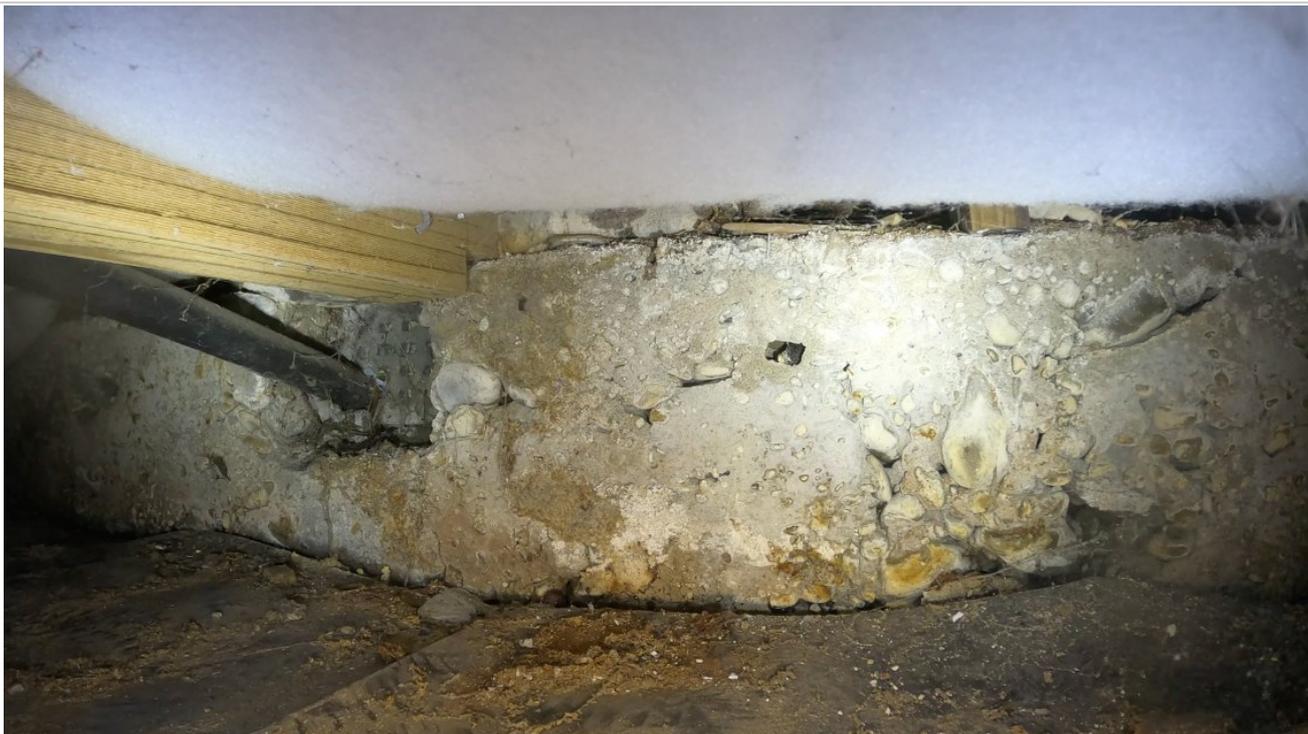
23: No damp course has been used under the bearer and it is only connected by 4 nails.

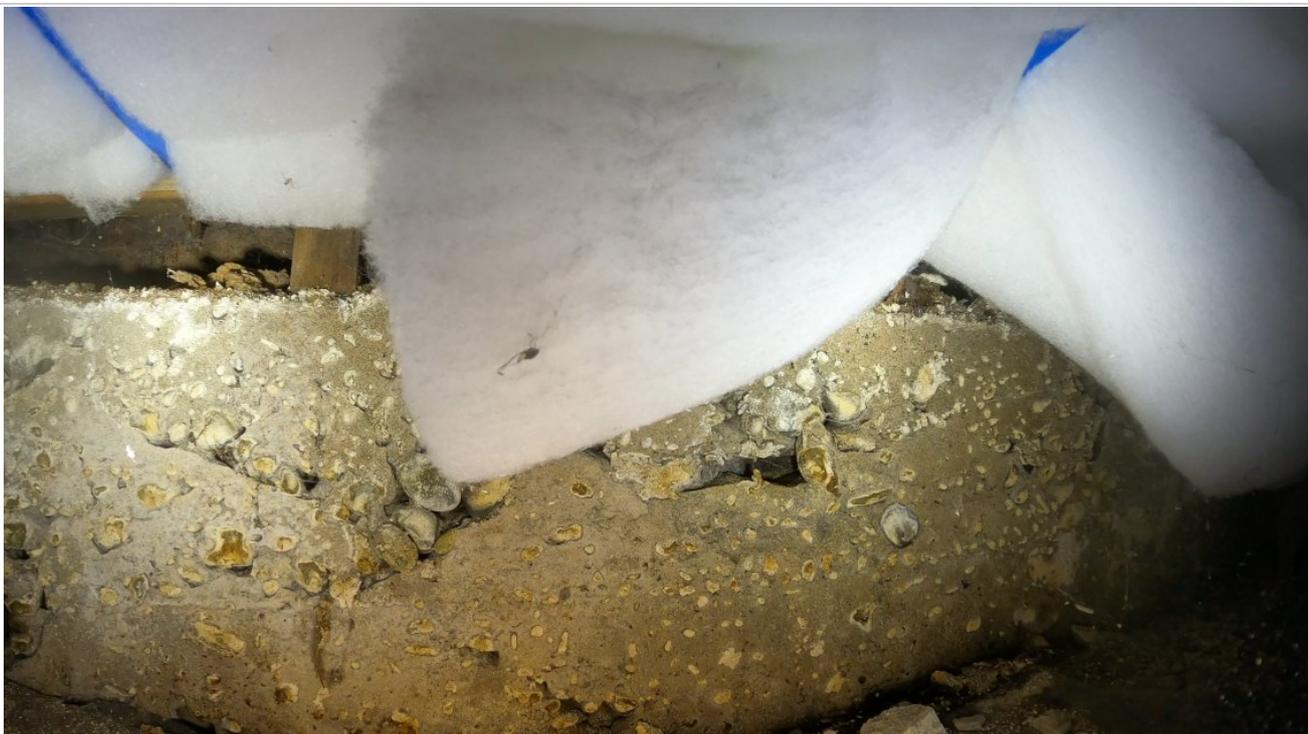
24: I can't see much due to the insulation but what I can see of the original timber appears rotten.

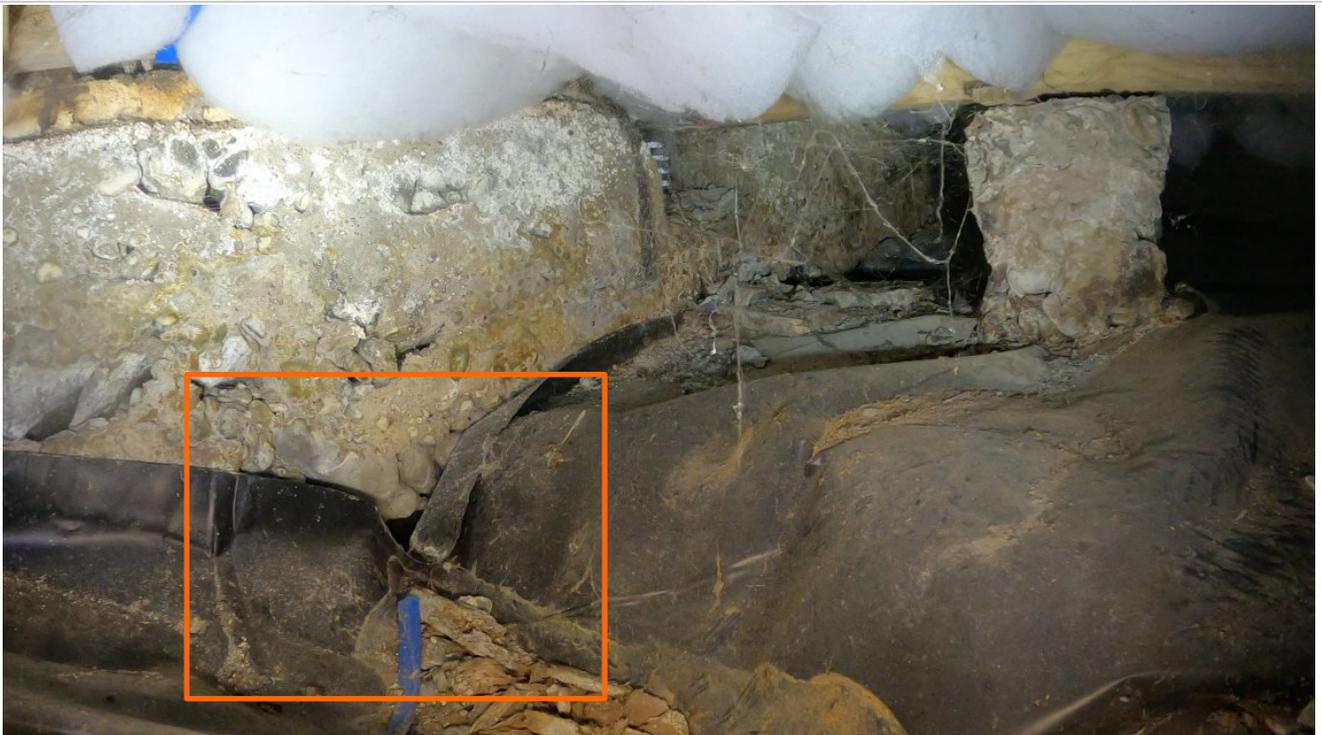
28: The water main would have come into the home here. I didn't sight a new one.

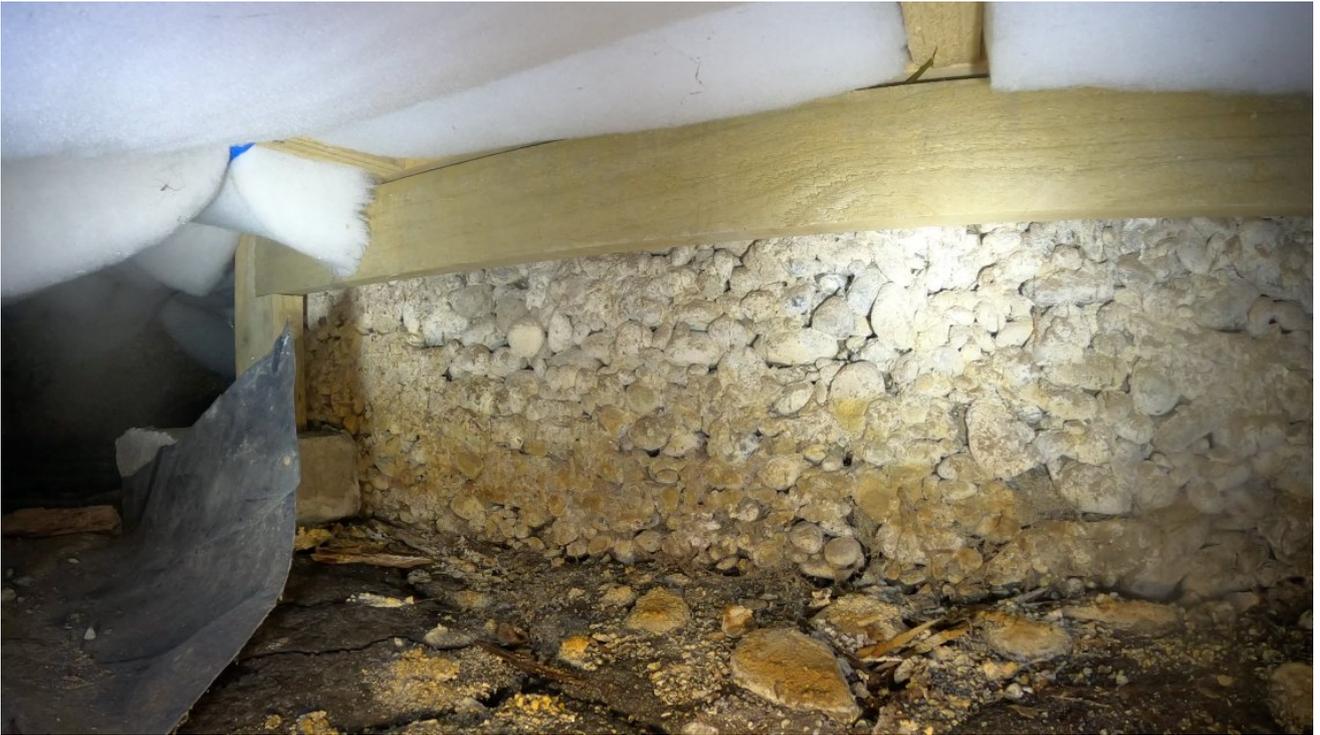
33: The prop is supporting a form of bearer which in turn is supporting the framing.

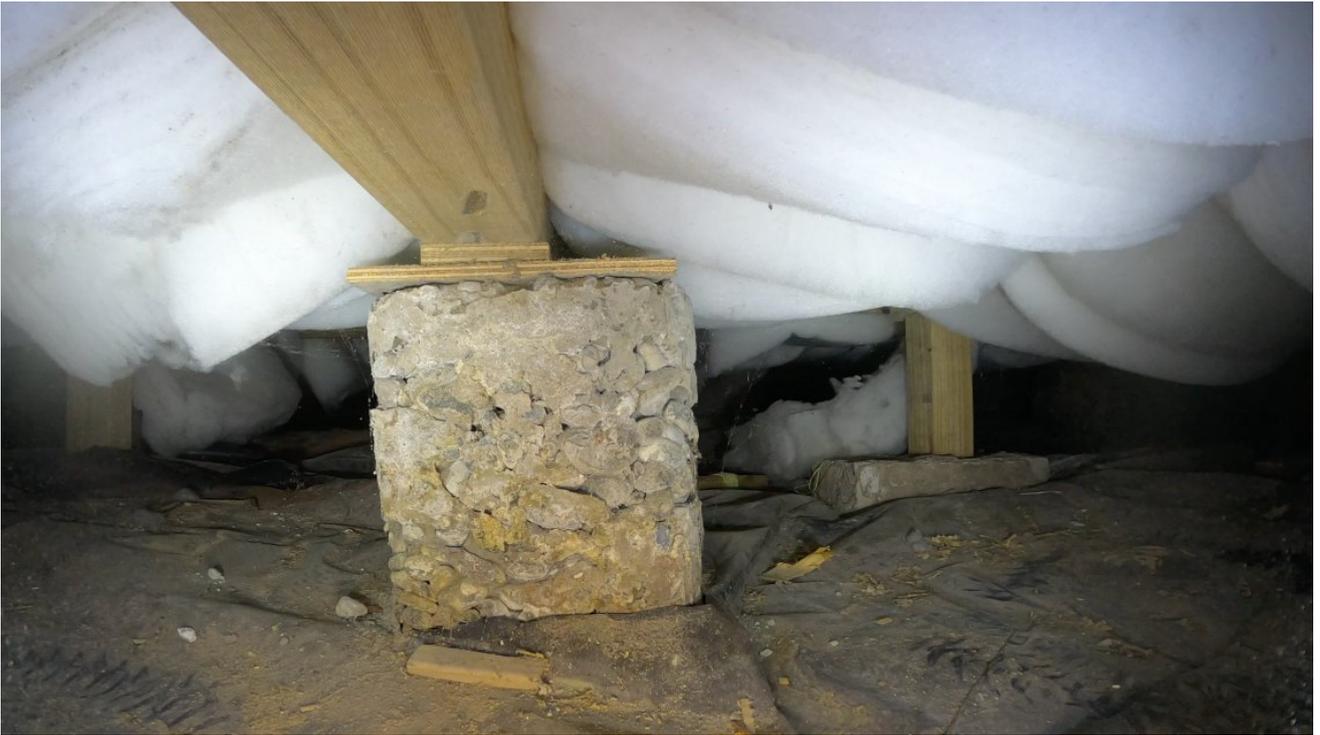
39: Jerry can pile with packing and no connection.

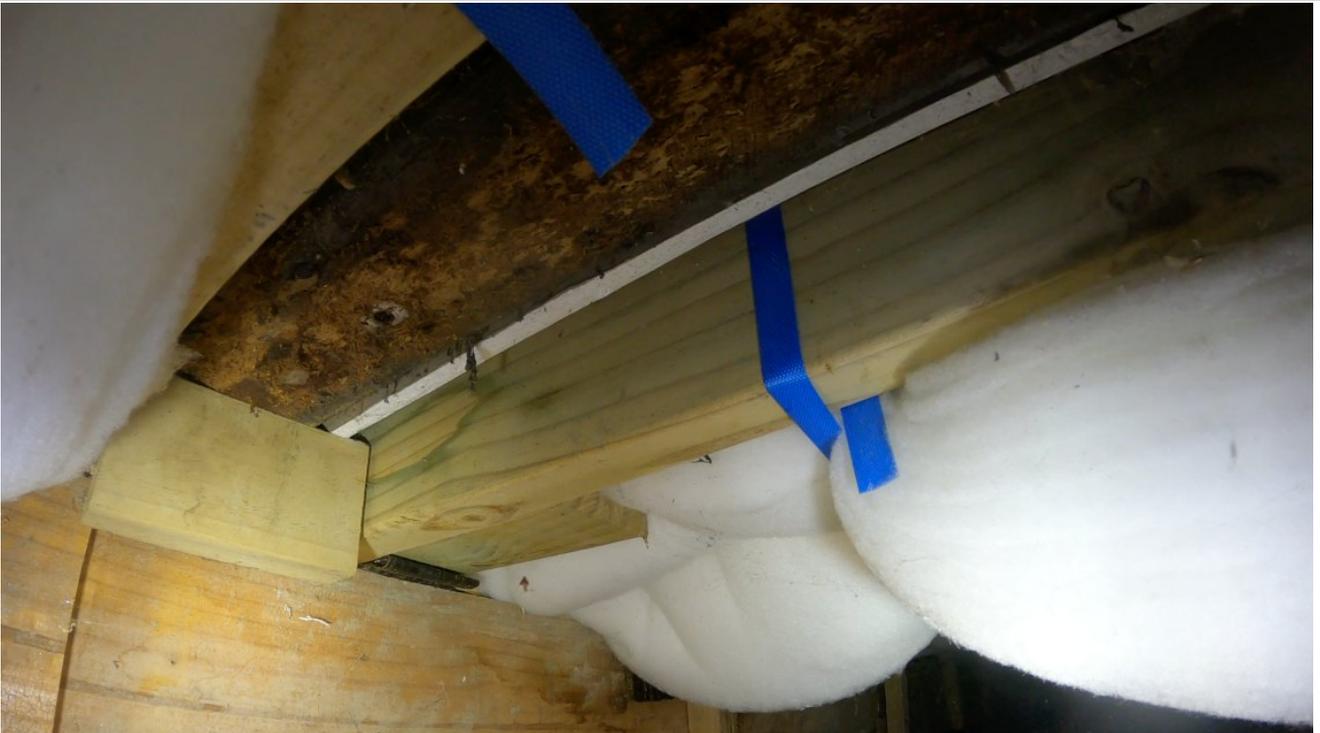
72: Here we see a rotten bearer.

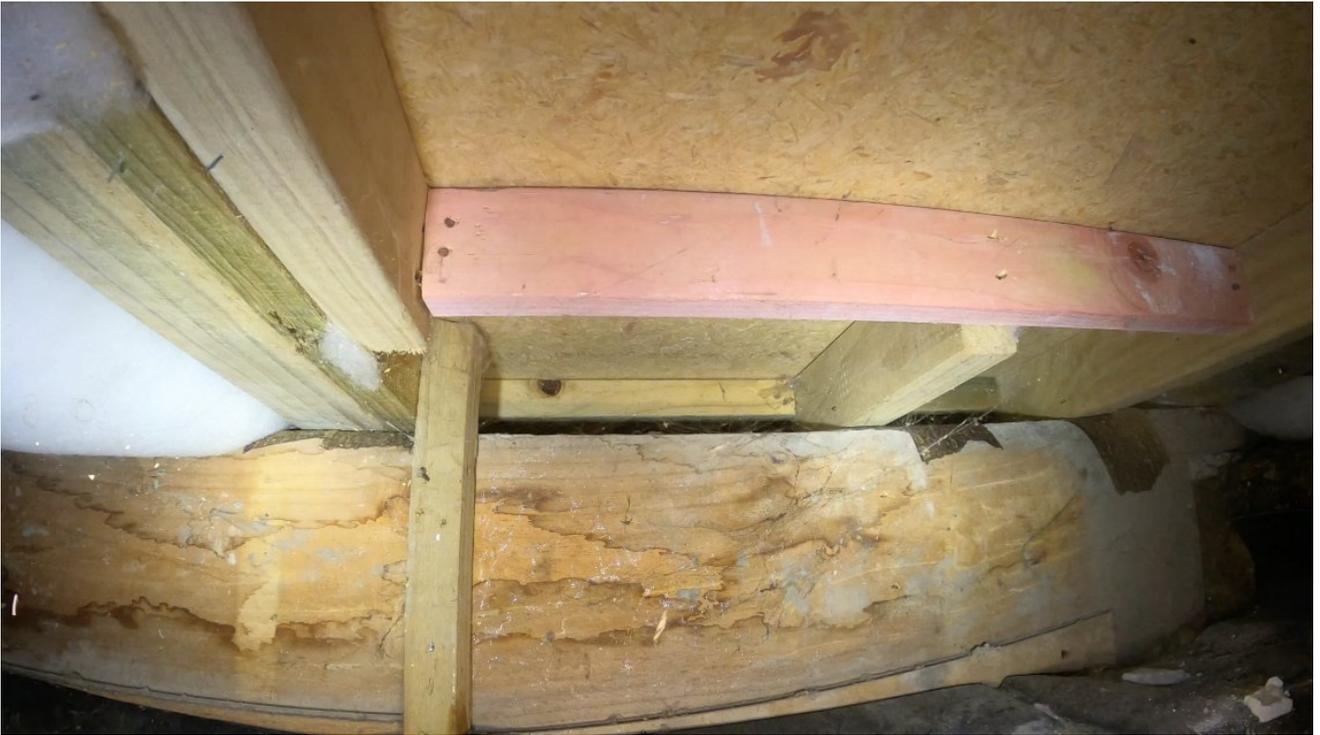
73: More use of H1.2 treated timber and particle board flooring.

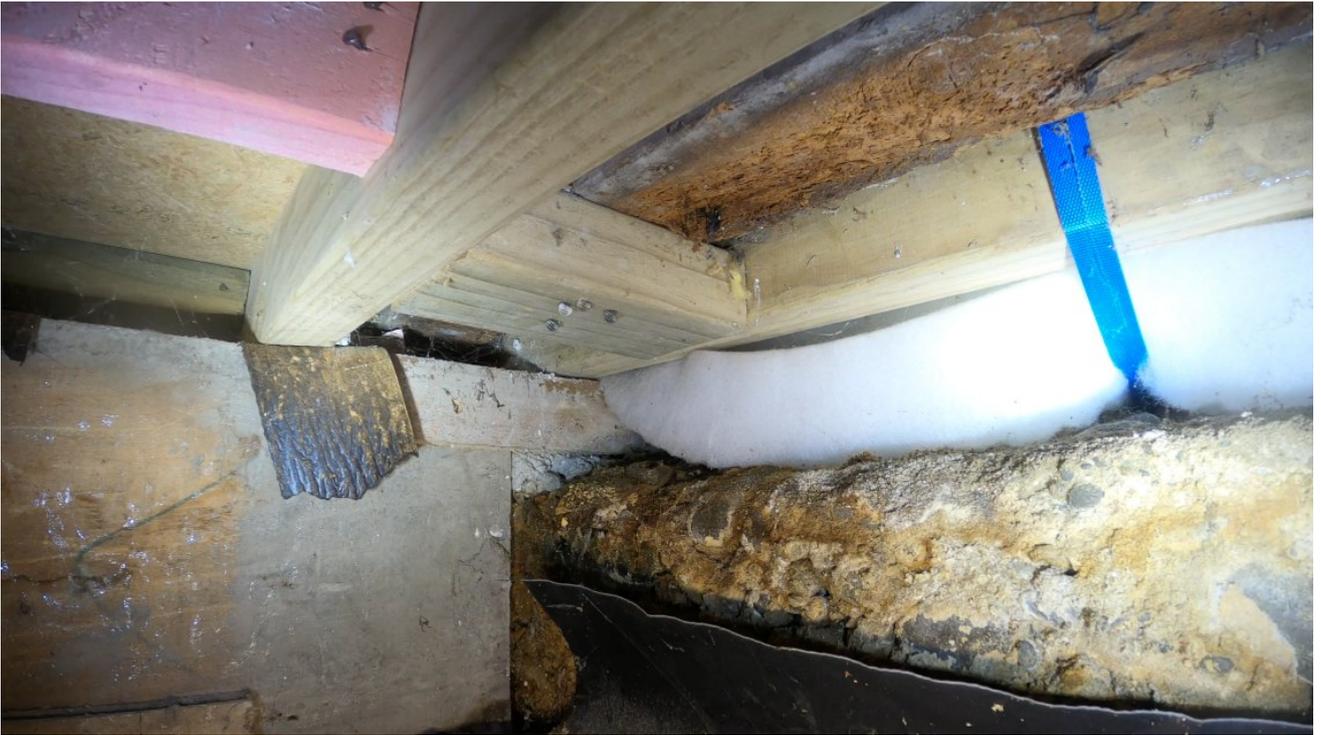
75: Note the rotten timber.
