2026 | COMPREHENSIVE WEATHERTIGHTNESS REPORT H/V

56 Kakariki Grove
Waikanae, Wellington Region 5036

MARCH 12, 2026

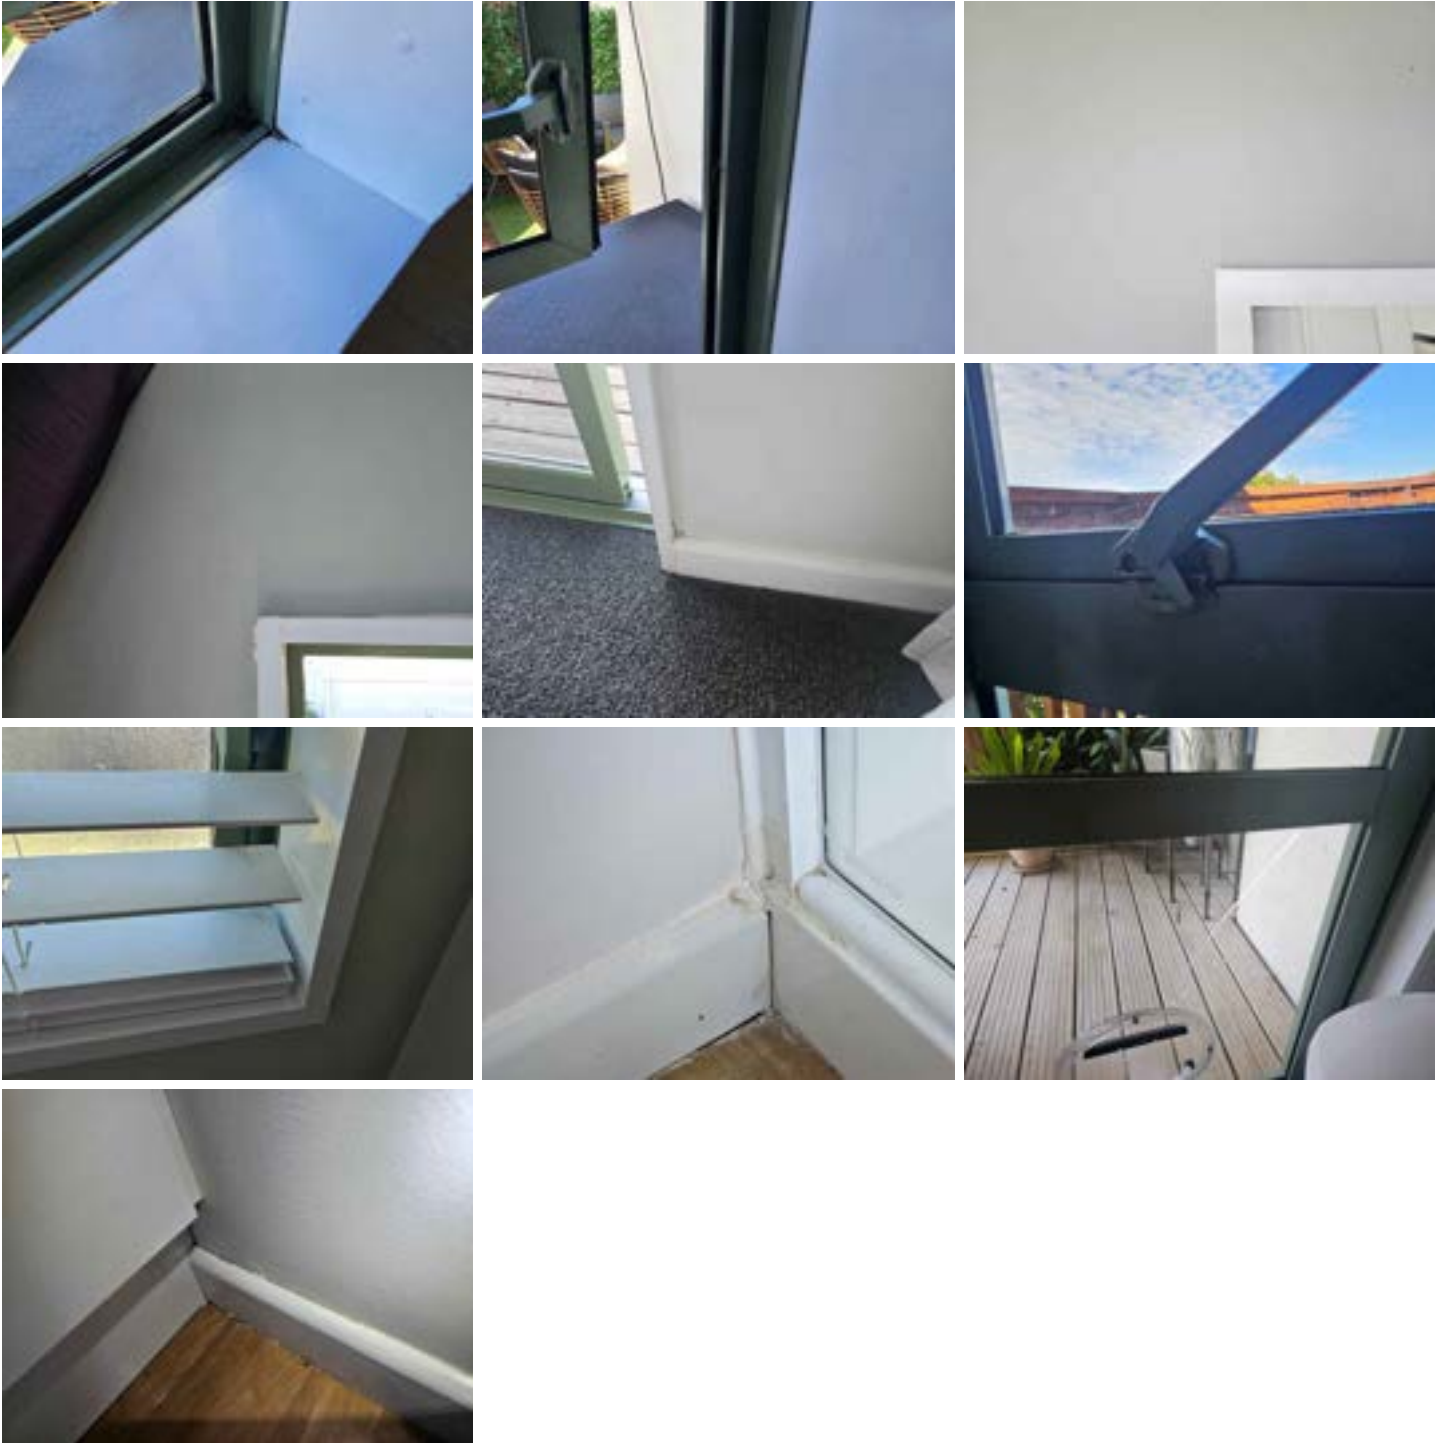
CONDENSATION DAMAGE AT JOINERY

These joinery observations may appear or be quite minor. However, we include them all because of how often we see moderate to major damage within wall cavities from condensation caused defects.

A single 1x1mtr window can produce 0.75 Litres of water "per day" in the optimum conditions. These types of observations may or may not be classed an aesthetic issue, Regardless, if it's left unsealed and/or exposed to the elements for too long it may become a much larger issue and more expensive repair/replacement. For timber joinery and/or surrounding cladding materials, buff/key the surface before applying any weather sealing paint and/or paintable silicone products.

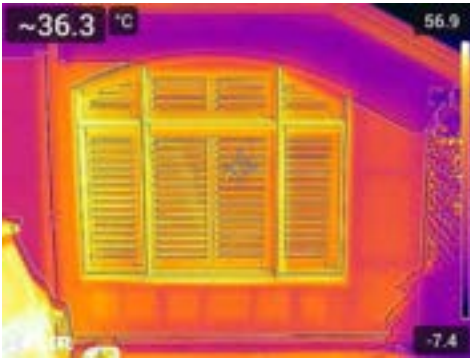
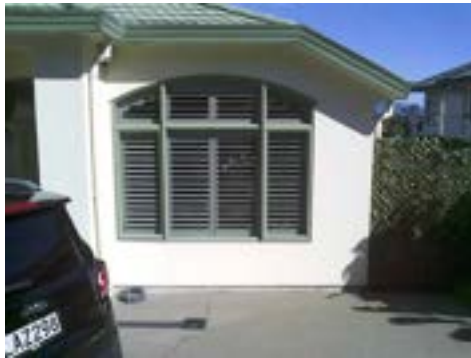
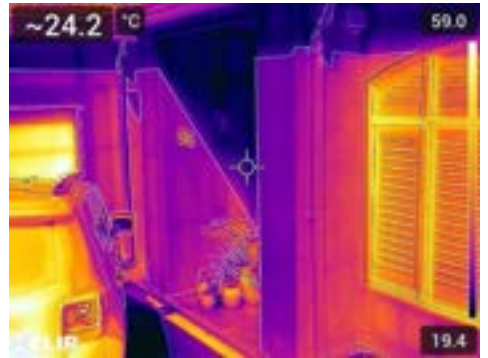
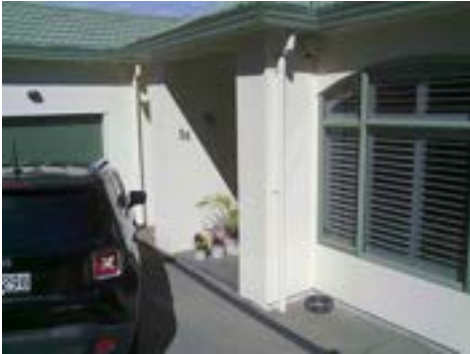
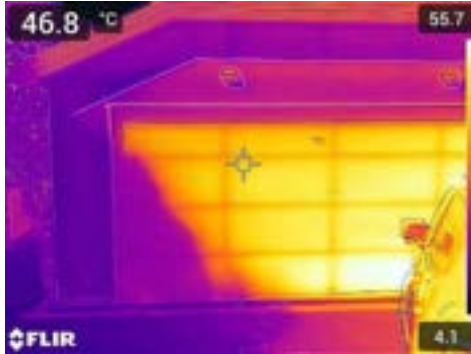
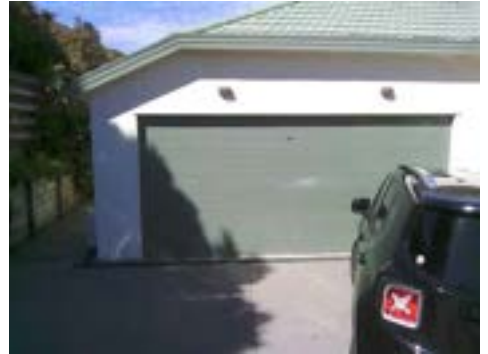
Maintenance Item

**THERMAL IMAGING RESULTS
FLIR T560**
