EQC CLAIM DOCUMENTATION

EARTHQUAKE RECOVERY (EQR) DOCUMENTATION

Released under the Official Information Act 1982
EQR Property Overview Report

EQC Property ID	Property Address	Vulnerable?	Property F Status	Property Finalisation Indicator		
2010061240	41 MACKENZIE AVENUE, WOOLSTON		F3 - Complete & Finalised	Some Finalisation has taken place		
Main Contractor:	CLOSED OUT-S.K. Hand Builders Limited ***** (SC30)		Property F2'd By:	Blair Jones	F2 Completed Date:	20-06-2016
Cont Managing Hub:	Ensors	Not Vulnerable	Property F3'd By:	Blair Jones	F3 Completed Date:	20-06-2016

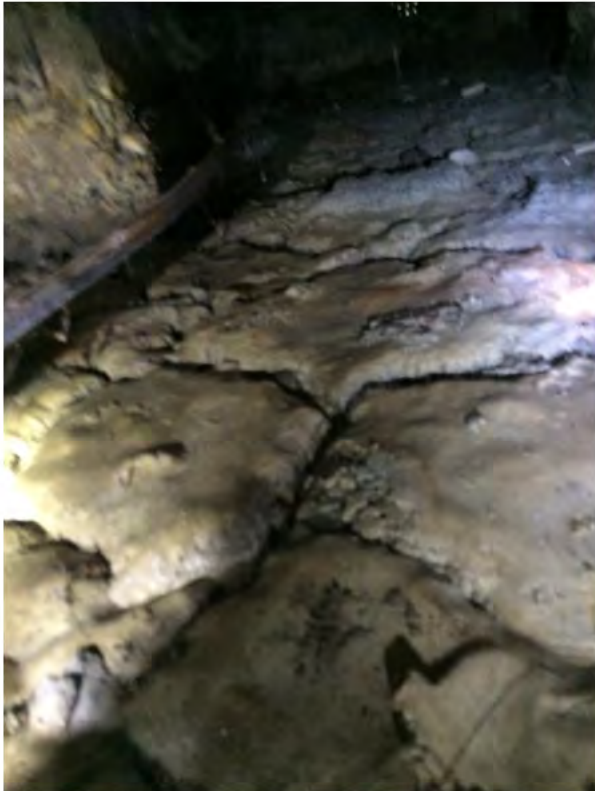
The property has suffered extensive damage during the Earthquake events in 2010 and 2011. Liquefaction is present under the timber floor of the house, and upon inspection, the subfloor space appears damp.

Appendix 1: Liquefaction in the subfloor space

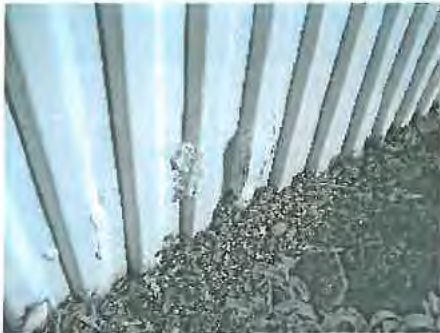
Filler patches were noted to the painted perspex cladding to the laundry and conservatory areas, not a recommended cladding for a house. A little softness or rot was noted to the bottom of bedroom two window facing. The conservatory has been built on top of the timber decking, with the decking protruding out from the walls, this is a potential rot problem although sealant has been applied. The timber facing to the conservatory is unprotected from the weather at the top. The gully trap needs cleaning out. Some filler has been applied to a small section of roofing and as there is some signs of water damage to ceiling areas below it may need further investigation (possible rust holes).

Patches to painted perspex cladding noted.

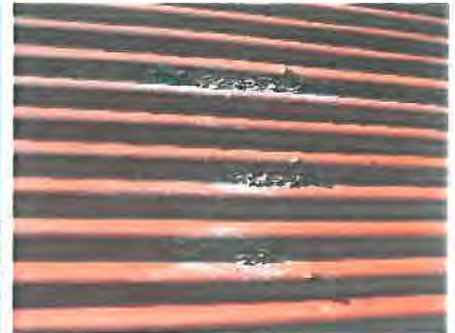
Some filler noted to roofing iron.

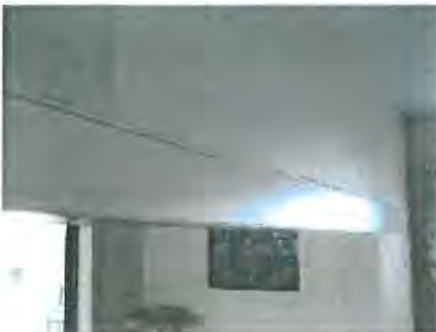
The beam between the lounge and the dining room has bowed down and as this is a load bearing wall it needs a suitable beam fitted. Loose hardboard was noted to the dining room ceiling. Some laminate is broken off the side of the kitchen cupboard. The kitchen drawers and cupboards need some adjustment and catches need fitting. Minor damage was noted to the conservatory window sash. The sliding door to the conservatory catches on the window lock. A small gap was noted to the dining room ceiling lining. Some interior trim needs re-coating. Rot was noted to the window sill in bedroom one. Door stops are missing. There appears to be some old water damage to bedroom three and the lounge ceilings. The old fireplace concrete pad was noted under bedroom three carpet. Some wall and ceiling cracks were noted, not of structural concern. Some minor wall damage noted (hallway). The bathroom extraction fan vents to the roof space. The moisture levels were found to be acceptable in all areas checked.

Beam between lounge and dining room is bowed down.

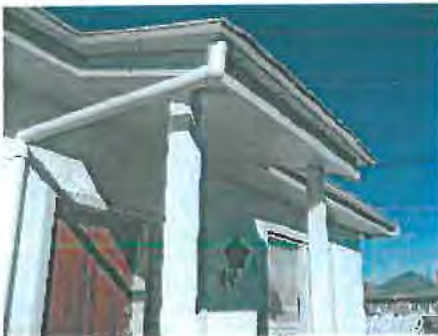
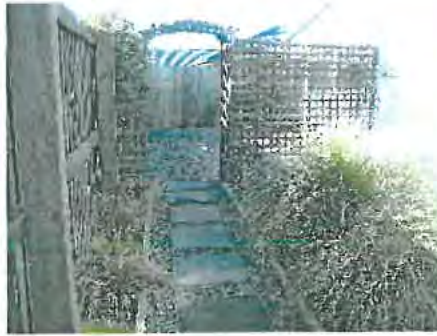
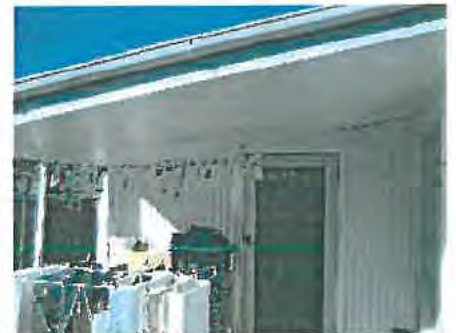
SUB-FLOOR

EXTERIOR FOUNDATION	TYPE	concrete ring foundation
	CONDITION	average
INTERIOR FOUNDATION, INCLUDING SLAB	TYPE	not able to sight no access found/limited crawl space
	CONDITION	unable to sight
BEARERS & JOISTS	CONDITION	unable to sight
BEARER TO PILE CONNECTIONS	SUFFICIENT	N/A
	COMMENT	no comment
BASE	TYPE	concrete
	CONDITION	average
VENTILATION	SUFFICIENT	yes
	TYPE	grills in concrete foundation
GROUND CONDITION		N/A
	COMMENT	no comment
FLOORING	TYPE	timber
	CONDITION	unable to sight
INSULATION	TYPE	unsighted
	CONDITION	not applicable
ACCESS DOOR	POSITION	no access found
	CONDITION	not applicable

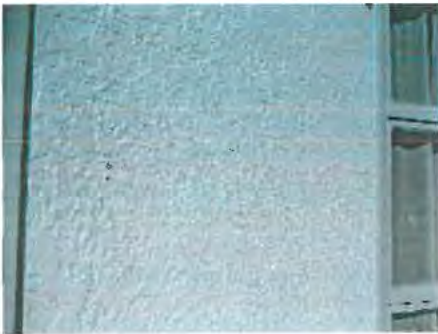
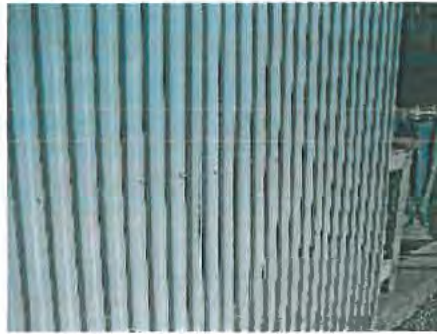
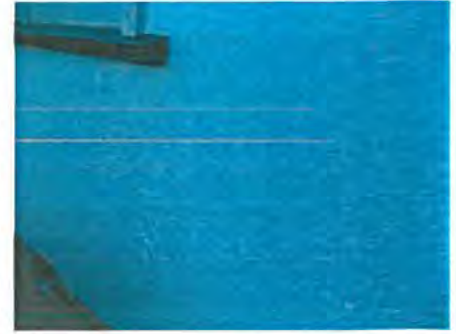
EXTERNAL STRUCTURE & CLADDING

WALL STRUCTURE	TYPE	timber framed
	CONDITION	appears sound but unable to sight
	COMMENT	no comment
BASEMENT	TYPE	no basement
	FINISH	not applicable
	CONDITION	not applicable
WALL CLADDING	COMMENT	no comment
	TYPE	solid plaster & perspex
	FINISH	paint
	CONDITION	generally good
	COMMENT	no comment

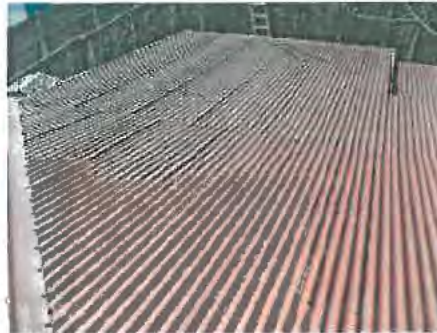
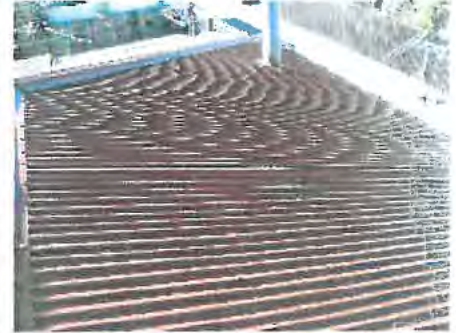
EXTERNAL STRUCTURE & CLADDING CONTINUED

ROOF	TYPE	corrugated iron
	FINISH	painted
	CONDITION	generally good
	INSPECTED	by getting on to
SOFFIT	COMMENT	no comment
	TYPE	Hardies sheet
	FINISH	painted
	CONDITION	average
FASCIA	COMMENT	no comment
	TYPE	timber
FLASHINGS	CONDITION	appears generally good
	TYPE	lead
SPOUTING	CONDITION	generally good
	COMMENT	no comment
	TYPE	mixture of plastic and steel
CHIMNEY	CONDITION	average
	COMMENT	no comment
TV AERIAL	TYPE	steel flue
	COMMENT	appears sound

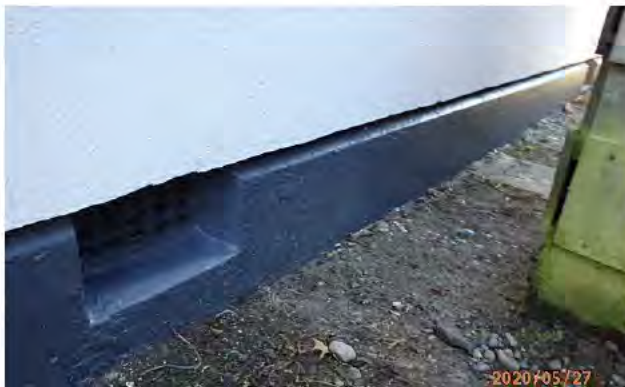
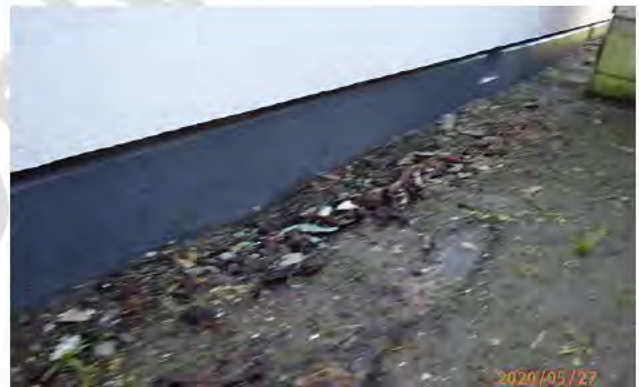
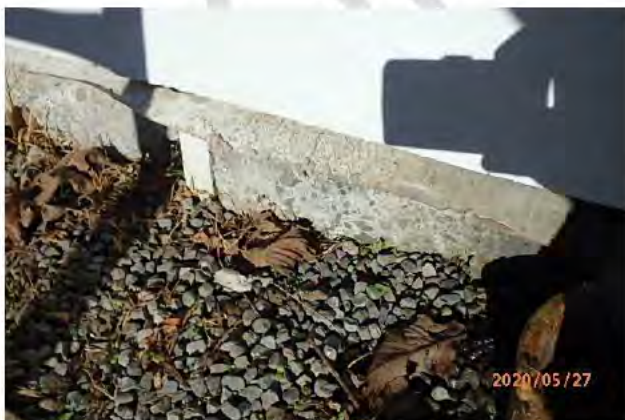
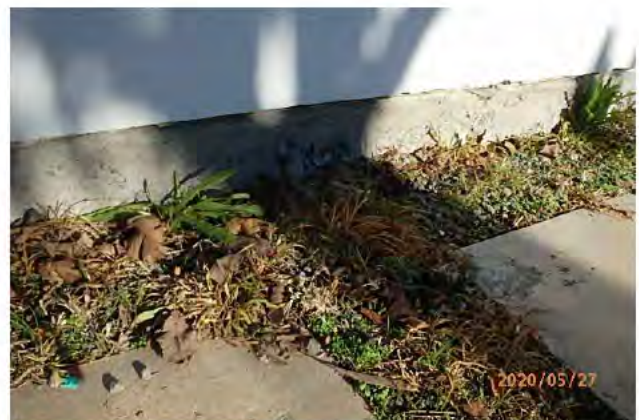
Subfloor access has not been provided, we however have sighted photos of subfloor work that has been completed. A polythene moisture barrier has been installed with a polyester insulation. Areas of joists and bearers have been replaced. We are unable to determine the extent of these works.

The subfloor works are restricted works, and therefore required to be completed by an LBP, it is recommended this documentation is available and kept on file.

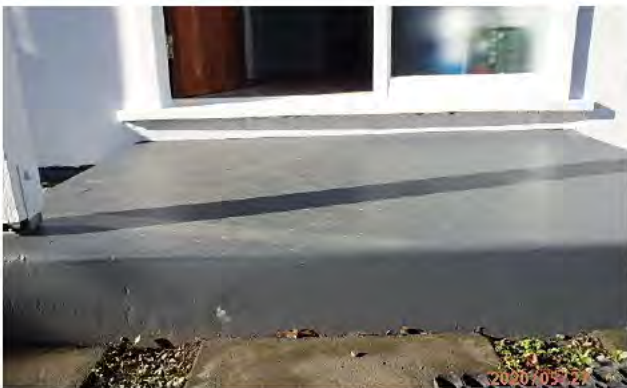
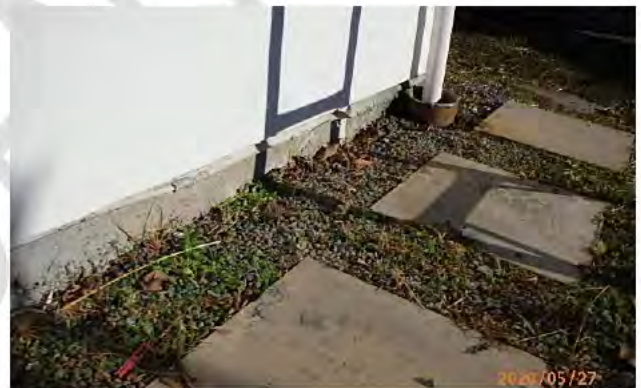
EXTERIOR FINISHED GROUND LEVELS

The current finished ground levels are more than satisfactory to prevent any moisture ingress by means of capillary action, with concreted and paved areas having the correct falls away from the dwelling and channelled into the appropriate cesspits.

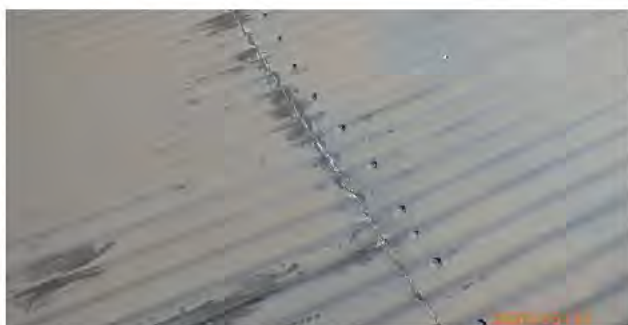
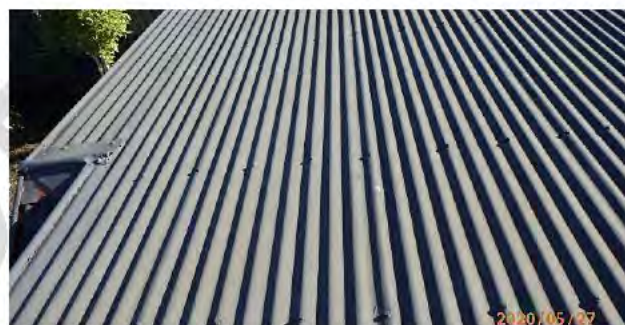
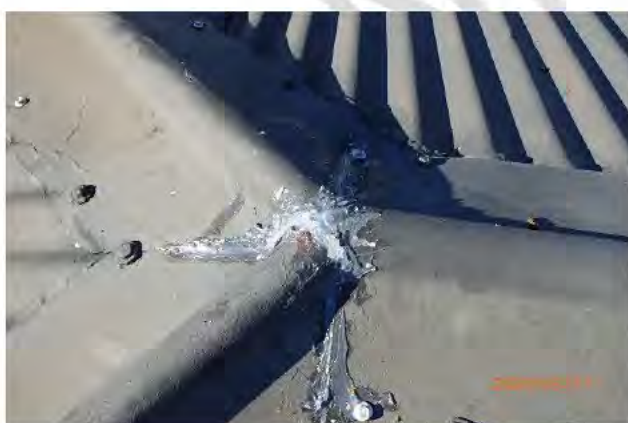
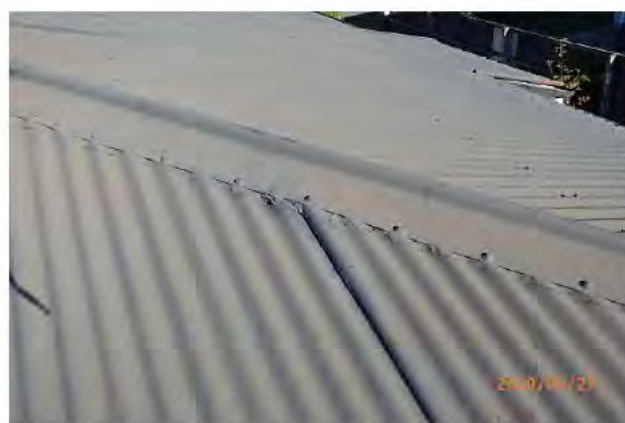
The roofing system is a corrugated iron roof in average condition for its age, it has been suitably fixed, however some fixing have become loose over time. At the time of inspection, it has been observed that previous attempts to seal the roof have been completed by way of silicone, some areas have had new fastenings installed however do not appear to be a roofing screw. A leak has been detected around the south east ridge. It is recommended that the leak and any other areas are repaired by a suitably qualified person.

Areas of the spouting have been observed as having rust in them with holes in some areas.

On inspection it is apparent that structural modifications have been made to the dwelling. It is strongly recommended that council records are checked to ensure that the correct consents were applied for, and that the work has been completed as per the consents, with the relevant inspections having been completed with a code of compliance having been issued.

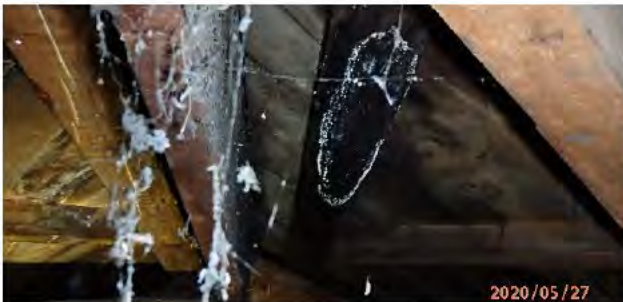
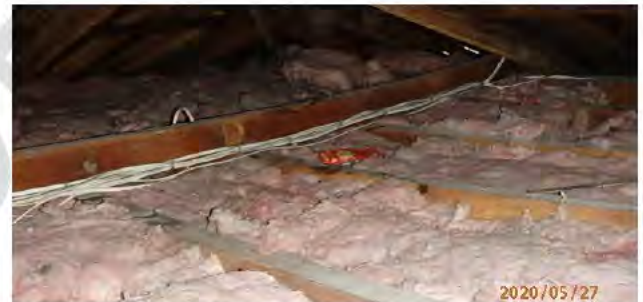
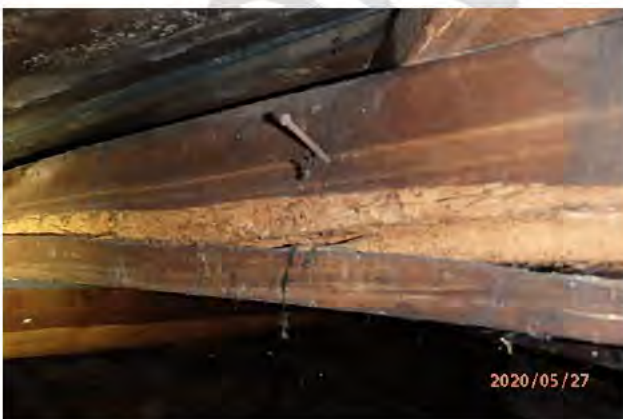
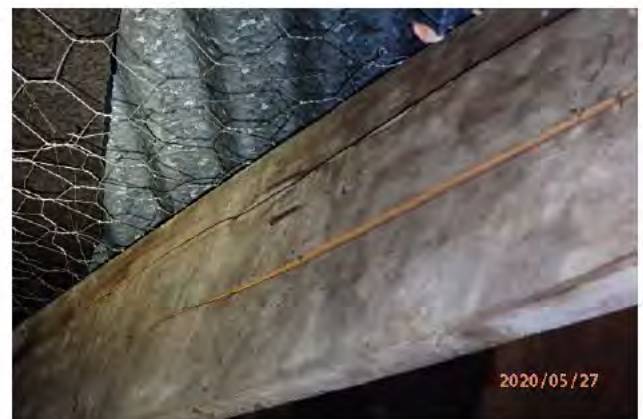
ROOF FRAMING AND INSULATION

The condition of the timber elements and insulation present in this area were of good condition. On inspection it has been found that a rafter does have a split to it and the ridge board to the north west elevation is also split. It is recommended that these are strengthened as required as replacement may not be practical.

As noted in the roofing section areas of leaks have been detected.

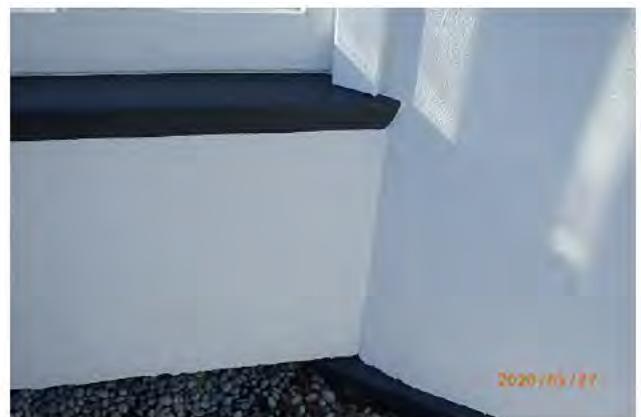
CLADDING

The cladding to addition to the north east appears to have been removed and replaced as a newer type of building wrap product can be seen protruding below the cladding in this area. 'overall, the cladding is in good condition. It is recommended that the cladding system is regularly cleaned and painted every 7-8 years.

The exterior has been recently re-plastered with a manufactured plaster system. This would have been completed by an LBP and it is recommended that the record of works is obtained and kept on file, it would also be expected that some form of warranty should apply.

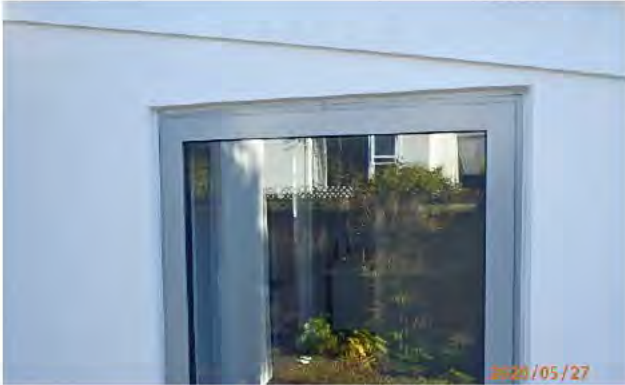
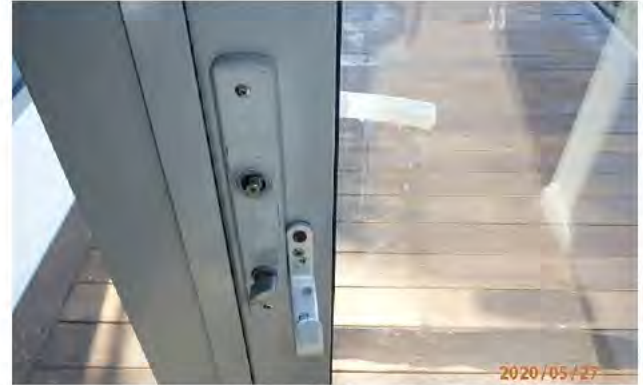
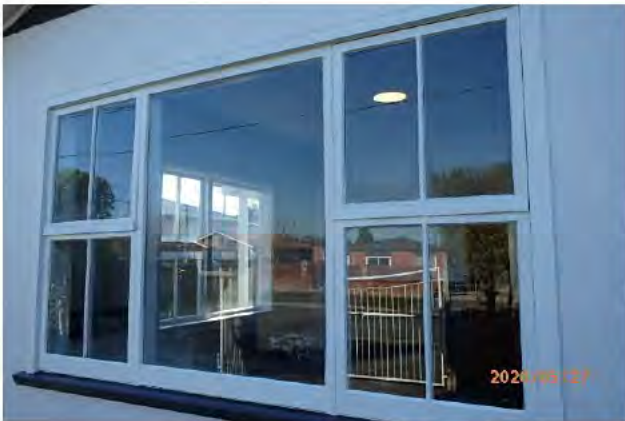
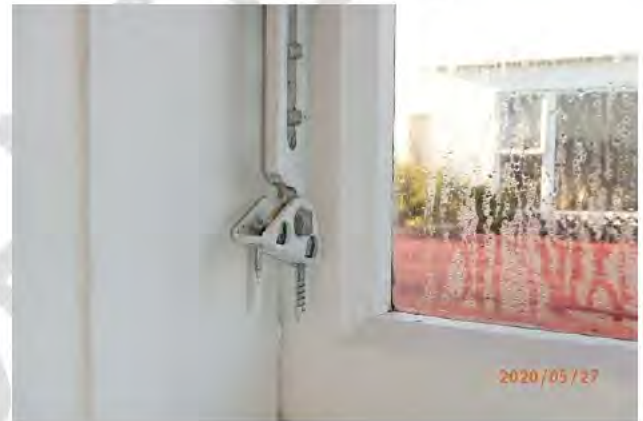
The timber joinery is in average condition having been recently painted and some windows need to be eased as part of general maintenance to achieve good working condition. Windows, catches and locks are not functioning adequately and require maintenance to restore functionality.

The French door to the deck has a damaged handle and the makeshift handle will leave holes when removed.

Joinery has been correctly fitted at the time of construction with some head flashings. Generally, the joinery is not well sealed to the cladding.

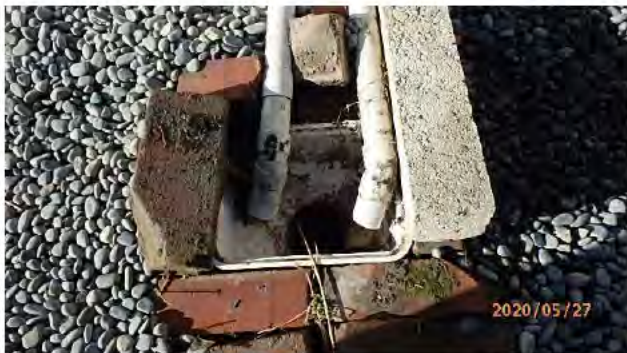
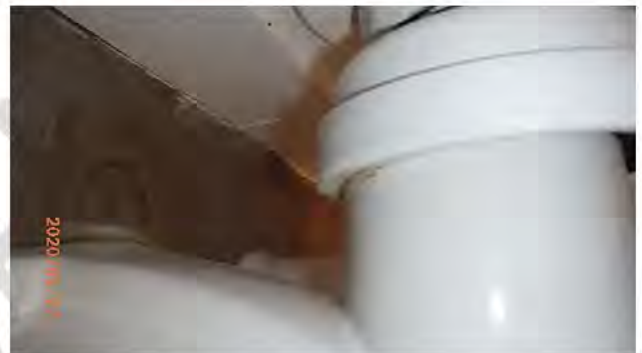
Wastepipes are correctly fitted to gully traps. Gully dish is correctly supported however could be done better; it is recommended that grates are installed to prevent debris entering the systems

The toilet to the east bathroom is leaking behind the toilet. The main bathroom toilet seat requires adjustment.

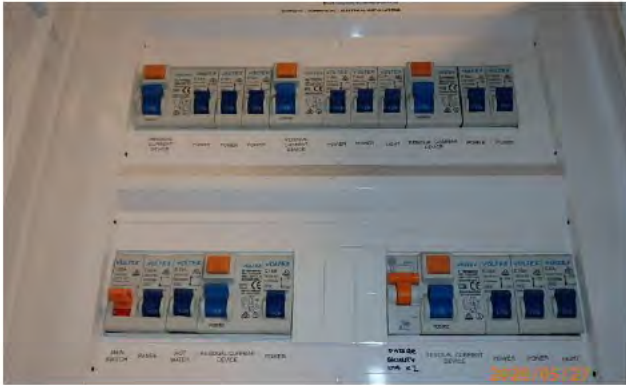
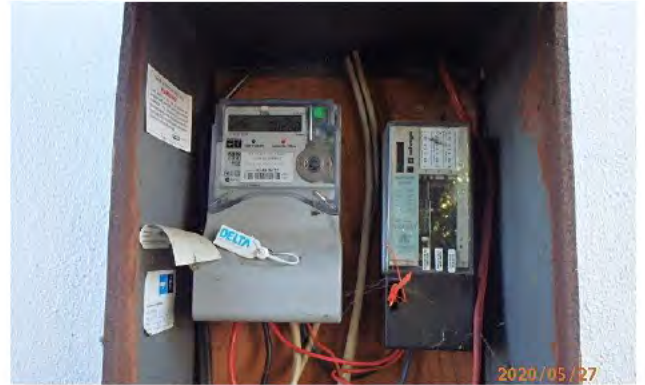
ELECTRICAL

A standard meter and distribution board has been installed to the interior wall, which has had some alterations.

NOTE: There have been several new electrical circuits added with new TPS wiring visible in the subfloor and new circuit breakers installed in the distribution board. All new electrical installations require an Electrical Certificate of Compliance which is issued by the electrician completing the work – this certificate is required whether or not an inspection is required and details the electrical work has been carried out in accordance with the requirements of the Electricity Act 1992 and the Electricity Regulations 1997.

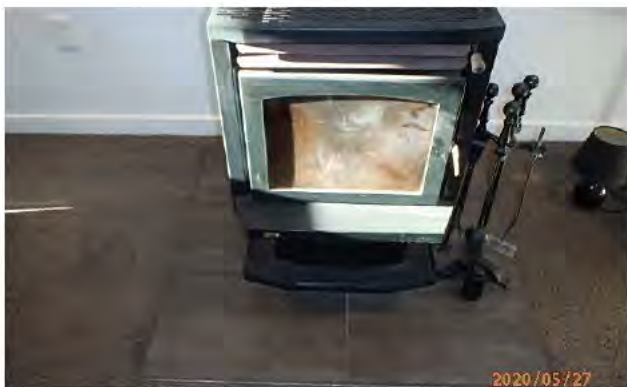
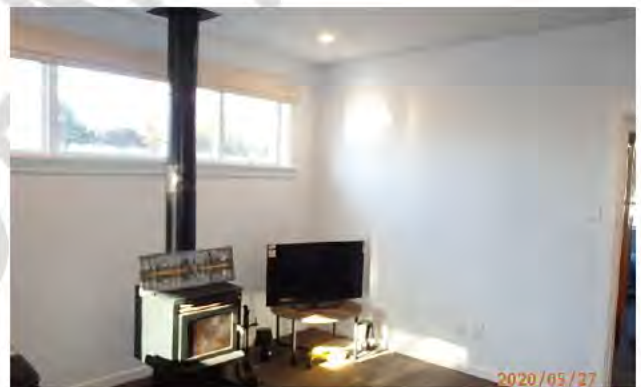
HEATING

A log burner has been installed in the living room; it appears to have been well installed with no current visible issues.

The fire handle is missing.

It is recommended that the council records are checked to ensure the consent is current. Ensure that the fireplace and flue are regularly cleaned.

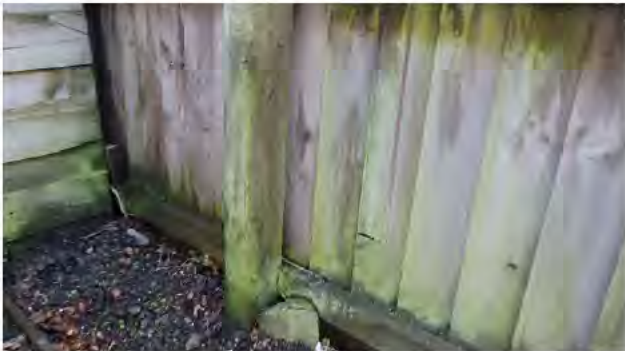
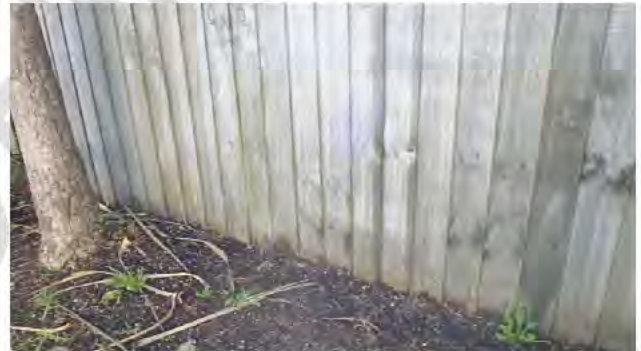
FENCING

In general fencing is in good condition however some areas are in contact with the ground and this can increase and promote decay to the bottom edges of the timber palings.

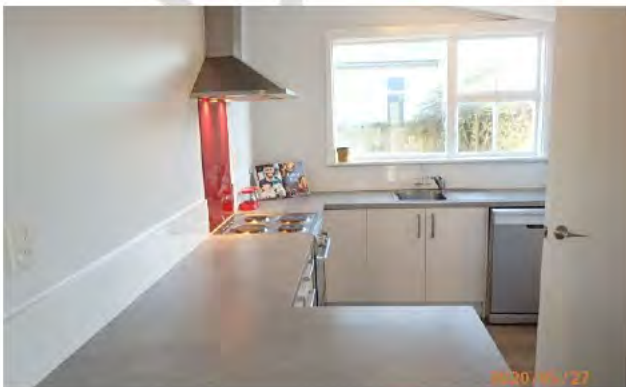
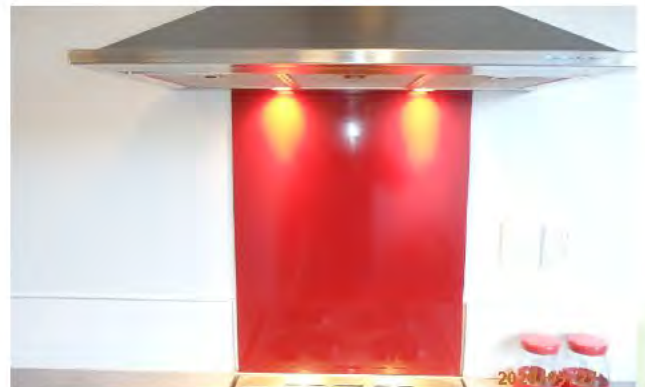
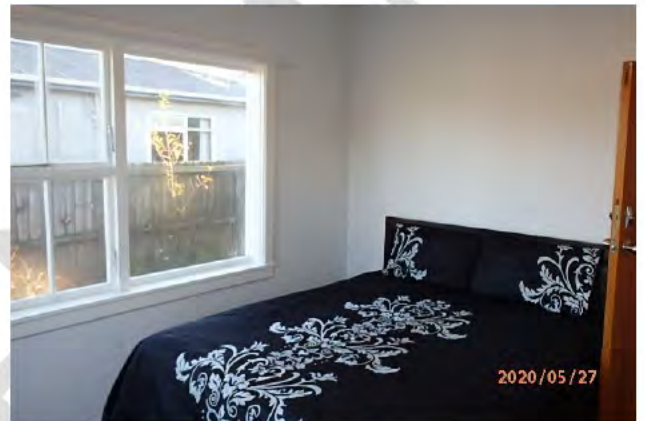
INTERIOR

Walls and ceilings consist of a plasterboard lining that has been plastered and painted to a good trade standard. These are currently in good condition. A leak stain is in the lounge ceiling.

Floor coverings consist of carpet and tiles to the wet areas, these are in good condition with wear and tear consistent with the age of the floor coverings. The tiles in all areas are missing grout in areas and should have silicone against skirtings and showers. The carpet transition to the east bedroom has not been completed.

The kitchen consists of manufactured timber joinery with Laminate benchtop which is in average condition, some cosmetic damage is visible, a vented range hood is functioning, the oven appears to be in good condition and working, the cooktop is electric and working, we could not get the oven to function, the sink does not appear to be leaking.

Bathrooms have been tested and found to be in good condition, the main bathroom vanity does require re-fixing to the wall, cracks are also visible in the sink. The toilet to the east bathroom has a visible leak.

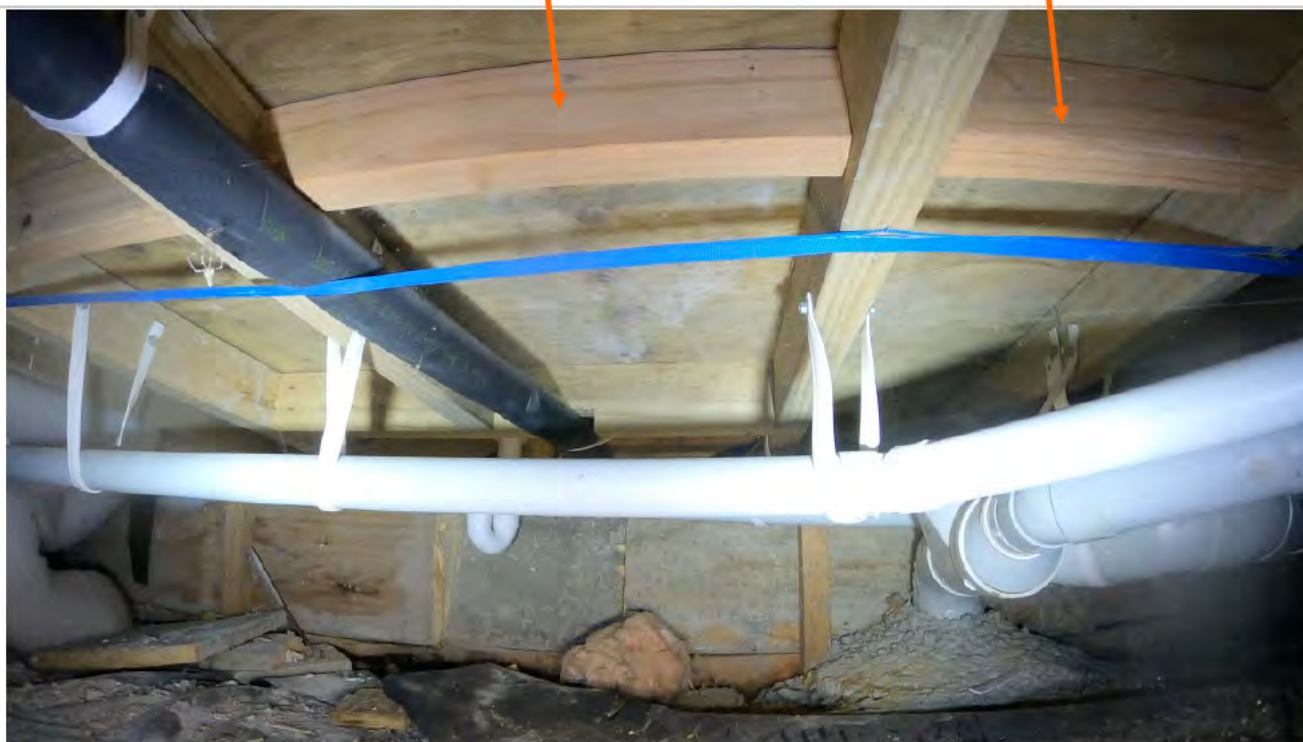
7: Most of the new timber used in the subfloor is the correctly treated H3.2 timber, however here we do see the use of some H1.2 which is not rated for use in this environment.

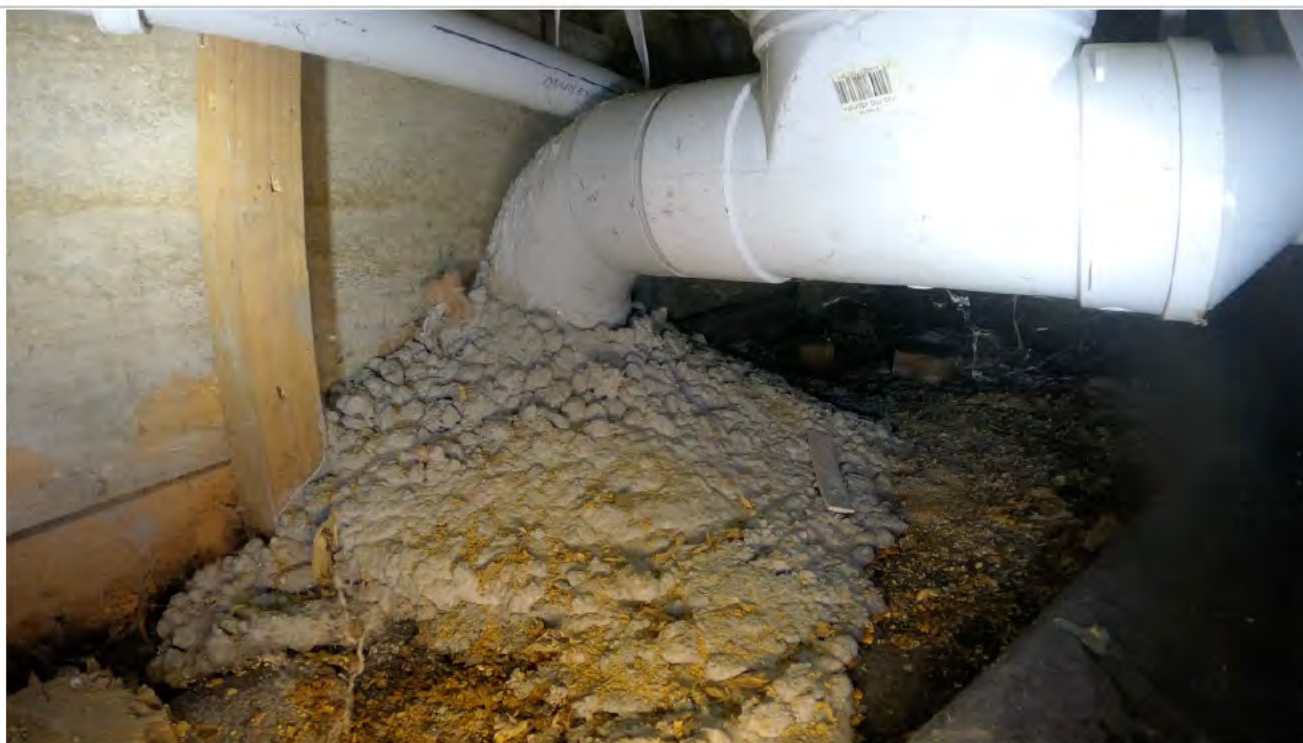
8: View of toilet connection.

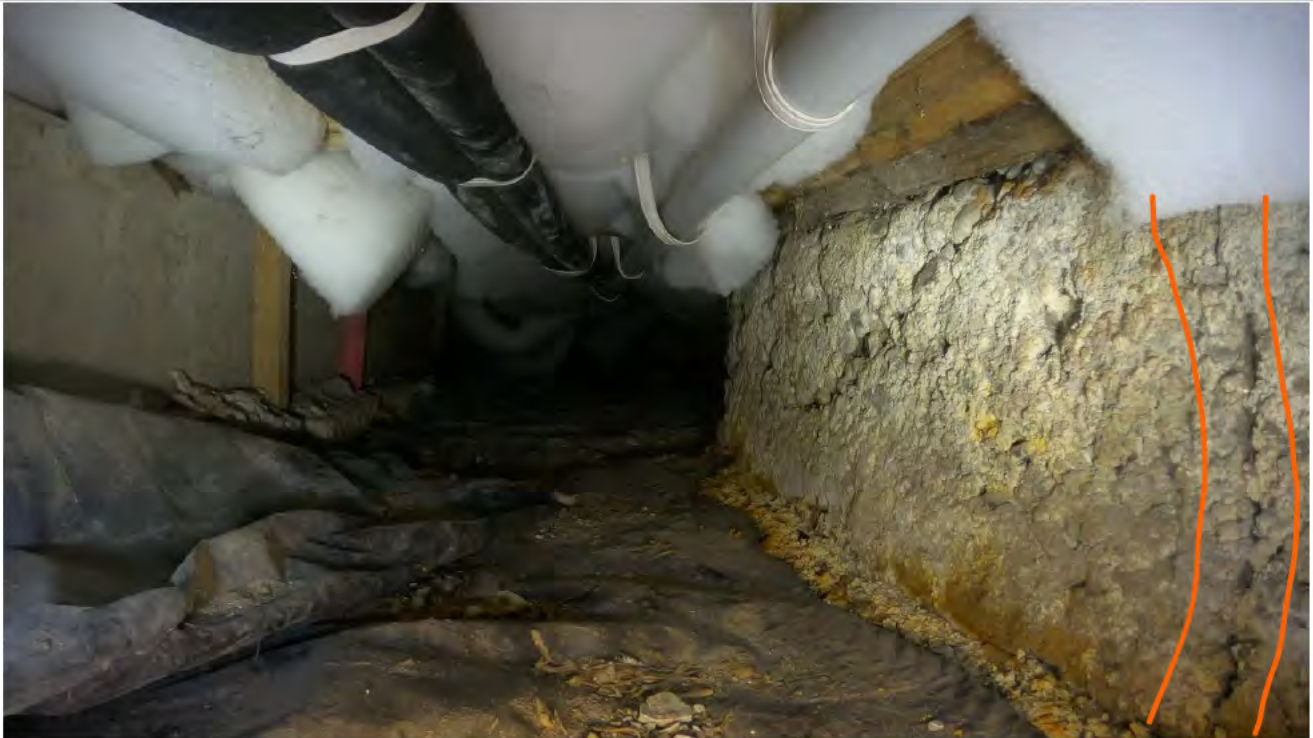
13: View along chimney breast with crack. These cracks are important as the concrete chimney breasts are still holding the load of the flooring and walls.

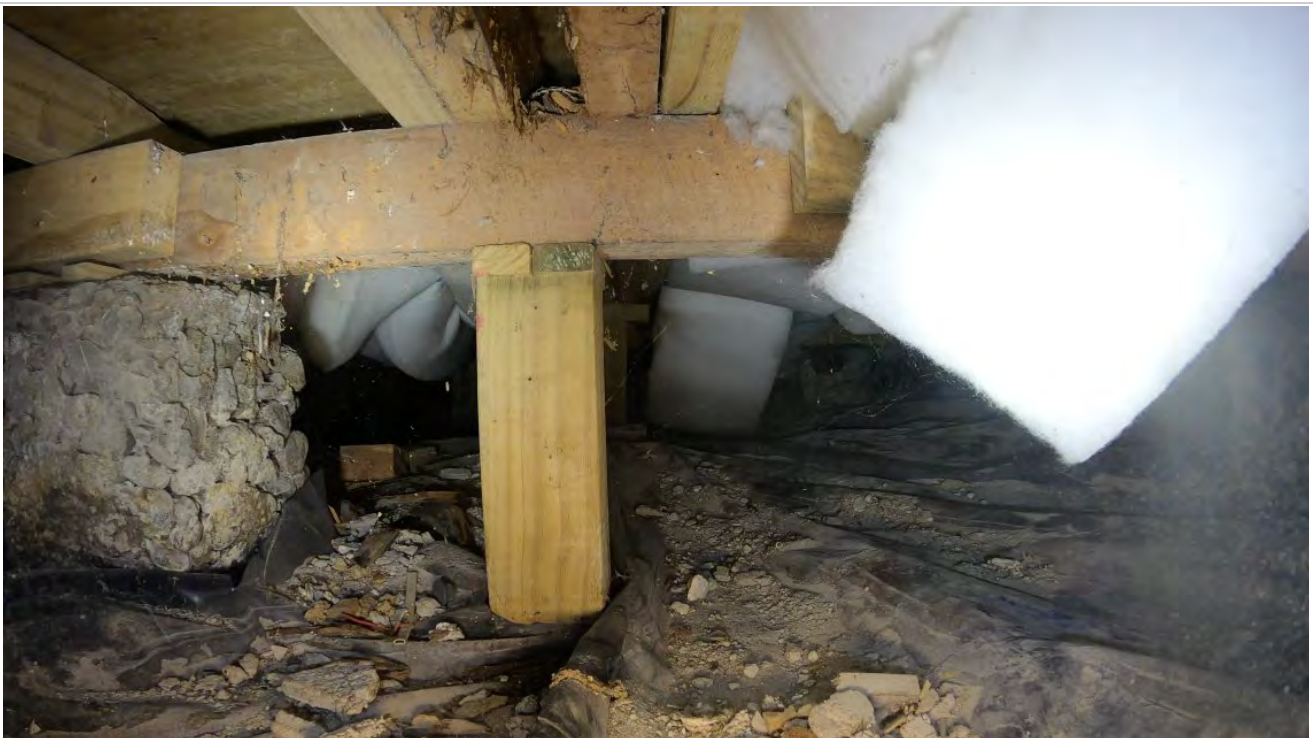
17: Jerry can pile with packing and no connection.

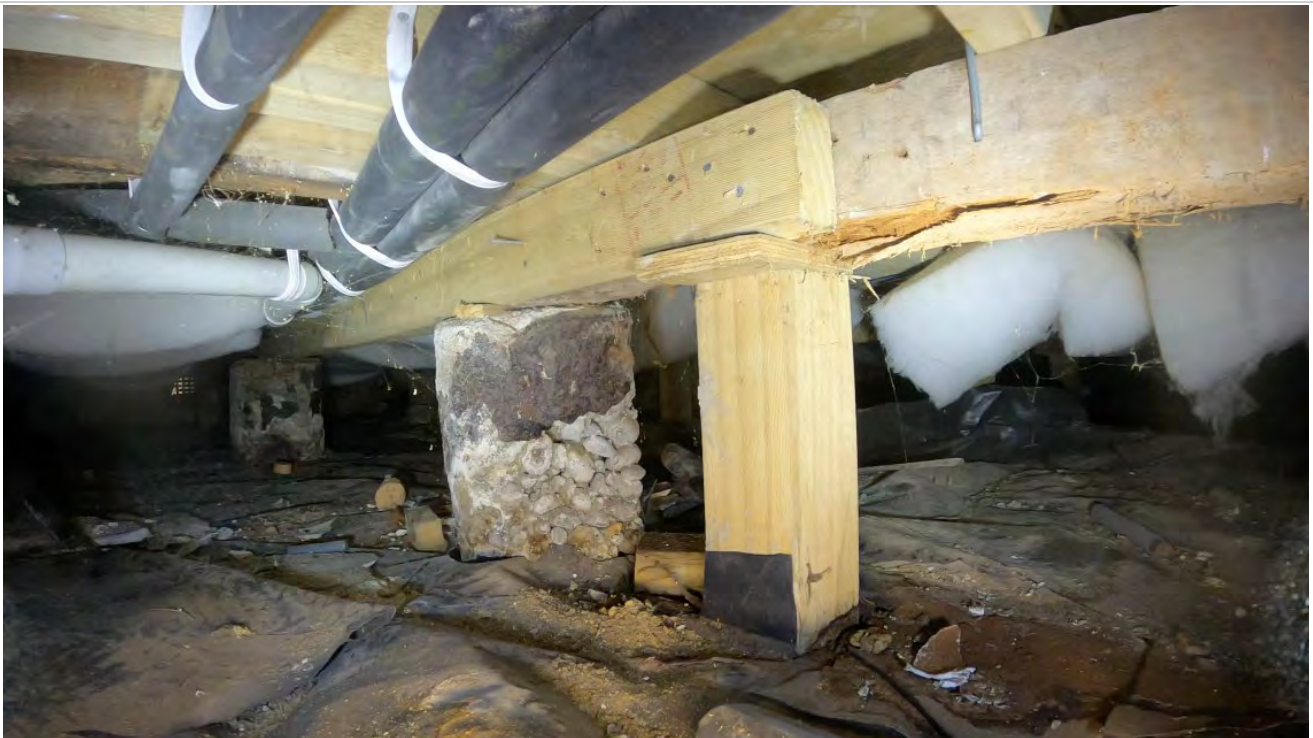
19: There is a new bearer to the right.

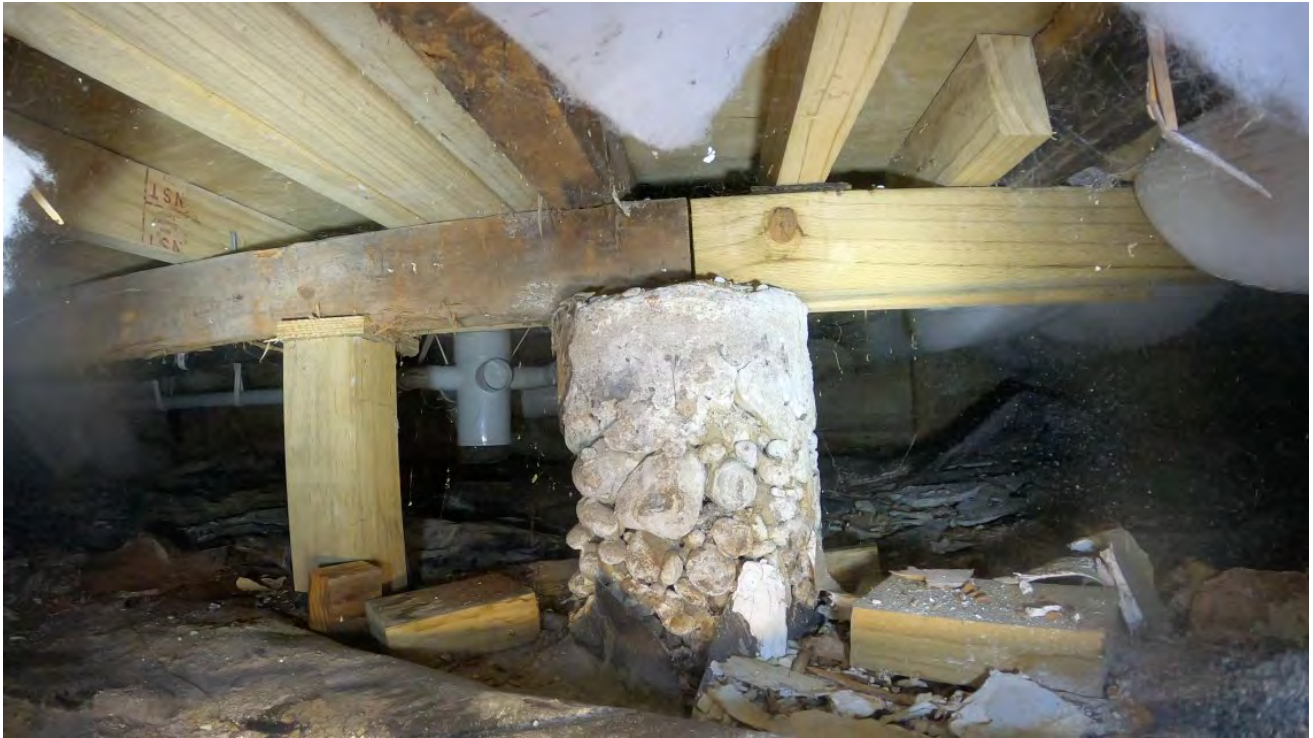
20: Jerry can pile with no connection.

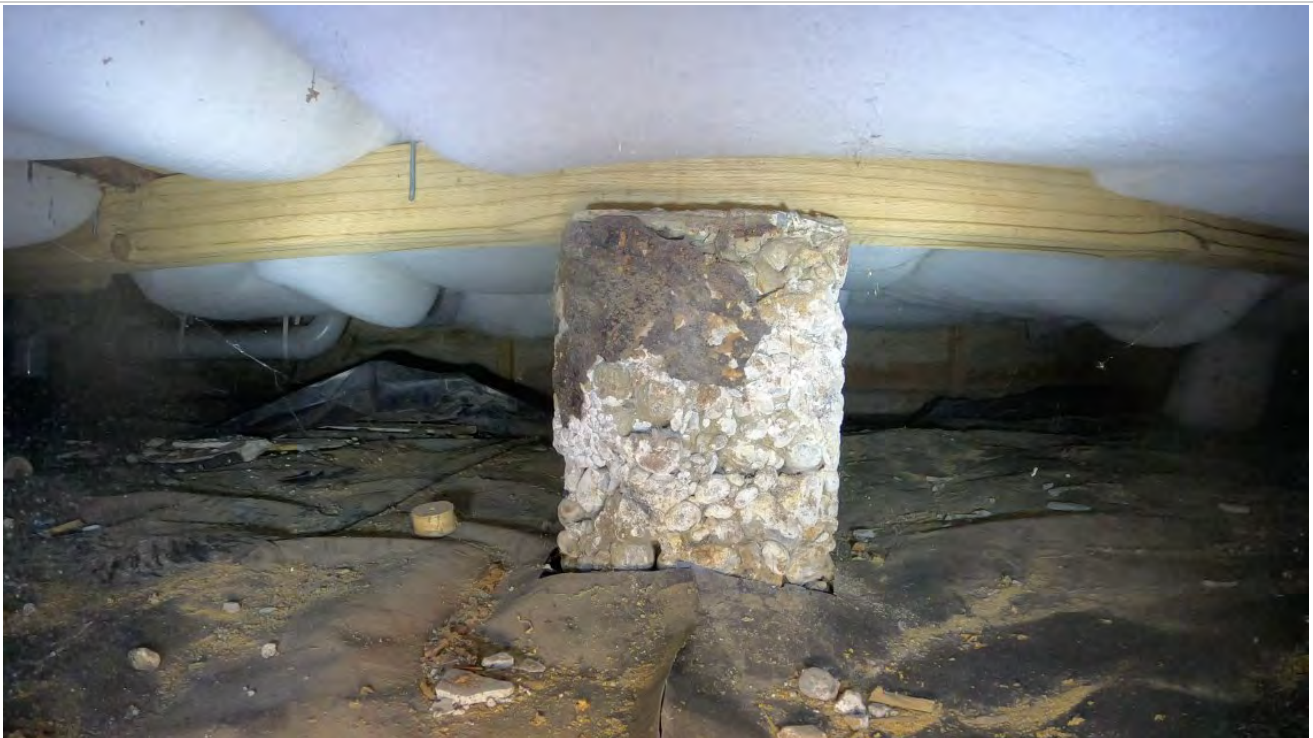
21: Jerry can pile with no connection.

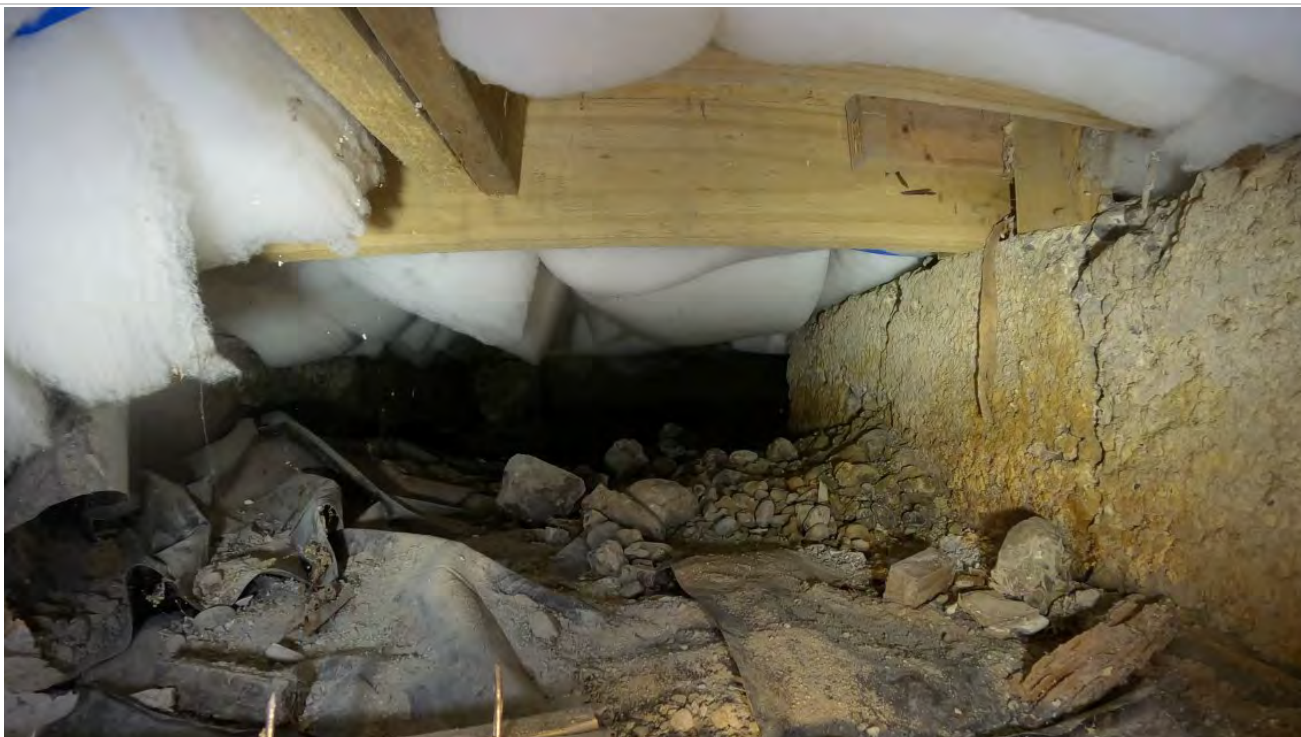
27: View of ring foundation.

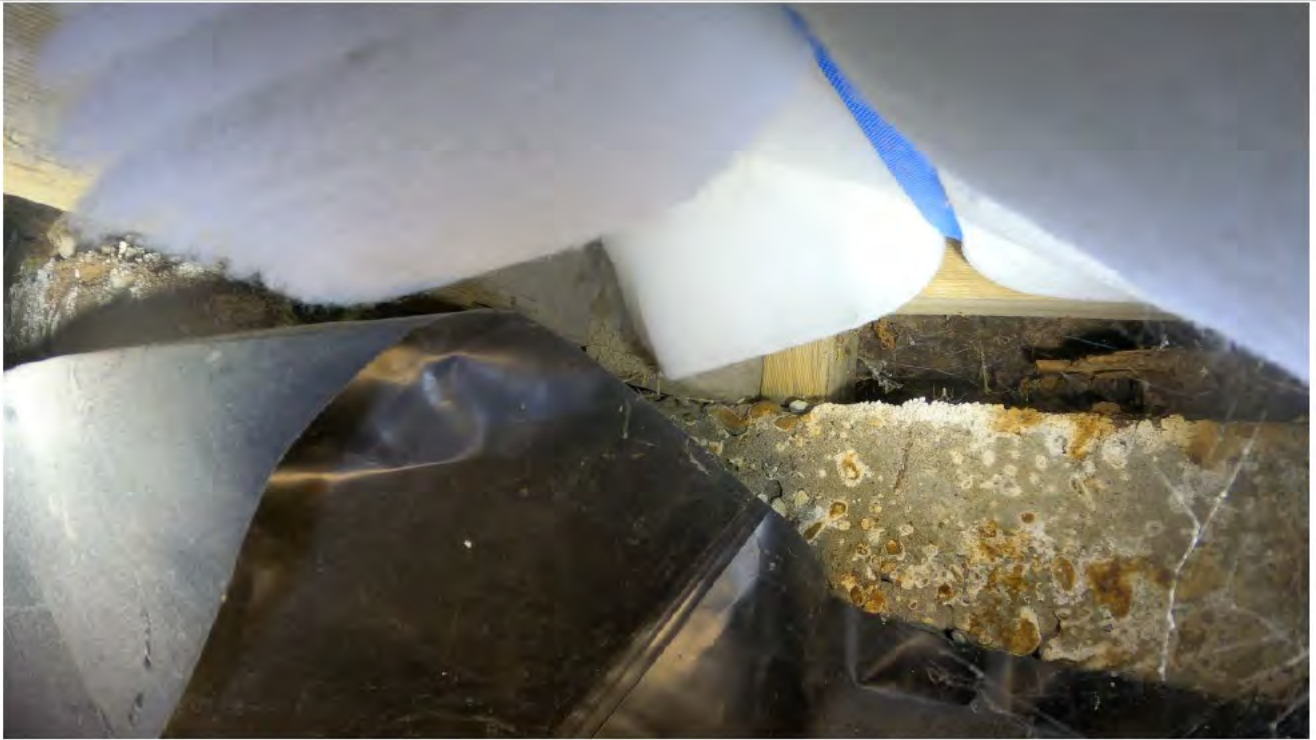
30: View of the chimney breast with cracking.

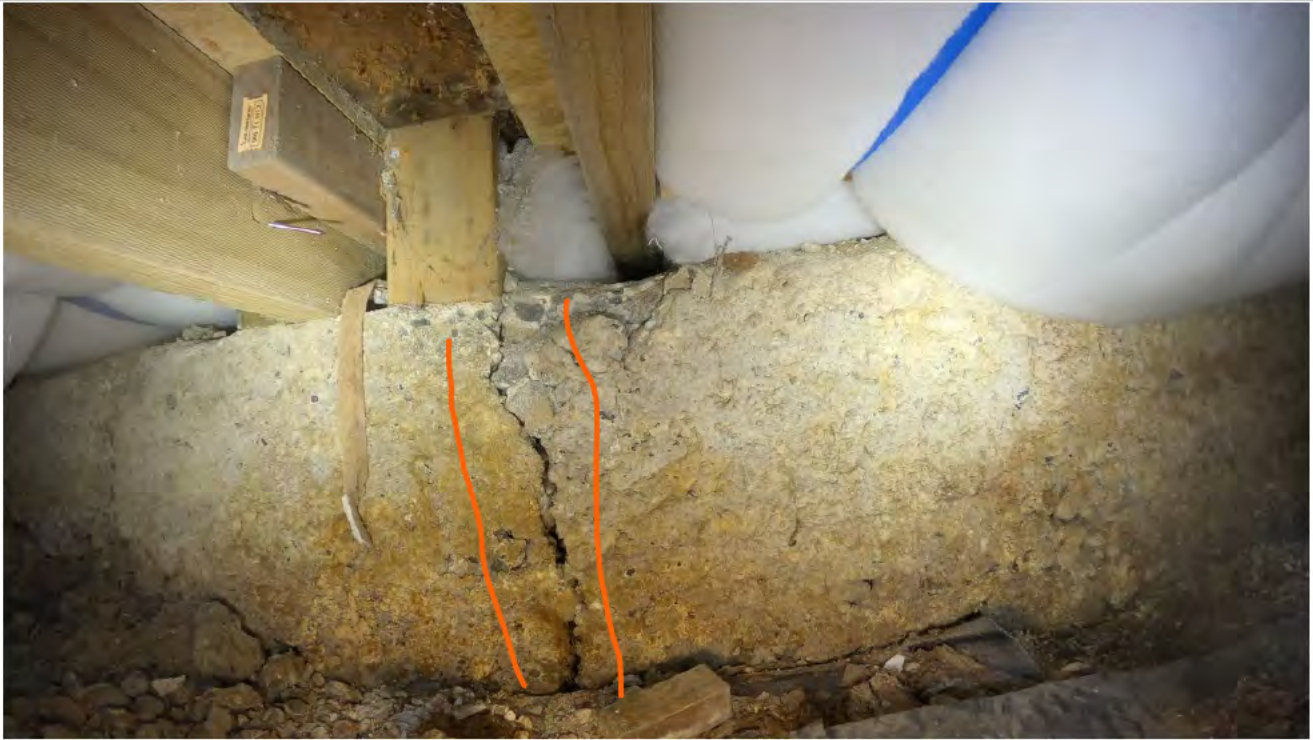
32: View of prop.

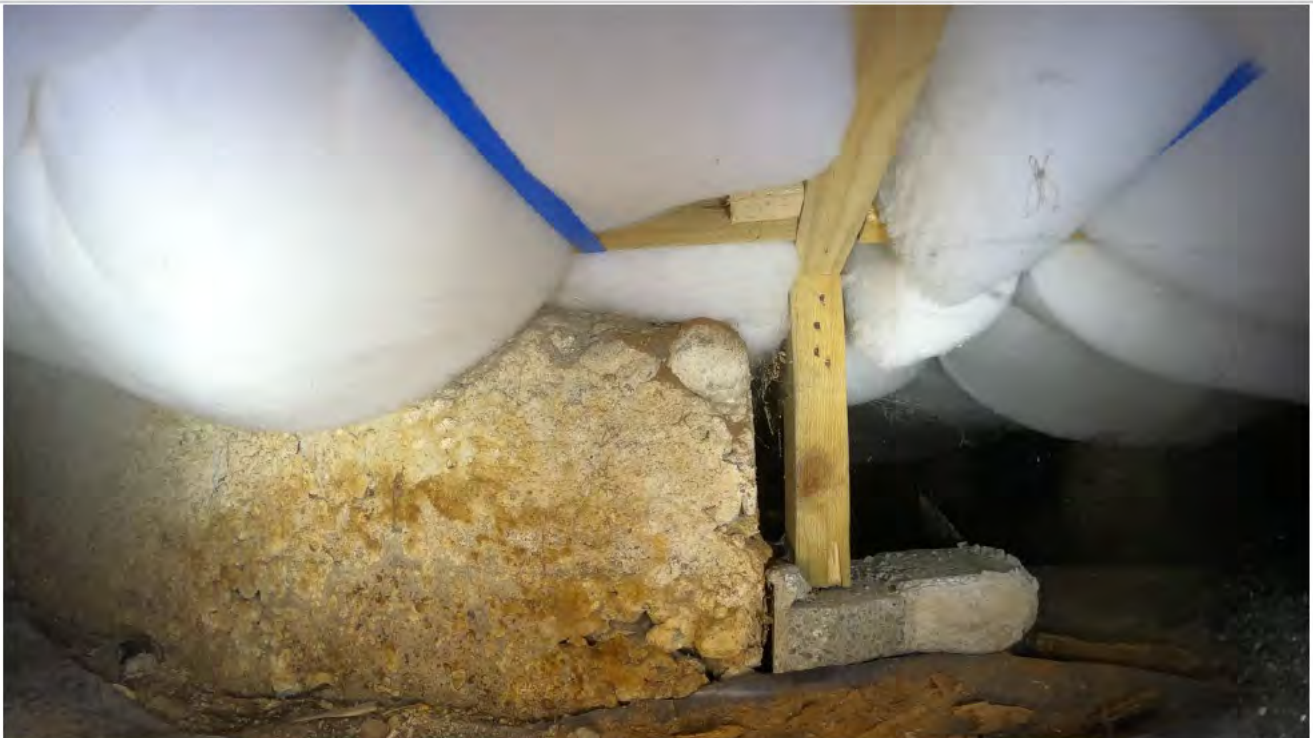
33: The prop is supporting a form of bearer which in turn is supporting the framing.
