EQC CLAIM DOCUMENTATION

EARTHQUAKE RECOVERY (EQR) DOCUMENTATION

Released under the Official Information Act 1982
EQR Property Overview Report

EQC Property ID	Property Address	Vulnerable?	Property F Status	Property Finalisation Indicator		
2010061240	41 MACKENZIE AVENUE, WOOLSTON		F3 - Complete & Finalised	Some Finalisation has taken place		
Main Contractor:	CLOSED OUT-S.K. Hand Builders Limited ***** (SC30)		Property F2'd By:	Blair Jones	F2 Completed Date:	20-06-2016
Cont Managing Hub:	Ensors	Not Vulnerable	Property F3'd By:	Blair Jones	F3 Completed Date:	20-06-2016

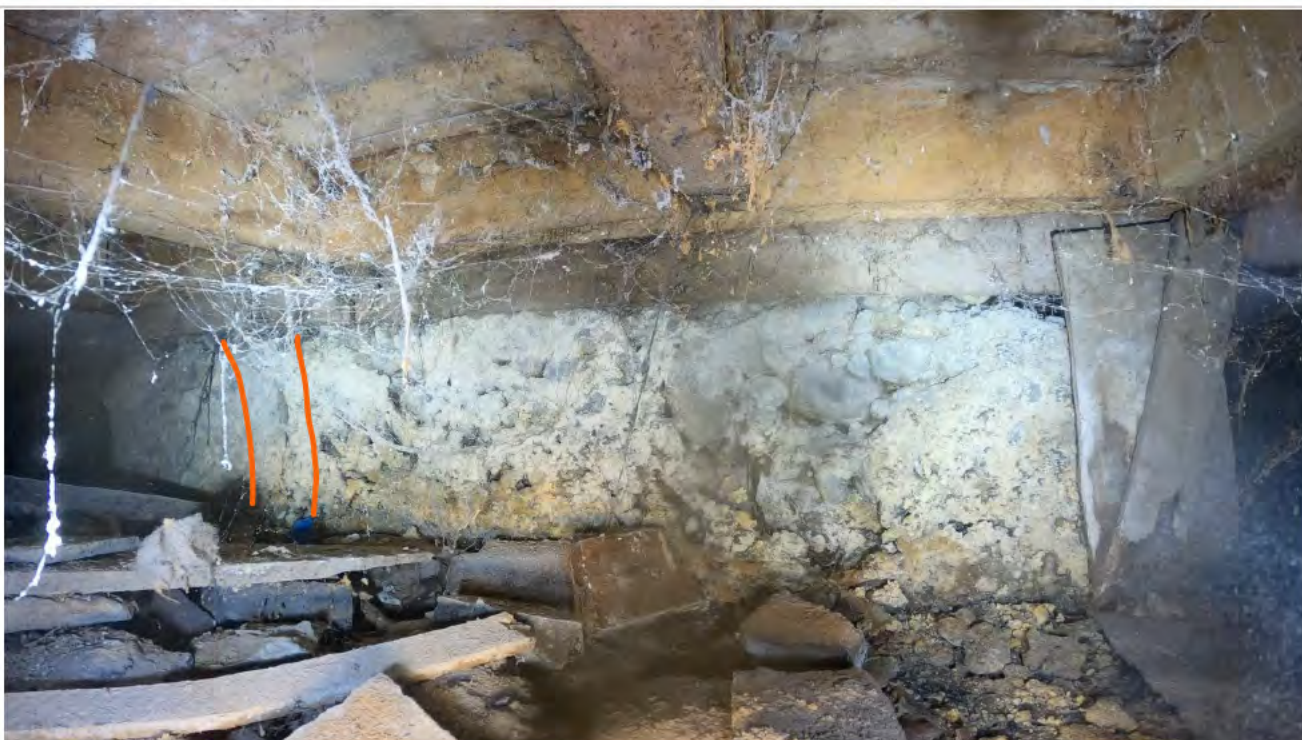
43: Jerry can pile with no connection.

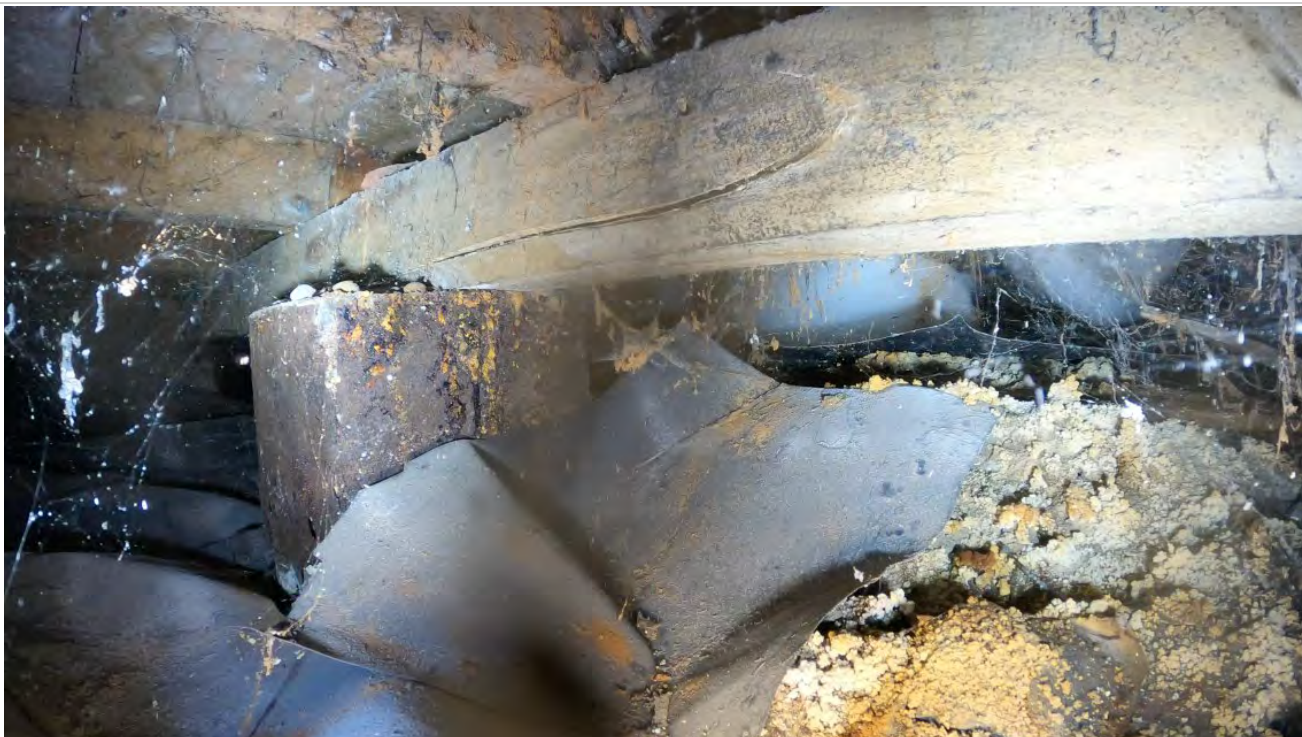
44: Jerry can pile with no connection.

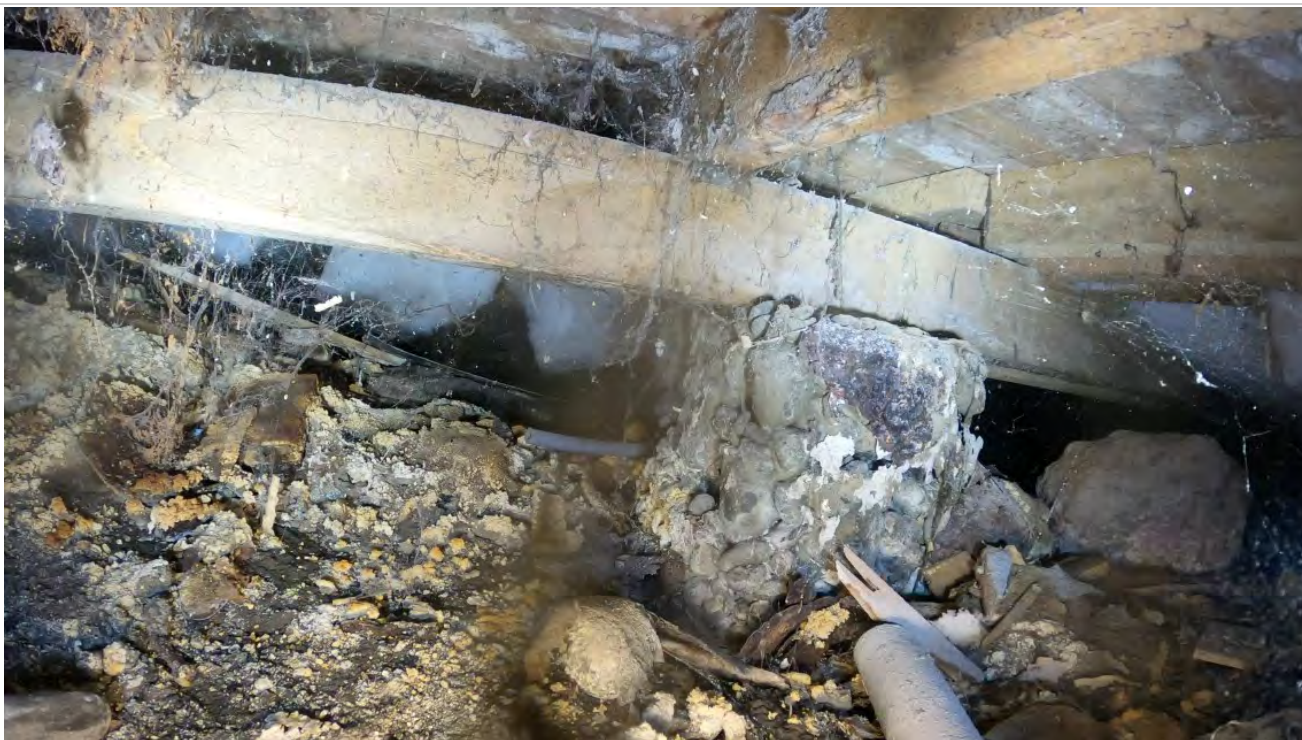
45: Jerry can pile with no connection.

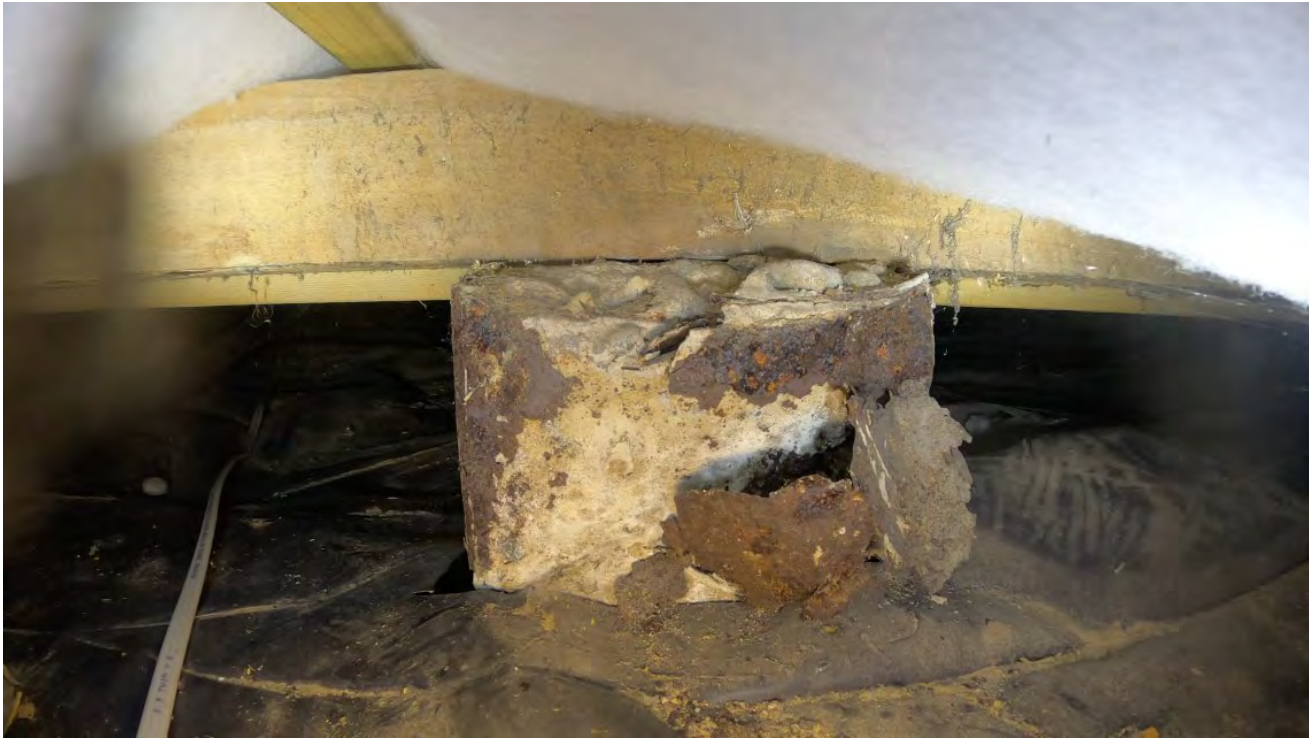
46: New concrete piles have been cast down this end of the home to support the bearers. No dampcourse has been used and no fixings are evident.

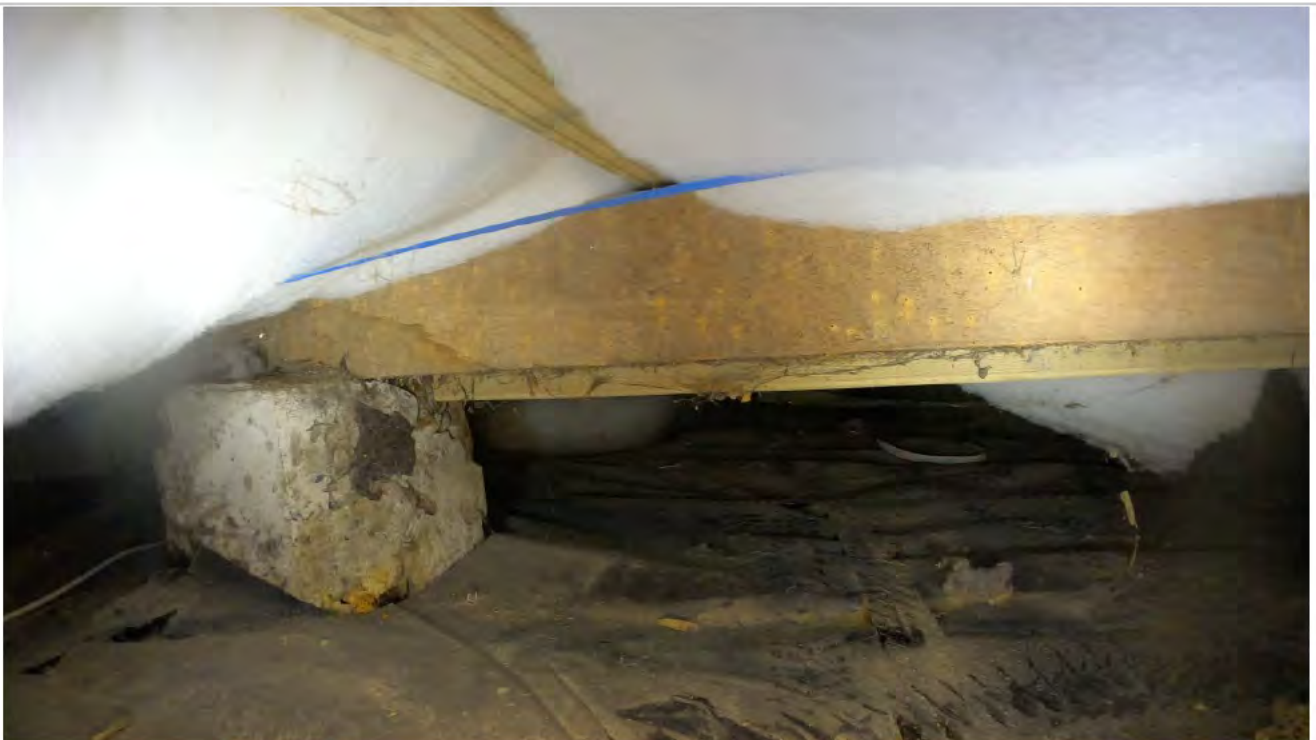
48: Jerry can pile with no connection. This bearer has extensive borer.

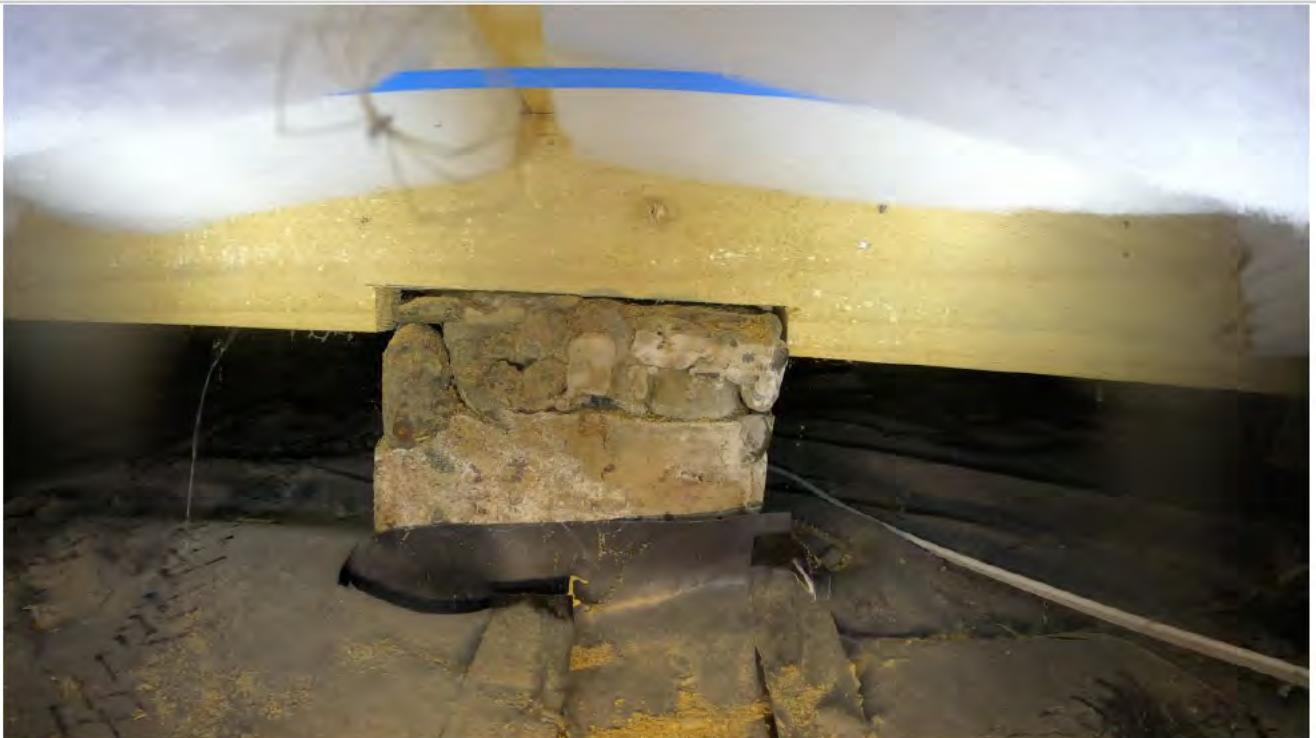
50: The bearer has been clashed on one side. The old bearer should have been removed.

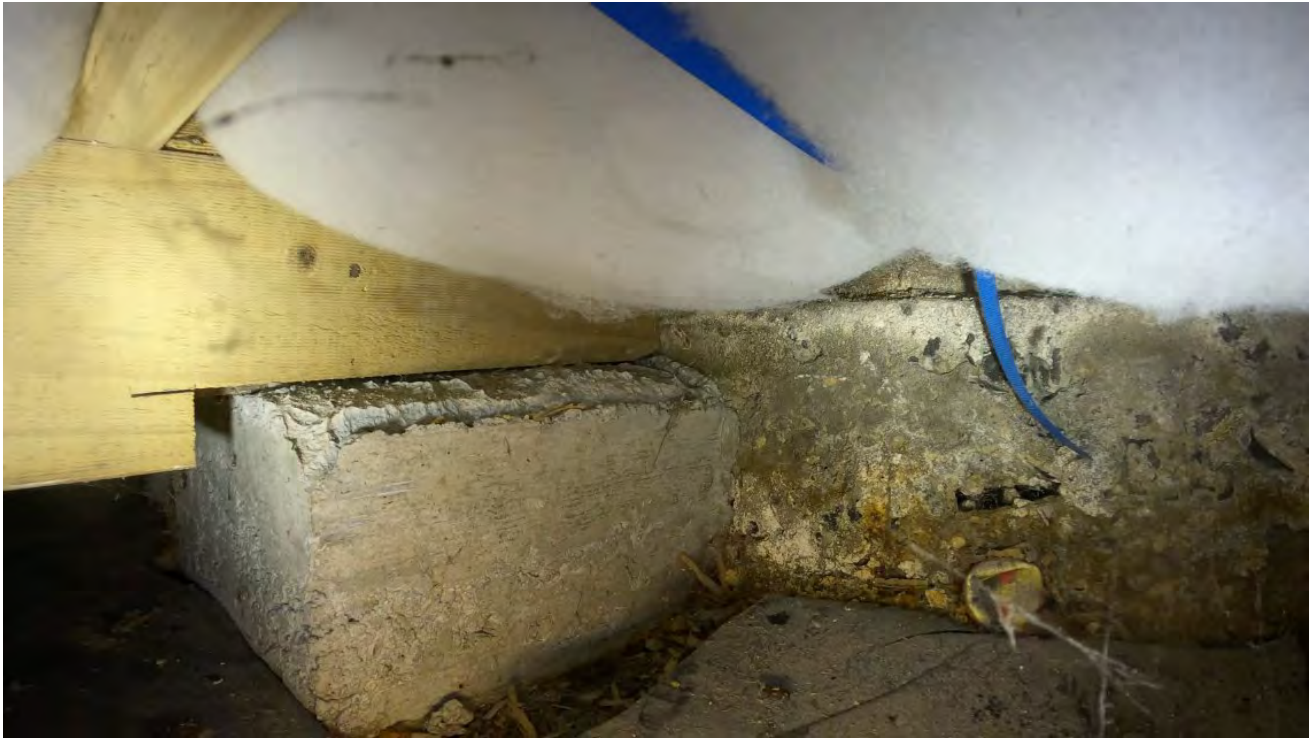
51: View of ring foundation pile.

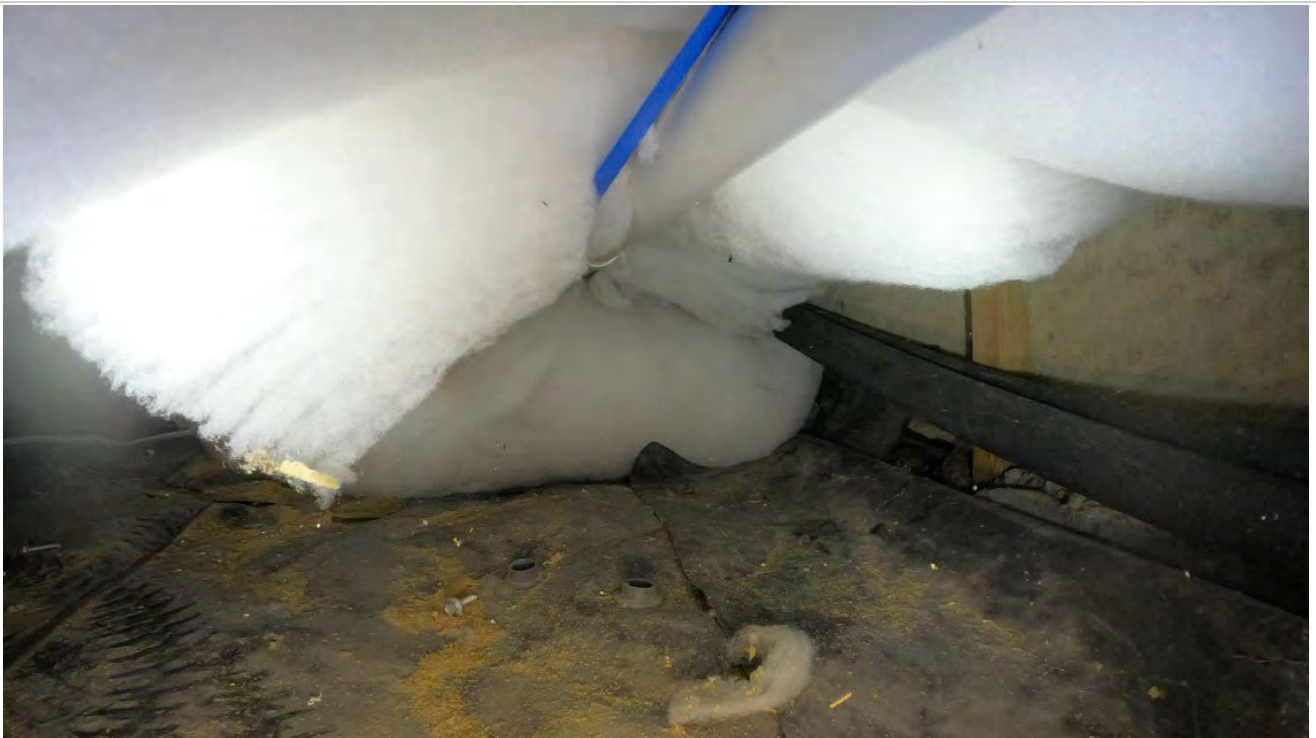
52: We could get into this area.

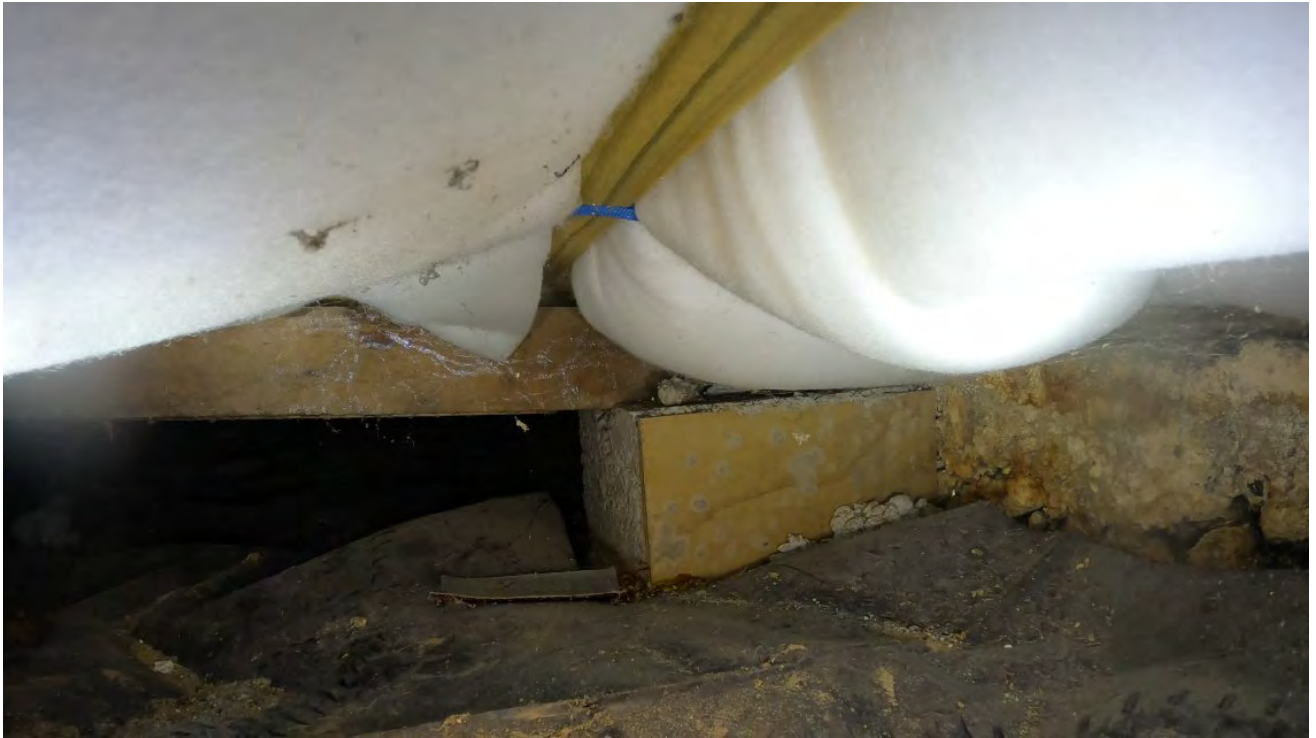
53: View of ring foundation pile.

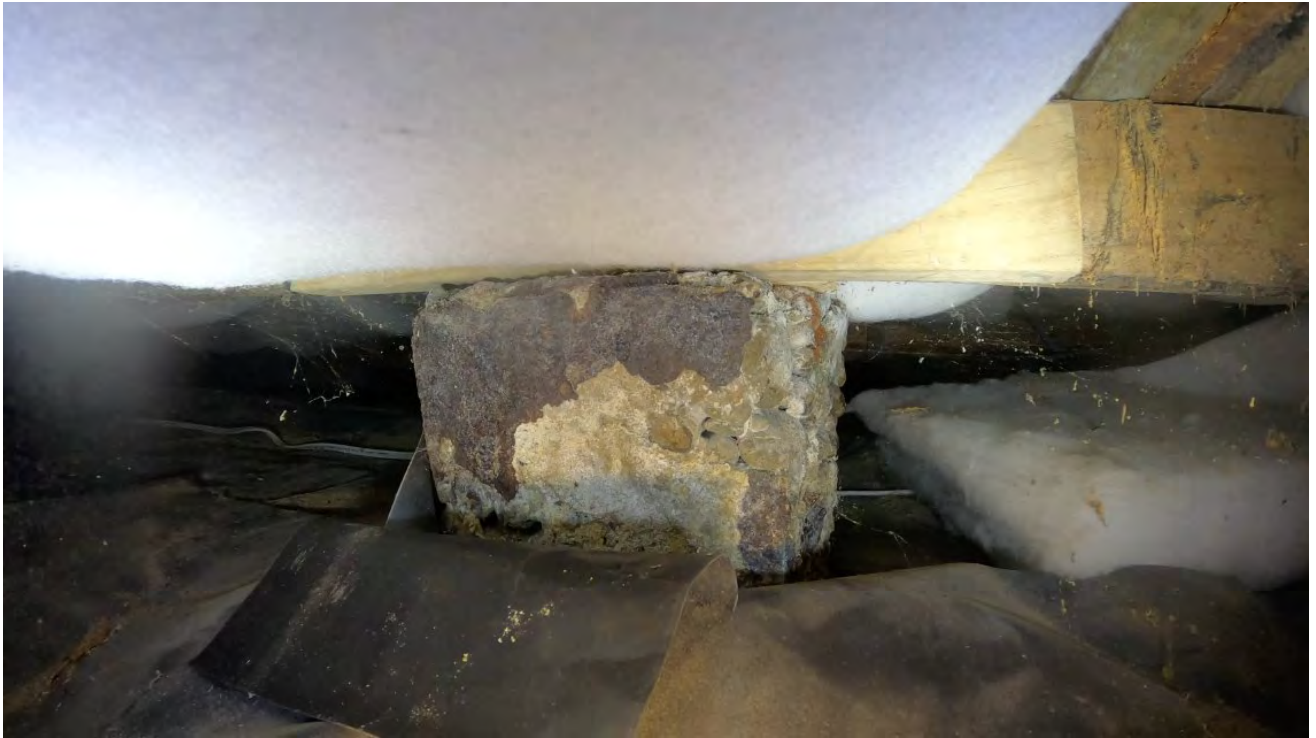
57: Jerry can pile with no connection.

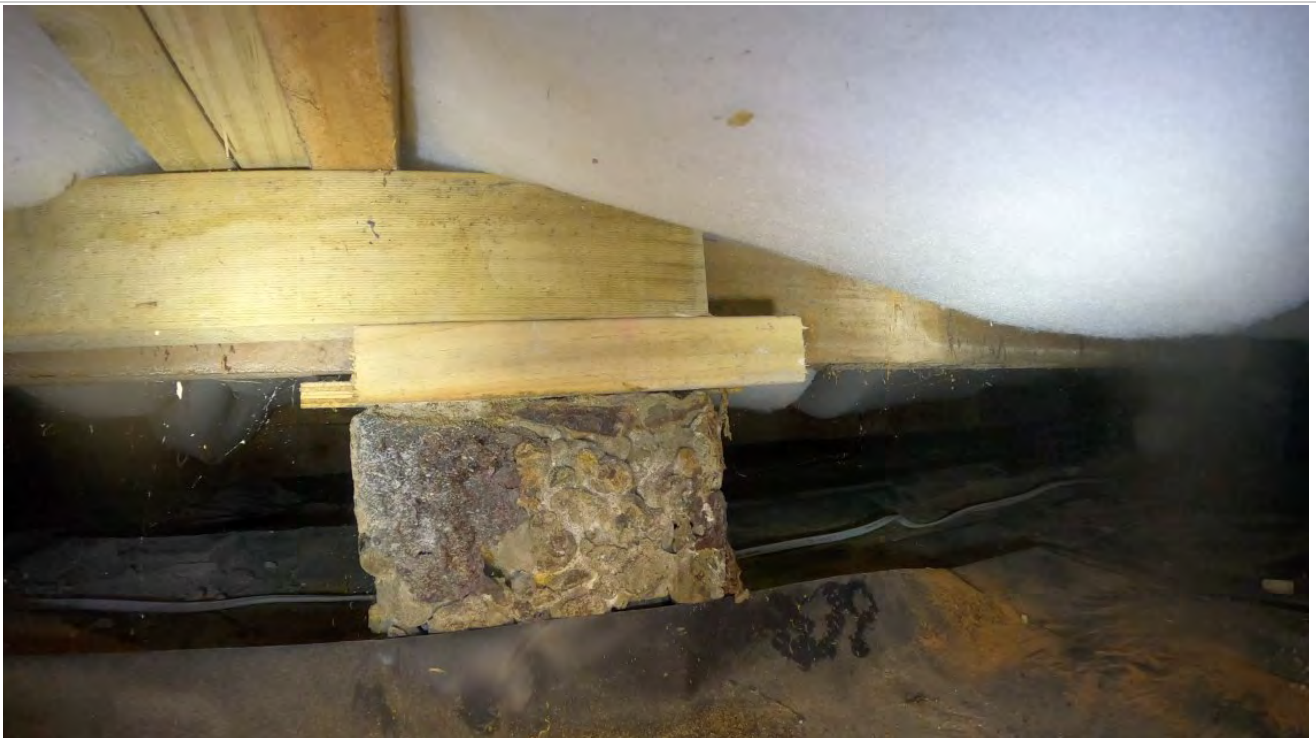
58: Jerry can pile with packing and no connection.

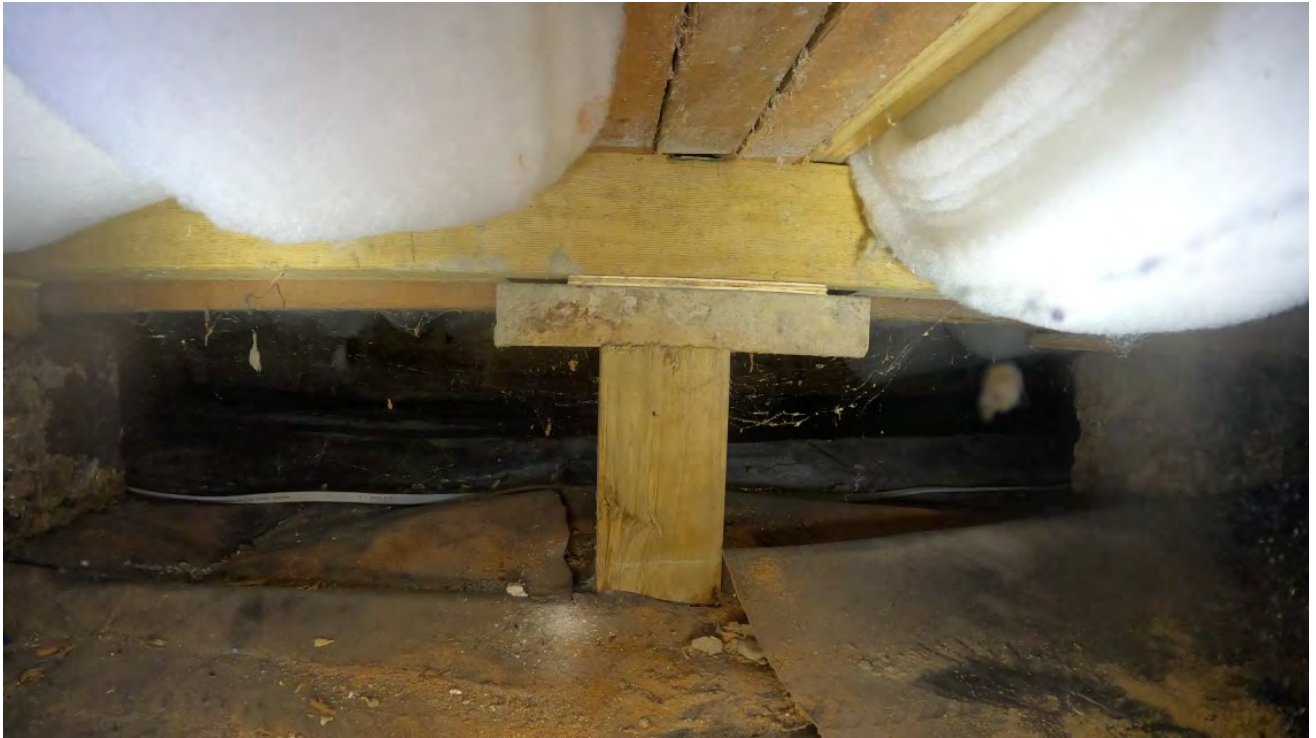
59: View of propping.

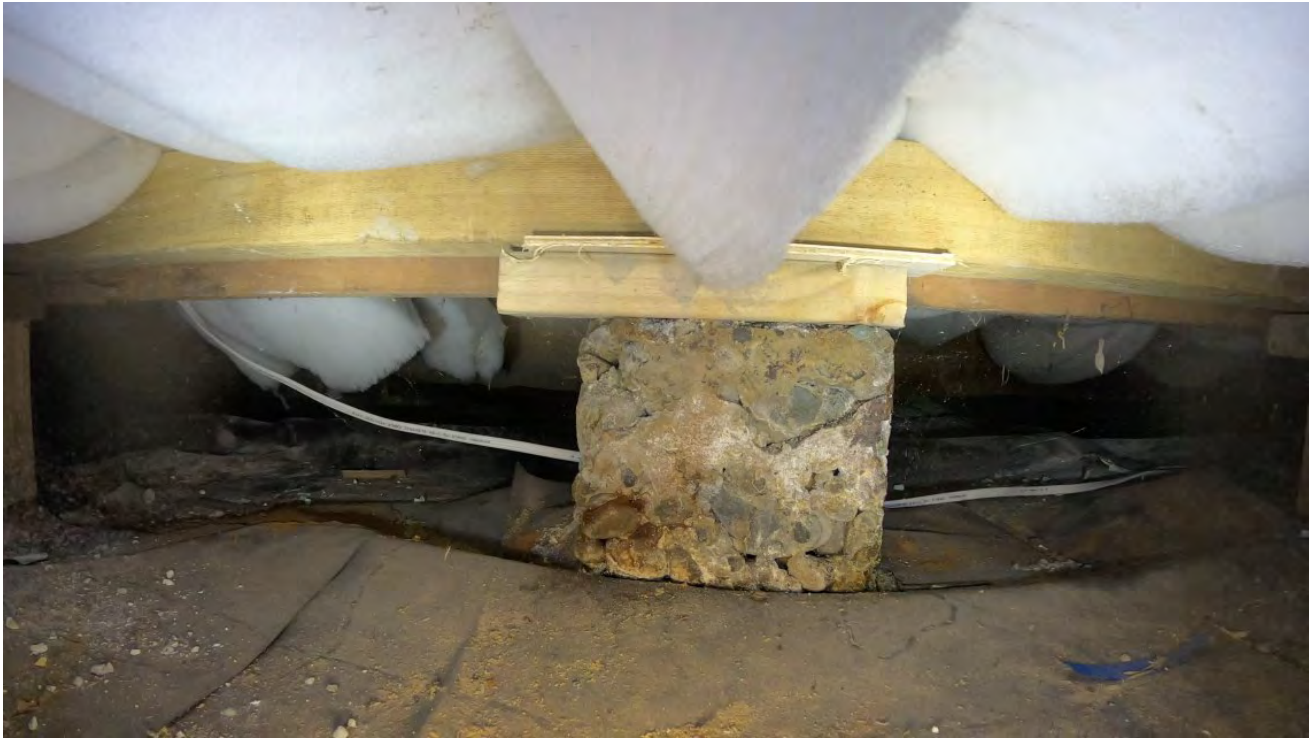
61: Jerry can pile with packing and no connection.

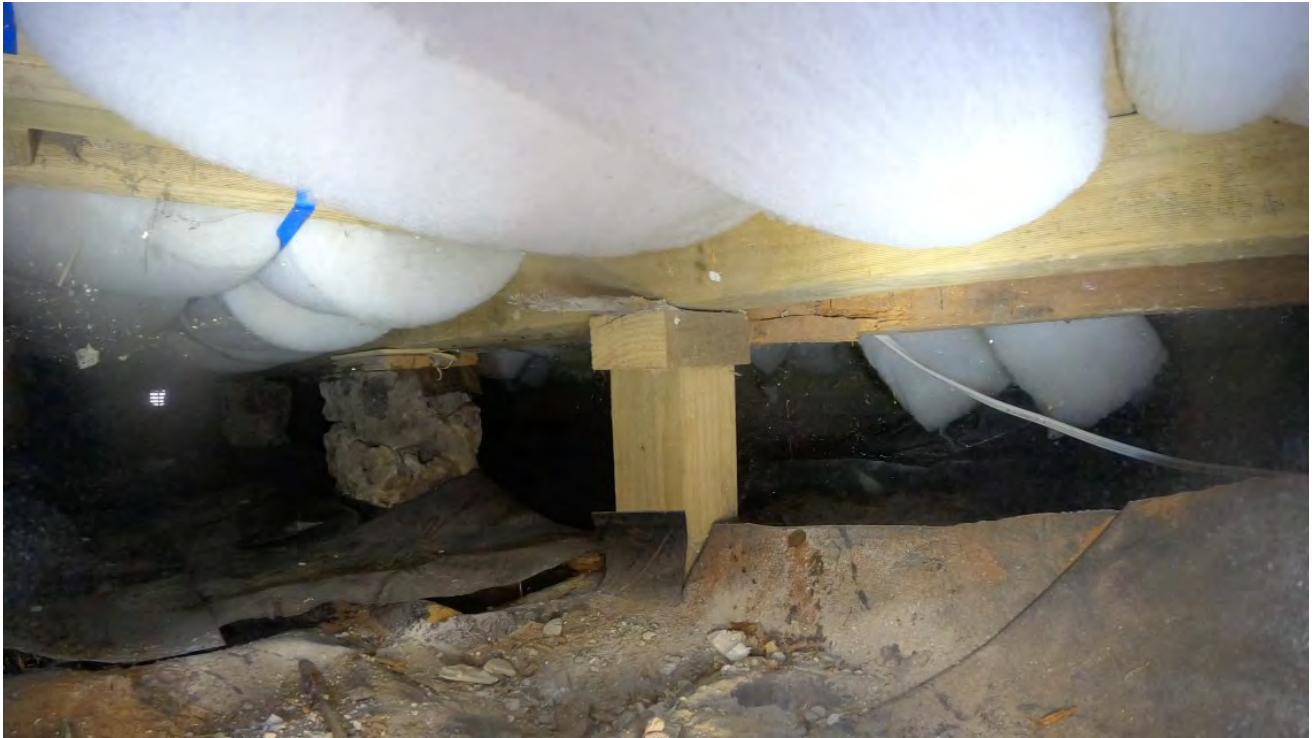
63: View of propping.

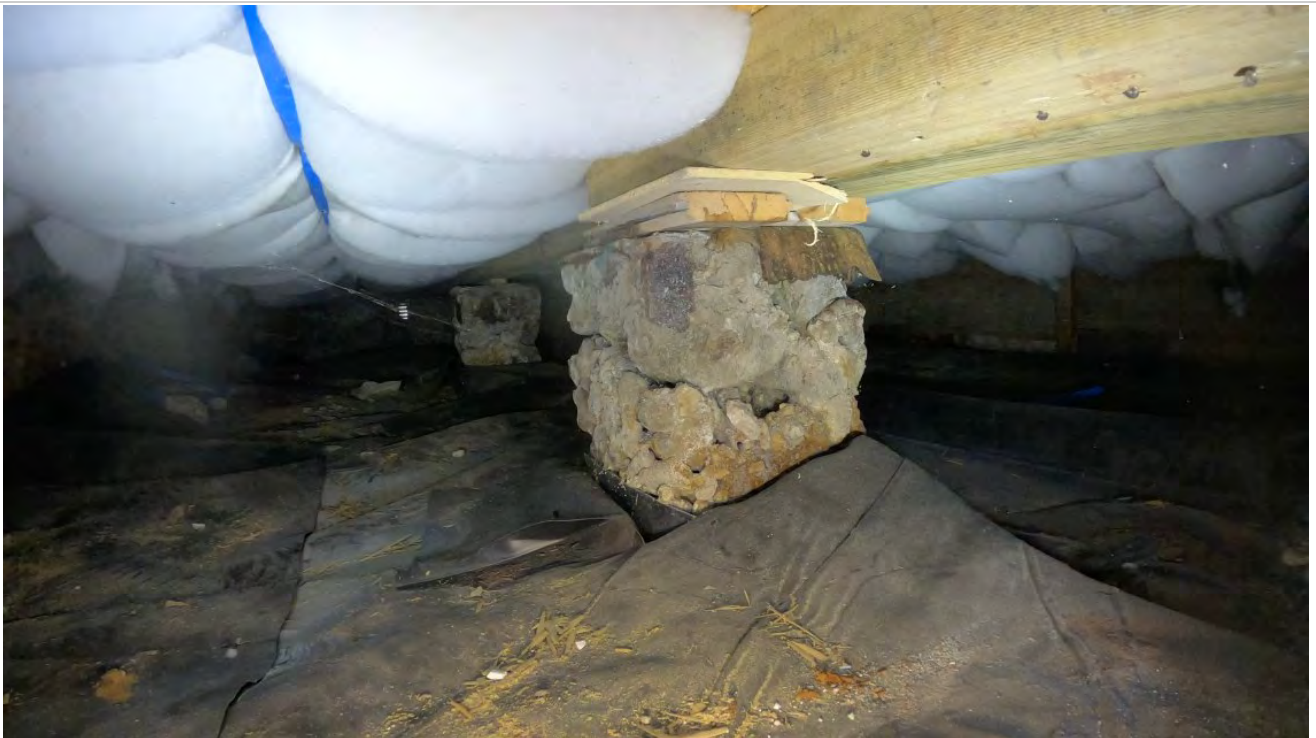
64: Jerry can pile with packing and no connection.

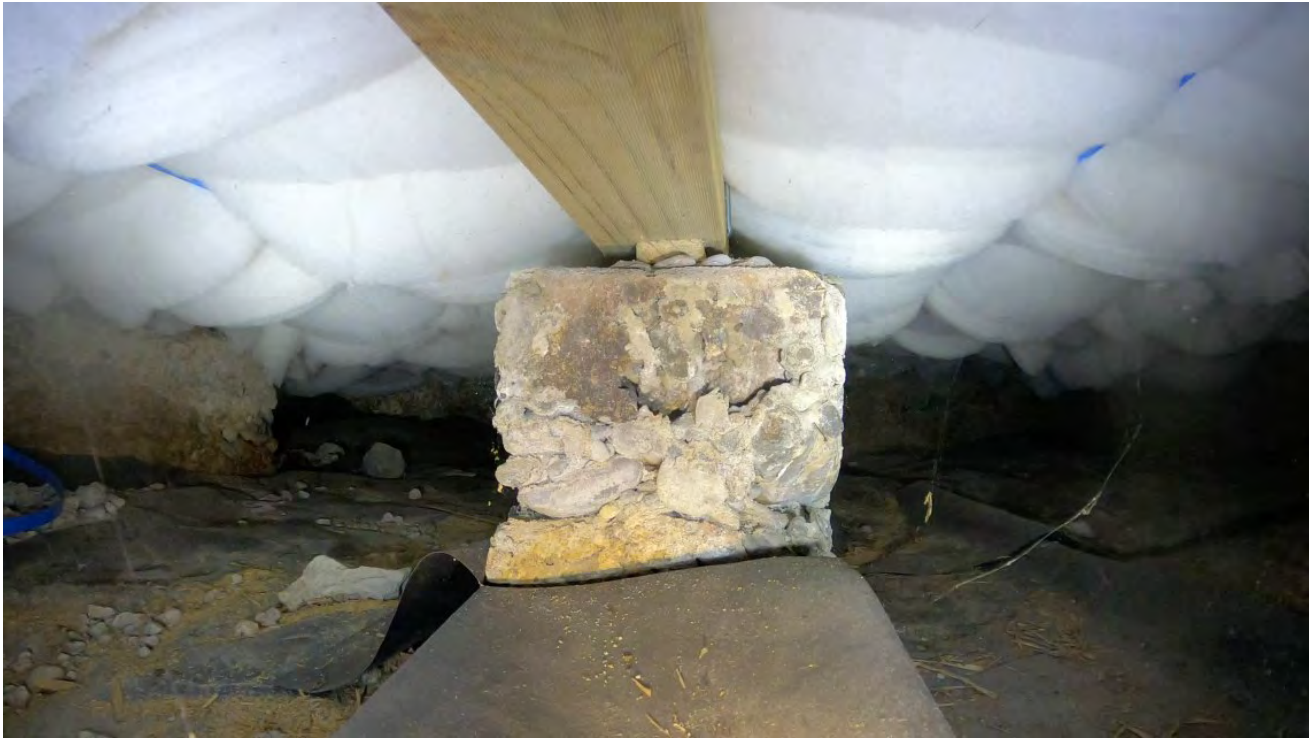
65: Jerry can pile with packing and no connection.

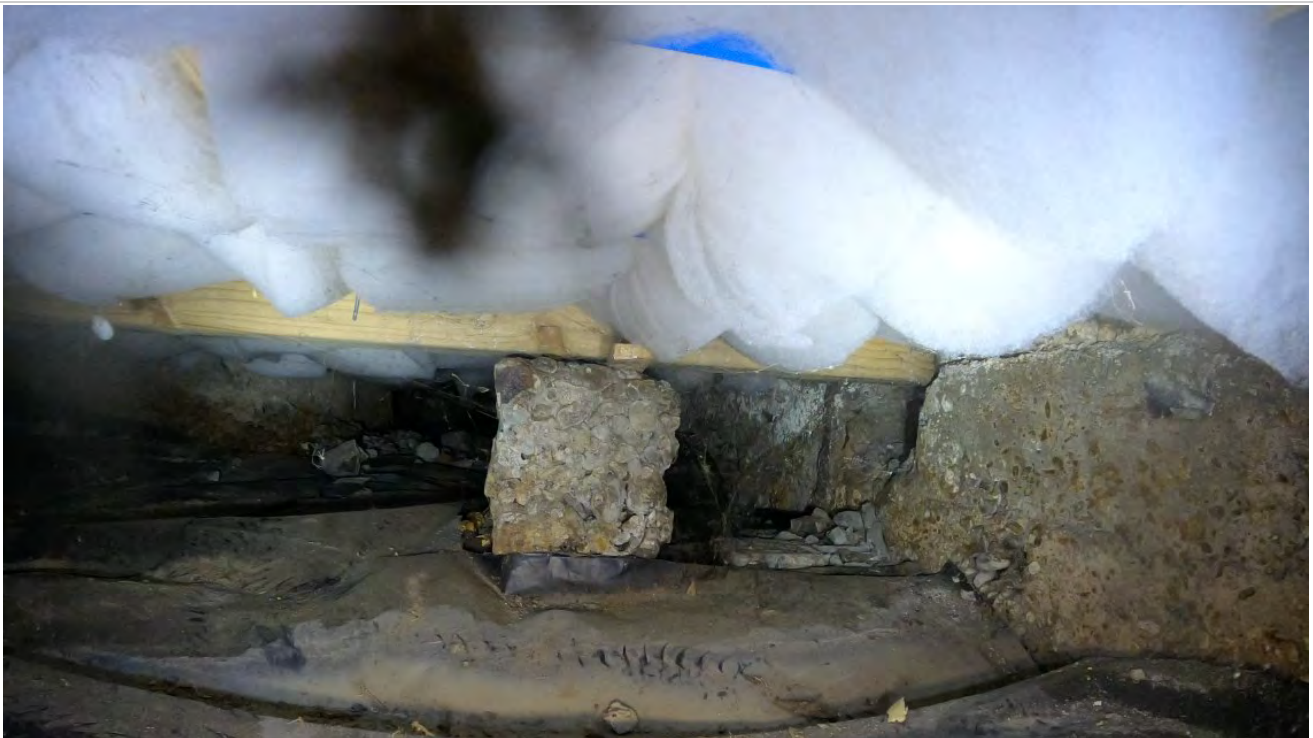
66: Jerry can pile with packing and no connection.

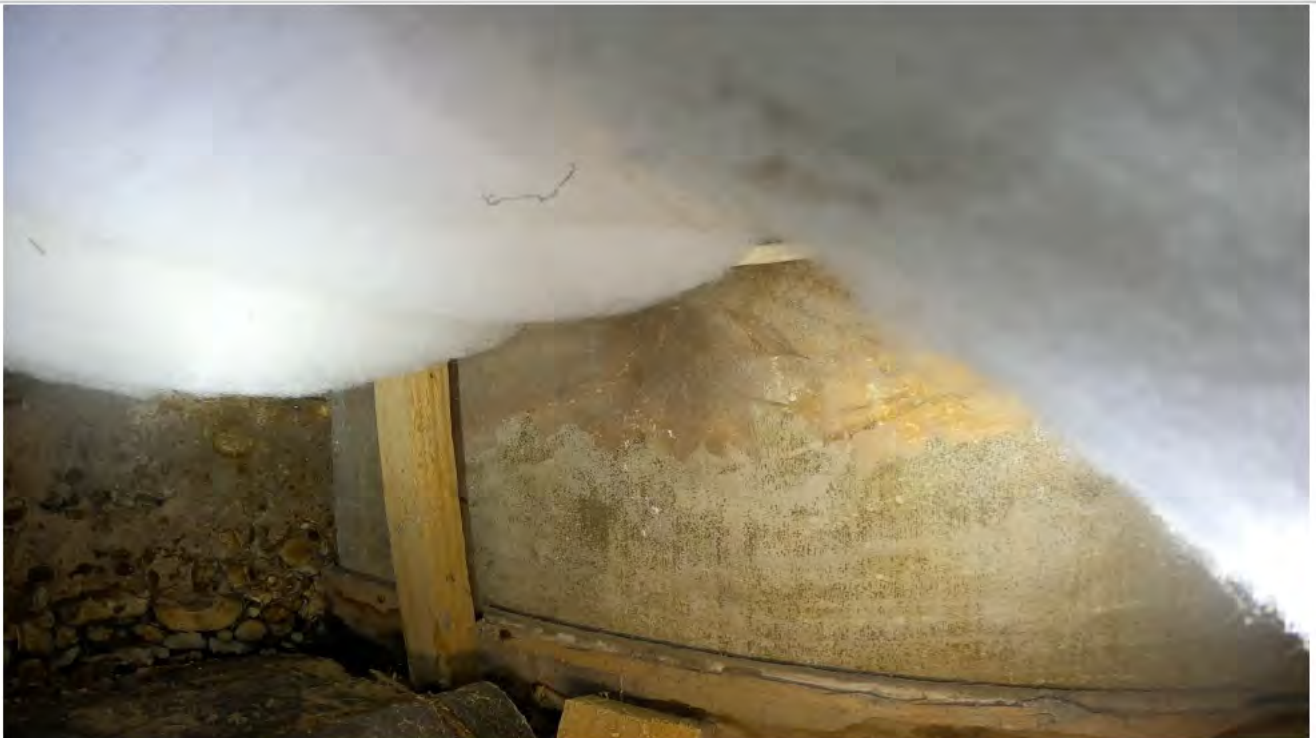
68: Here again, we see new concrete foundations but with the boxing left on.

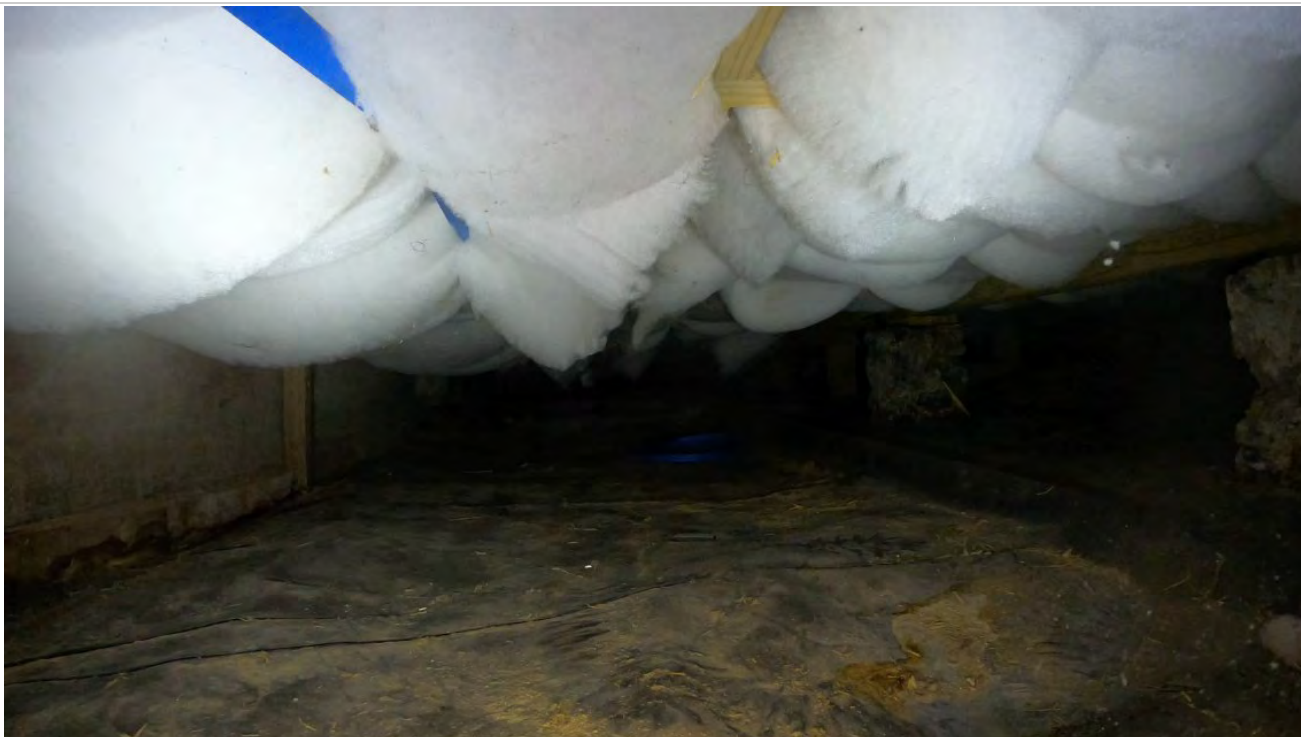
69: All the vents are blocked along this side too.

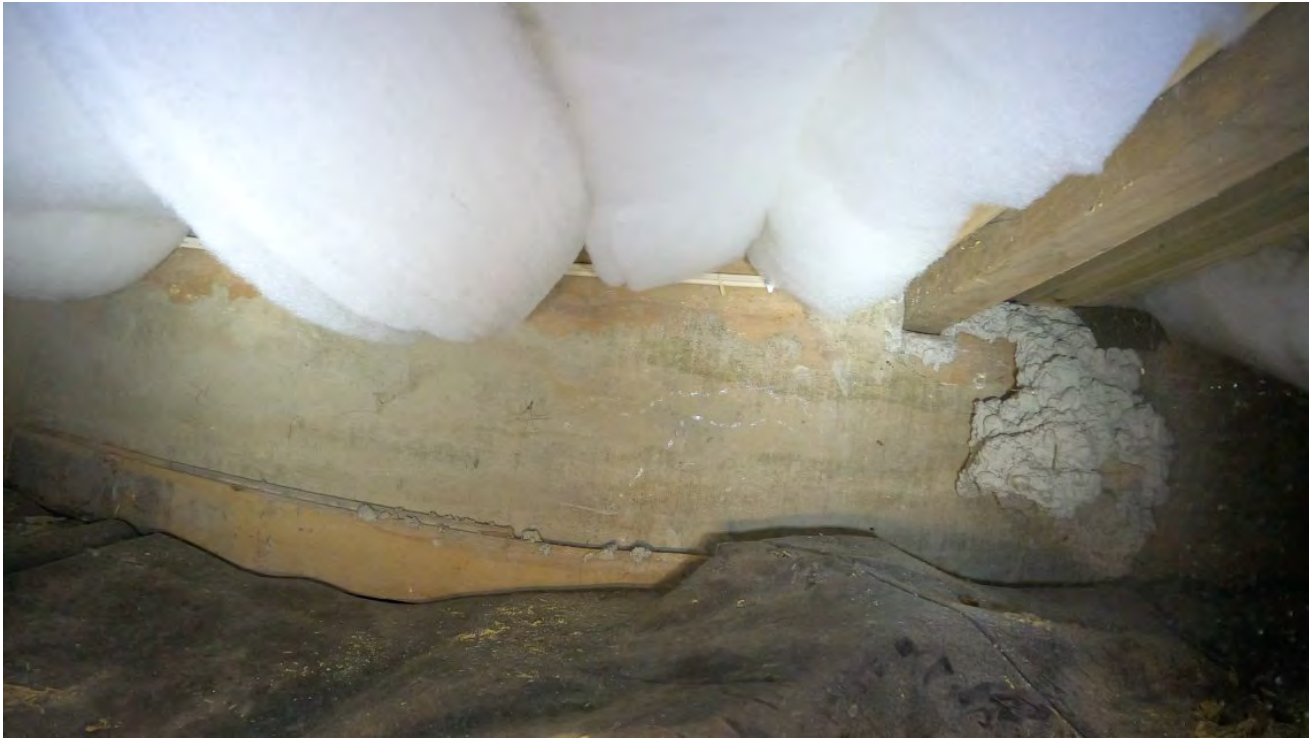
71: View of foundation.

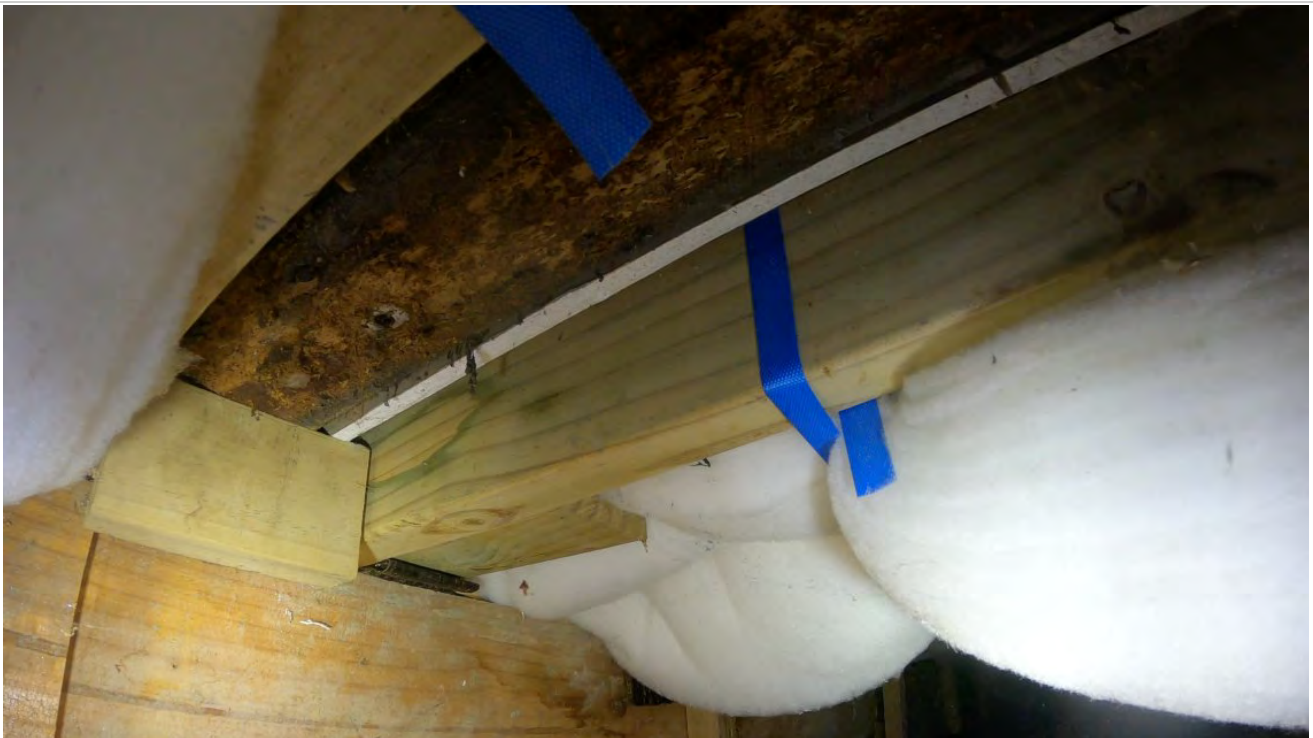
72: Here we see a rotten bearer.

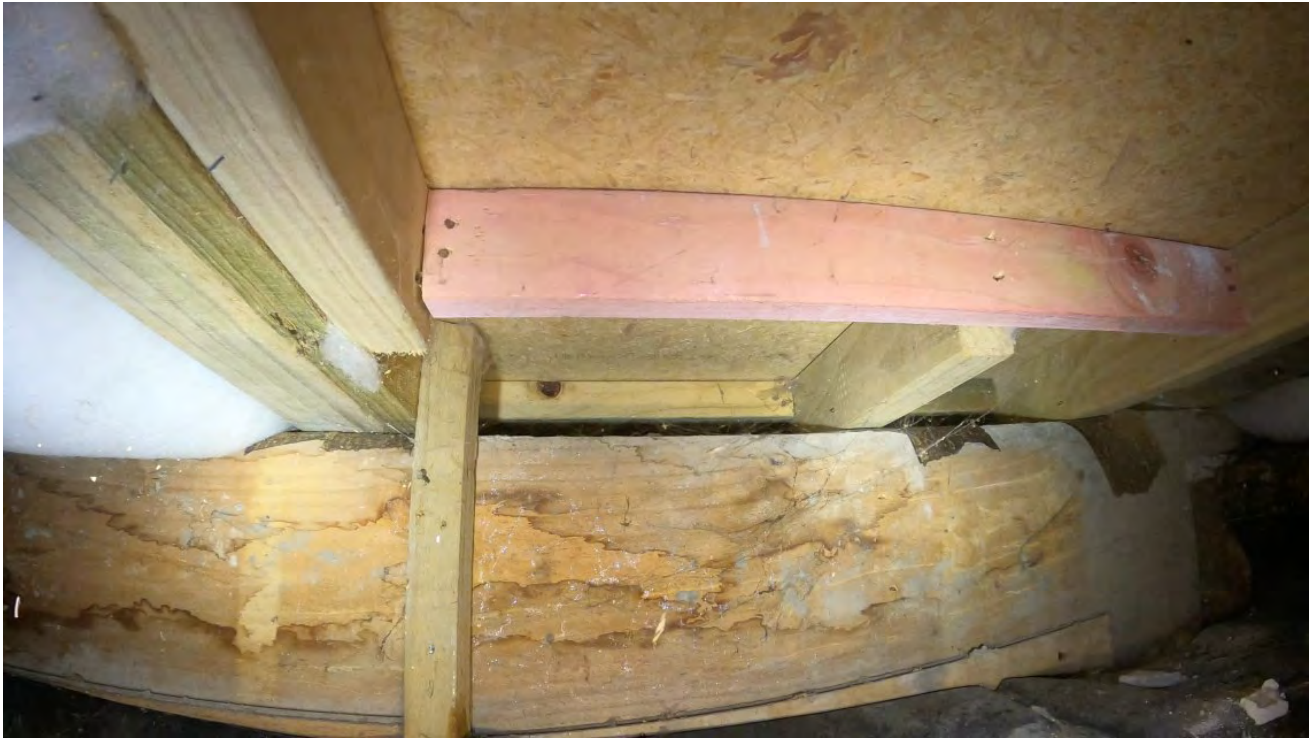
73: More use of H1.2 treated timber and particle board flooring.

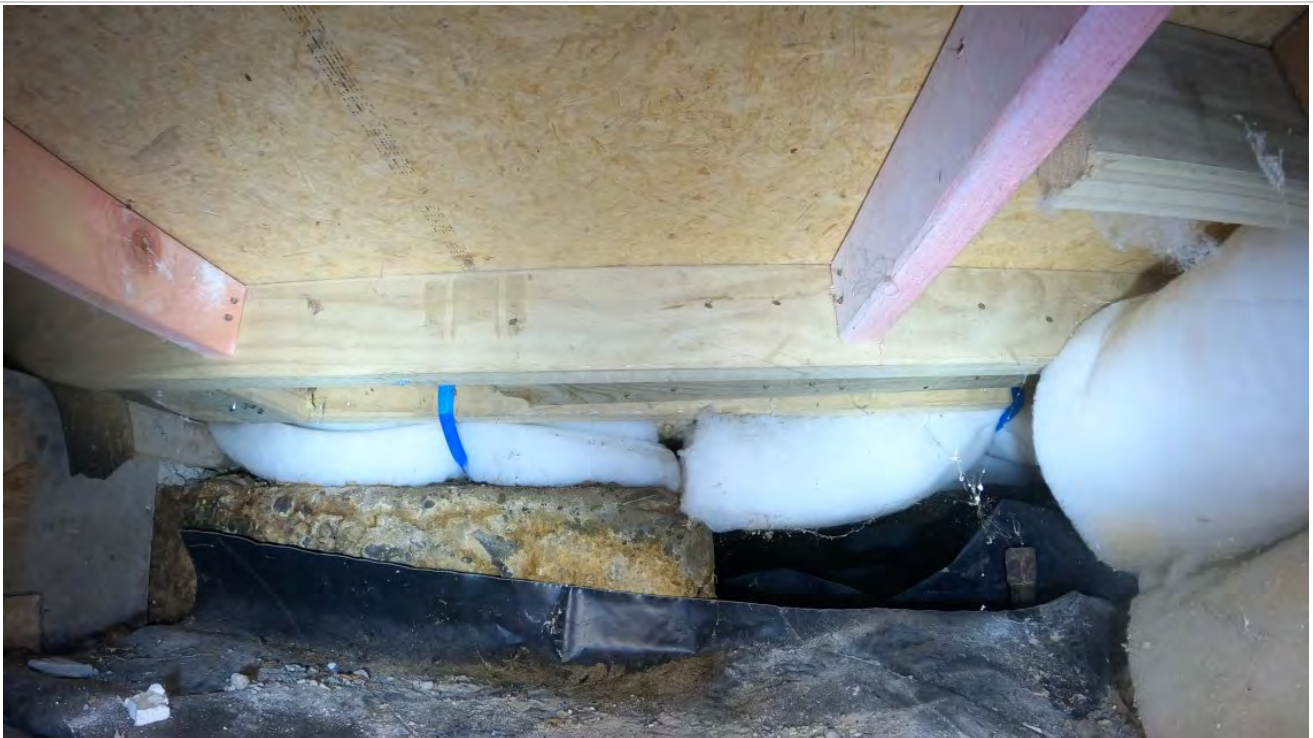
74: View of concrete base.
