EQC CLAIM DOCUMENTATION

EARTHQUAKE RECOVERY (EQR) DOCUMENTATION

Released under the Official Information Act 1982
EQR Property Overview Report

EQC Property ID	Property Address	Vulnerable?	Property F Status	Property Finalisation Indicator		
2010061240	41 MACKENZIE AVENUE, WOOLSTON		F3 - Complete & Finalised	Some Finalisation has taken place		
Main Contractor:	CLOSED OUT-S.K. Hand Builders Limited ***** (SC30)		Property F2'd By:	Blair Jones	F2 Completed Date:	20-06-2016
Cont Managing Hub:	Ensors	Not Vulnerable	Property F3'd By:	Blair Jones	F3 Completed Date:	20-06-2016

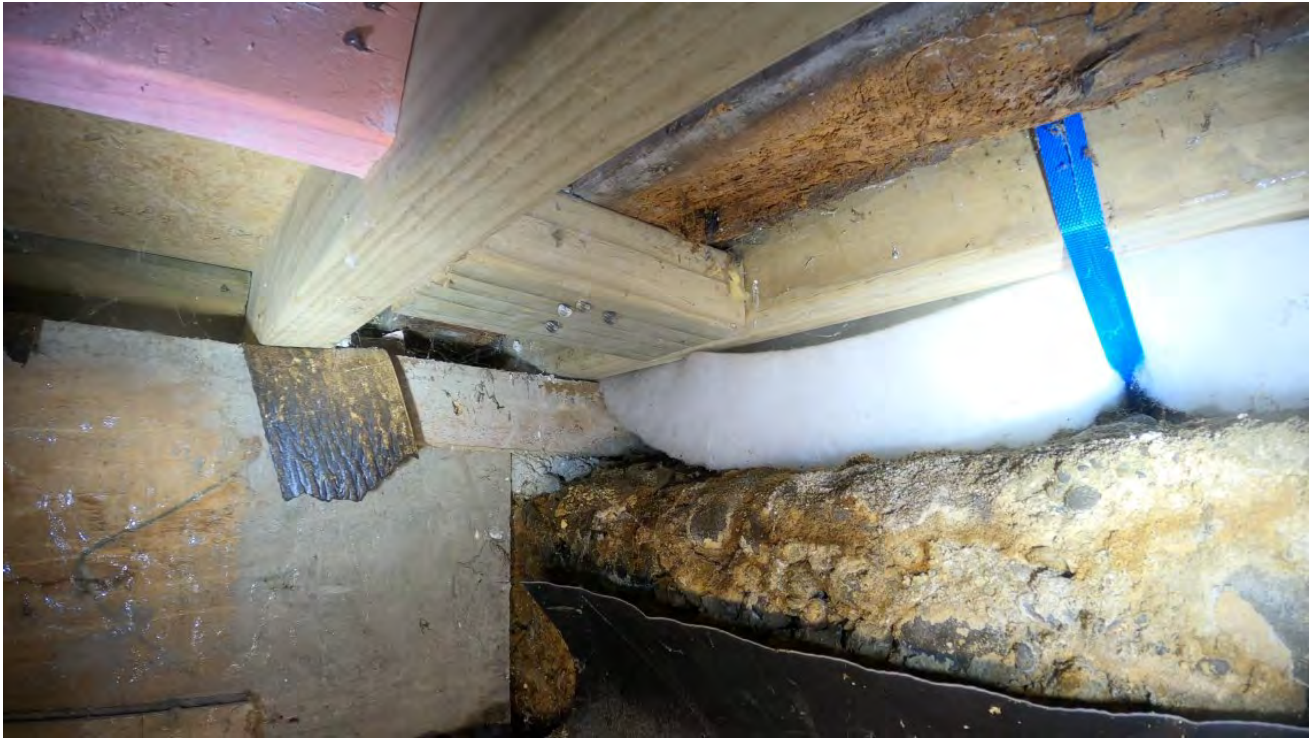
75: Note the rotten timber.

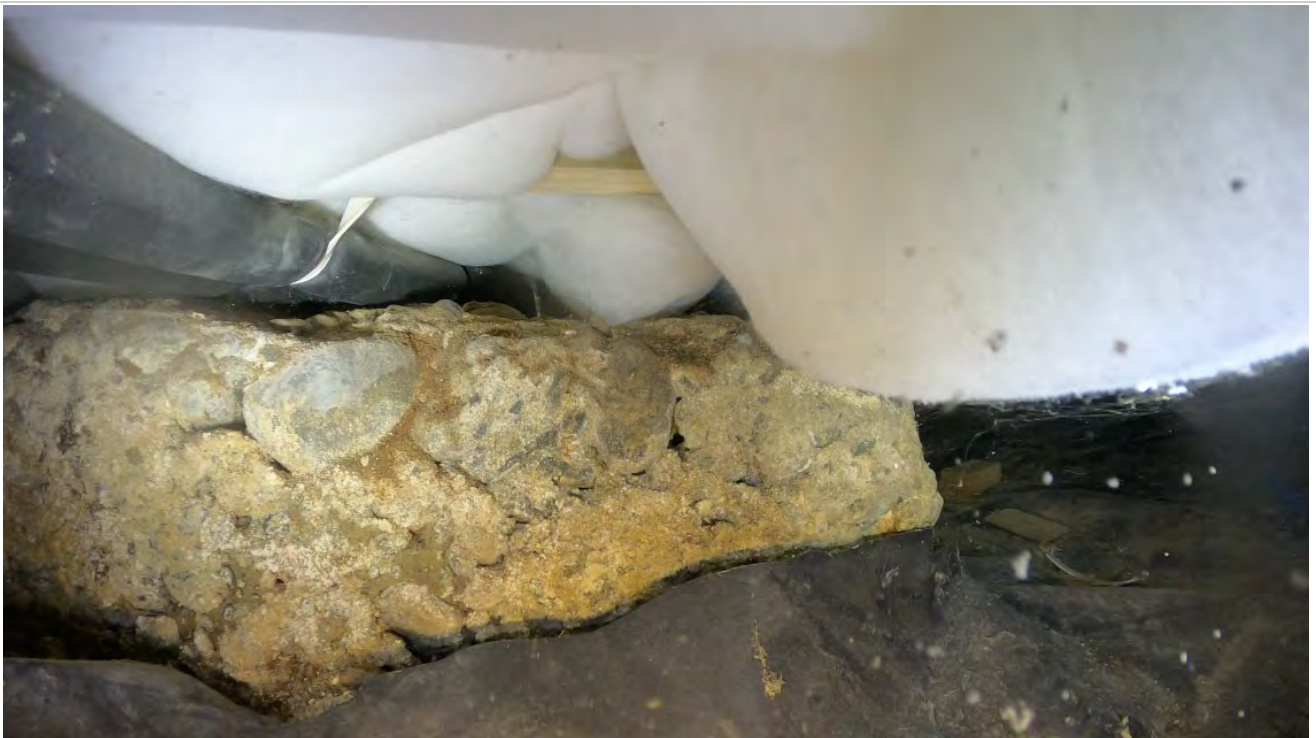
76: View of concrete base.

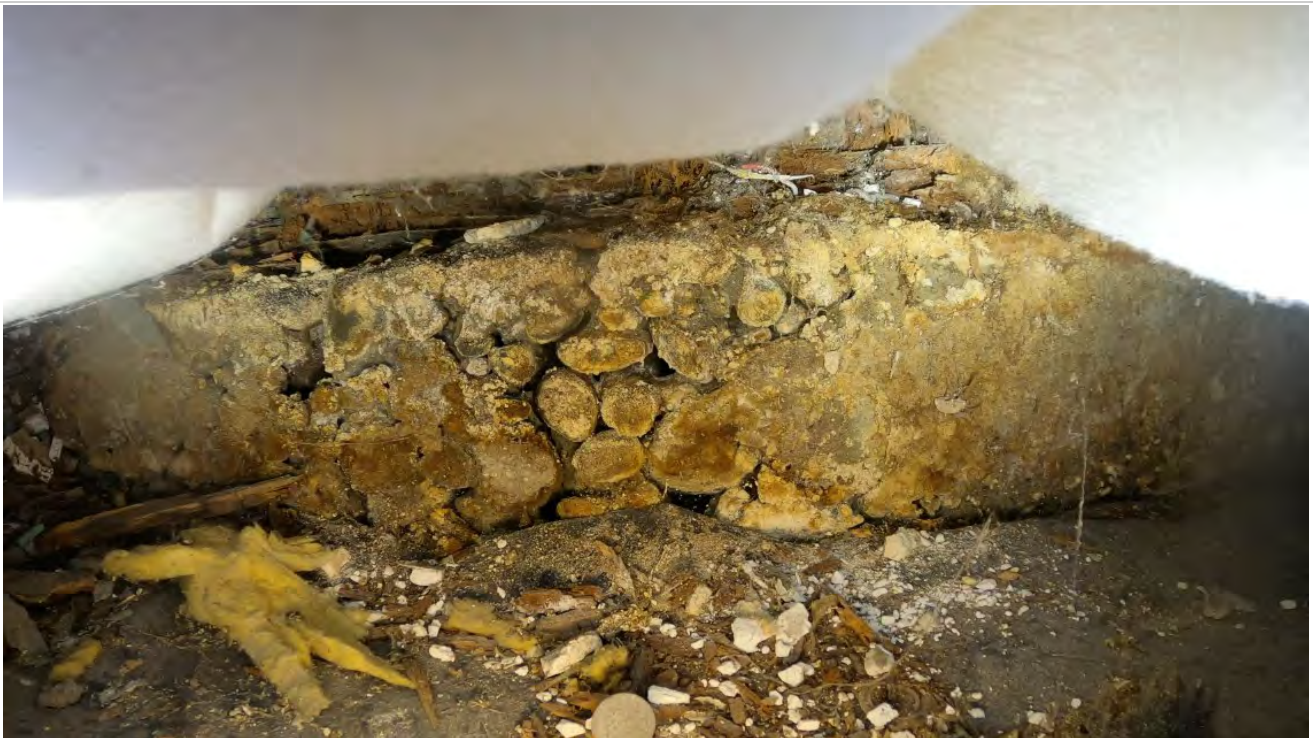
78: View of ring foundation with crack and rotten timber.

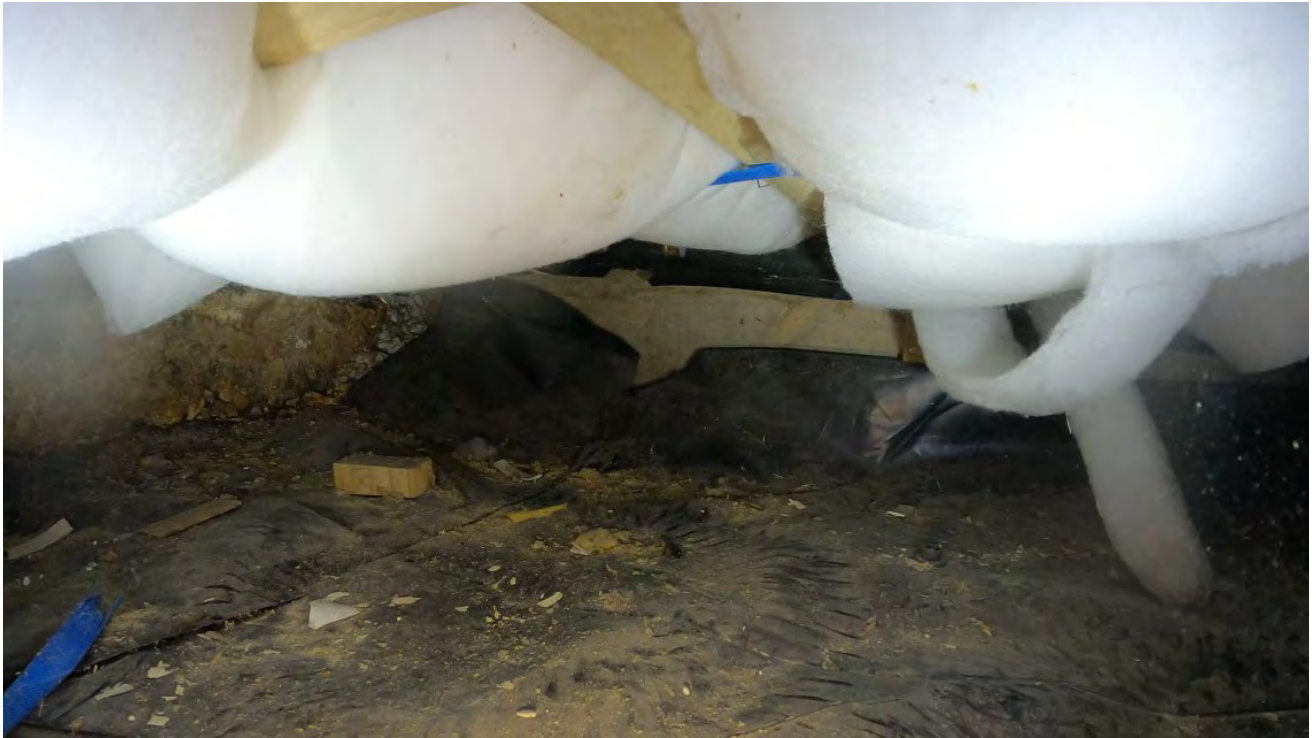
79: View of foundation.

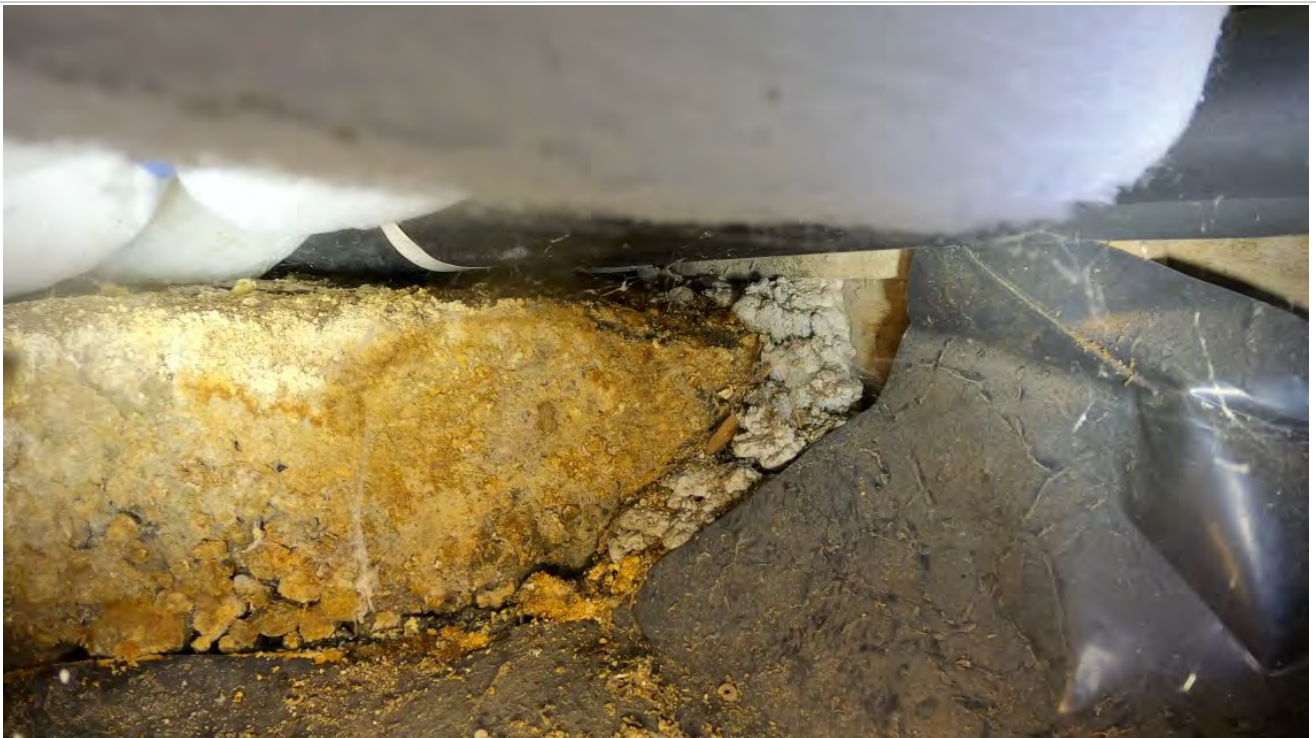
80: View of ring foundation with concrete base to the left.
