RED LBP PRE-PURCHASE REPORT

PRE-PURCHASE BUILDING REPORT

Property Address	42 Trafford Street, Harewood, Christchurch 8051
Client	Elmerlito Palino Landicho Erja Arranchado
Date of Inspection	29th April 2026
Time	8:00 am
Inspector	Jamie Chapman National Certificate in Carpentry
LBP Number	BP137228
People Present	Inspector, Owner
House Occupied	Yes

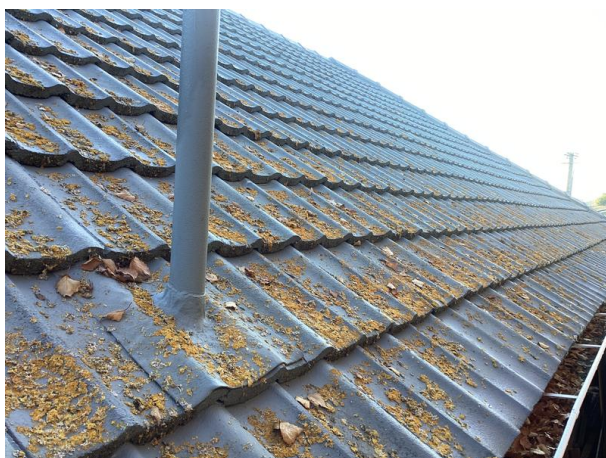
Photo 4

Moss/lichen was visible on the south side. Appears to have been sprayed and is currently dying/falling off.

The masonry tiled roof is in a condition expected for age. Recommend keeping up regular maintenance.

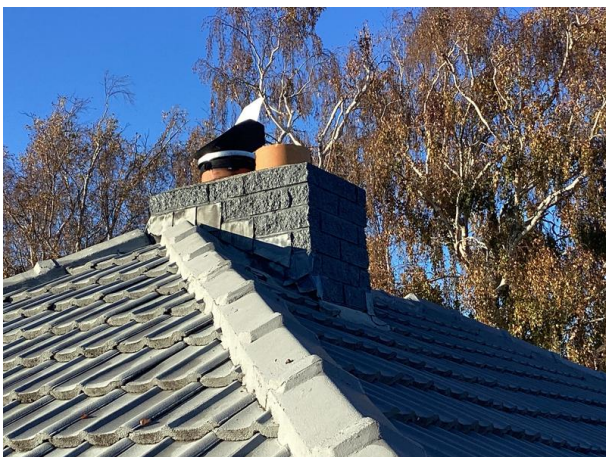
Photo 9
Chimney with lead flashings.

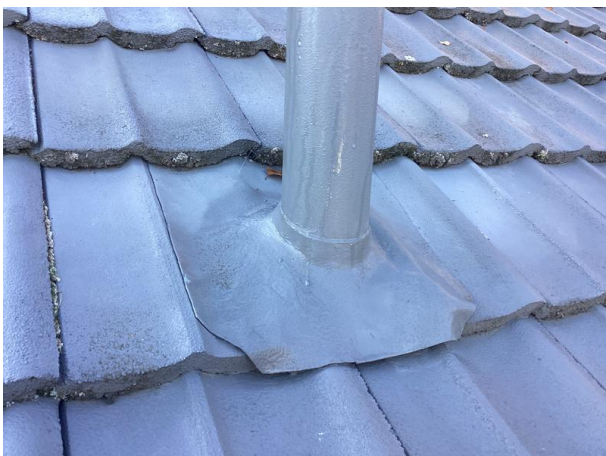
Photo 11
West side vent penetration with lead flashing.

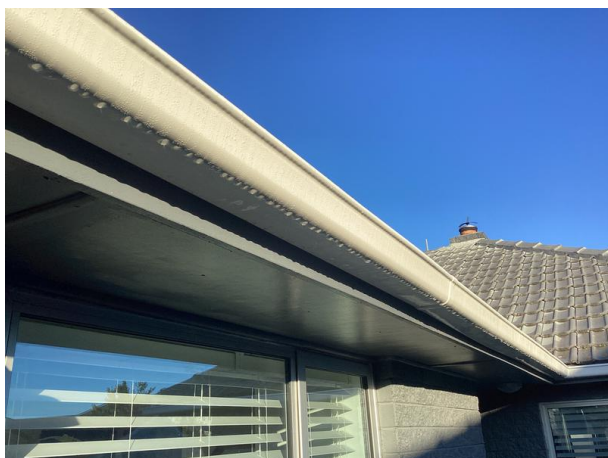
Photo 12

PVC gutters and timber fascia boards are located around the dwelling.

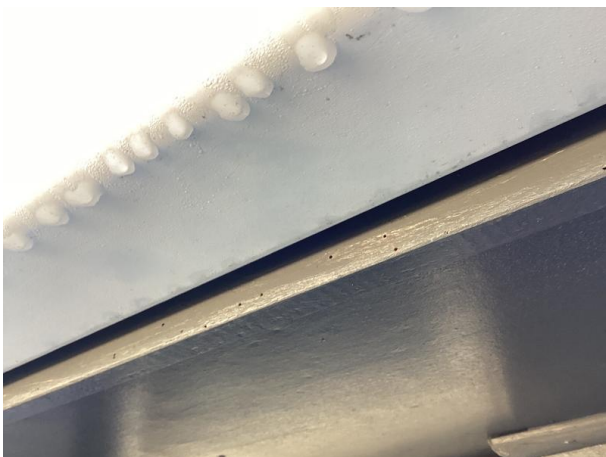
Photo 13

Borer flight holes were noticed in a couple areas of the timber fascia boards.

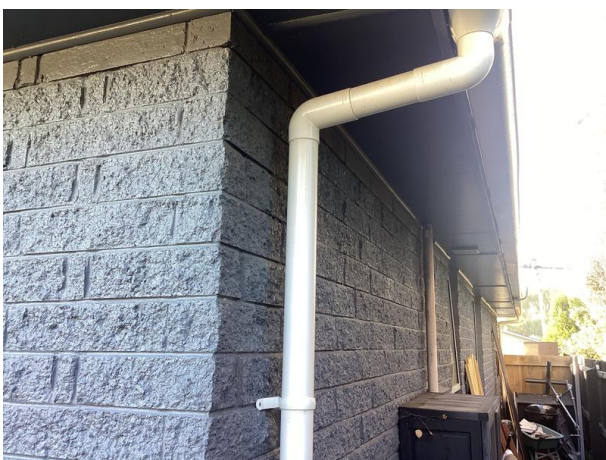
Photo 14

The PVC downpipes were securely attached to the dwelling during the inspection.

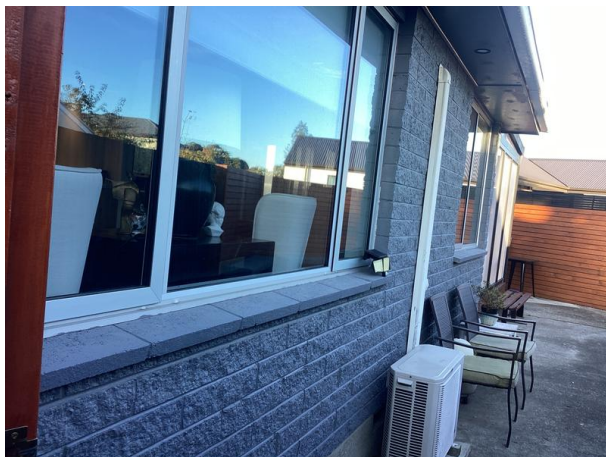
Photo 17

Painted split face masonry bricks are located around the dwelling.

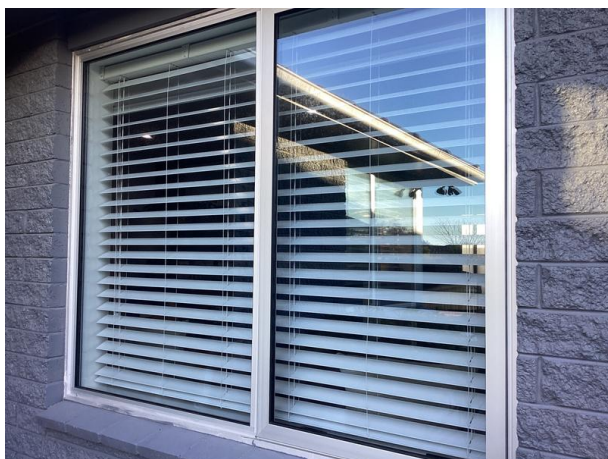
Photo 22

Double glazed aluminium windows located around the dwelling.

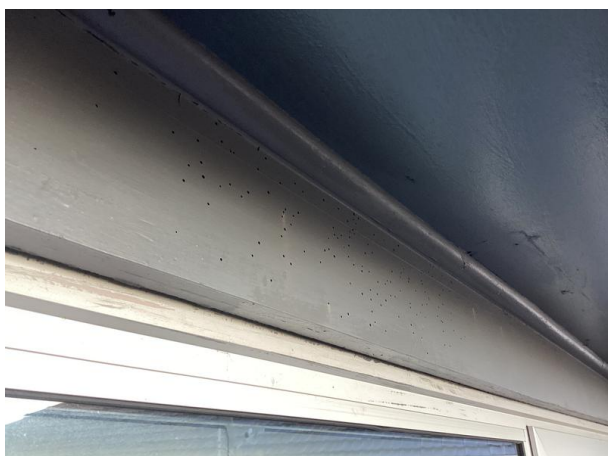
Photo 23

Borer was noticed on a headboard near the entrance area.

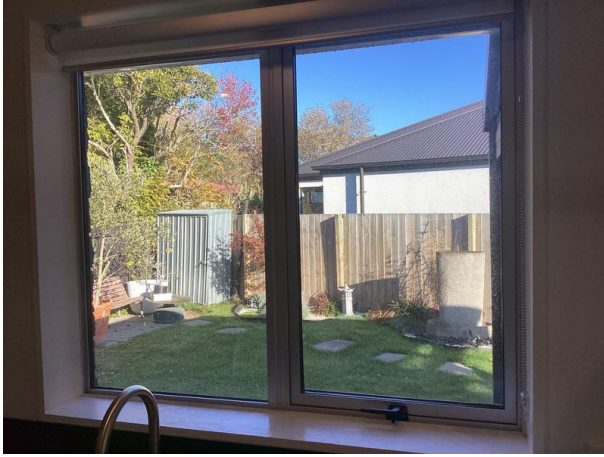
Photo 24
Double glazed aluminium windows
viewed from inside the dwelling. No
significant visible issues during the
inspection.

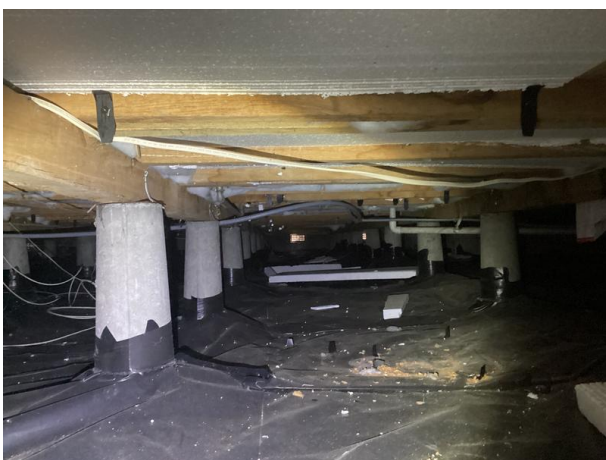
Photo 29

View of inside the subfloor.

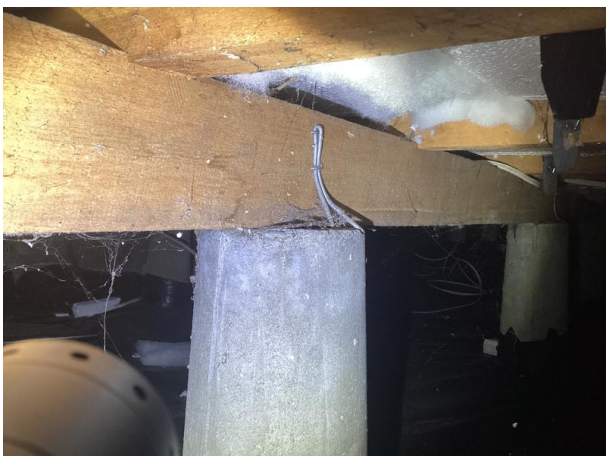
Photo 30

Tie wire connections were visible between the concrete piles and timber bearers.

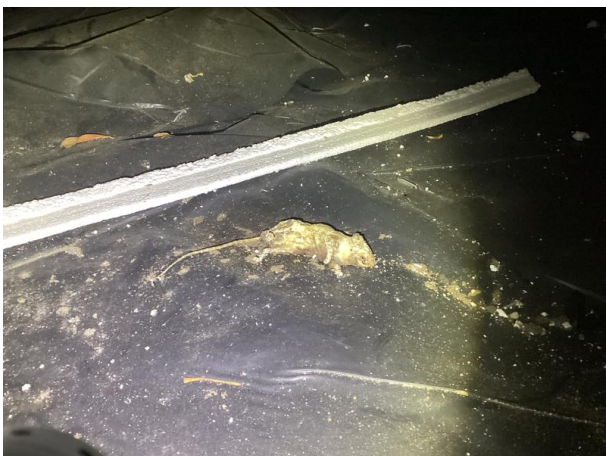
Photo 33
A dead rodent was noticed in the subfloor.

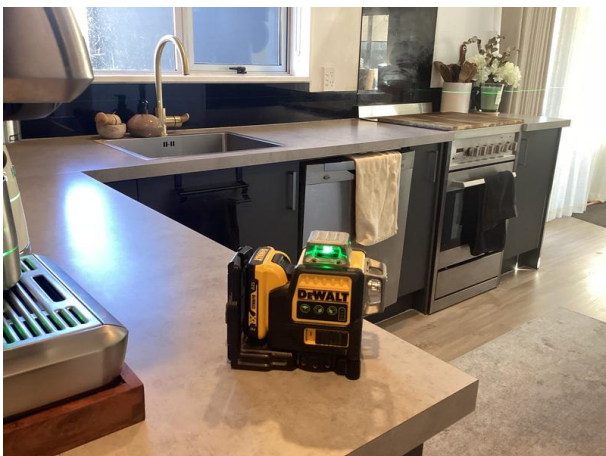
Photo 36

The kitchen Benchtops were also checked and were level.

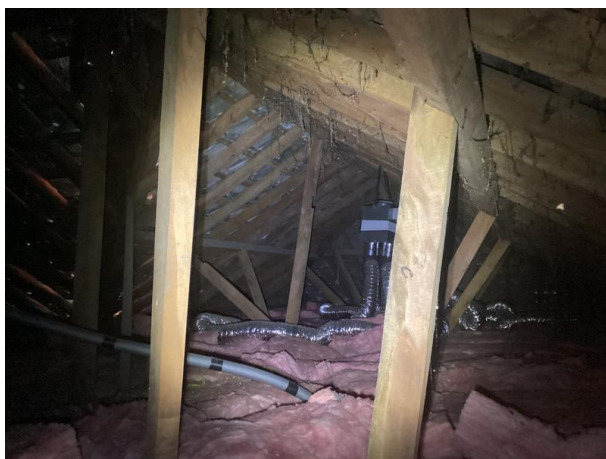
Photo 37

View of inside the roof space.

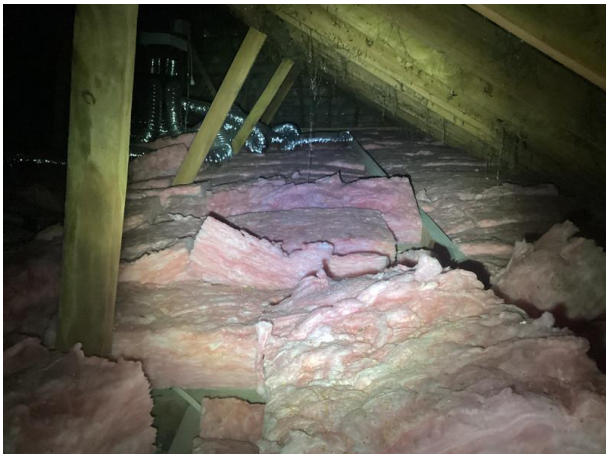
Photo 38
Glass wool insulation is located in the roof space.

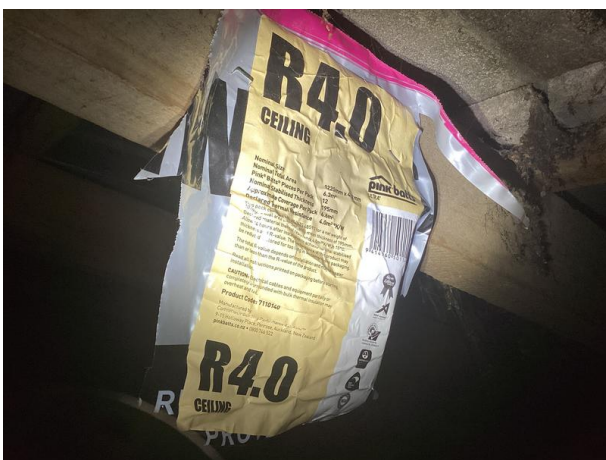
Photo 39
Insulation label.

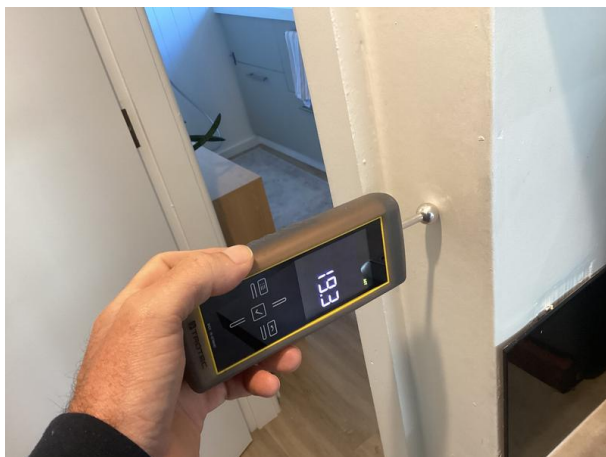
Photo 42
Example of a base reading that was taken on an internal wall. This was the average moisture reading for this dwelling during the inspection.

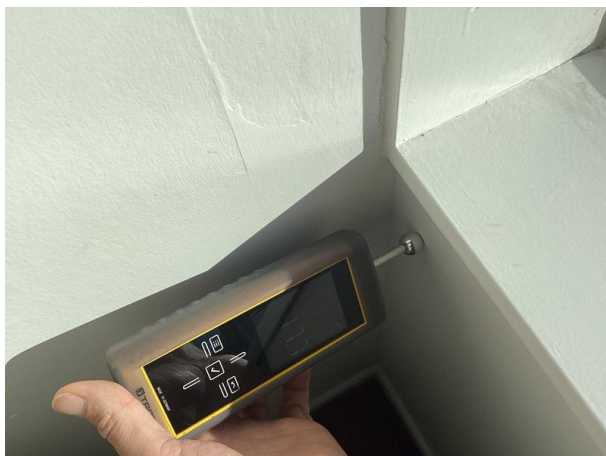
Photo 44
Moisture testing was done around the external window joining.

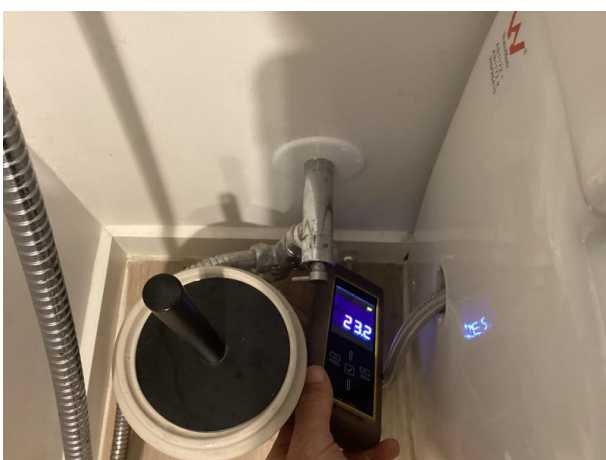
Photo 46
Moisture testing was done around plumbing and wet areas.

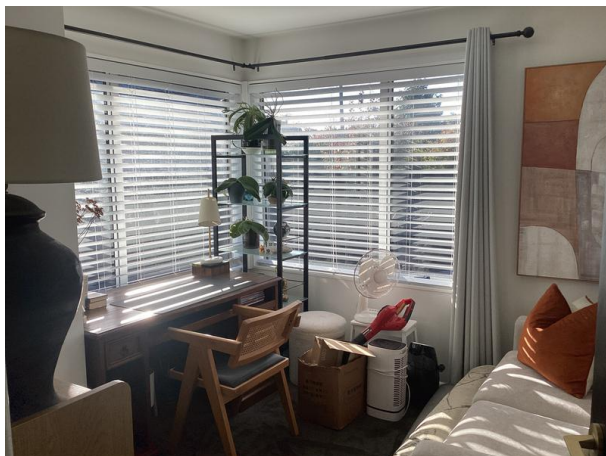
Photo 50
Bedroom 1.

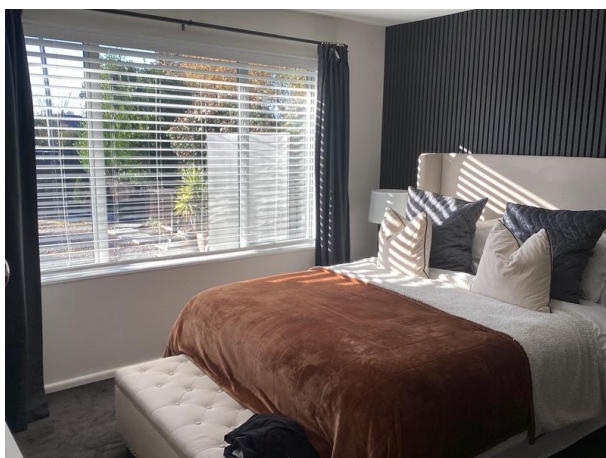
Photo 51
Bedroom 2.

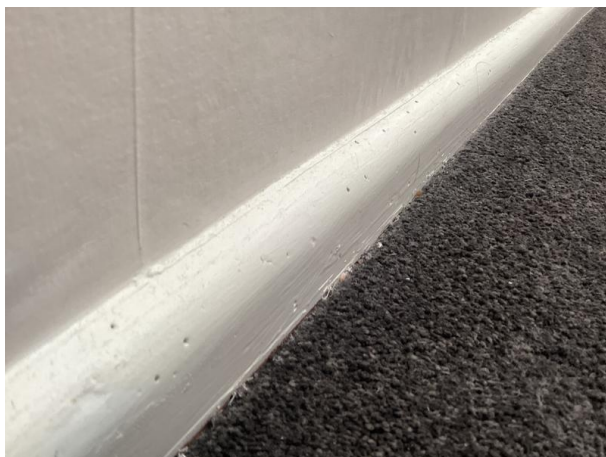
Photo 52
Borer holes noticed on the external wall skirting boards.

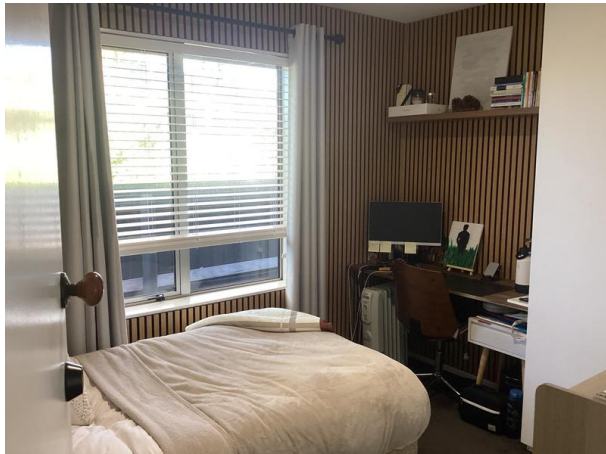
Photo 53
Bedroom 3.

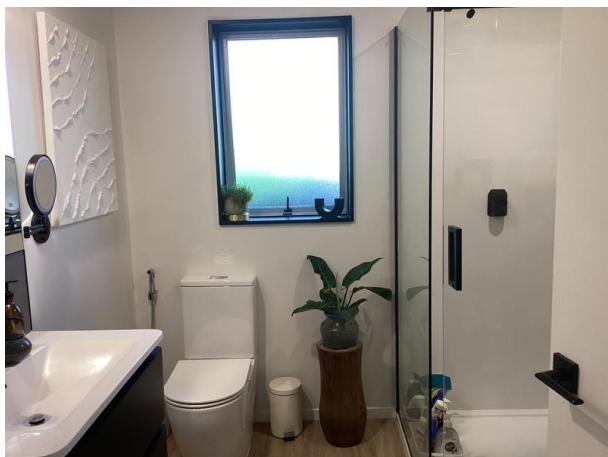
Photo 54
Bathroom.

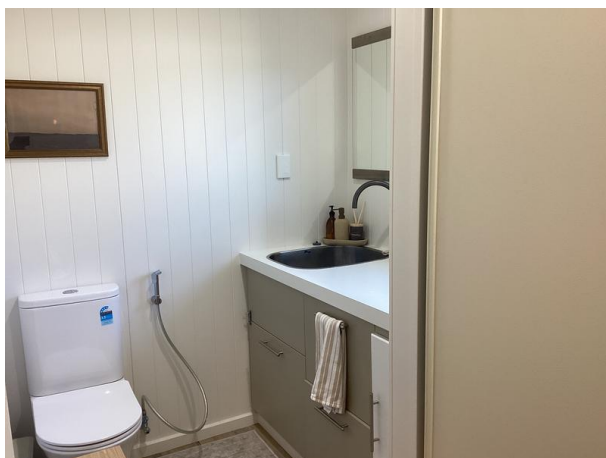
Photo 58
Laundry with toilet.

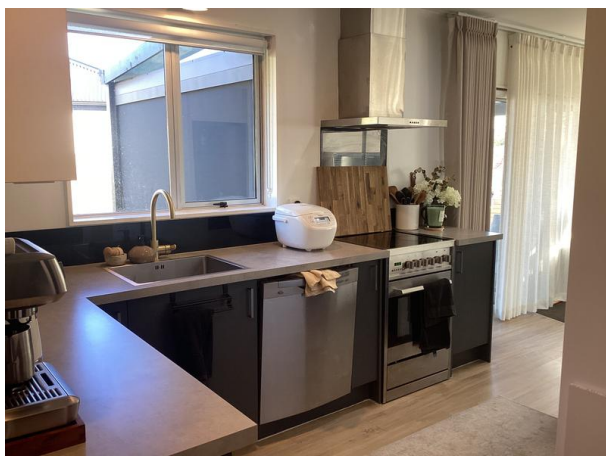
Photo 59
Kitchen.

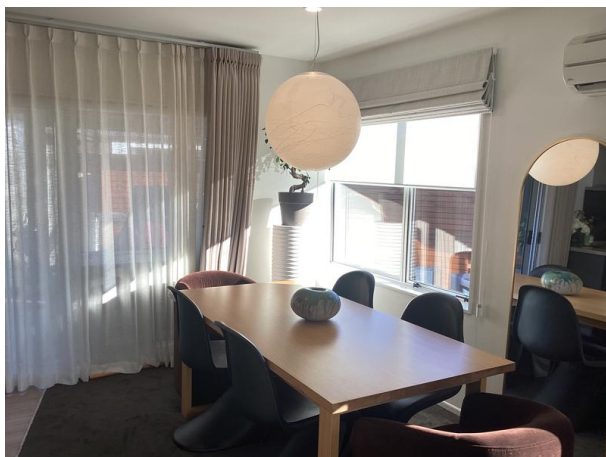
Photo 60
Dining room.

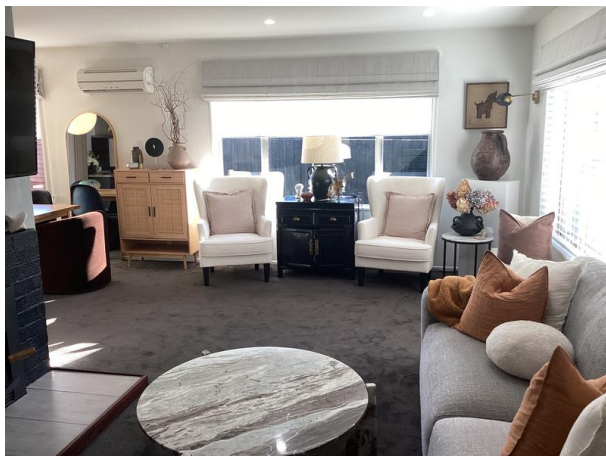
Photo 61
Living room.

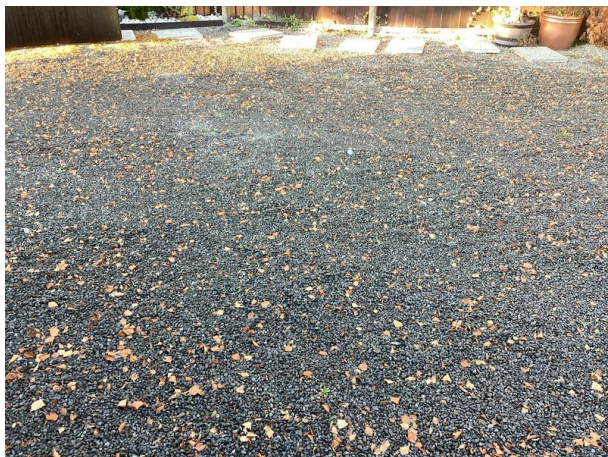
Photo 62
Shingle driveway, no significant issues.

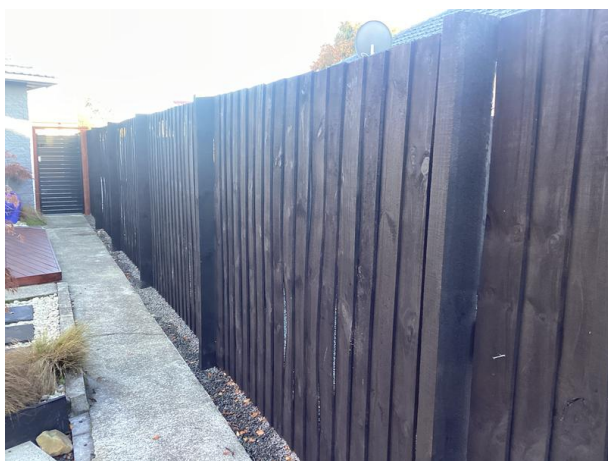
Photo 63
Timber fences, in a condition expected for age.

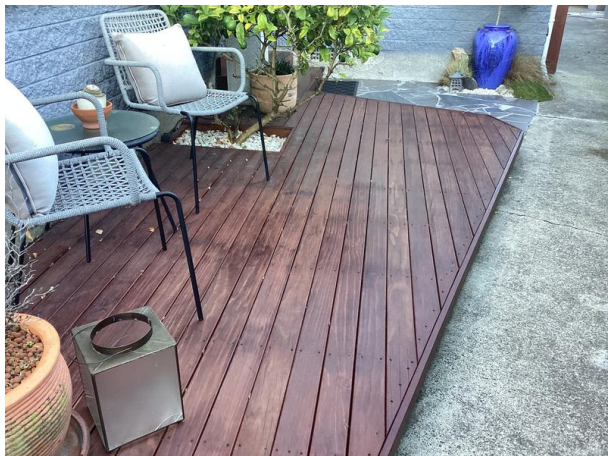
Photo 65
Timber deck located by the front entrance, no significant issues.

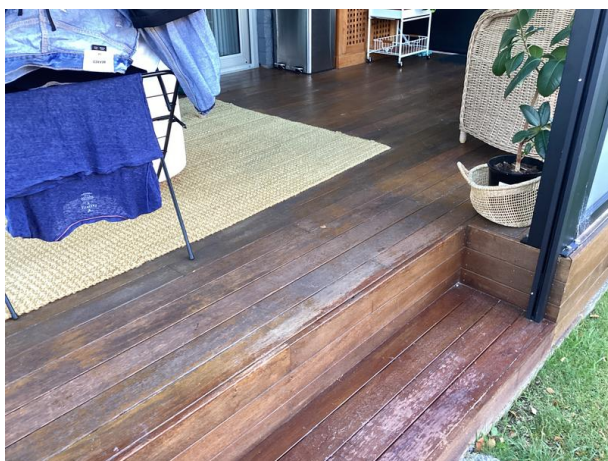
Photo 66
West side timber deck, no significant issues.

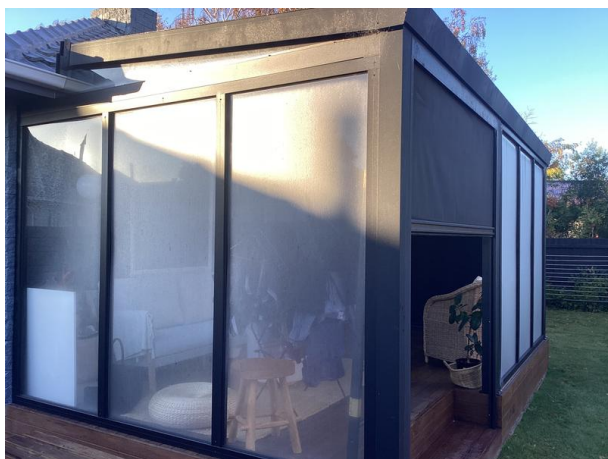
Photo 67
Metal structure located over the west side timber deck.

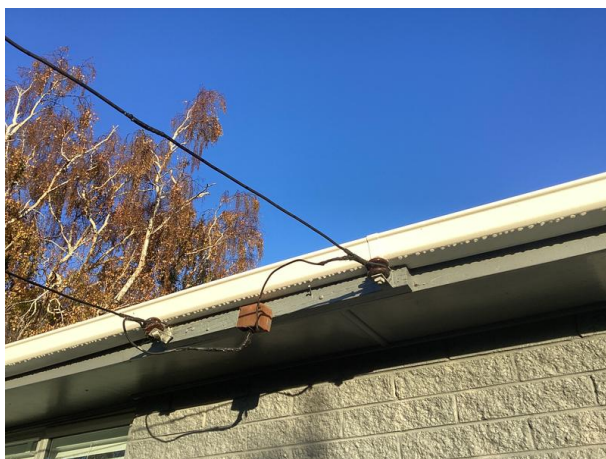
Photo 68
Over head power supply,

It is recommended to have a registered electrician advise on the electrical system.

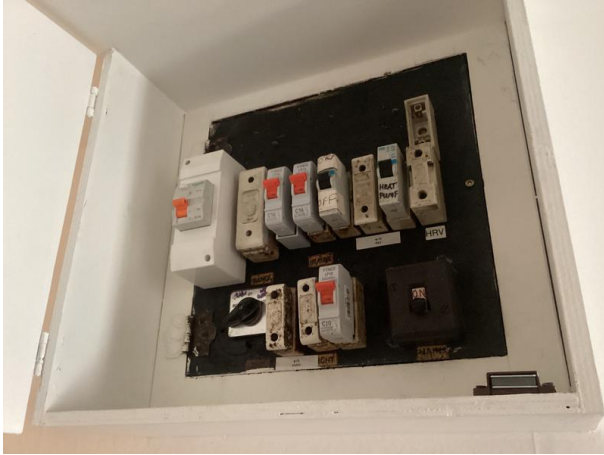
Photo 70
Meter box located in the hallway.

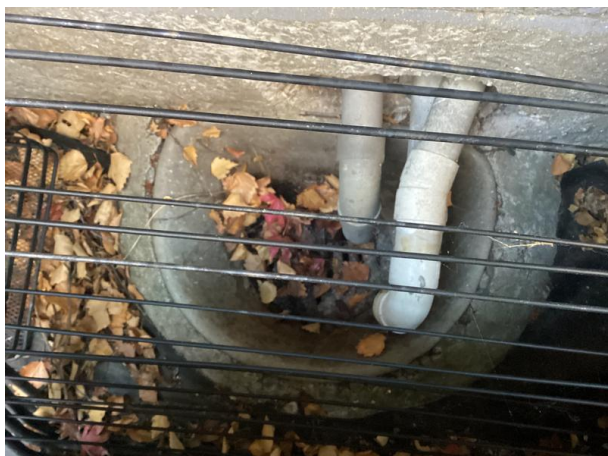
Photo 71
South side gully trap.

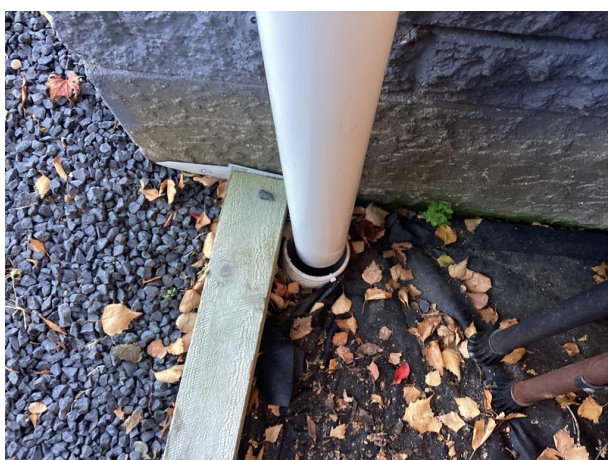
Photo 72
South side stormwater riser.

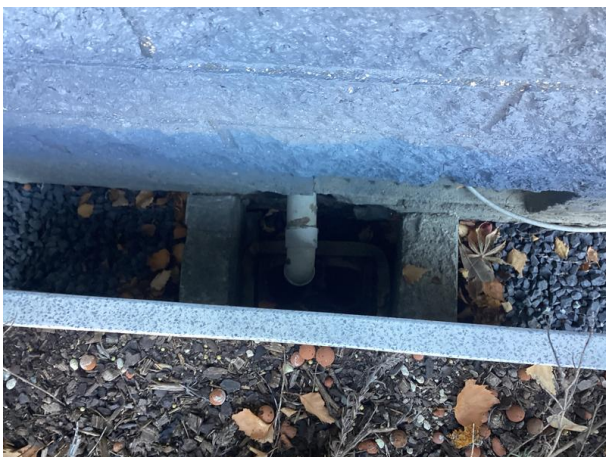
Photo 73
West side gully trap.

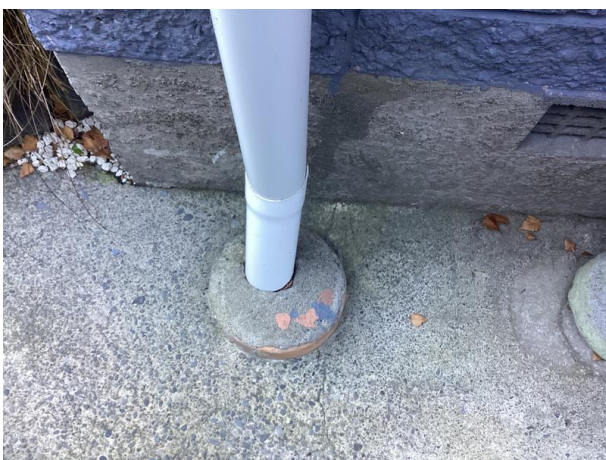
Photo 74
Inside the North side stormwater riser
was not visible.

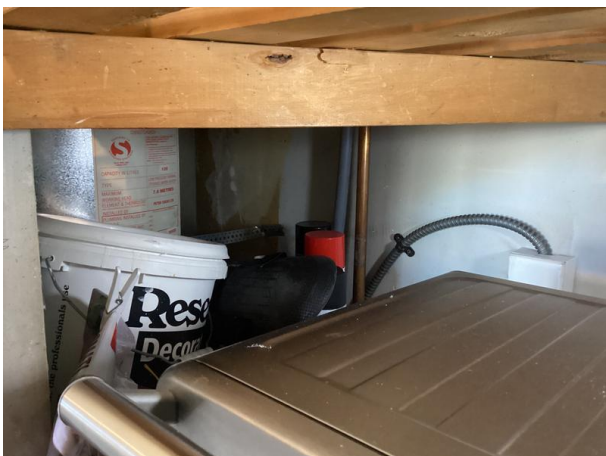
Photo 75
Hot water cylinder viewed from the
kitchen cupboard. Limited visibility due
to personal belongings.

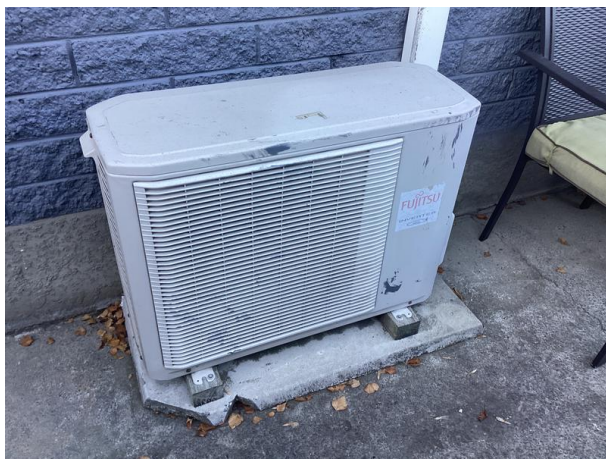
Photo 76
External Fujitsu heatpump system.

Follow the manufacturer's recommended servicing schedule to ensure the equipment operates efficiently and maintains optimal performance. Adhering to these guidelines helps identify and address potential issues early, reducing the risk of costly repairs and ensuring compliance with warranty requirements.

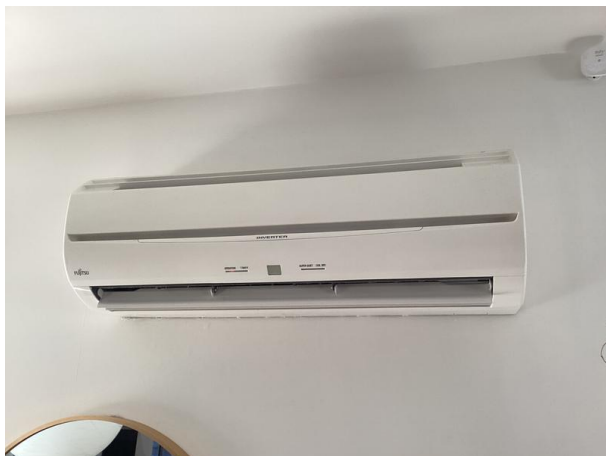
Photo 77
Fujitsu heat pump located in the living room.

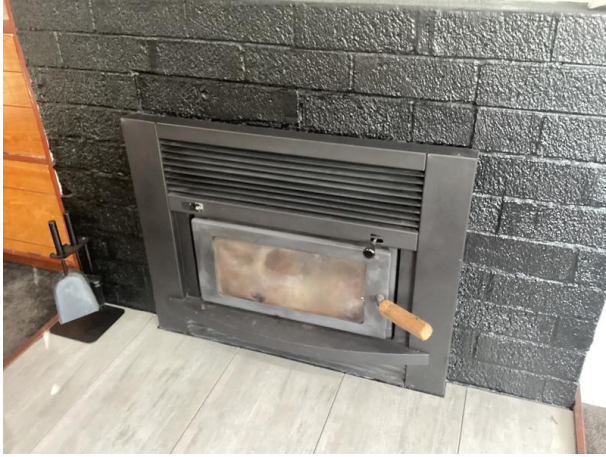
Photo 78
Fireplace located in the living room.

Check with territorial authority for solid fuel burners compliance.

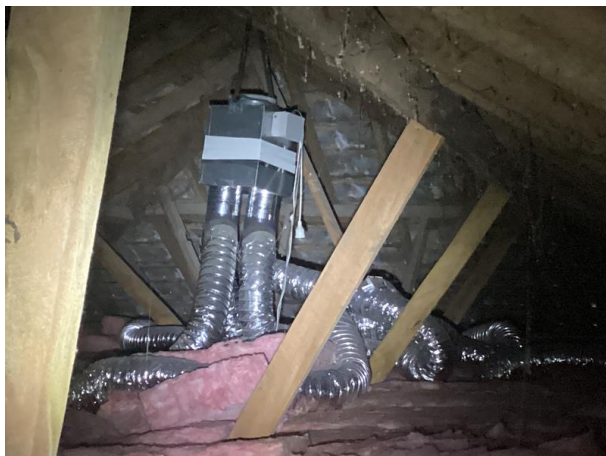
Photo 79
Ventilation system located in the roof space.

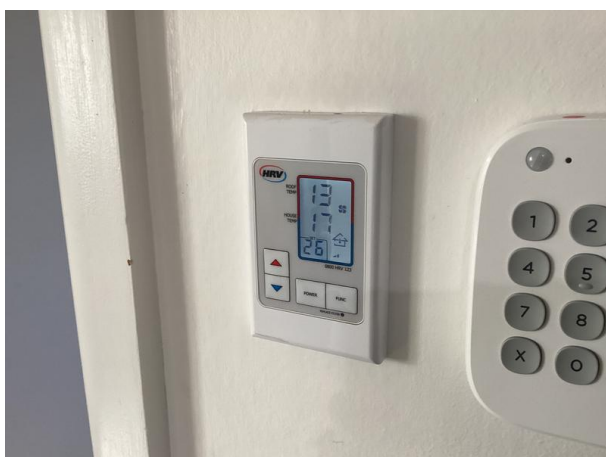
Photo 80
HRV control panel located in the hallway.

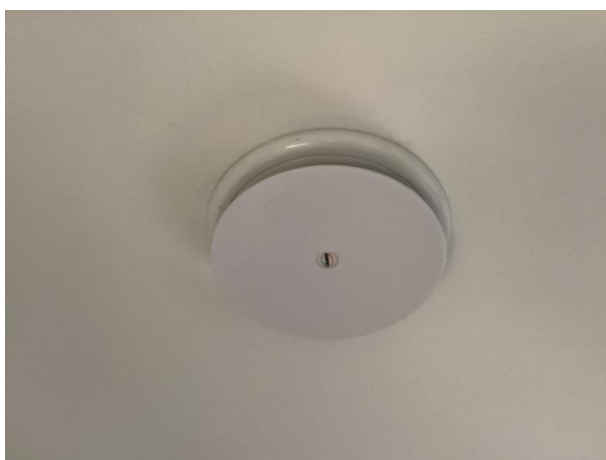
Photo 81
The HRV system is located around some of the dwelling. Not tested.

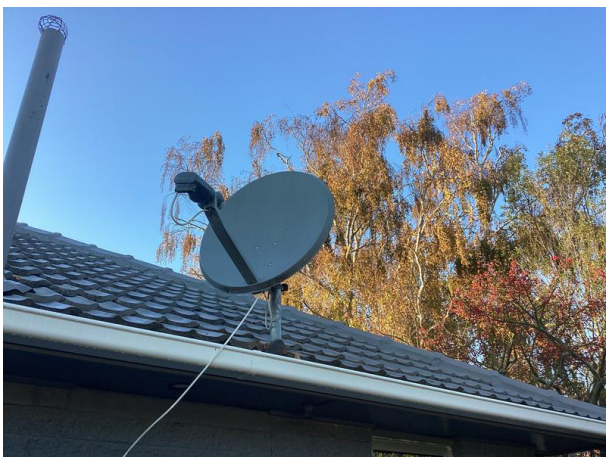
Photo 82
Satellite aerial located on the roof system.

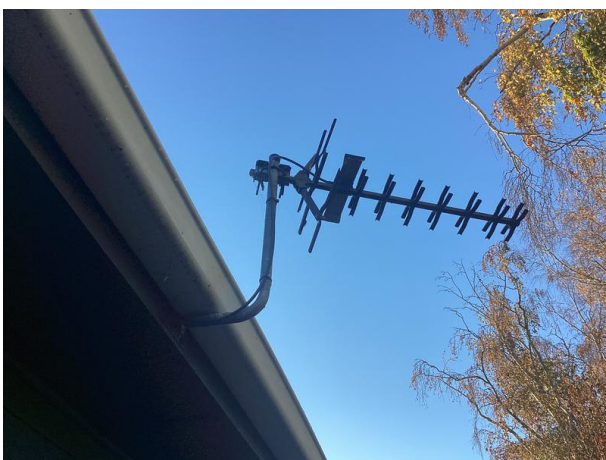
Photo 83
South side antenna.

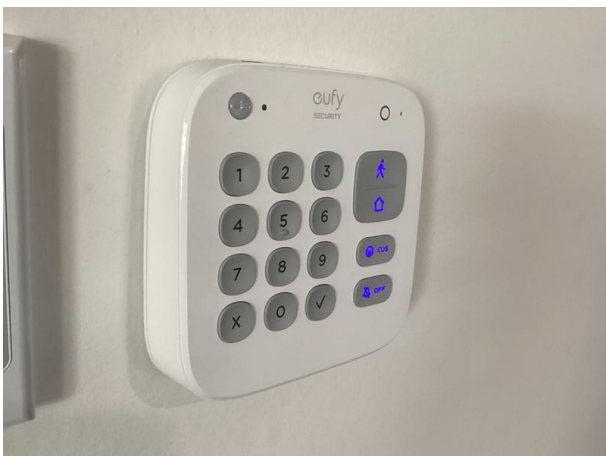
Photo 84
Security control panel located in the hallway.
