BUILDING INSPECTION REPORT

RED LBP PRE-PURCHASE REPORT

PRE-PURCHASE BUILDING REPORT

Property Address	9 Guyon Street, Marshland, Christchurch 8083
Client	Simon McSherry
Date of Inspection	8th May 2026
Time	12:30 am
Inspector	Jamie Chapman National Certificate in Carpentry
LBP Number	BP137228
People Present	Inspector, Owner
House Occupied	Yes

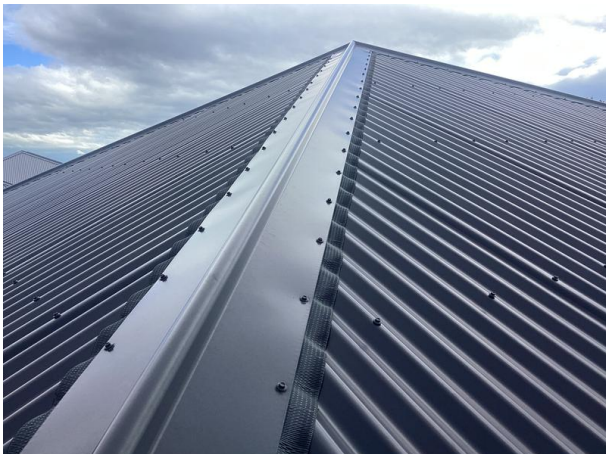
Photo 5
Metal hips and ridges located around the roof system.

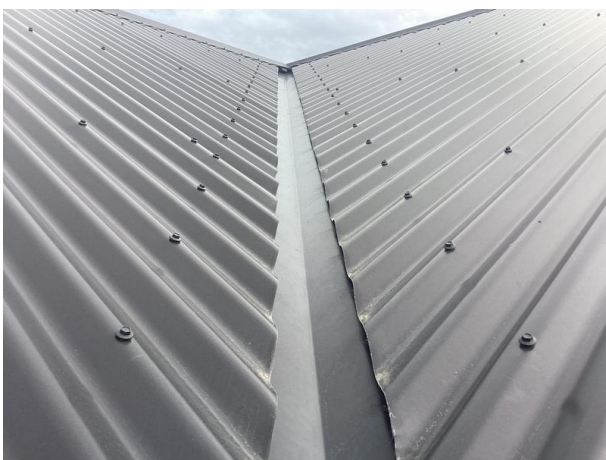
Photo 6
Metal valleys located around the roof system.

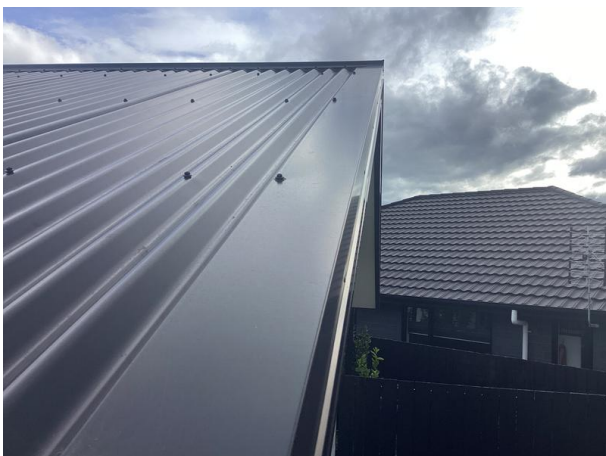
Photo 7
Metal barge flashings installed on the Gable ends.

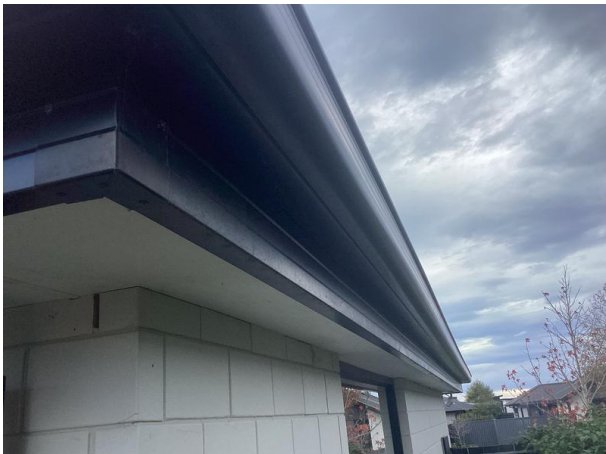
Photo 8
Metal fascia and gutter system located around the dwelling.

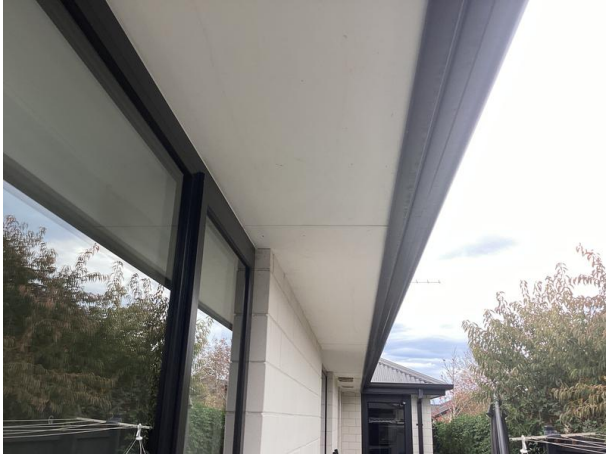
Photo 11
Painted fibre cement soffits located
around the dwelling.

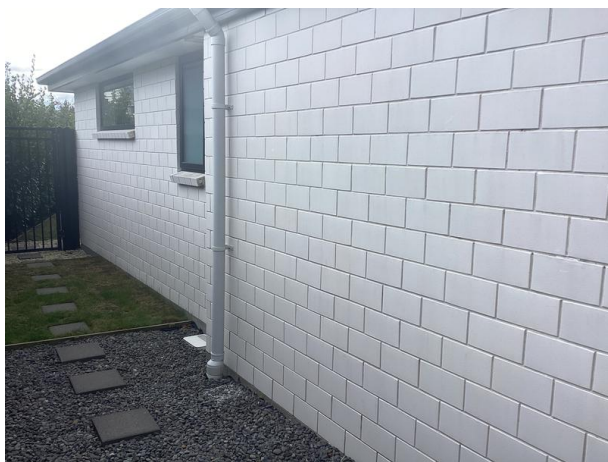
Photo 12

Brick veneer is located around most of the dwelling.

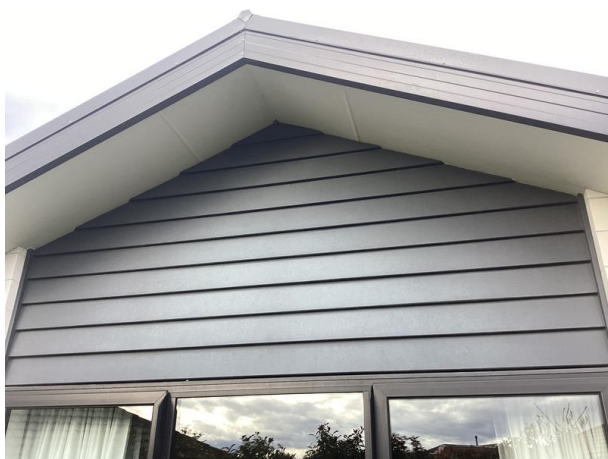
Photo 16
Horizontal fibre cement weatherboards are also located around parts of the dwelling.

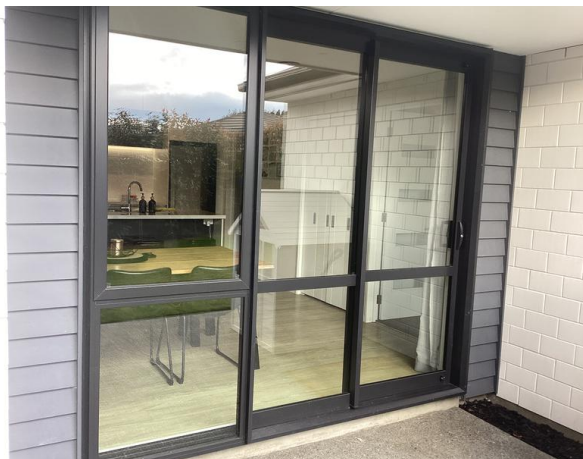
Photo 18

Double glazed aluminium windows located around the dwelling.

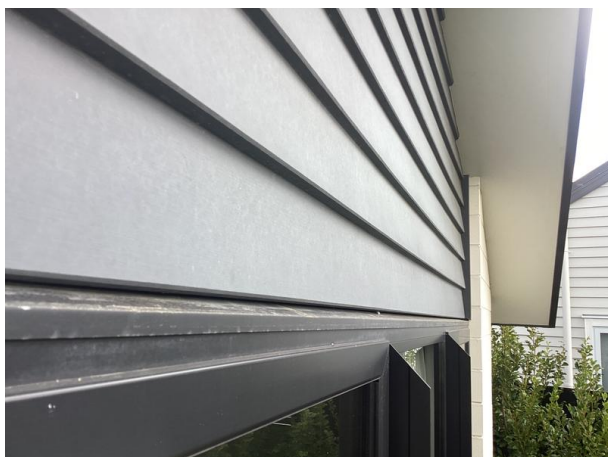
Photo 19

Metal head flashings installed above the aluminium windows were required.

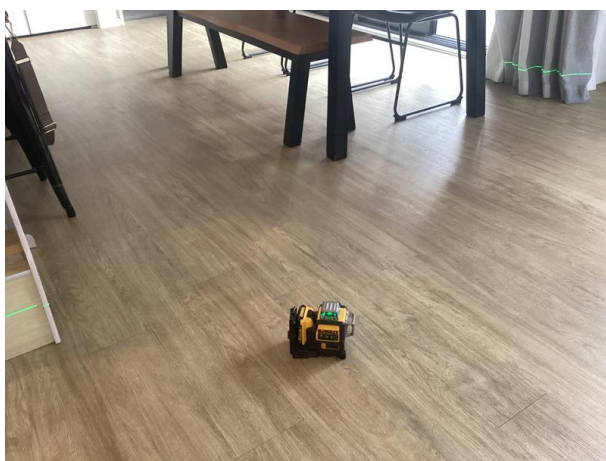
Photo 21

The floor levels were spot checked around the dwelling using a self levelling laser.

No significant deviations were observed during the inspection. That approximate overall floor level difference was 10 mm.

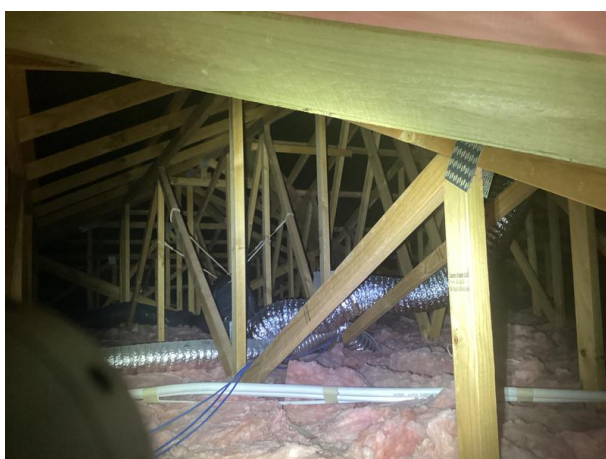
Photo 26

Manufactured timber trusses supports the roof system.

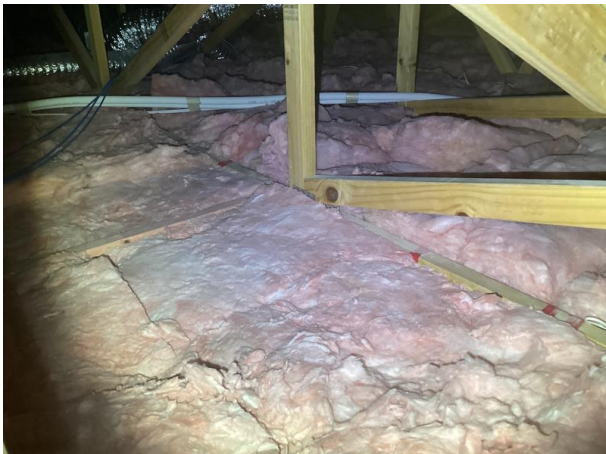
Photo 27
Glass wool insulation located in the roof space.

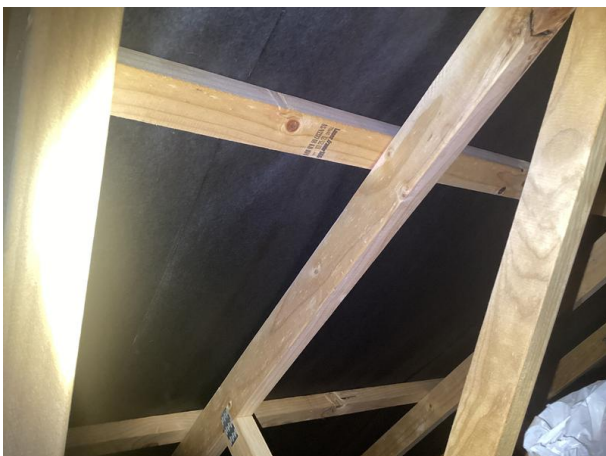
Photo 29
Self supporting roofing underlay installed below the roof system.

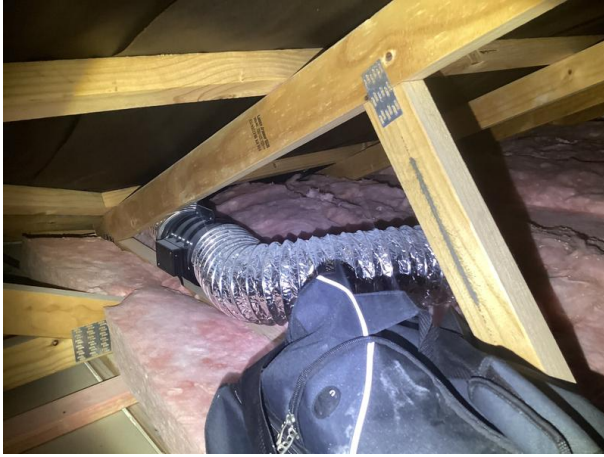
Photo 30
The bathroom, kitchen and laundry ventilation systems are ducted to the exterior of the dwelling.

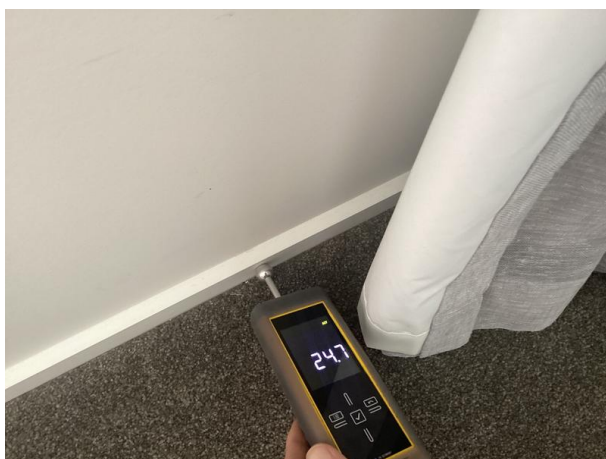
Photo 32

Moisture testing was done around the external walls of the dwelling.

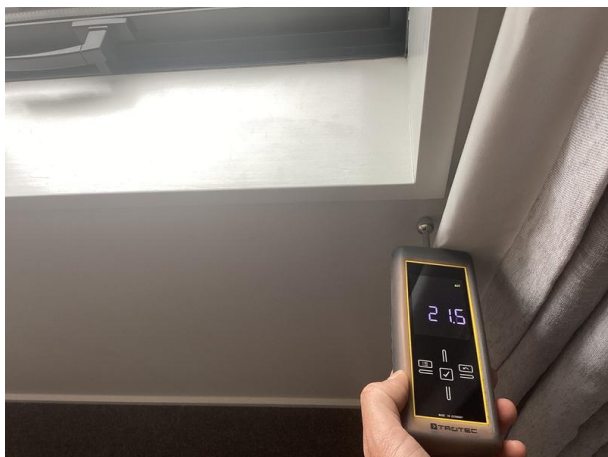
Photo 33
Moisture testing was done around the external window joinery.

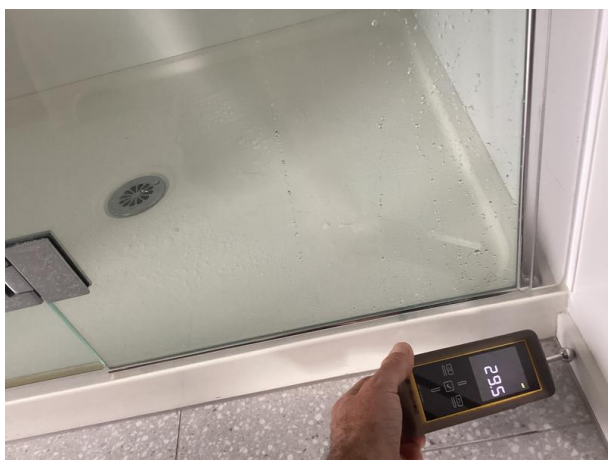
Photo 34
Moisture testing was done around plumbing and wet areas.

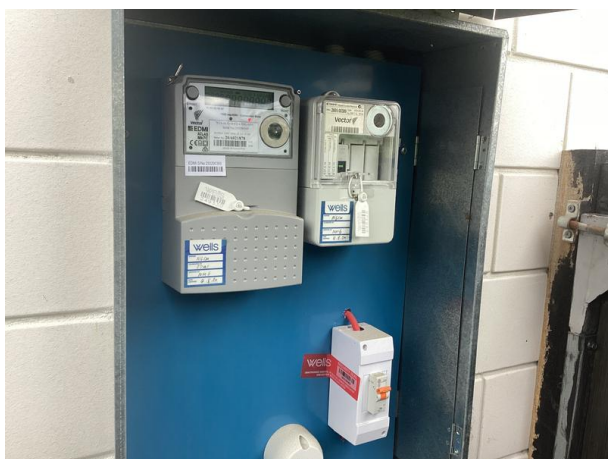
Photo 54
South side meter box.

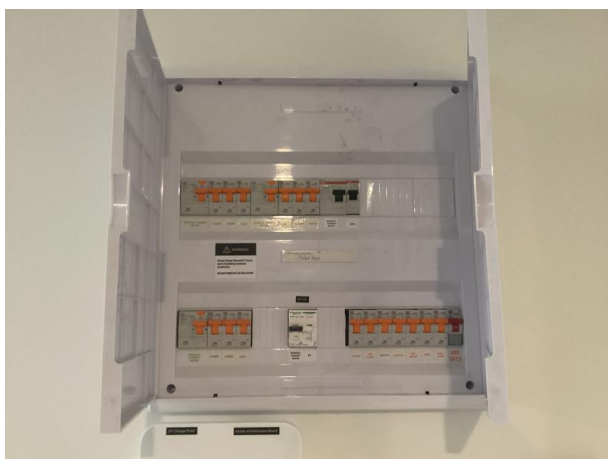
Photo 55
Switchboard located in the garage.

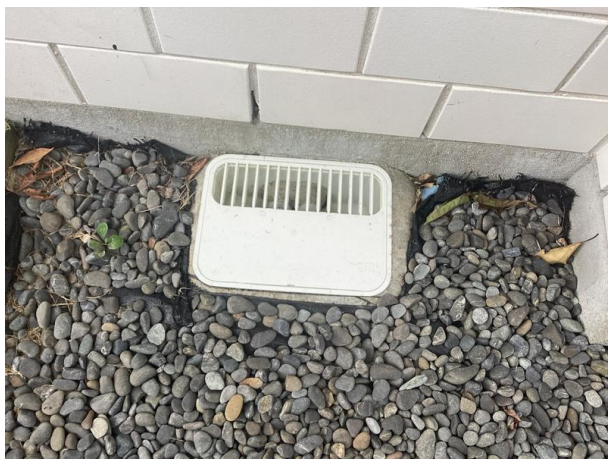
Photo 56
West side gully trap.

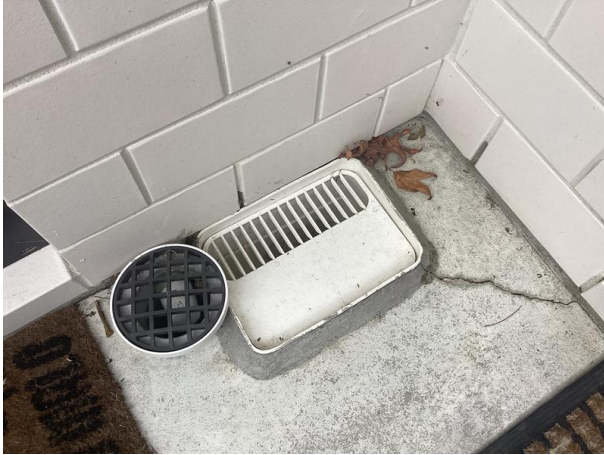
Photo 58
Laundry gully trap.

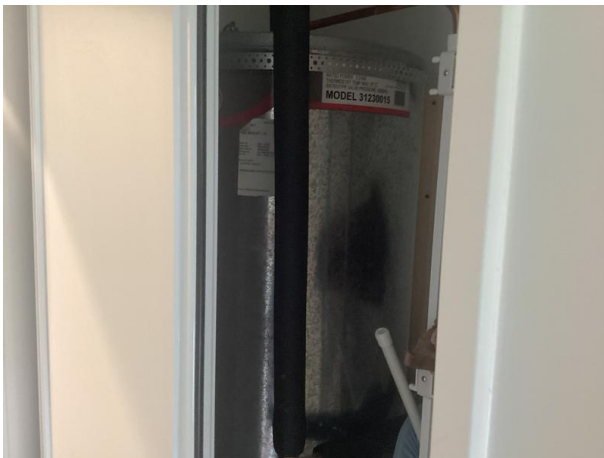
Photo 59
Hot water cylinder viewed from the
laundry cupboard.

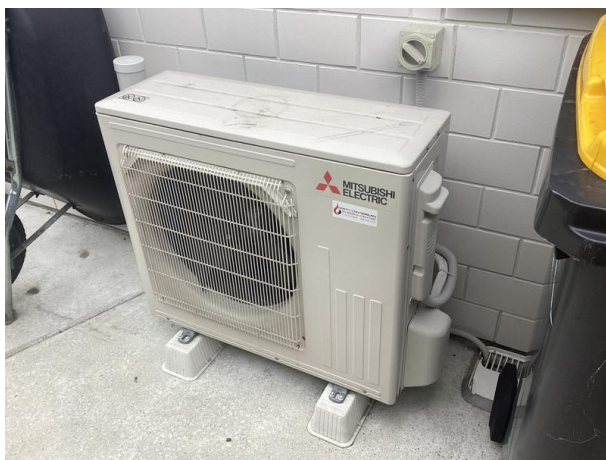
Photo 60
External Mitsubishi heatpump system.

Follow the manufacturer's recommended servicing schedule to ensure the equipment operates efficiently and maintains optimal performance. Adhering to these guidelines helps identify and address potential issues early, reducing the risk of costly repairs and ensuring compliance with warranty requirements.

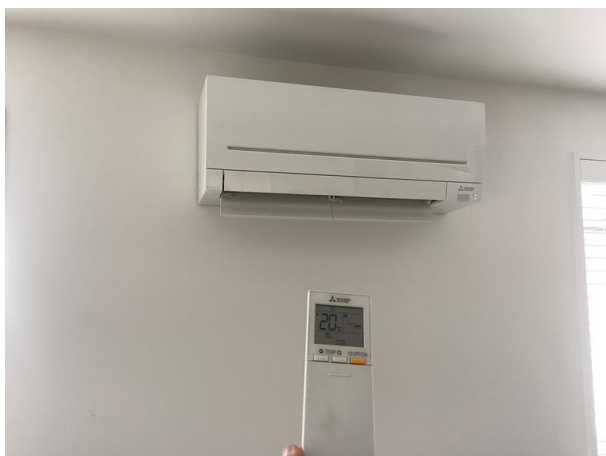
Photo 61
Mitsubishi heatpump located in the living room.

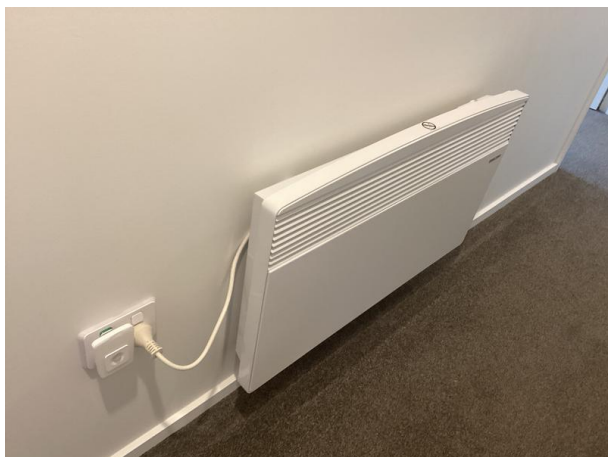
Photo 62
Wall heater located in the hallway.

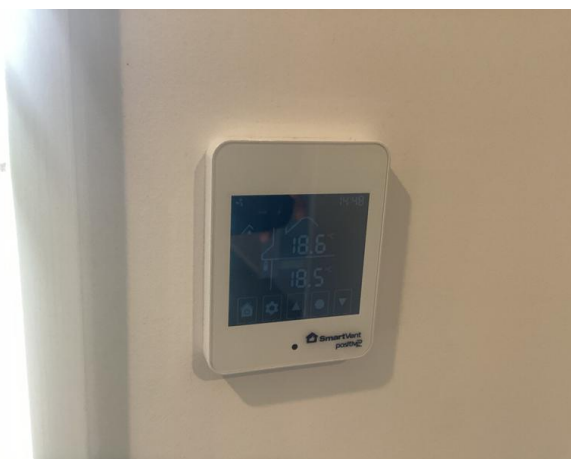
Photo 63
Smart vent control panel located in the entrance. Not tested.

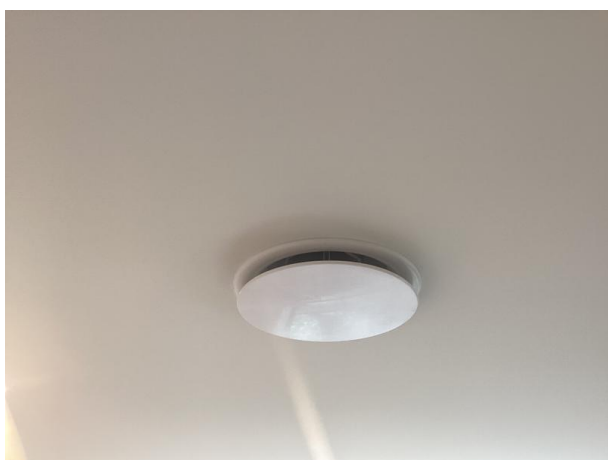
Photo 64
The smart vent outlets are located around the dwelling.

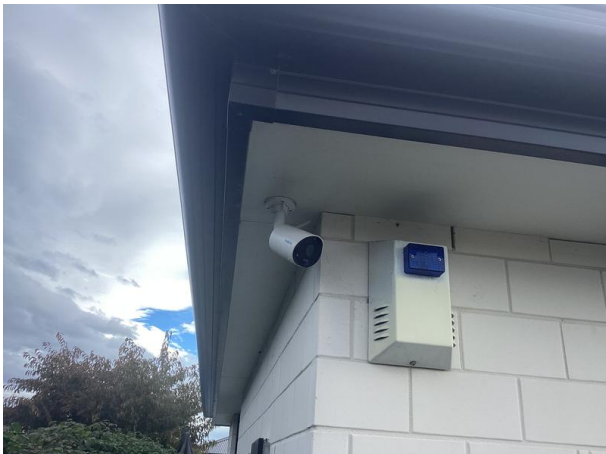
Photo 65

Security cameras were located around the dwelling. Not tested.

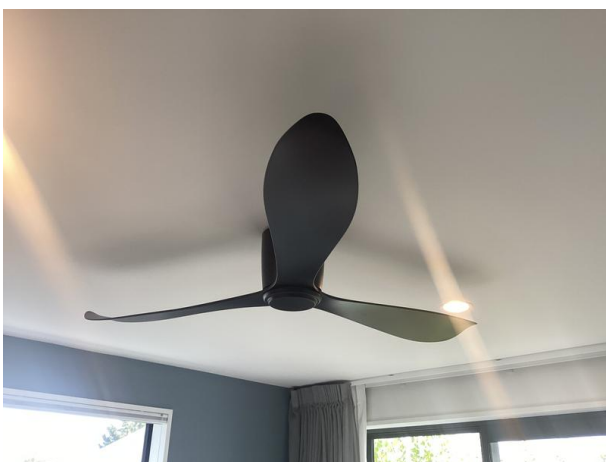
Photo 66

Ceiling fan located in bedroom three.

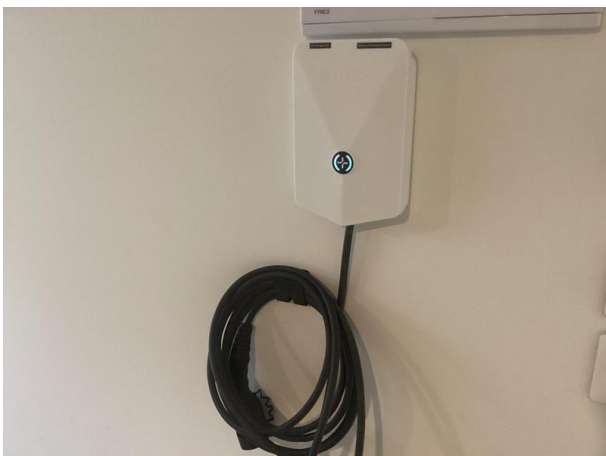
Photo 67

EV change point located in the garage.

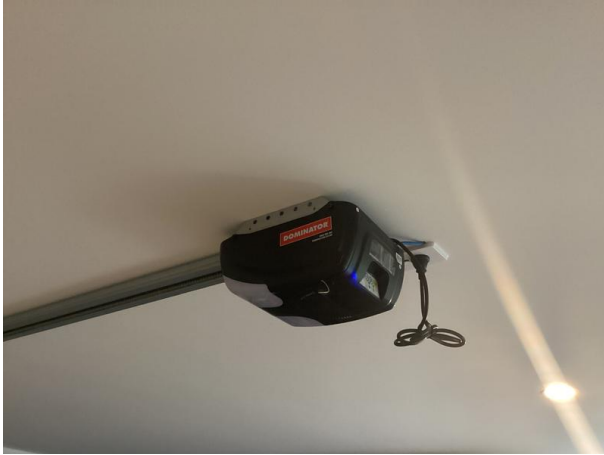
Photo 68
Automatic garage door opener.

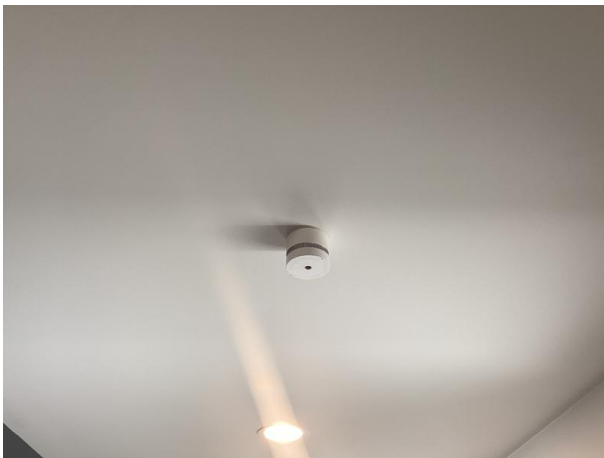
Photo 69
Smoke alarms located in the hallway
and entrance area.
