# Independent Builders Report

Total Home Inspection Services Porirua City Ltd

Mon 18 May 2026

## **34 Clunie Ave, Raumati South, Paraparaumu, 5032, New Zealand**

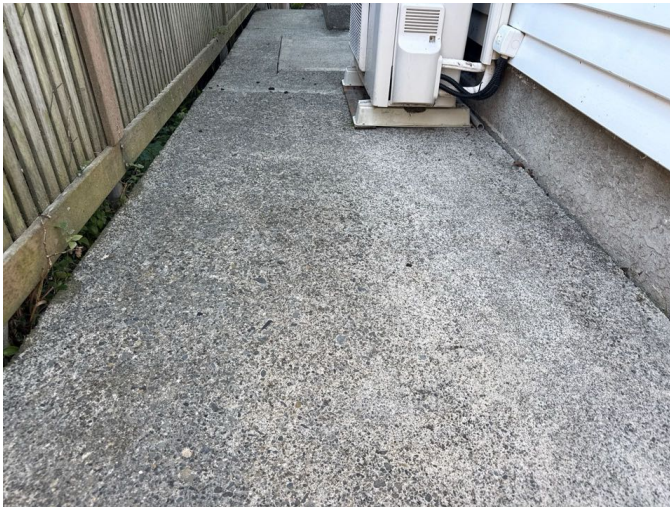
The paths are well formed and in good condition

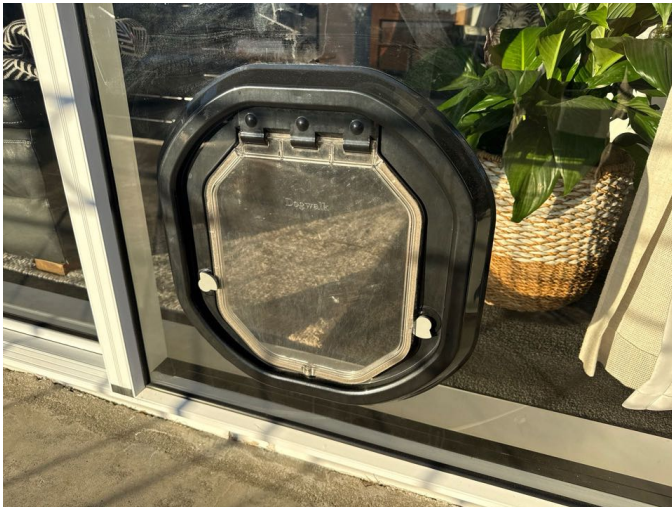
Dog door installed

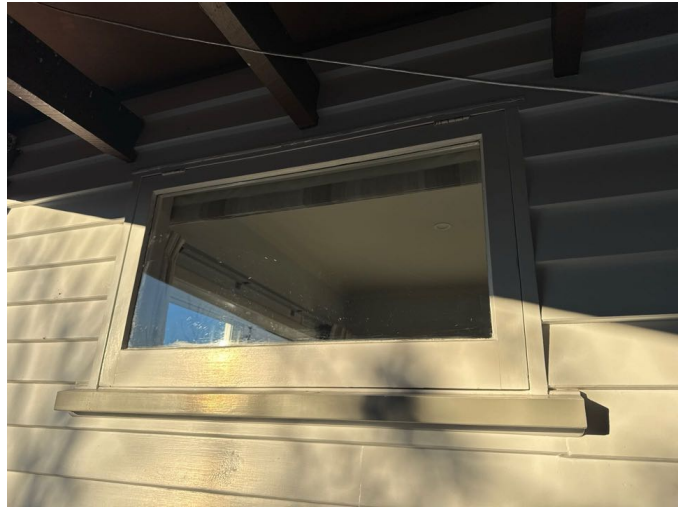
Timber windows are generally detailed with a head flashing and sill

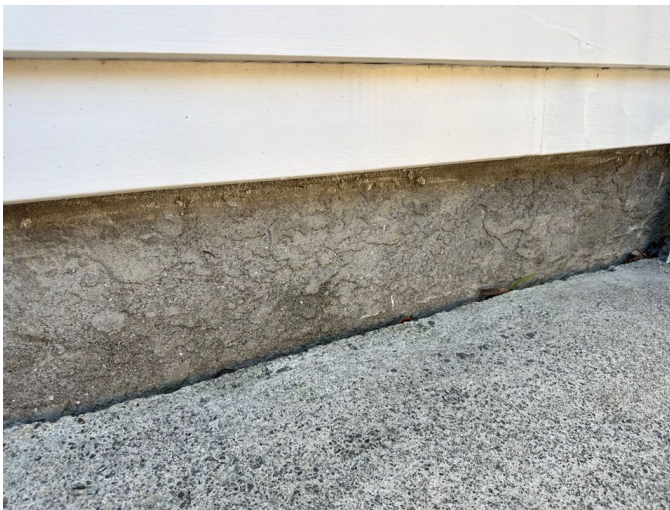
Good ground clearance around the perimeter. The current building code requires a 150mm clearance between the internal floor height and the sealed ground and 225mm to unsealed ground.

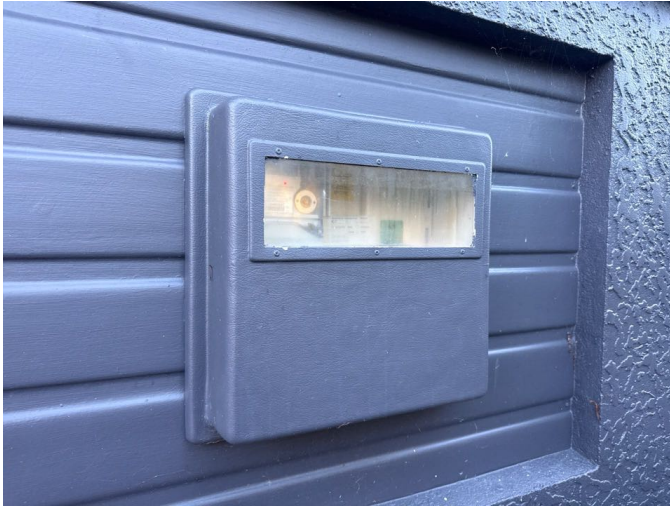
The meter board appears to be sufficiently sealed at the time of inspection. Smart meter installed, no obvious concerns sighted.

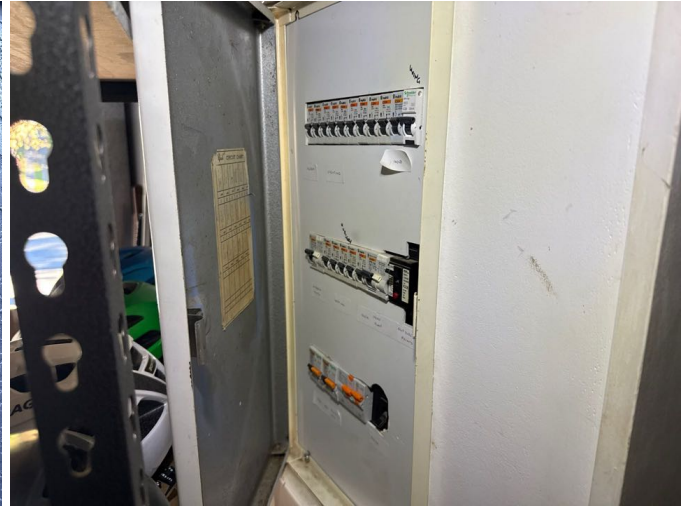
A visual inspection of the electrical system did not show any evidence of electrical overload to switches or power points. Cover plate(s) were not removed and the wiring behind the distribution board not inspected. This is beyond our scope of expertise. Please note. The assessor is not a registered electrician; no electrical safety tests or electrical component tests were undertaken. Power points, lights and switch testing therefore does not form part of this report.

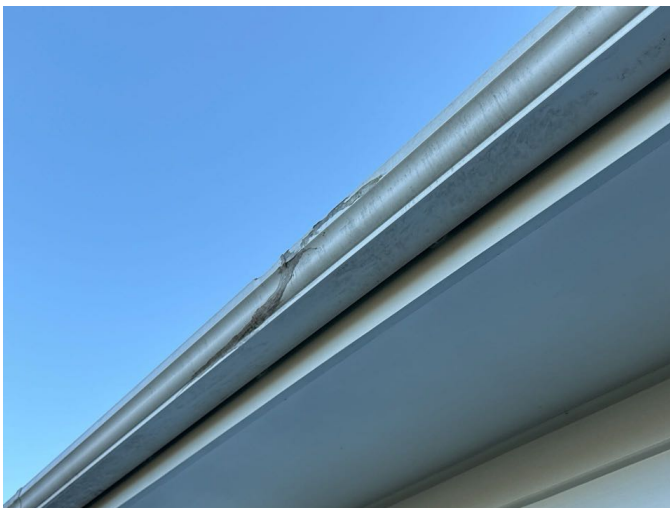
The South spouting is damaged and has been repaired with sealant. This area should be monitored over time and will need to be eventually replaced.

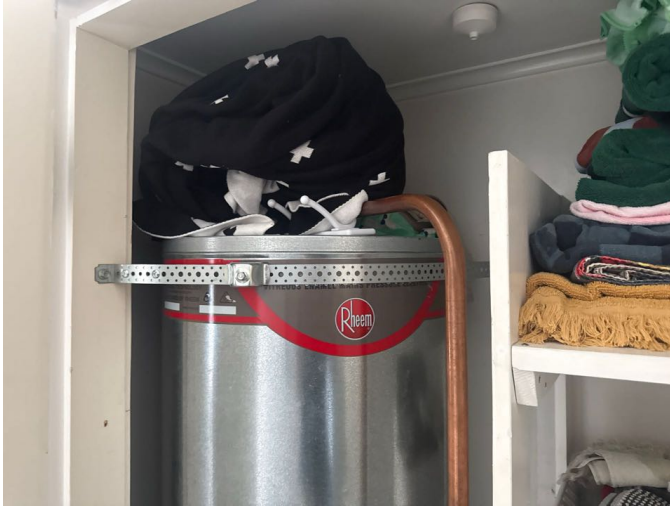
Hallway cupboard.  
 Rheem 177L Mains Pressure Electric Hot Water Cylinder. Seismic restraints installed.  
 The pressure-reducing valve that is located at the top of the mains pressure hot water cylinder should be tested every 6 months or in accordance with the manufacturer's instructions to make sure that it is in working order.

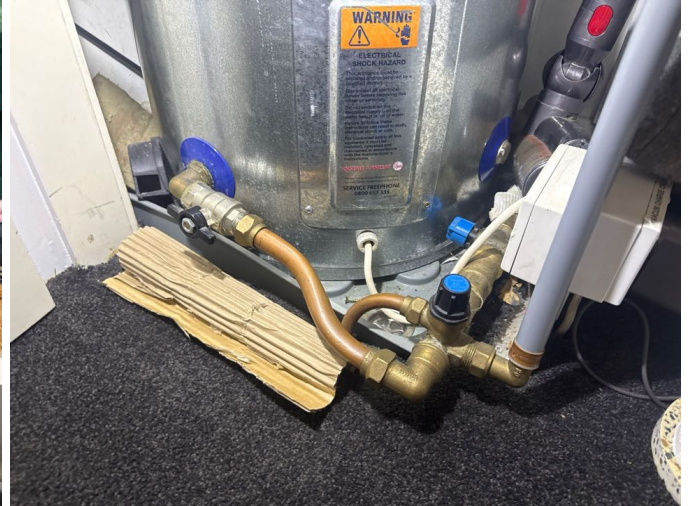
No sign of leaks around the base of the cylinder. The cylinder is placed in a safe tray with a drainage outlet as required.

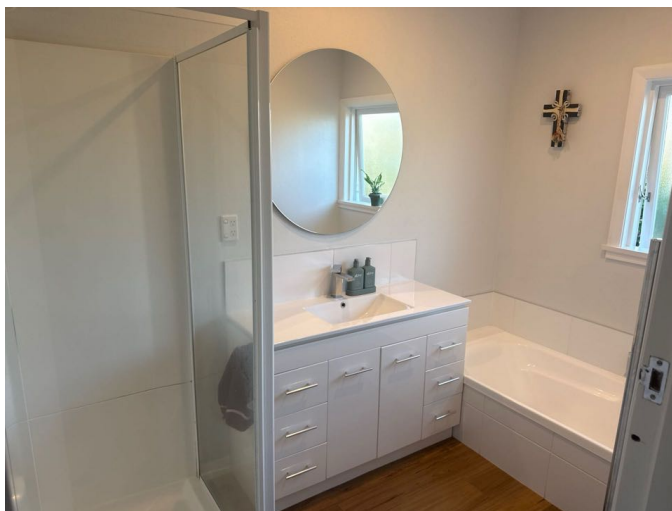
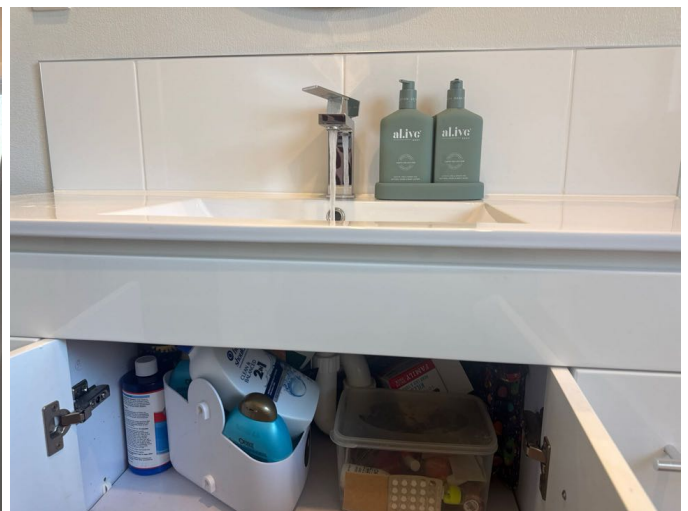
The rear edge of the vanity is well sealed. The tap is functioning well. No concerns with the water feeds or waste under the vanity

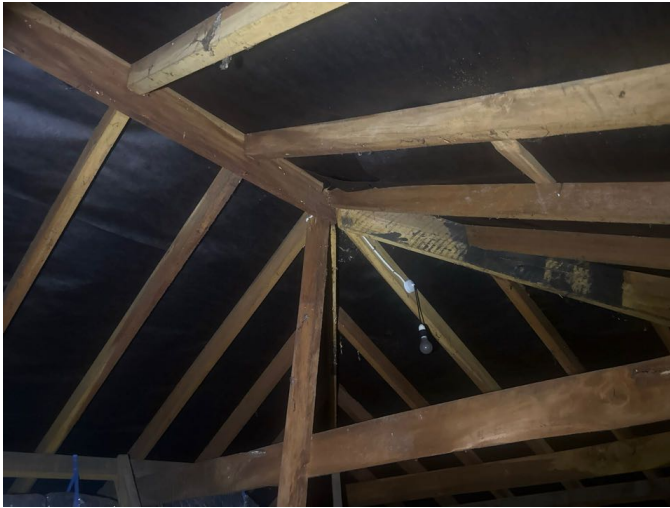
There was no evidence of current or past moisture ingress issues under the roof framing or linings (where accessible) at the time of inspection. The roof framing structure appears to be solid.

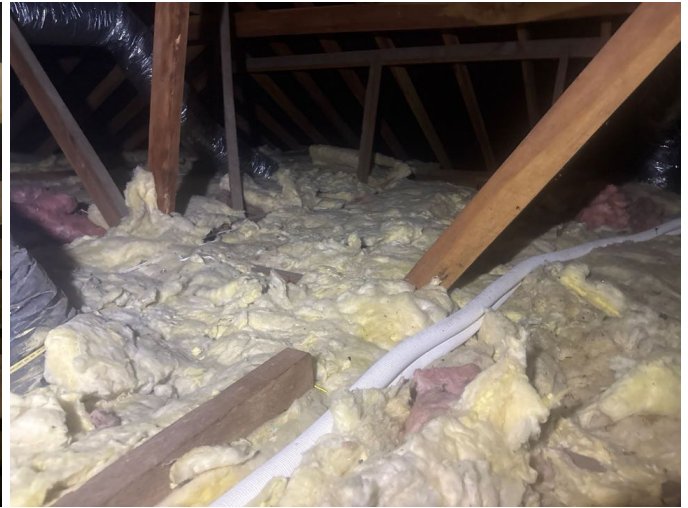
Batt type insulation installed. There was no labelling present to indicate the R-Value of the material. The thermal resistance rating or R-Value is the measure used most commonly in the building and construction industry to determine a material's ability to resist the transfer of heat. The higher the R-Value the better thermal resistance the product will provide.

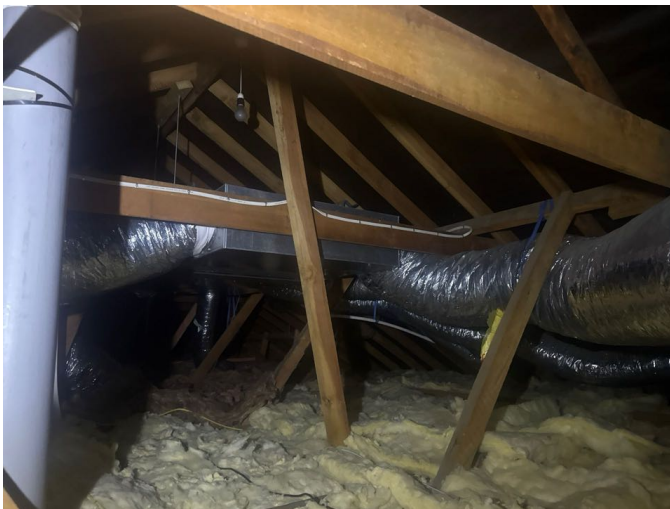
The ducted Heatpump systems internal unit is located in the ceiling cavity. Information relating to any future servicing requirements should be made available for purchasers.

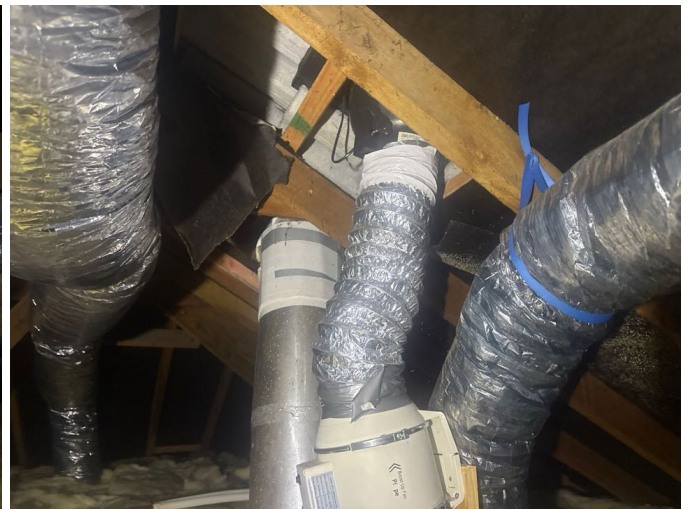
Extraction units vented to the exterior. The roof penetrations were effectively sealed at the time of the inspection.

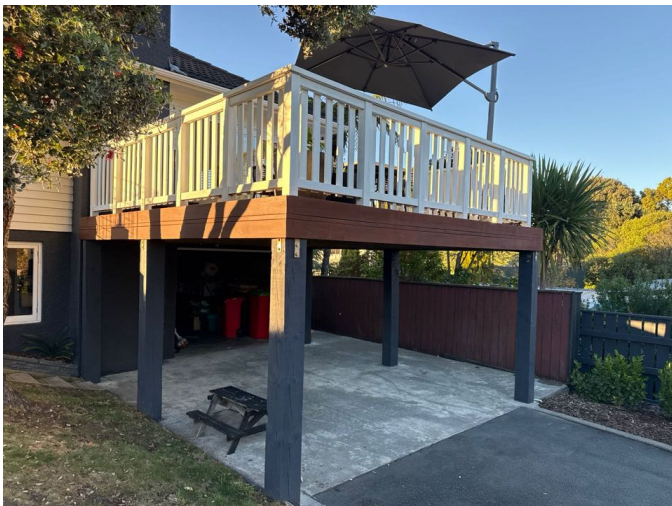
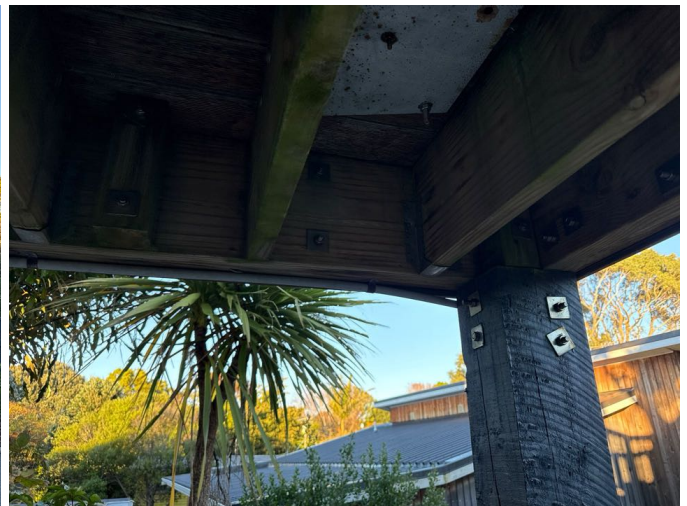
No concerns with the framing structure. Solid and well connected.

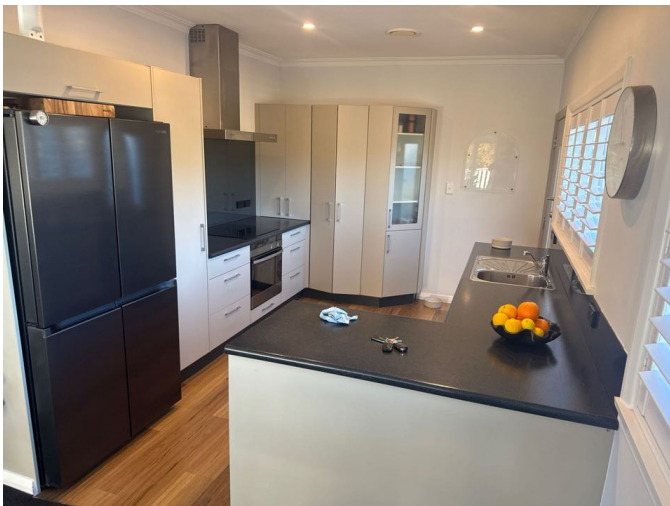
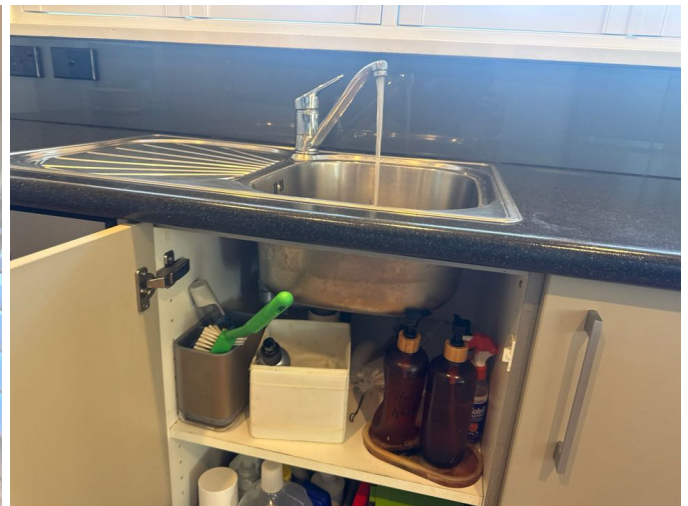
The rear edge of the bench top is well sealed. The tap is functioning well. No concerns with the water feeds or waste pipes under the sink.

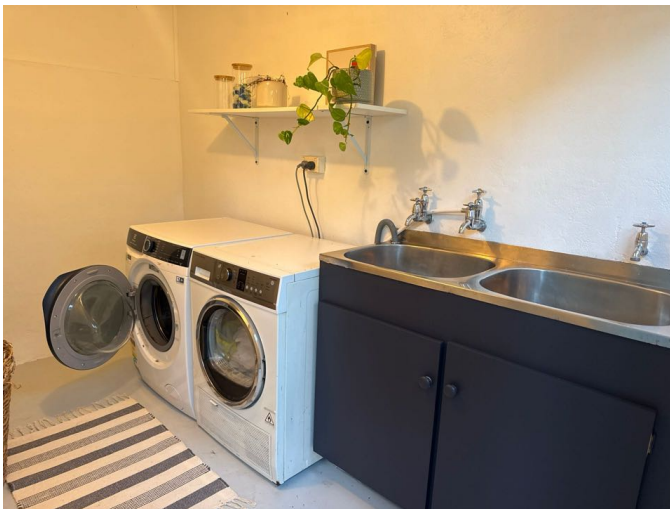
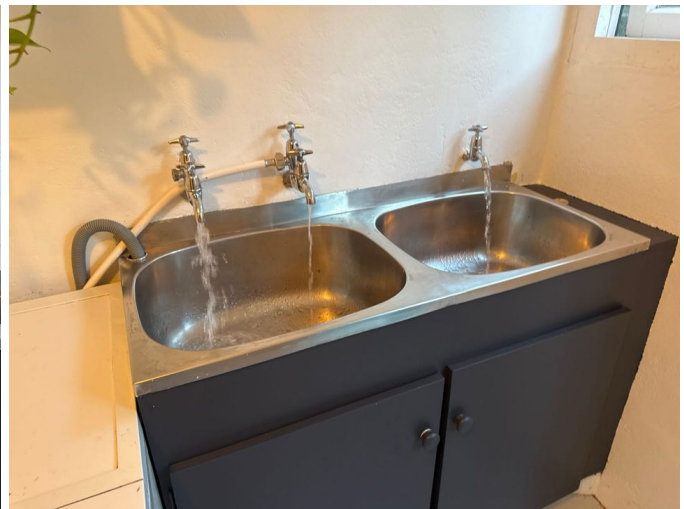
The laundry tubs are tidy and functional

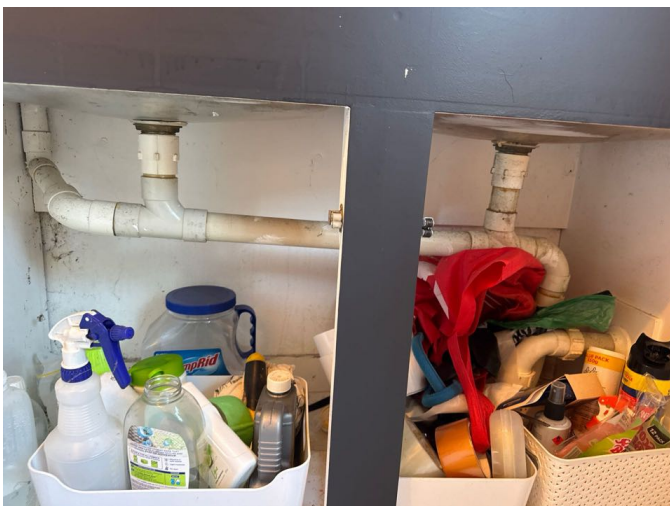
No concerns with the waste or water feeds beneath the tub

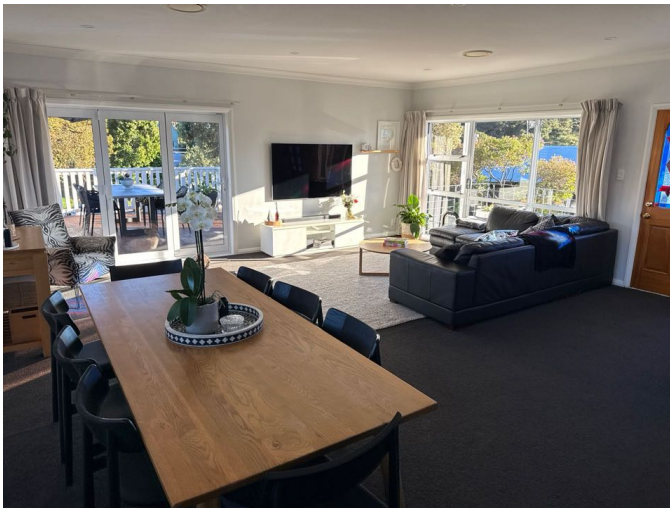
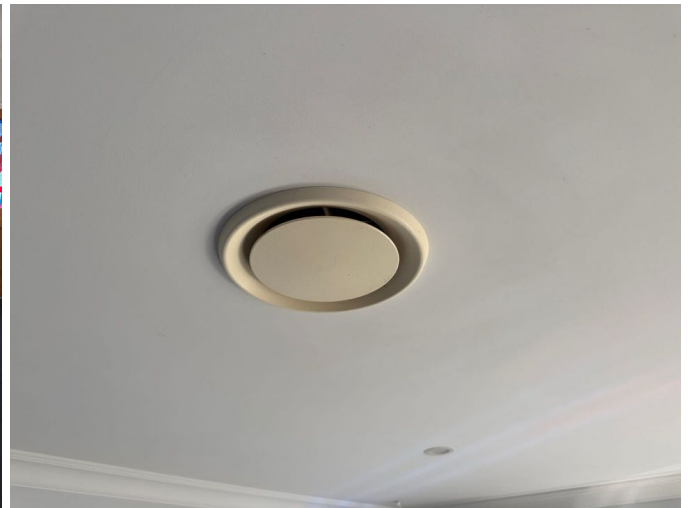
Heating is provided by a ducted Heatpump system and ceiling vents

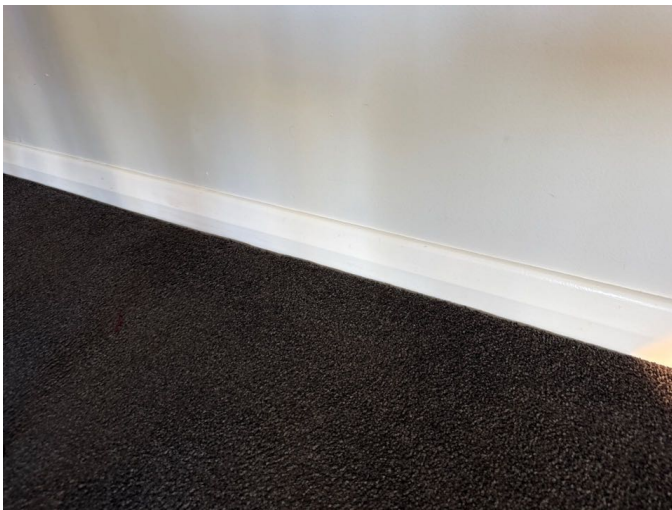
The wall and ceiling linings and carpet are in good condition

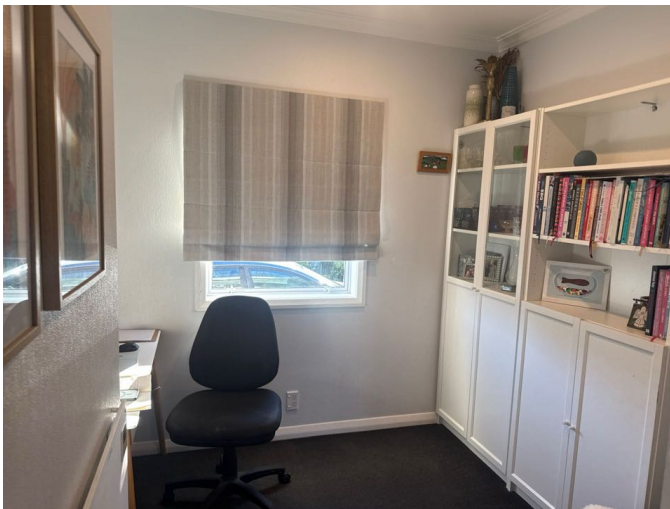
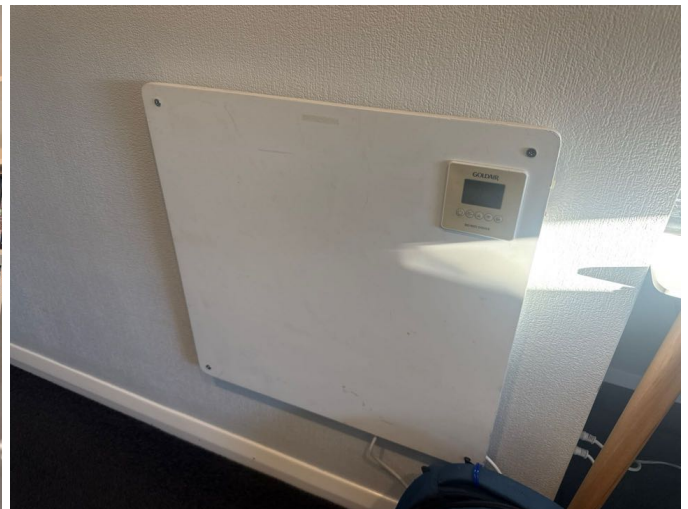
The heating appliances are not tested as part of the inspection process.

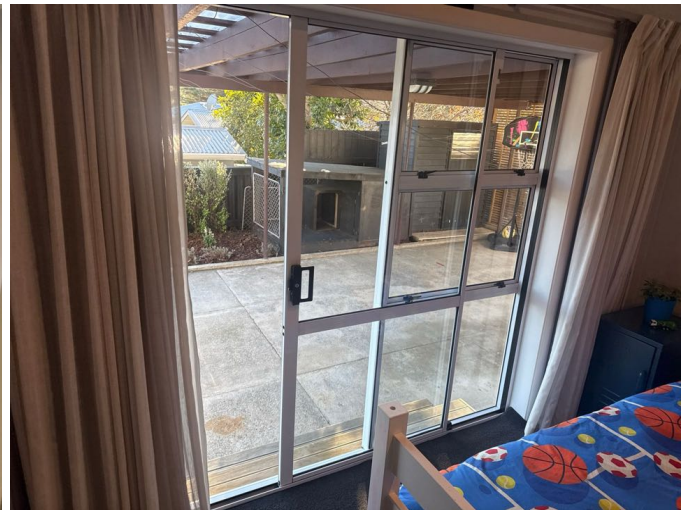
The sliding door and windows are functional

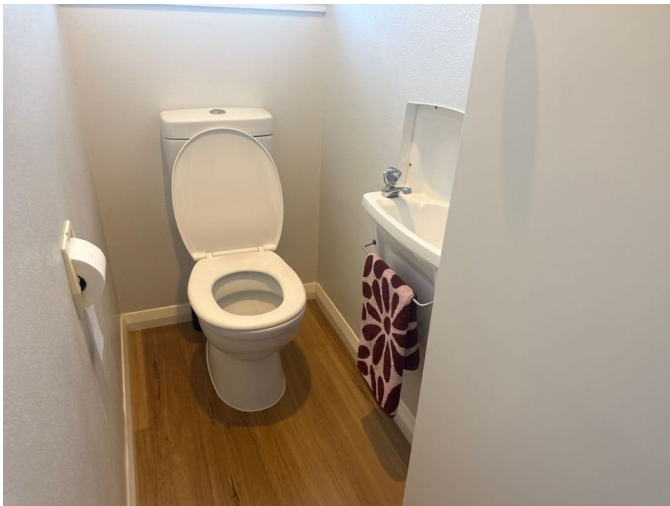
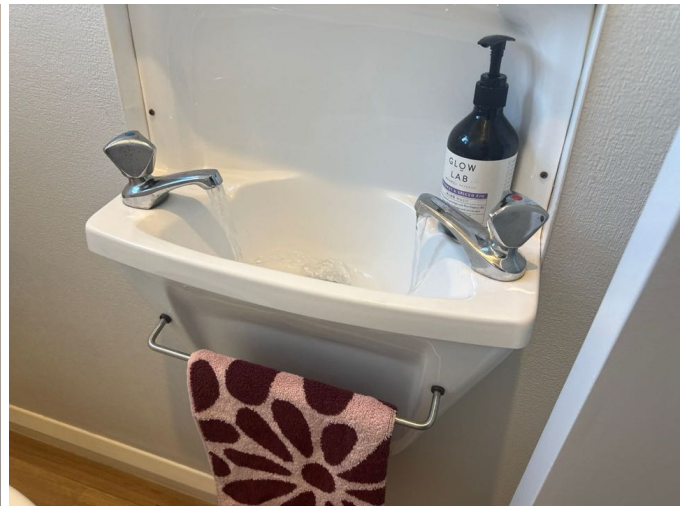
The sink is well sealed to the wall. The taps are functioning well. No visible concerns with the water feeds or waste beneath the sink.

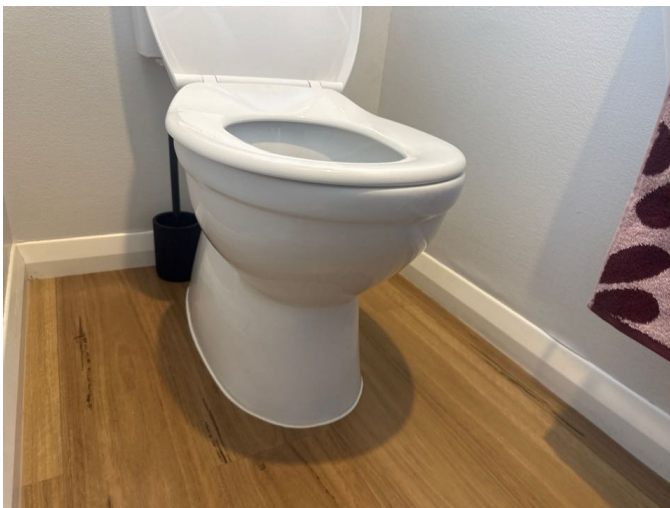
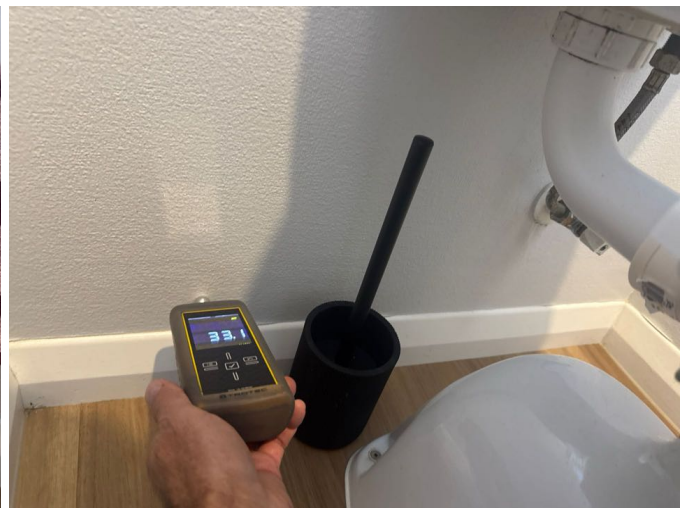
The base of the toilet is well sealed and is secure. The toilet is in a functioning condition.

Moisture levels behind the toilet were within the normal range at the time of inspection

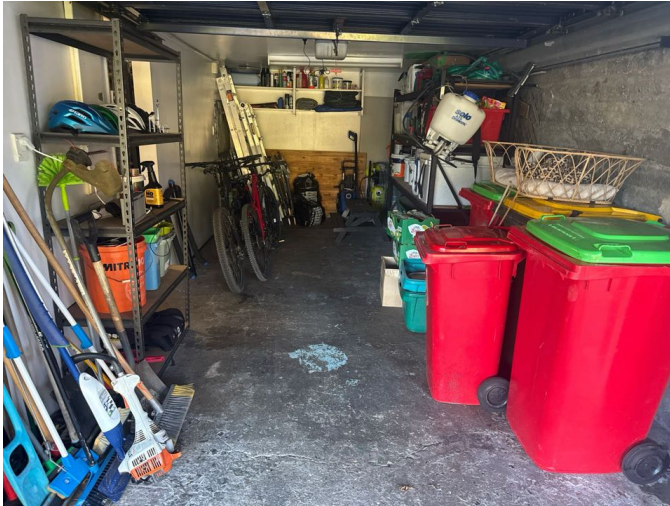
Not all areas of the garage could be fully inspected due to the presence of stored items. A full inspection is recommended once cleared. This applies to all concealed locations throughout the house.

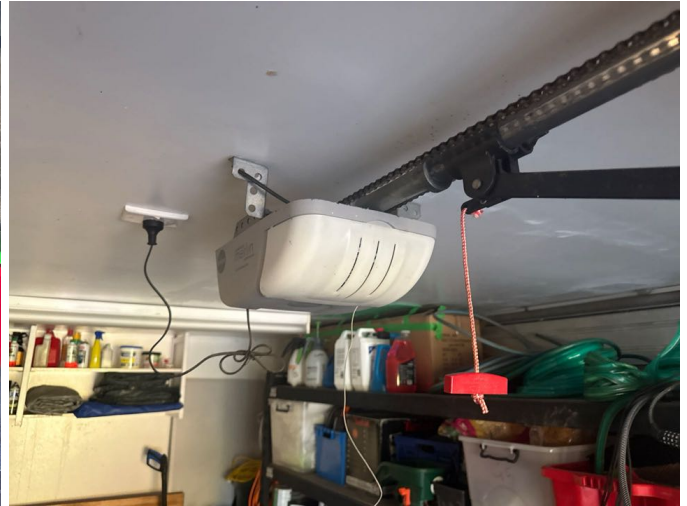
The electric garage door is functioning

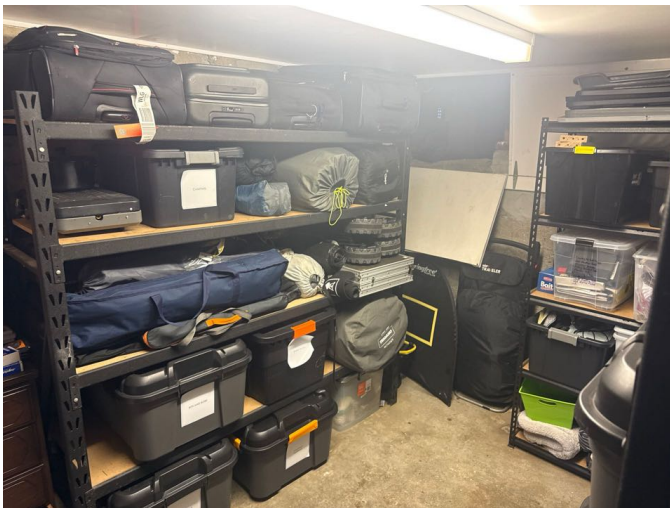
Large storeroom to the side of the garage

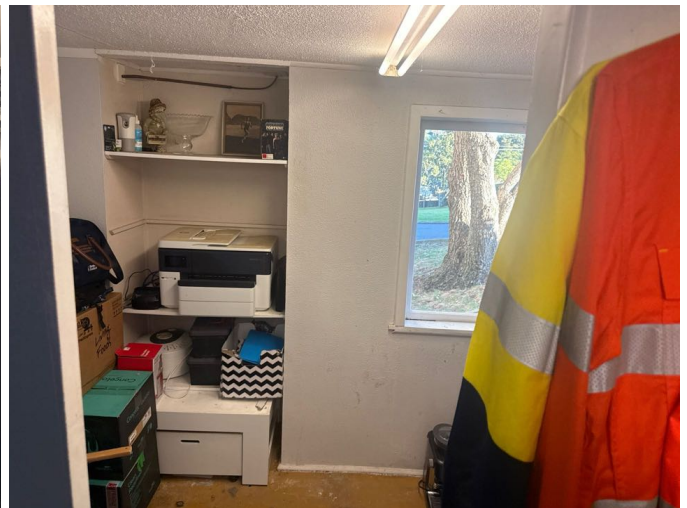
Potential office also next to the garage. No concerns found.

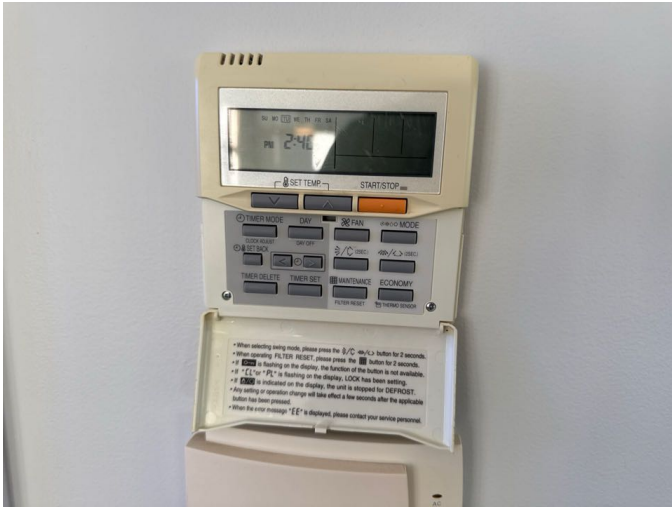
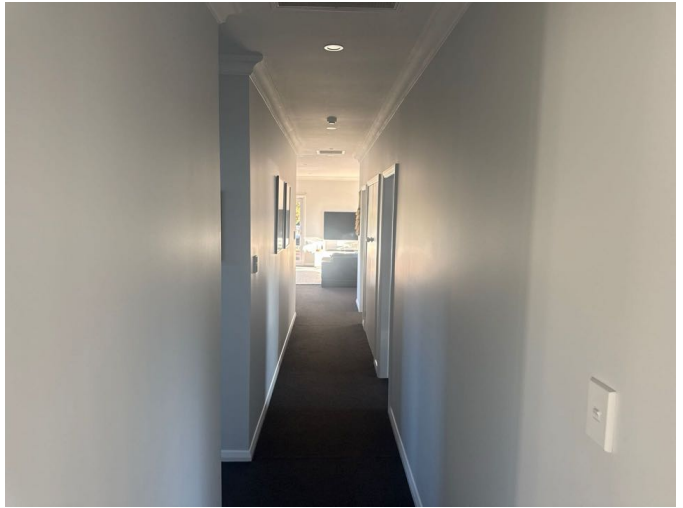
The control panel for the ducted system is located in the dining area. Untested. The hallway is tidy
