Property Inspection Report

- Habit Hawkes Bay Limited -

***20 Aintree Rd
Havelock North***

***This report is for the sole benefit of:
Brittain Family Trust***

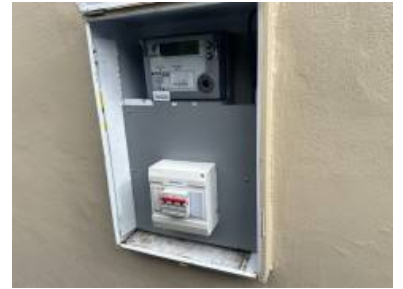
Mains power fuse board is found at the front of the dwelling. All modern fuses are installed here.

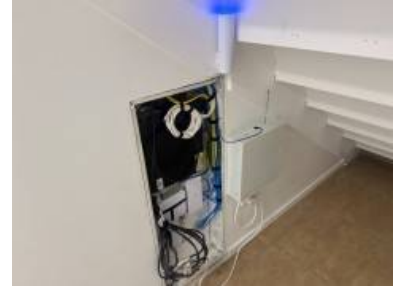
Data panel installed here.

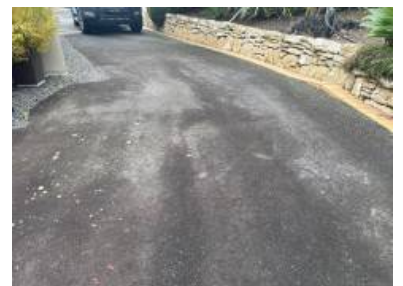
Asphalt, Good fall for drainage, Good condition.

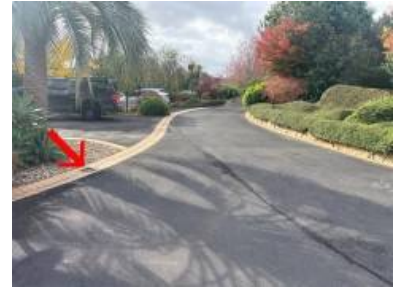
Drainage installed. Good condition.

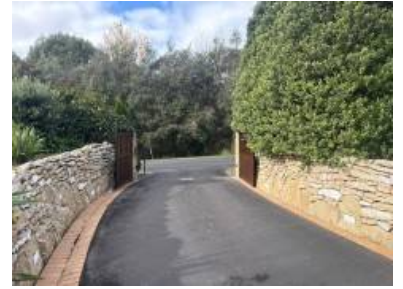
Gates were not tested on inspection. Material in Good condition.

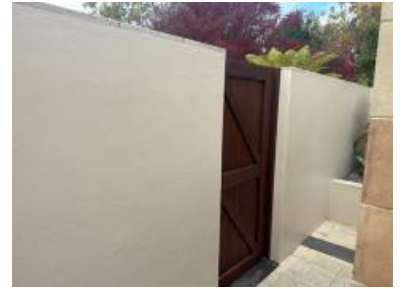
Concrete Block, Plaster Finish, Fencing material in: Good Condition.

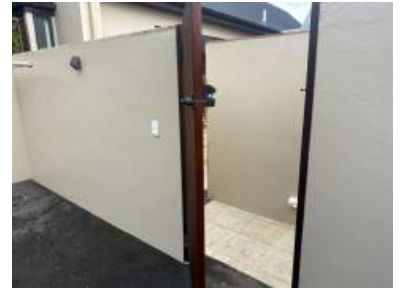
Timber Good condition.

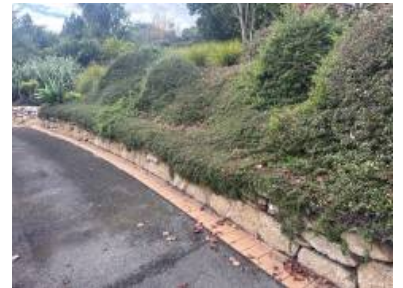
Stone, Good Condition.

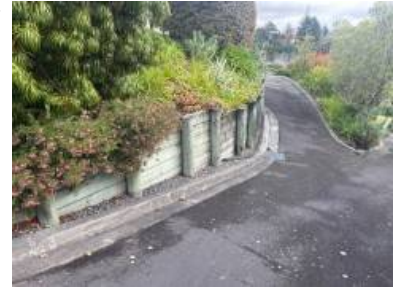
Timber, Reasonably secured, aging, and minor deterioration evident. Not of a structural concern.

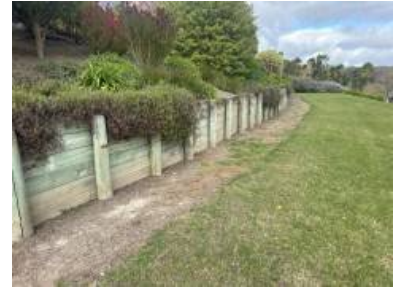
Timber, Secured in a professional manner, Good Condition.

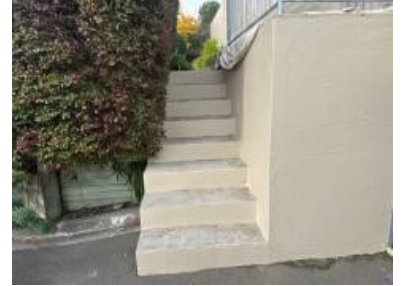
Concrete, Good Condition, Suggest a handrail is installed to stair areas.

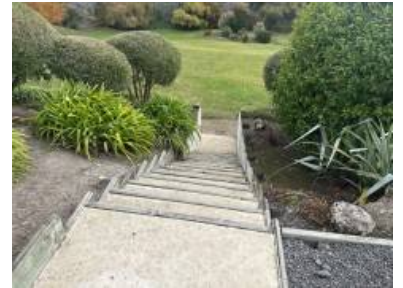
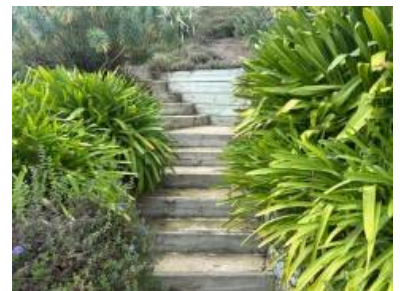
Timber. Good Condition.

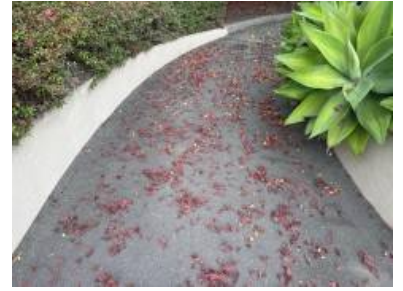
Asphalt, Good Condition.

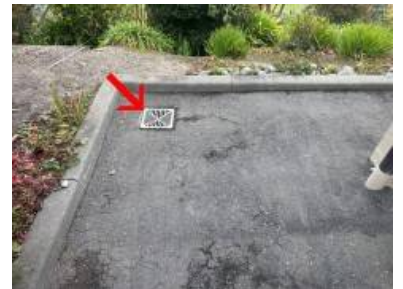
Good fall and Drainage installed.

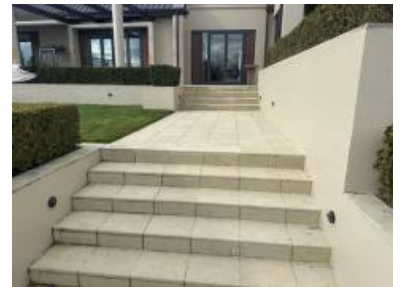
Paving installed, Reasonable Condition.

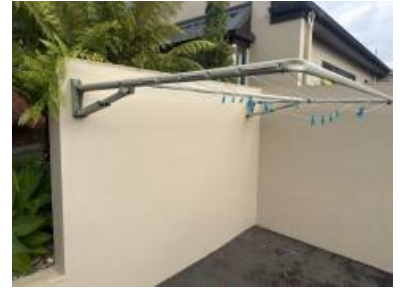
Fold Away clothesline is installed here. Good Condition. Not tested.

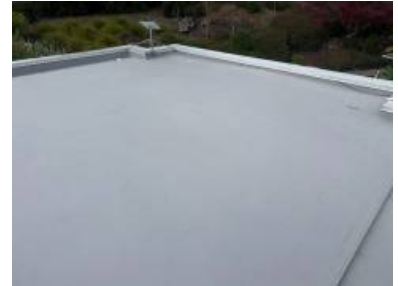
Roof cladding: Flat roof membrane installed visually in good condition. This roofing material is a specialist trade. If further information is required I suggest a flat roof membrane expert inspects this area.

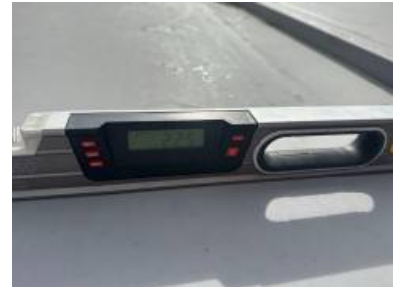
Roof Pitch The minimum roof pitch for this type of roof cladding which meets today's current regulations is one degree. The pitch of this roof is two degrees. This roof pitch meets today's code.

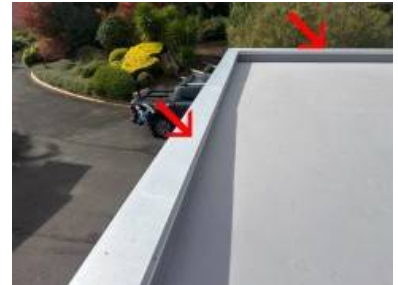
Garage roof flashings & ridge capping: Good flashings, well secured, Material in, Good condition.

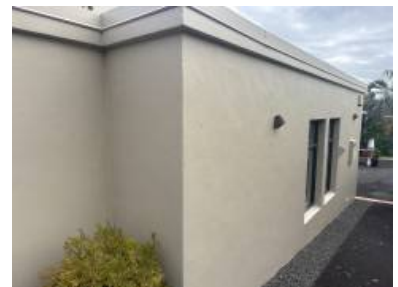
External Wall Cladding: Concrete block, Plaster finish, Material in, Good Condition.

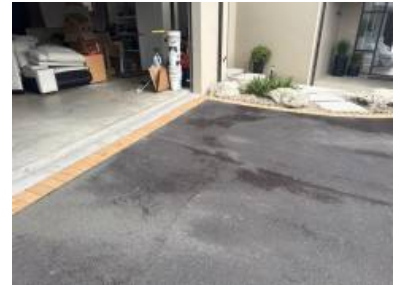
Good fall away from door.

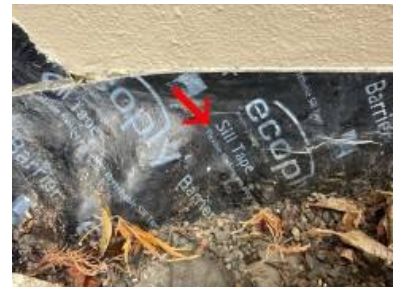
The back corner of the garage has signs of moisture ingress with efflorescence present to the internal block work and elevated moisture readings to the timber joinery. A retrofitted "sill tape" flashing was observed to some areas of the garage where moisture could not be seen internally, however where the moisture staining is visible internally the flashing appears to stop at the slab for the gas bottles and does not extend behind this area. Confirmation of the product used on the side with visible moisture staining could not be determined on our non invasive inspection.

Pictured here is on the opposite corner of the garage to the moisture staining internally, showing the product used here is a flexible sill tape, this product is generally used for sealing window penetrations rather than a dedicated below-ground tanking membrane. Confirmation of the product used on the side with visible moisture staining could not be determined on our non invasive inspection.

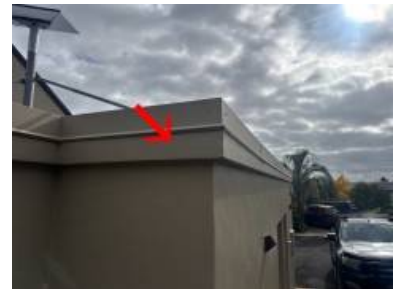
Plaster finish fascia in good condition.

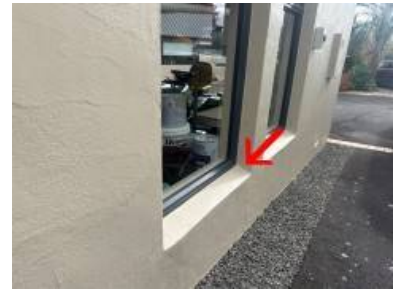
Concrete block, Plaster finish, Recessed design, Good Condition.

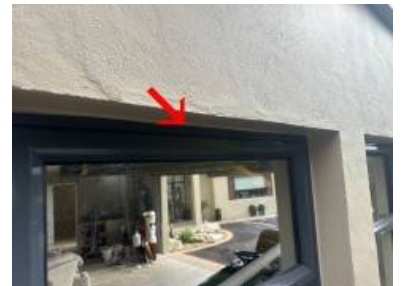
No flashings over the door and windows, not required.

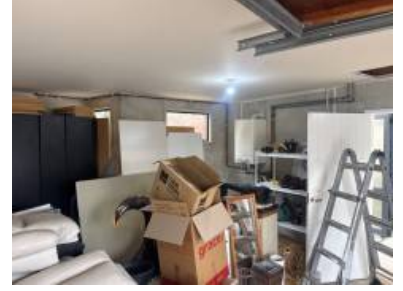
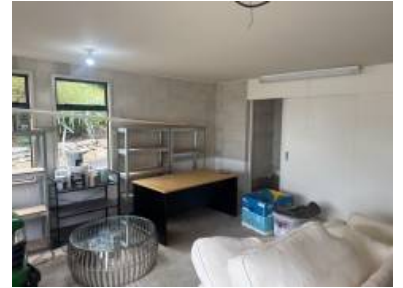
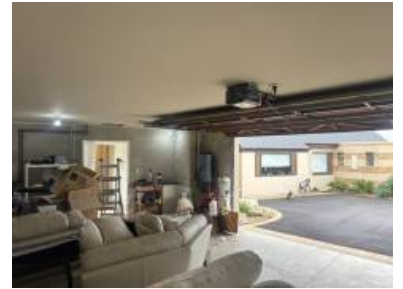
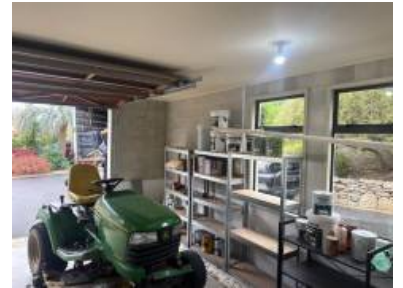
Concrete block installed in this area. Material in, Reasonable Condition.

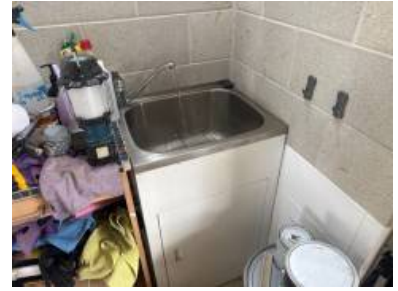
Super tub installed, draining well without leaks or blockages.

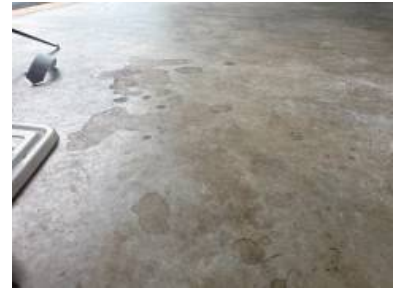
Concrete floor slab (unpainted), Good Condition.

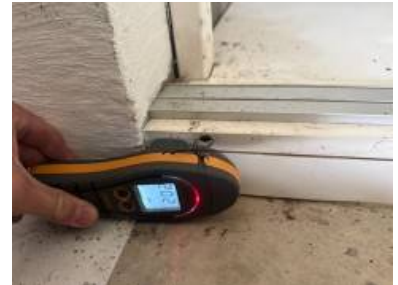
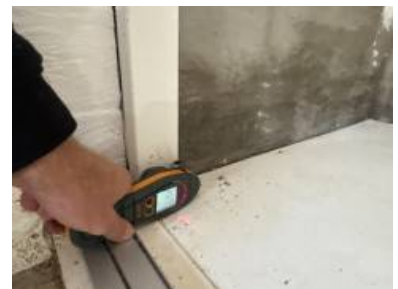
Areas of moisture

Relative moisture readings of concern were found to the timber in this area and efflorescence is present to the concrete blocks.

General summary and comments from the inspector on this area. Reasonable condition. Shows signs of deterioration, decay or cosmetic damage due to lack of maintenance, age or misuse. This area may continue to deteriorate if not maintained.

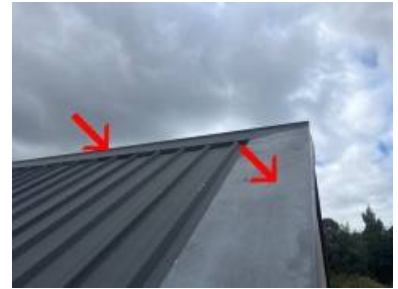
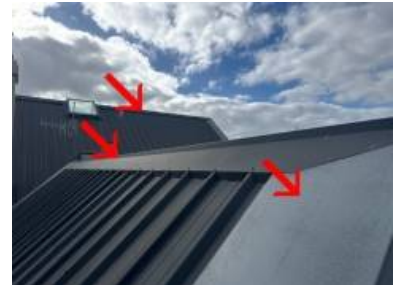
Main roof flashings & ridge capping:

Good flashings, well secured, Material in, Reasonable condition.

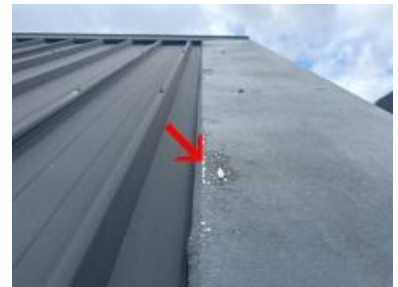
Painting is suggested to the barge flashings to prolong the materials life as the coating can be seen peeling.

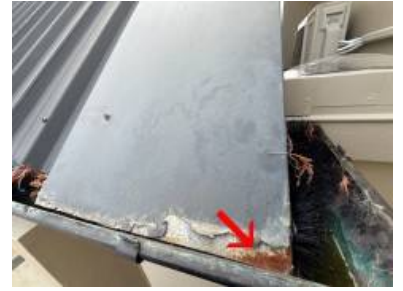
I suggest this roof to wall junction is resealed to prevent future moisture ingress. This is pictured outside the hallway adjacent to the middle wing bathroom where the membrane roof area meets the colour-steel roofing area.

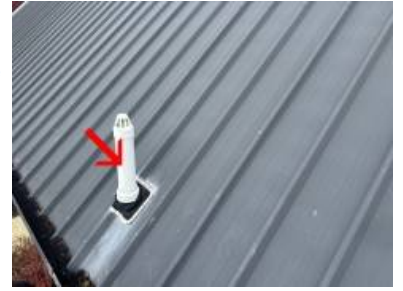
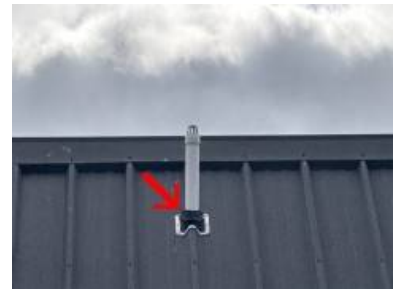
Outlet Pipes:

PVC, Material in, Good Condition. The flashing should be on a diagonal to the roofing iron to ensure water does not pool and cause deterioration to the roofing iron.

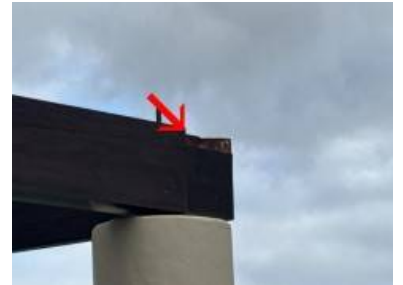
Damage to fascia here above pool area. Repair or replacement is suggested.

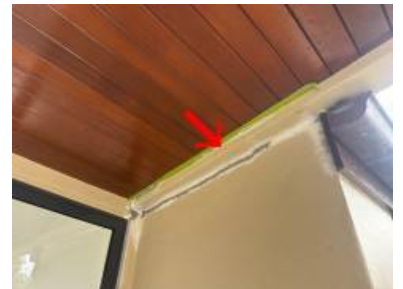
Painters were on site at time of inspection were not 100% finished.

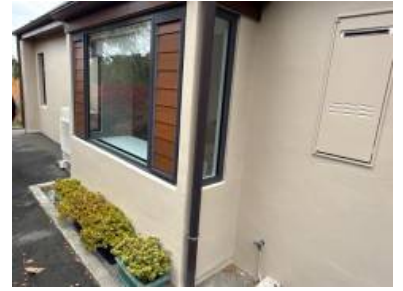
Drainage installed to these areas.

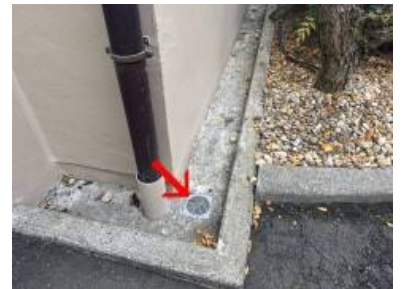
Tiles over Concrete block Material in, Good Condition.

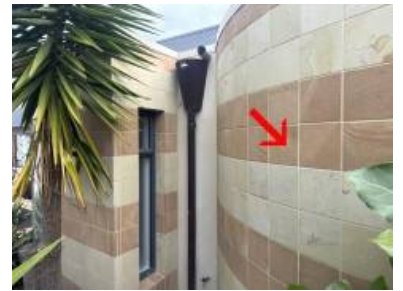
Cladding Penetrations:

The penetrations through the cladding have been well sealed here.

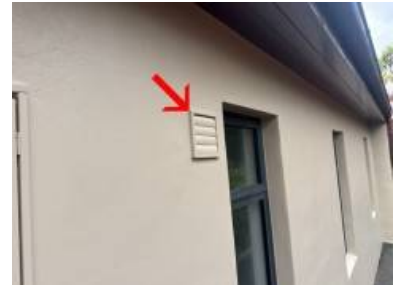
Ground Clearances

Good ground clearance from the finished ground level outside to the finished floor level inside.

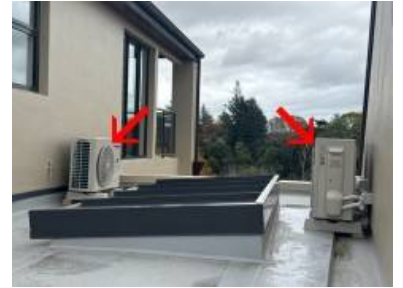
The heat pump unit is found at the back of the house. The refrigeration drainage pipe drains onto the ground, it is good trade practice to have this draining to a gully trap but legally is not required.

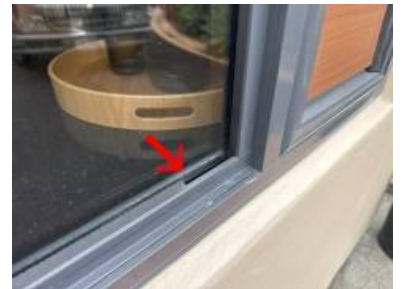
Window Sills & Scribes

Plaster finish, Recessed design, Good Condition.

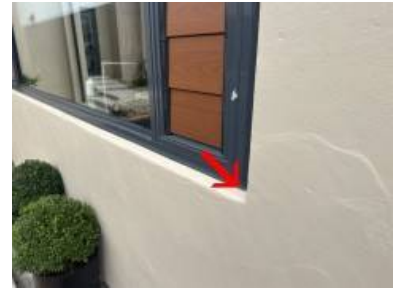
Flashings over windows and door areas: Well fitted flashings, Good Condition.

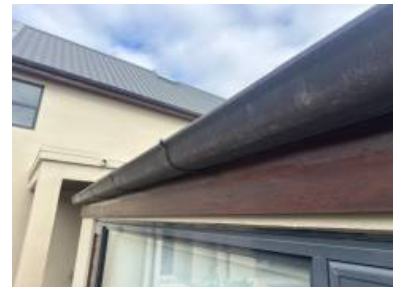
Leaf brush installed inside of guttering could not be viewed.

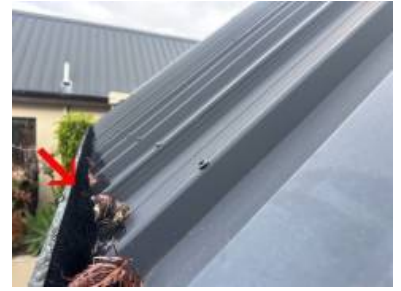
Internal gutters installed in this area. Internal gutters are a high risk area where water has the potential to enter the building envelope. Be sure keep cleaned and clear from debris at all times in order to prevent any moisture ingress issues in the future. This needs to be an ongoing maintenance task.

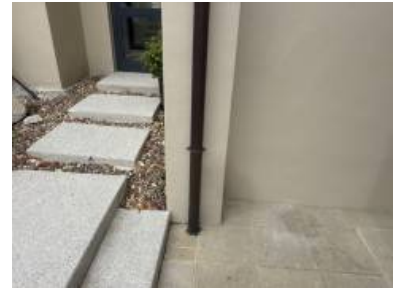
Copper rainwater heads installed
Material in good condition.

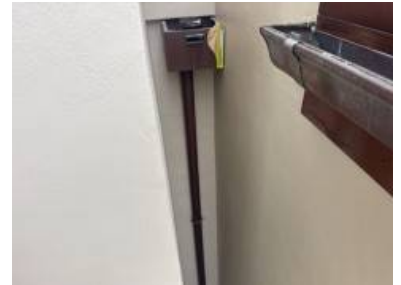
Overflow for flat roof area also seen installed here.

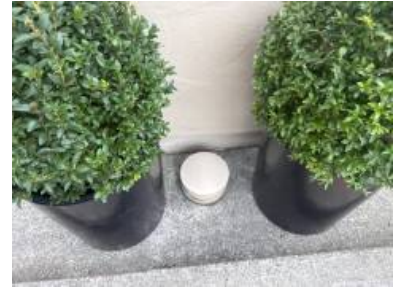
Paint:

Good Condition.

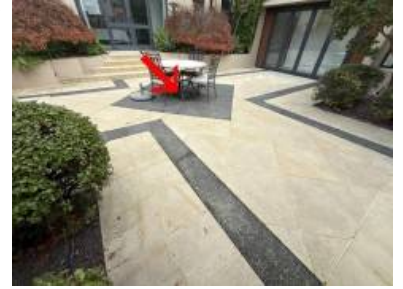
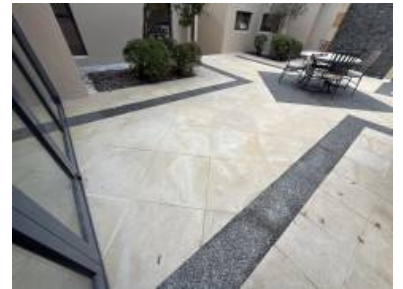
Ground Floor Patio:

Paver's installed, Good fall away from joinery and drainage installed.

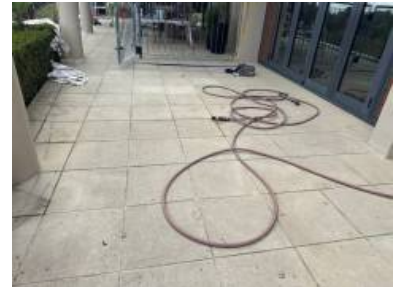
Tiles with good fall away from joinery. Good Condition.

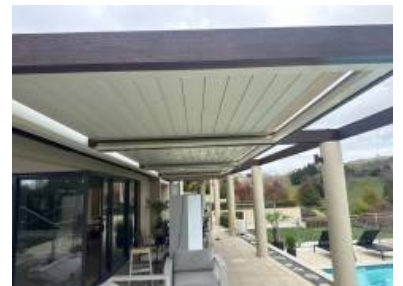
Post and overhead coverage. Good Condition.

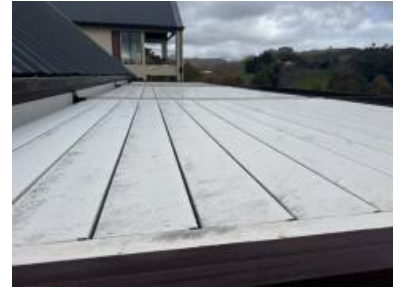
Louver roof system not tested.

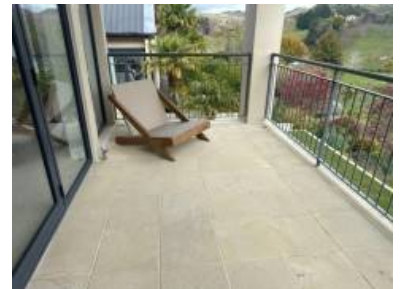
First Floor Patio:

Tiled, Good Condition.

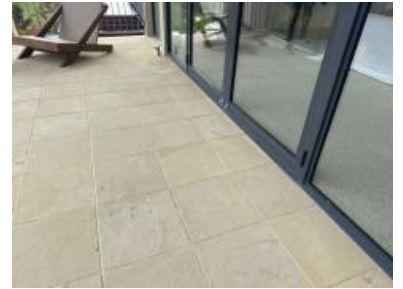
Good fall away from joinery.

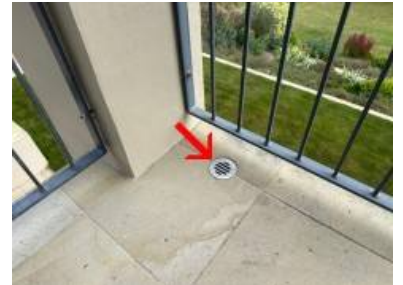
Drainage installed here.

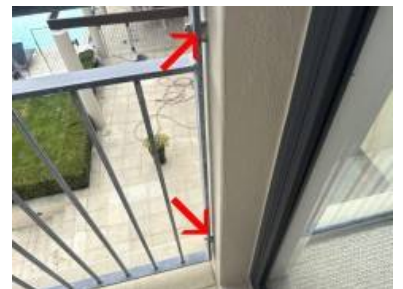
Handrail fitted and is packed off the cladding as required.

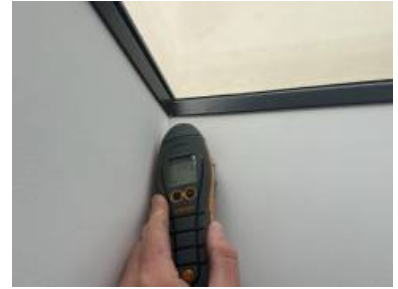
Internal ceiling and wall linings:

Base linings intact, Skylight installed. Skylights are not inspected as this is a specialised field. To learn more about this area further investigation will need to be carried out by a skylight installer or roofer. We checked for moisture around the skylight on the day of inspection. No elevated moisture readings or water staining of concern were found. Good Condition.

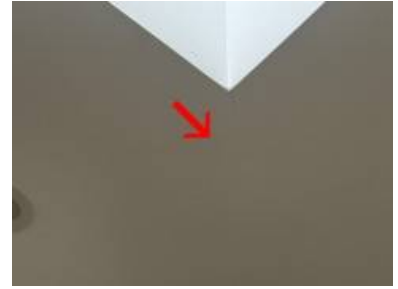
Cracking evident to the plaster joins at the corners of openings this is a common place where you will get movement.

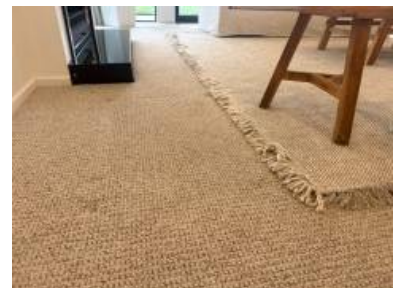
Floor Covering: Carpet fitted, Good Condition.

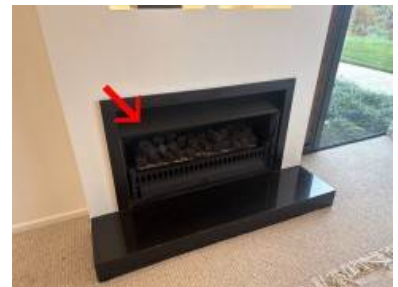
Heating: Built in gas fire/heater. Not tested or inspected, this is outside of our scope.

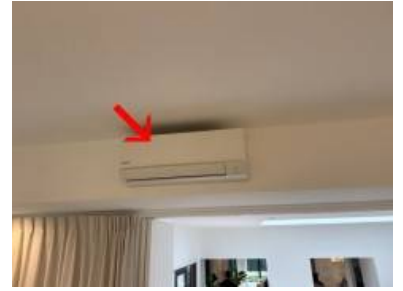
Heat pump Installed. Not tested or inspected, this is outside of our scope.

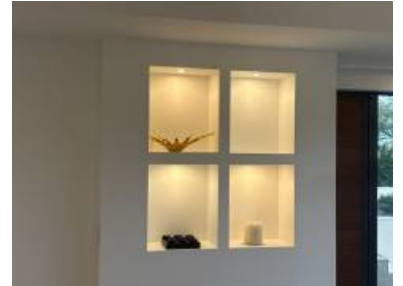
Storage:

Shelving installed here.

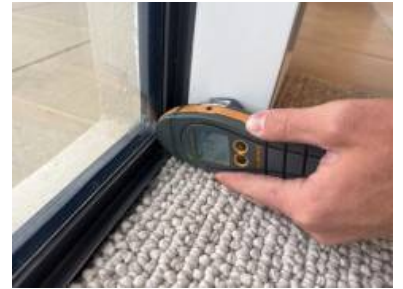
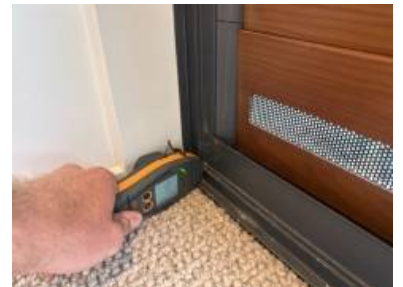
No moisture readings of concern were found in this room on the day of inspection.

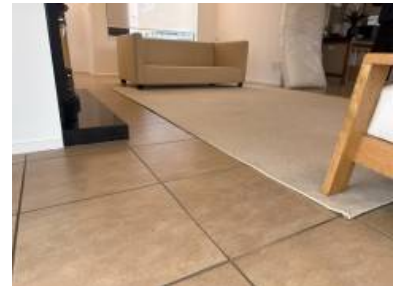
Floor Covering: Tiles fitted, Good Condition.

Minor grout repair suggested this is pictured beside the corner sliding door.

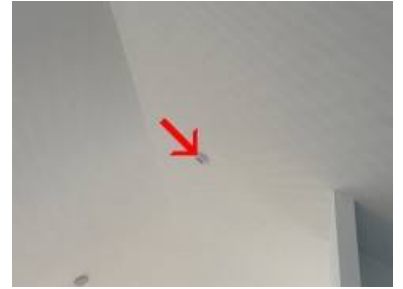
Hard wired smoke detector fitted in this room.
Securely Installed.

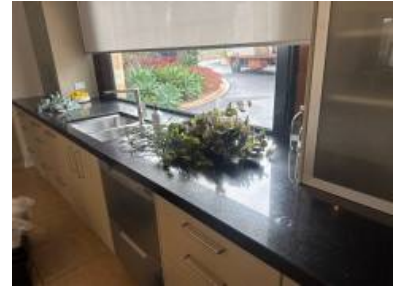
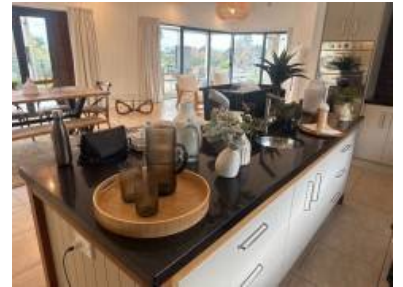
Bench top:

Manufactured stone. Good condition.

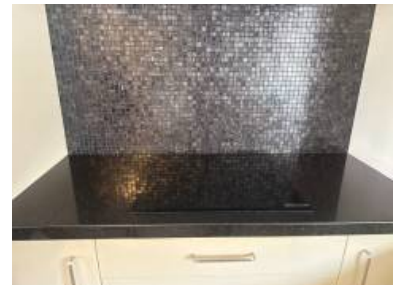
Splash back fitted, Good condition.

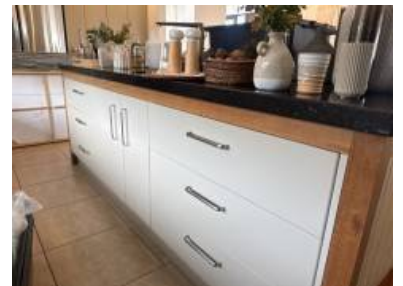
Joinery Units:

Good condition, good working order.

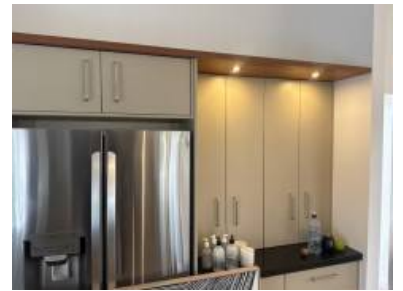
Pantry Area: Double size.

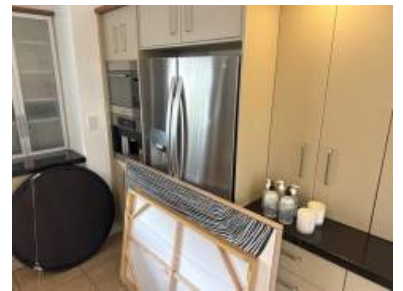
Refrigerator Area: An area has been built within the joinery units.

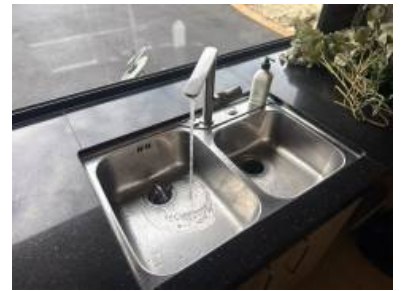
Sink Area: Double, Stainless steel, Good condition.

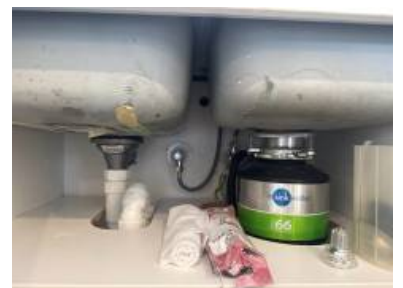
Plumbing: Flexi hose installed here. No plumbing running in the wall cavity was viewed, the plumbing product is unknown unless viewed in the ceiling space and this will be noted on in their respective areas of the report. The waste pipe in this area is modern PVC.

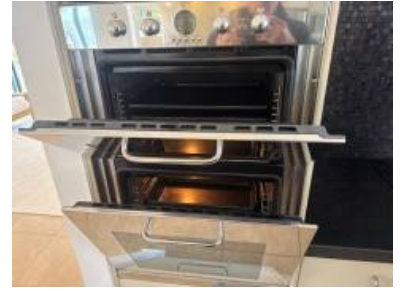
Wall mounted design, Tested, working. **Be aware thermostats are not checked. This is a specialized inspection which we do not carry out. We simply check if the oven heats up or not.** Good condition.

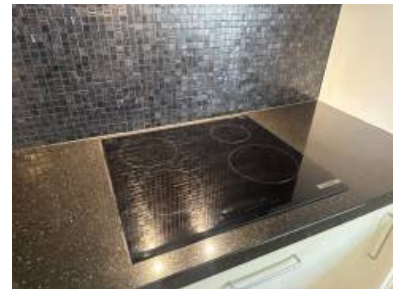
Electric hot plates, Induction stove top. This system requires a pot to be placed on unit to activate. It is not practical for us to do so, this unit was not tested.

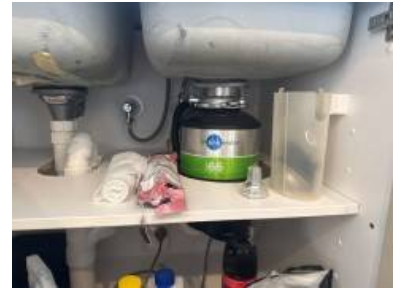
Wastemaster installed, Tested, working, Good condition.

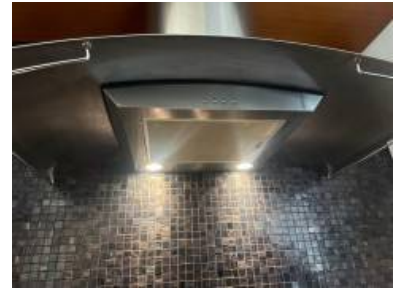
Range hood installed, Tested, working, Good condition.

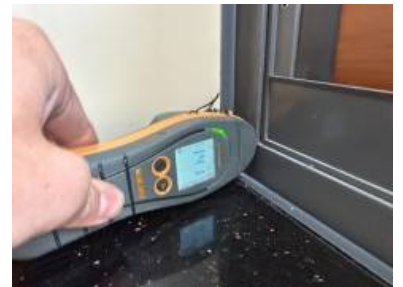
No moisture readings of concern were found in this room on the day of inspection.

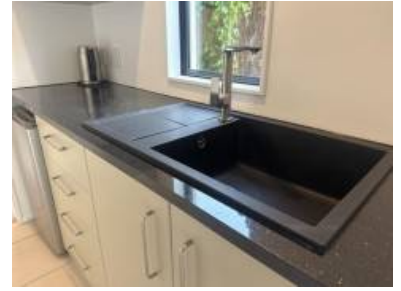
Bench top: Manufactured stone, Good condition.

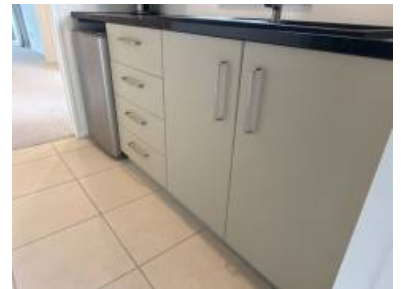
Joinery Units: Good condition, good working order.

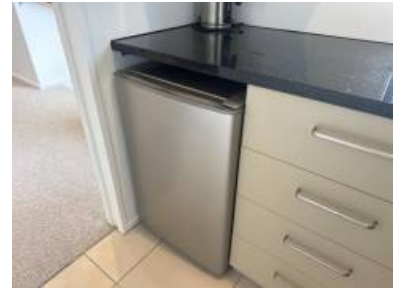
Refrigerator Area: An area has been built within the joinery units.

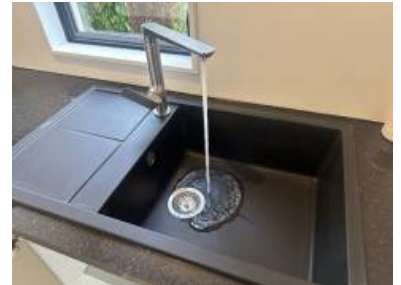
Sink Area: P.V.C, Good condition.

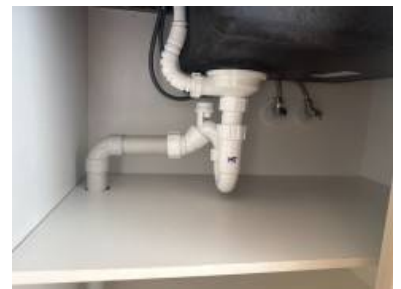
Plumbing: Flexi hose installed here. No plumbing running in the wall cavity was viewed, the plumbing product is unknown unless viewed in the ceiling space and this will be noted on in their respective areas of the report. The waste pipe in this area is modern PVC.

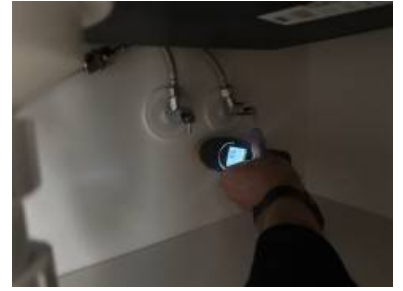
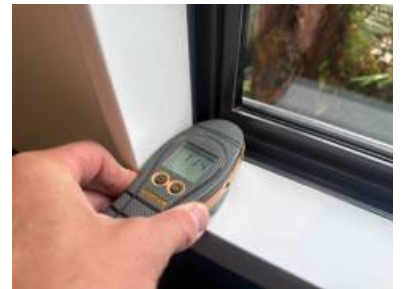
No moisture readings of concern were found in this room on the day of inspection.

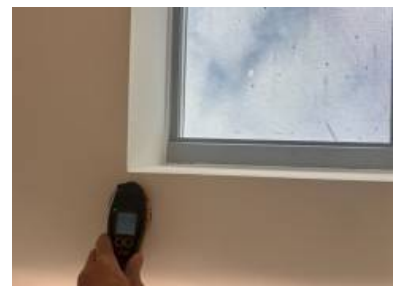
Base linings intact, Skylight installed. Skylights are not inspected as this is a specialised field. To learn more about this area further investigation will need to be carried out by a skylight installer or roofer. We checked for moisture around the skylight on the day of inspection. No elevated moisture readings or water staining of concern were found. Good Condition.

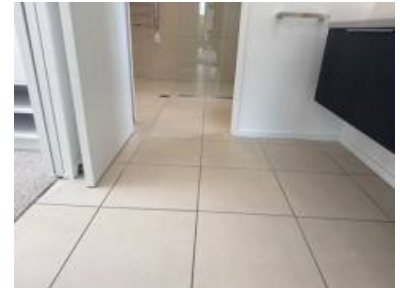
Floor Covering: Tiles fitted, Good Condition.

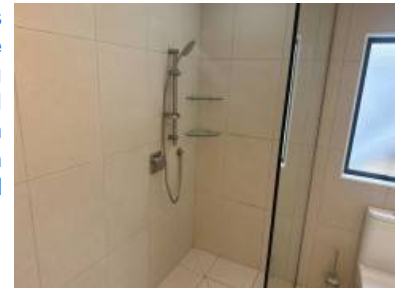
Shower: Walk in design, Tile surround, [These tiles should have a water proofing membrane installed behind them, this is done before tiling by the tiler. A producer statement and waterproofing warranty documentation for both the application and product should have been supplied by the installer. Make sure to view and obtain a copy for your future warranties.](#) Glass surround, Good Condition.

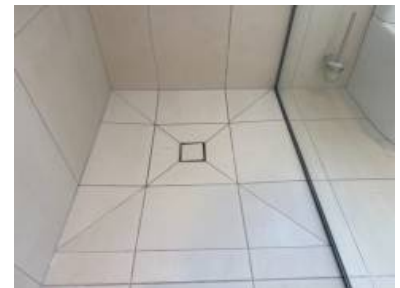
Shower Base: Tiled, Good Condition.

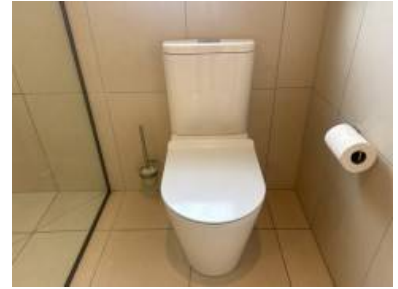
Toilet Cistern: Double flush porcelain cistern, Good Condition.

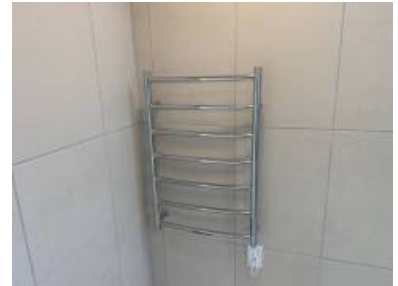
Towel Rail: Heated towel rail, not tested. Well secured & in good condition.

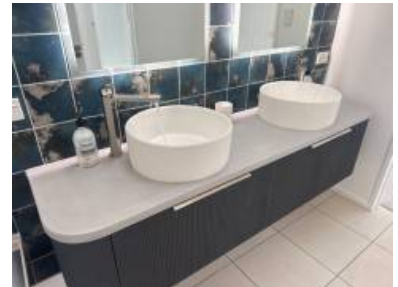
Vanity Unit General: 2 units, Good Condition. Draining well without leaks or blockages.

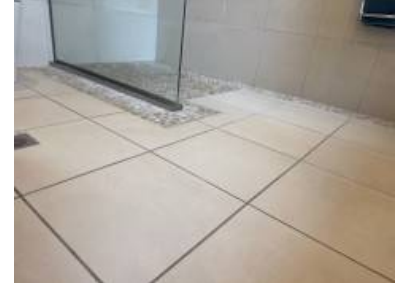
Floor Covering: Tiles fitted, Reasonable Condition.

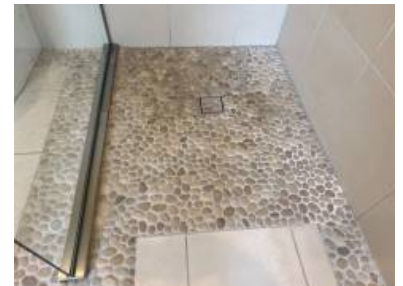
Shower Base: Tiled, Good Condition.

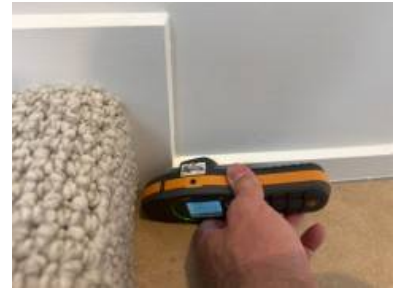
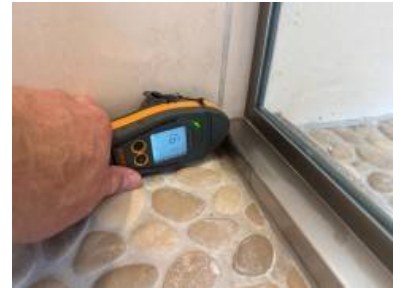
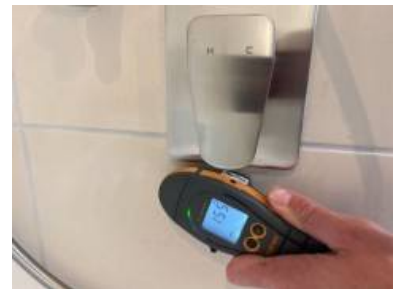
No moisture readings of concern were found in this room on the day of inspection. Pictured here is in the hallway behind the shower.

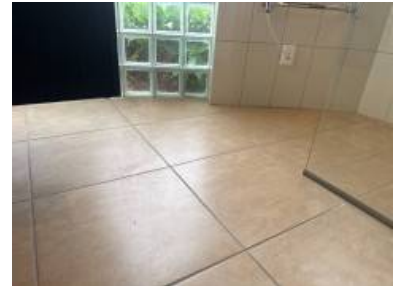
Floor Covering: Tiles fitted, Good Condition.

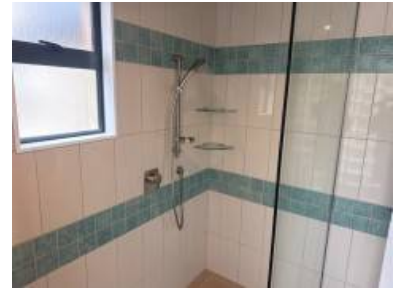
Shower: Walk in design, Tile surround, These tiles should have a water proofing membrane installed behind them, this is done before tiling by the tiler. A producer statement and waterproofing warranty documentation for both the application and product should have been supplied by the installer. Make sure to view and obtain a copy for your future warranties. Glass surround, Good Condition.

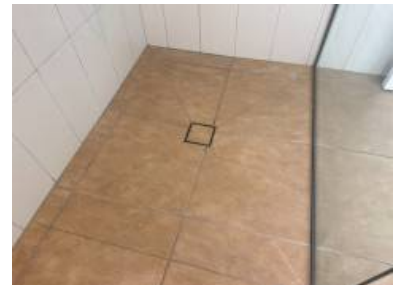
Shower Base: Tiled, Easy Waste Fitted, Good Condition.

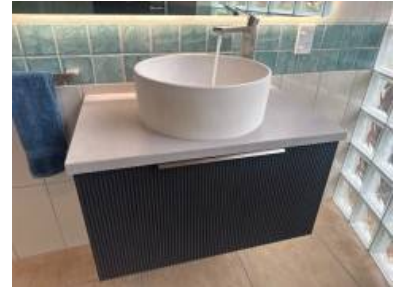
Plumbing:

Flexi hose installed here. No plumbing running in the wall cavity was viewed, the plumbing product is unknown unless viewed in the ceiling space and this will be noted on in their respective areas of the report. The waste pipe in this area is modern PVC.

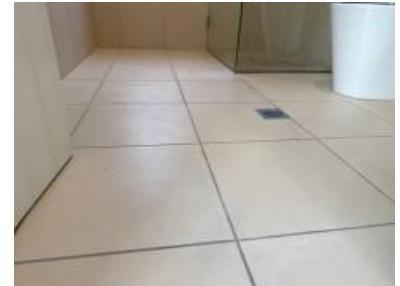
Floor Covering: Tiles fitted, Reasonable Condition.

Re-grouting to tile joins is suggested.

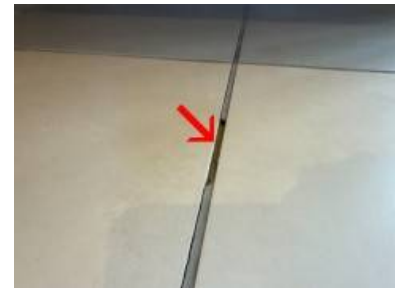
Minor damage to the tiles here.

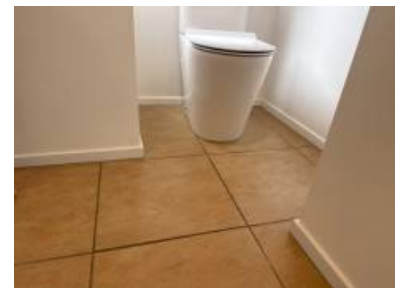
Tiles fitted, Good Condition.

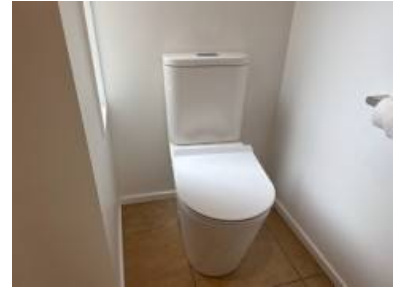
Toilet Cistern: Double flush porcelain cistern, Good Condition.

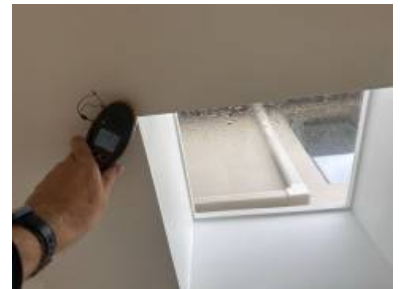
Base linings intact, Skylight installed. Skylights are not inspected as this is a specialised field. To learn more about this area further investigation will need to be carried out by a skylight installer or roofer. We checked for moisture around the skylight on the day of inspection. No high moisture readings or water staining of concern were found. Good Condition.

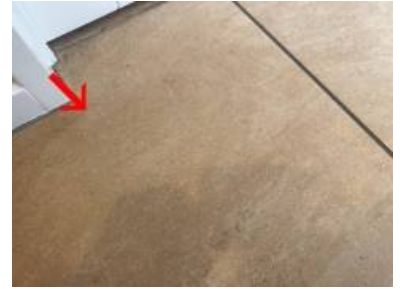
And here In the entry of the under-stairs storage.

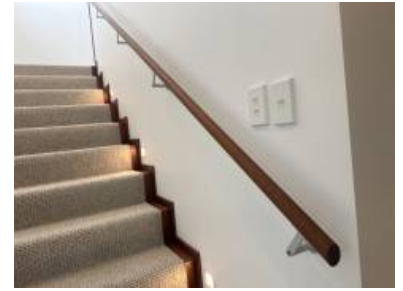
Handrails: Timber, Firmly secured. Good Condition.

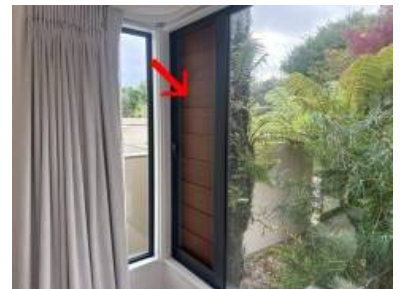
Double glazed, Aluminium frame, Fixed pane, Louver Not tested on day of inspection as it was tapped shut by the contractor for painting.

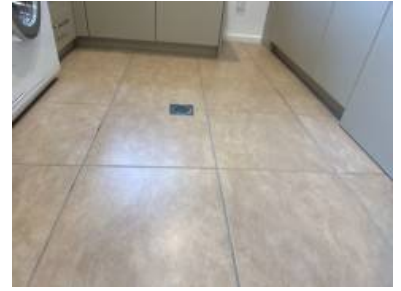
Floor Covering:

Tiles fitted, Good Condition.

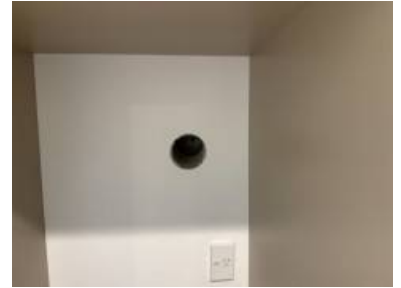
Ventilation installed:

Drying vent fitted, Manual type.

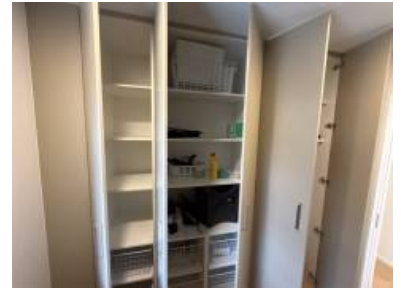
Storage:

Shelving installed here, Storage cupboards here.

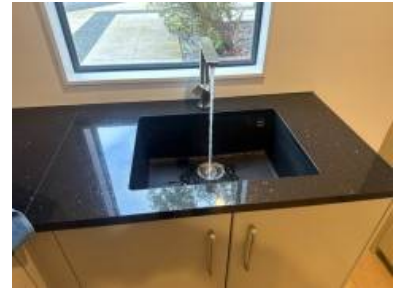
Tub:

PVC tub on timber cabinet, Draining well without blockages. Good Condition.

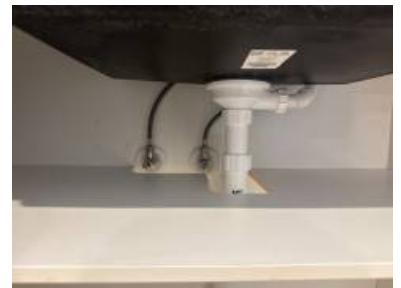
Plumbing:

Flexi hose installed here. No plumbing running in the wall cavity was viewed, the plumbing product is unknown unless viewed in the ceiling space and this will be noted on in their respective areas of the report. The waste pipe in this area is modern PVC.

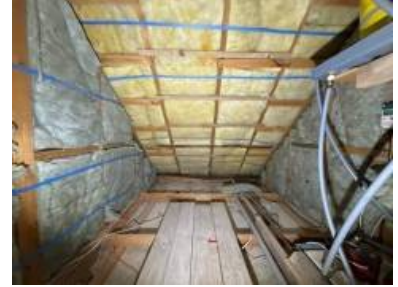
Insulation Fiberglass or wool batts. Good insulation here. Good thickness, may show signs of some movement. Installed around light fittings to current regulations and safety standards. We do not determine the R rating as per our terms and conditions Habits reports are not a compliance report.. A architect or insulation installation company may be able to help you determine the R rating and what is required.

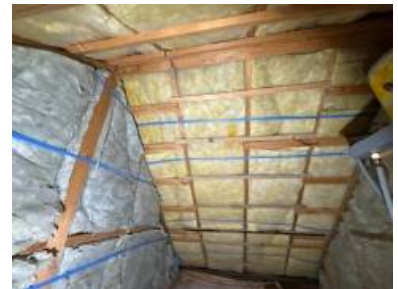
Roof lining Not viewed due to insulation.

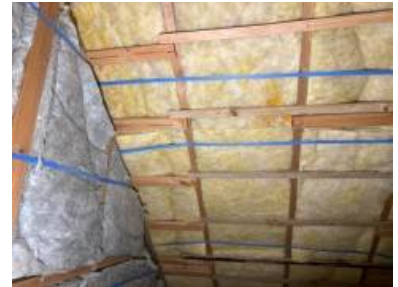
Roofing type Timber pitched roof installed here, The timber pitched roof here is in a good sound secure condition, signs of age, no areas of movement or timber damage evident. Not all viewed due to insulation.

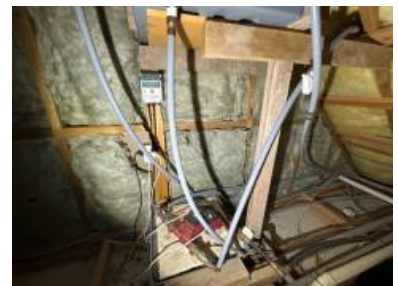
Plumbing Copper, P.V.C, The plumbing installed in this area is secure, and shows no signs of any moisture leaks, or damage.

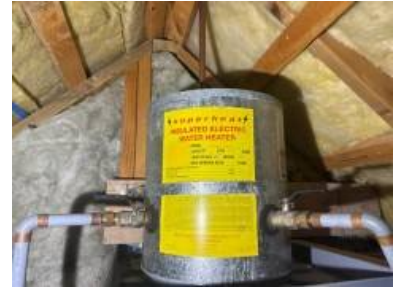
Header Tank

The header tank and drip tray installed here, are reasonably well secured, shows signs of aging, but there is no evidence of any moisture leaks.

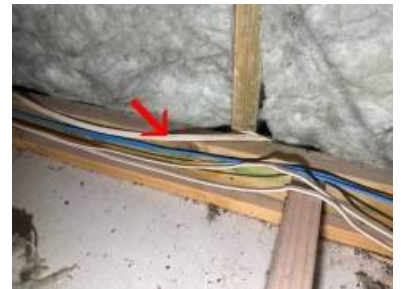
Wiring installed here, The wiring installed here is modern plastic coated. Not well stowed generally, but in reasonable condition.

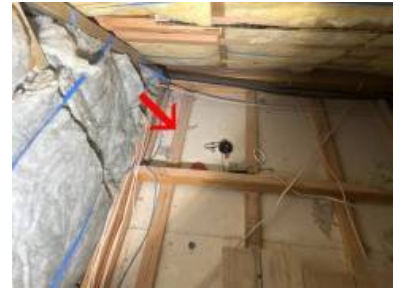
Ceiling construct

Ceiling baton construction in this dwelling, The ceiling baton construction here is tidy, and in a good sound condition.

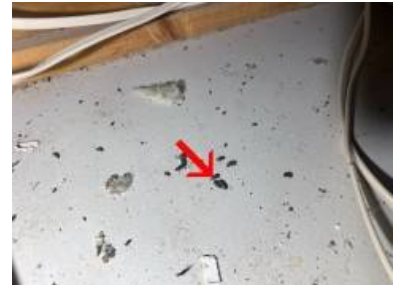
Pest & debris:

Rodent droppings were found in the ceiling space. We suggest this issue is attended to by either using poison or traps. It is hard to determine where the rodents may be entering the ceiling space so these two options will be your best to help eradicate this issue.

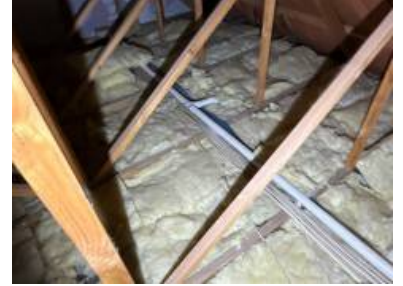
Insulation

Fiberglass or wool batts. Good insulation here. Good thickness, may show signs of some movement. Installed around light fittings to current regulations and safety standards. [We do not determine the R rating as per our terms and conditions Habits reports are not a compliance report.. A architect or insulation installation company may be able to help you determine the R rating and what is required.](#)

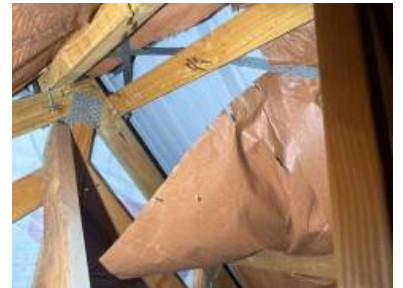
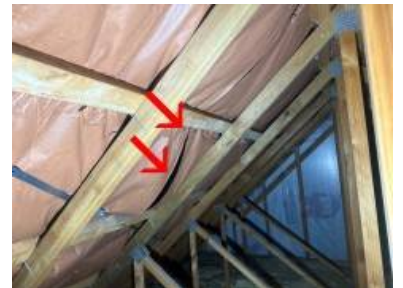
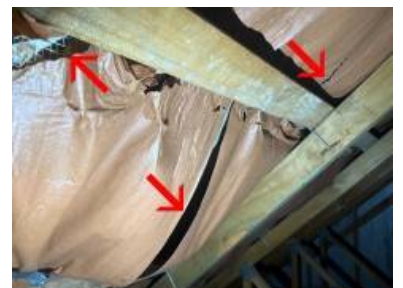
Roof lining

Lining paper, **Remedial attention suggested to the roof lining installed. Damaged and requires re-fixing, repairing, or re-placing.**

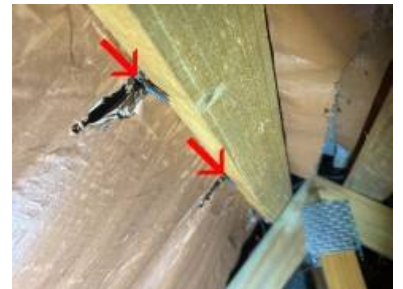
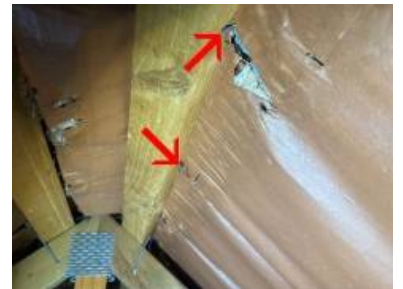
Not every screw for the ridge flashing installed here appear to be fixed to the purlin. I suggest this is re fixed to prevent any future damages.

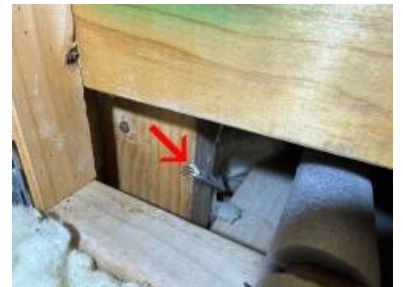
Exposed wiring seen here just south of the access panel at the junction of the gable end wall and ceiling, a registered electrician can confirm the safety of this wire.

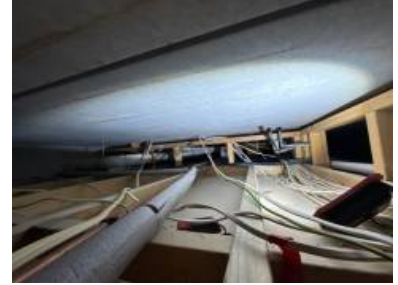
Access into Movement into and in the internal ceiling space is generally poor and difficult, care is required when moving in this area.

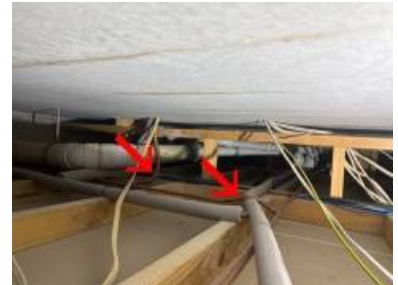
Plumbing Combination, Copper, P.V.C, Lagged or insulated, The plumbing installed here, is reasonably well secured, shows signs of aging, but there is no evidence of any moisture leaks.

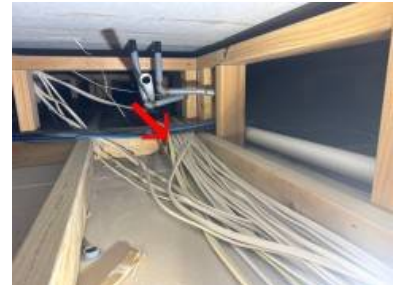
Wiring Wiring installed here, The wiring installed here is modern plastic coated. Not well stowed generally, but in reasonable condition.

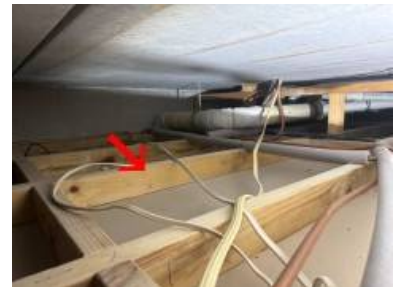
Ceiling construct Ceiling joist construction in this dwelling, The ceiling joist construction appears to be in a good sound condition. No major movement or major deterioration here.

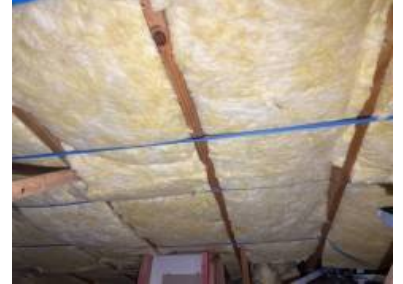
Insulation

Fiberglass or wool batts. Good insulation here. Good thickness, may show signs of some movement. Installed around light fittings to current regulations and safety standards. [We do not determine the R rating as per our terms and conditions Habits reports are not a compliance report.. A architect or insulation installation company may be able to help you determine the R rating and what is required.](#)

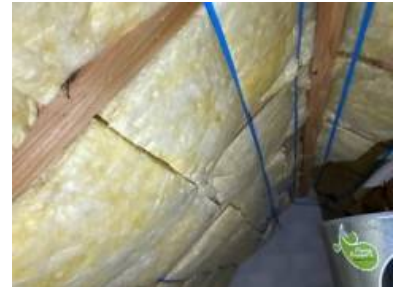
Roofing type

Timber pitched roof installed here, The timber pitched roof here is in a good sound secure condition, signs of age, no areas of movement or timber damage evident.

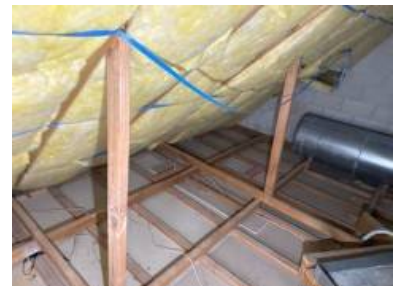
Support Timber

Support timbers, under purlins, jack stays, ceiling joist support hangers, The support timbers here, are secure and in good condition. Adequate support in place. Slight movement overtime.

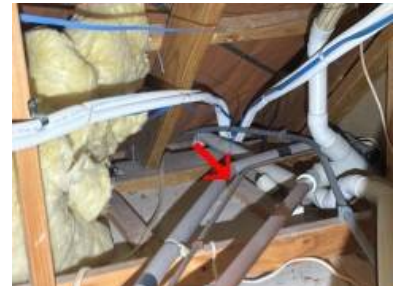
Plumbing

Combination, Copper, P.V.C, The plumbing installed in this area is secure, and shows no signs of any moisture leaks, or damage.

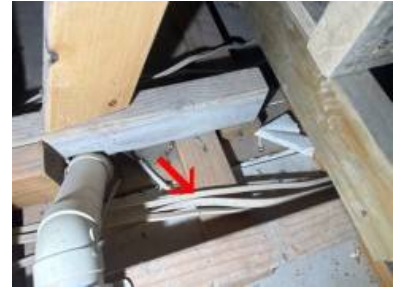
Wiring installed here, The wiring here is a modern plastic coated design in reasonable condition.

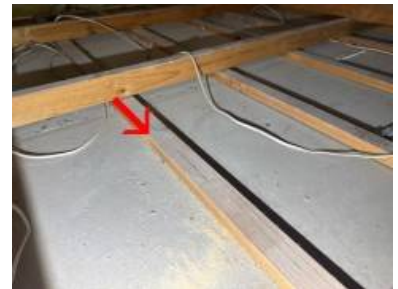
Ceiling construct

Ceiling baton construction in this dwelling, The ceiling baton construction here is tidy, and in a good sound condition.

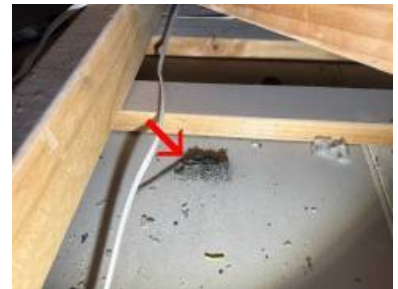
Pest & debris:

Rodent droppings and carcass were found in the ceiling space. We suggest this suggest this issue is attended to by either using poison or traps. It is hard to determine where the rodents may be entering the ceiling space so these two options will be your best to help eradicate this issue.

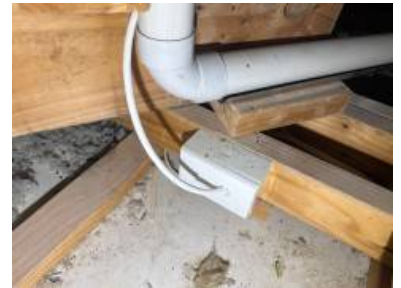
Method of heating: Electric.

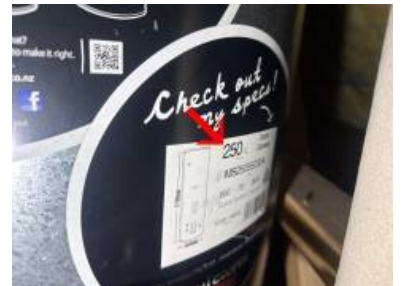
Size: 250 litre.

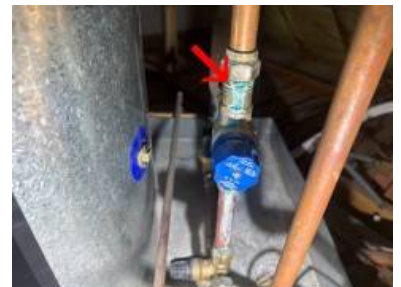
Plumbing Copper, Water staining evident, but no moisture was evident on the day of inspection.

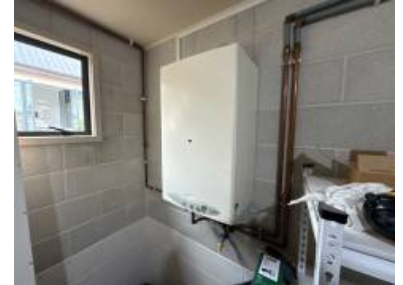
Location: Garage.

General comments on the connections: The connections here are in a good sound condition. No sign of any damage or moisture leaks evident on the day of inspection.

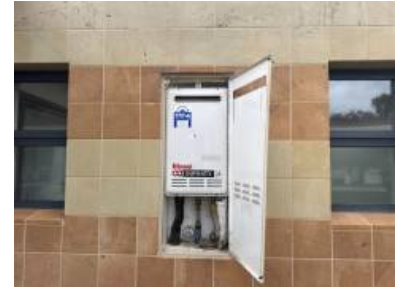
Location: The system is found outside.

General comments on the connections: The connections here are in a good sound condition. No sign of any damage or moisture leaks evident on the day of inspection.

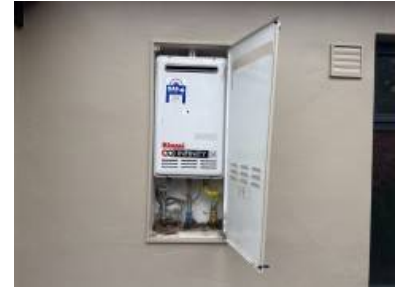
Hot Water Heating System #3:

Location: The system is found outside.

Method of heating: Gas.

Pressure: Mains Pressure.

General comments on the connections: The connections here are in a good sound condition. No sign of any damage or moisture leaks evident on the day of inspection. Infinity door was slightly open and A birds nest was present in here. I removed this on the day of inspection as this presents fire hazard. I suggest this area is thoroughly cleaned regularly and the door remains closed.
