BUILDING INSPECTION REPORT

RED LBP PRE-PURCHASE REPORT

PRE-PURCHASE BUILDING REPORT

Property Address	20 Robin Street, Burwood, Christchurch 8083
Client	Ben Brook
Date of Inspection	19th May 2026
Time	8:30 am
Inspector	Jamie Chapman National Certificate in Carpentry
LBP Number	BP137228
People Present	Inspector, Owner
House Occupied	Yes

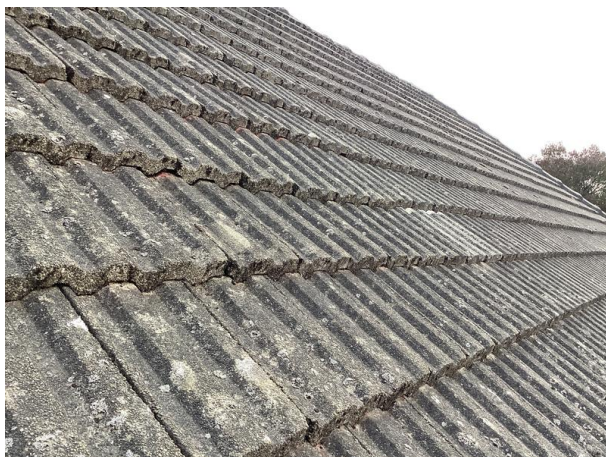
Photo 3

A masonry roof is located over the dwelling.

The masonry tile roof cladding has surface deterioration and requires cleaning and recoating to help restore weathertightness. An LBP specialising in tile roof cladding should be engaged to assess and report on necessary repairs and maintenance.

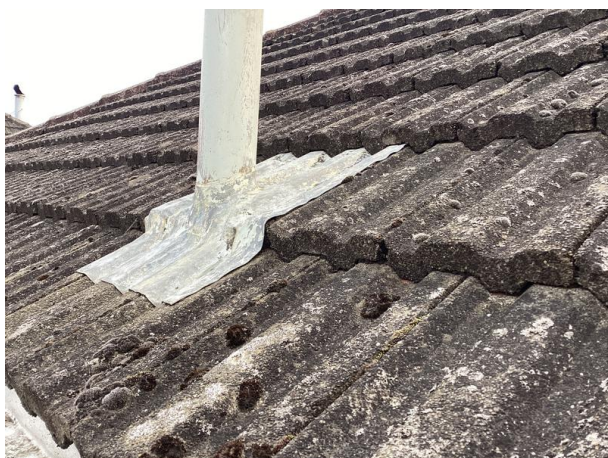
Photo 6

South side roof penetration with lead flashing.

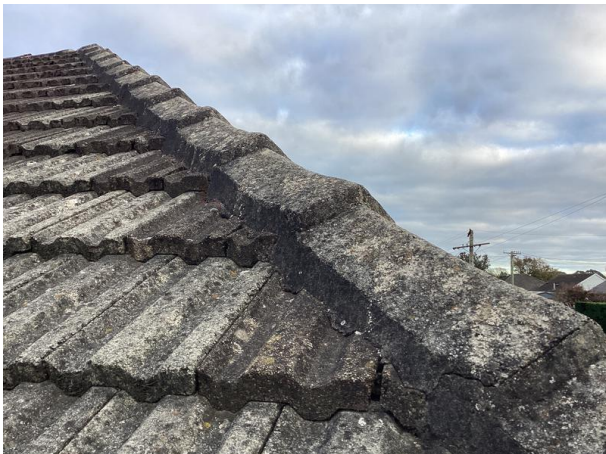
Photo 7
Masonry tiled hips and ridges located around the roof system.

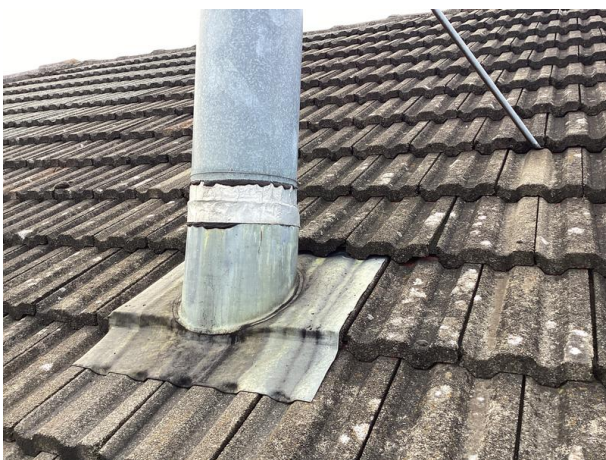
Photo 8
Flue penetration with lead flashing.

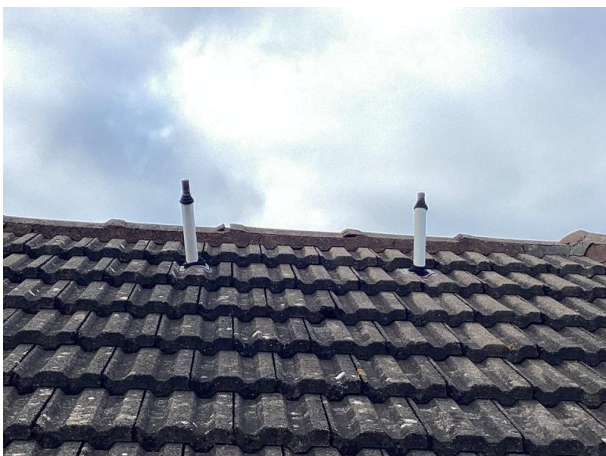
Photo 9
Decommissioned overflow penetrations with boot flashings.

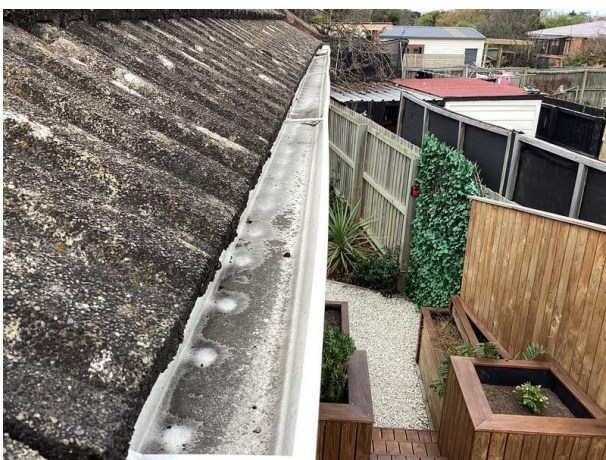
Photo 12
However, most of the gutter system was clean and clear during the inspection.

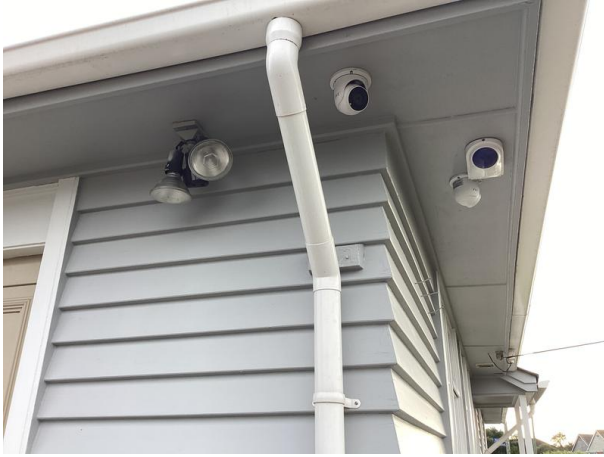
Photo 14

The PVC downpipes were securely attached to the dwelling during the inspection.

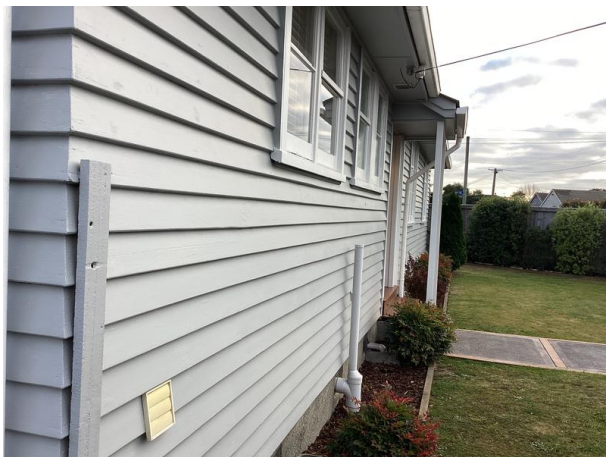
Photo 15
Horizontal timber weatherboards are located around the dwelling.

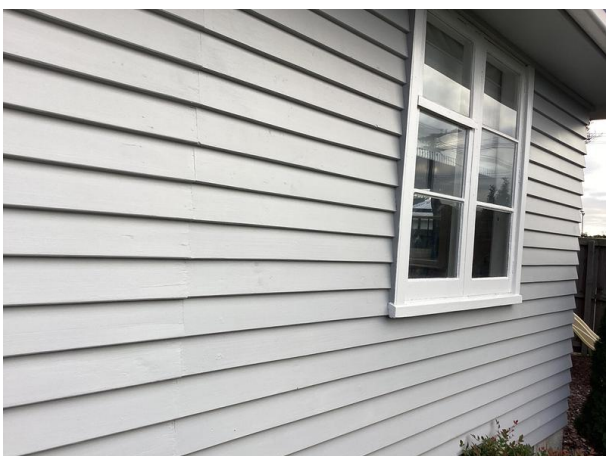
Photo 16
Consistent weatherboard joins were noticed on the north side of the dwelling indicating this is where the extension has happened to this dwelling.

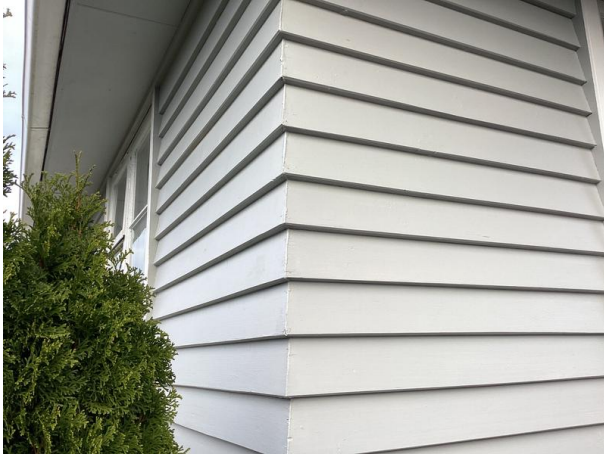
Photo 17
Mitred weatherboard joins located on the external corners.

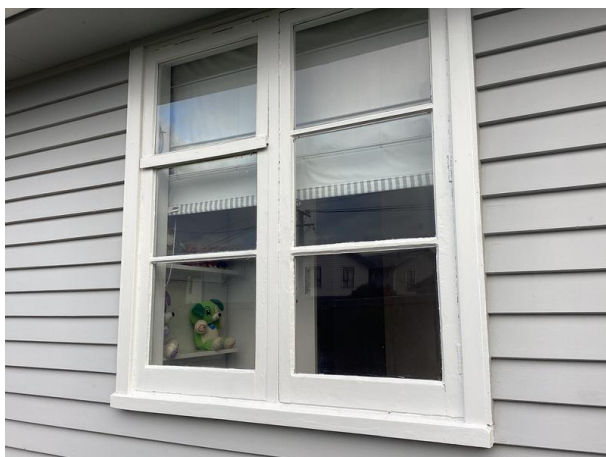
Photo 19

Single glazed timber windows are located around most of the dwelling.

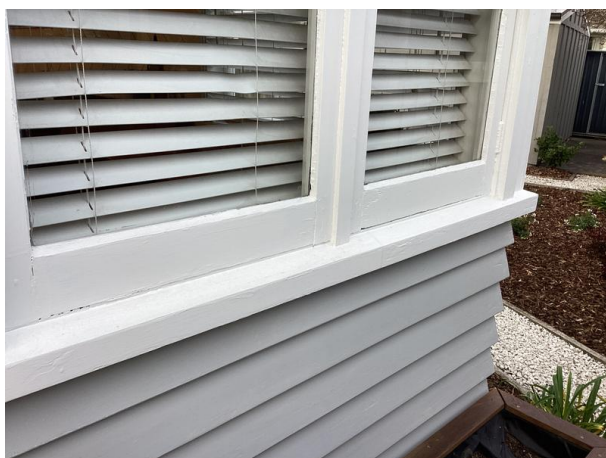
Photo 20

No significant issues with the timber windows viewed from outside the dwelling.

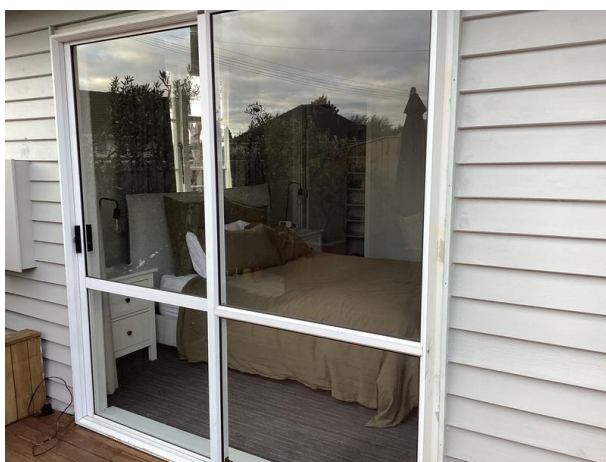
Photo 24

Single glazed aluminium windows located in bedroom one and living area.

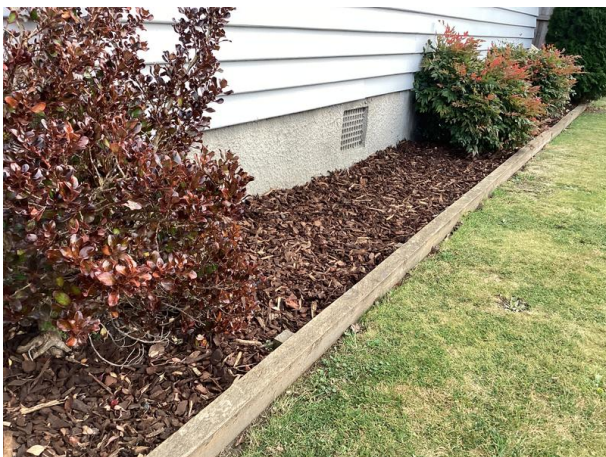
Photo 25
A concrete ring foundation with vent holes is located around the subfloor.

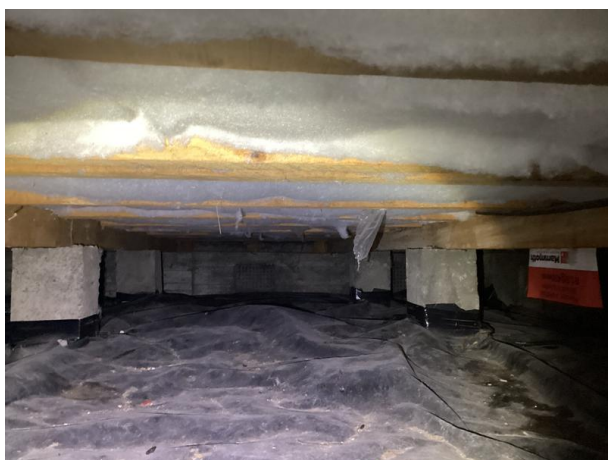
Photo 29
View of inside the subfloor.

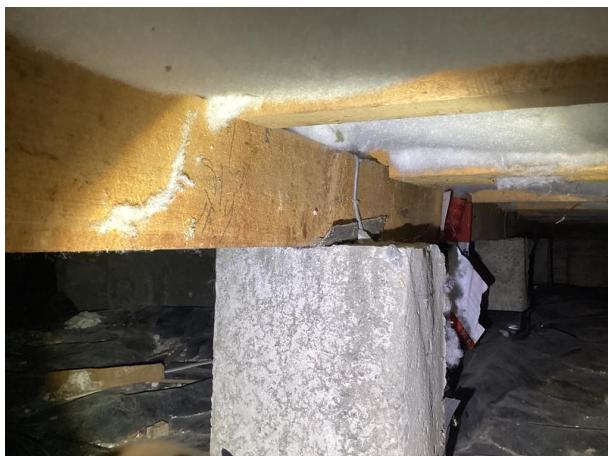
Photo 30
Tie wire connections were visible between the concrete piles and timber bearers.

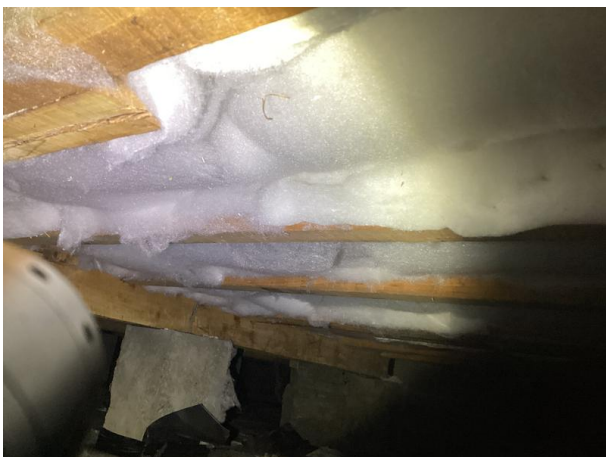
Photo 31
Polyester insulation located in the subfloor.

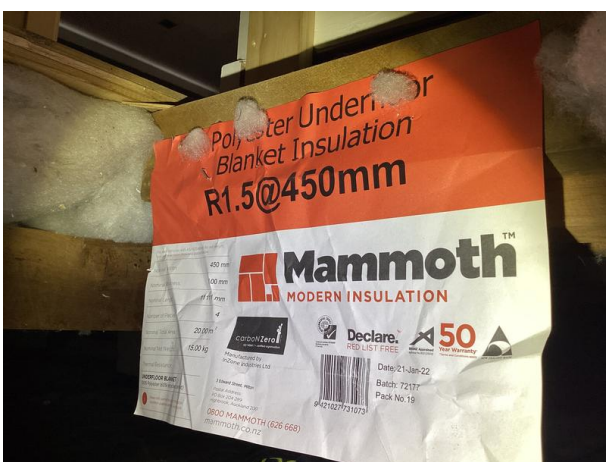
Photo 32
Insulation label.

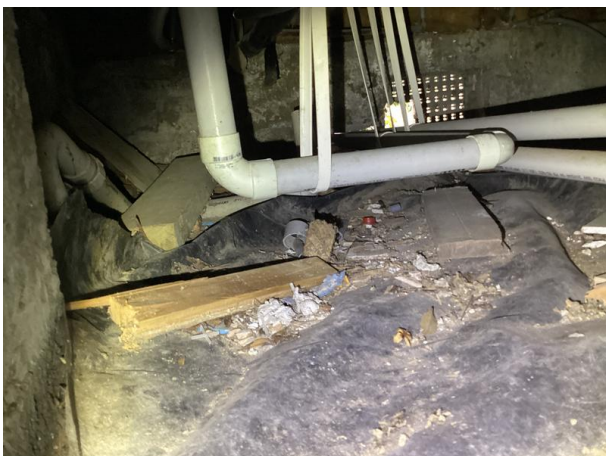
Photo 33
Debris was noticed in the subfloor mainly under the bathroom area.

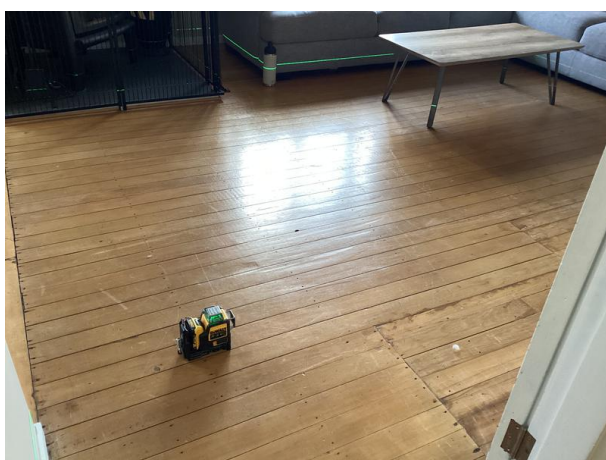
The overall level difference measured in the sampled areas was approximately 30mm. This assessment is limited to a visual, non-invasive spot-check and is not a full floor-level survey or certification of compliance.

Photo 35
The floor levels were spot checked around the dwelling using a self levelling laser.

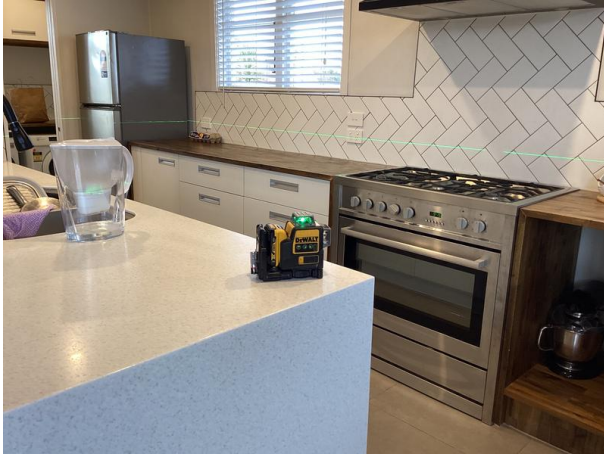
Photo 37
The kitchen bench tops were checked
and were level.

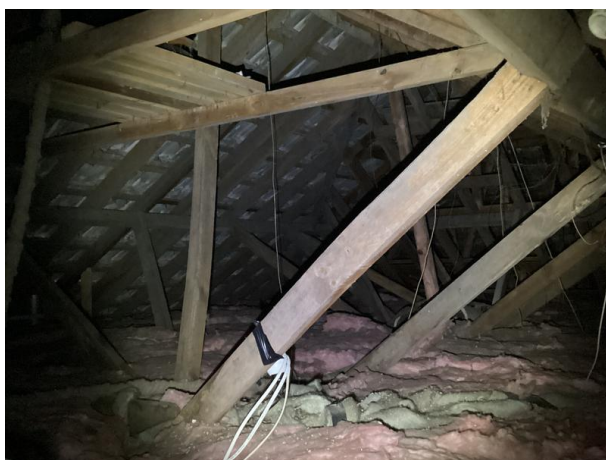
Photo 38

View of inside the roof space.

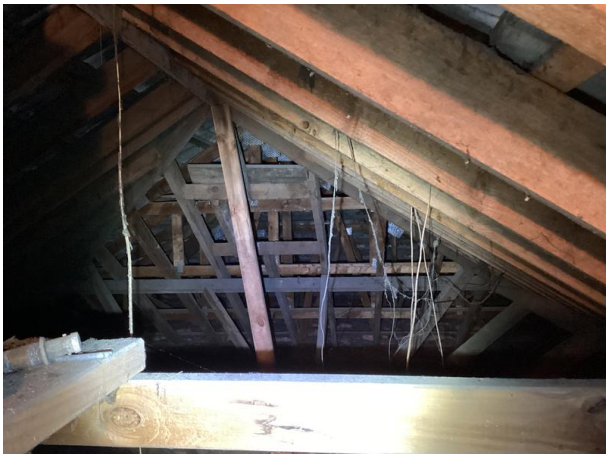
Photo 39
Example of where the extension has started from on the north side of the dwelling with manufactured timber trusses visible.

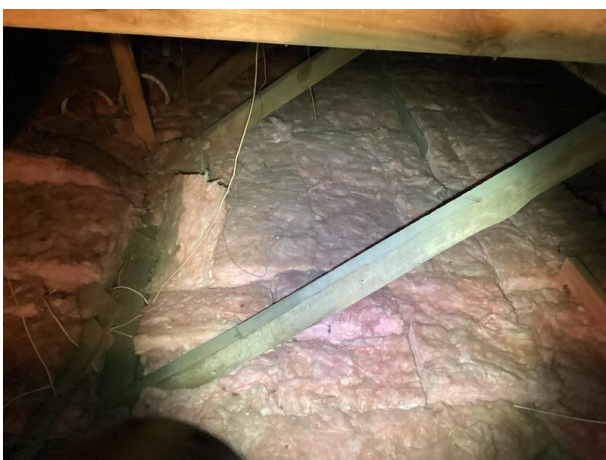
Photo 40
Glass wool insulation located in the roof space.

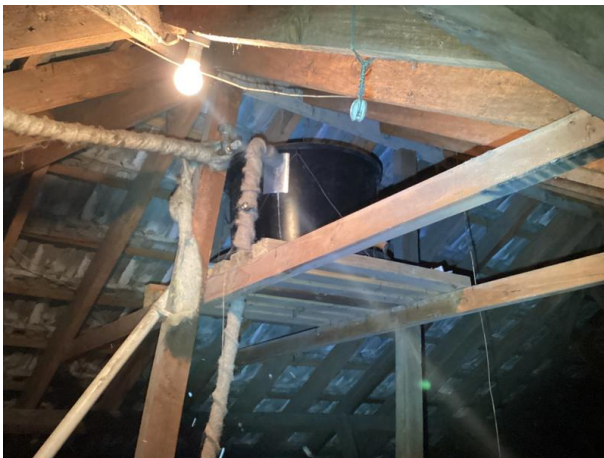
Photo 43

Decommissioned header tank located in the roof space.

Future maintenance could include removing this decommissioned concrete header tank from the roof space.

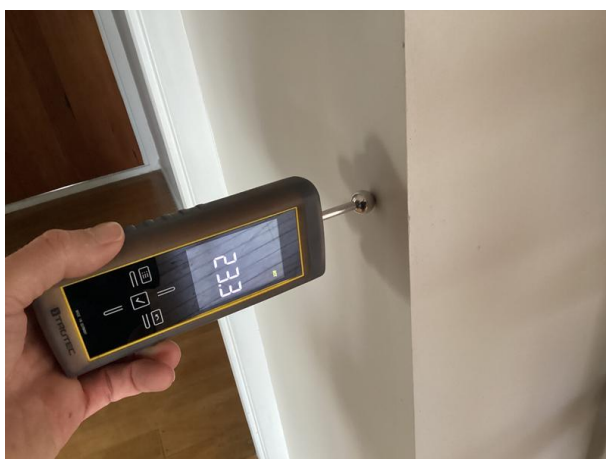
Photo 44

Example of a base reading that was taken on an internal wall. This was the average moisture reading for this dwelling during the inspection.

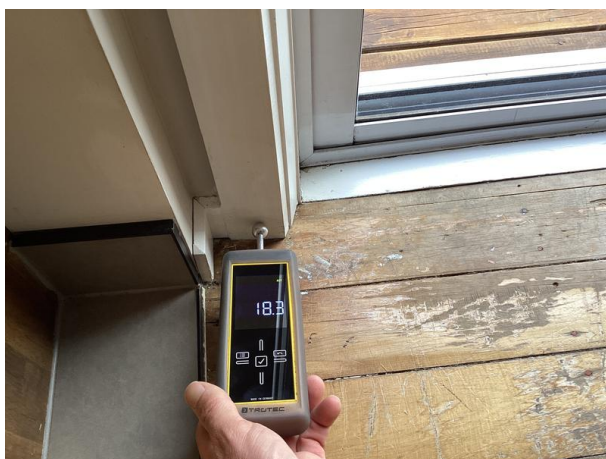
Photo 45

Moisture testing was done around the external walls of the dwelling.

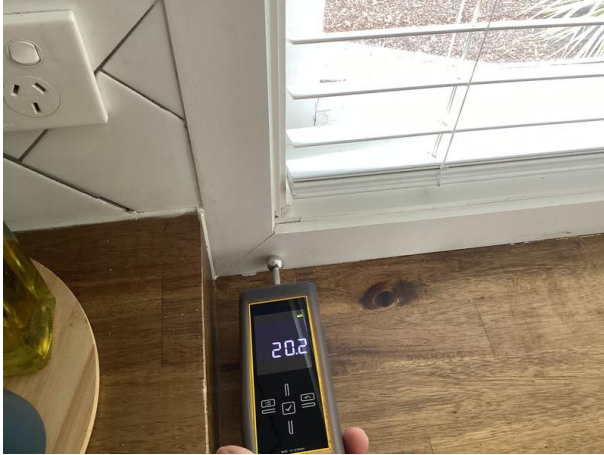
Photo 46
Moisture testing was done around the external window joinery.

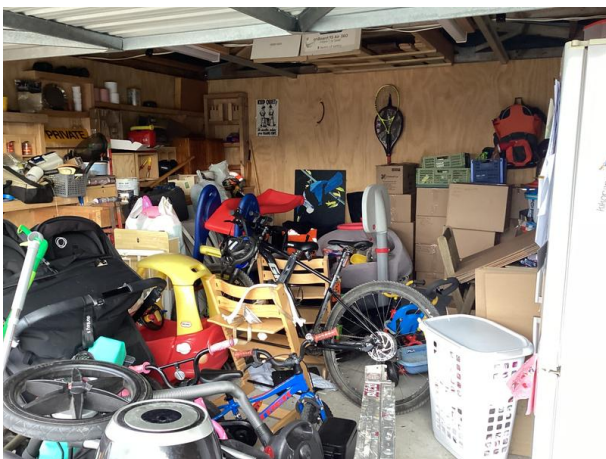
Photo 60
View of inside the garage, limited inspection due to personal belongings.

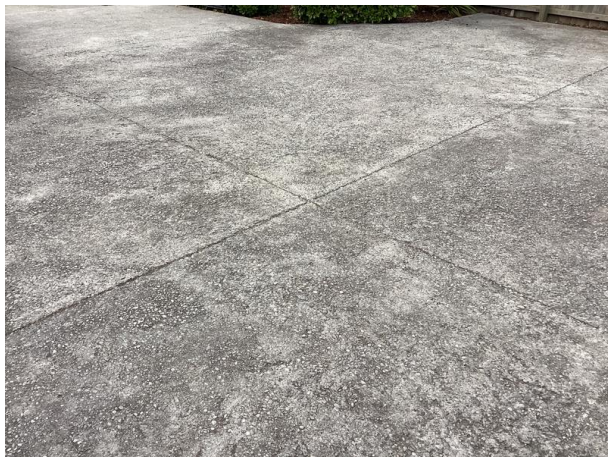
Concrete.
Saw cuts or construction joints - Yes.
Cracking - Areas of cracking visible.

Photo 62
Concrete driveway, no significant issues.

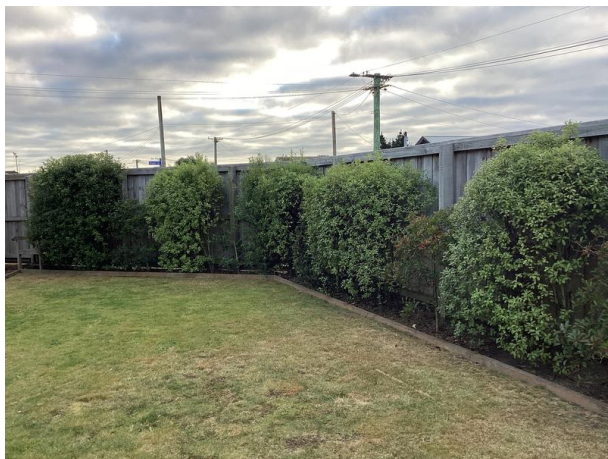
Unpainted timber palings fixed to timber rails with timber posts.
Condition of cladding - In a condition expected for age.
Alignment - No visible issues.
Post and rail condition - No visible issues.
Average height - 1.8 metres.

Photo 63
Timber fences, no significant issues.

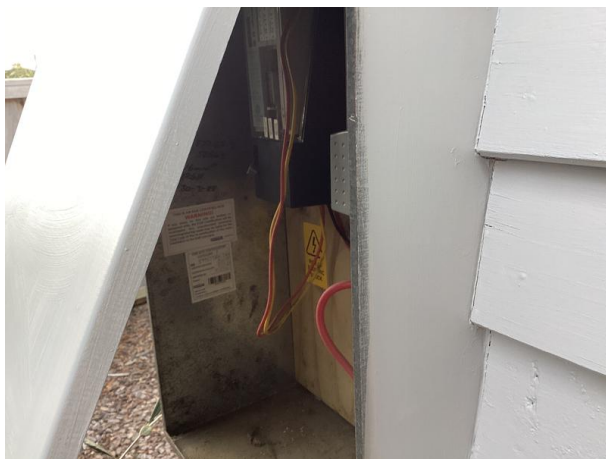
Photo 66
Meter box located on the north west side of the dwelling.

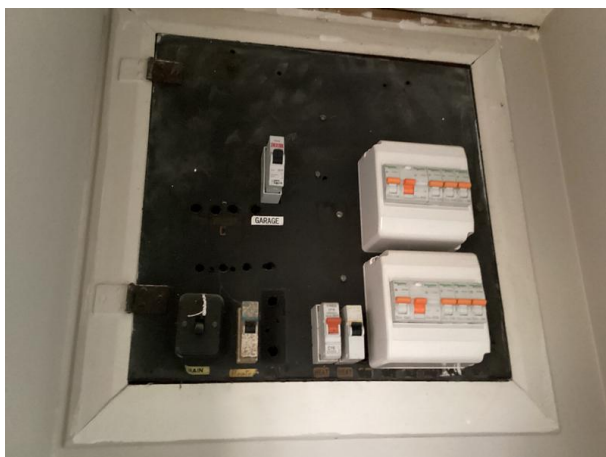
Photo 67
Switchboard located in the entrance area.

This type of distribution board is of an age where, if upgrades are required to the electrical system, replacement of the board may also be required.

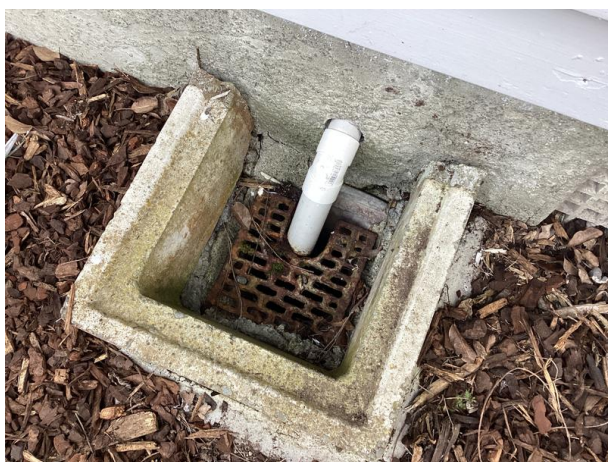
Photo 68
South side gully trap.

Condition - No observable issues.

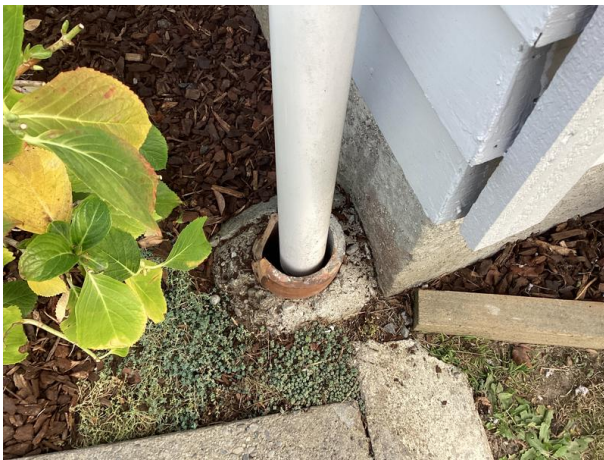
Photo 71
Stormwater risers are located around the dwelling.

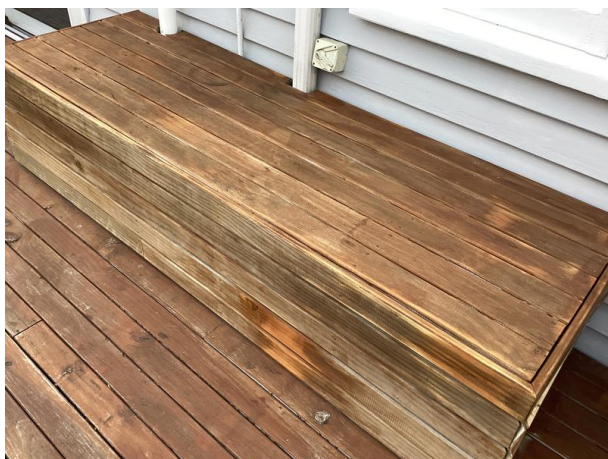
Photo 72

External heatpump system located under this bench seat on the west side.

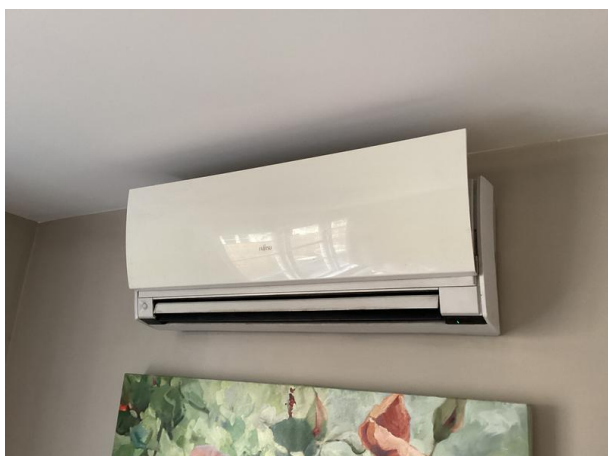
Photo 73

Fujitsu heat pump located in the living area.

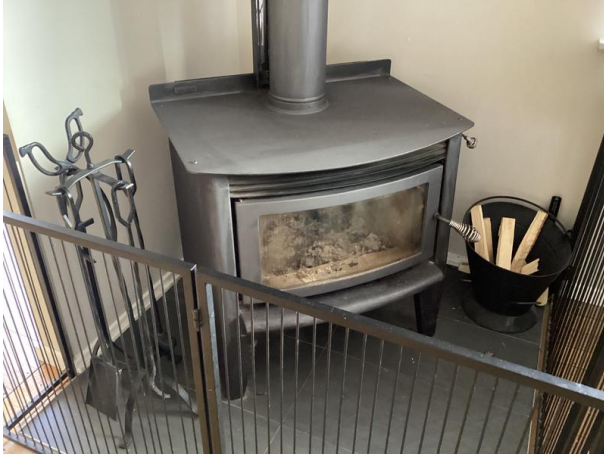
Photo 74
Metro fire place located in the living area.

Follow the manufacturer's recommended servicing schedule to ensure the equipment operates efficiently and maintains optimal performance. Adhering to these guidelines helps identify and address potential issues early, reducing the risk of costly repairs and ensuring compliance with warranty requirements.

Check with territorial authority for solid fuel burners compliance.

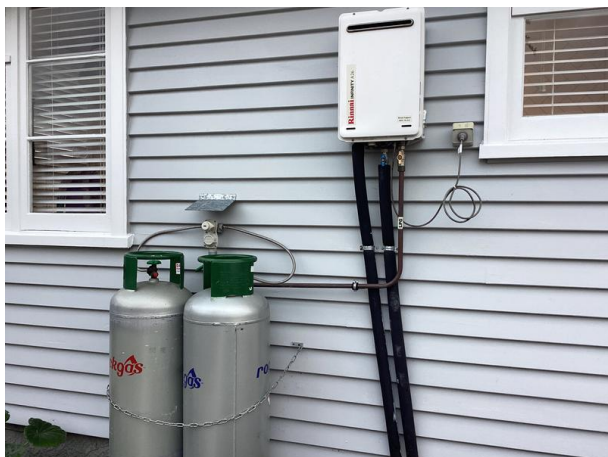
Photo 75
South side gas bottle station and hot water Calfont.

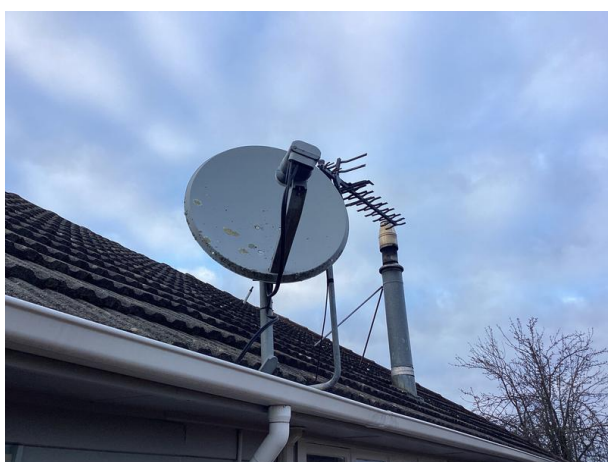
Photo 76
Satellite aerial located on the roof system.

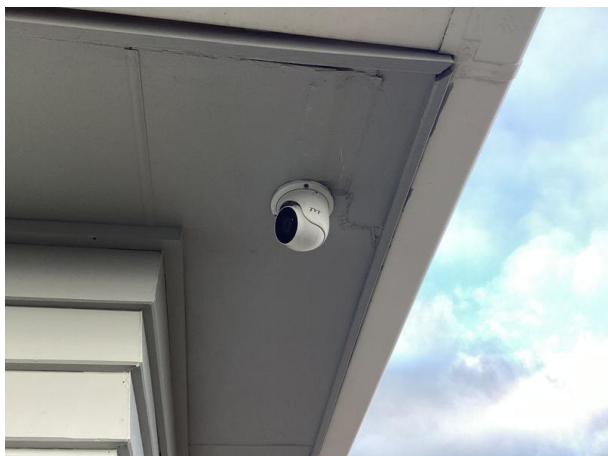
Photo 77
Security camera located around the dwelling. Not tested.
