EQC CLAIM DOCUMENTATION CAVITY CRITTER REPORT

Under floor Inspections

Property address: 191 Westminster Street

Property address: 191A Westminster Street

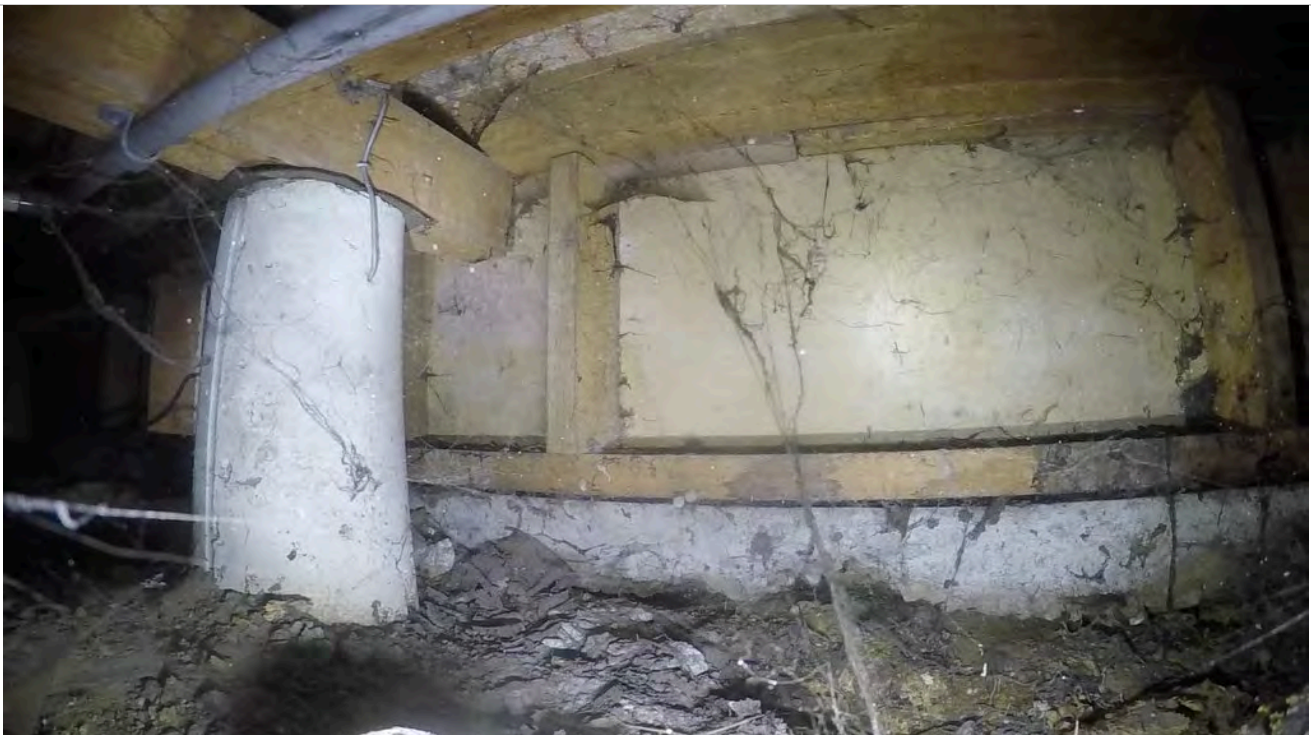
3: The joist has been cut for the waste. Both joist ends are now unsupported.

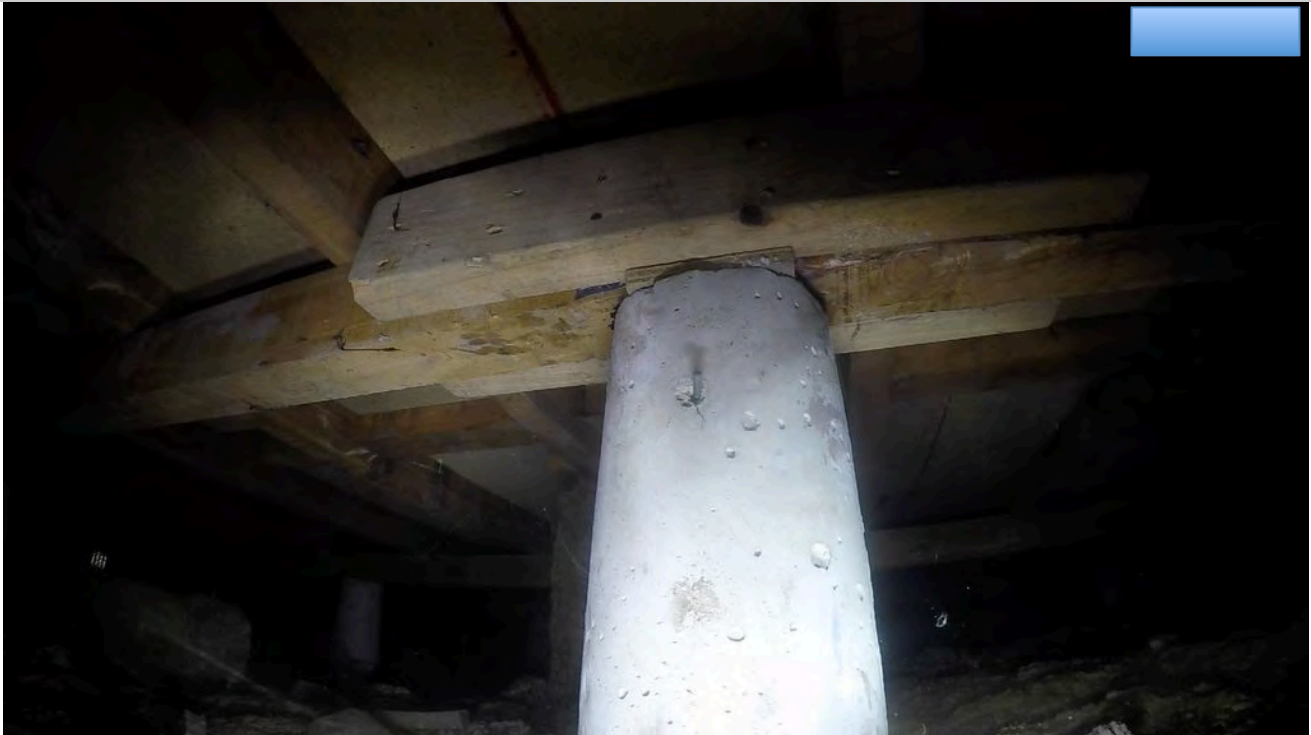
21: The bearer has been clashed on both sides. However the timber used is not of h3.2. The packer used appears to be a piece of plywood.

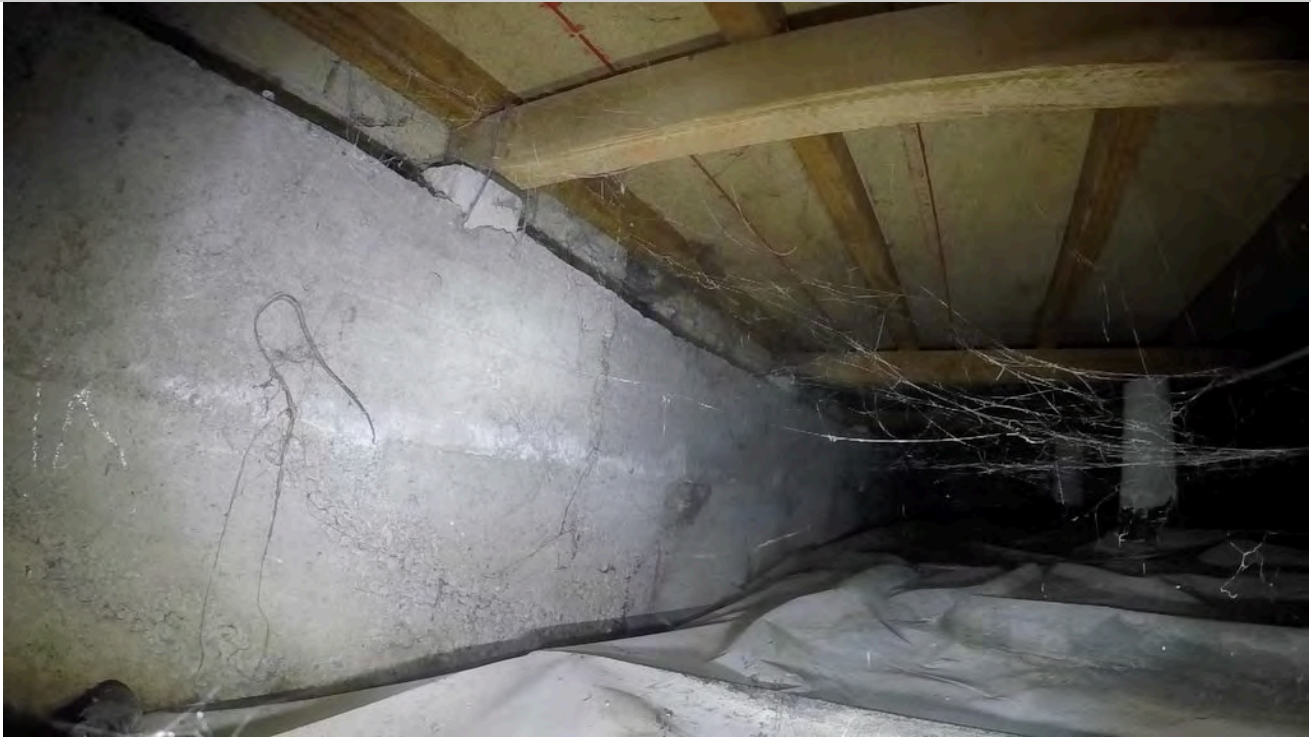
7: View of bearer meeting ring foundation with connection.

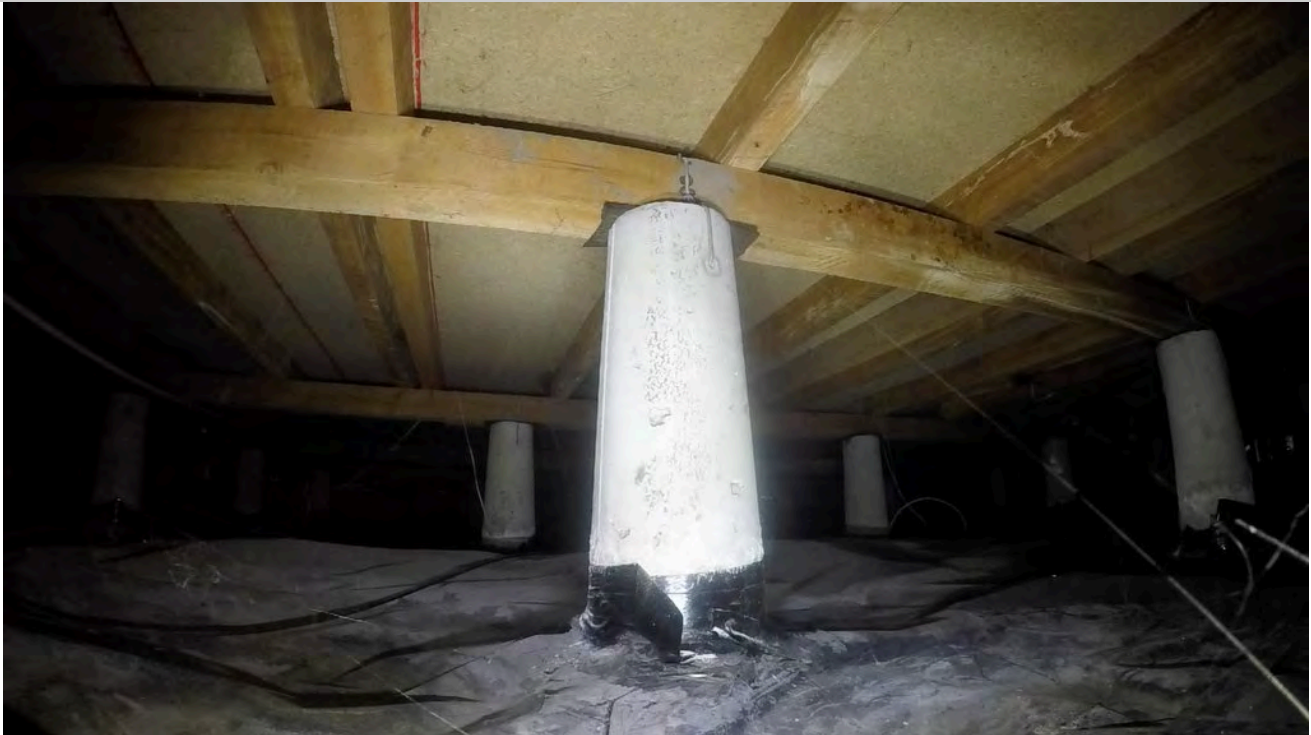
9: Pile with connection.

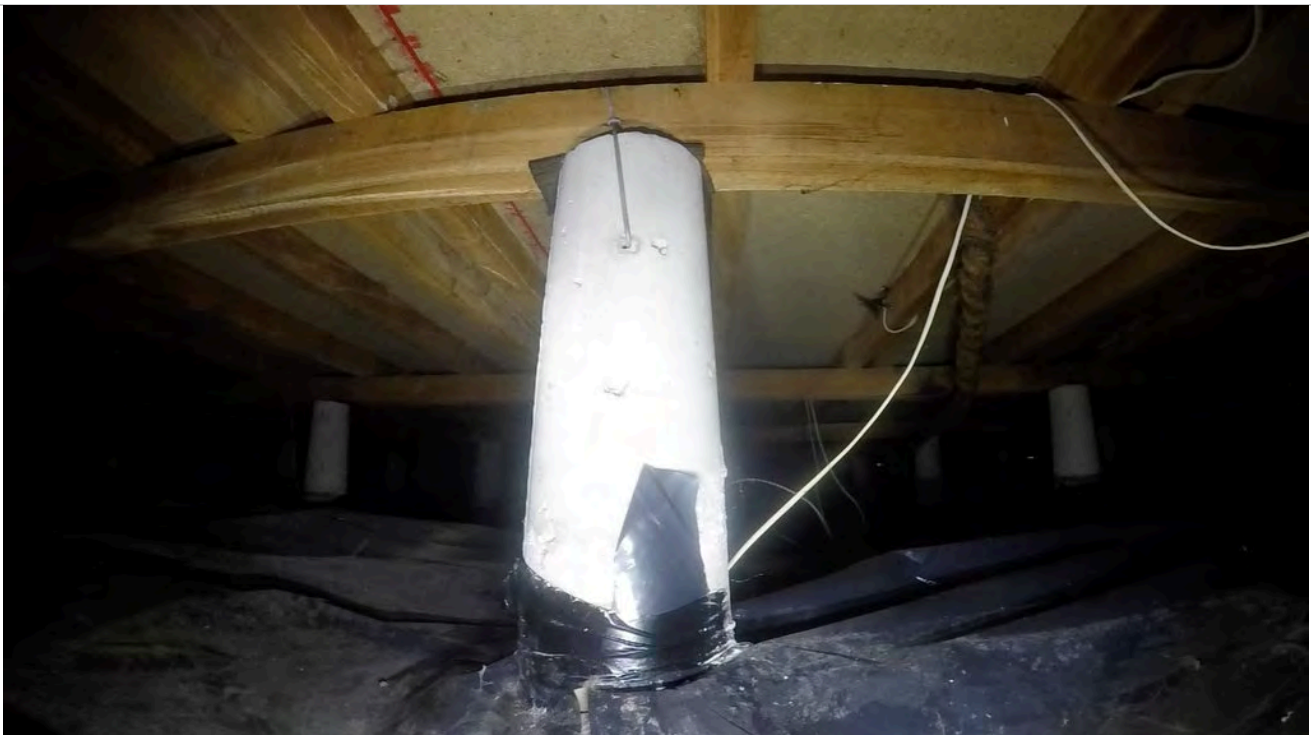
10: Pile with connection.

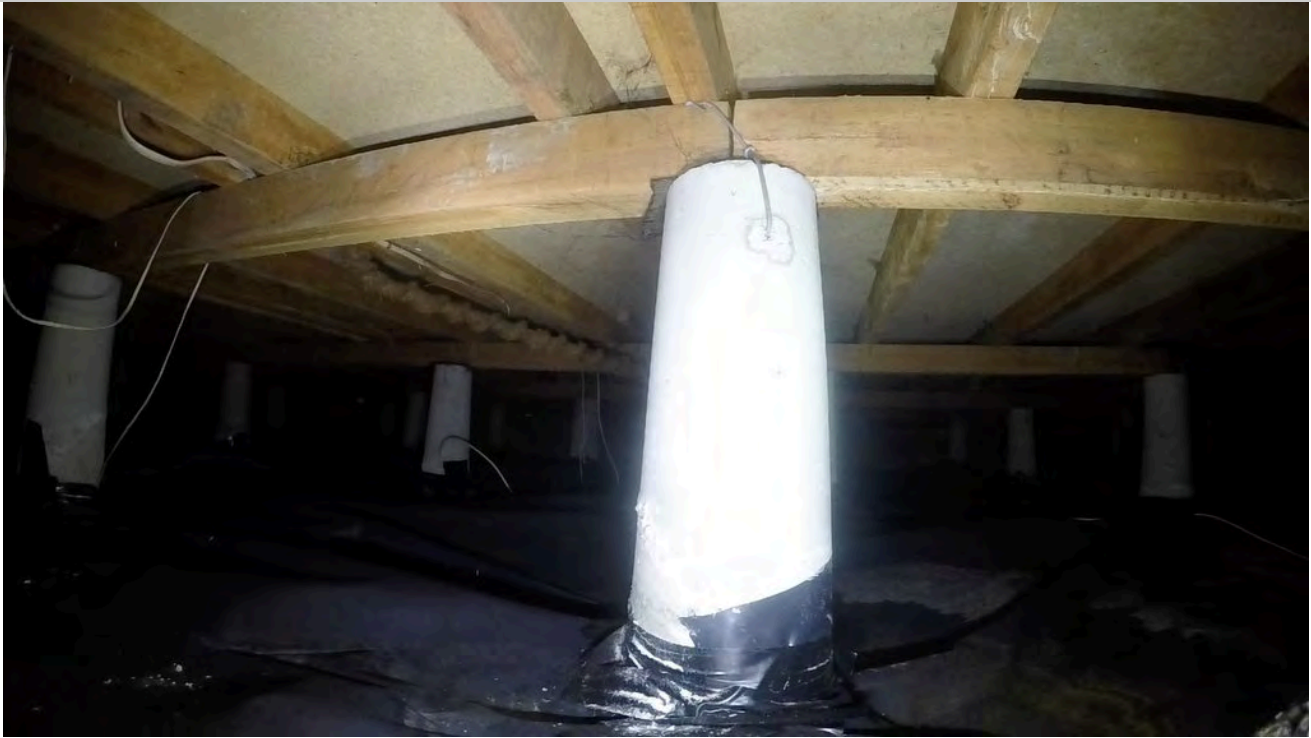
11: Pile with bearer join.

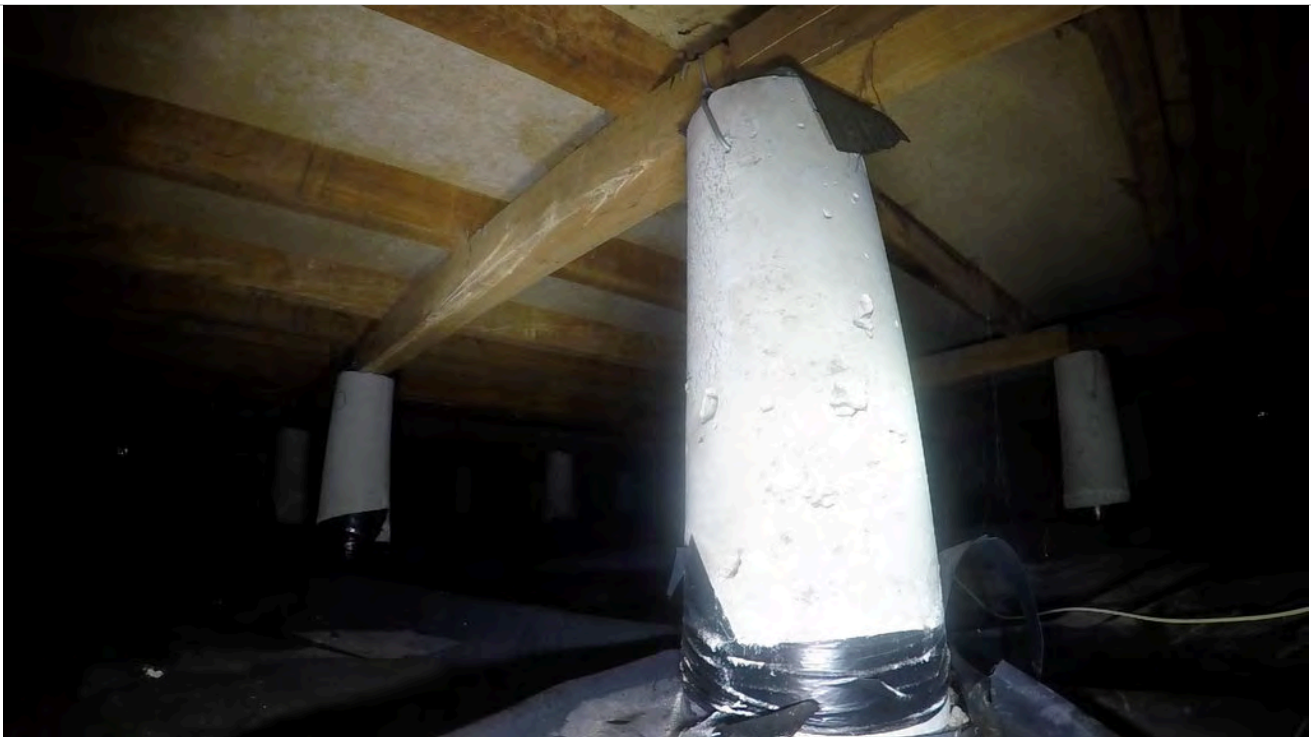
12: Pile with bearer join.

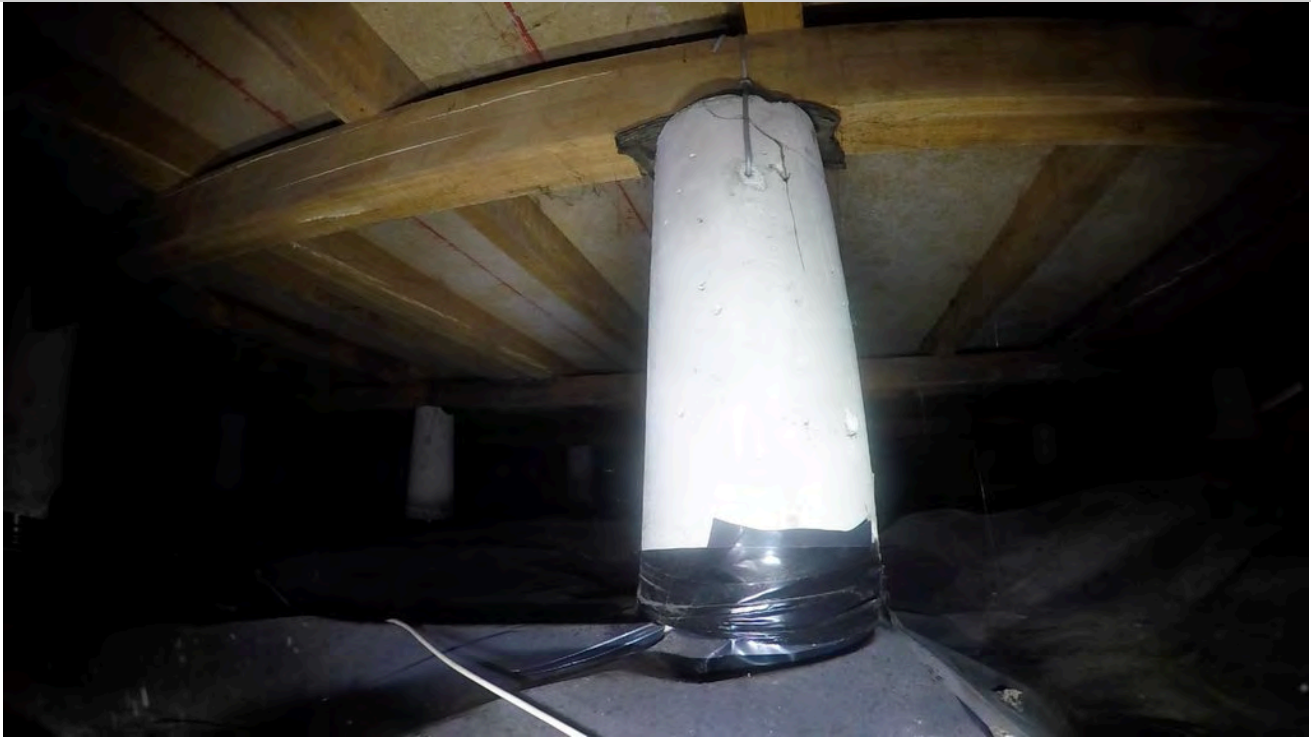
13: Pile with connection.

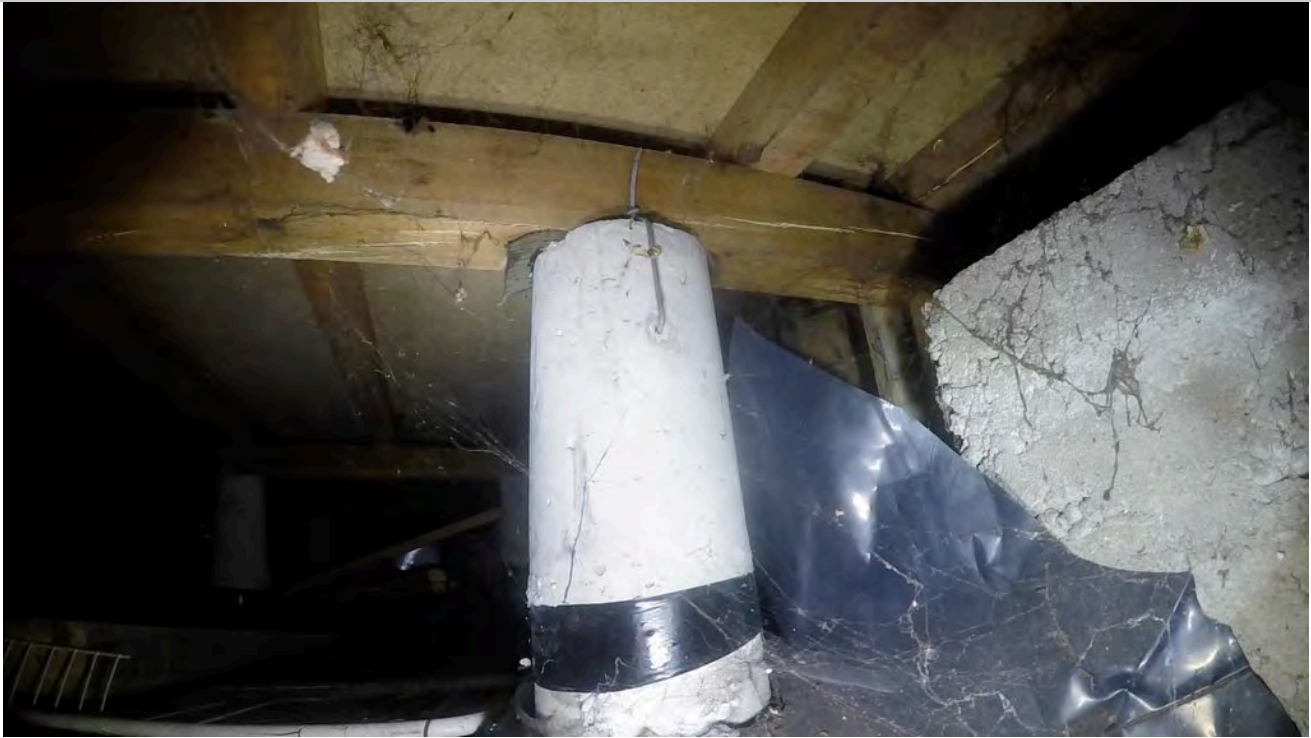
15: Pile with connection.

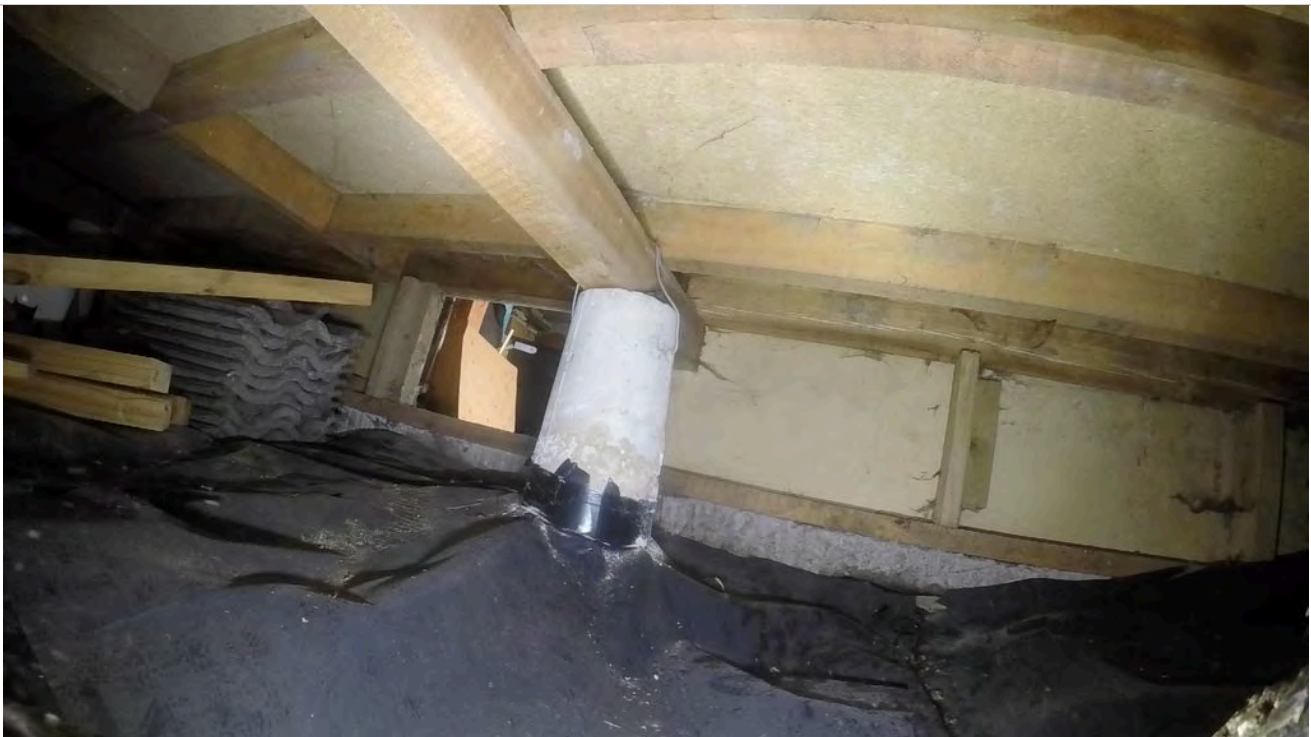
16: Pile with connection.

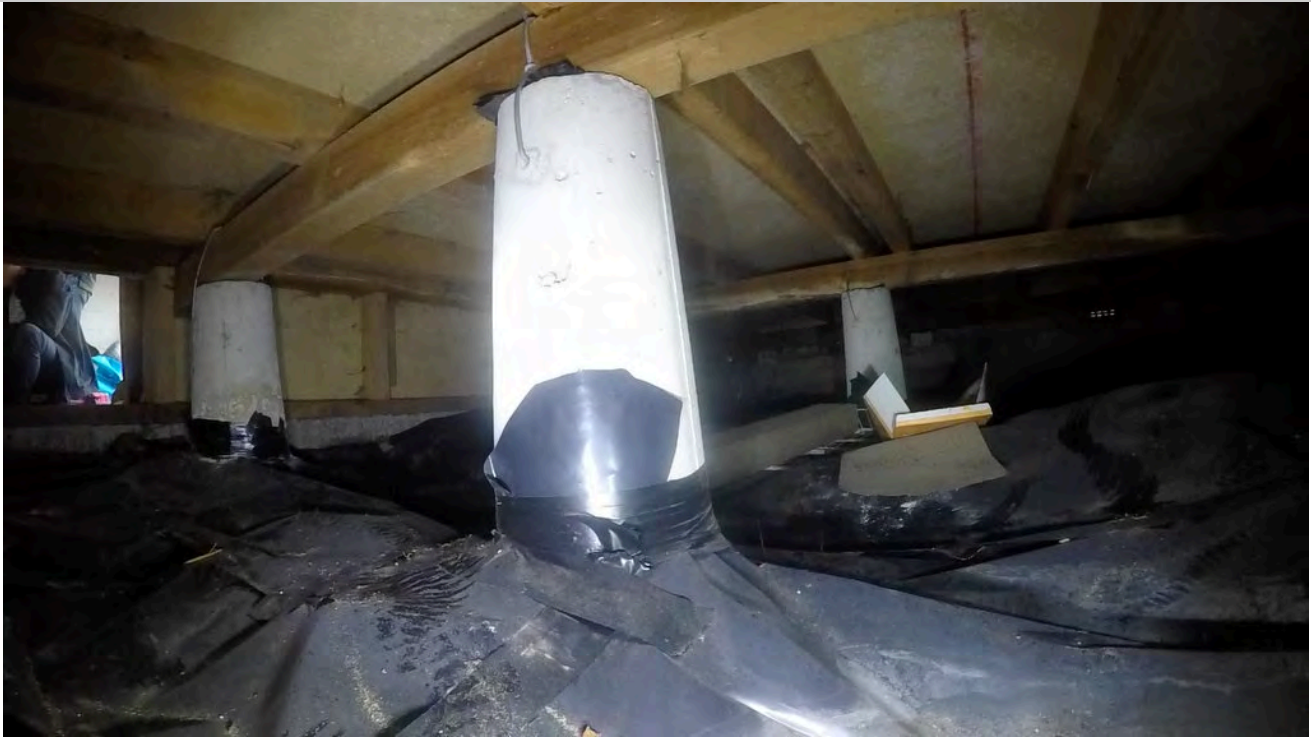
17: Pile with connection.

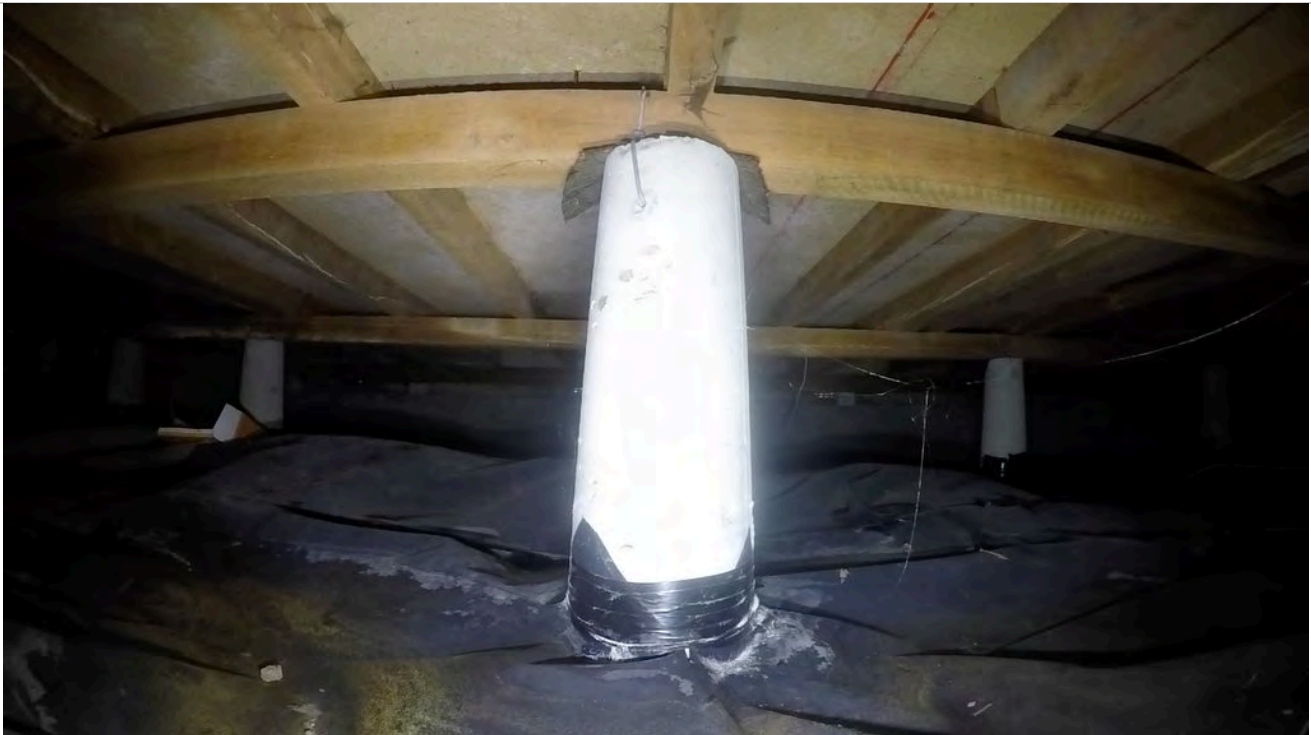
18: Pile with connection.

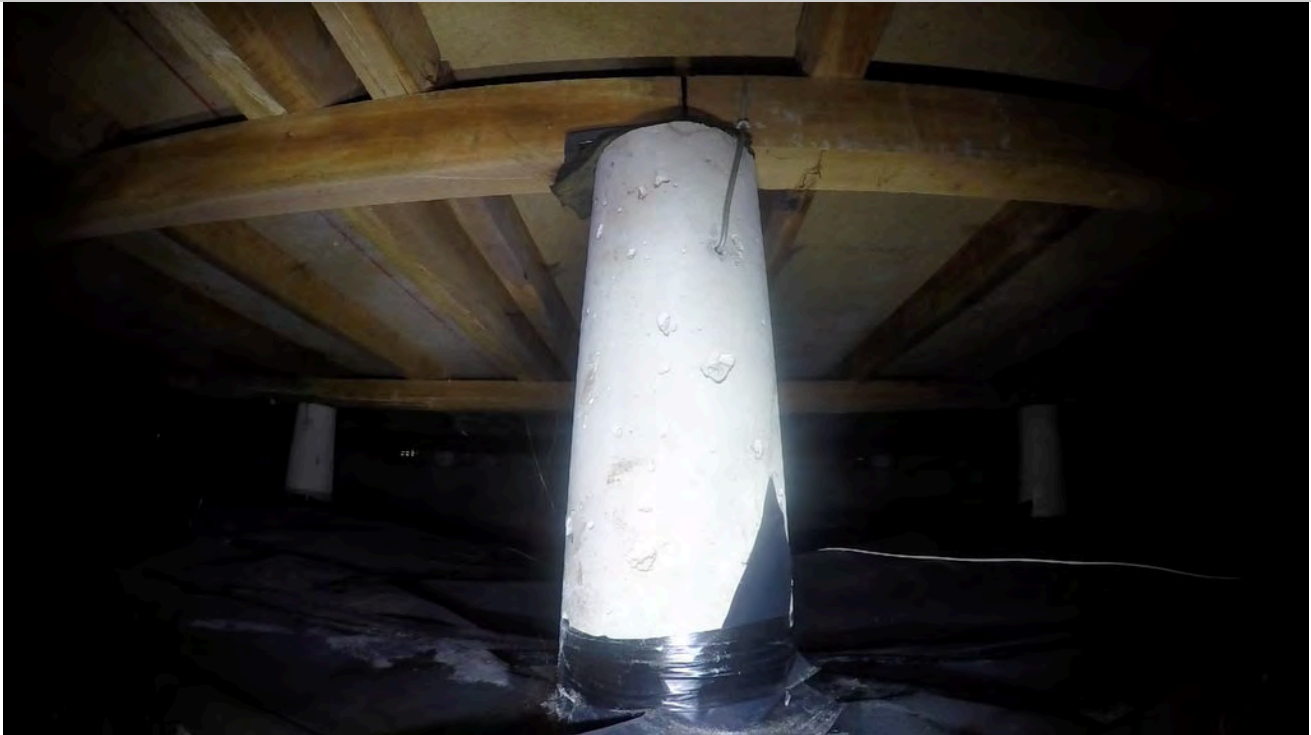
19: Pile with bearer join.

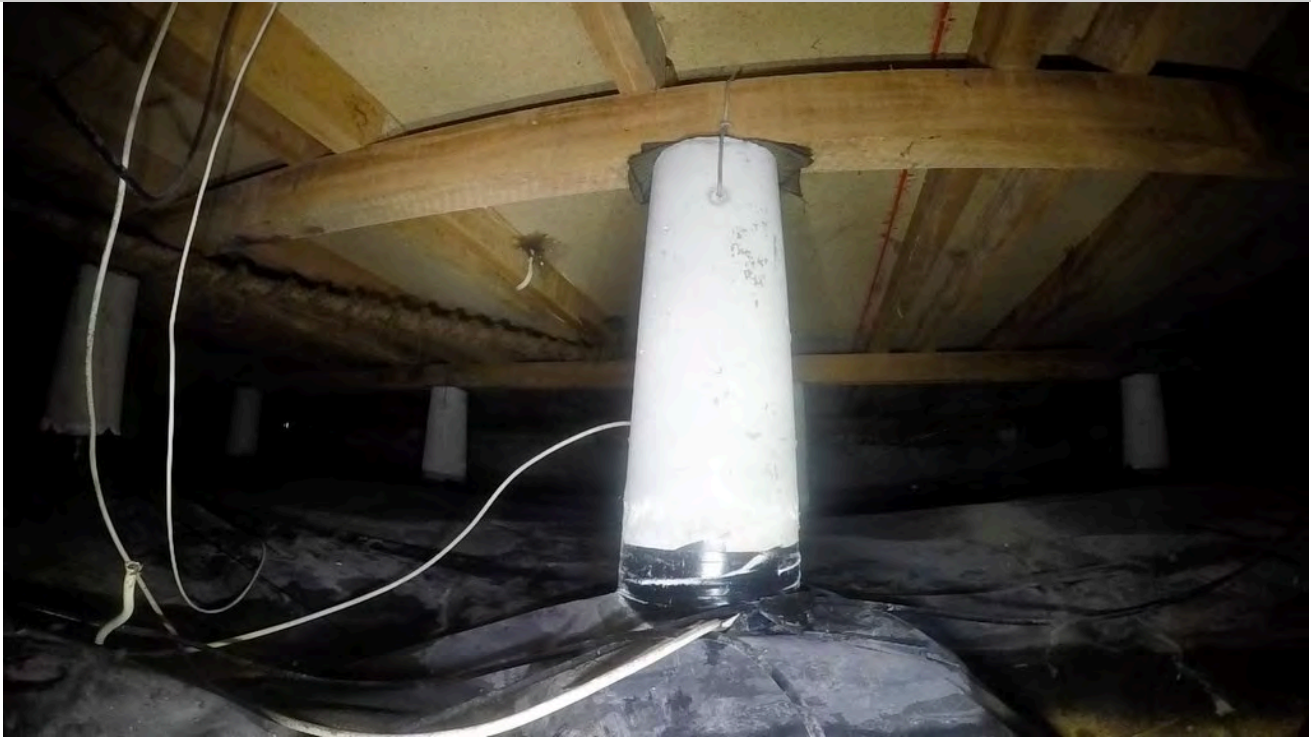
21: Pile with connection.

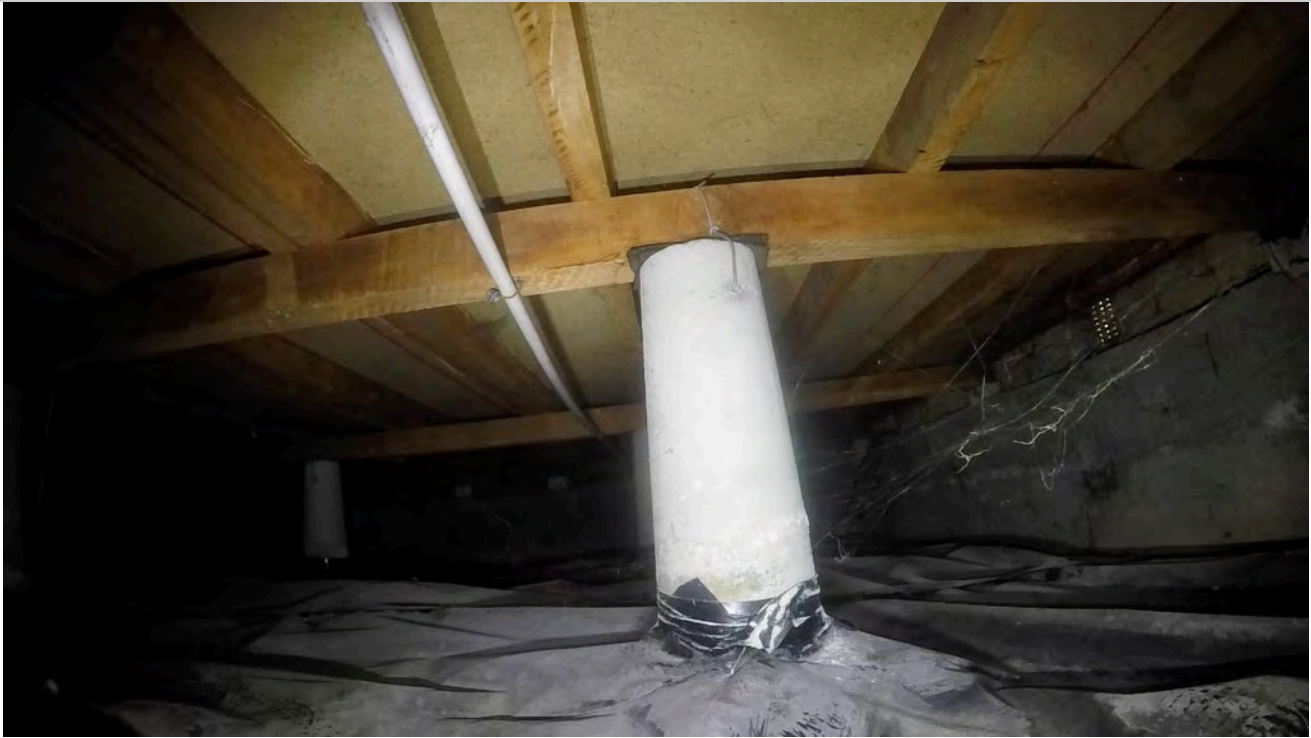
23: Pile with connection.

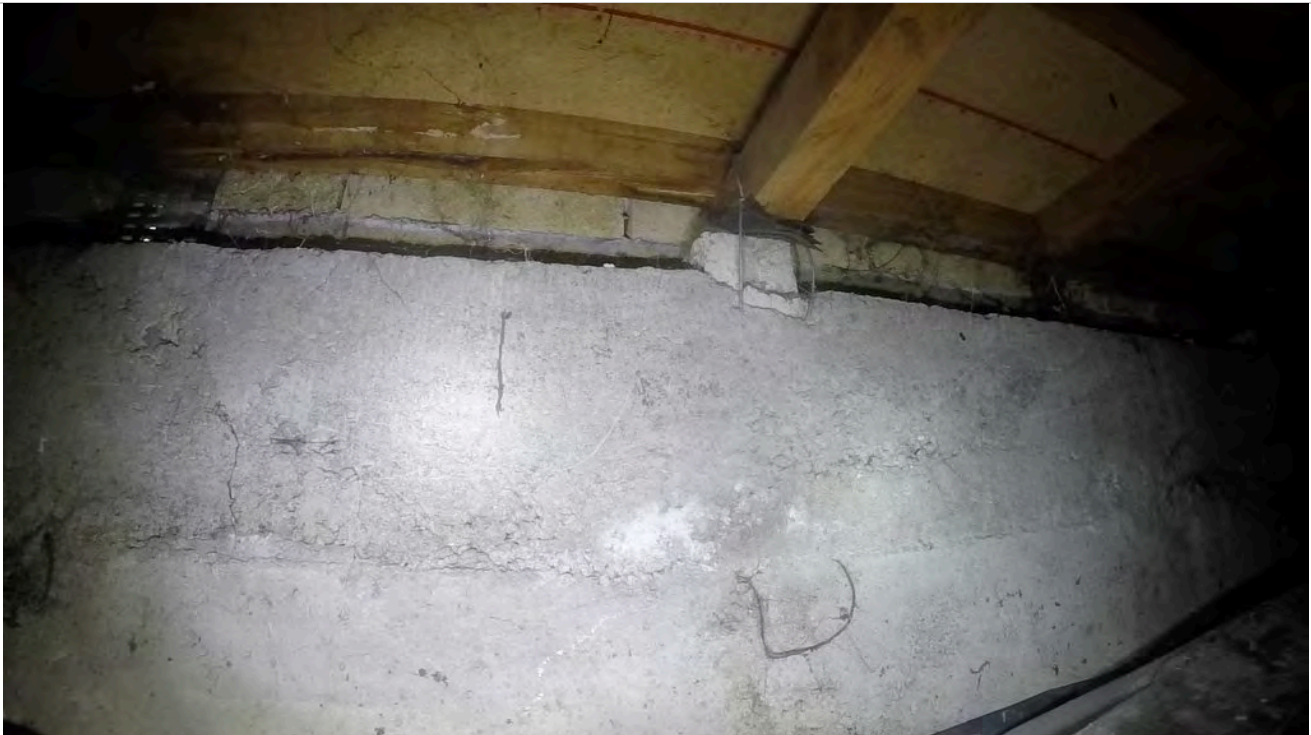
24: View of bearer meeting ring foundation with connection.

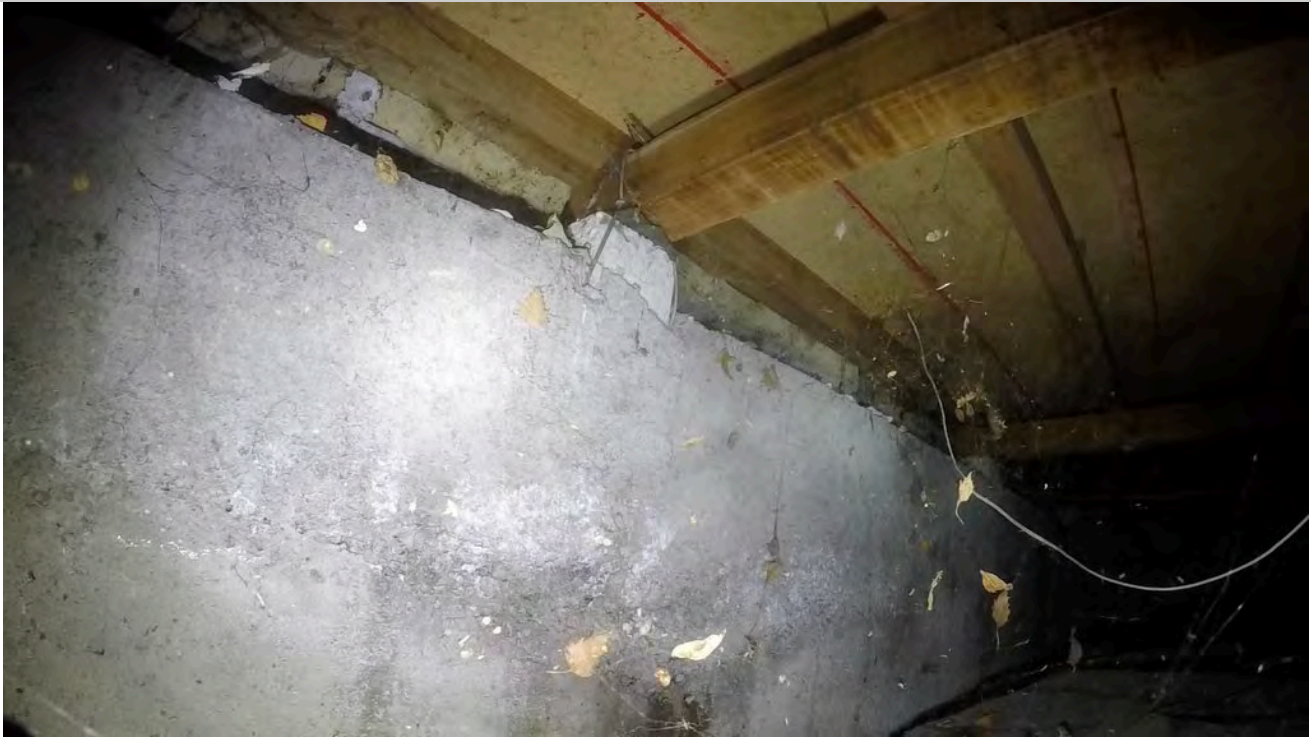
25: View of bearer meeting ring foundation with connection.

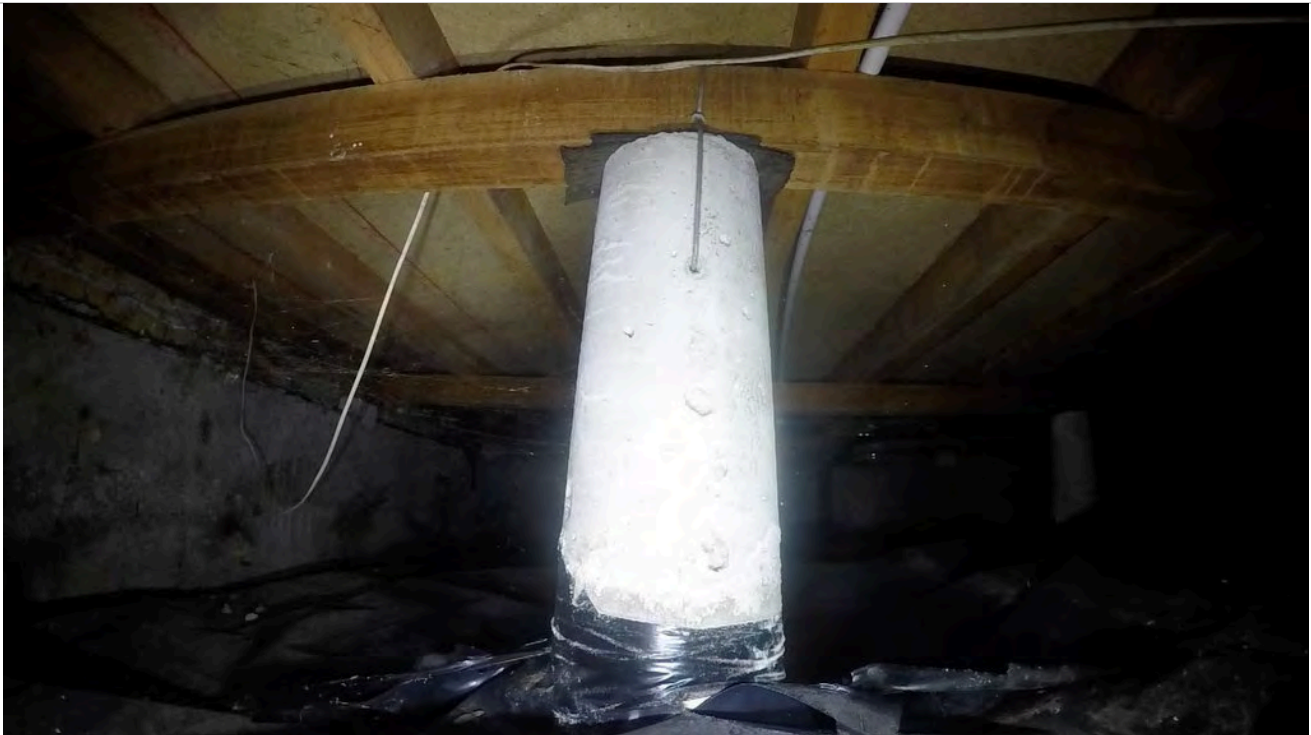
26: Pile with connection.

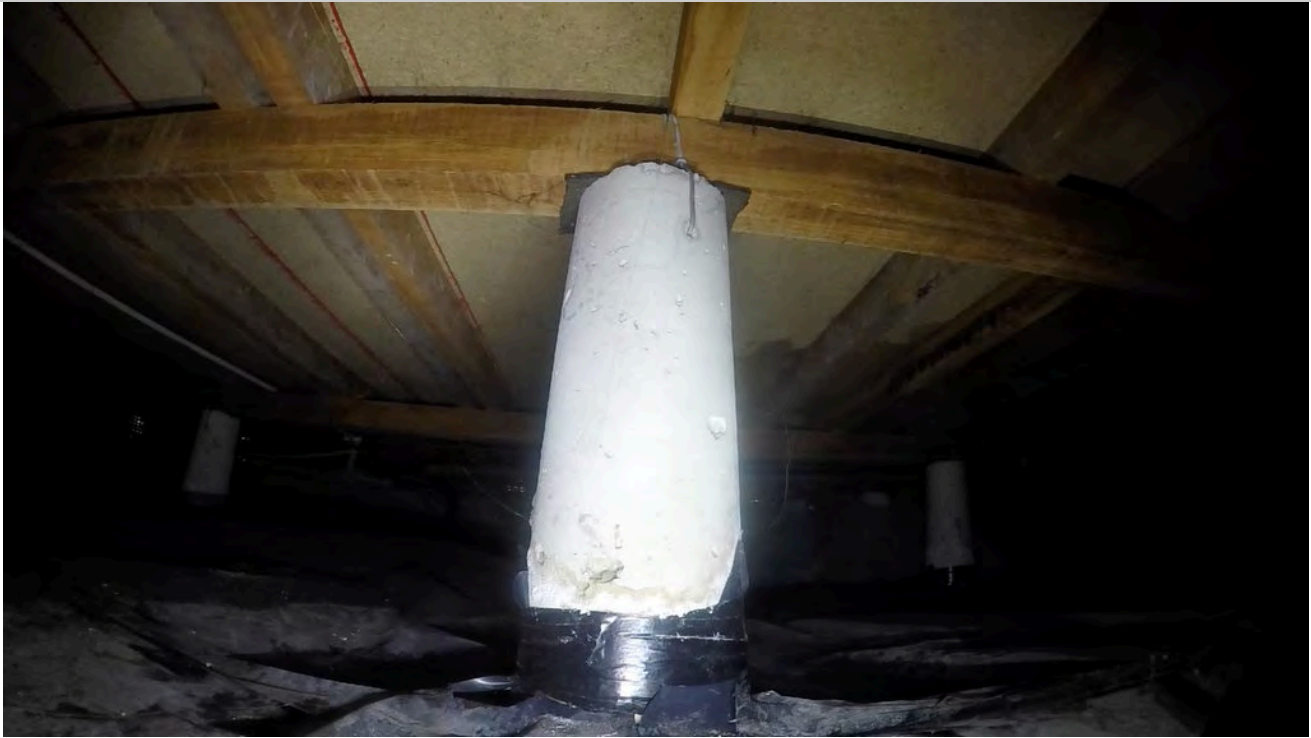
27: Pile with connection.

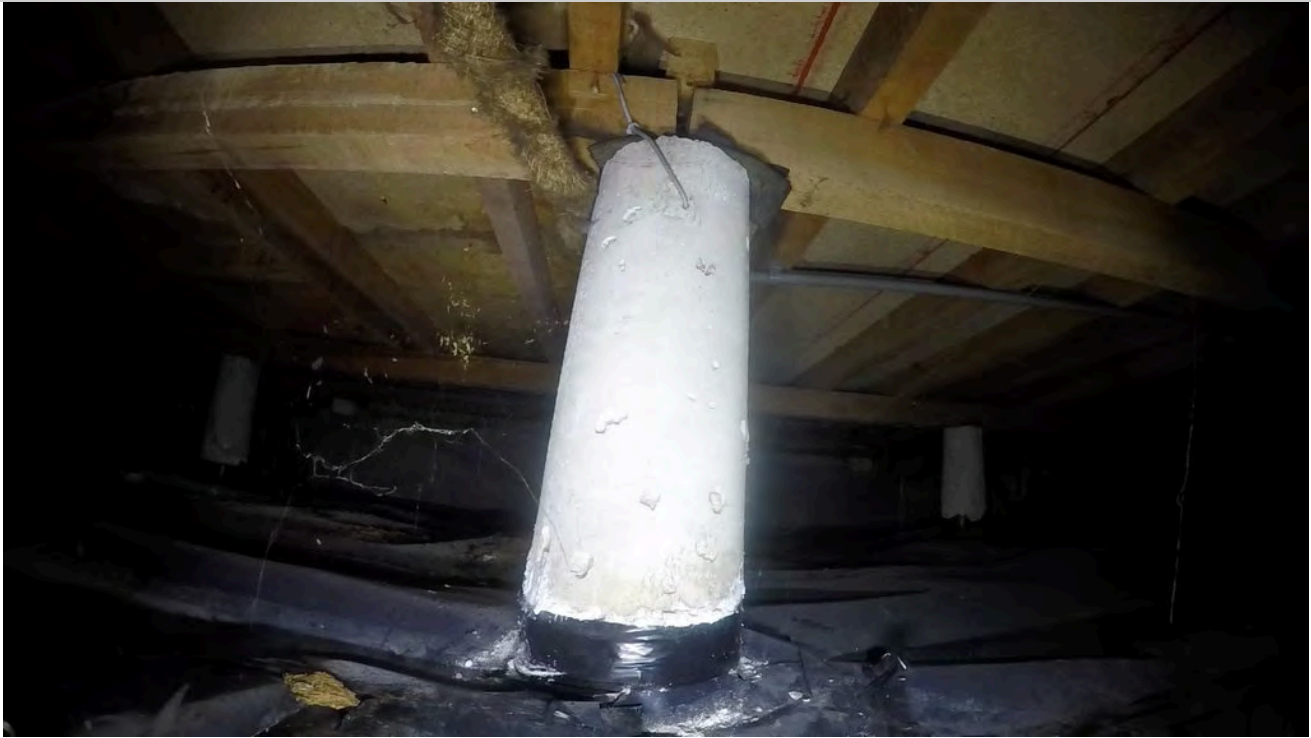
29: Pile with bearer join.

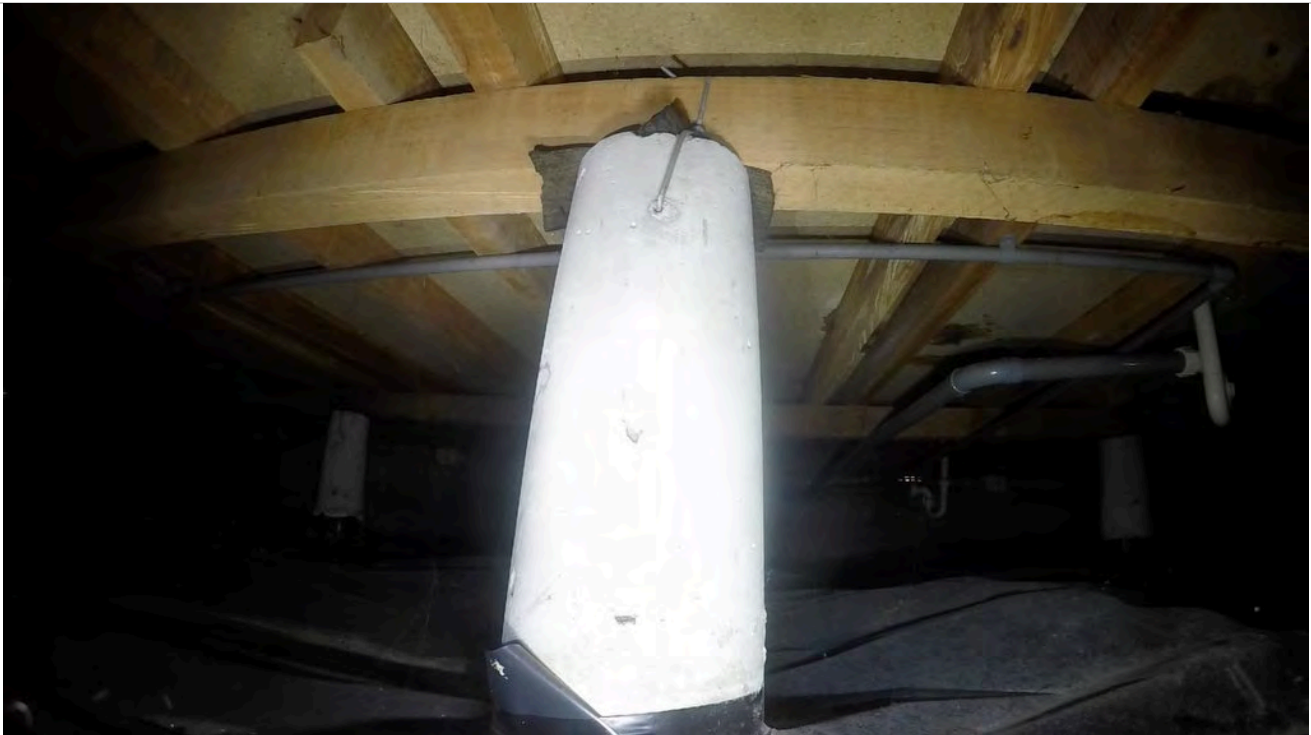
30: Pile with connection.

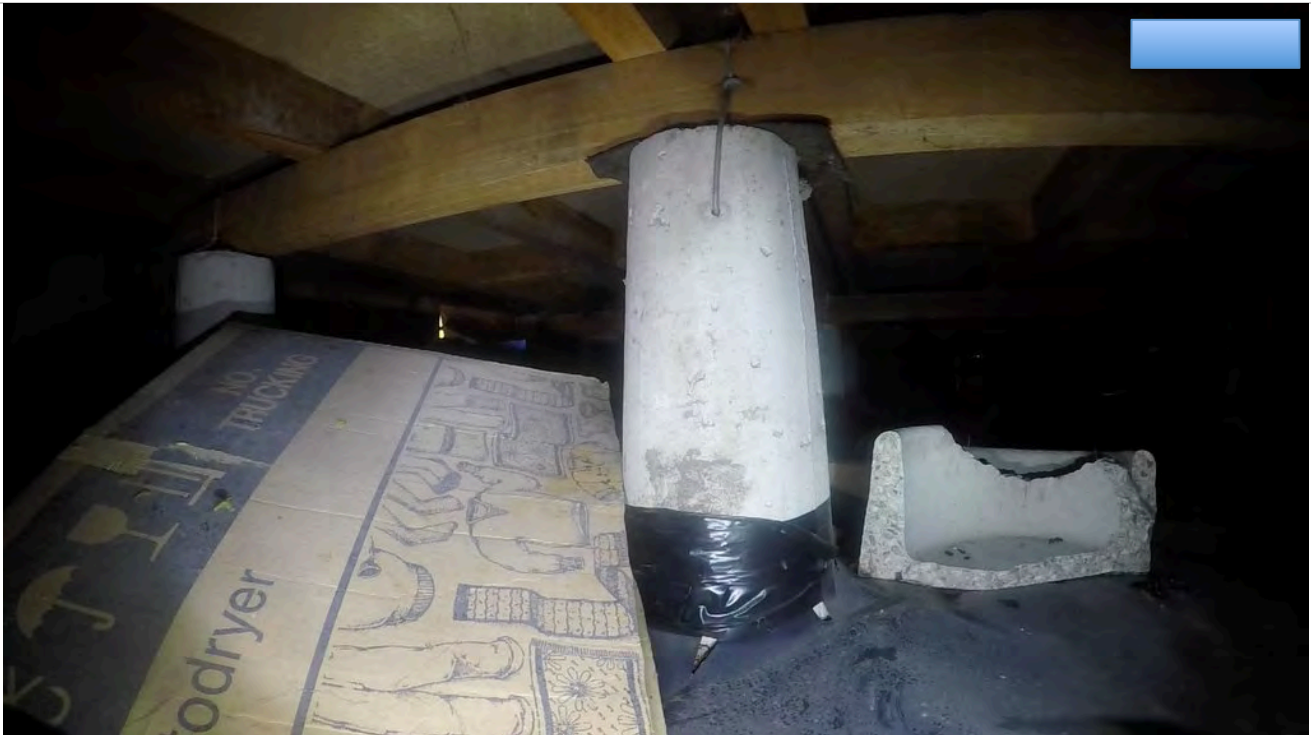
32: Pile with connection.

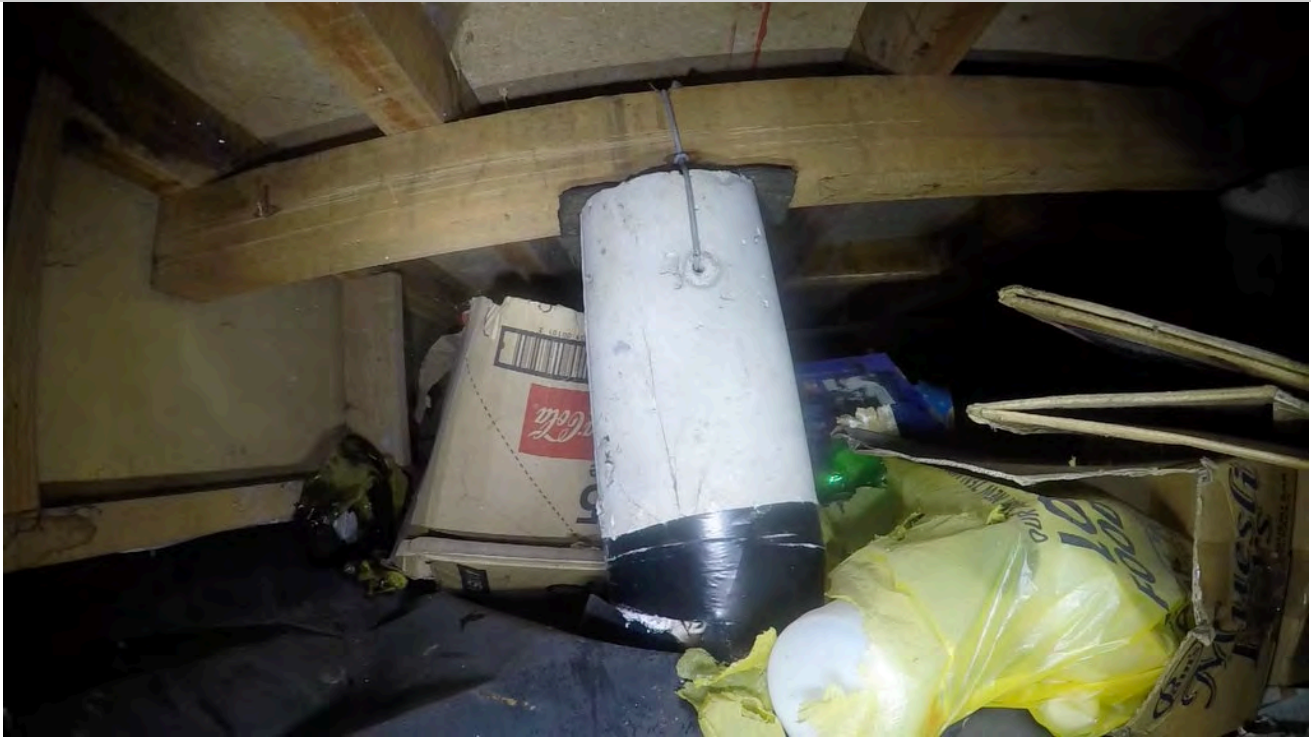
33: Pile with connection.
