EQC CLAIM DOCUMENTATION CAVITY CRITTER REPORT

Under floor Inspections

Property address: 191 Westminster Street

Property address: 191A Westminster Street

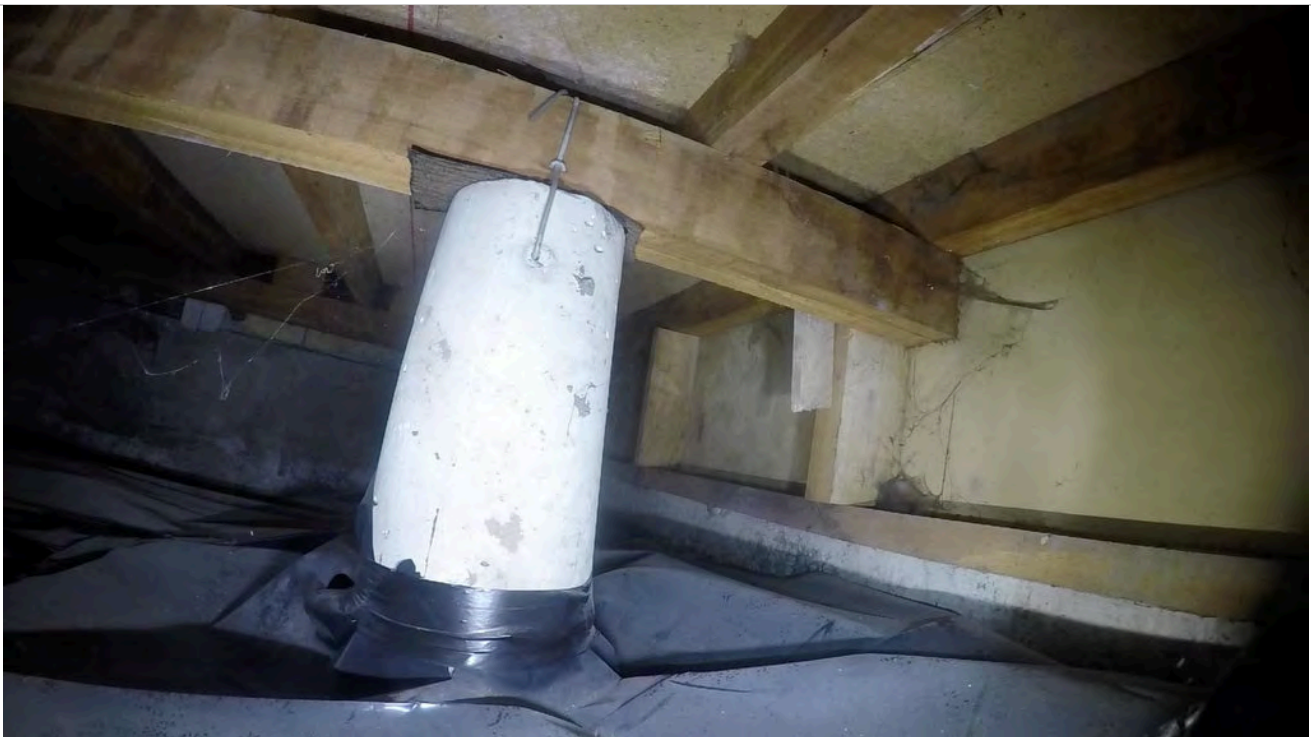
34: Pile with connection.

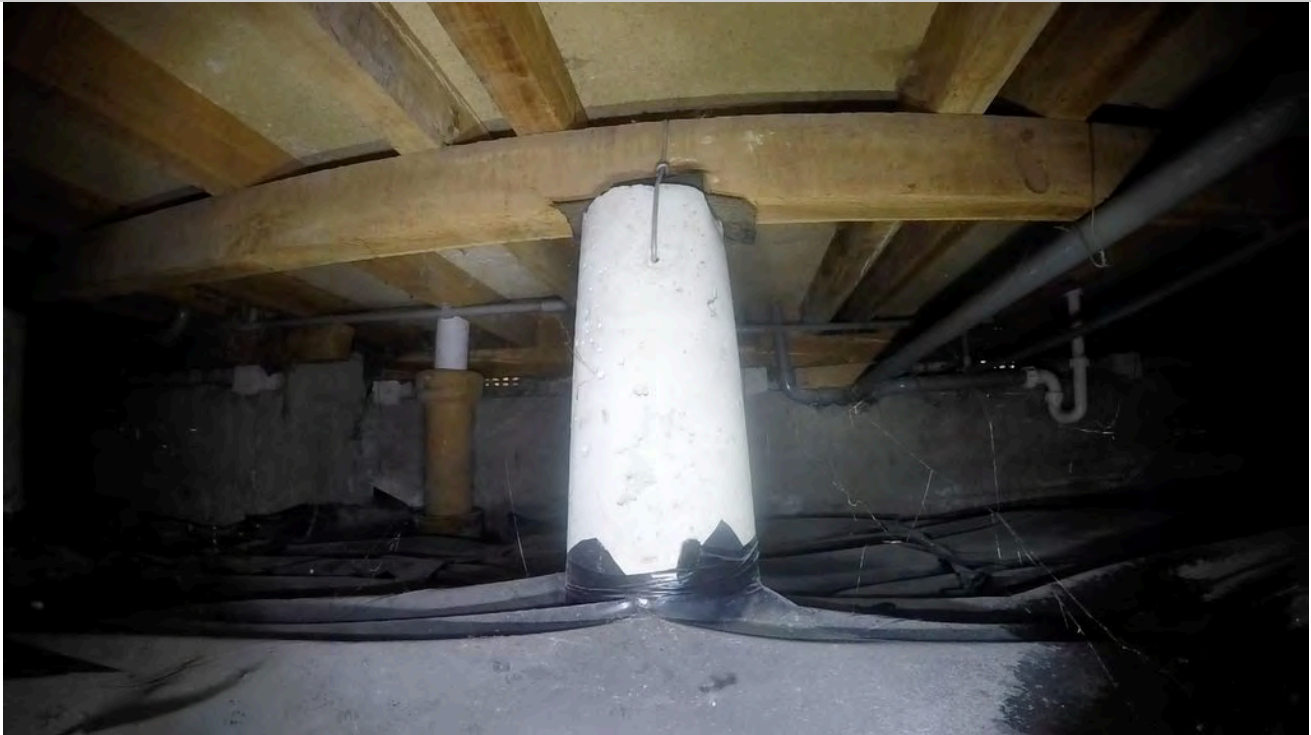
37: Pile with connection.

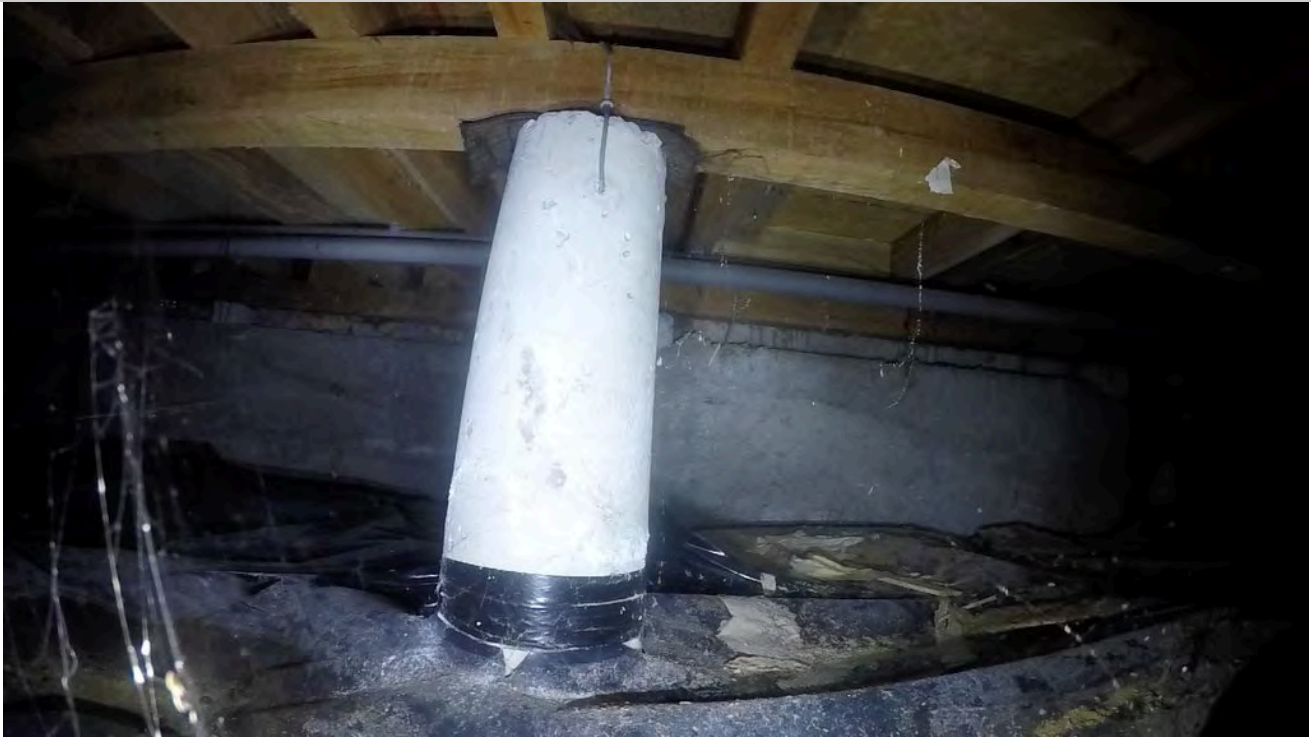
39: Pile with connection.

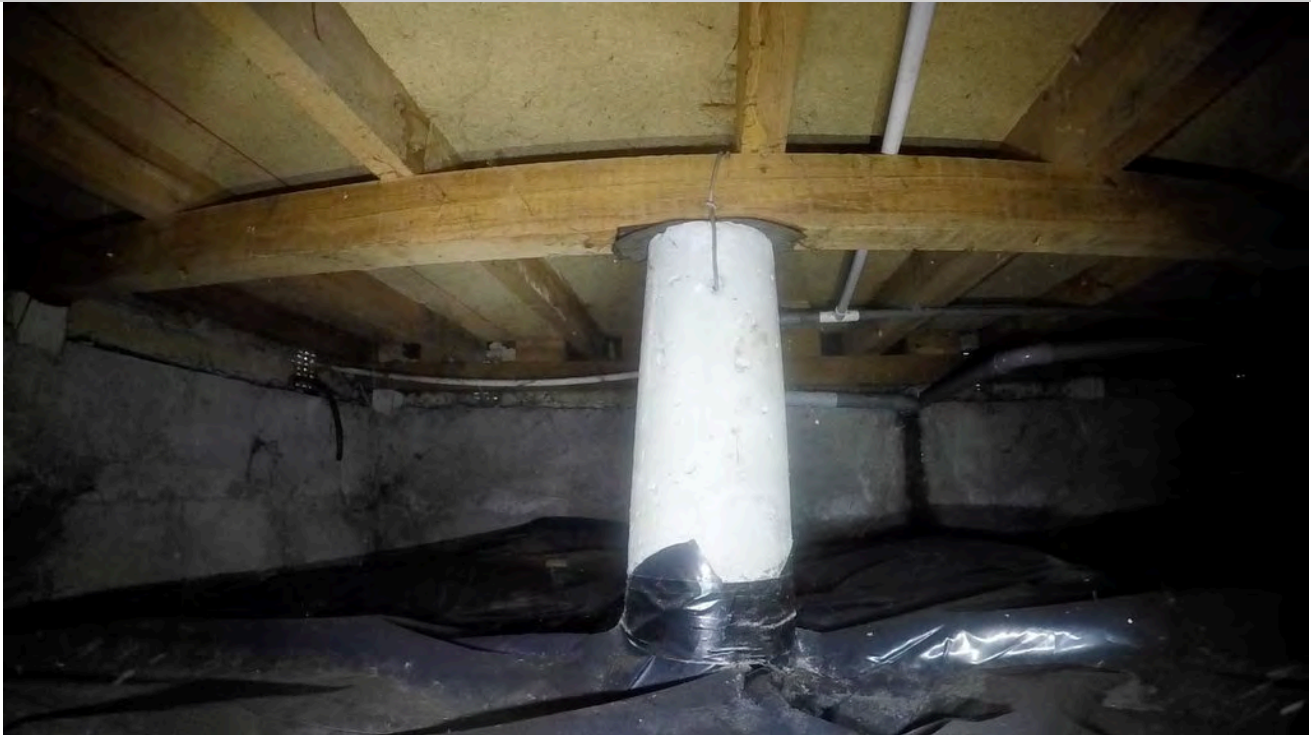
41: Pile with connection.

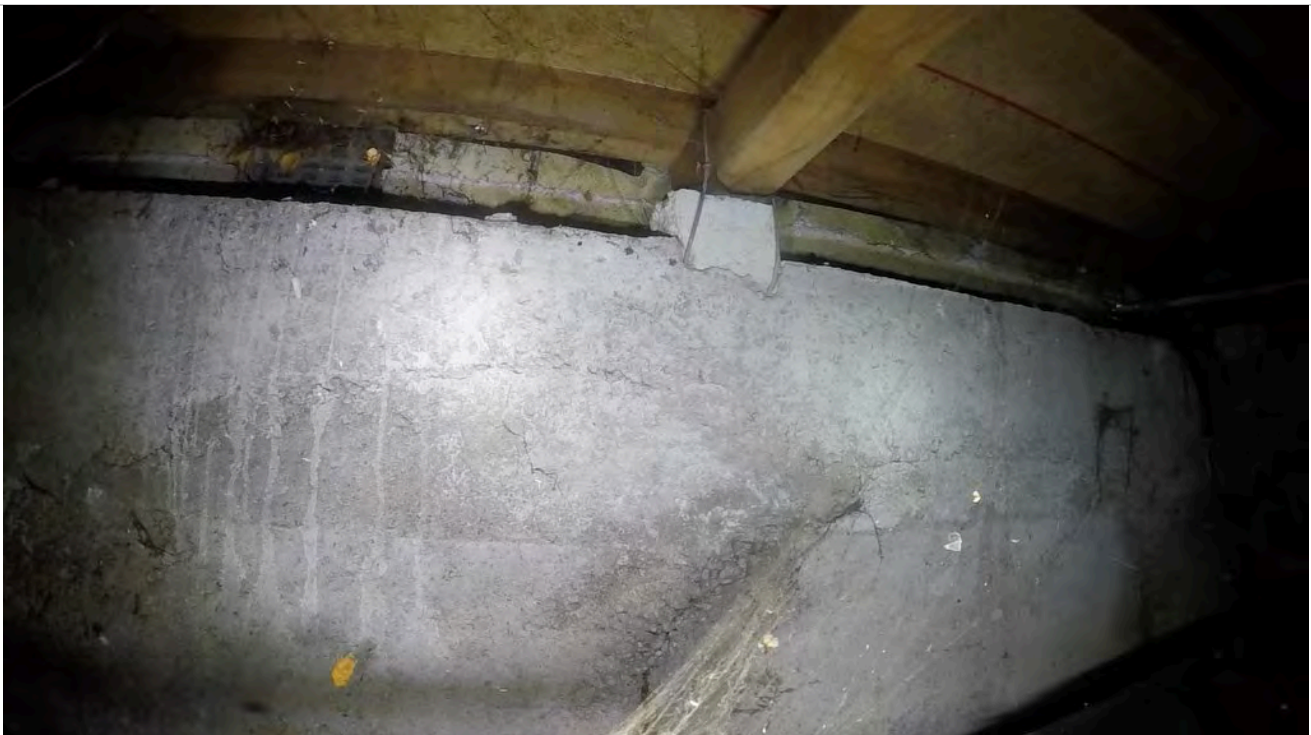
42: View of bearer meeting ring foundation with connection.

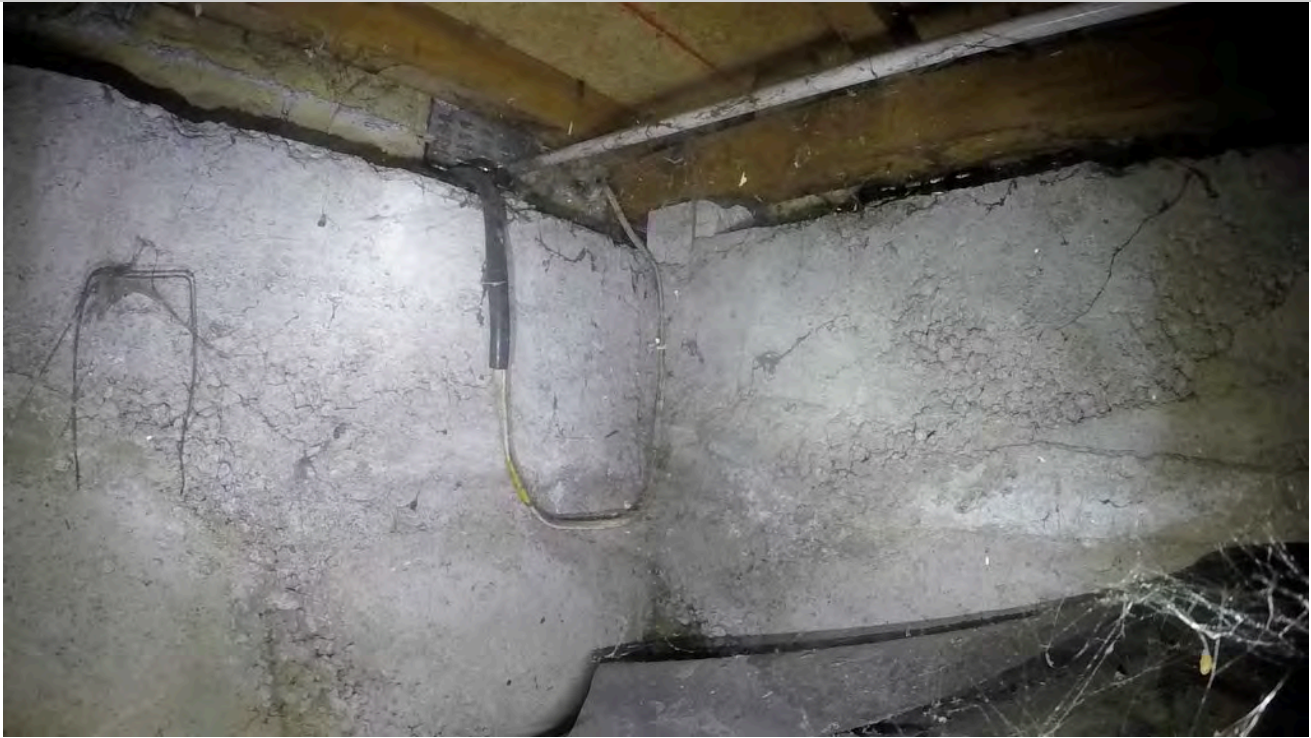
43: View of ring foundation.
