EQC CLAIM DOCUMENTATION CAVITY CRITTER REPORT

Under floor Inspections

Property address: 191 Westminster Street

Date: 26 July 2017

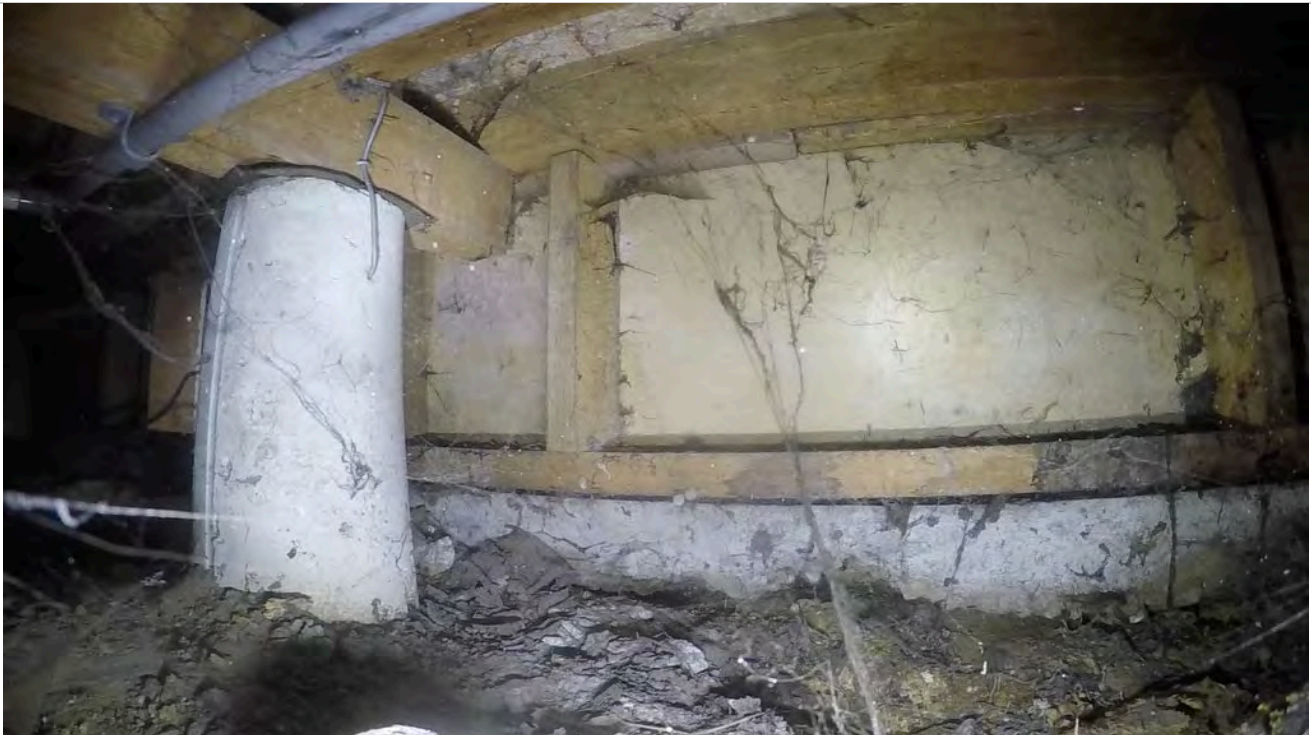
2: All piles in this home are precast concrete piles. The majority of the piles appear to have their original connections, however there are several connections that are not stapled correctly.

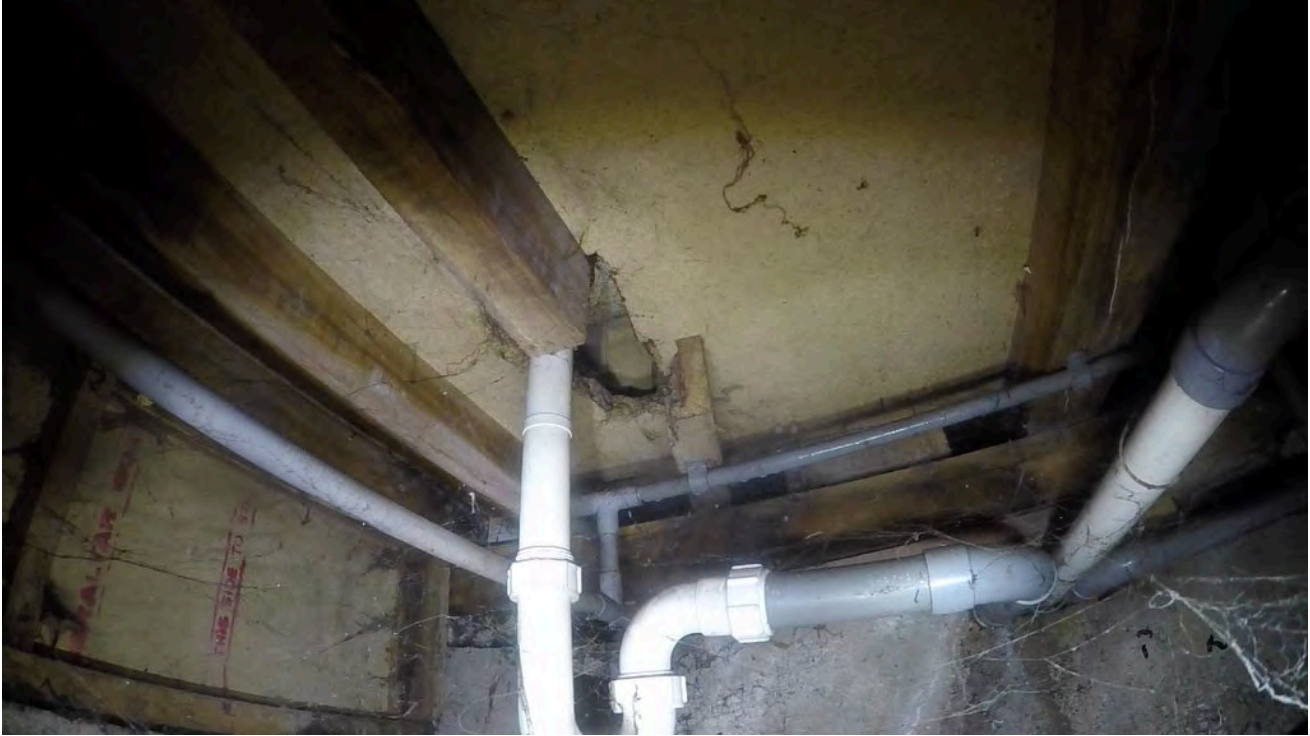
3: The joist has been cut for the waste. Both joist ends are now unsupported.

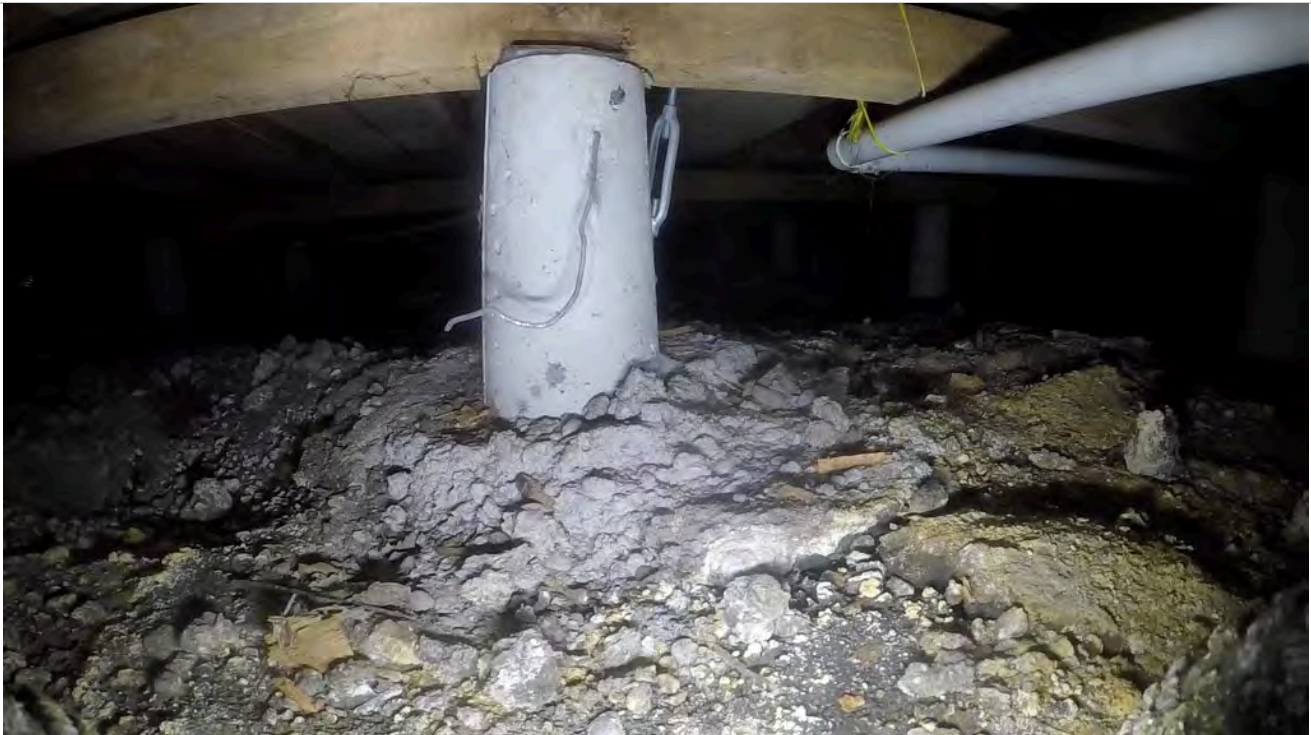
14: It appears the bearer has been notched and a turnbuckle has been used to pull the bearer down to meet the pile. No compliant connection has been used.

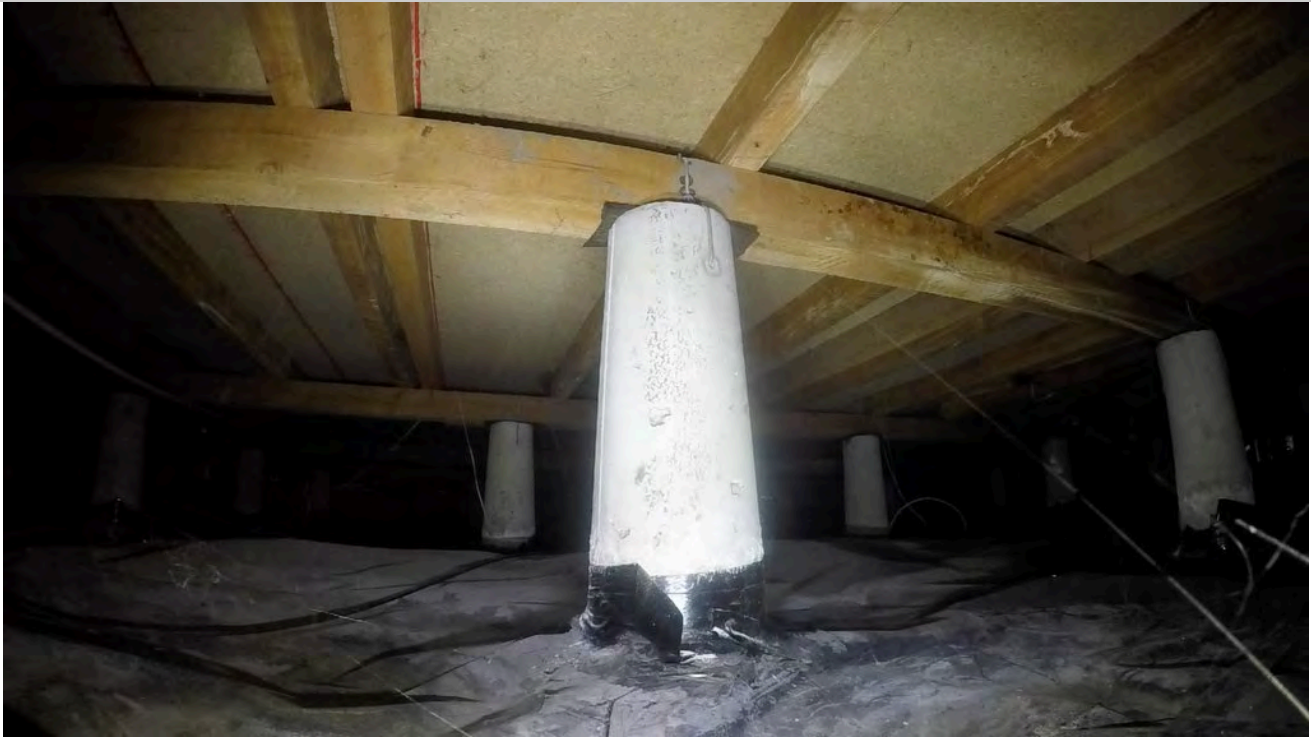
9: Pile with connection.

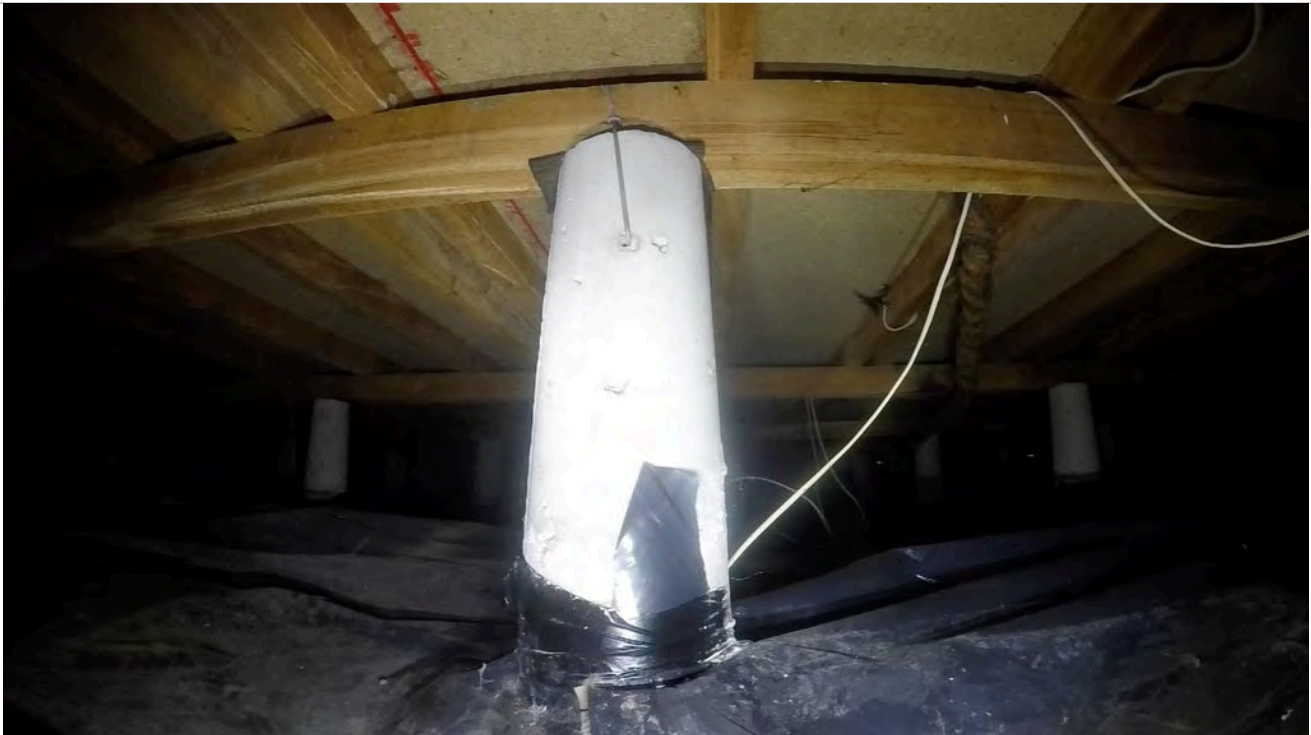
10: Pile with connection.

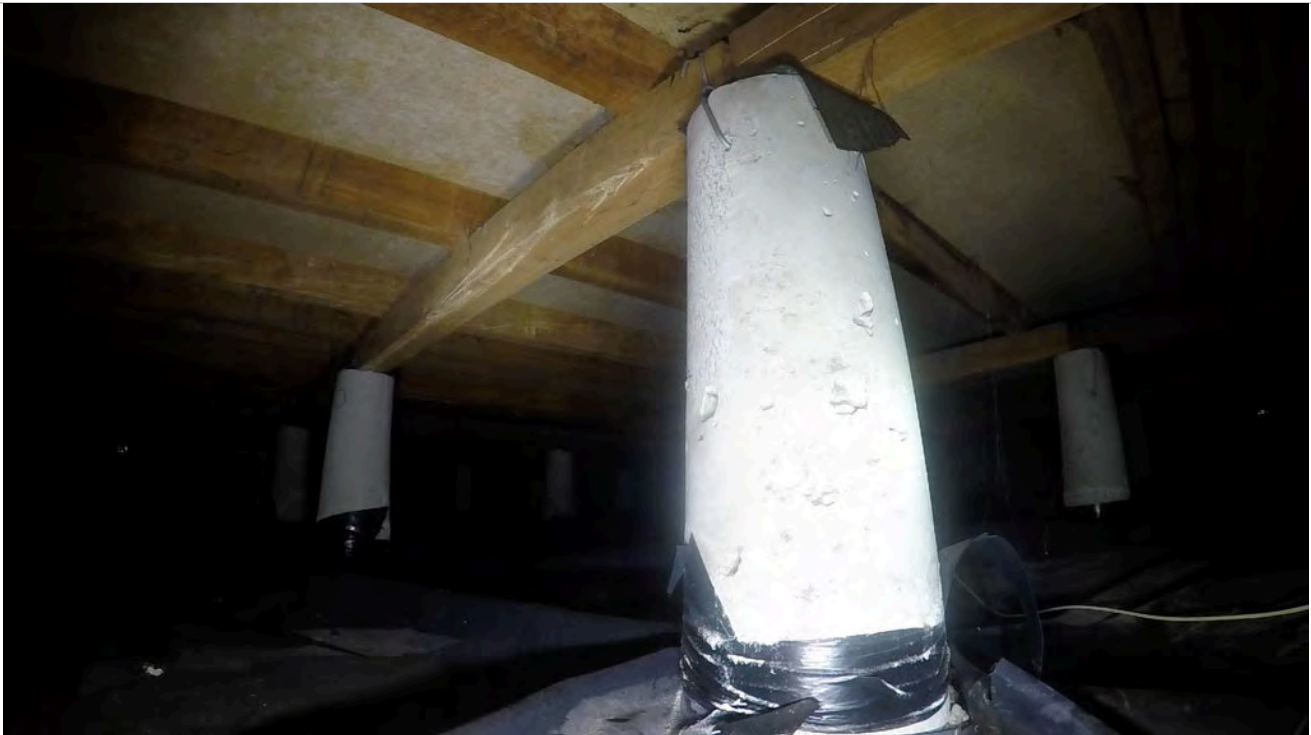
12: Pile with bearer join.

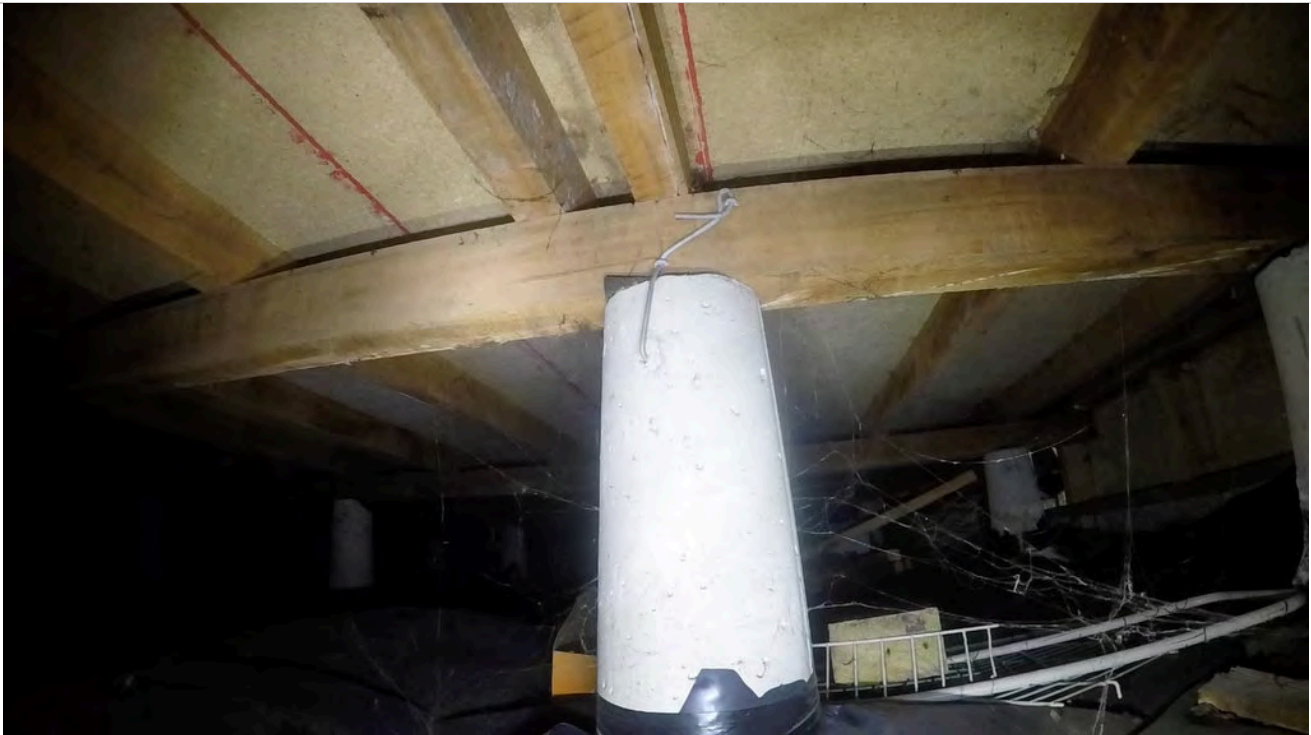
14: Pile with connection.

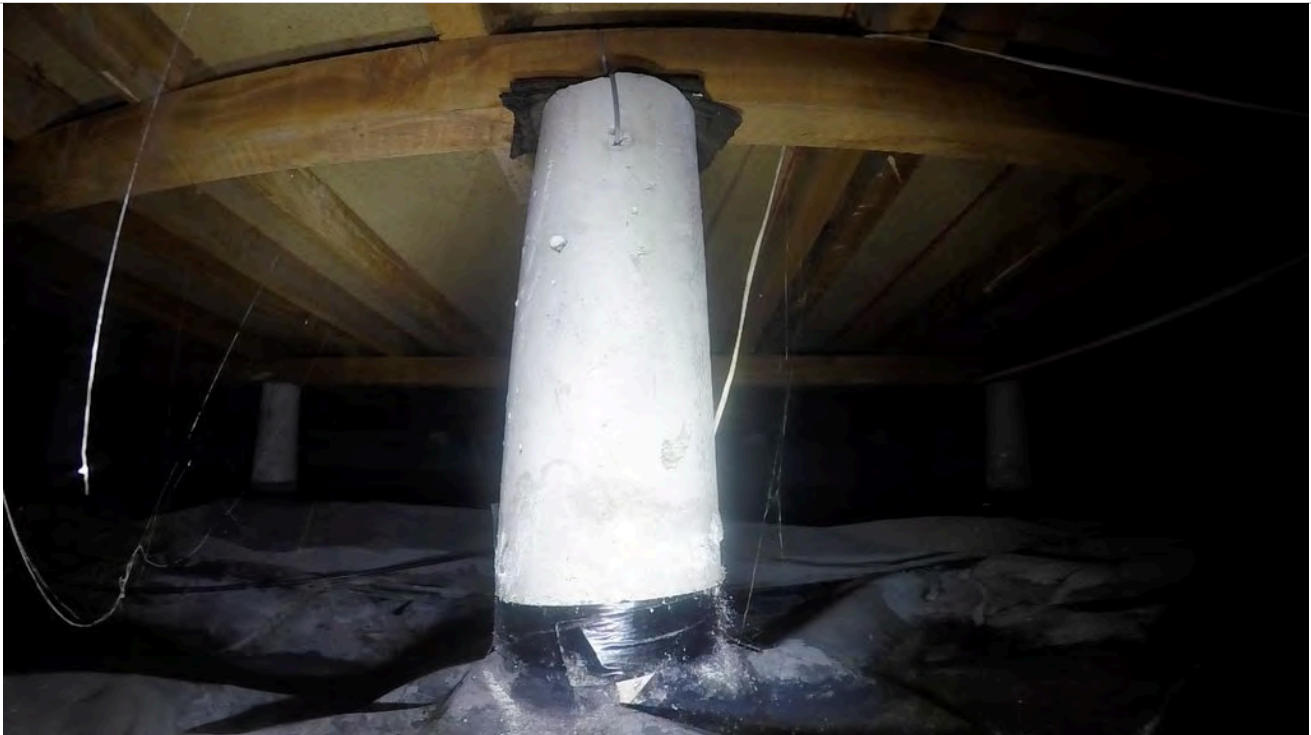
22: Pile with connection.

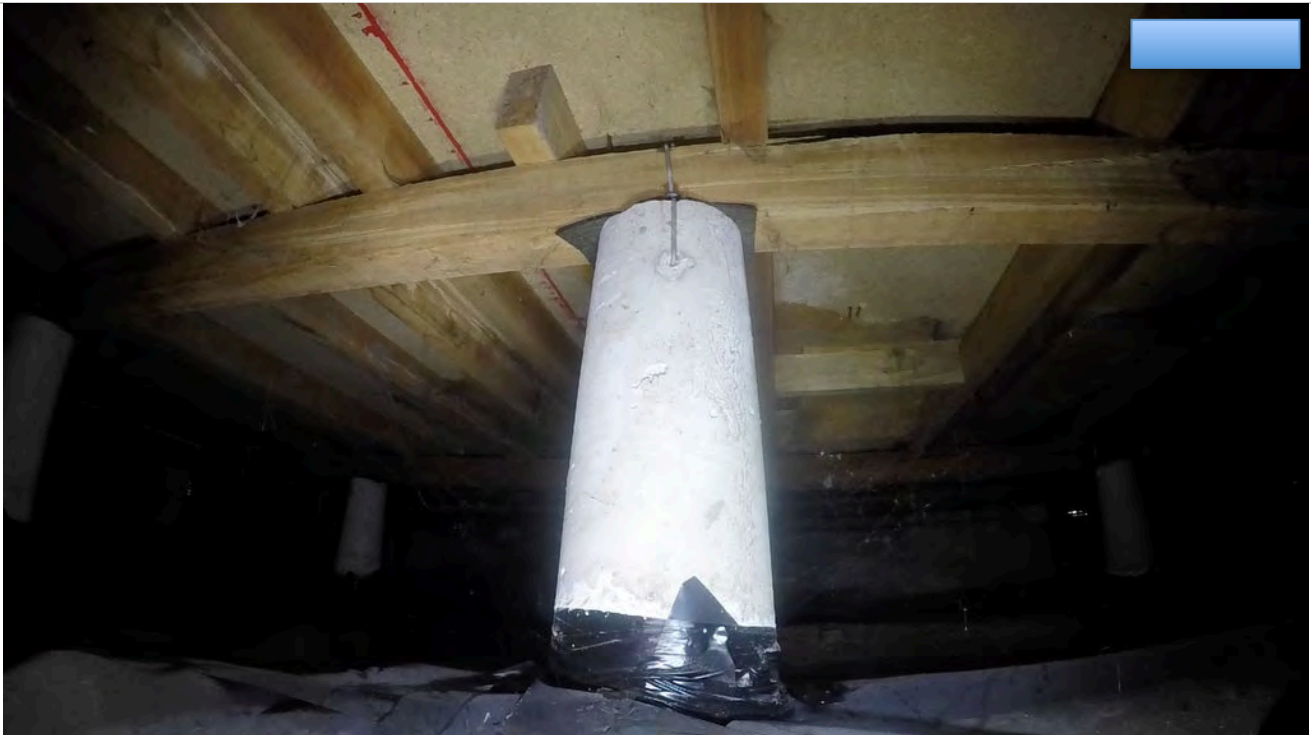
28: Pile with connection.

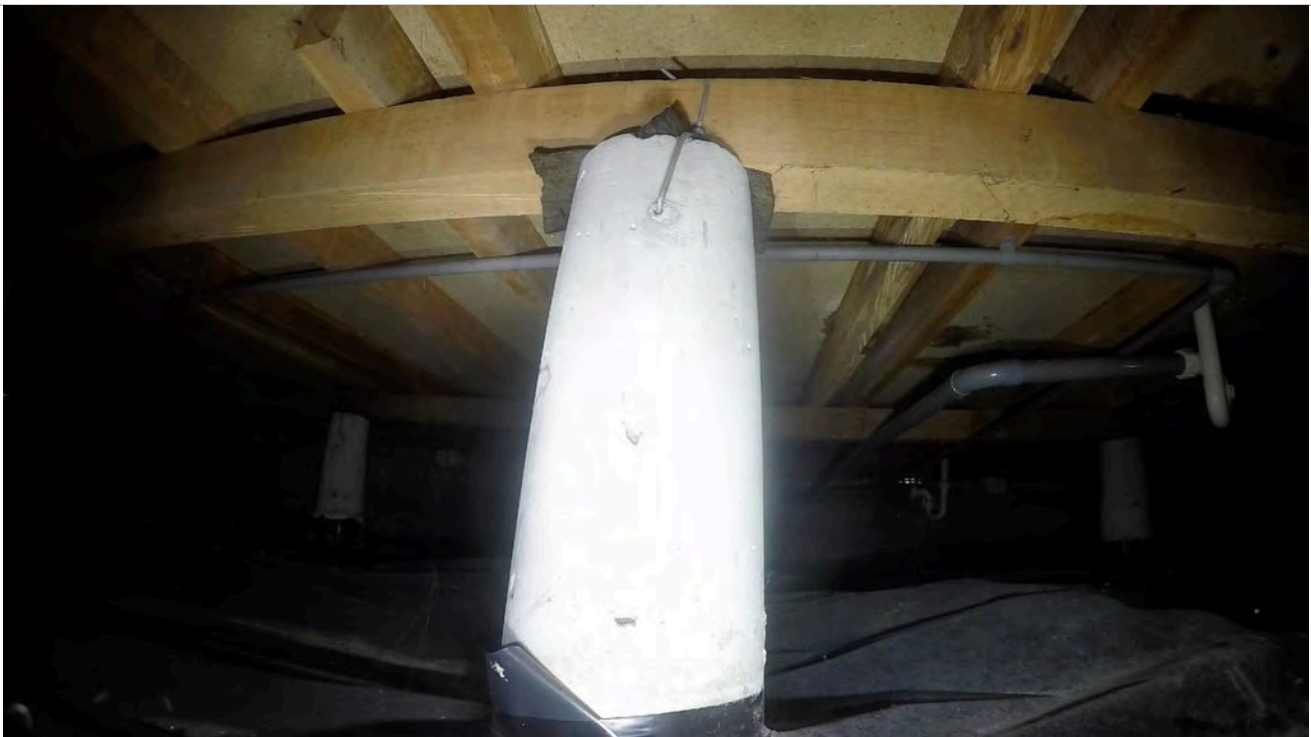
30: Pile with connection.

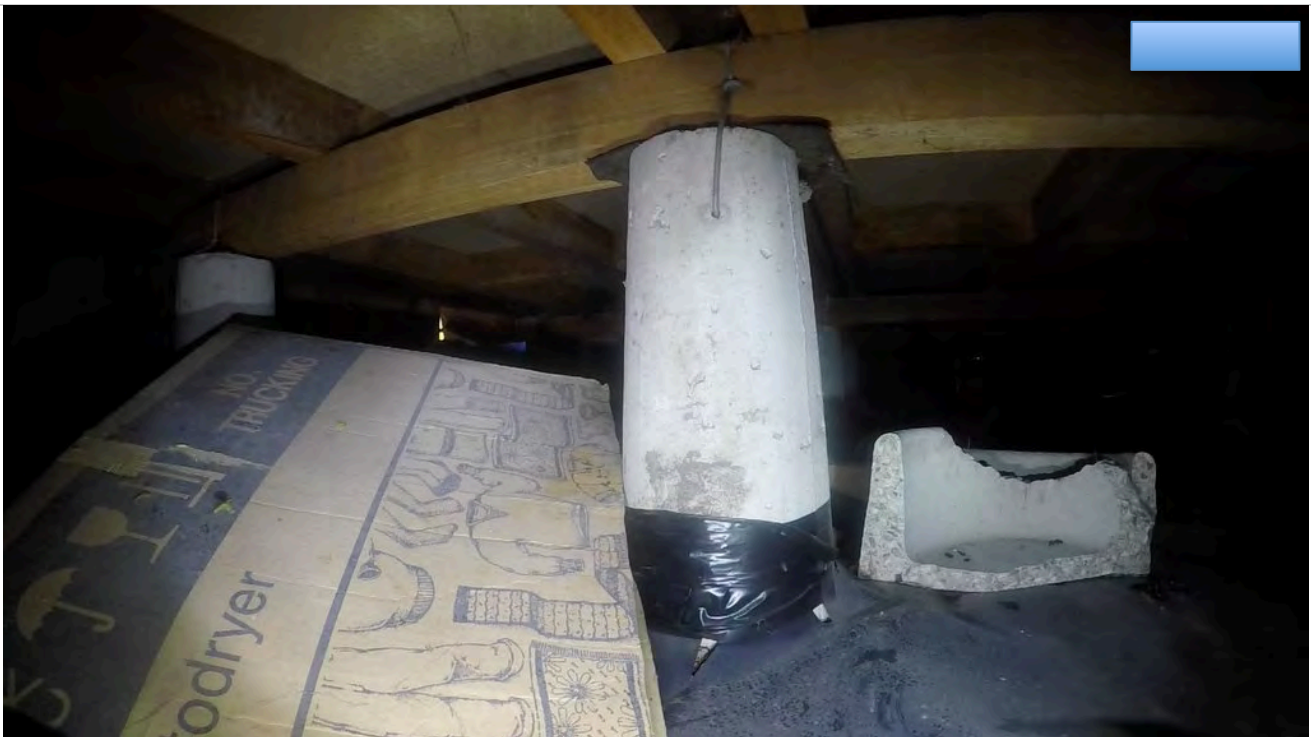
32: Pile with connection.

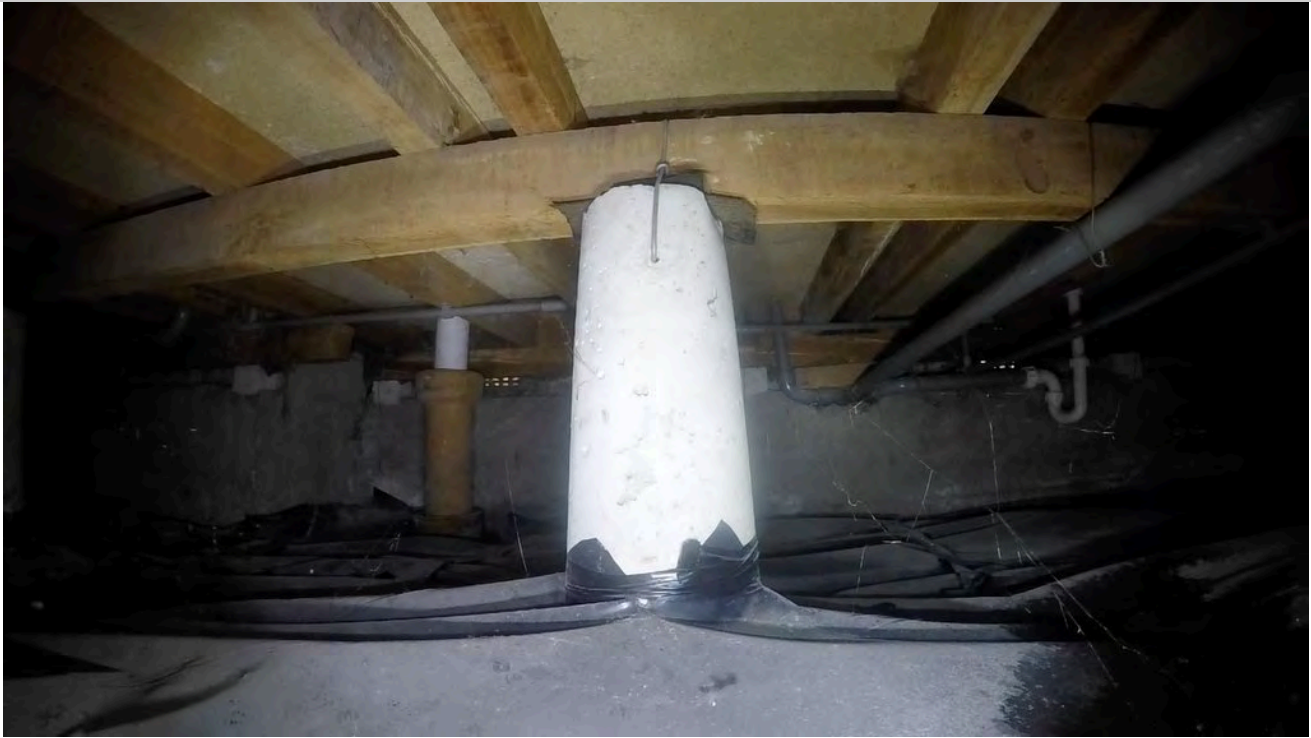
37: Pile with connection.

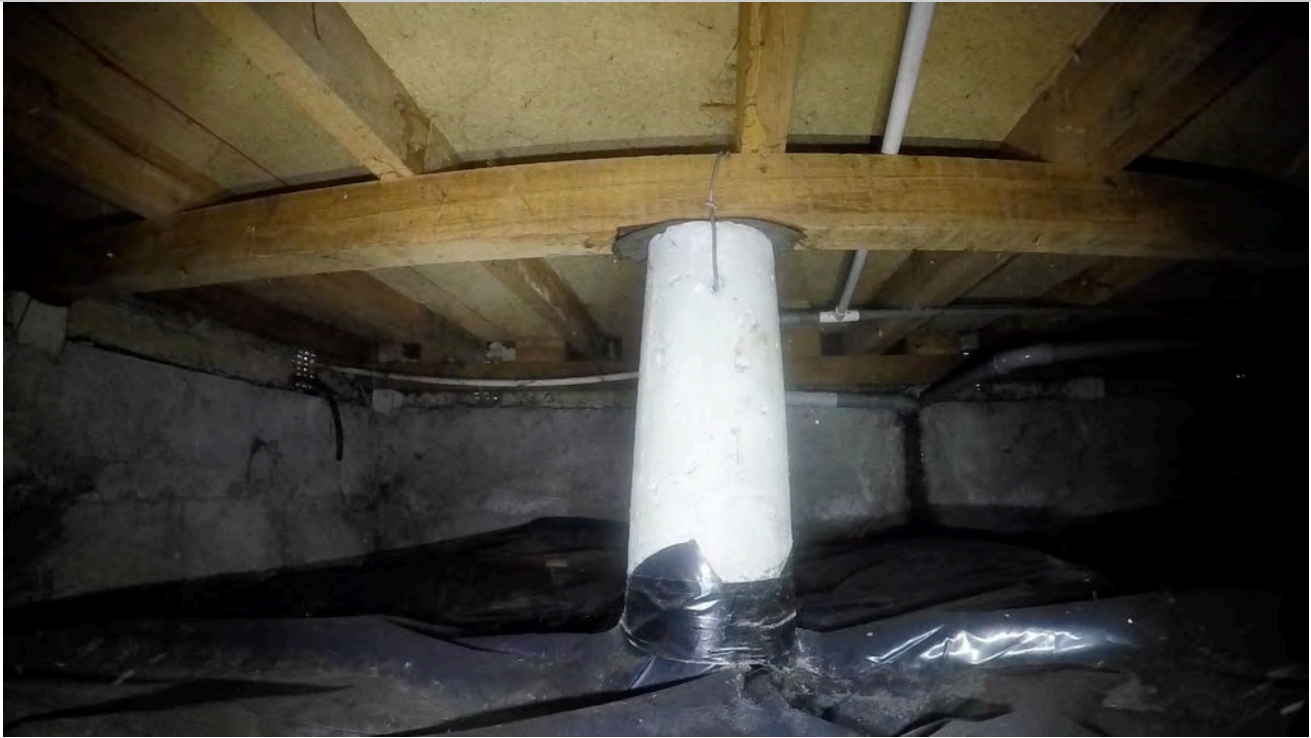
41: Pile with connection.

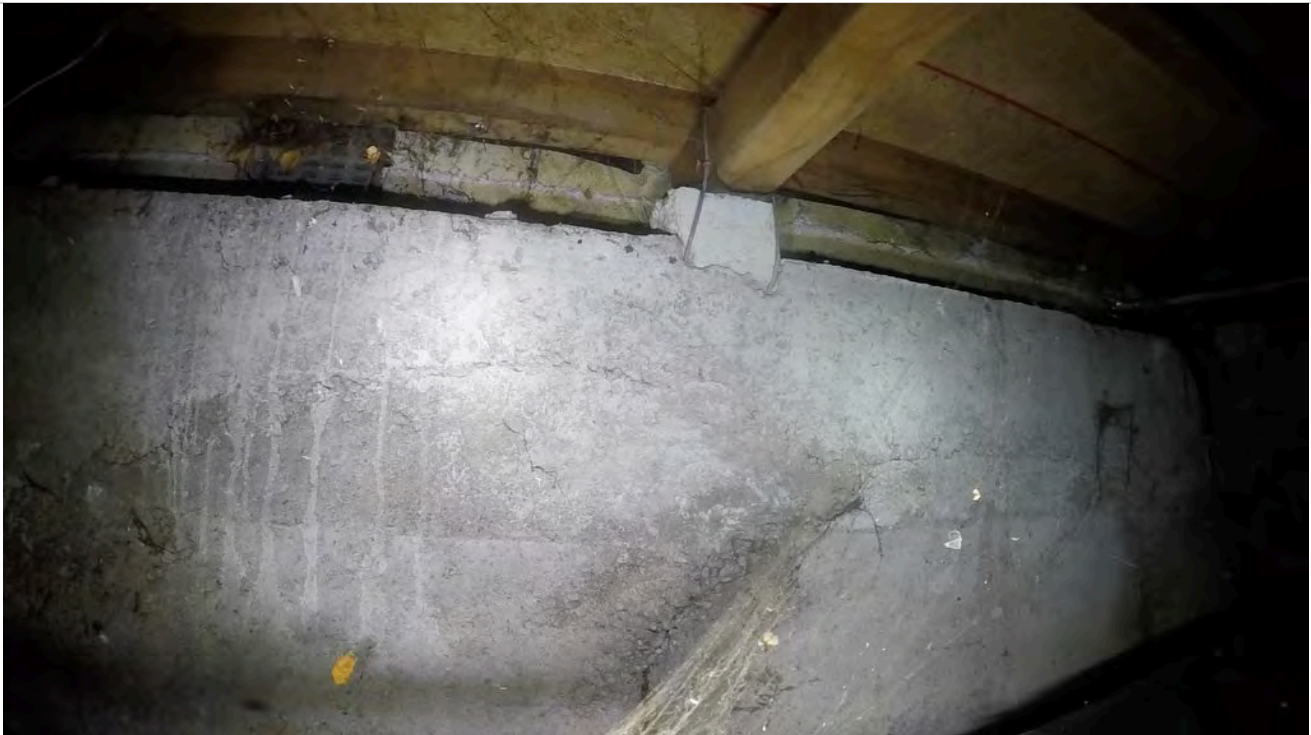
42: View of bearer meeting ring foundation with connection.
