RED LBP WEATHERTIGHT REPORT

CERTIFICATE OF INSPECTION IN ACCORDANCE WITH NZS 4306:2005

Company: Property Support Ltd Ltd trading as RedLBP Kapiti/Porirua
Client: Carl and Jane Olsson
Date of Inspection: 26th May 2026
Site Address: 10 Edgewater Street Waikanae
Inspector: Trevor Garrett
Qualifications: MSc, LBP, Advanced Trade Cert Carpentry, Nat Diploma Construction Management. Member of NZIOB.

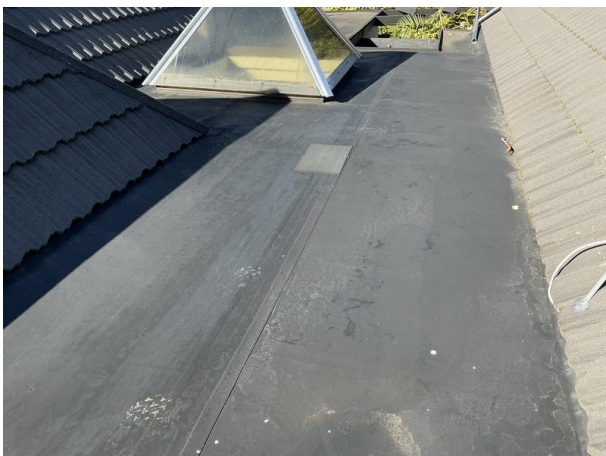
Photo 5
Centre area has visible patches.

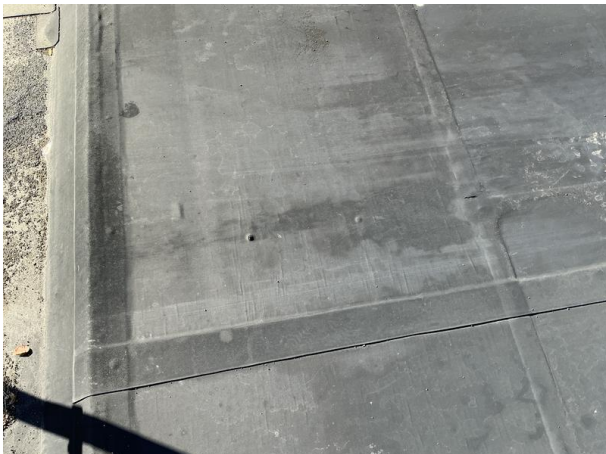
Photo 6
Northside split membrane and raised
substrate fixings.

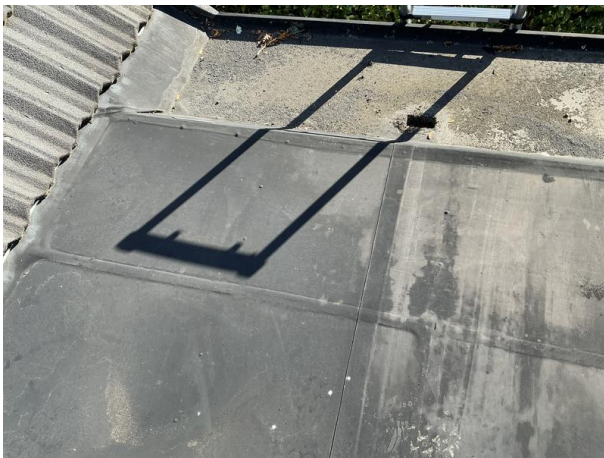
Photo 10
North side raised fixings.

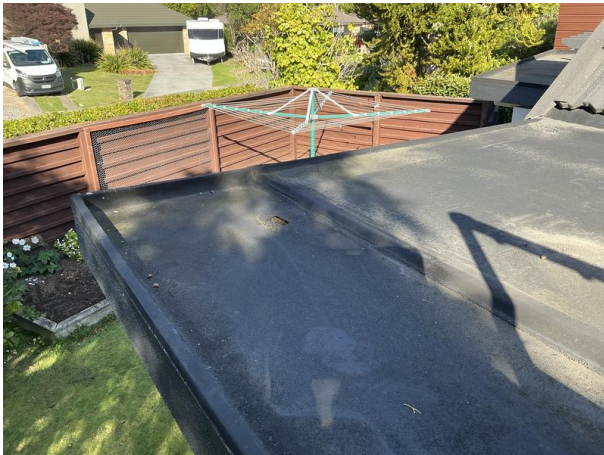
Photo 11
Southeast outlet.

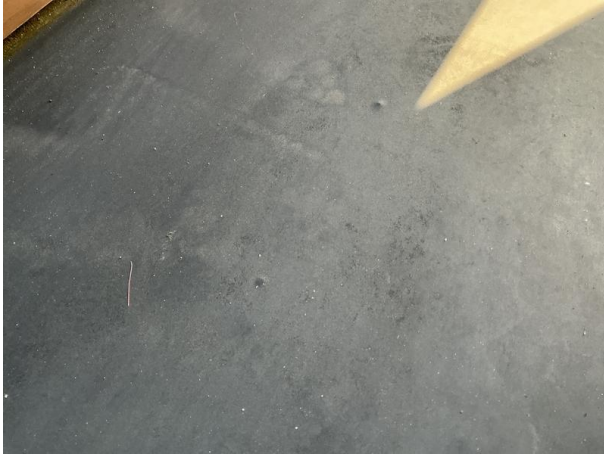
Photo 15
Fixing rising up through the
membrane.

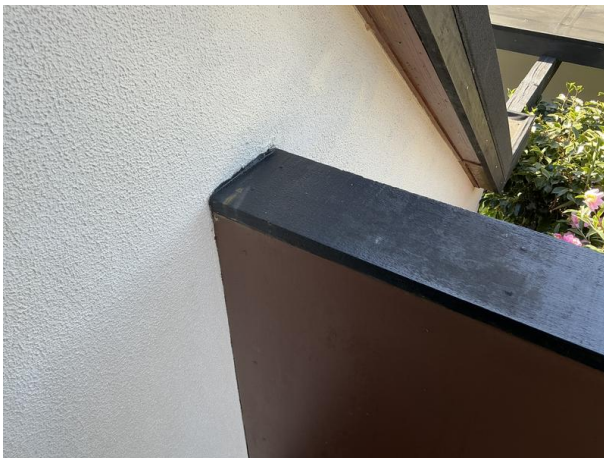
Photo 16
Barrier wall has a timber top with no
visible cap or saddle flashing.

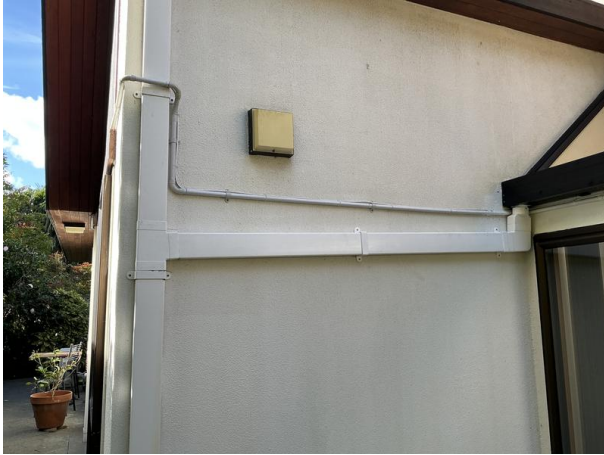
Photo 29
Northside services penetrate the cladding.

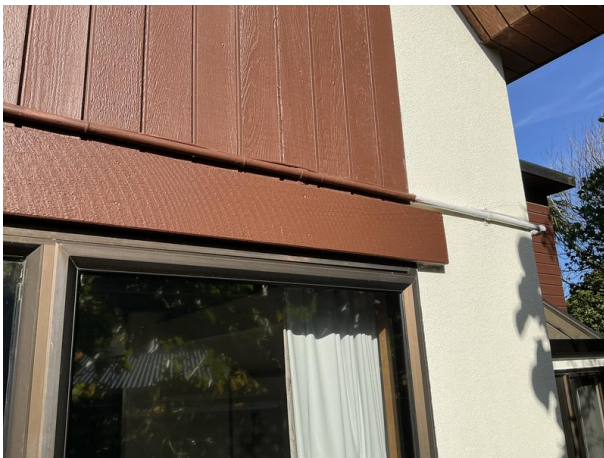
Photo 30
Northside no head flashing to window.

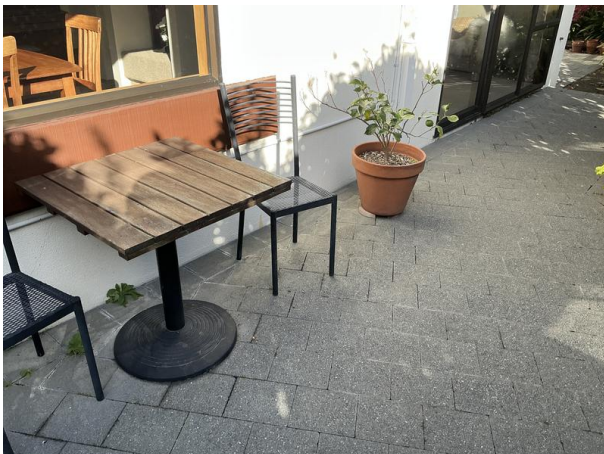
Photo 31
Northside reduced ground clearance.

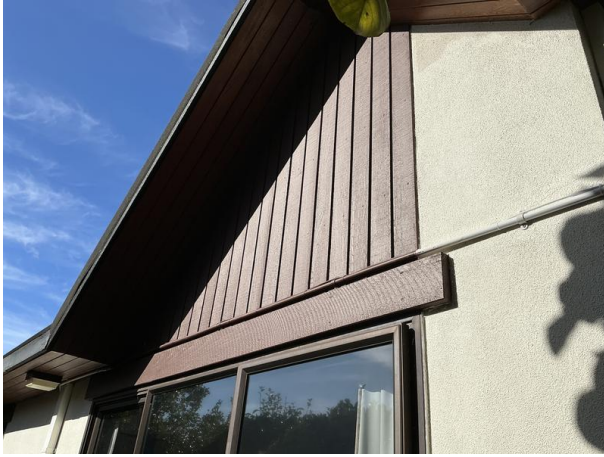
Photo 37
North side structure fixings penetrates the cladding.

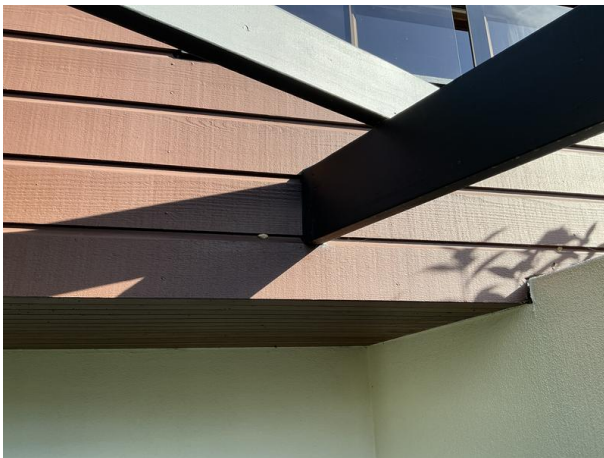
Photo 38
Structure penetrating the cladding.

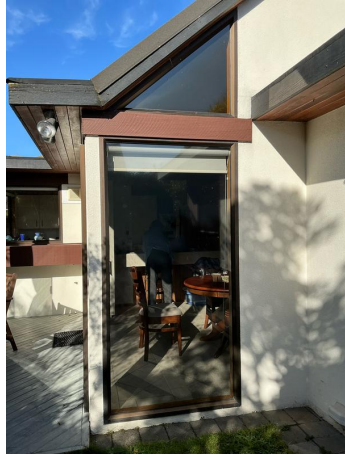
Photo 40
East side no head flashing.

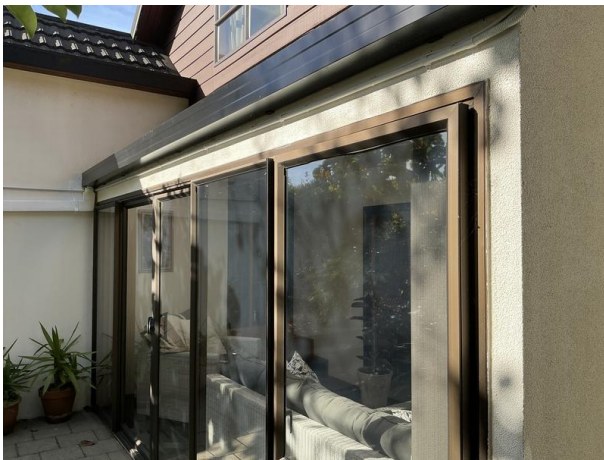
Photo 41
North side no head flashing.

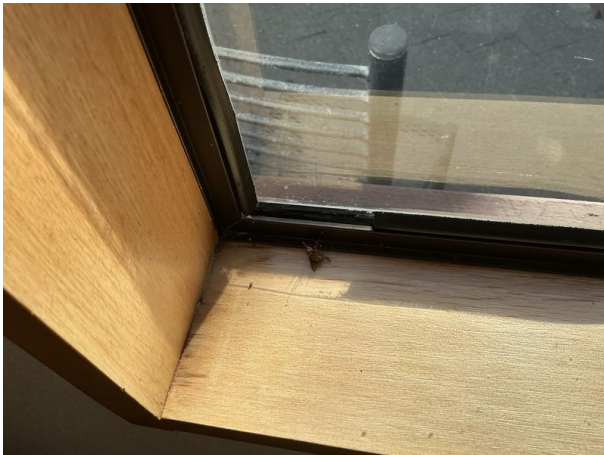
Photo 42
Shrunk glazing rubber.

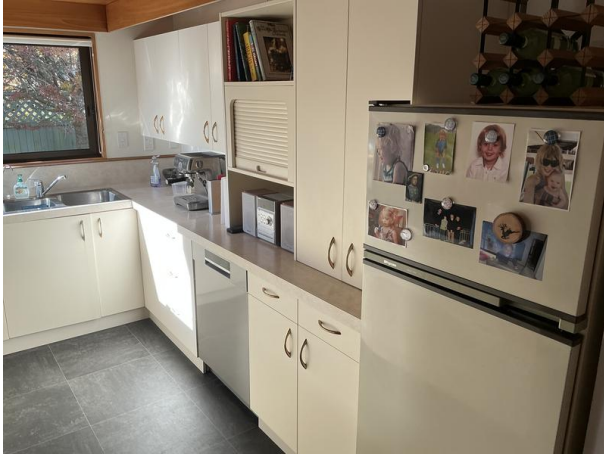
Photo 75
Kitchen.

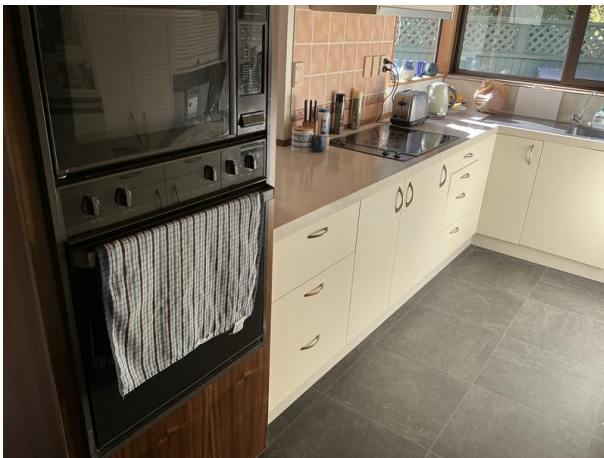
Photo 76
Kitchen.

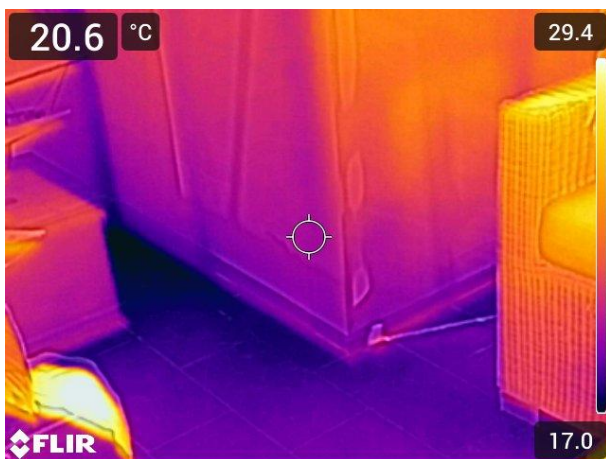
Photo 79
Northwest corner of the conservatory has no notable temperature differences.

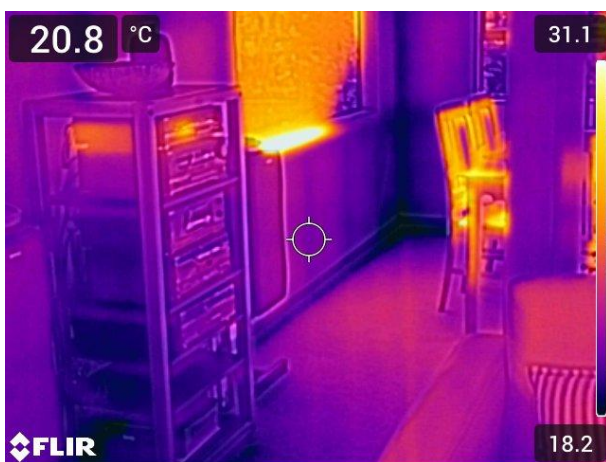
Photo 80
Living room north wall has no notable temperature differences.

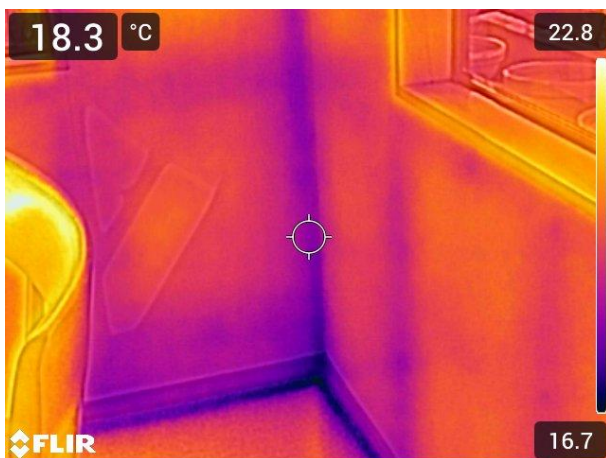
Photo 81
Dining area has no notable temperature differences.

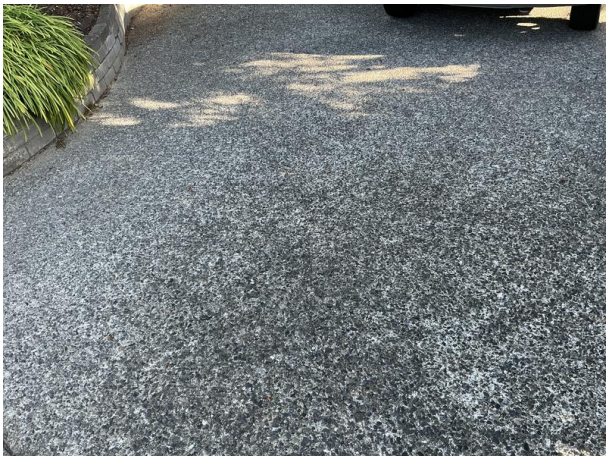
Photo 82
Driveway is functional.

General upkeep and maintenance of driveway by cleaning and keeping free of debris.

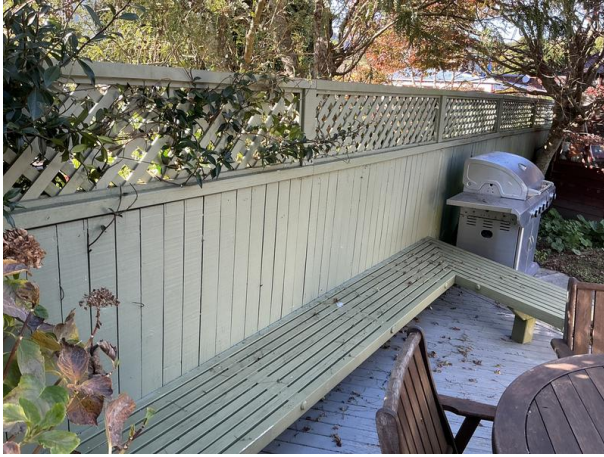
Photo 85
East side functional.

General upkeep and maintenance, keep vegetation and soils clear of timbers as these timbers are only exterior treated and will rot if vegetation or soils are up against them.

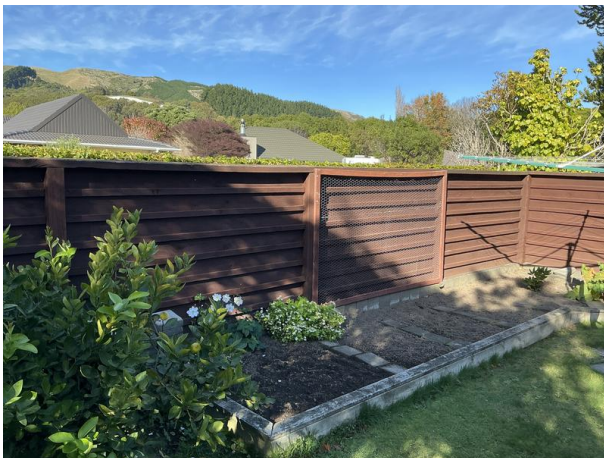
Photo 86
Southside functional.

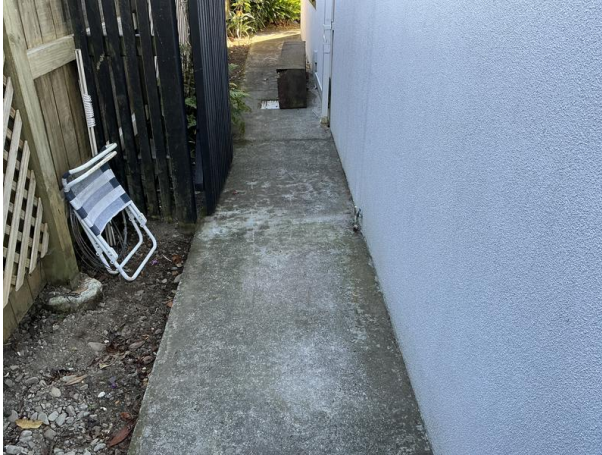
Photo 87
Which side functional.

General upkeep and maintenance.

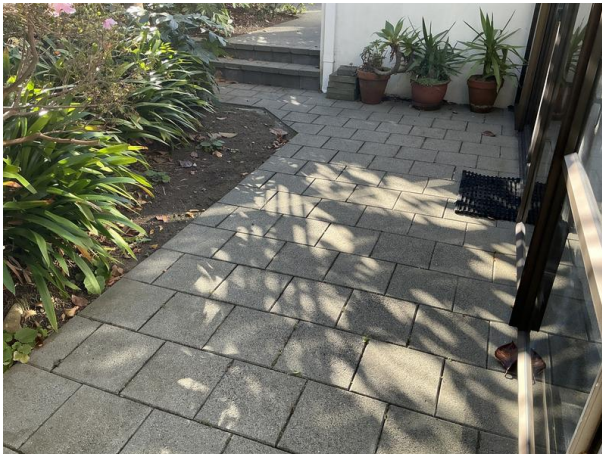
Photo 88
Northside functional.

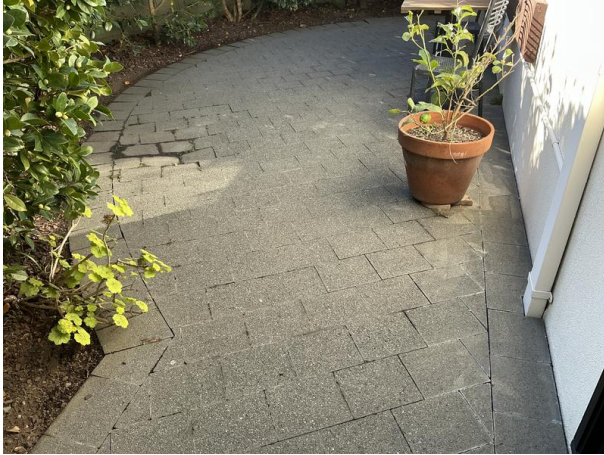
Photo 89
Northside functional.

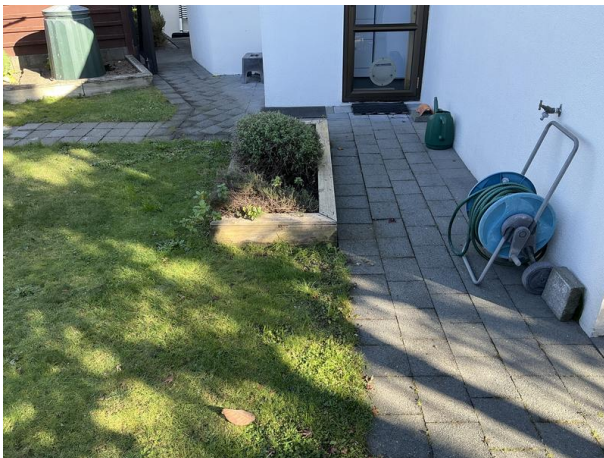
Photo 90
Southside functional.

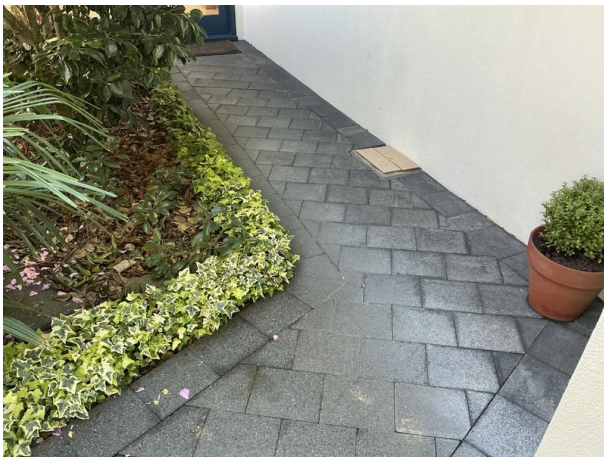
Photo 91
Southside functional.

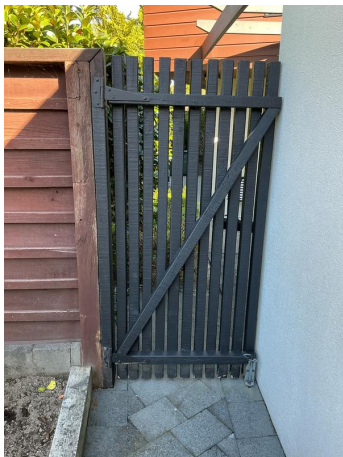
Photo 94

Southside functional.

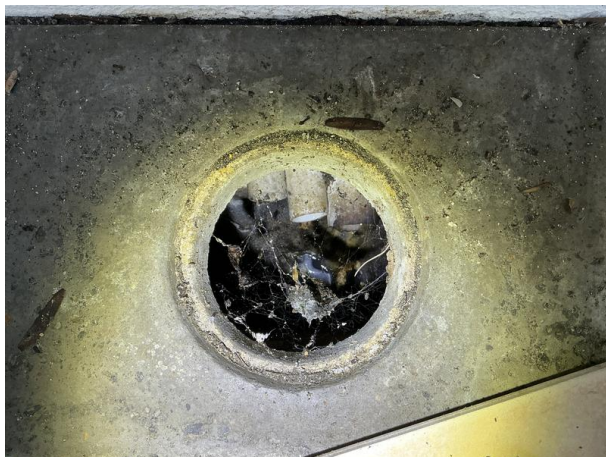
Photo 95
Southside gully trap.

Keep vegetation and soils clear of drainage.

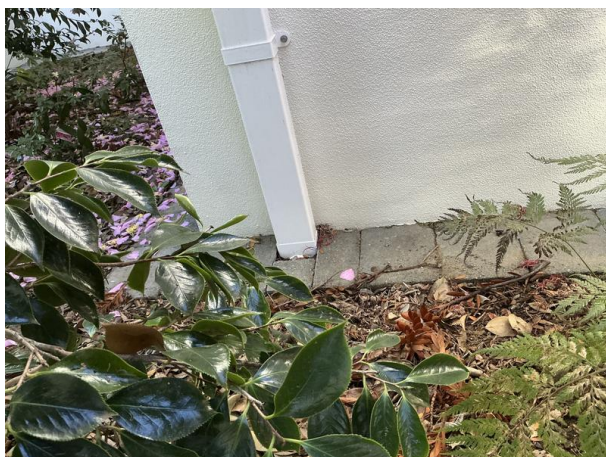
Photo 96
Southside downpipe connection visible.

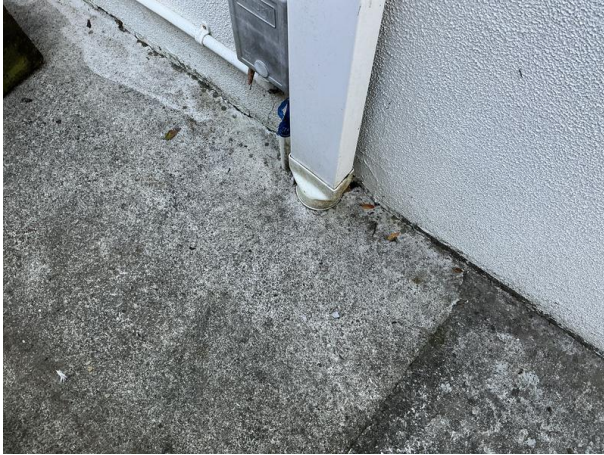
Photo 97
Westside downpipe connection visible.

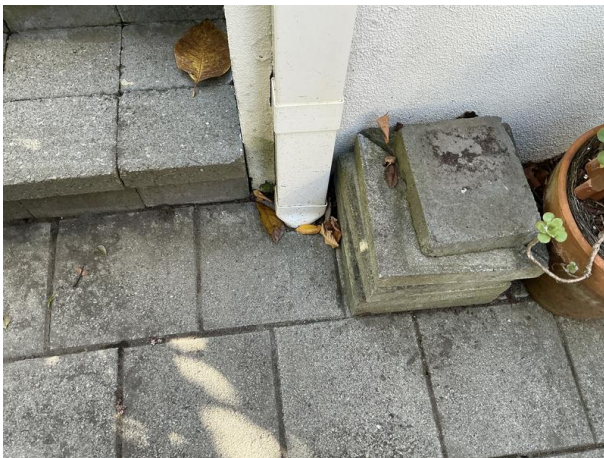
Photo 98
Northside downpipe connection visible.

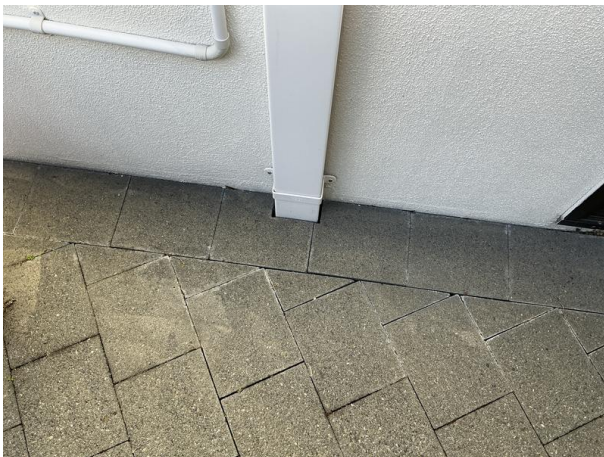
Photo 99
Northside downpipe connection not visible.

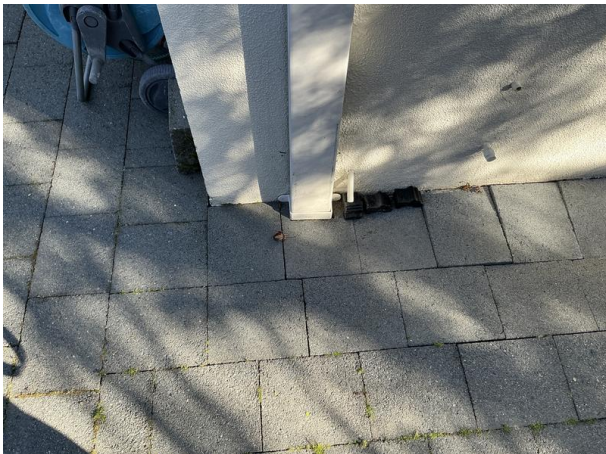
Photo 100
Northside downpipe connection is not visible.

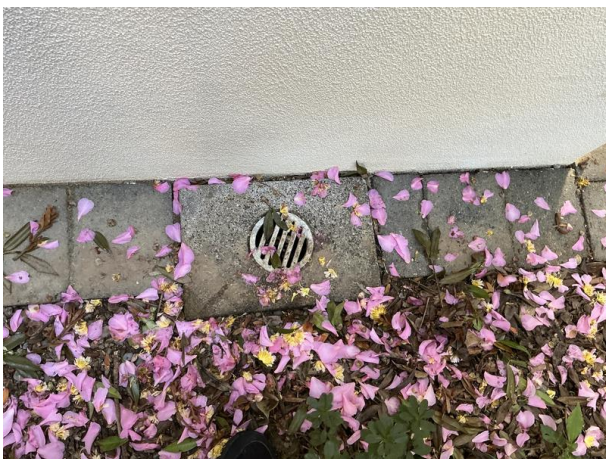
Photo 102
Southside gully trap.

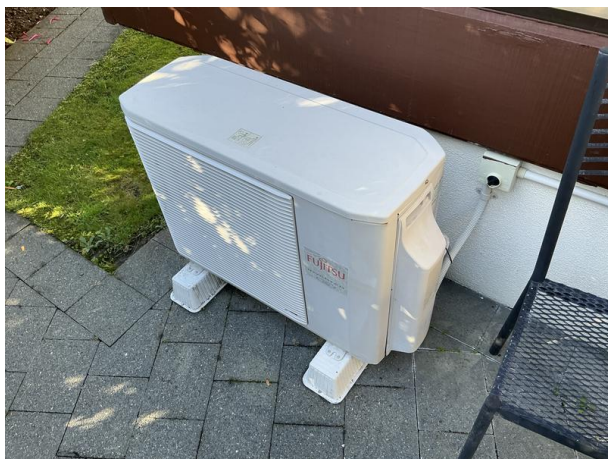
Photo 103

Outdoor heat pump unit located on the north side.

Follow the manufacturer's recommended servicing schedule to ensure the equipment operates efficiently and maintains optimal performance. Adhering to these guidelines helps identify and address potential issues early, reducing the risk of costly repairs and ensuring compliance with warranty requirements.

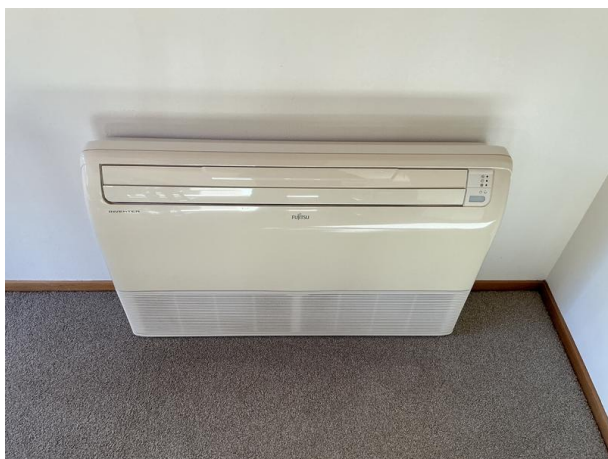
Photo 104

Indoor unit is located in the living room.

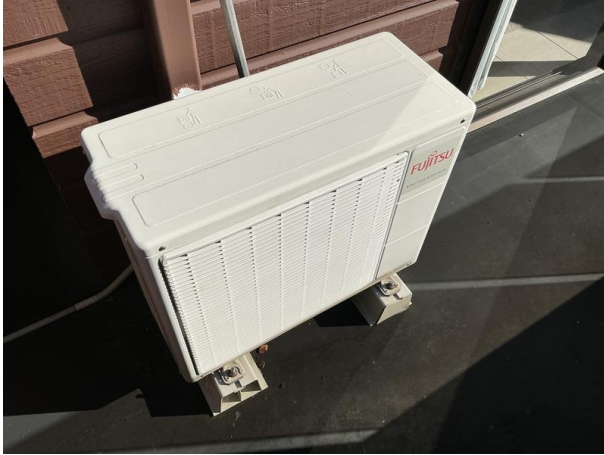
Photo 105
Outdoor heat pump unit located on the south side.

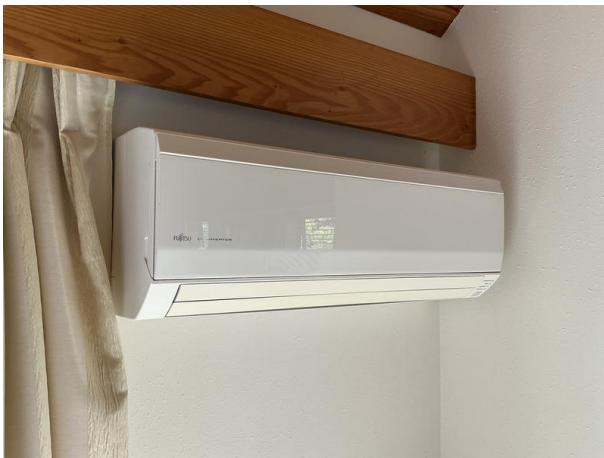
Photo 106
Indoor unit located in bedroom 1.

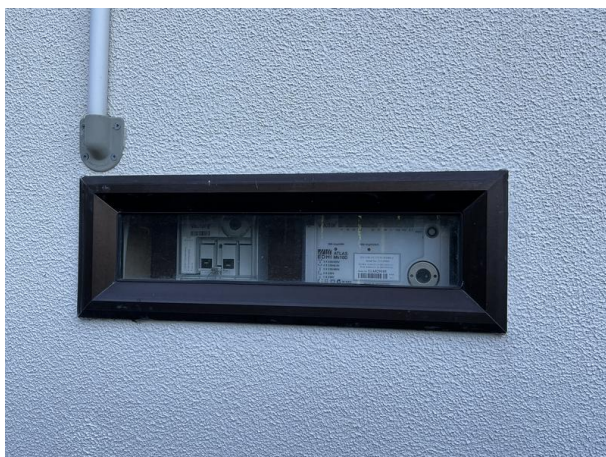
Photo 108
Meterboard located on the west side.

All services should be tested and maintained by certified professionals to the manufacturer's specifications.
Regular checks to ensure smoke detectors are functional.

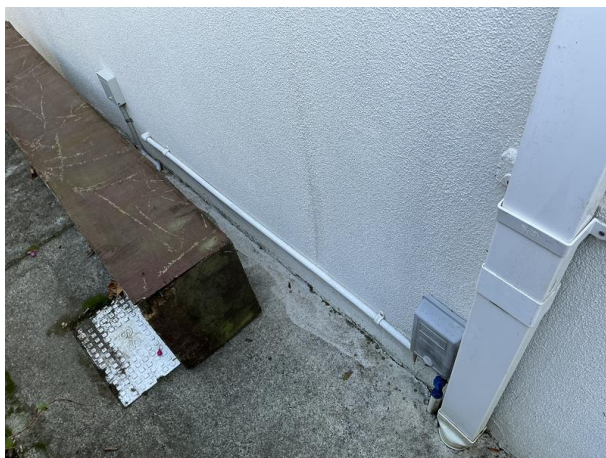
Photo 109
Cable TV and data located on the west side.

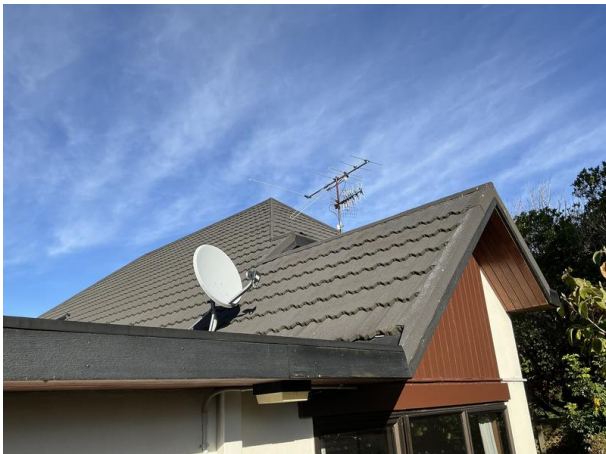
Photo 110
TV aerials located on the north side.

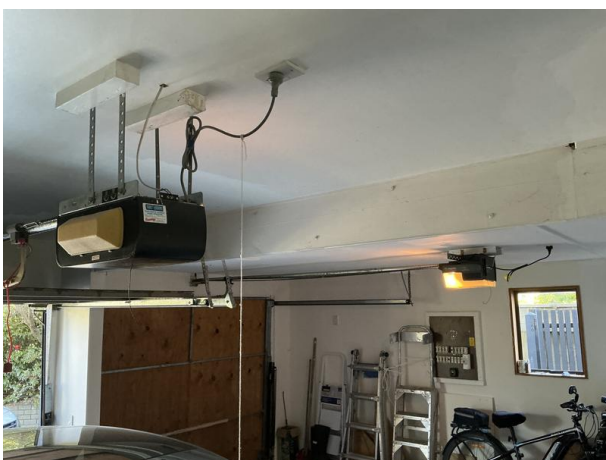
Photo 111
Garage door openers are functional.

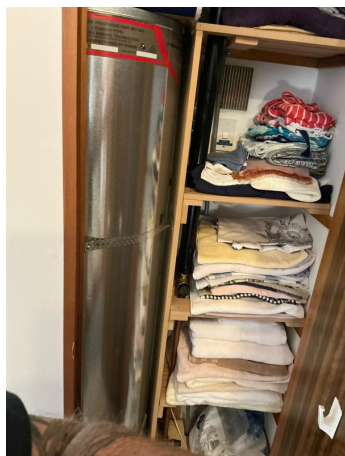
Photo 112
Hotwater cylinder located in the hallway cupboard.

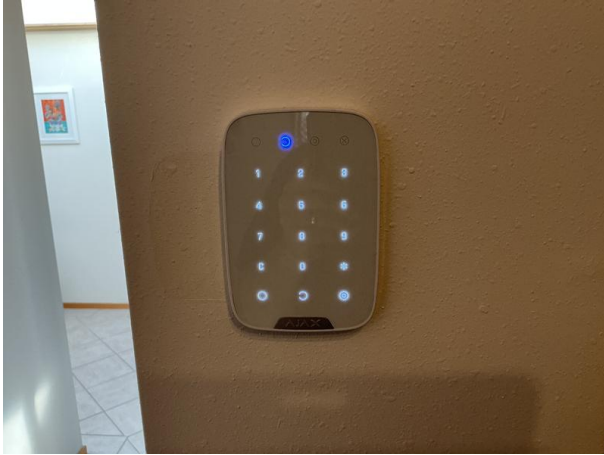
Photo 113
Security system keypad located in the hallway.

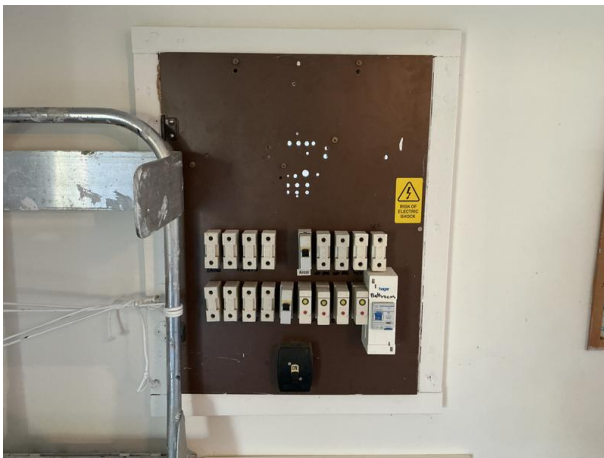
Photo 114
Distribution board located in the garage.
