PRE-PURCHASE BUILDING REPORT

Property Address	179 Tutere Street Waikanae Beach		
Client	Robert Hunsley		
Date of Inspection	18th October 2023	Time	1:00 pm
Inspector	Trevor Garrett MSc, LBP, Advanced Trade Cert Carpentry, Nat Diploma Construction Management. Member of NZIOB.		
LBP Number	131790		
Inspection Type	Pre-Purchase Report		
People Present	Owner		
House Occupied	No

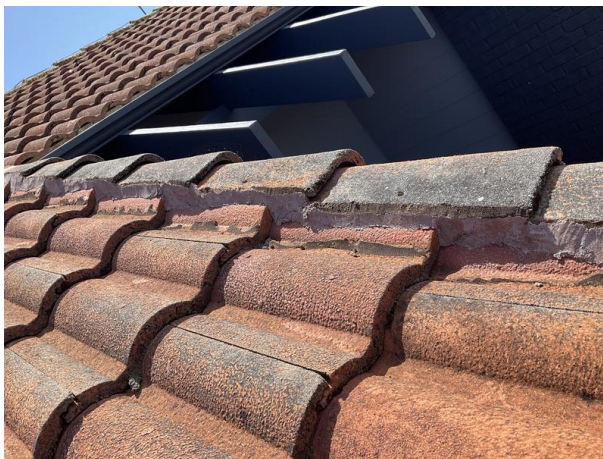
Photo 4

East side barge capping.

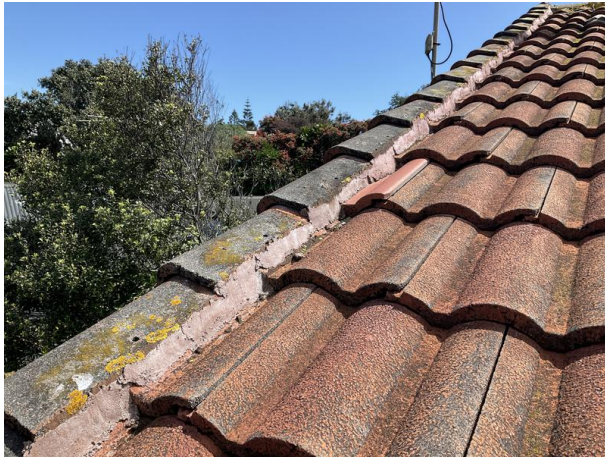
Photo 5

South side barge capping.

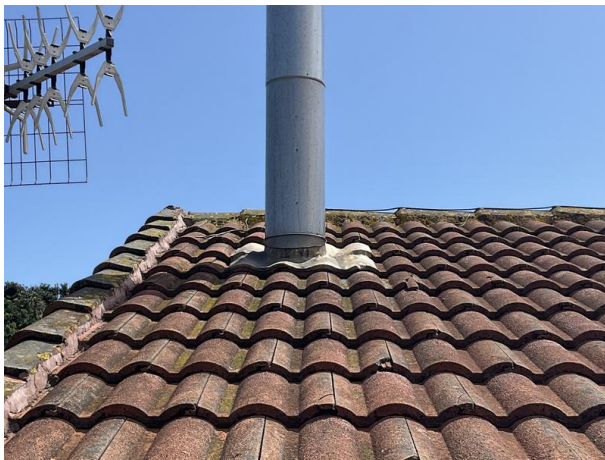
Photo 6

South side wood burner penetration, no visible issues.

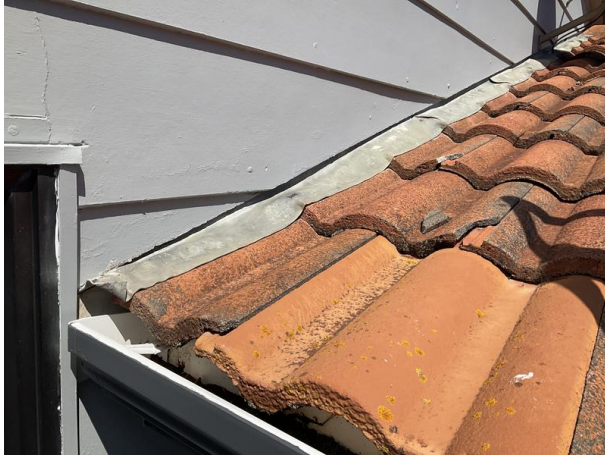
Photo 8

West side roof and wall junction does not have a kick out flashing.

It is recommended to install kick-out flashings to any apron flashing that flows into a gutter, these are a critical flashing in protecting the roof/wall/fascia/gutter junction, that when correctly installed diverts water away from a high weathertight area of risk. Refer to the wall framing section for moisture testing.

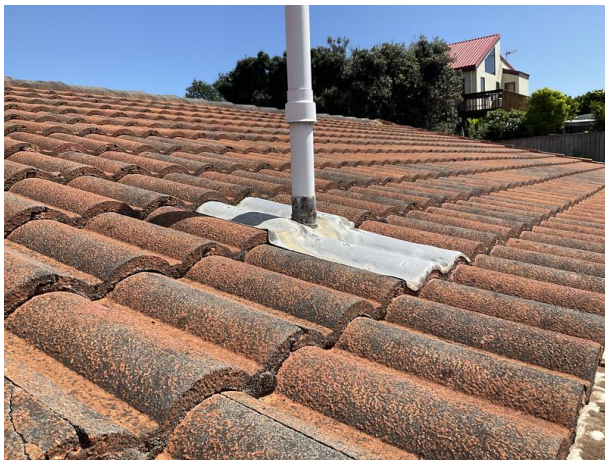
Photo 9

North side vent penetration.

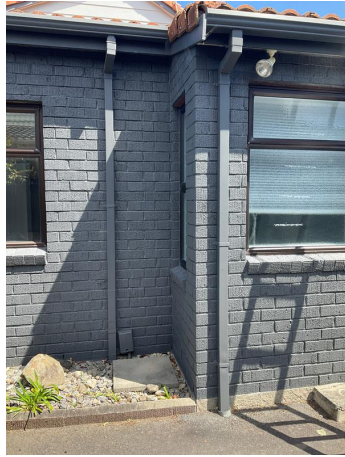
Photo 10

North side downpipes, no visible issues.

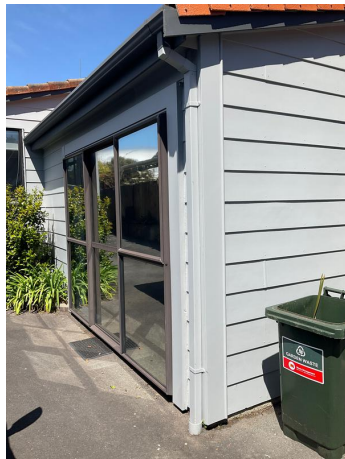
Photo 11

North side downpipe, no visible issues.

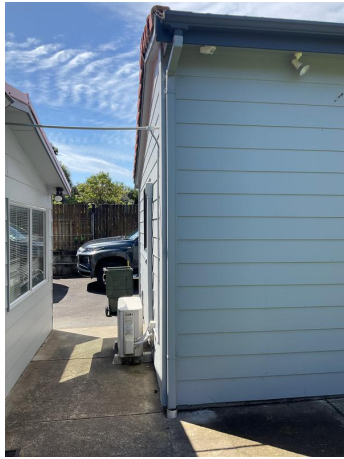
Photo 12

South side downpipe, no visible issues.

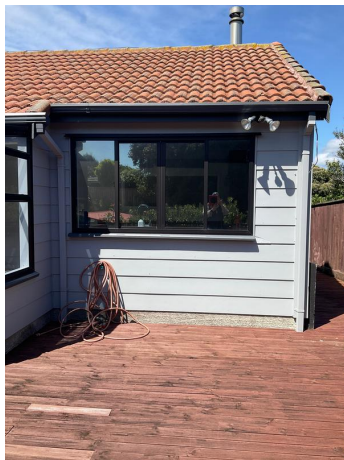
Photo 13

West side downpipes, no visible issues.

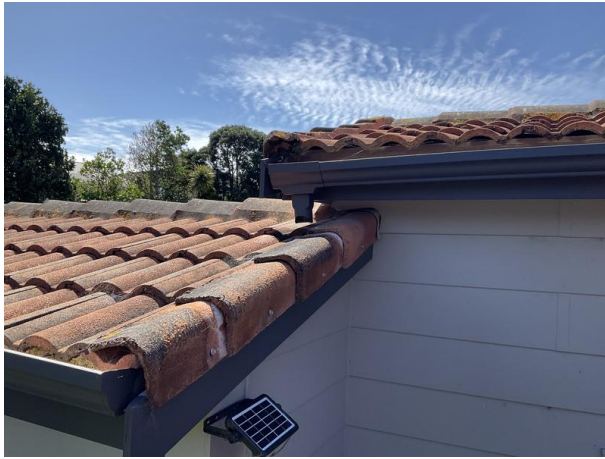
Photo 15

South side downpipe does not have a spreader.

It is recommended to install spreaders to downpipes that discharge onto lower roofs. This installation helps to distribute the flow of water evenly, preventing excessive water concentration in specific areas and reducing the risk of damage to the lower roofs.

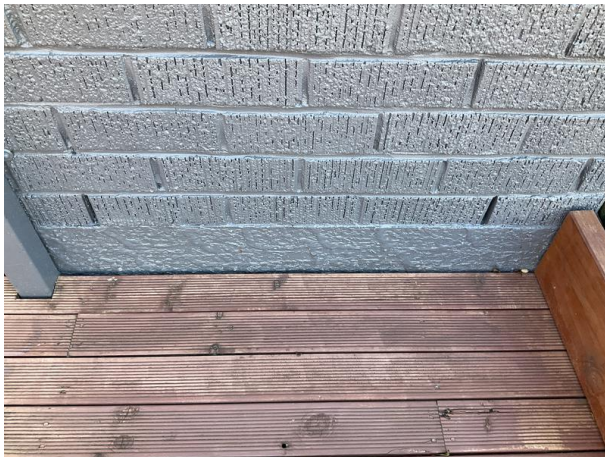
Photo 22

Weep holes are present throughout the brick work.

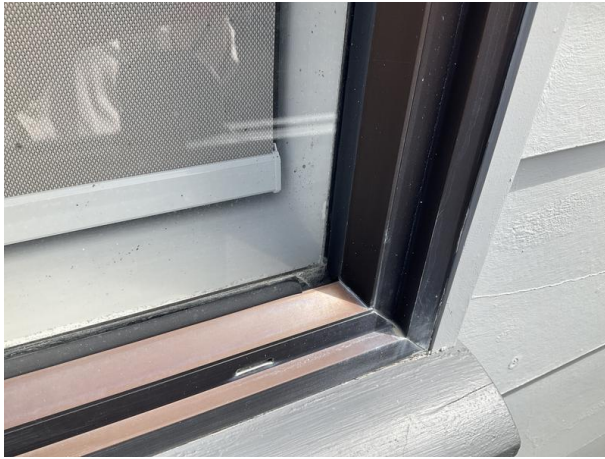
Photo 29

Shrunk glazing rubber.

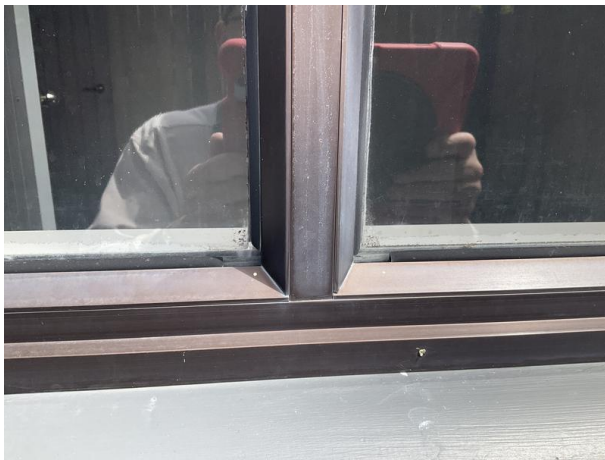
Photo 30

Shrunk glazing rubber.

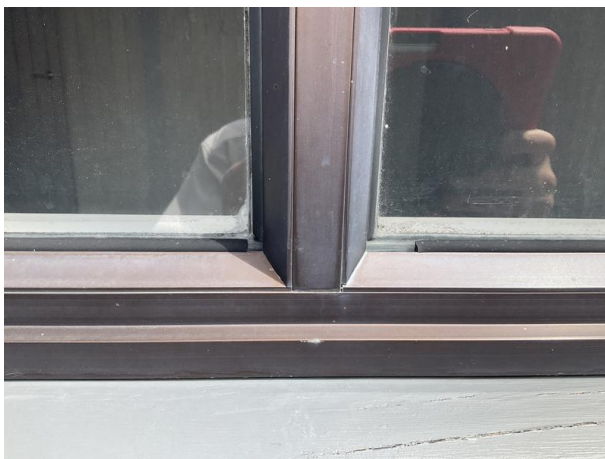
Photo 31

Shunk glazing rubber.

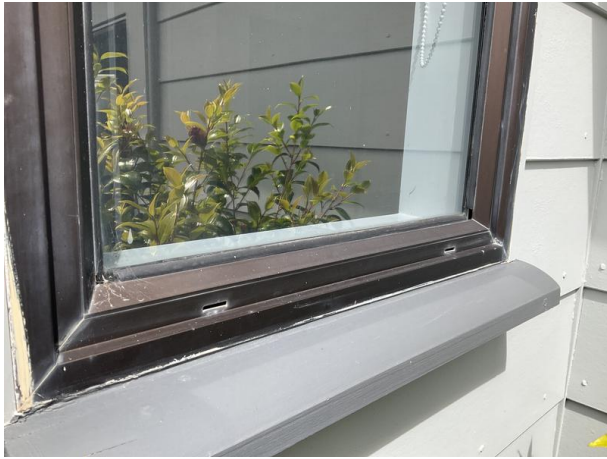
Photo 32

Shrunk glazing rubber.

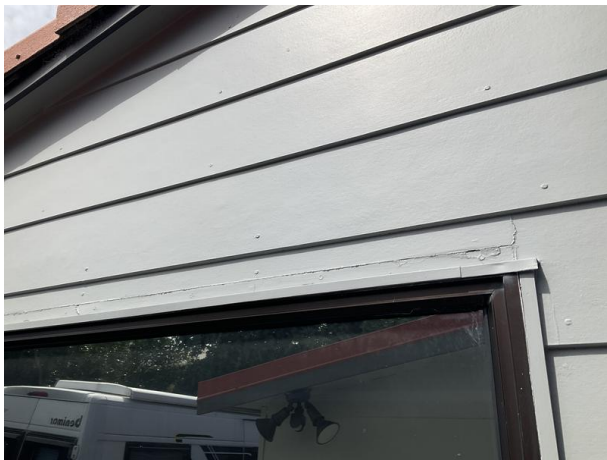
Photo 33

West side historic maintenance to the headflashings.

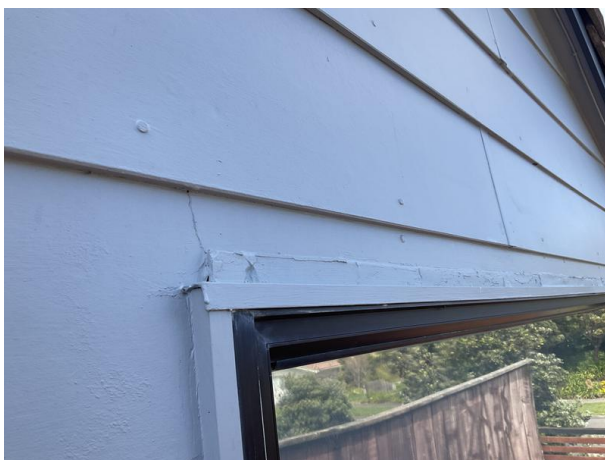
Photo 36

South side head flashing appears to be surface fixed.

Window head flashings should be tucked under weatherboards rather than surface fixed.

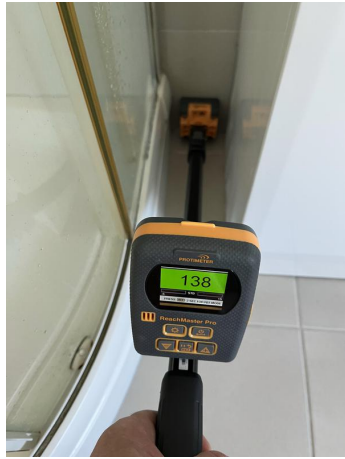
Photo 38

Corner of the shower has indications of normal moisture readings.

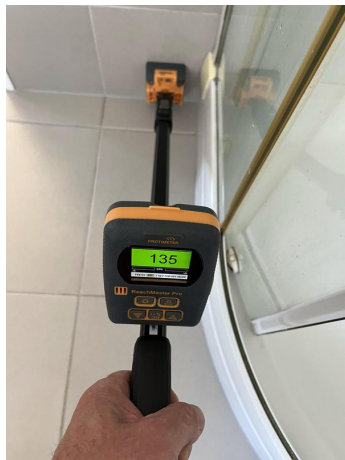
Photo 39

Corner of the shower has indications of normal moisture readings.

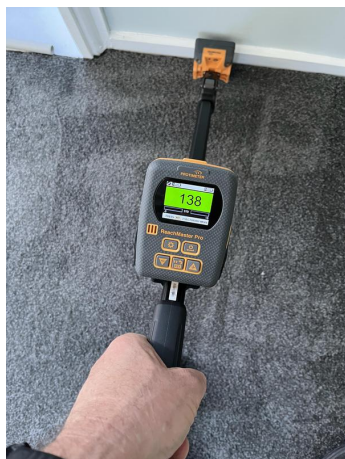
Photo 40

Bedroom 4 north wall adjacent to the raised garden bed has indications of normal moisture.

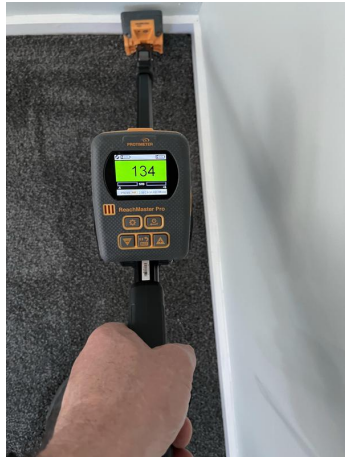
Photo 41

Bedroom 4 north wall adjacent to the raised garden bed has indications of normal moisture.

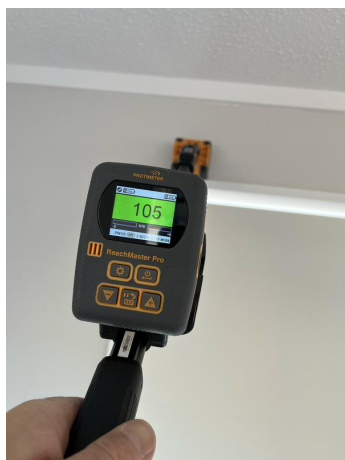
Photo 42

Lounge south window head has indications of normal moisture.

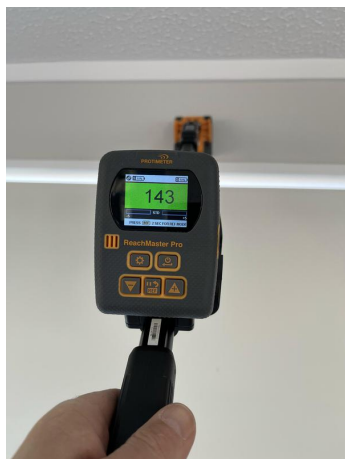
Photo 43

Lounge south window head has indications of normal moisture.

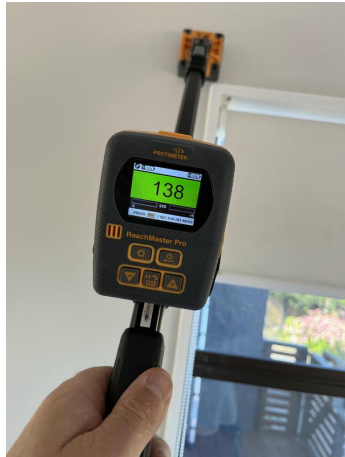
Photo 44

Lounge north window head adjacent to the rusty lintel has indications of normal moisture.

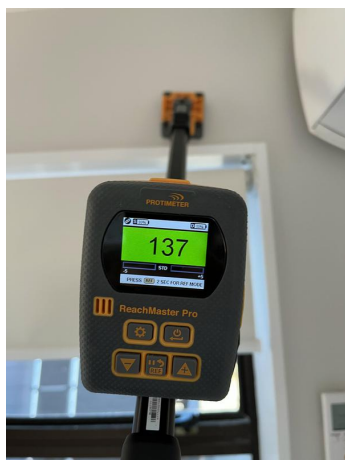
Photo 45

Lounge north window head adjacent to the rusty lintel has indications of normal moisture.

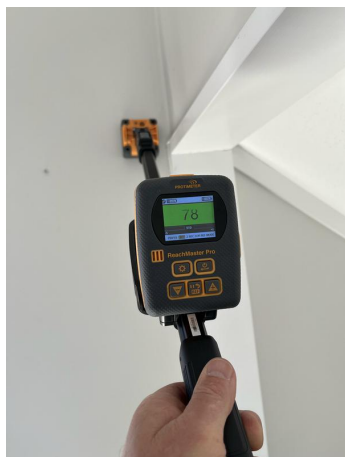
Photo 46

Entrance west facing wall adjacent to the roof and wall junction has indications of normal moisture.

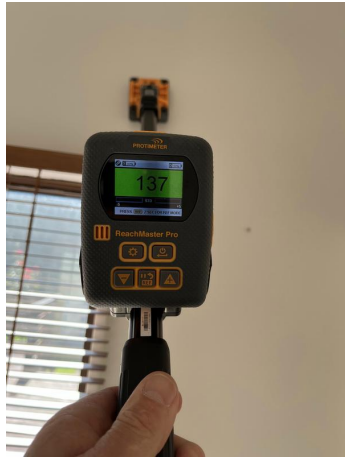
Photo 47

Entrance west facing wall adjacent to the roof and wall junction has indications of normal moisture.

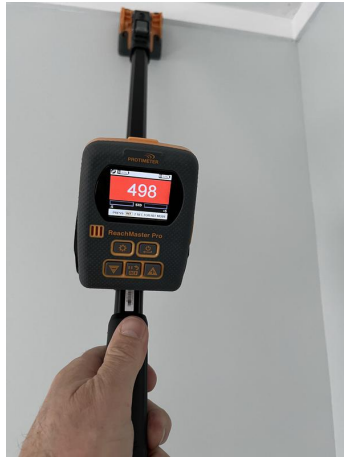
Photo 50

Bedroom 4 north wall adjacent to the roof wall junction has indications of elevated moisture.

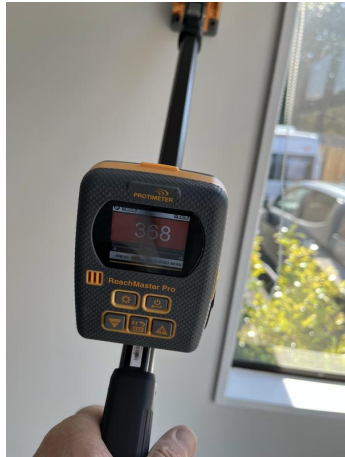
Photo 53

Bedroom 3 below the roof wall junction has indications of elevated moisture.

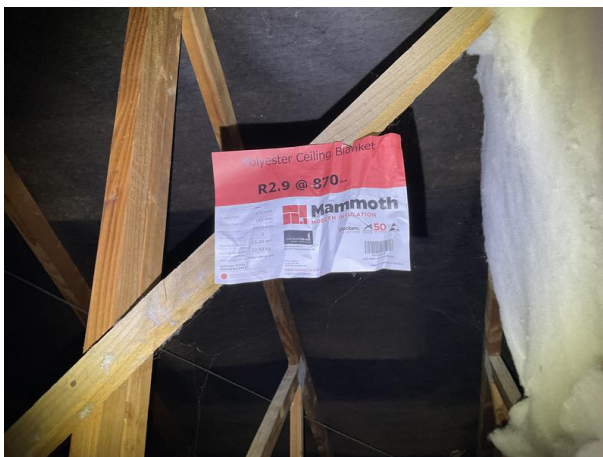
Photo 57

Insulation installation record, R value 2.9.

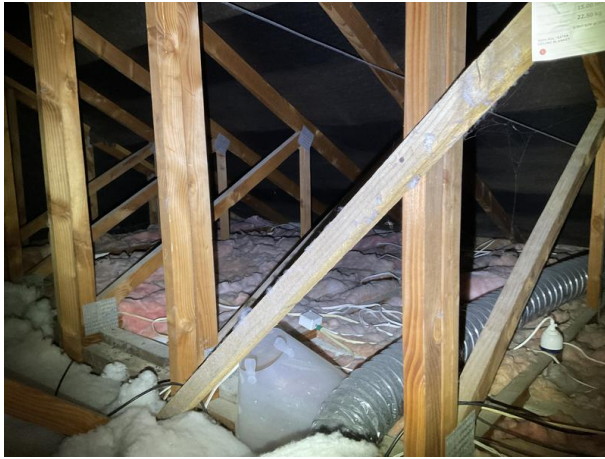
Photo 58

Over the kitchen has 100mm glass wool insulation.

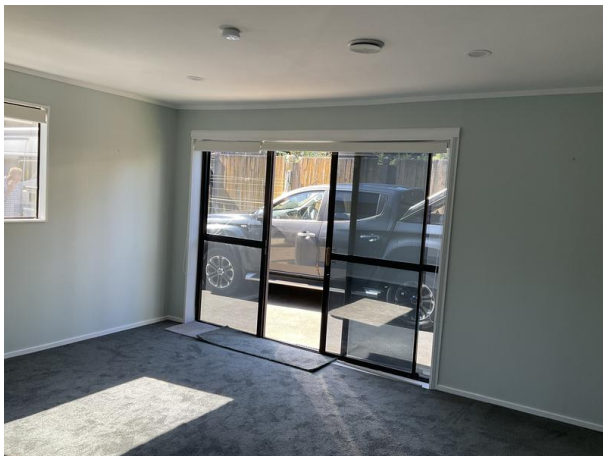
Photo 68

Defects - Refer to the wall framing section for moisture testing to this room.

Bedroom 4.

Refer to the wall framing section for moisture testing.

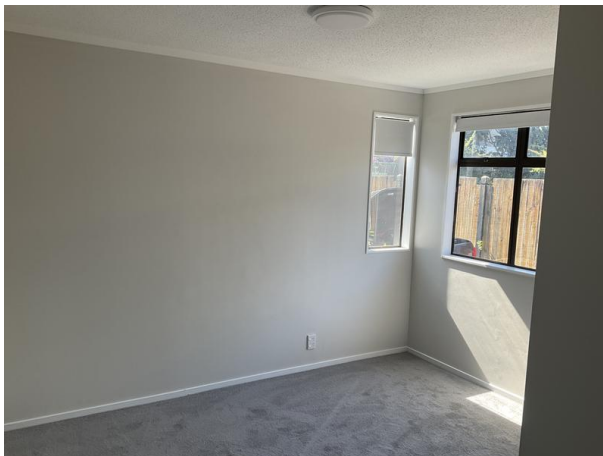
Photo 69

Defects - Refer to the wall framing section for moisture testing.

Bedroom 3.

Refer to the wall framing section for moisture testing.

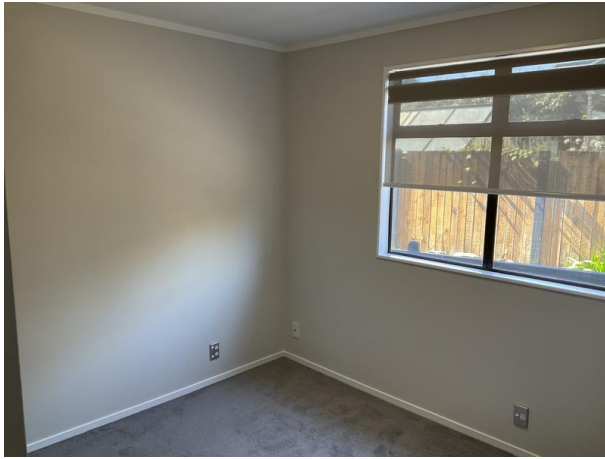
Photo 70

Bedroom 2.

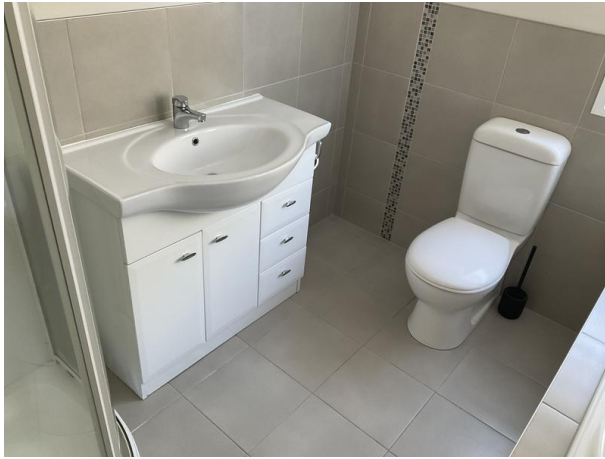
Photo 71

Vanity and toilet.

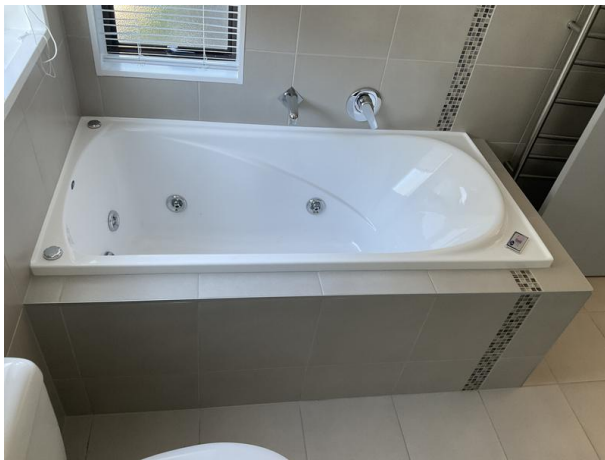
Photo 72

Spa bath, function not tested.

Inbuilt baths can be prone to maintenance issues. Depending on how the bath has been installed and maintained depends on how watertight it remains and how much future maintenance it will require. Typical failure points are where the bath meets the wall and around the tap units. It is recommended you constantly monitor these junctions to ensure damage is not occurring to the adjacent walls. No visible issues were noted during the inspection.

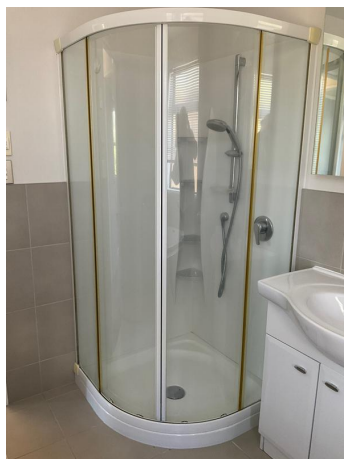
Photo 73

Shower.

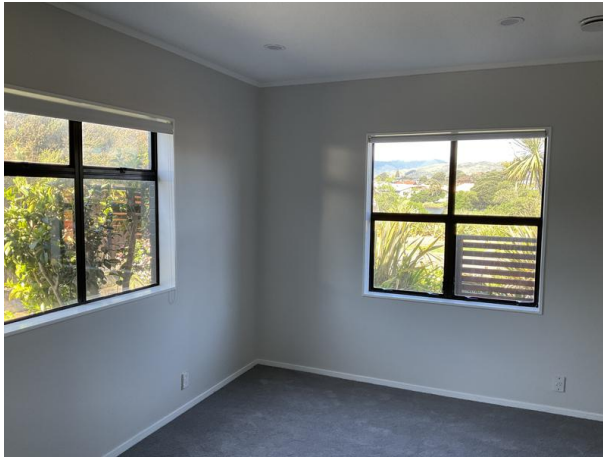
Photo 74

Bedroom 1.

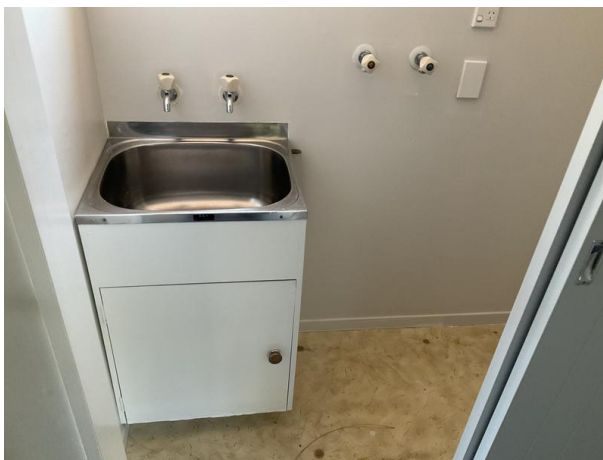
Photo 75

Laundry.

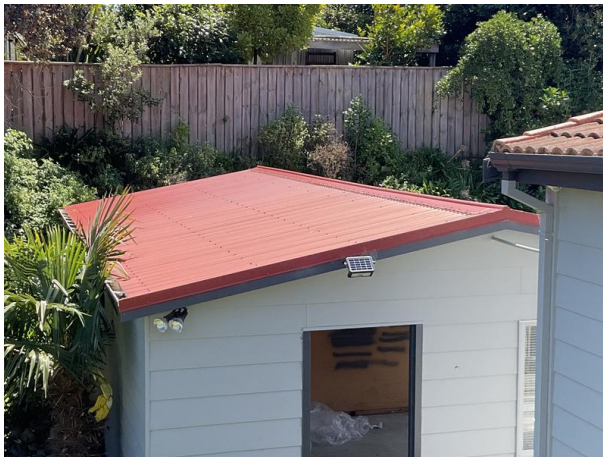
Photo 76

Roof is in serviceable condition.

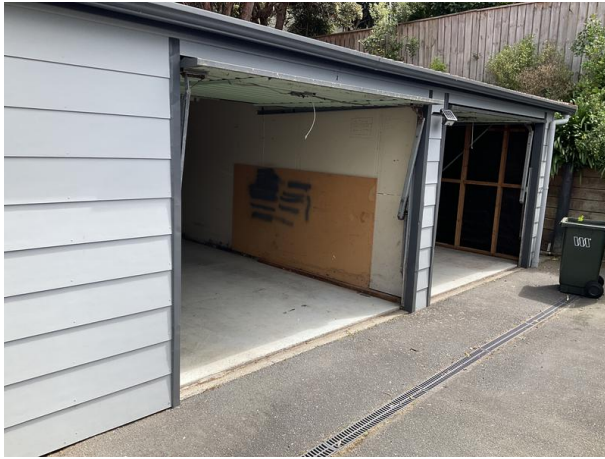
Photo 77

Garage is divided into separate spaces. the far space has no power.

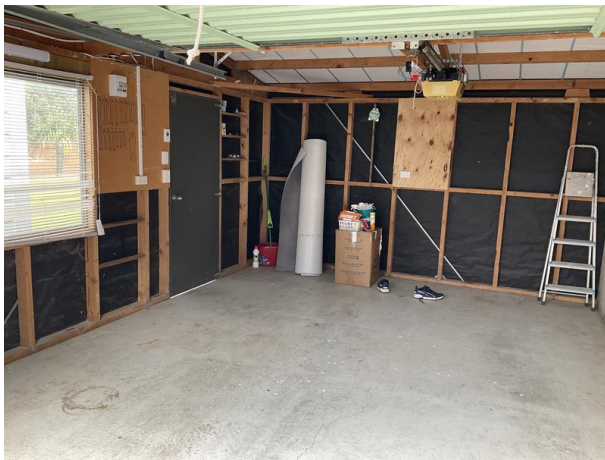
Photo 78

Garage one has a auto door, power and lighting.

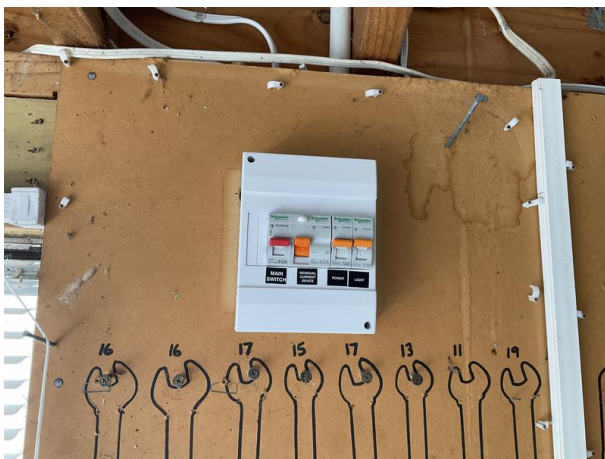
Photo 79

Distribution board.

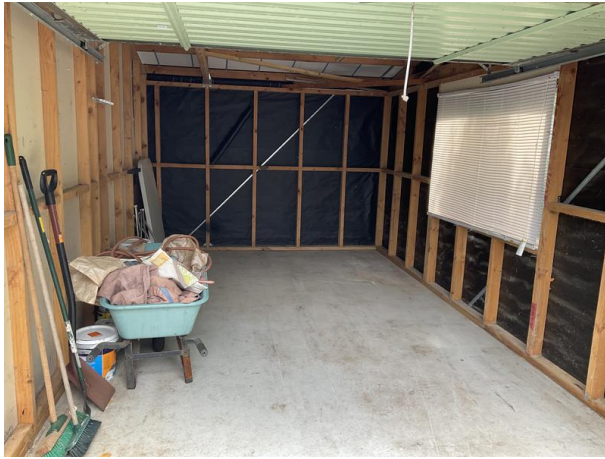
Photo 80

Garage 2 has no power.

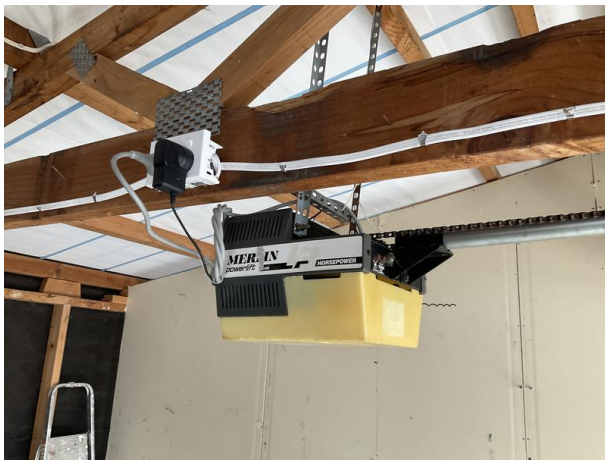
Photo 81

Garage door opener is functional.

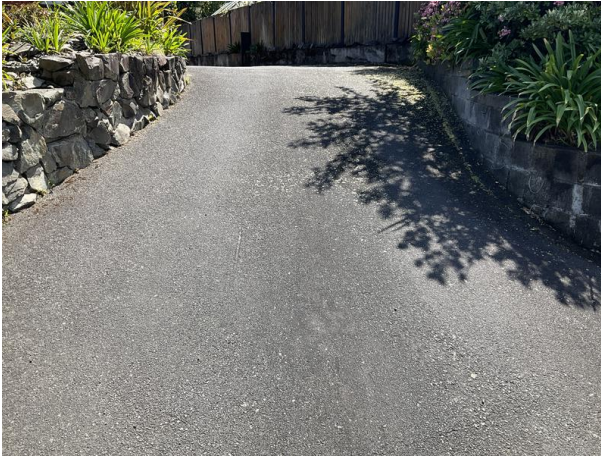
Photo 82

Driveway, functional.

General upkeep and maintenance of driveway by cleaning and keeping free of debris.

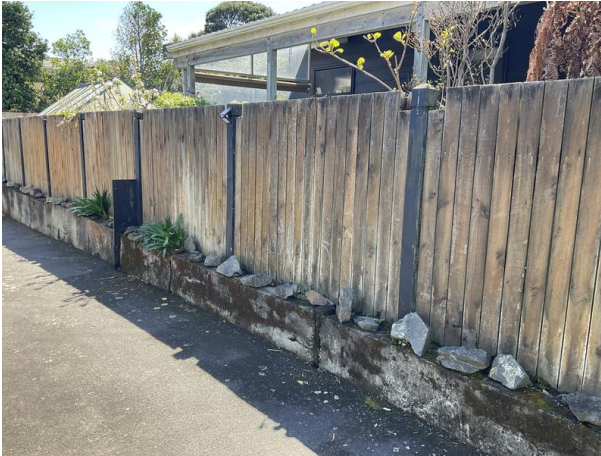
Photo 83

North side, functional.

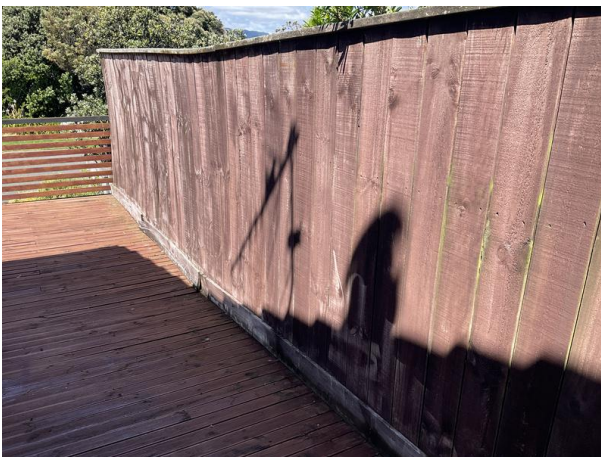
Photo 84

South side, functional.

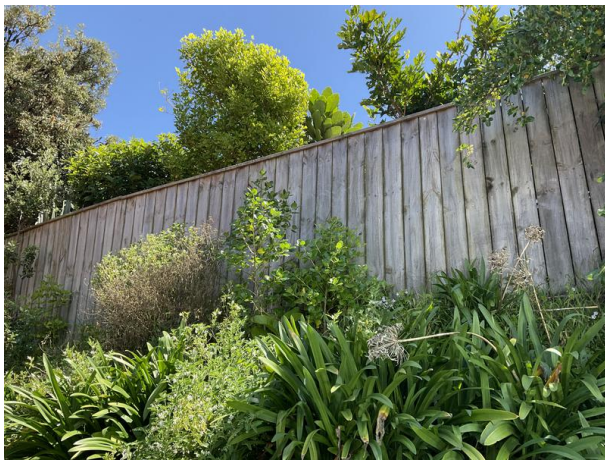
Photo 86

West side, functional.

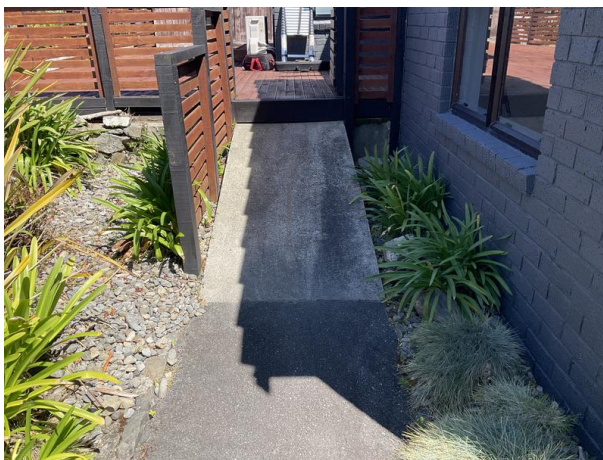
Photo 89

East side, functional.

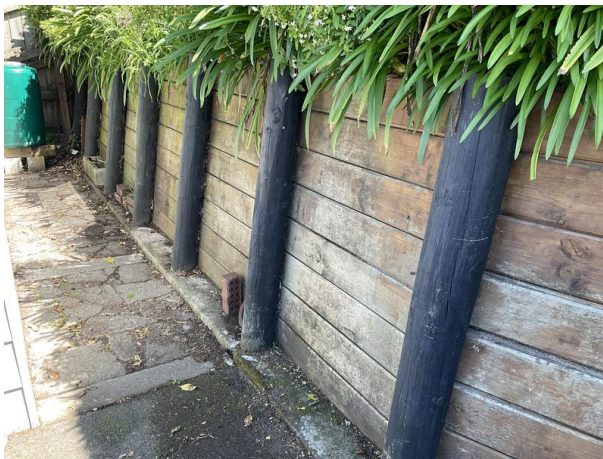
Photo 90

West side functional. 1.2

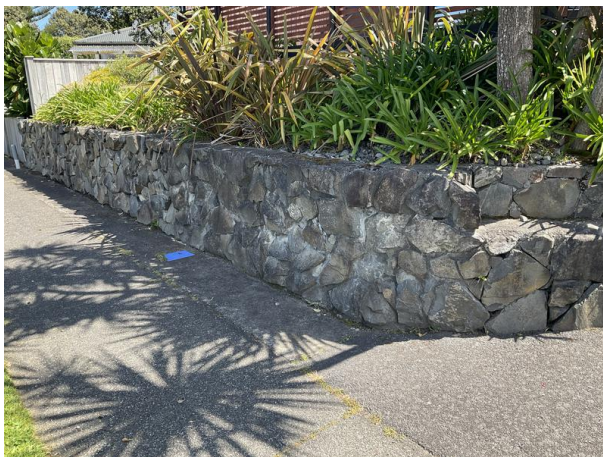
Photo 91

East side, functional.

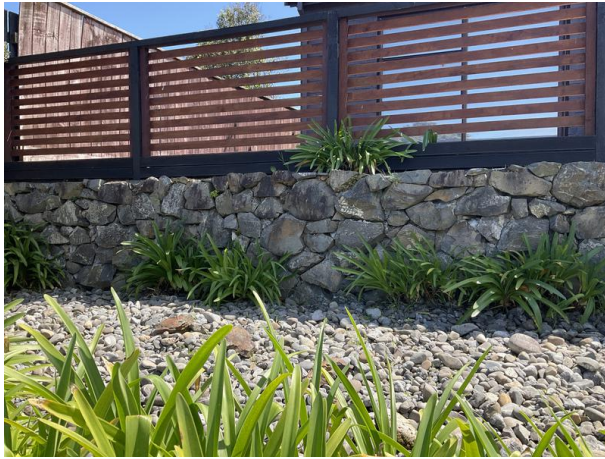
Photo 92

East side, functional.

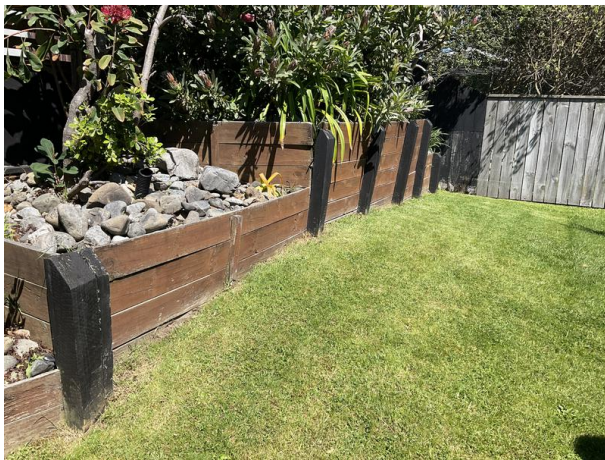
Photo 93

Rotation - Slight rotation noted in photo below.

West side is rotated (leaning the wrong way)

Earth bound, visual inspection to exposed sections only.

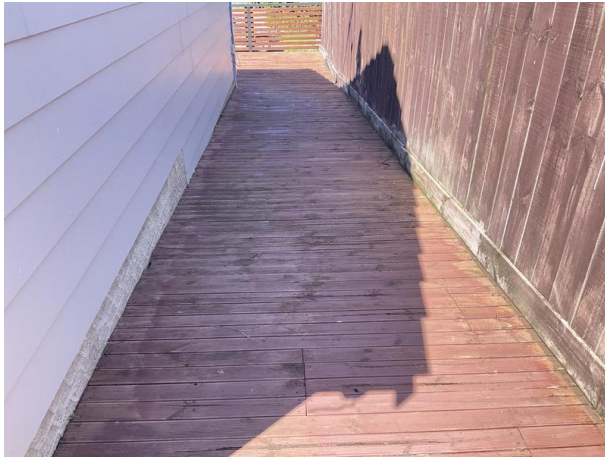
Photo 96

South side, functional.

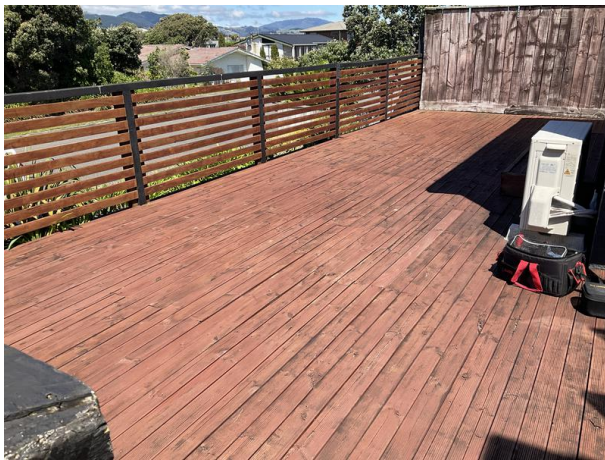
Photo 97

East side functional. The joists are at 800 mm centres making some boards springy.

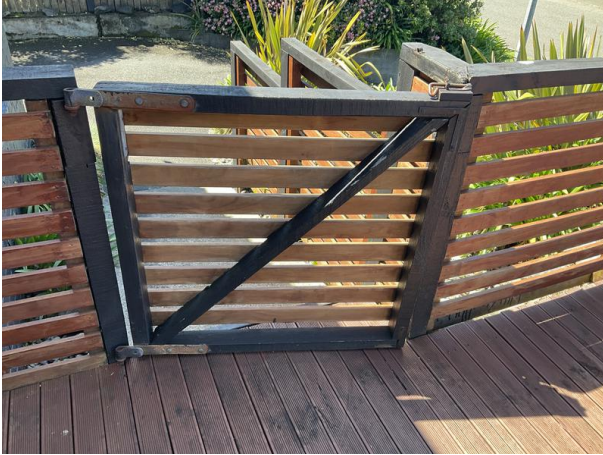
Photo 99

East side, functional.

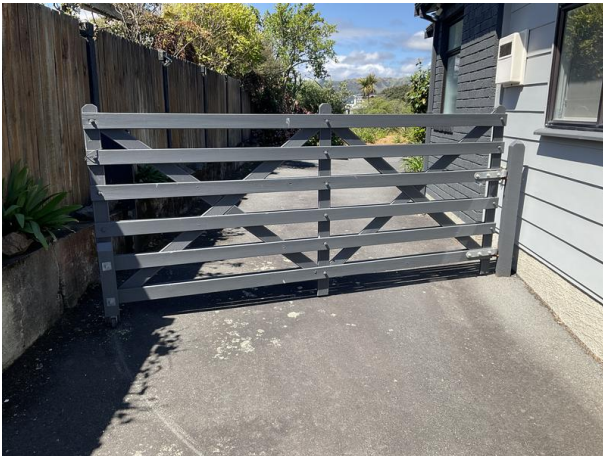
Photo 100

North side, functional.

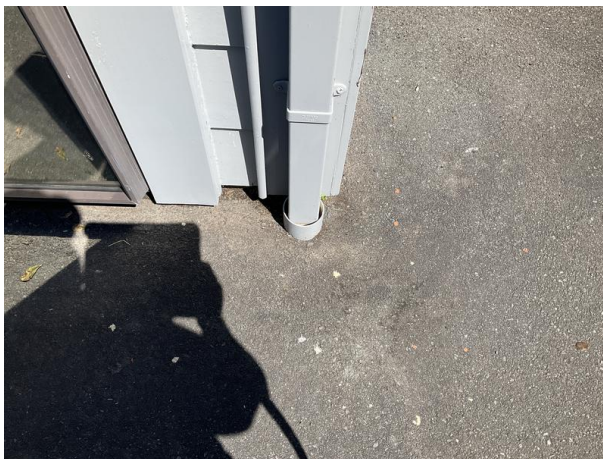
Photo 101

North side downpipe connection visible.

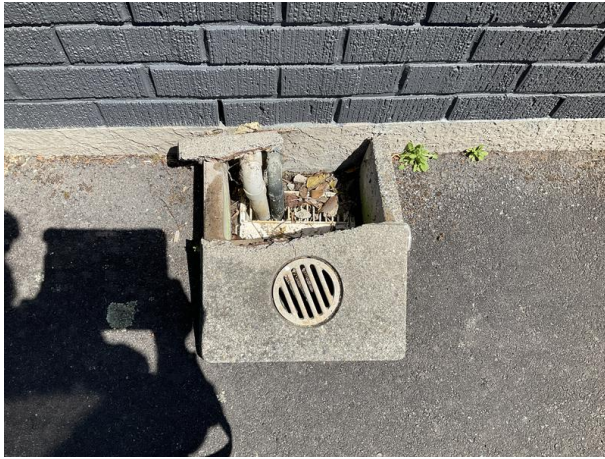
Photo 102

North side gully trap.

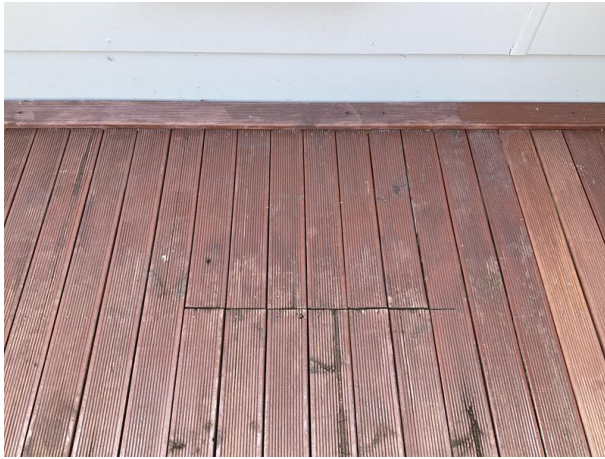
Photo 108

West side gully trap under the access hatch.

A deck may be built over a gully trap, but at least 600 mm of clear access space above the trap must be provided. This is for access to the gully trap for drainage inspections and maintenance in the event of blockages.

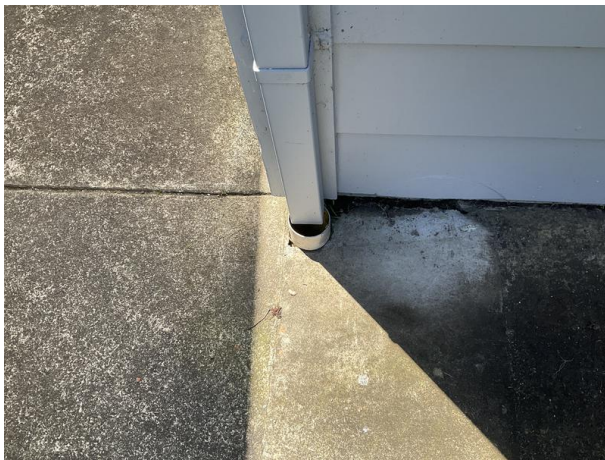
Photo 109

West side downpipe connection visible.

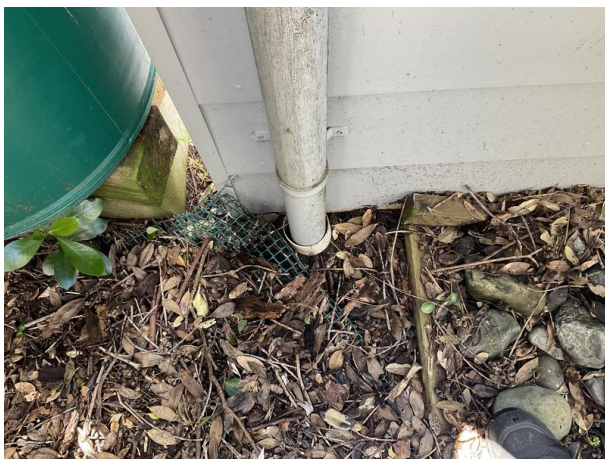
Photo 110

Southwest garage downpipe connection is visible.

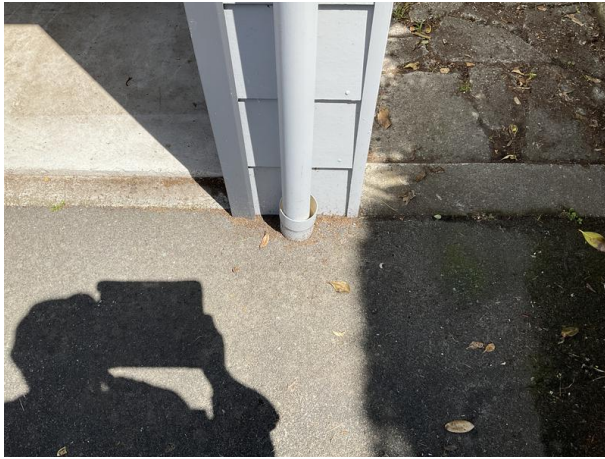
Photo 111

Northwest garage downpipe connection is visible.

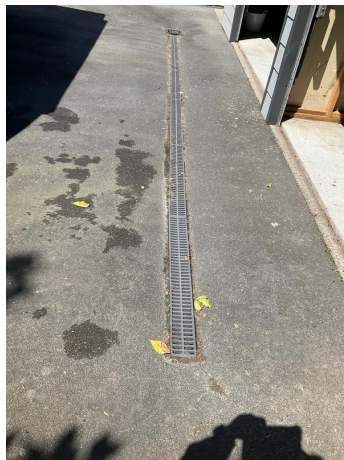
Photo 112

Strip drain on the north side of the garage.

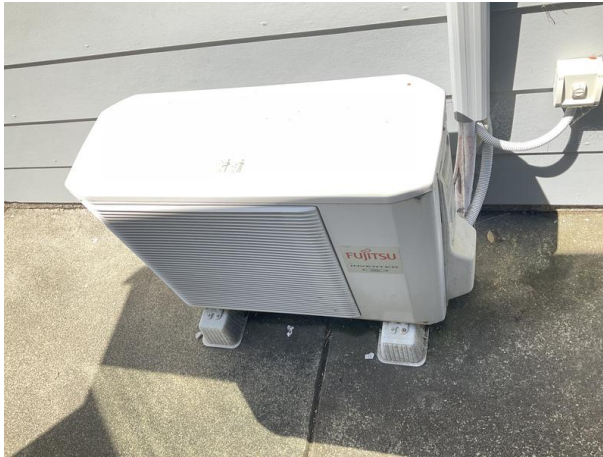
Photo 113

Outdoor unit is located on the west side.

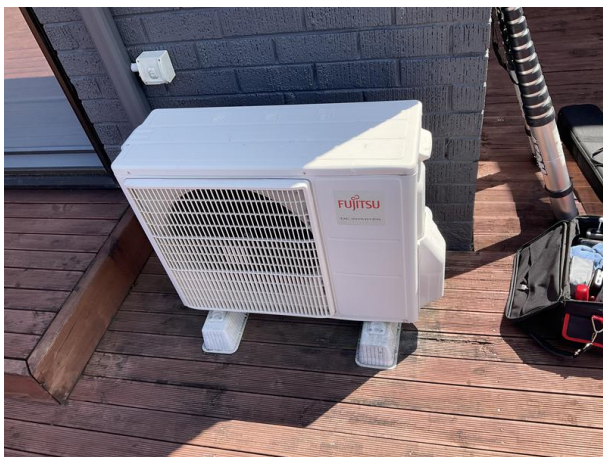
Photo 115

Outdoor unit located on the east side.

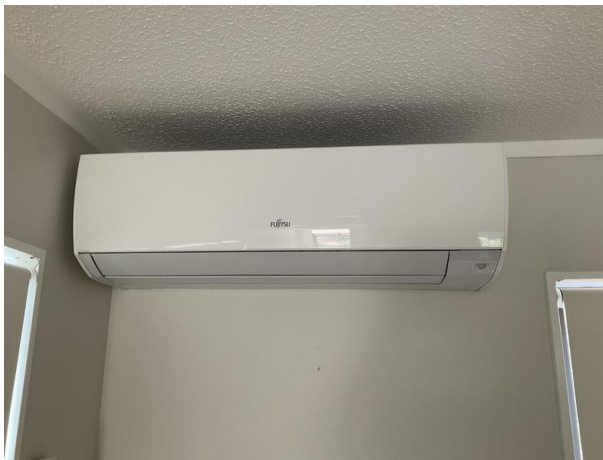
Photo 117

Indoor unit is located in the lounge.

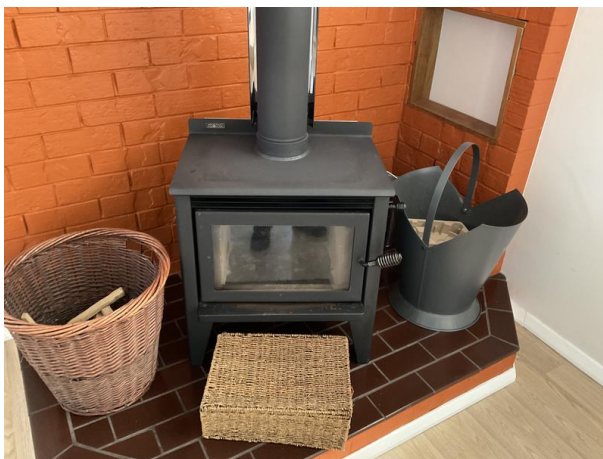
Photo 118

Wood burner is located in the lounge.

It is recommended to have the wood burner flue cleaned and checked annually.

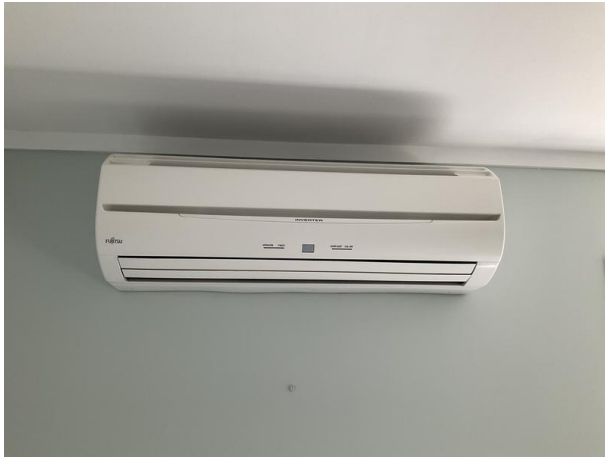
Photo 119

Indoor unit is located in bedroom 4.

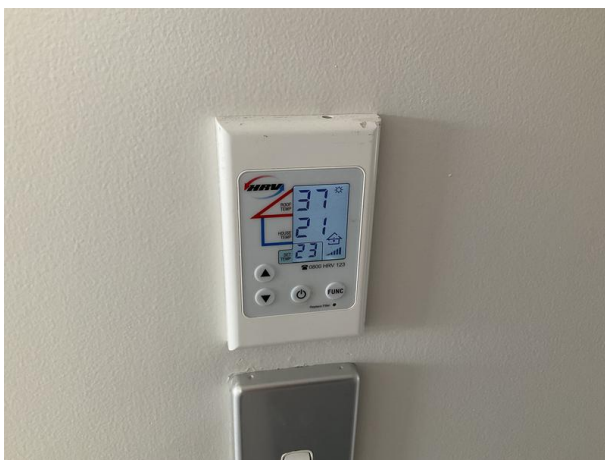
Photo 120

Ventilation system controller is located in the hallway.

Ventilation system filters should be inspected annually and replaced periodically or as required by the manufacturer.

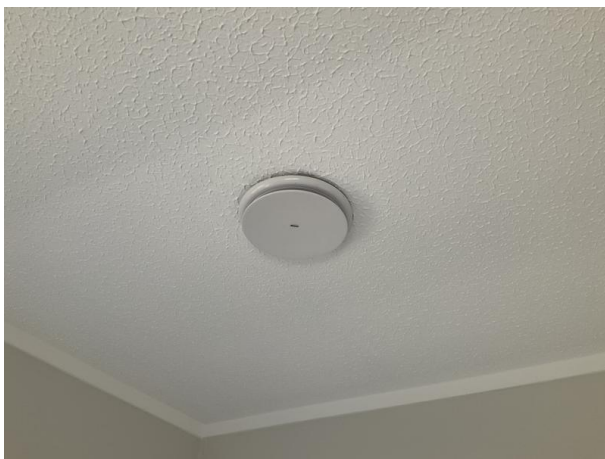
Photo 121

Outlets are located in the kitchen and bedrooms.

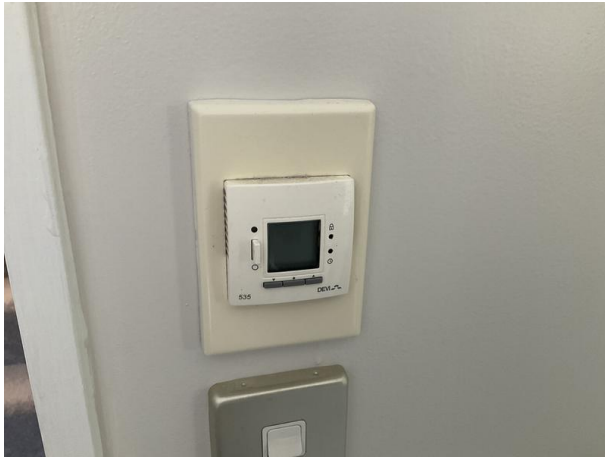
Photo 122

Under floor heating controller is located in the bathroom.

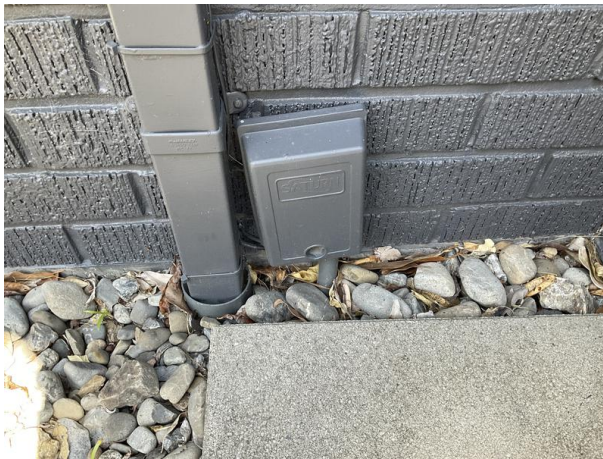
Photo 123

Cable TV is located on the north side.

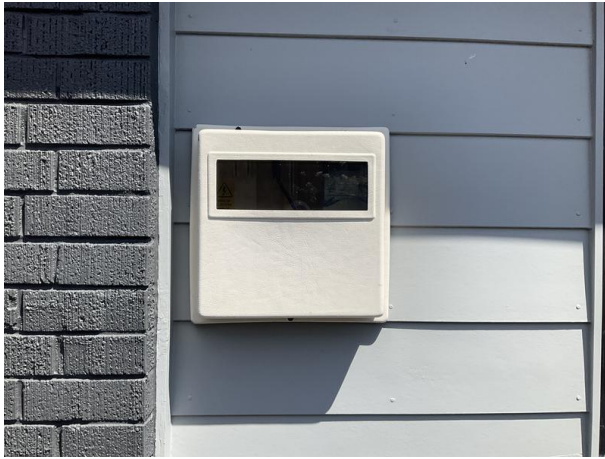
Photo 124

Meter board is located on the north side.

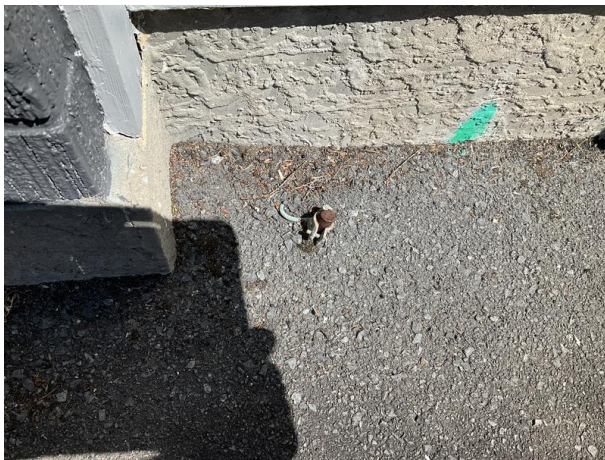
Photo 125

Earth stake is located on the north side.

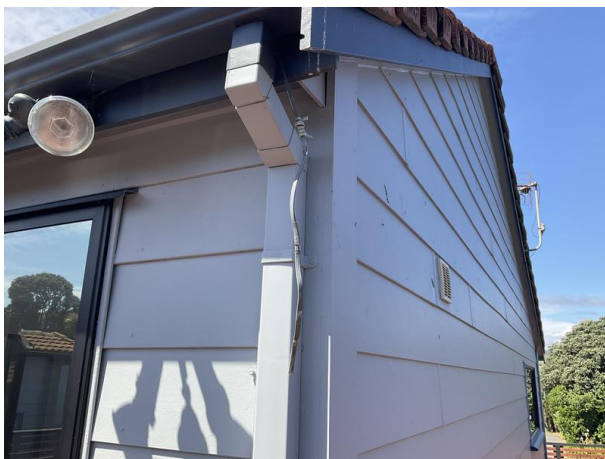
Photo 126

South side cable hanging.

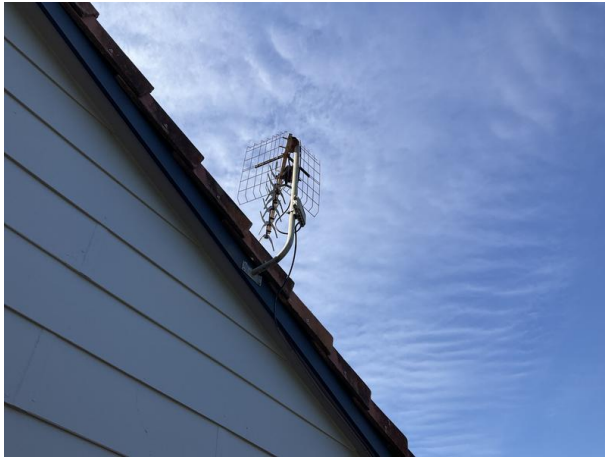
Photo 127

TV aerial is located on the south side.

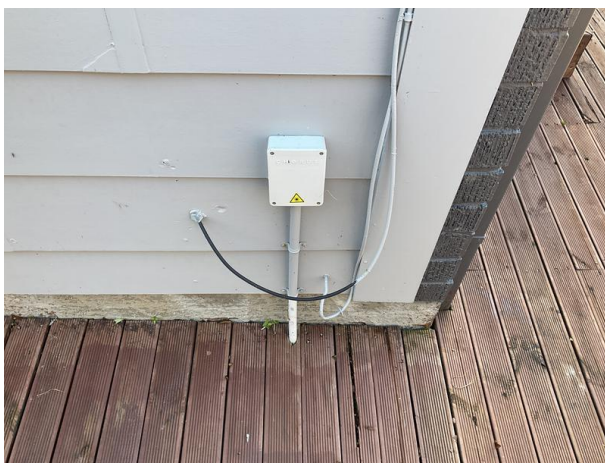
Photo 128

Data is located on the south side.

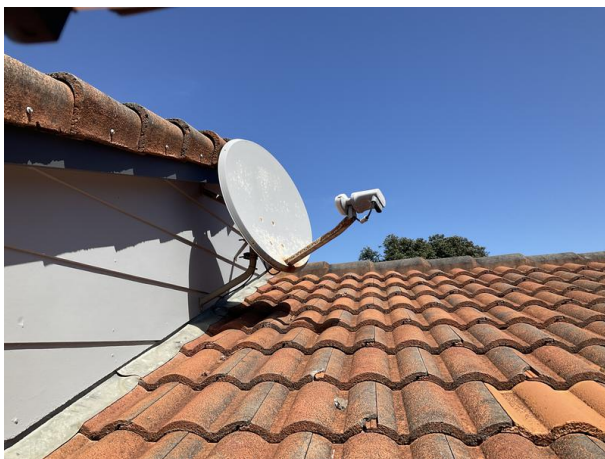
Photo 129

Sky dish is located on the west side.

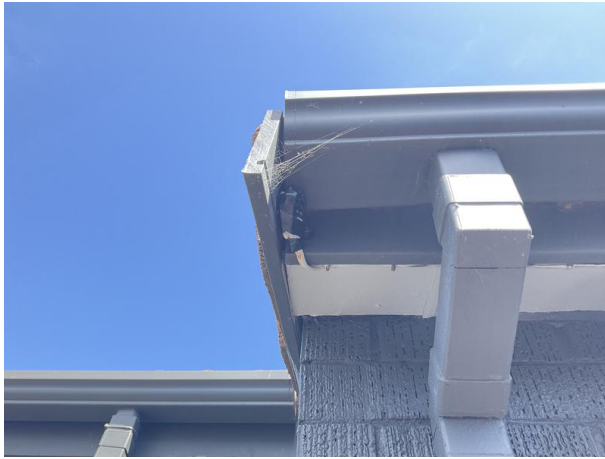
Photo 130

North side taped up cable.

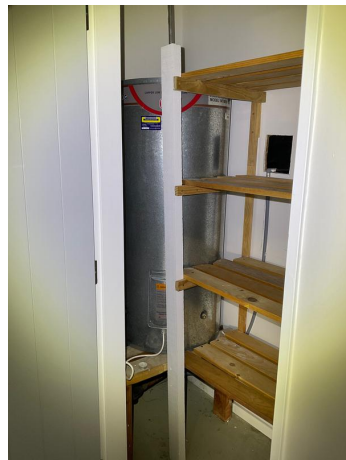
Photo 131

Type - Low pressure electric cylinder.
Capacity - 180L.
Approximate age - 2013.
Seismic bracing - No.
Area serviced - Entire house.
Any visible defects - None visible.

Hotwater cylinder is located in the hallway cupboard, capacity 180L, manufactured in 2013.

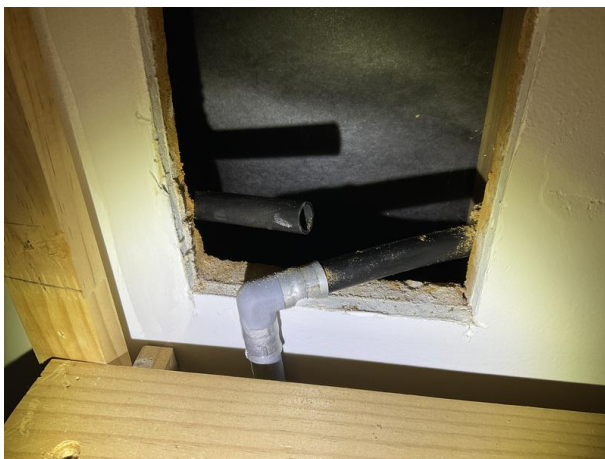
Photo 132

Dux Qest was introduced in the mid - late 1970's as one of the first plastic plumbing products to replace copper plumbing.

Dux Qest is black in colour and can be difficult to distinguish from other black polybutylene plumbing. The tell-tale sign is that you can often find "Qest Dux" written in white on the pipe. Damage resulting from the splitting and leaking of these pipes is the issue and the product should be replaced as soon as possible.

Dux-qest plumbing sited in the hallway cupboard.

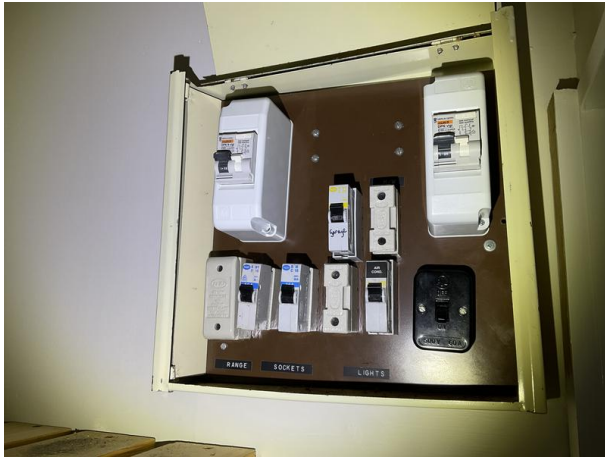
Photo 133

Distribution board is located in the hallway cupboard.
