PRE-PURCHASE BUILDING REPORT

Property Address	179 Tutere Street Waikanae Beach		
Client	Robert Hunsley		
Date of Inspection	18th October 2023	Time	1:00 pm
Inspector	Trevor Garrett MSc, LBP, Advanced Trade Cert Carpentry, Nat Diploma Construction Management. Member of NZIOB.		
LBP Number	131790		
Inspection Type	Pre-Purchase Report		
People Present	Owner		
House Occupied	No

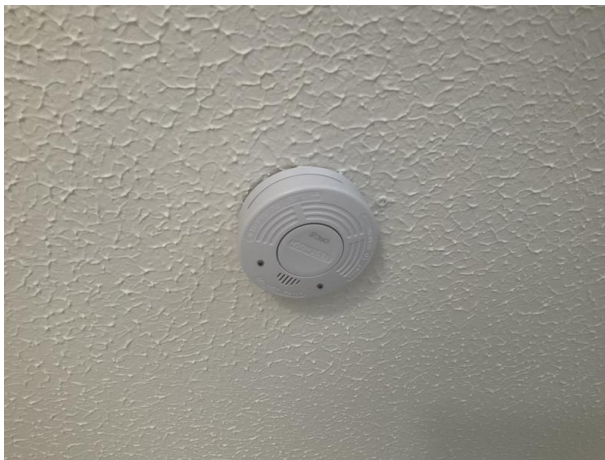
Photo 134

Three smoke detectors are located in the hallway.

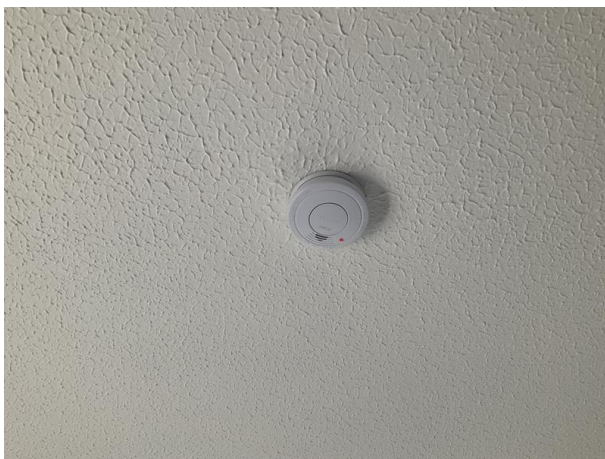
Photo 135

Smoke detector is located in bedroom 1.

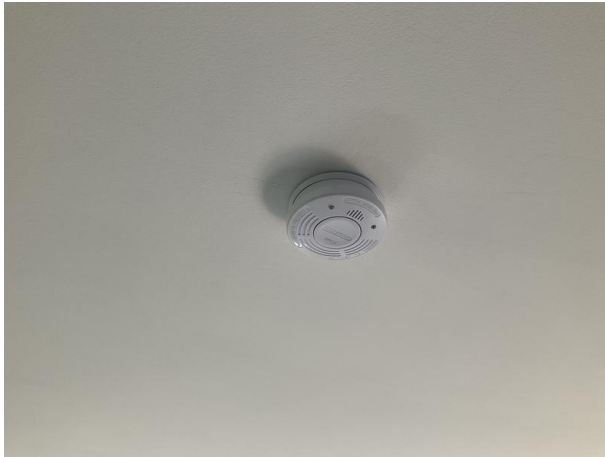
Photo 136

Smoke detector is located in bedroom 4.

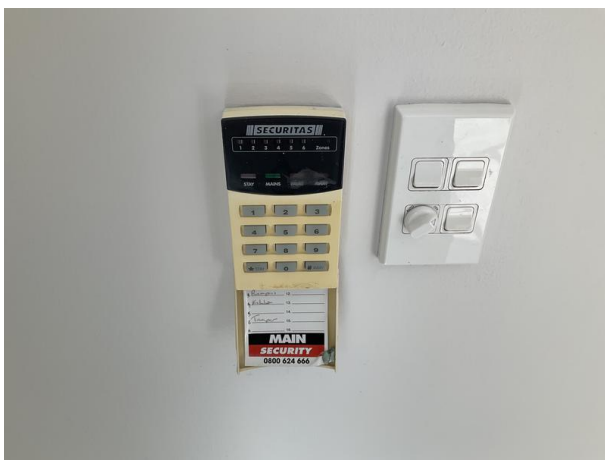
Photo 137

Security system keypad is located in the kitchen.
