## Vendor Supplied Building Report

## RED LBP WEATHERTIGHT REPORT

# CERTIFICATE OF INSPECTION IN ACCORDANCE WITH NZS 4306:2005

**Company:** Property Support Ltd Ltd trading as RedLBP Kapiti/Porirua  
**Client:** Carl and Jane Olsson  
**Date of Inspection:** 26th May 2026  
**Site Address:** 10 Edgewater Street Waikanae  
**Inspector:** Trevor Garrett  
**Qualifications:** MSc, LBP, Advanced Trade Cert Carpentry, Nat Diploma Construction Management. Member of NZIOB.

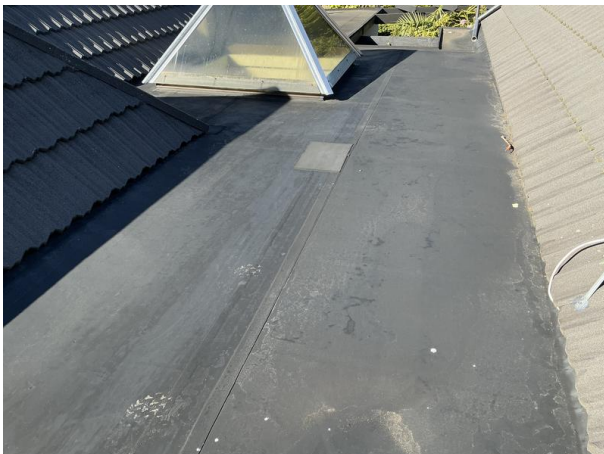
**Photo 5**  
Centre area has visible patches.

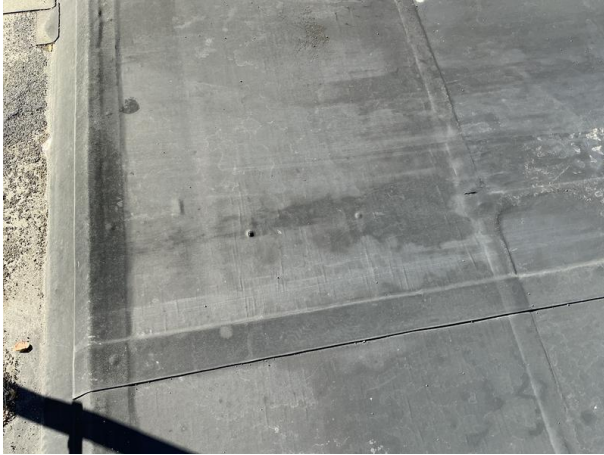
**Photo 6**  
Northside split membrane and raised  
substrate fixings.

It is recommended to engage a Licensed Building Practitioner (LBP) specialising in roofing to undertake a comprehensive assessment of the roof's condition and provide a detailed report. Without proper evaluation and timely repairs, undetected or unresolved roofing issues could lead to leaks, water intrusion, and subsequent damage to the underlying structures, insulation, and interior spaces. Over time, this could result in costly repairs, reduced energy efficiency, and compromised structural integrity. A thorough inspection ensures potential issues are identified and addressed promptly, safeguarding the long-term durability and performance of the roof system.

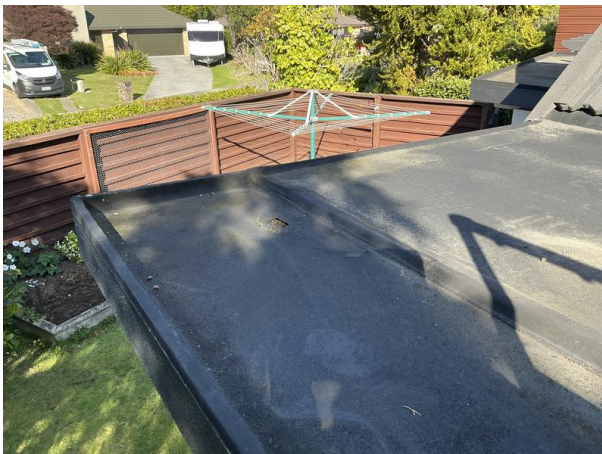
**Photo 11**  
Southeast outlet.

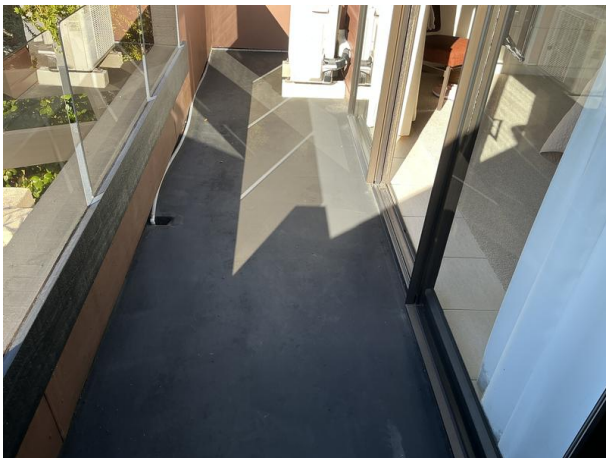
**Photo 14**  
Bedroom 1 balcony.

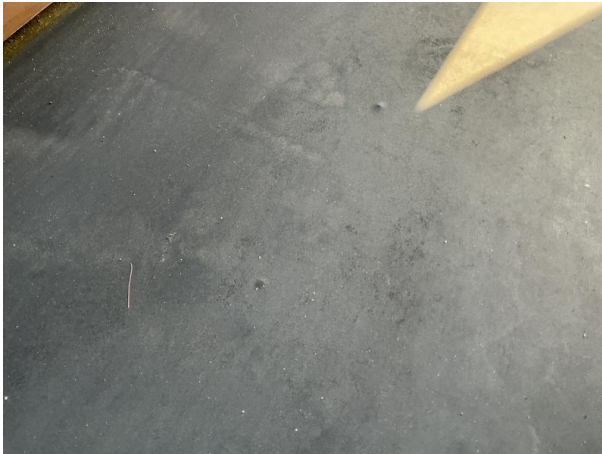
**Photo 15**  
Fixing rising up through the  
membrane.

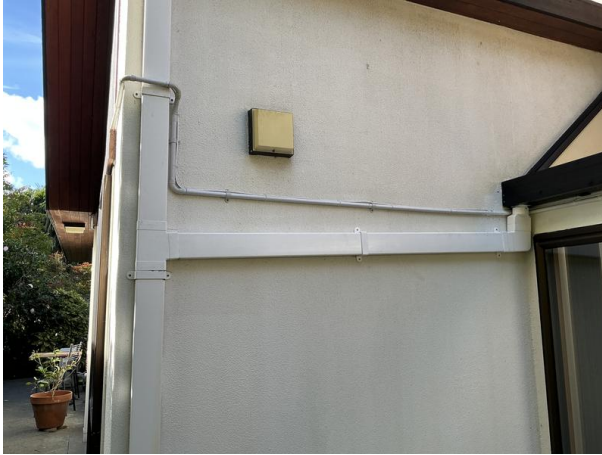
**Photo 29**  
Northside services penetrate the cladding.

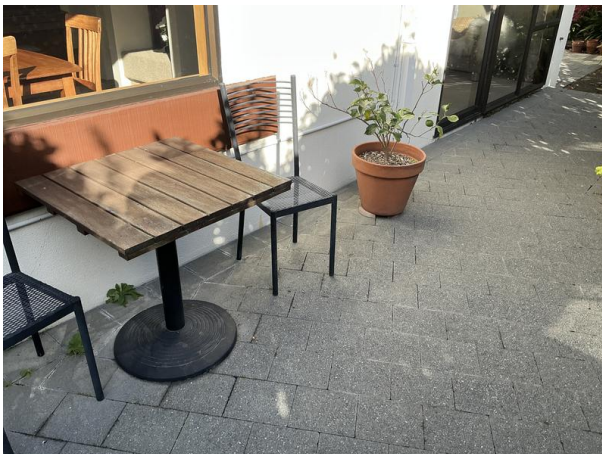
There is a number of windows exposed to the elements with no head flashings. The plaster system has visible cracking on the west side. Generally, the home has reduced ground clearances. Recommendations to address these issues are in the exterior cladding and joinery sections.

**Photo 31**  
Northside reduced ground clearance.

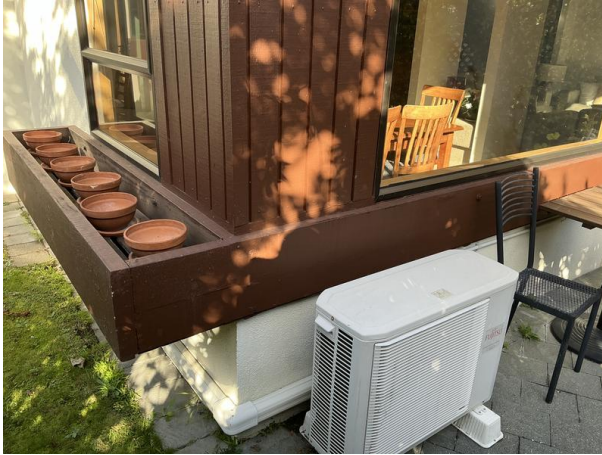
**Photo 32**  
Northside structure fixings penetrate the cladding.

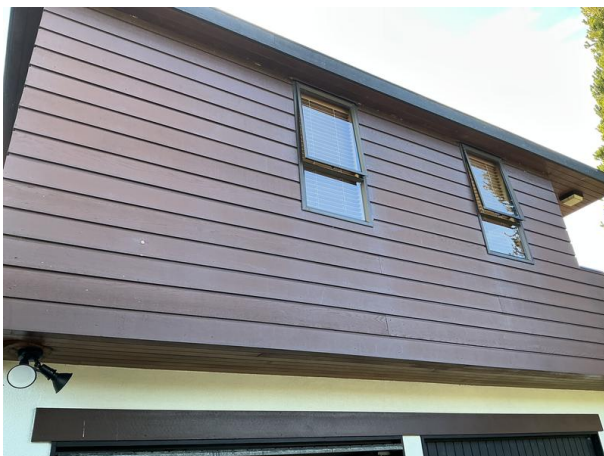
**Photo 36**

South side weatherboards.

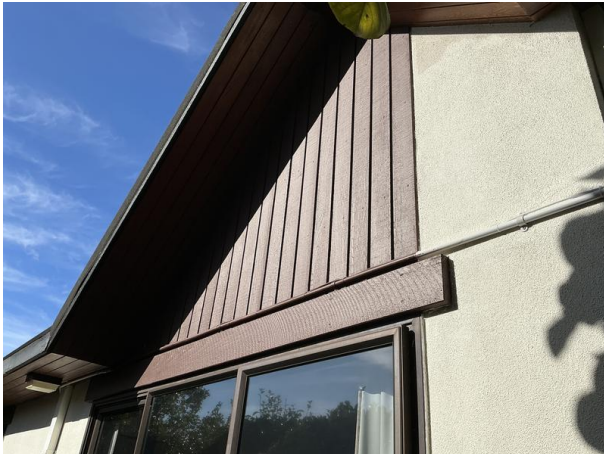
**Photo 37**  
North side structure fixings penetrates the cladding.

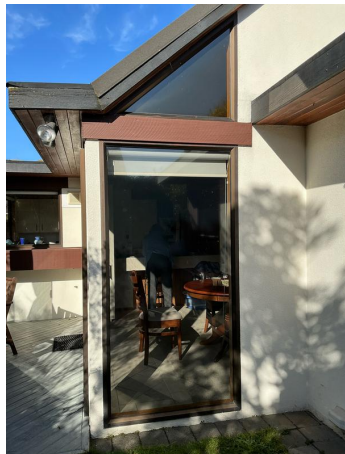
**Photo 40**  
East side no head flashing.

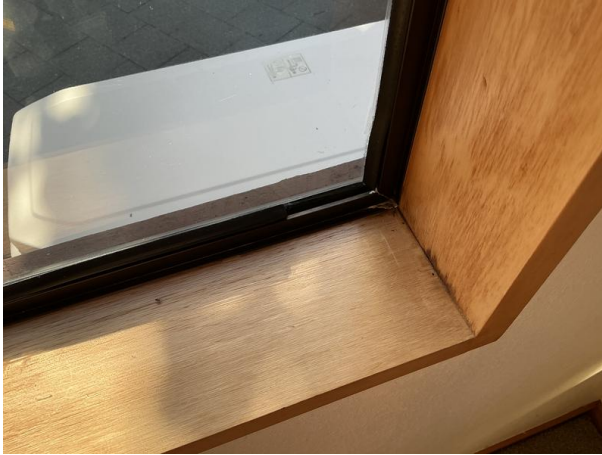
**Photo 43**  
Shrunk glazing.

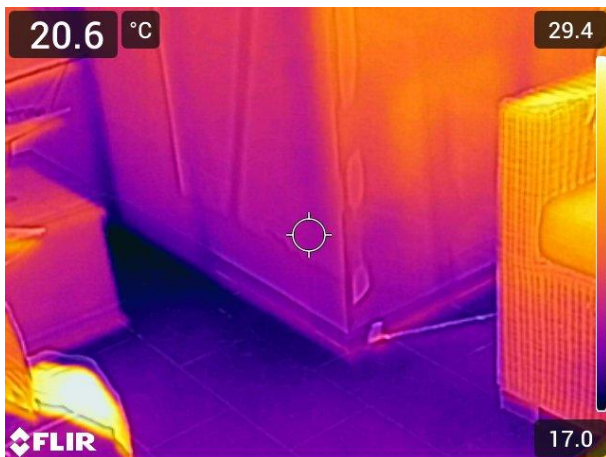
**Photo 79**  
Northwest corner of the conservatory has no notable temperature differences.

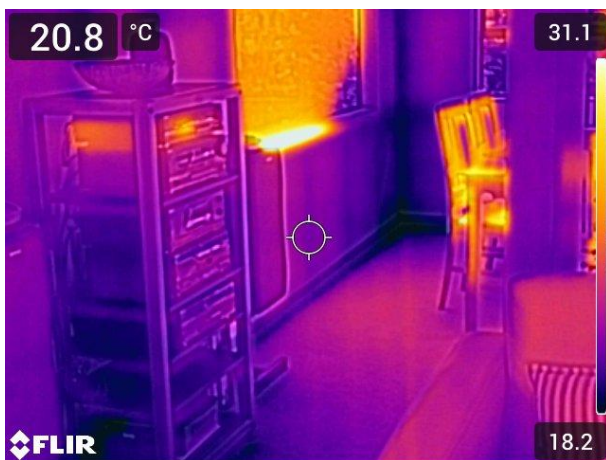
**Photo 80**  
Living room north wall has no notable temperature differences.

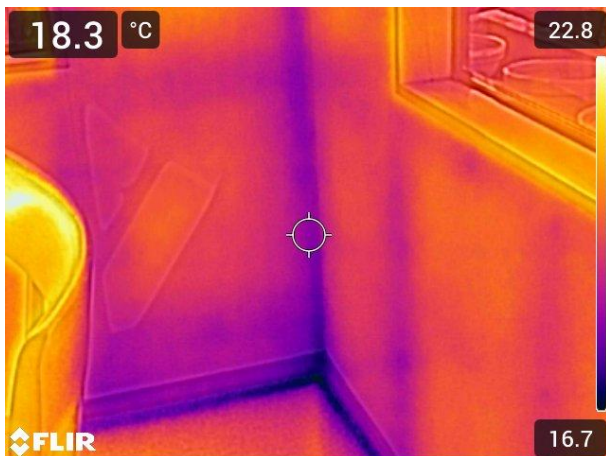
**Photo 81**  
Dining area has no notable temperature differences.

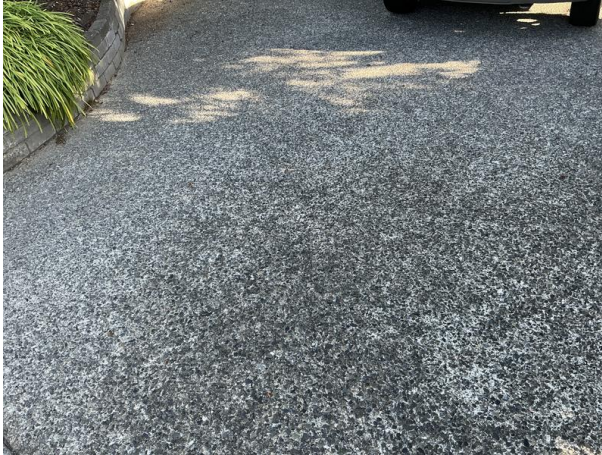
**Photo 82**

Driveway is functional.

General upkeep and maintenance of driveway by cleaning and keeping free of debris.

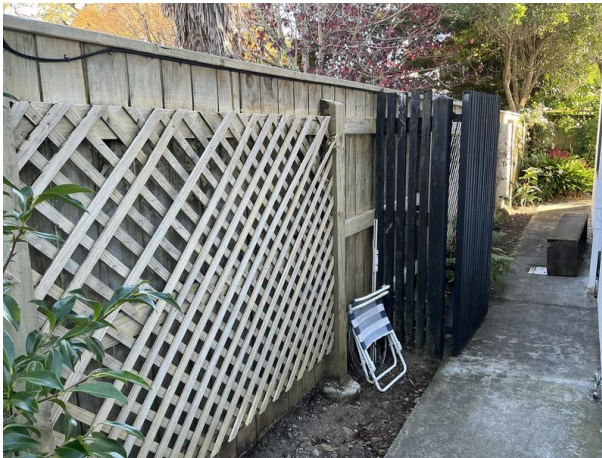
**Photo 83**  
Westside functional.

General upkeep and maintenance, keep vegetation and soils clear of timbers as these timbers are only exterior treated and will rot if vegetation or soils are up against them.

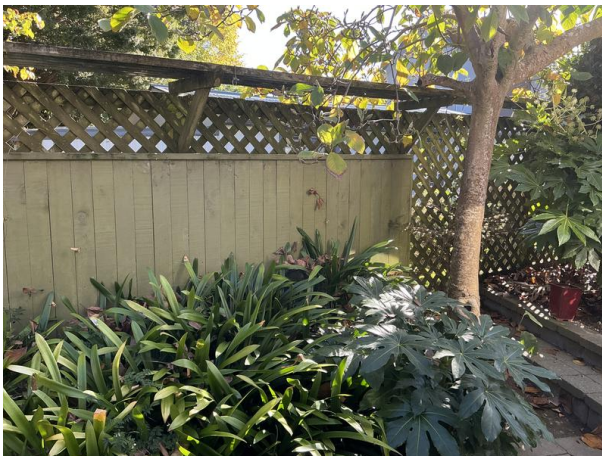
**Photo 84**  
Northside functional.

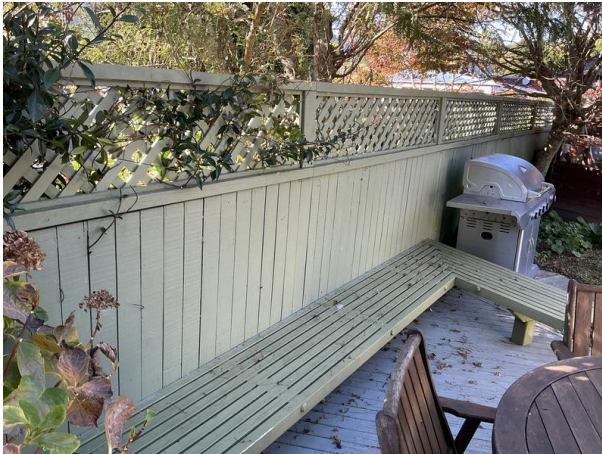
**Photo 85**  
East side functional.

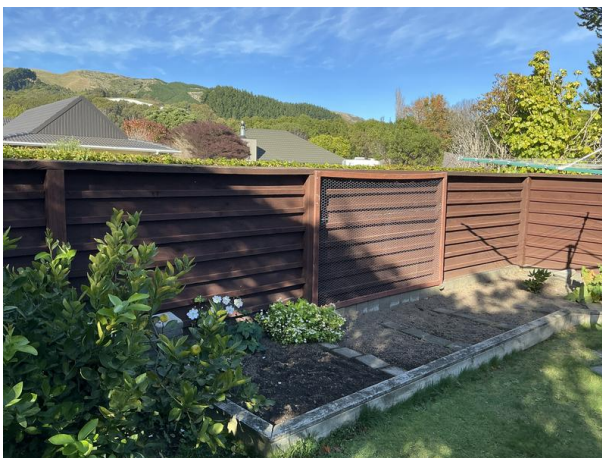
**Photo 86**  
Southside functional.

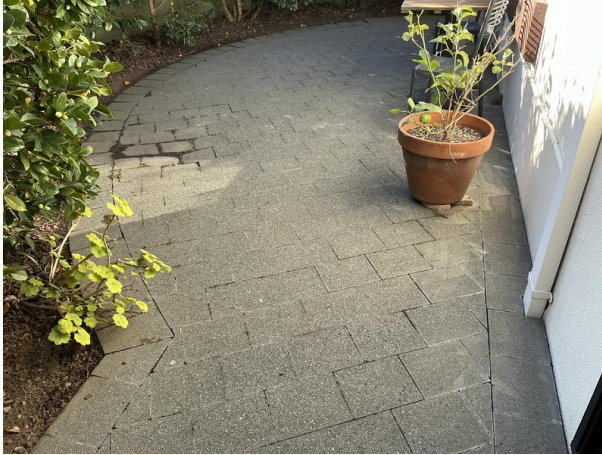
**Photo 89**  
Northside functional.

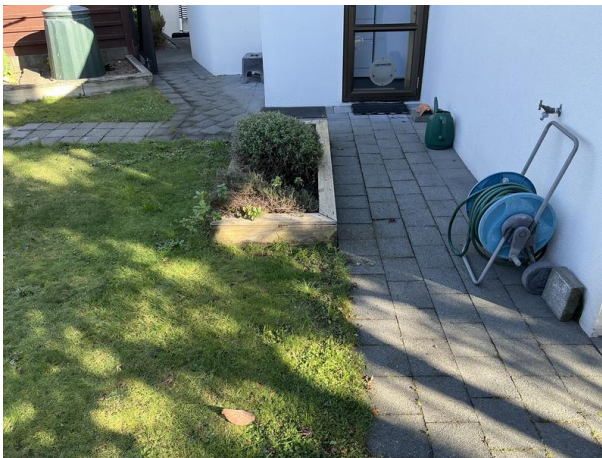
**Photo 90**  
Southside functional.

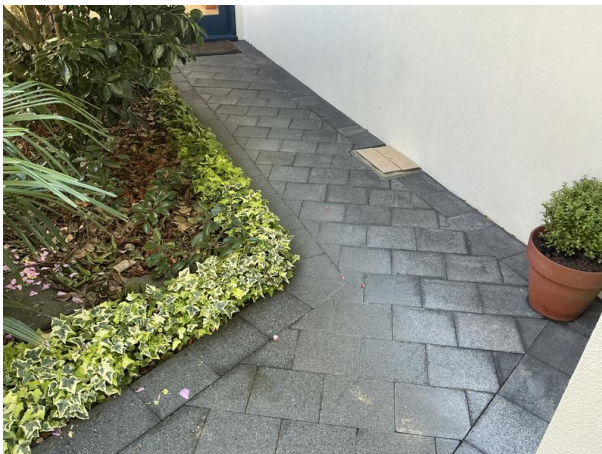
**Photo 91**  
Southside functional.

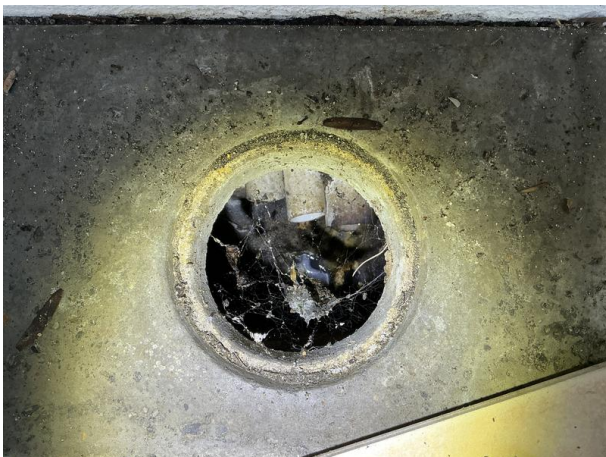
**Photo 95**  
Southside gully trap.

Keep vegetation and soils clear of drainage.

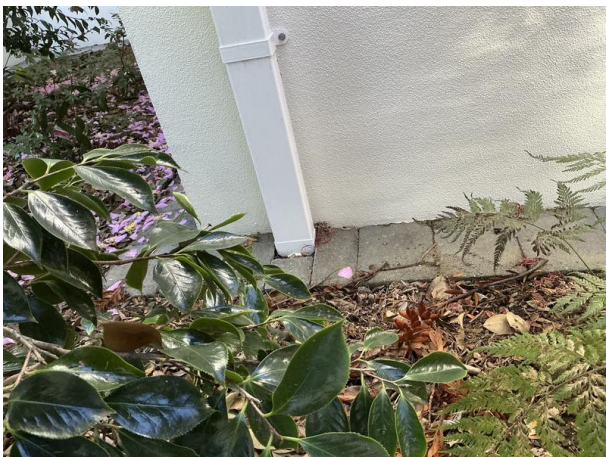
**Photo 96**  
Southside downpipe connection visible.

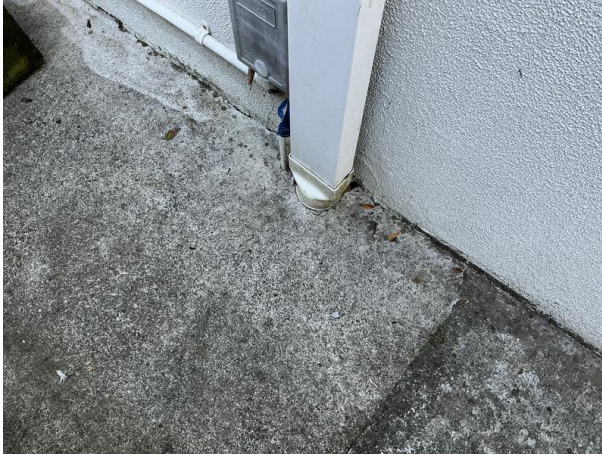
**Photo 97**

Westside downpipe connection visible.

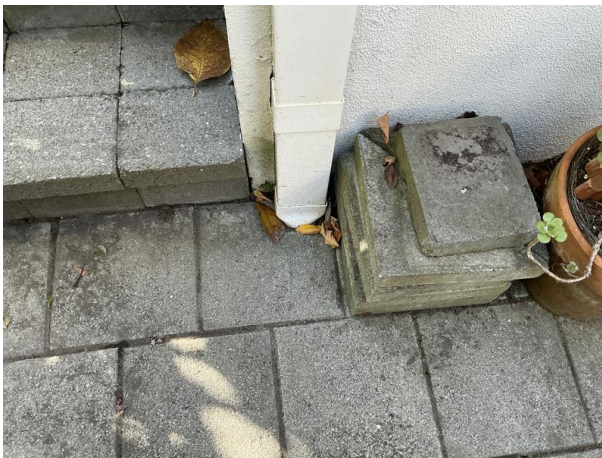
**Photo 98**

Northside downpipe connection visible.

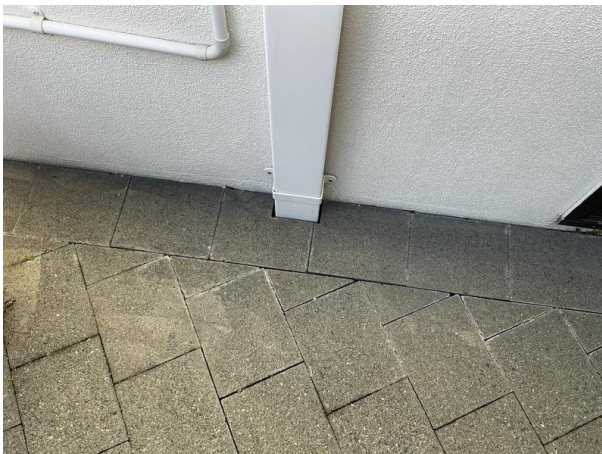
**Photo 99**

Northside downpipe connection not visible.

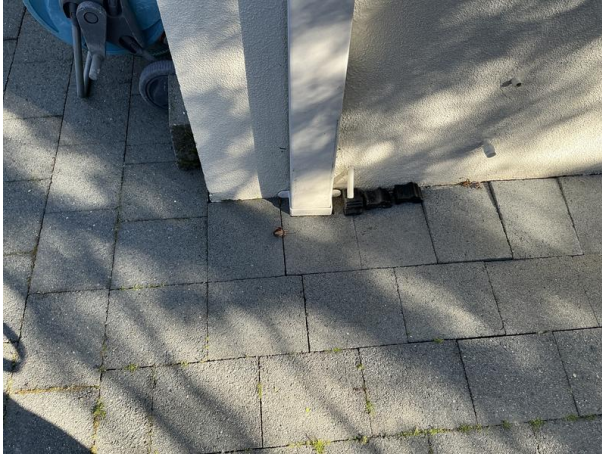
**Photo 100**

Northside downpipe connection is not visible.

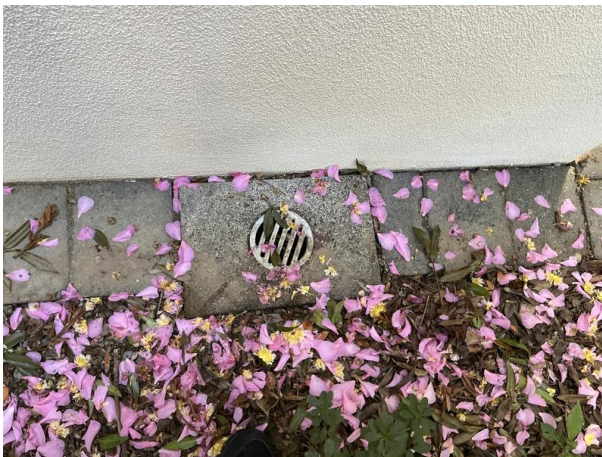
**Photo 102**

Southside gully trap.

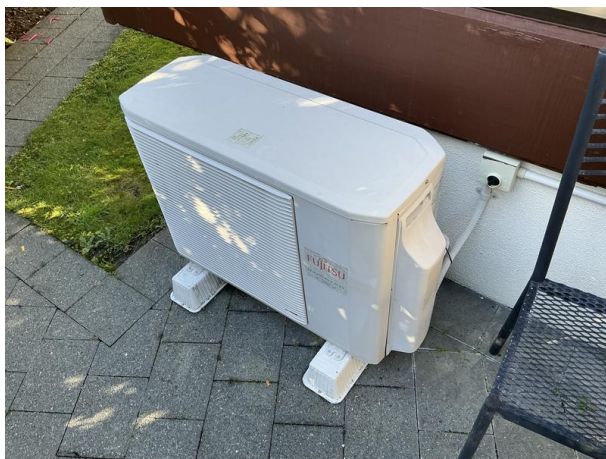
**Photo 103**

Outdoor heat pump unit located on the north side.

Follow the manufacturer's recommended servicing schedule to ensure the equipment operates efficiently and maintains optimal performance. Adhering to these guidelines helps identify and address potential issues early, reducing the risk of costly repairs and ensuring compliance with warranty requirements.

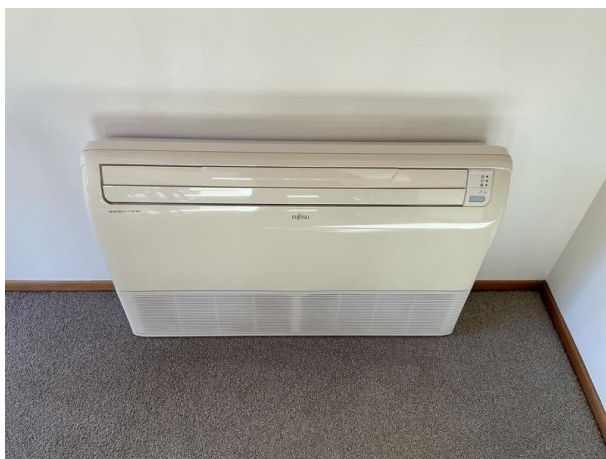
**Photo 104**

Indoor unit is located in the living room.

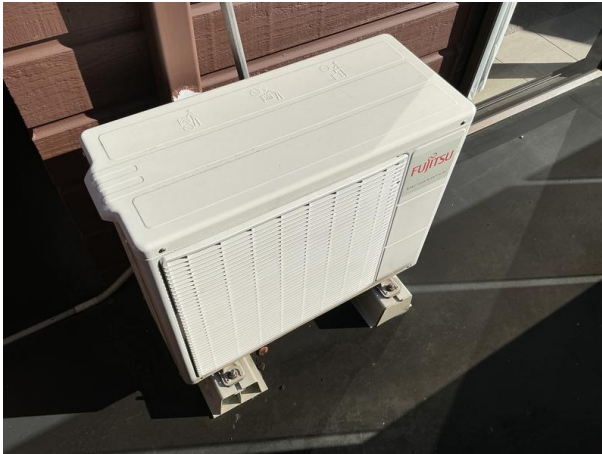
**Photo 105**  
Outdoor heat pump unit located on the south side.

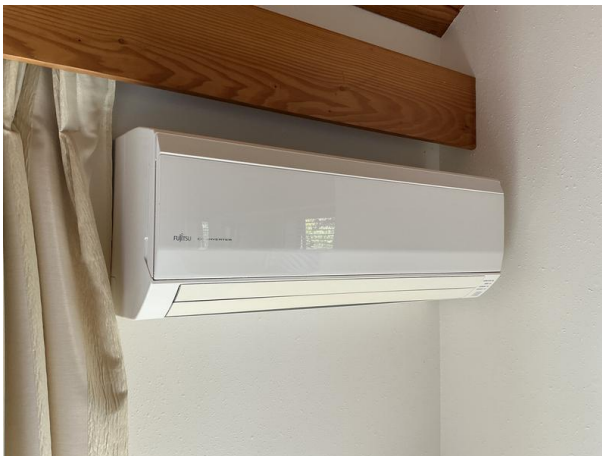
**Photo 106**  
Indoor unit located in bedroom 1.

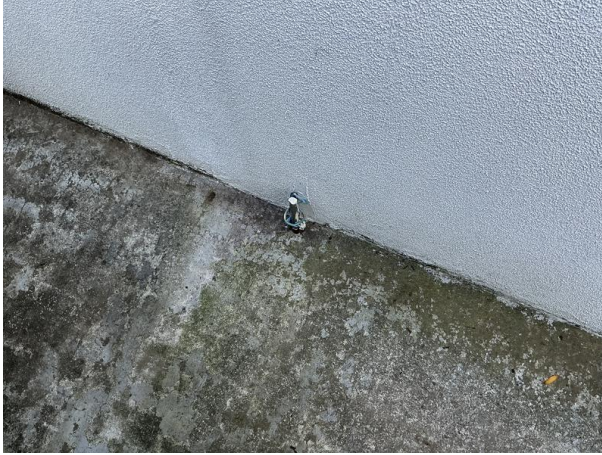
**Photo 107**

Earth stake is located on the west side.

All services should be tested and maintained by certified professionals to the manufacturer's specifications.  
Regular checks to ensure smoke detectors are functional.

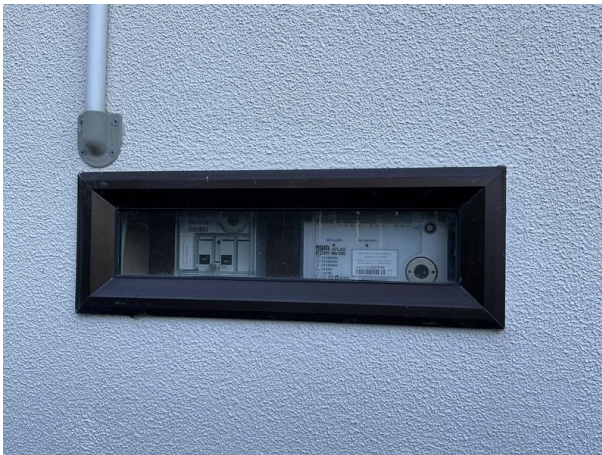
**Photo 108**

Meterboard located on the west side.

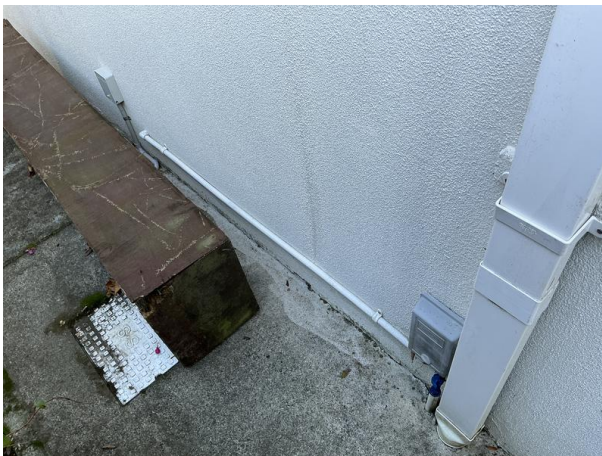
**Photo 109**

Cable TV and data located on the west side.

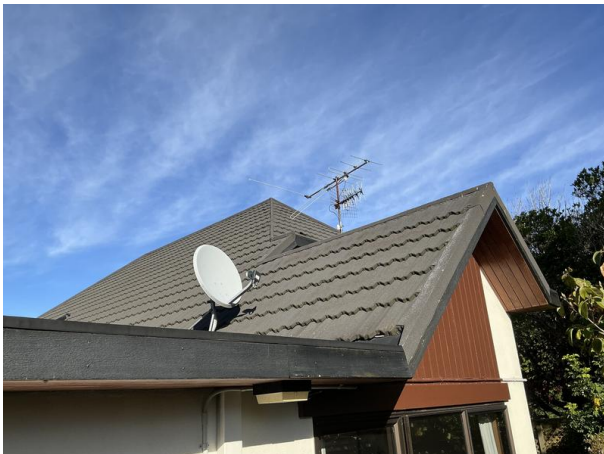
**Photo 110**  
TV aerials located on the north side.

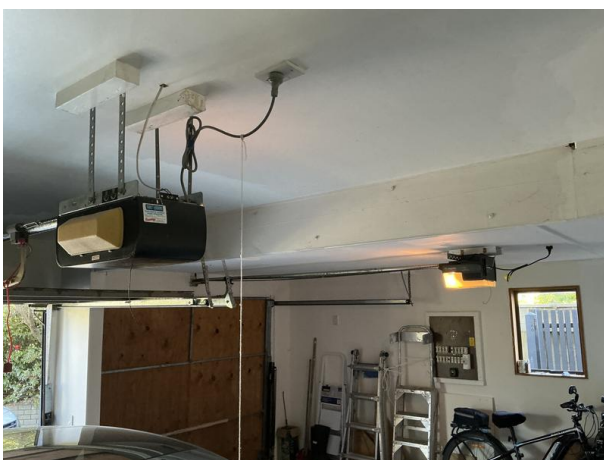
**Photo 111**  
Garage door openers are functional.

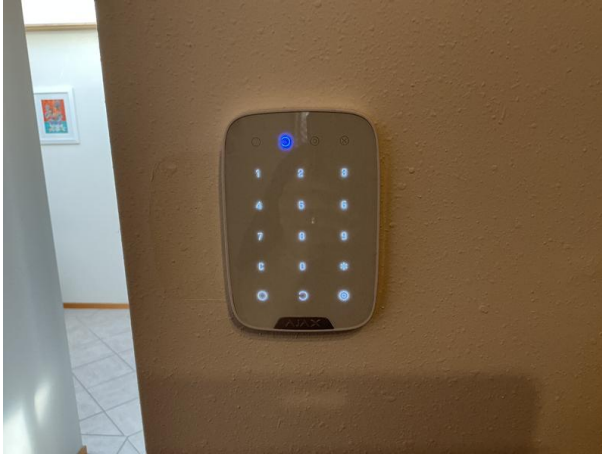
**Photo 113**  
Security system keypad located in the hallway.

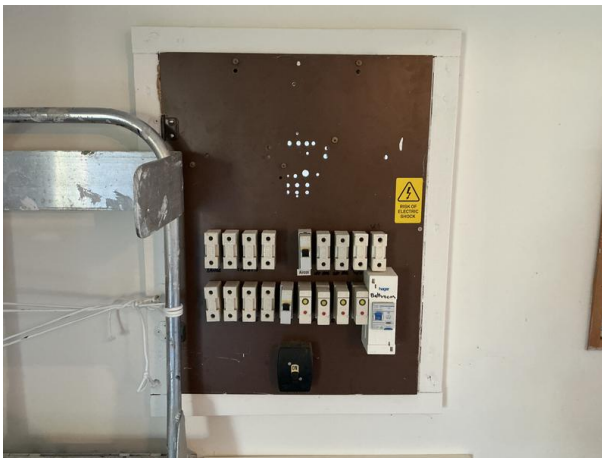
**Photo 114**  
Distribution board located in the garage.
