# Independent Builders Report

Total Home Inspection Services Porirua City Ltd

Fri 29 May 2026

**75B Paremata Haywards Hill Rd, Pāuatahanui, Porirua,**  
**5381, New Zealand**

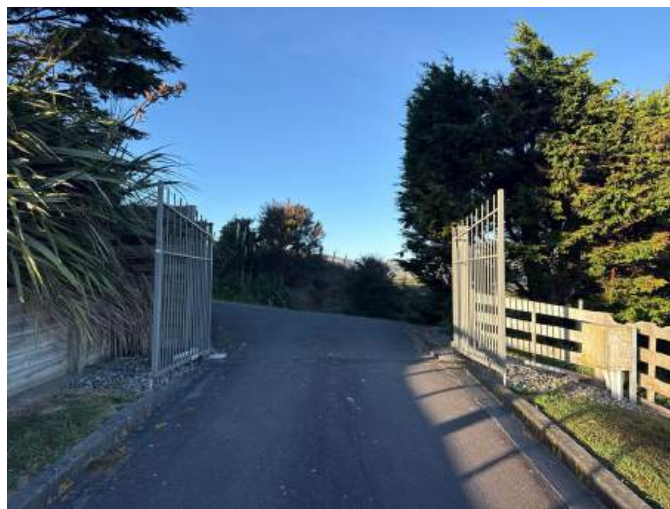
The electric gates to the driveway are functioning. Note these can be remotely controlled from the house.

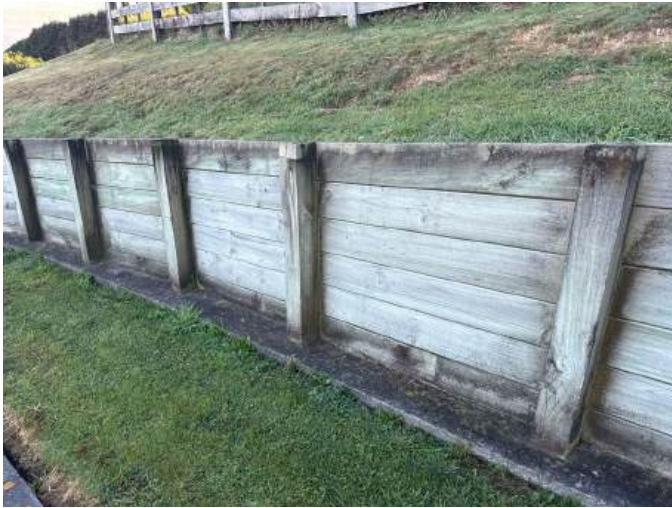
The condition of the retaining walls is consistent with the age of the property. The retaining walls will require ongoing monitoring. No signs of significant damage or movement at the time of inspection.

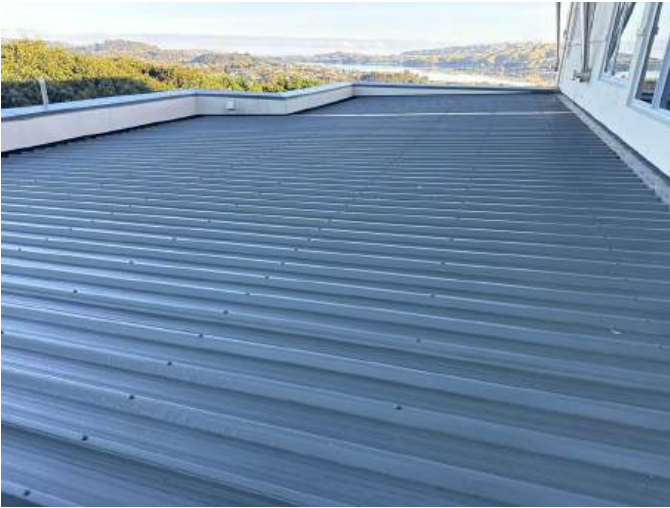
A once or twice yearly wash will help maintain the roofs surface condition and prevent premature deterioration

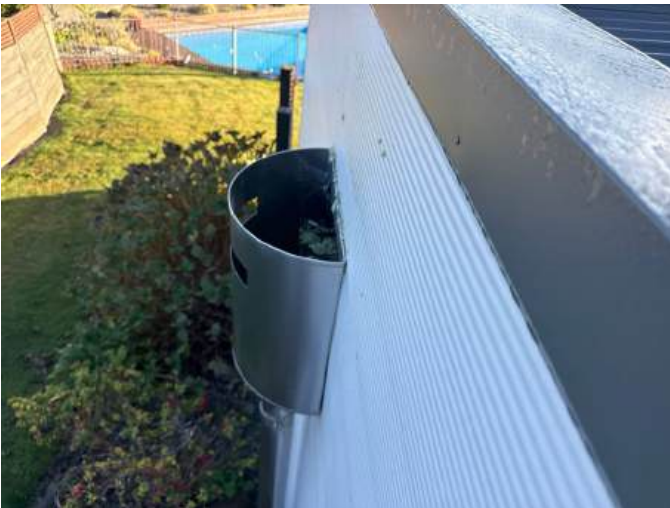
The scupper outlets are well detailed, clear and in good condition

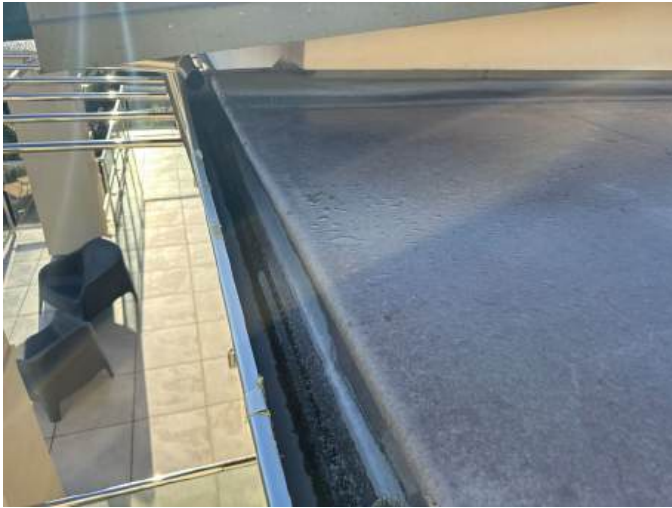
The spouting is in good condition at most locations and is clear. The effectiveness of the spouting will need to be checked during rainy periods. Due to the dry conditions that were evident on the day of our inspection we cannot comment on any leaks that maybe evident to the spouting or down pipes.

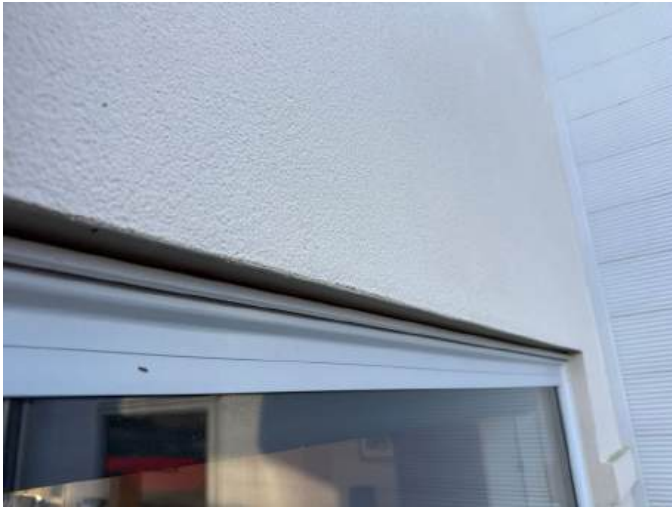
The cavity system is not clearly visible in the EIFS cladding. The council records will note if there is a modern 20mm cavity system.

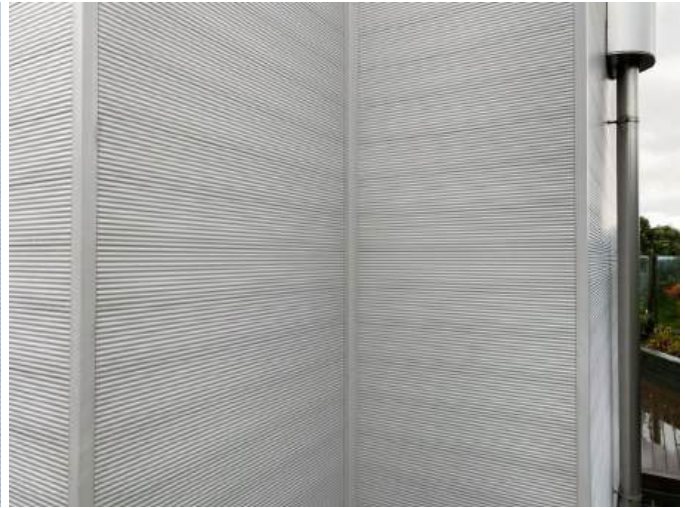
The internal and external corners are protected with metal flashings which will deflect water away from the junctions.

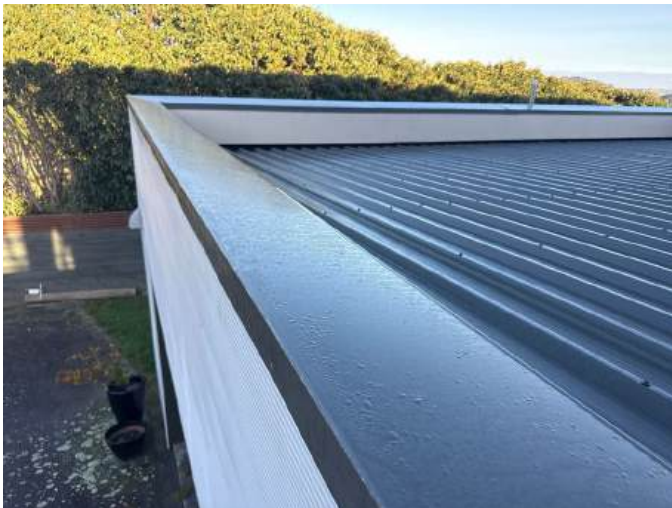
The parapet walls have been flashed, which is a necessary detail to prevent water ingress at the roof-wall interface. Properly installed flashing helps divert water away from vulnerable joints and prevents moisture penetration into the wall assembly and roofing structure.

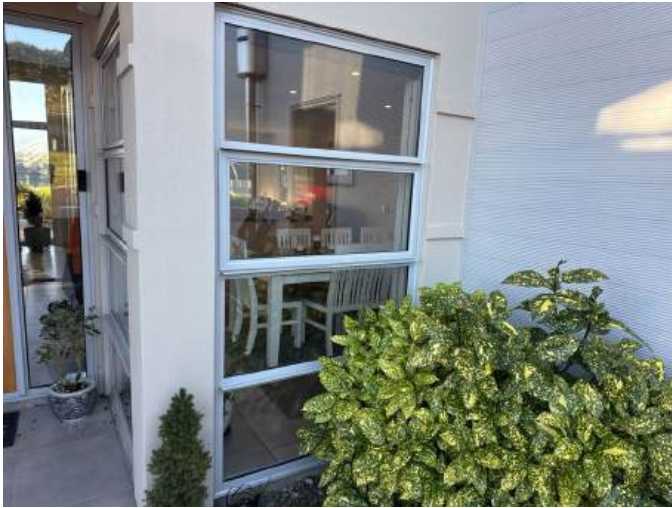
The typical double glazed aluminium window (EIFS) detail is rebated with a visible head flashing and concealed cladding specific flashings. The sides are effectively sealed.

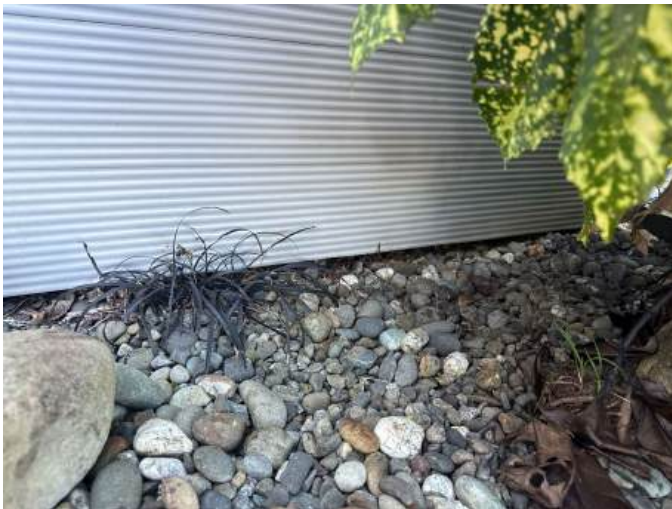
Poor ground clearance can sometimes result in moisture ingress via capillary action, a particularly high risk due to the bottom plate being at risk of decay. The current building code requires a 150mm clearance between the internal floor height and the sealed ground and 225mm to unsealed ground.

At the time of the inspection all non invasive moisture tests completed to the bottom plate at these locations presented within the acceptable range. T.H.I.S recommends maintaining the recommended ground levels to prevent unnecessary maintenance.

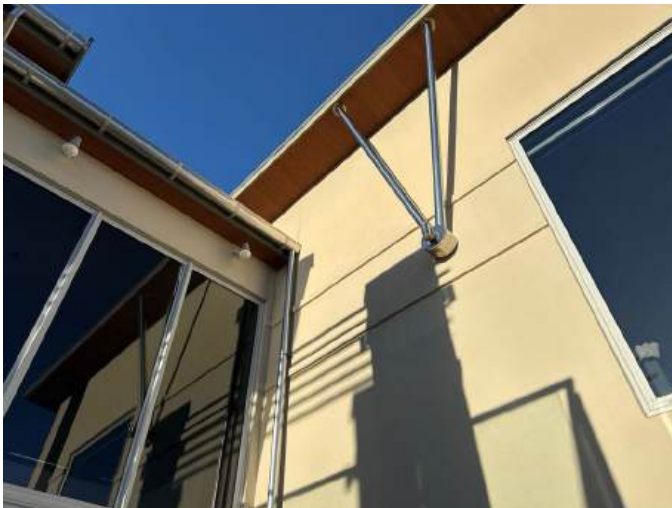
The timber fascia and soffits are in an average/good condition

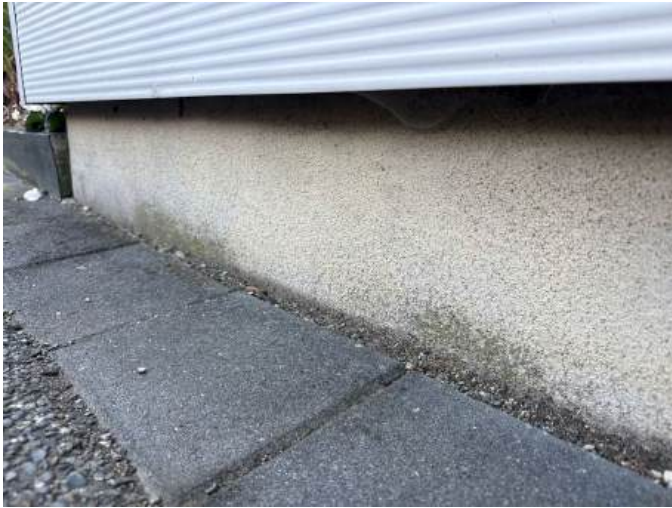
Very limited space to sight the concrete foundation but where visible it appears solid. No damage or significant deterioration could be found at the time of inspection.

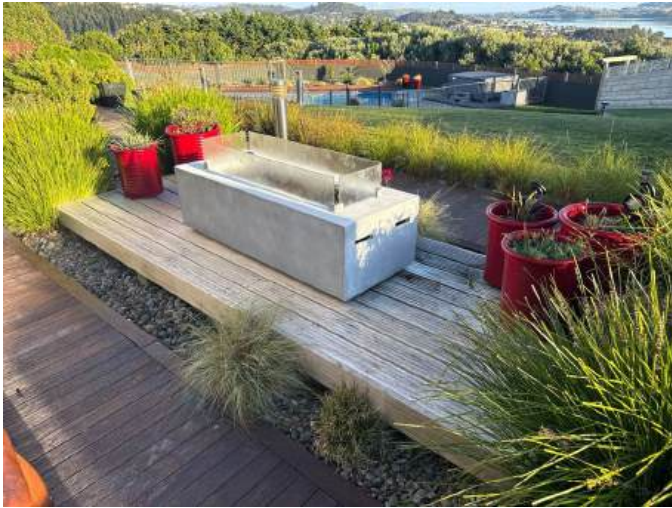
There is a well and water pump installed under the outdoor fire which supplies the storage tanks. Outside the scope of this inspection.

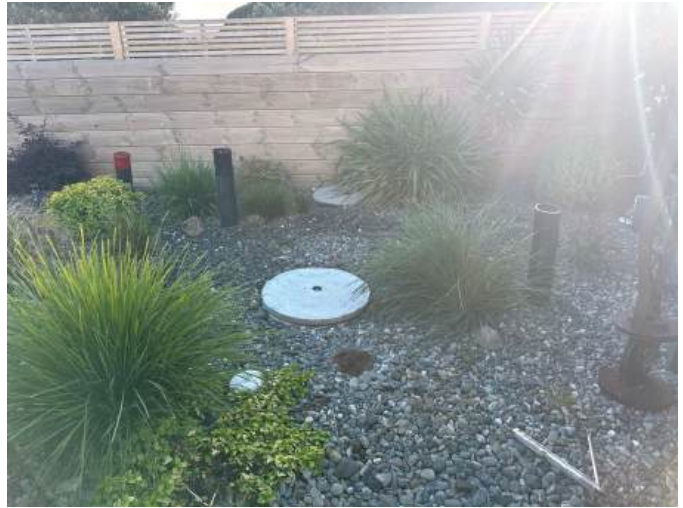
3 chamber septic tanks installed on the north side

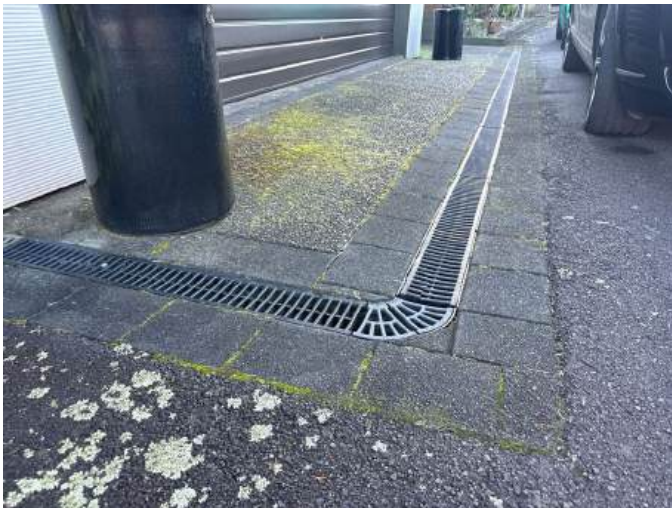
Channel drains and sump to the front. There was no evidence of current blockages or recent overflows. The effectiveness of the drains (in general) will need to be monitored over time.

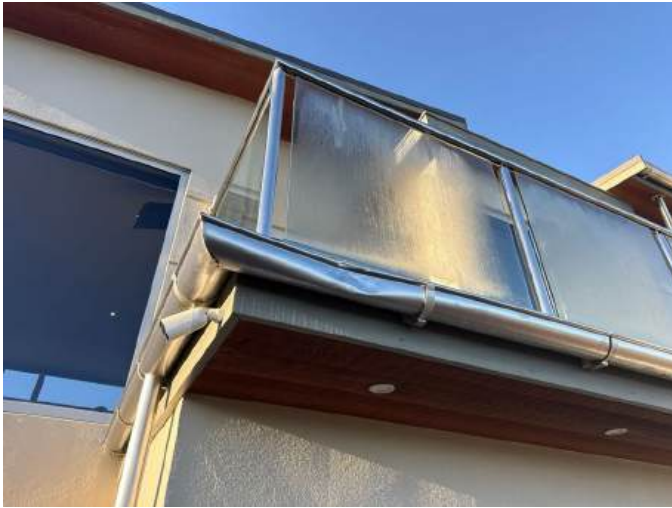
The spouting has been crushed under the rear deck which has caused the mitre join at the corner to open up. The corner should be sealed if possible to prevent water escaping.

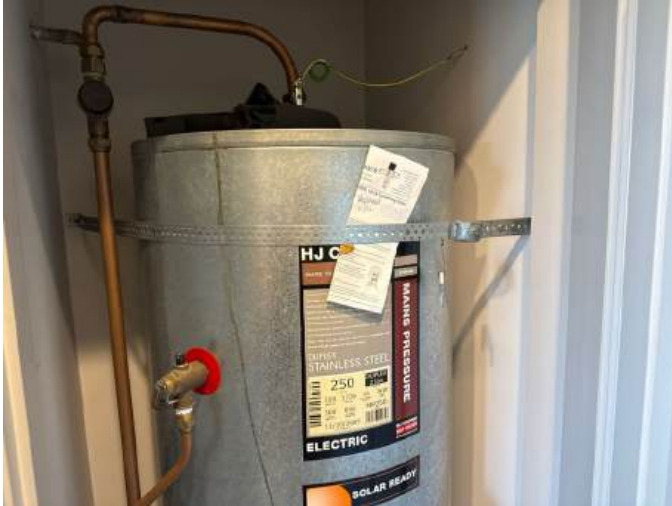
Kitchenette.

HJ Cooper 250L Mains Pressure Electric Hot Water Cylinder. Seismic restraints installed.

The pressure-reducing valve that is located at the side of the mains pressure hot water cylinder should be tested every 6 months or in accordance with the manufacturer's instructions to make sure that it is in working order.

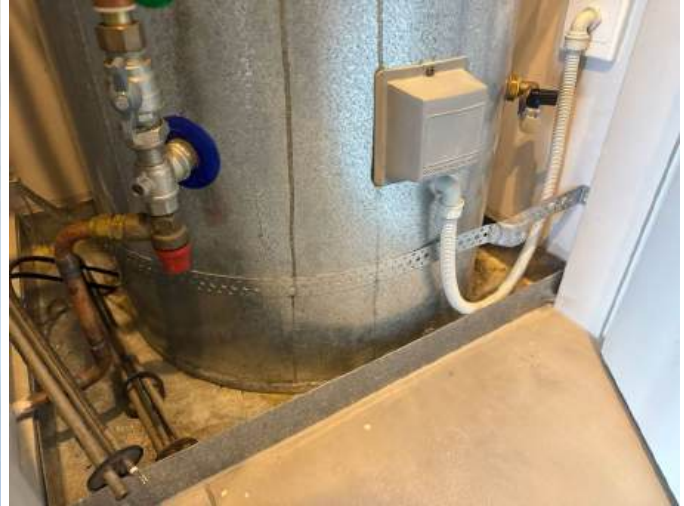
No sign of leaks around the base of the cylinder. The cylinder is placed in a safe tray with a drainage outlet as required.

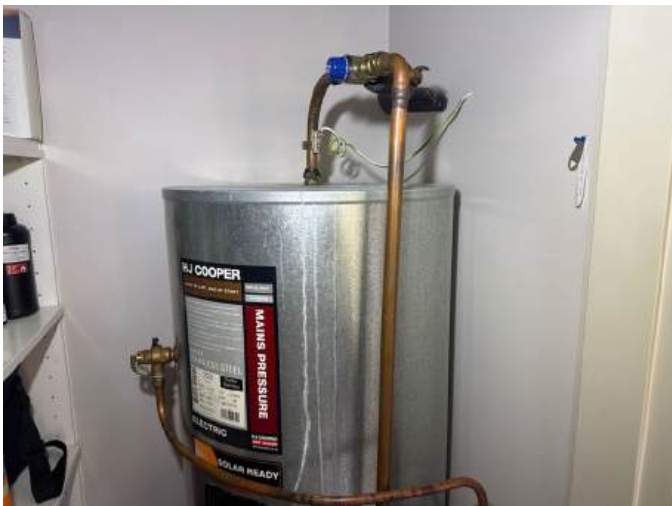
Laundry cupboard.

HJ Cooper 250L Mains Pressure Electric Hot Water Cylinder. Seismic restraints installed.

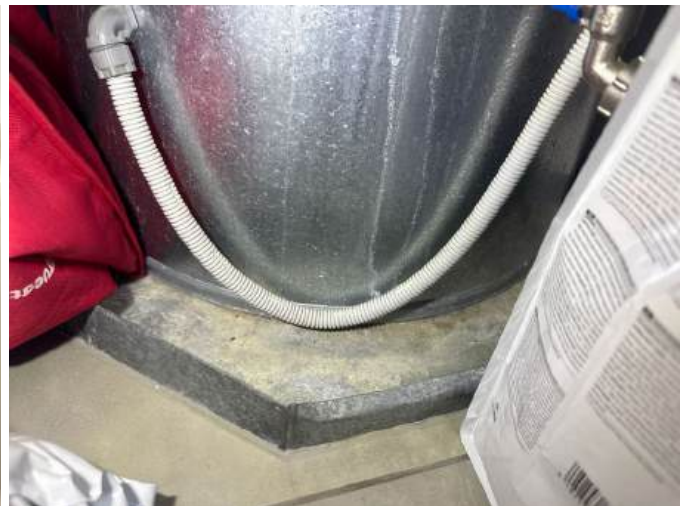
No sign of leaks around the base of the cylinder. The cylinder is placed in a safe tray with a drainage outlet as required.

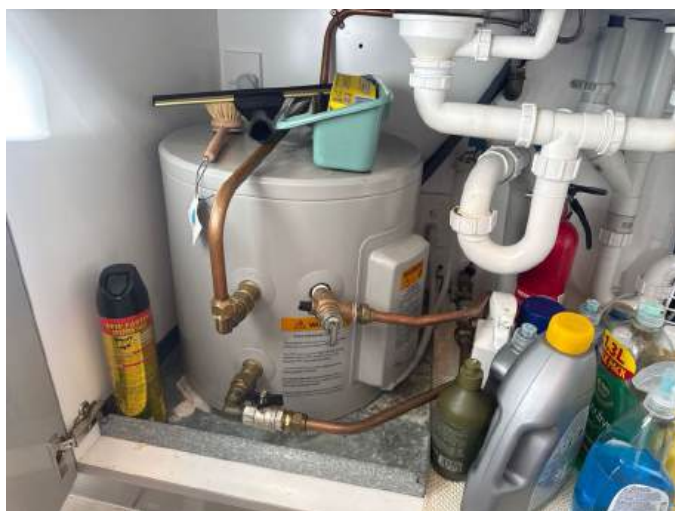
Kitchen cupboard. Rheem Mains pressure, 25L hot water cylinder supplies the kitchen tap. No concerns sighted.

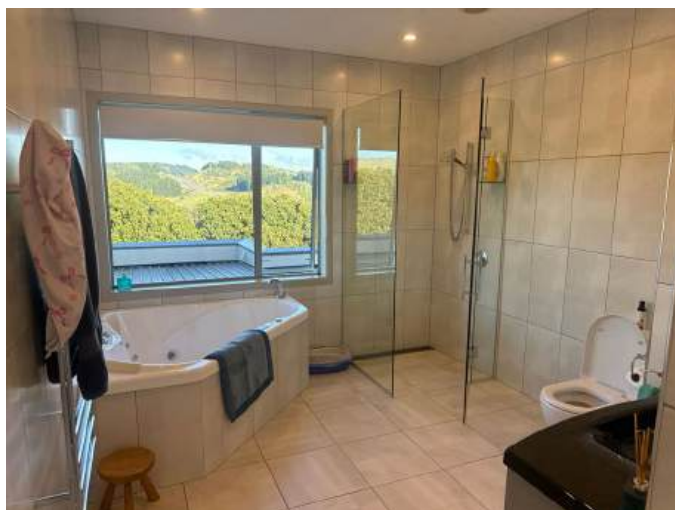
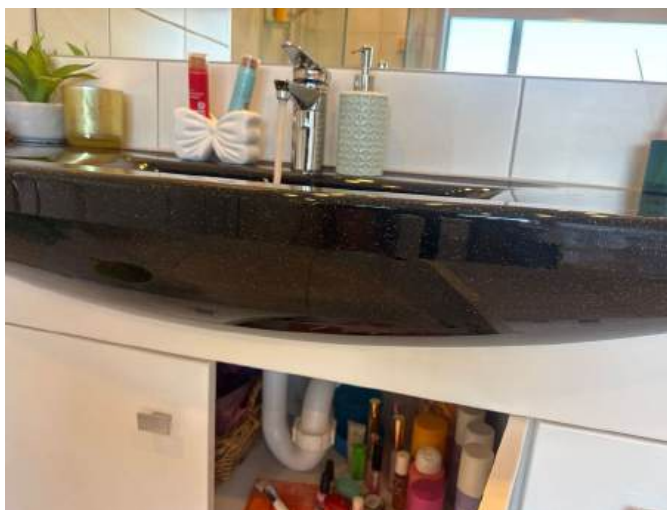
The rear edge of the vanity is well sealed. The tap is functioning well. No concerns with the water feeds or waste under the vanity

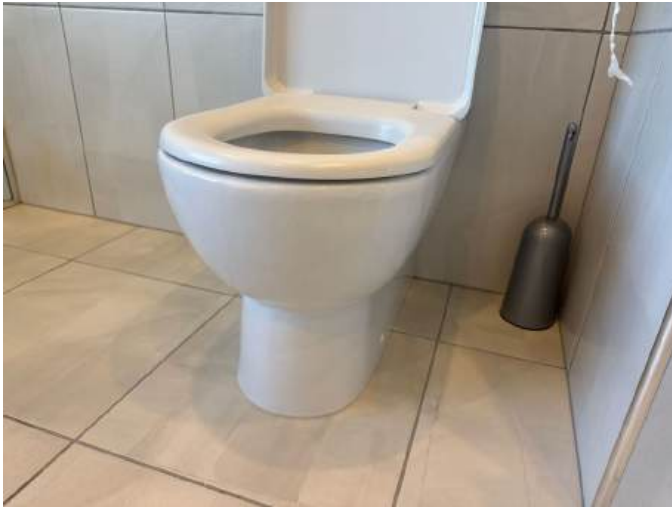
The base of the toilet is well sealed and secure. The toilet is in a functioning condition.

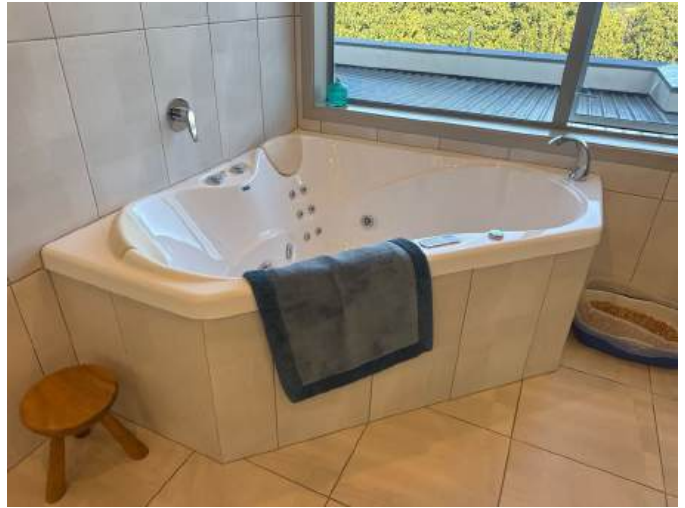
The perimeter of the bath is well detailed and sealed. The tap is functioning well.

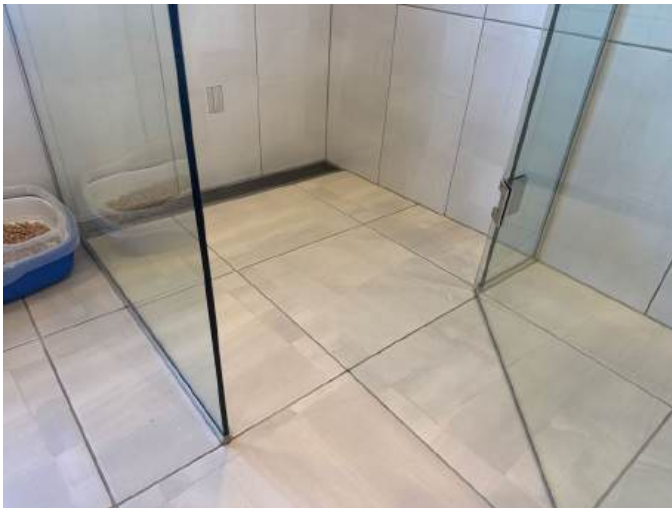
The tile grout and silicone type sealant form part of the water proofing system. Cracked grout or degradation to the sealant can result in water penetrating through the underside of the tiles. Unable to comment on the condition of the water proof membrane. Recommend maintaining grout and sealant when required. No evidence of deterioration or failure could be found at the time of the inspection.

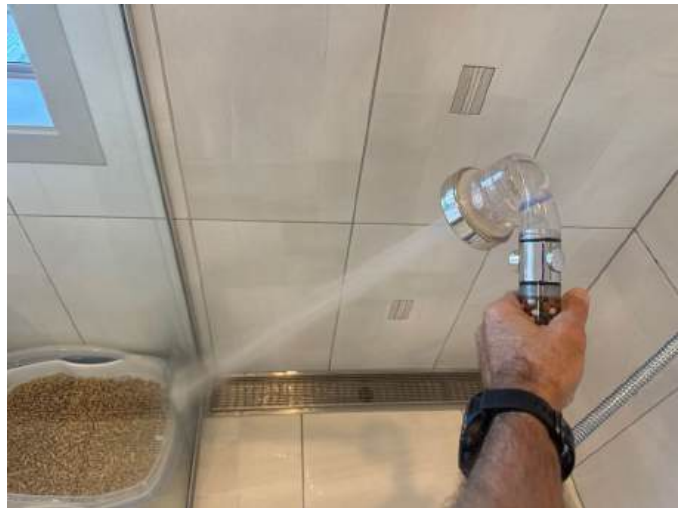
Good water pressure noted. No sign of current leaks from the shower frame during water testing.

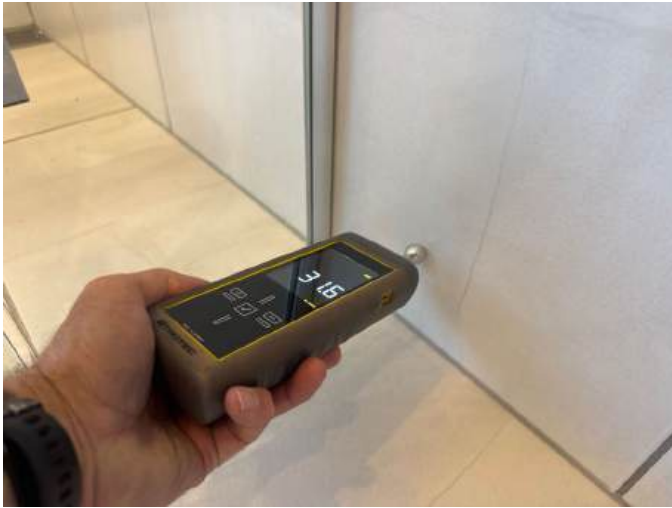
The common fail areas of the shower and plumbed areas were checked for elevated moisture. Moisture levels were within the normal range.

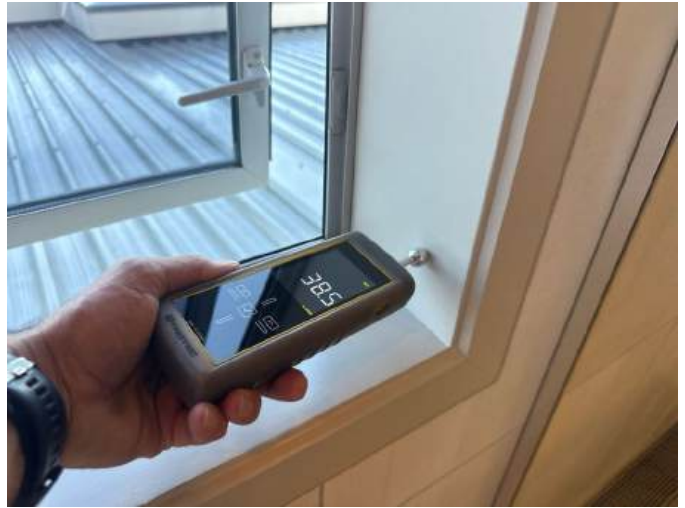
Moisture levels to the exterior walls were within the normal range

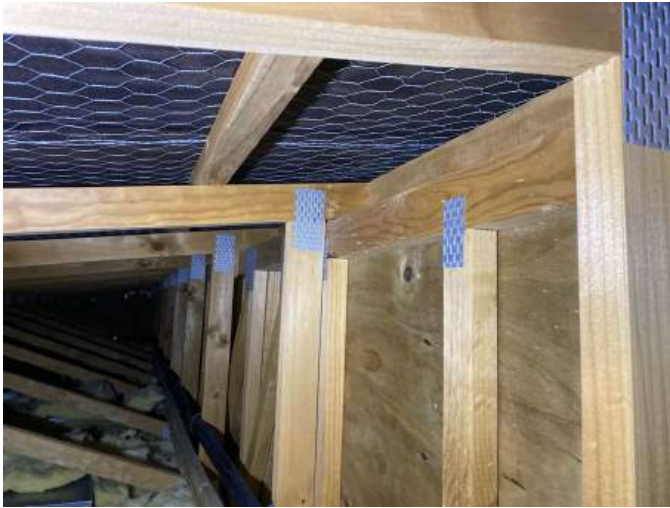
There was no evidence of current or past moisture ingress issues under the roof framing or linings (where accessible) at the time of inspection. The roof framing structure appears to be solid.

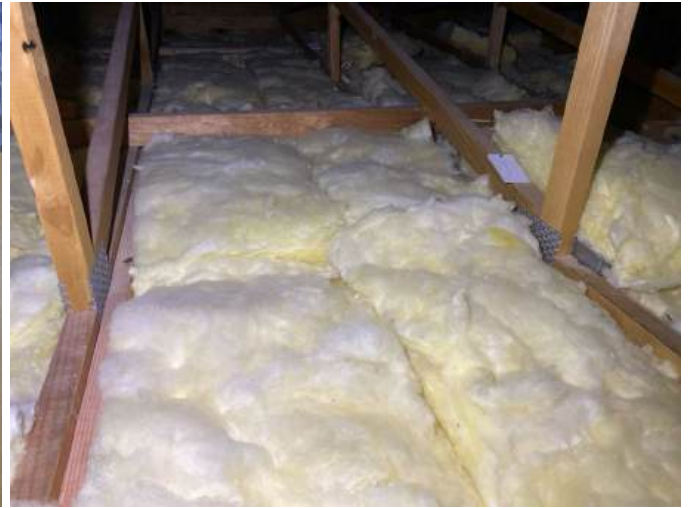
Average level of insulation in place. There was no labelling present to indicate the R-Value of the material.

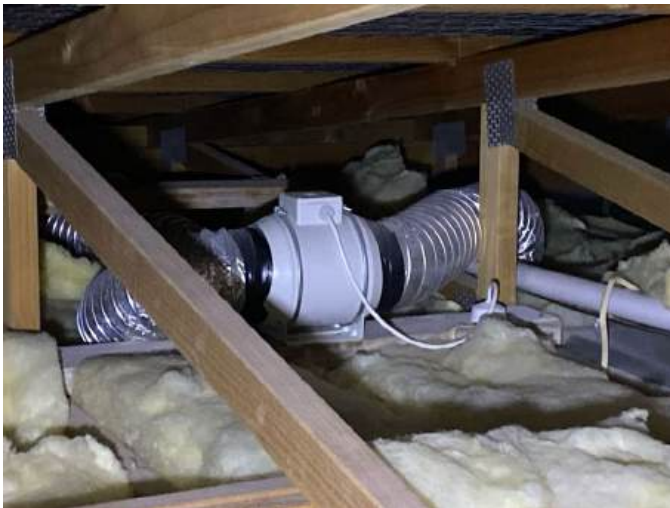
Extraction units vent to the exterior as required

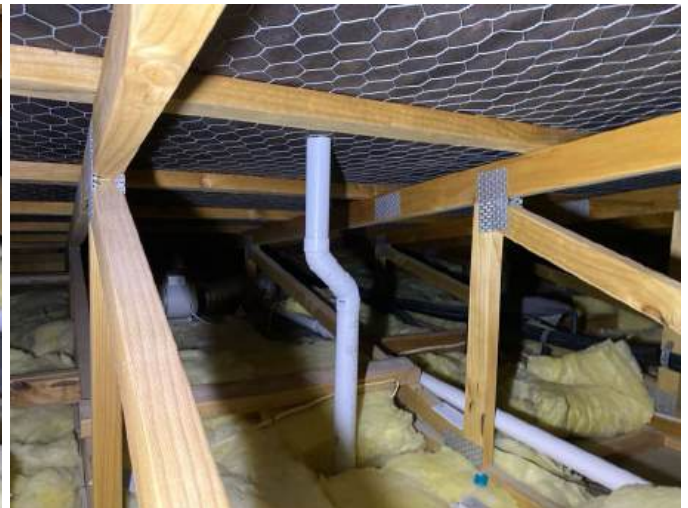
Roof penetrations are effectively sealed. There was no evidence of current water ingress issues sighted.

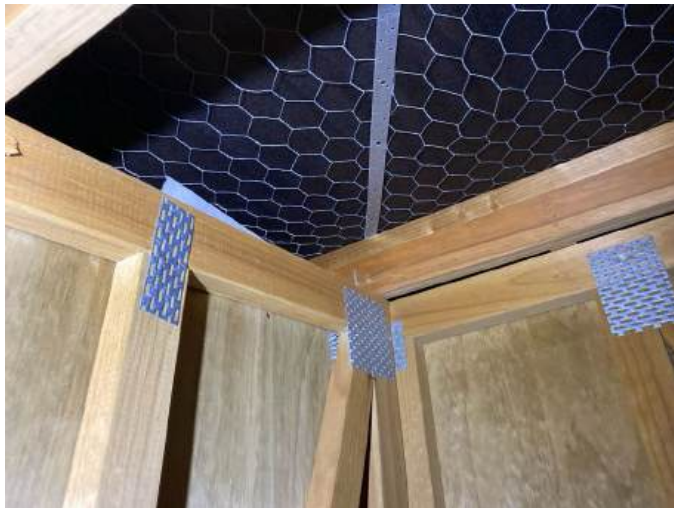
There was no evidence of current or past moisture ingress issues under the roof framing or linings (where accessible) at the time of inspection. The roof framing structure appears to be solid.

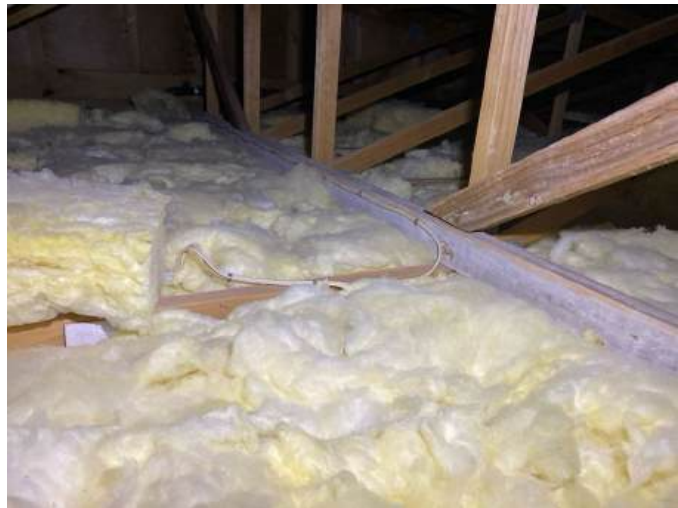
Average level of insulation in place. There was no labelling present to indicate the R-Value of the material.

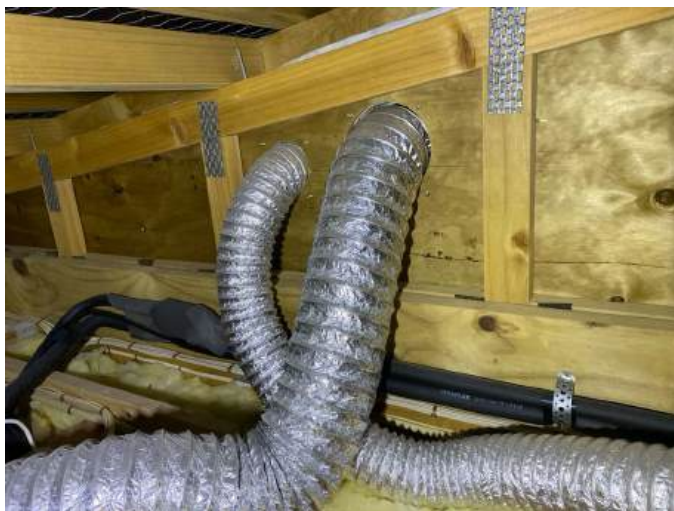
Extraction units vent to the exterior as required

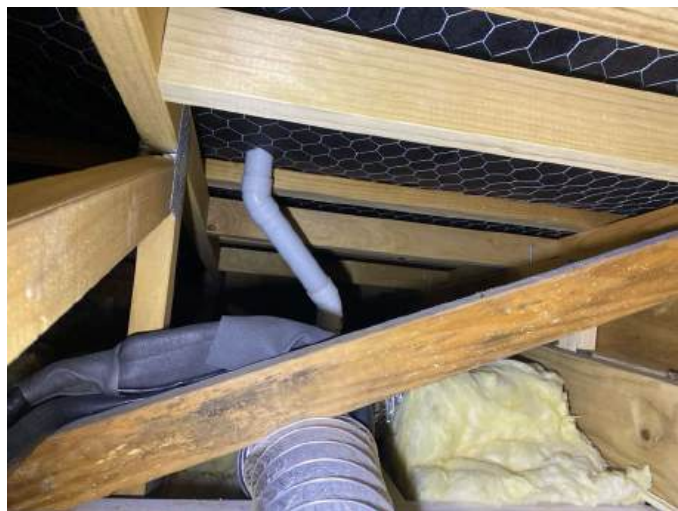
Roof penetrations are effectively sealed. There was no evidence of current water ingress issues sighted.

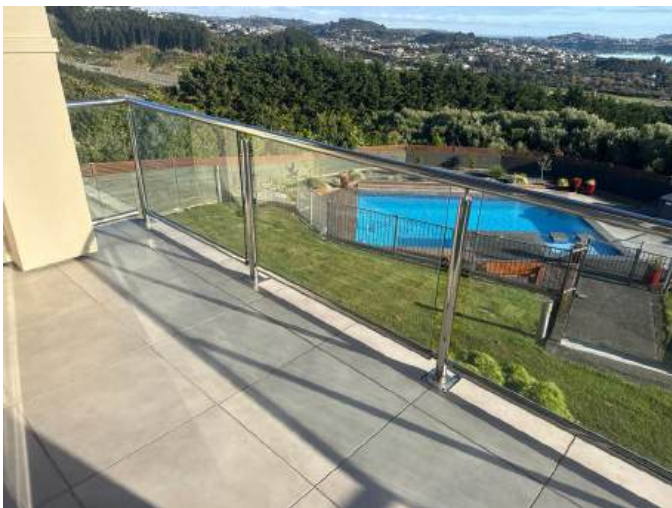
Since 2005, gluing tiles to membrane decks has been prohibited according to page 54 of the E2/AS1 compliance document of the New Zealand Building Code. There is no way of cleaning or inspecting the membrane beneath. If installed now this would require a removable raised surface. There was no evidence of significant deterioration or failure found at the time of the inspection. Ongoing monitoring is required.

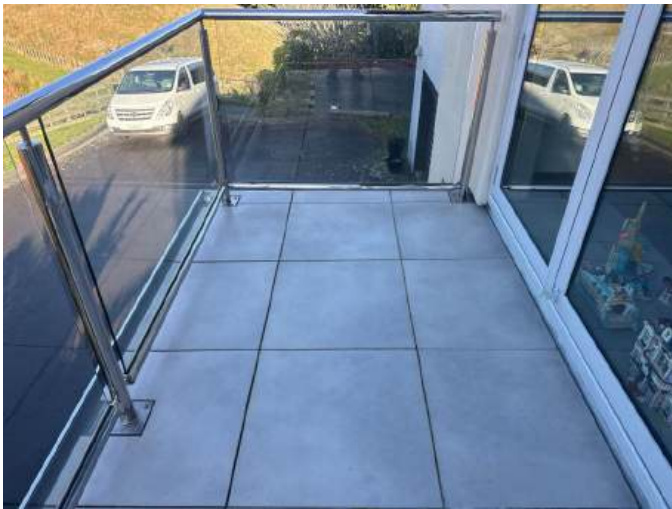
The tiles are in good condition and are directly fixed to the membrane beneath

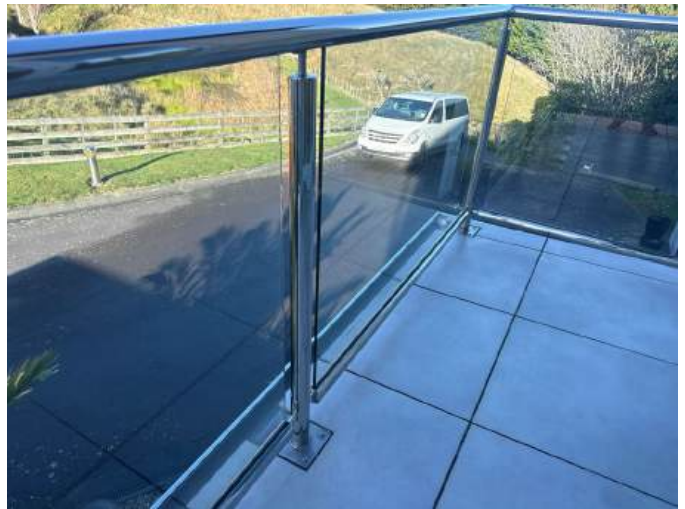
The balustrade is secure

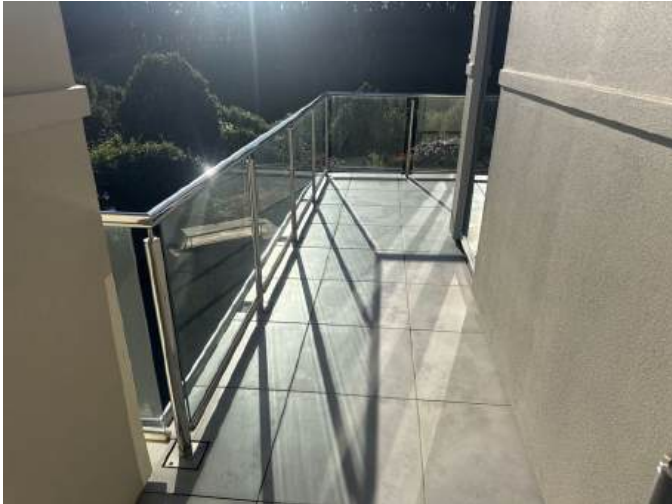
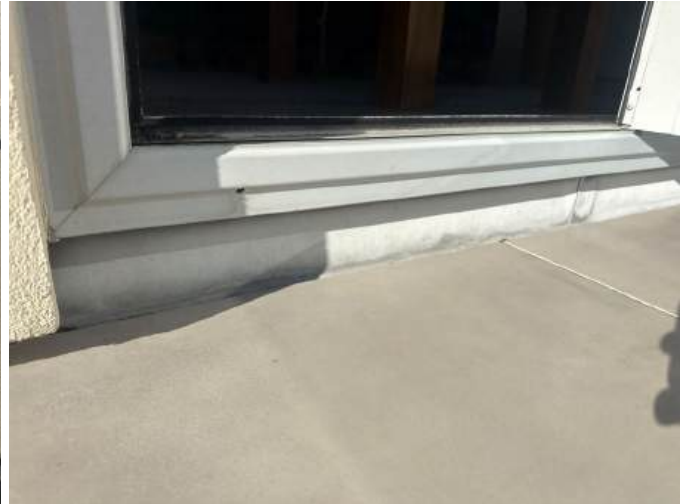
The membrane extends under the joinery and cladding. The lap appears to be effective and no sign of failure could be found internally during moisture testing. Good clearance between the internal floor and the deck surface. Good fall away from the house noted.

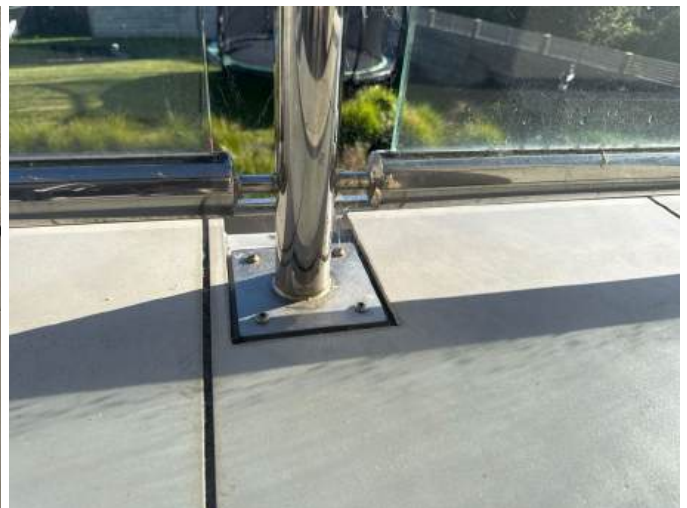
The balustrade is secure

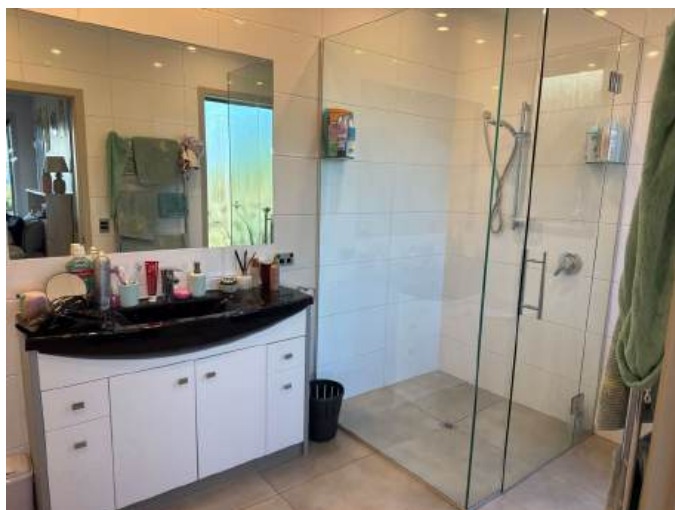
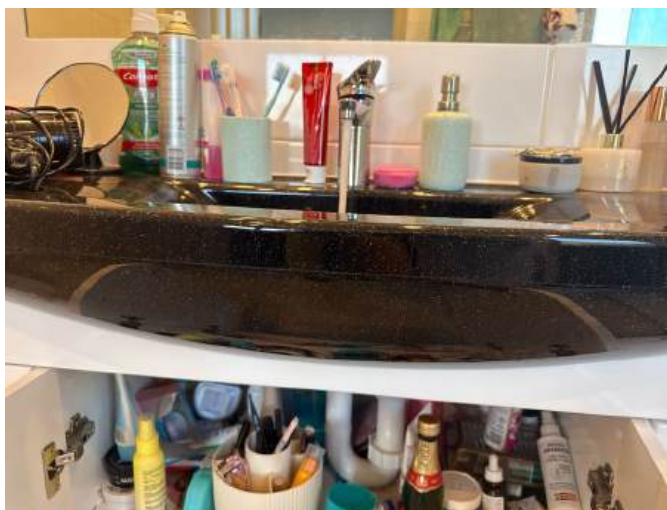
The rear edge of the vanity is well sealed. The tap is functioning well. No concerns with the water feeds or waste under the vanity

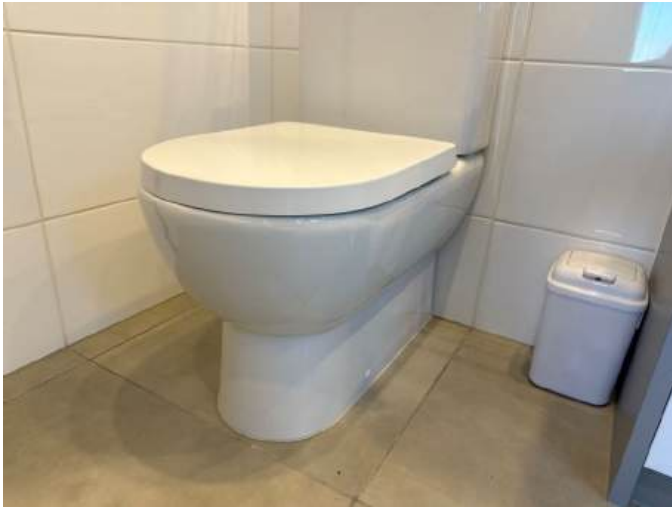
The base of the toilet is well sealed and secure. The toilet is in a functioning condition.

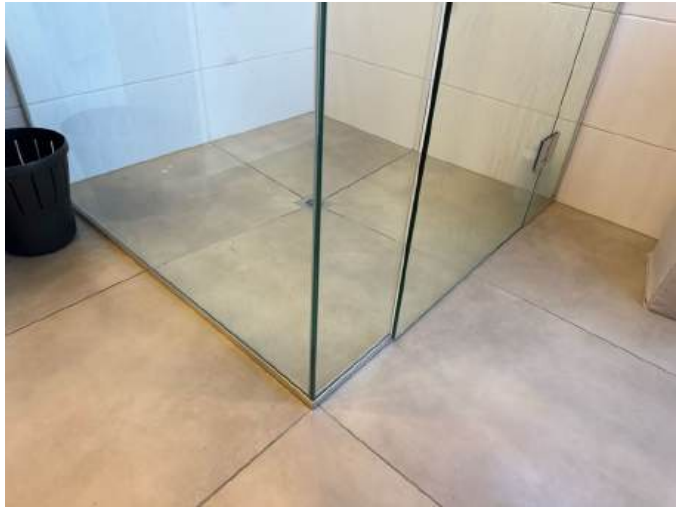
The tiled shower is showing no evidence of deterioration or failure at the time of the inspection. If there are any concerns with the condition of the tiles, sealant or grout in the future, a professional Tiler should be engaged for further assessment.

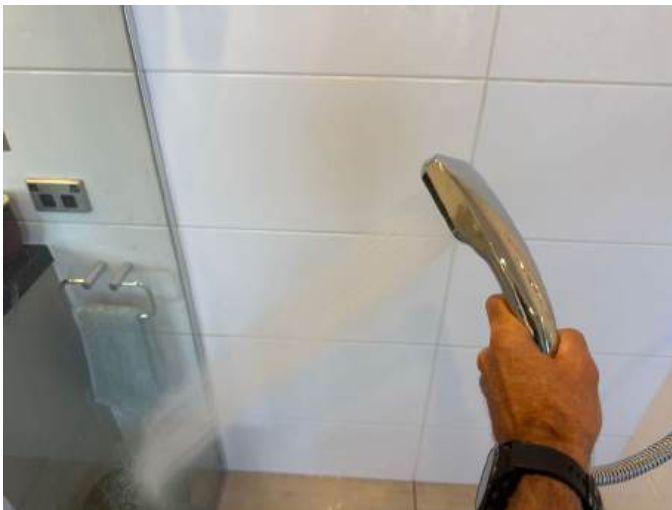
Good water pressure noted. No sign of current leaks from the shower frame during water testing.

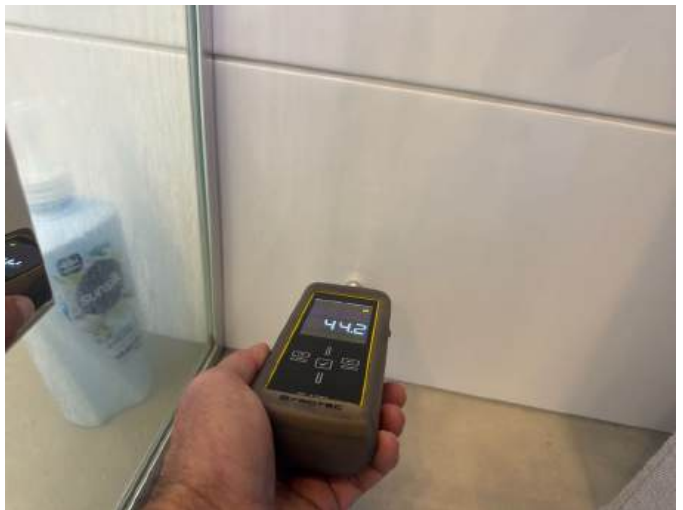
The common fail areas of the shower and plumbed areas were checked for elevated moisture. Moisture levels were within the normal range.

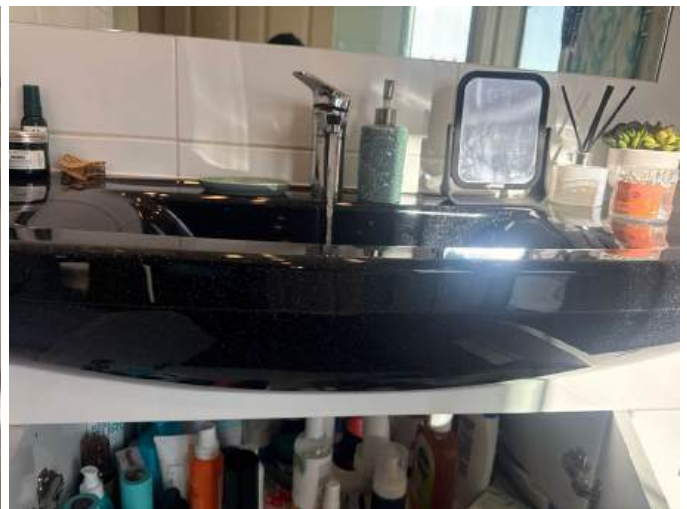
The rear edge of the vanity is well sealed. The tap is functioning well. No concerns with the water feeds or waste under the vanity

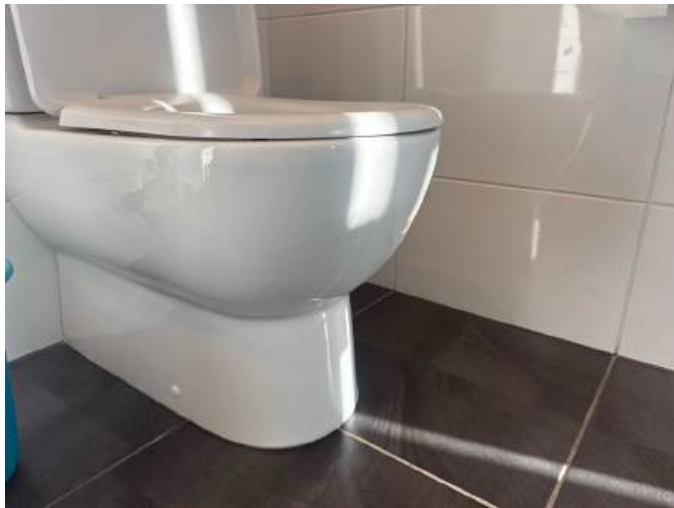
The base of the toilet is well sealed and secure. The toilet is in a functioning condition.

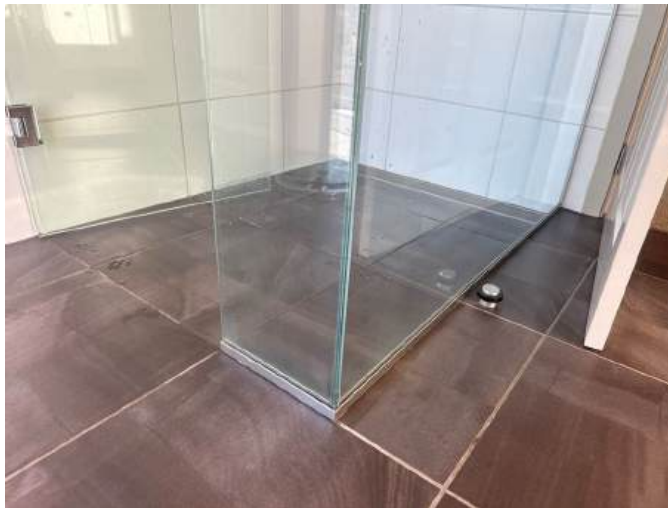
The tiled shower enclosure is in good condition and appears to be well sealed. No evidence of failure could be found.

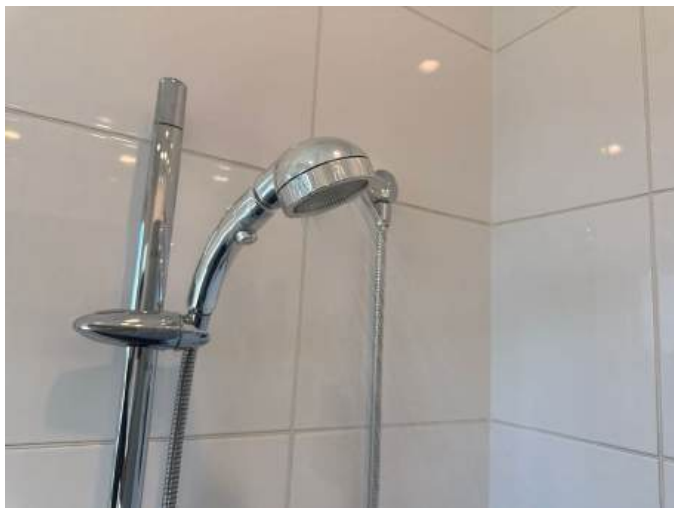
Good water pressure noted. No sign of current leaks from the shower frame during water testing.

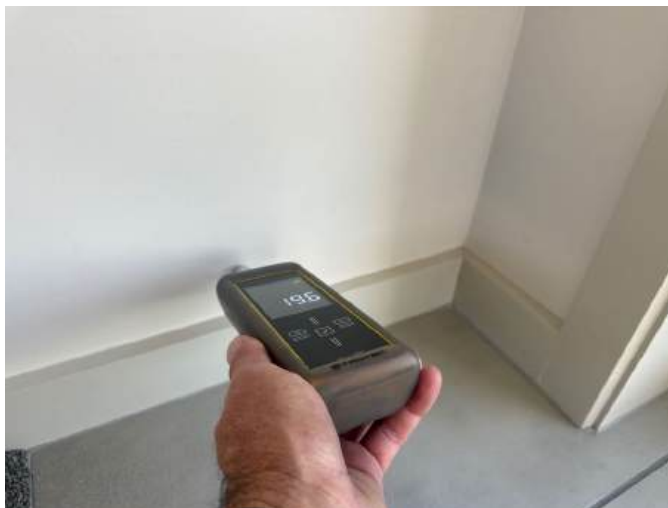
The common fail areas of the shower and plumbed areas were checked for elevated moisture. Moisture levels were within the normal range.

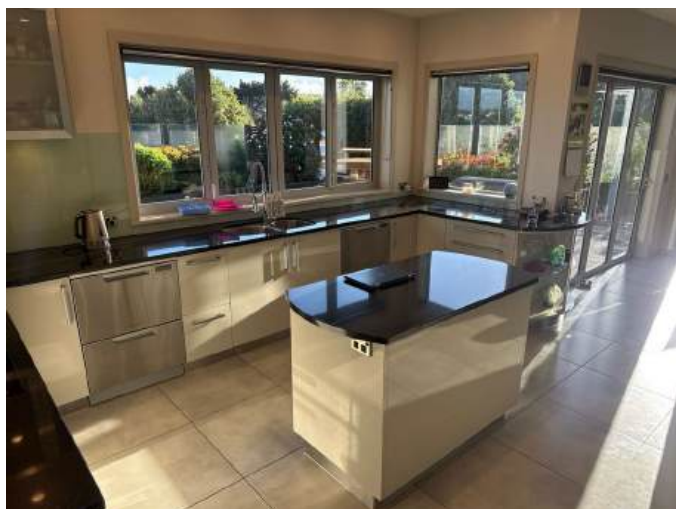
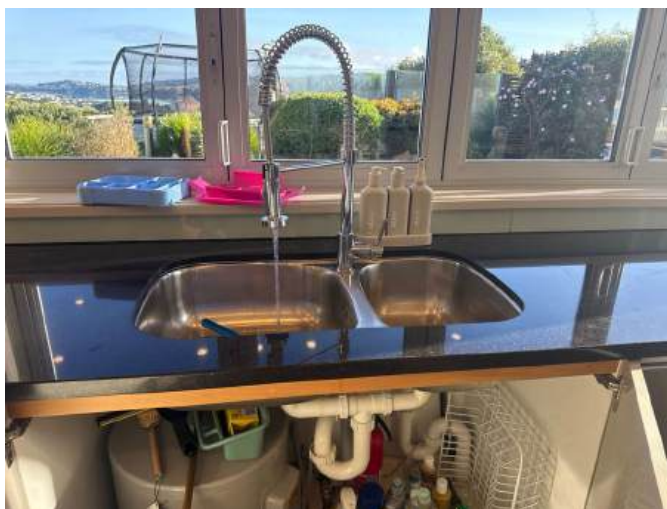
The rear edge of the bench top is well sealed. The tap is functioning well. No concerns with the water feeds or waste pipes under the sink.

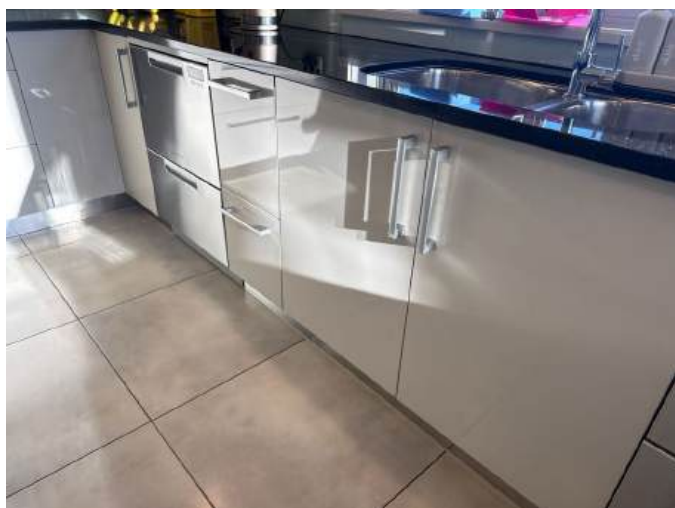
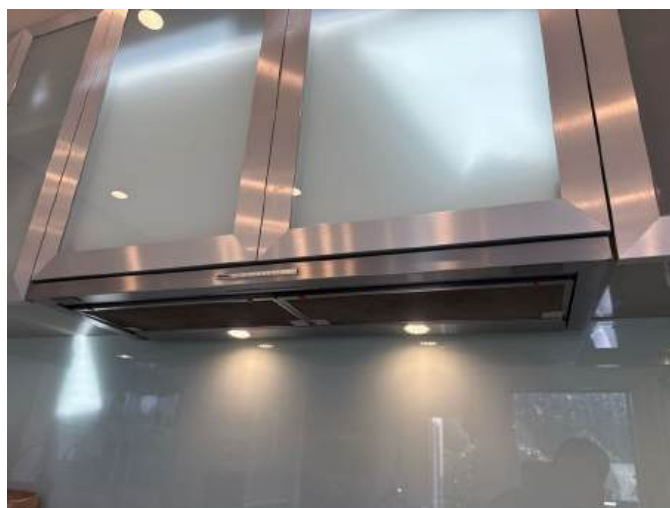
The stone bench tops, kitchen cabinetry and tile floor are in good condition. The range hood extraction unit is functioning.

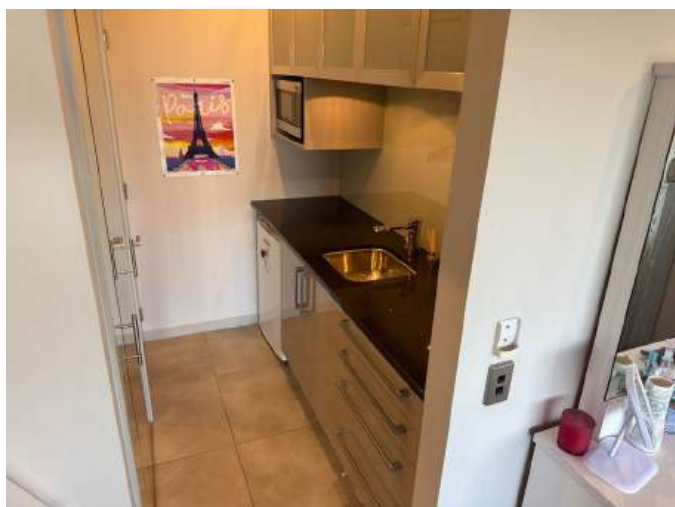
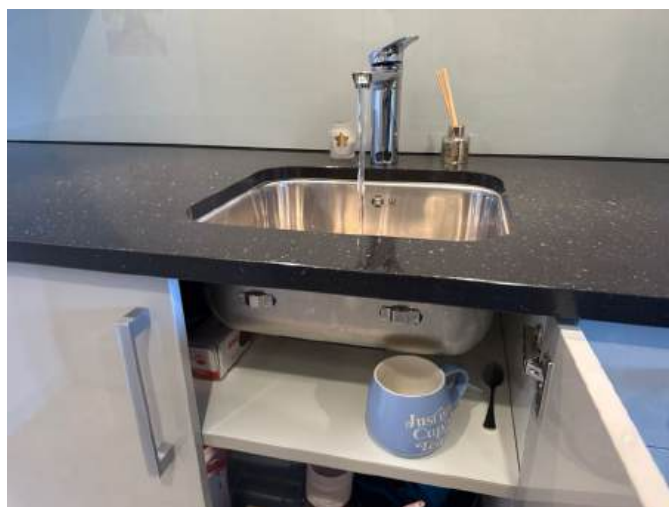
The rear edge of the bench top is well sealed. The tap is functioning. No concerns with the water feeds or waste pipes under the sink.
