# Independent Builders Report

Total Home Inspection Services Porirua City Ltd

Fri 29 May 2026

**75B Paremata Haywards Hill Rd, Pāuatahanui, Porirua,**  
**5381, New Zealand**

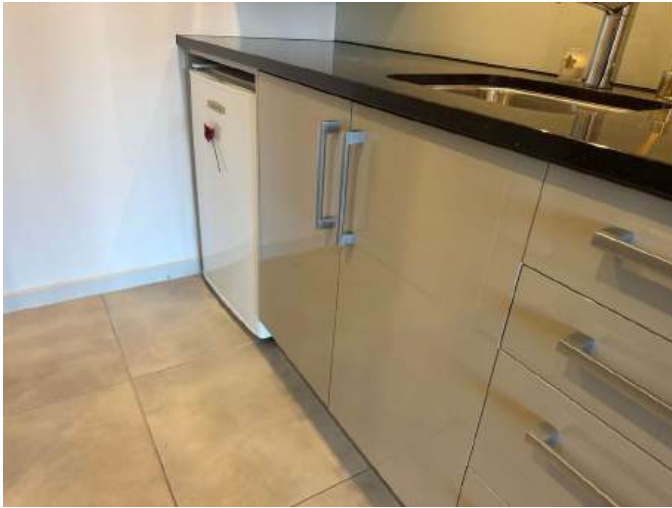
The kitchen cabinetry and tile floor are in good condition

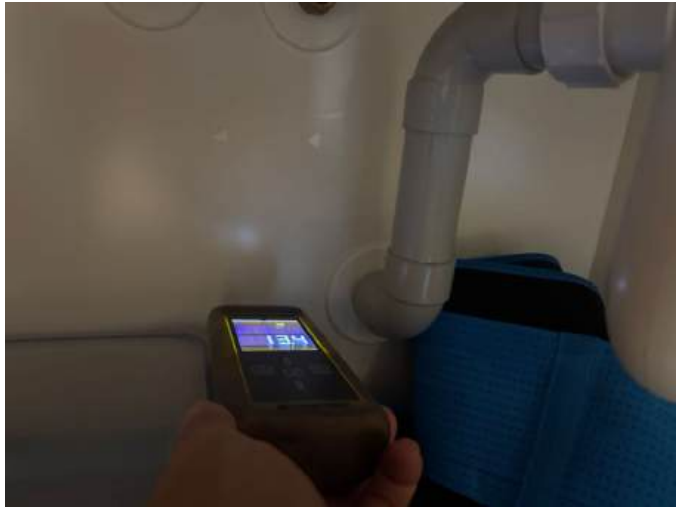
Moisture levels in the kitchen were within the normal range

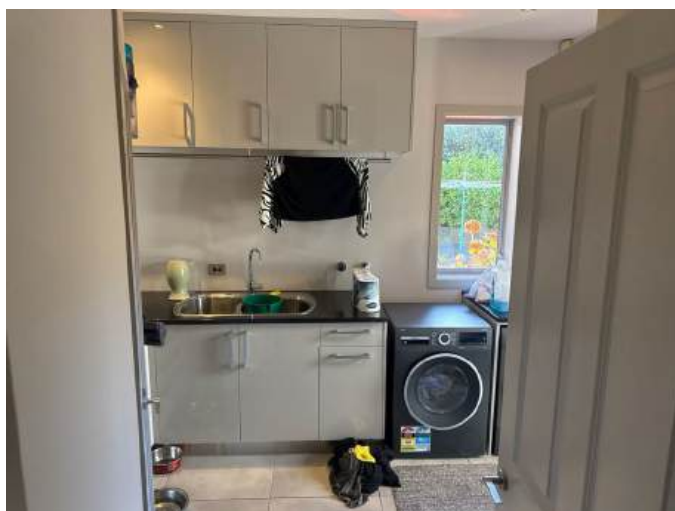
The cabinetry and tile flooring are in good condition

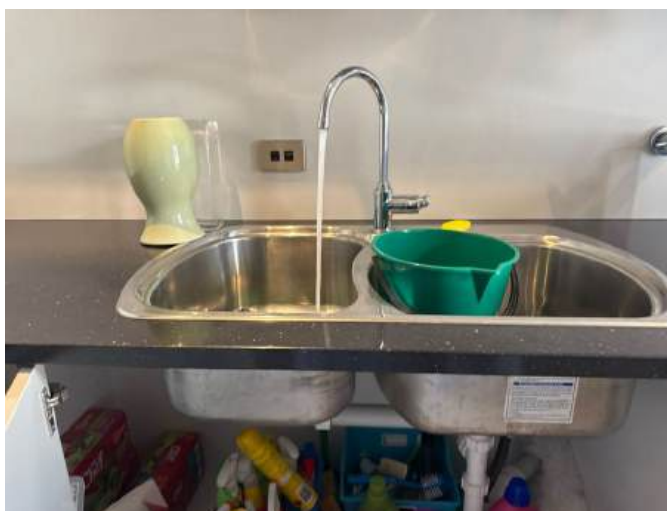
The bench is well sealed. The tap is functioning well.

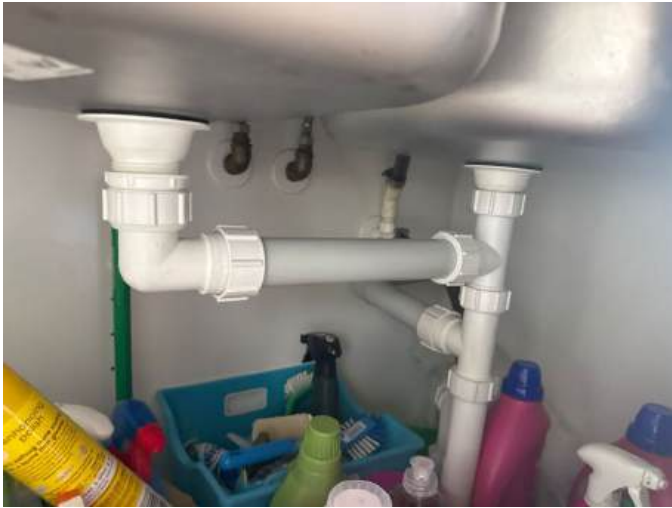
No visible concerns with the water feeds or waste under the tub.

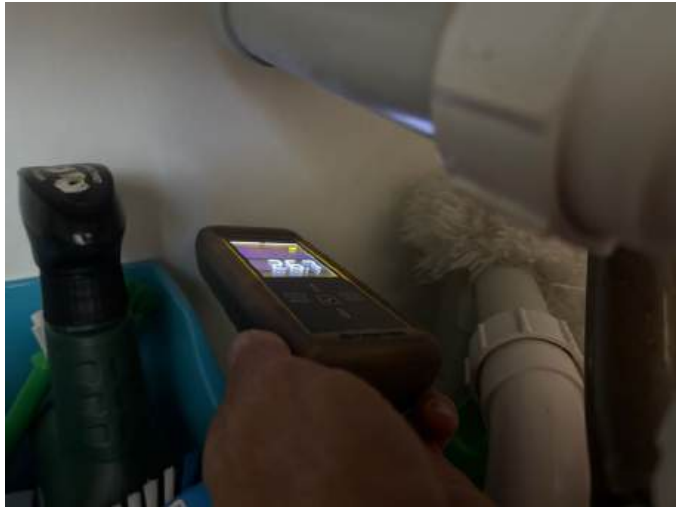
Moisture levels in the laundry were within the normal range at the time of inspection.

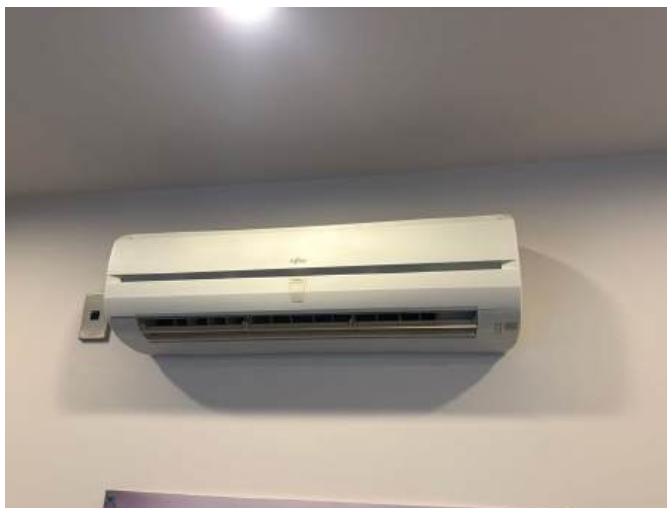
A Heat pump is installed in all bedrooms. Untested. Heat pumps require regular servicing to be efficient. The manufacturers instructions should be checked and understood with regards to future servicing requirements.

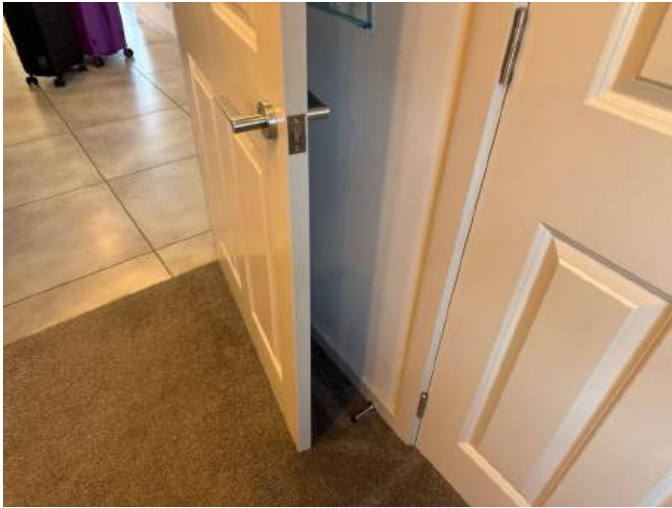
The internal doors are functioning well. Door stops installed behind the doors.

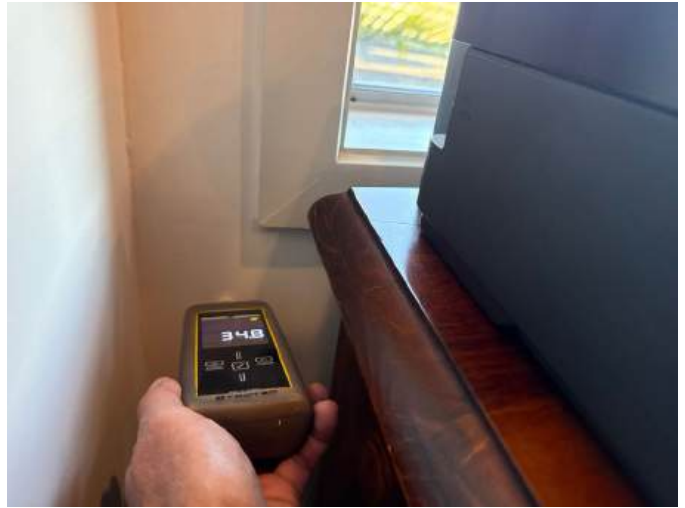
Moisture levels to the external walls scanned within the normal range at the time of inspection

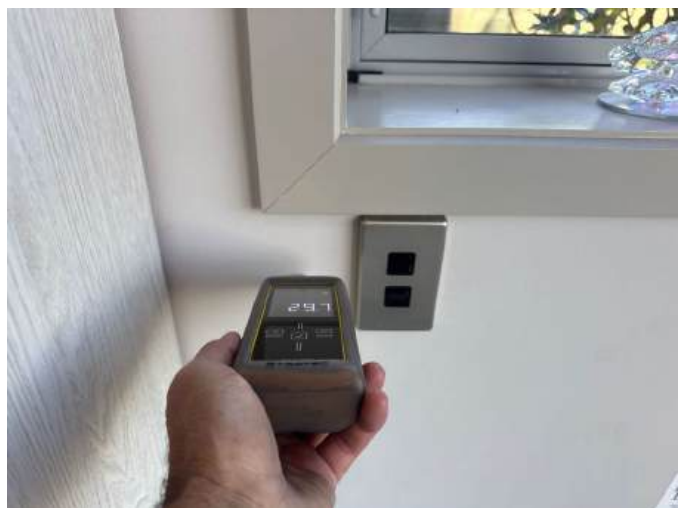
Moisture levels to the external walls were within the normal range at the time of inspection

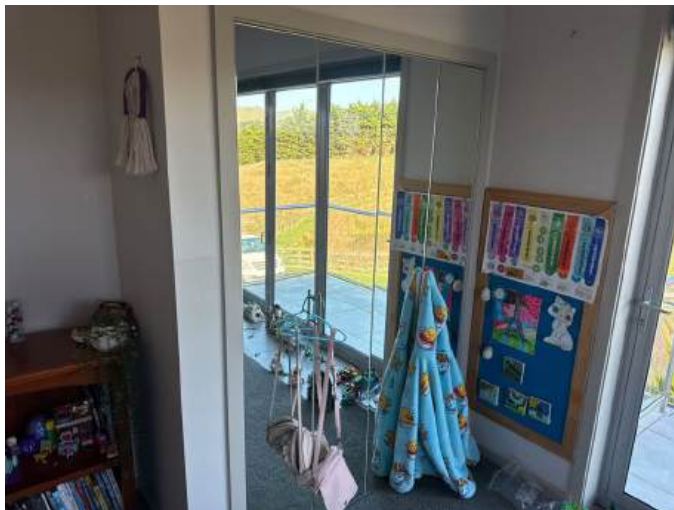
The mirror glass wardrobe is in good condition

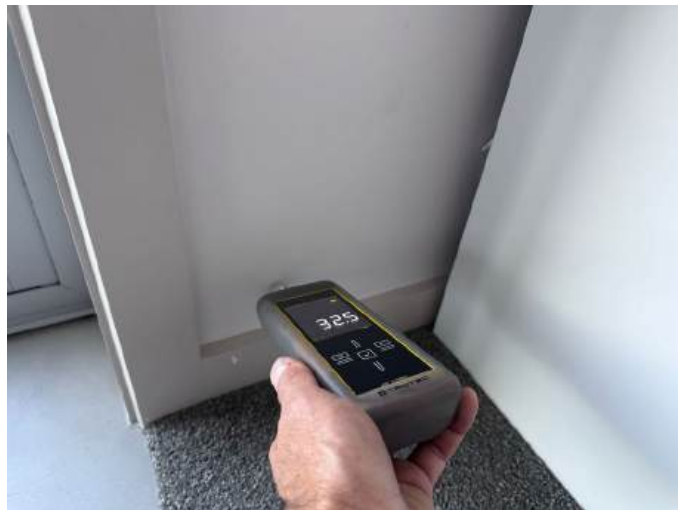
Moisture levels to the external walls were within the normal range at the time of inspection

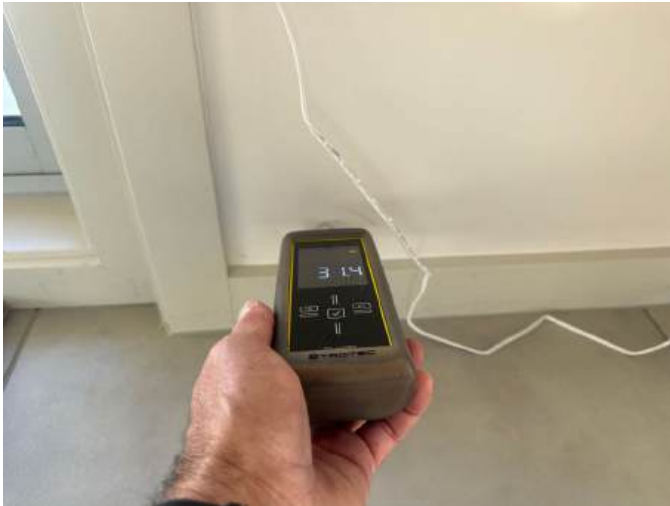
Moisture levels to the external walls were within the normal range at the time of inspection

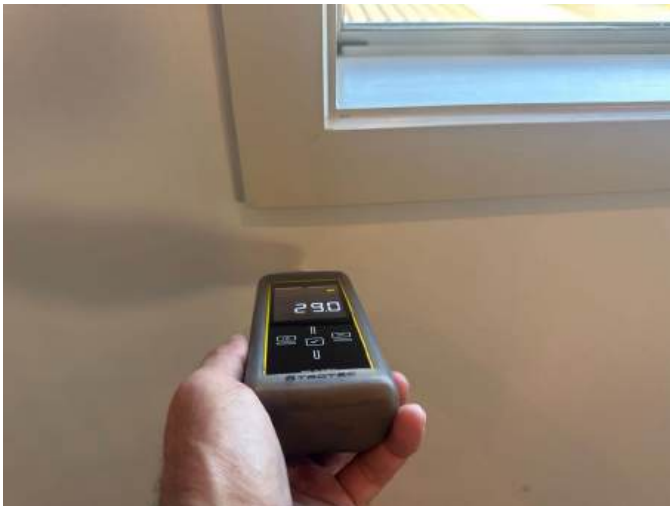
Moisture levels to the external walls were within the normal range at the time of inspection

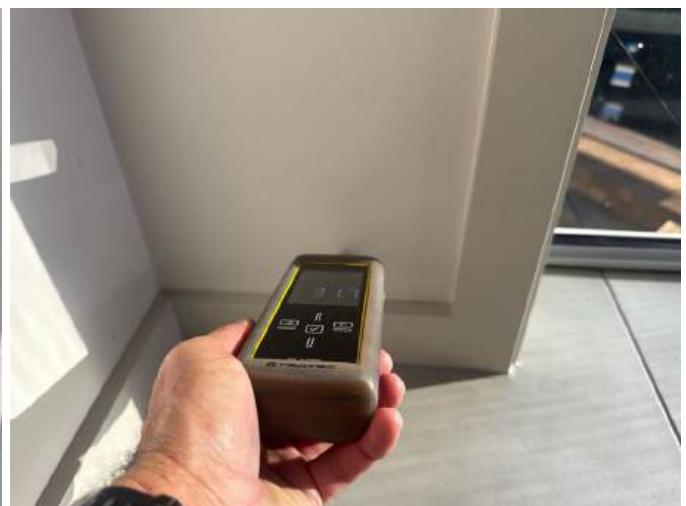
Moisture levels to the external walls were within the normal range at the time of inspection

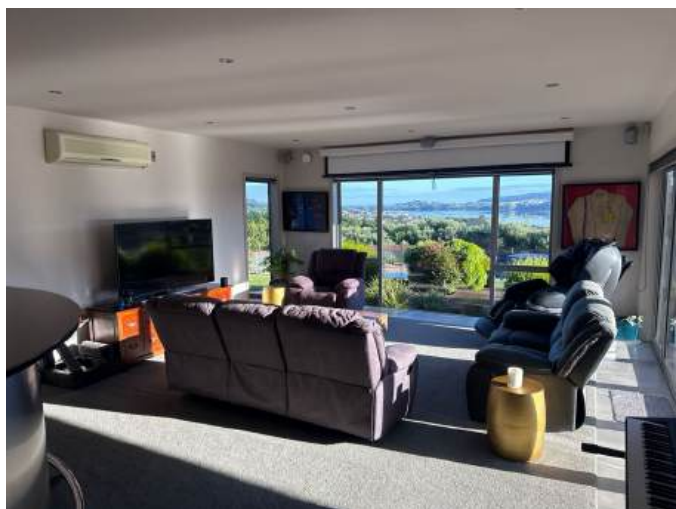
Heatpump installed. Untested.

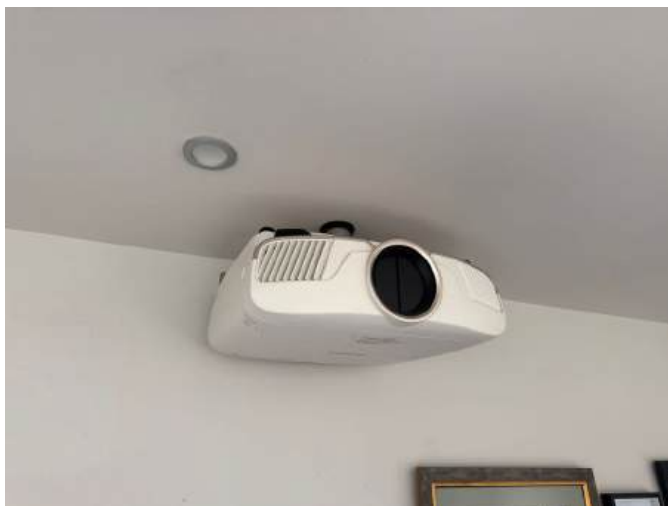
The projector and speakers were not tested

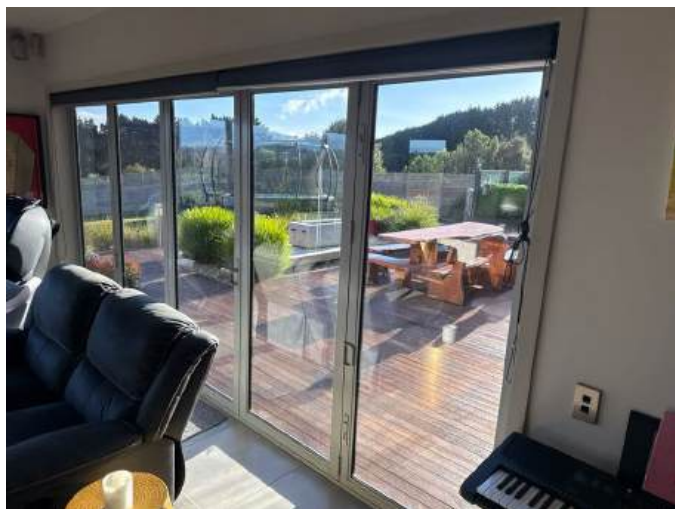
The external doors and windows are functioning well

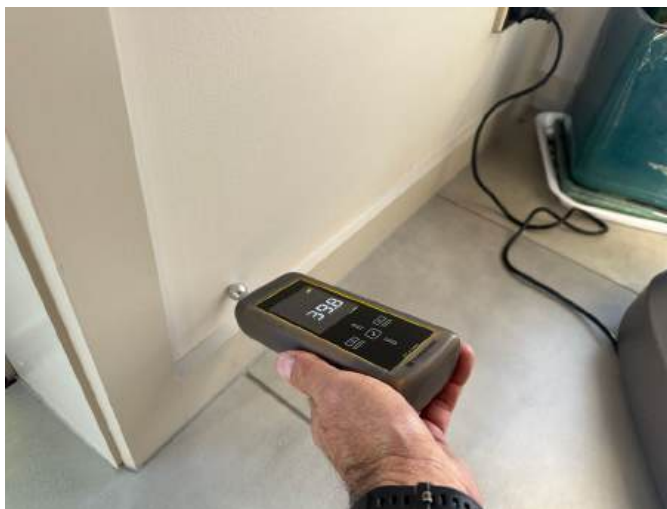
Moisture levels to the external walls were within the normal range at the time of inspection

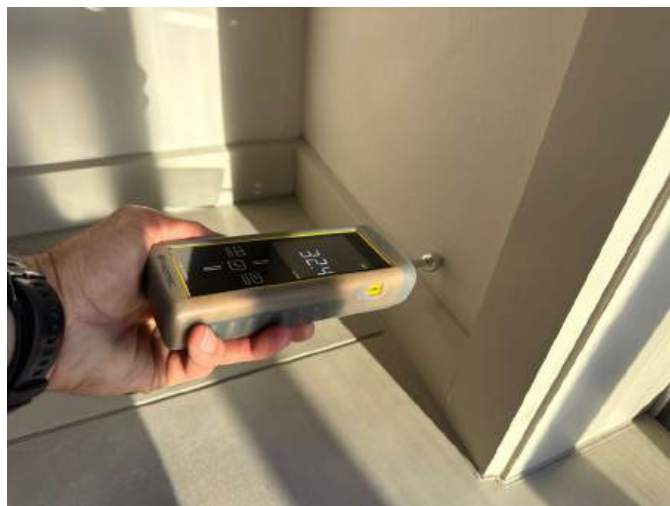
Moisture levels to the external walls were within the normal range at the time of inspection

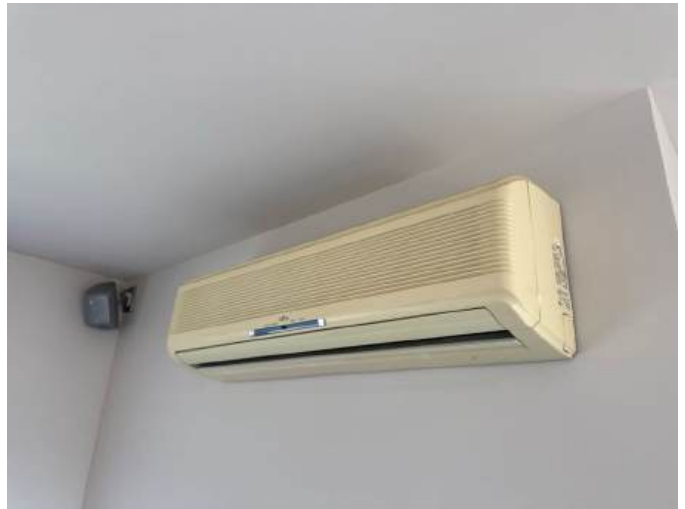
The speakers and heatpump were not tested

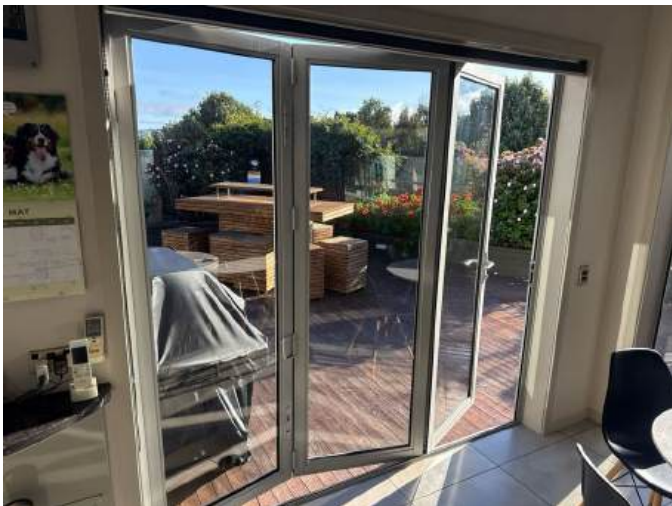
The external doors and windows are functioning

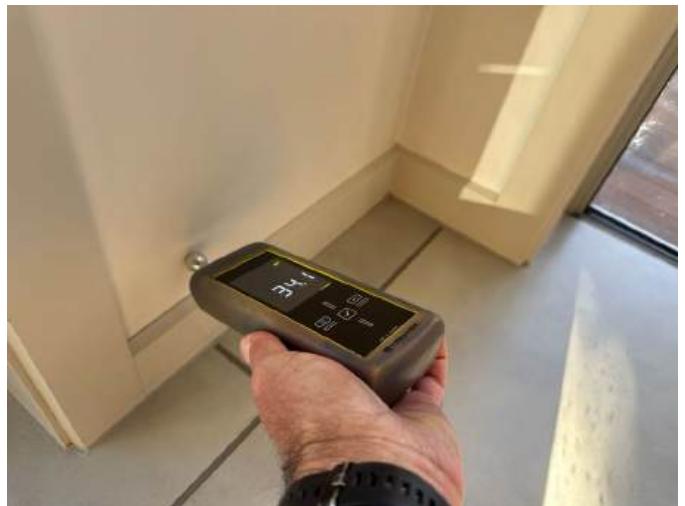
Moisture levels to the external walls scanned within the normal range at the time of inspection

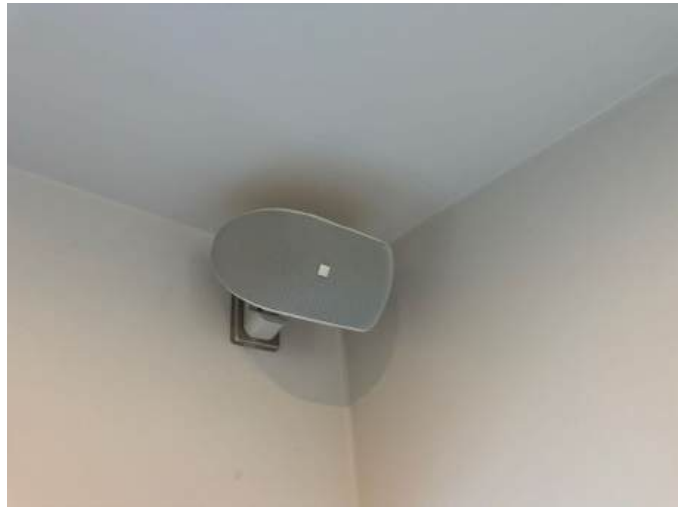
The integrated speaker system was not checked as part of the inspection process

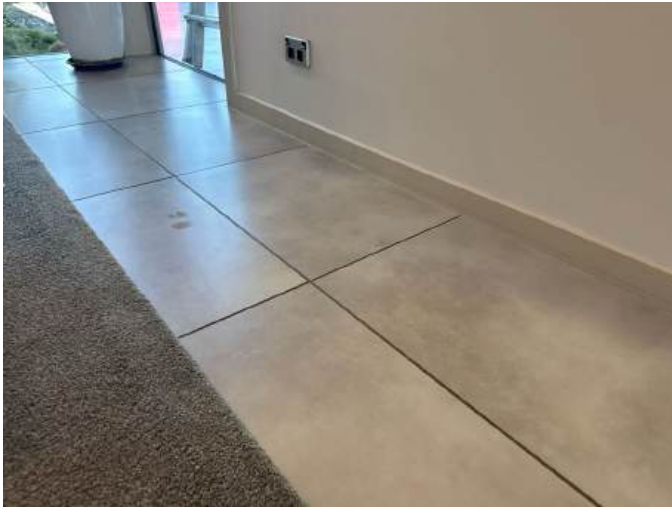
The tiles are in good condition. The condition of the tiles under the rug will need to be determined once removed.

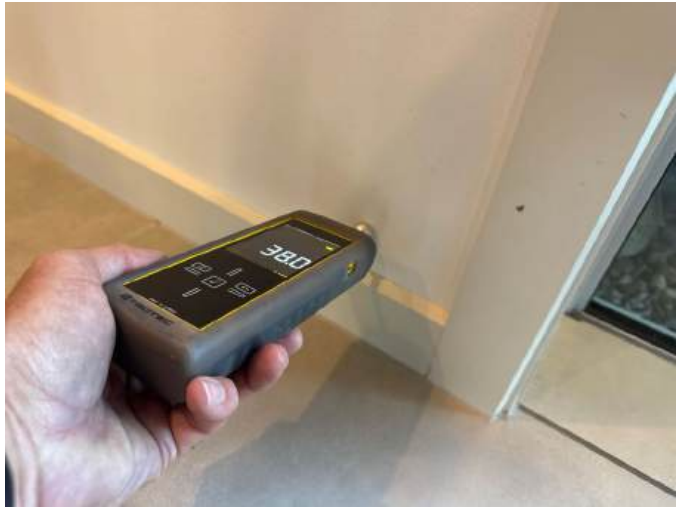
Moisture levels to the external walls were within the normal range at the time of inspection

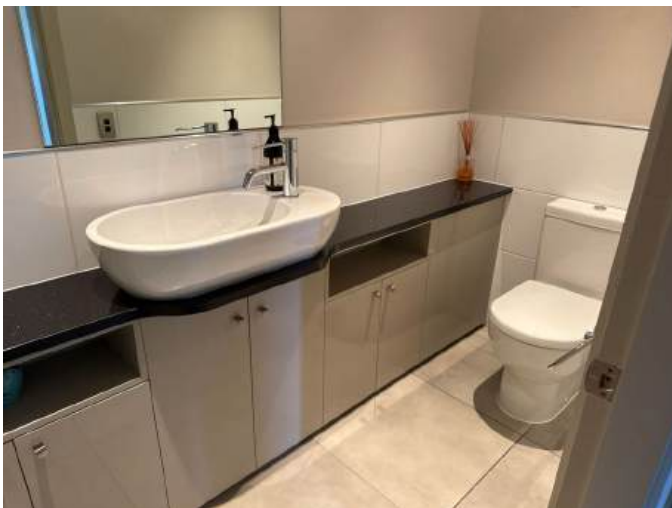
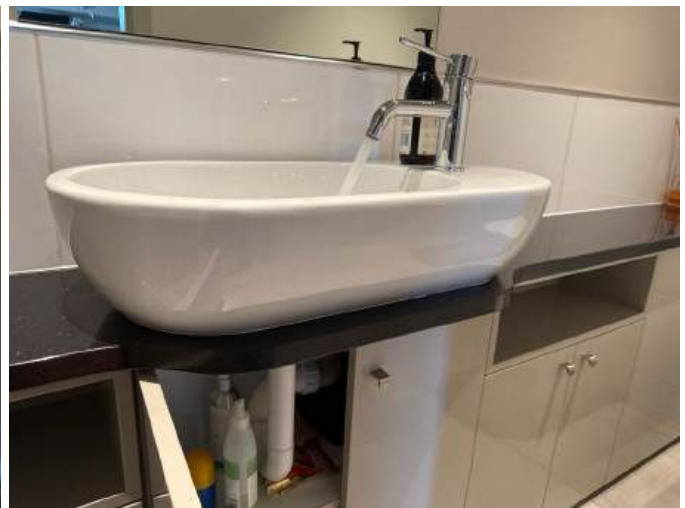
The sink is well sealed to the wall. The tap is functioning well. No visible concerns with the water feeds or waste beneath the sink.

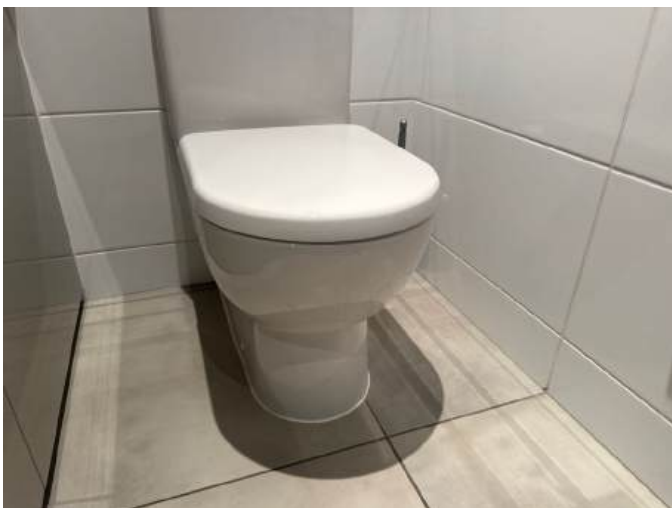
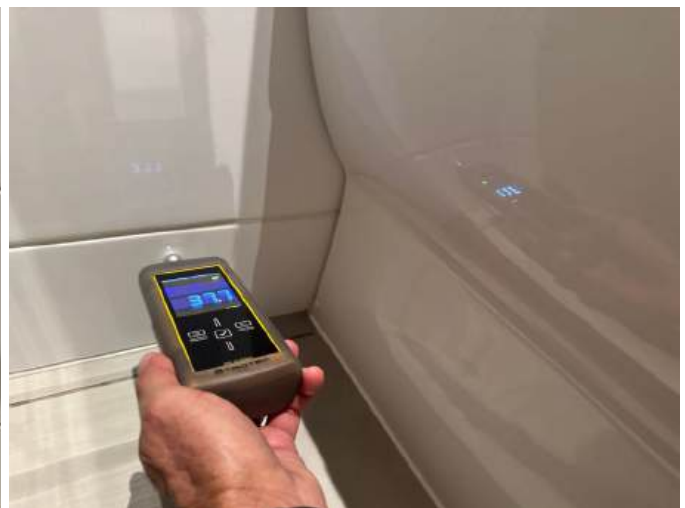
The base of the toilet is well sealed and is secure. The toilet is in a functioning condition.

Moisture levels behind the toilet were within the normal range at the time of inspection

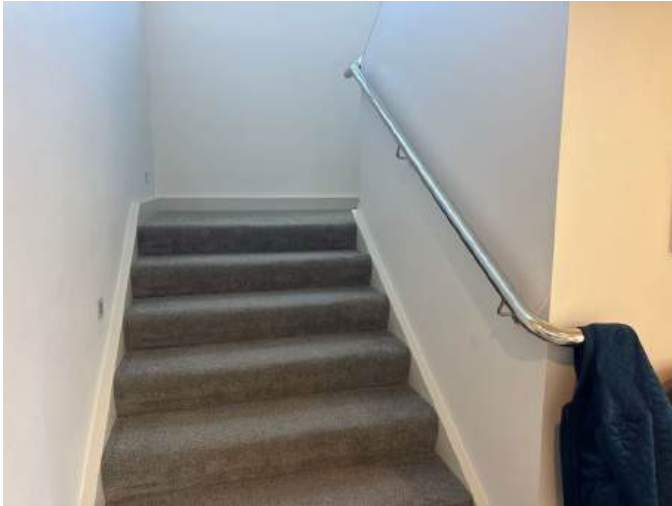
The timber stairs and stainless steel balustrade are solid and secure

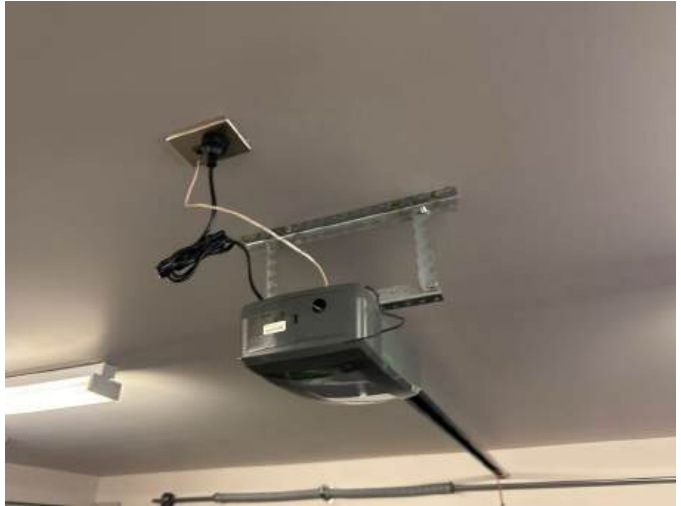
The electric garage doors are functioning

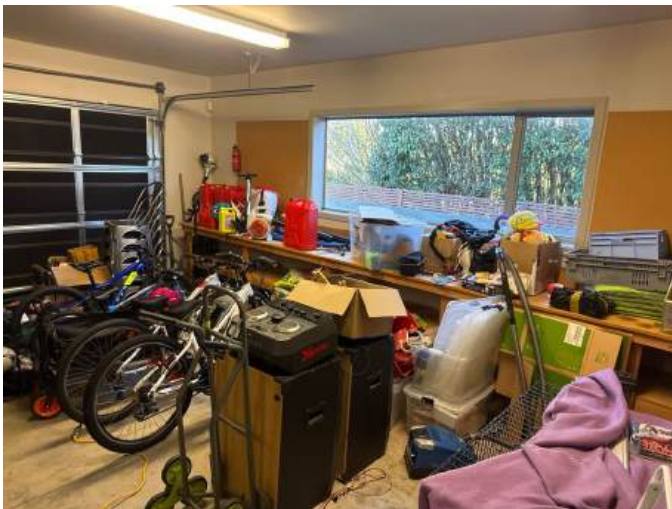
Example. Not all areas of the garages could be fully inspected due to the presence of stored items. A full inspection is recommended once cleared. This applies to all concealed locations throughout the house.

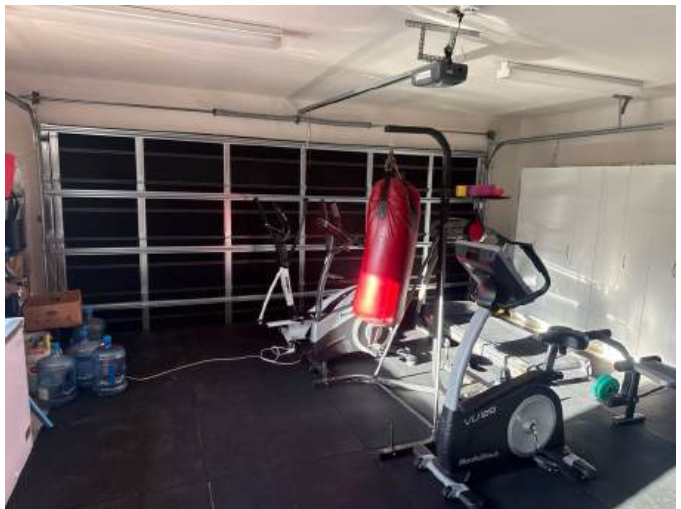
No obvious concerns sighted inside garage #2

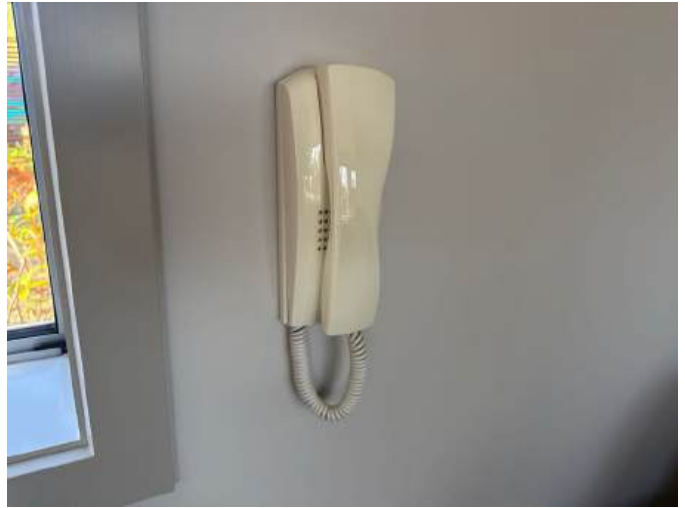
There are phones for the intercom system located at various locations

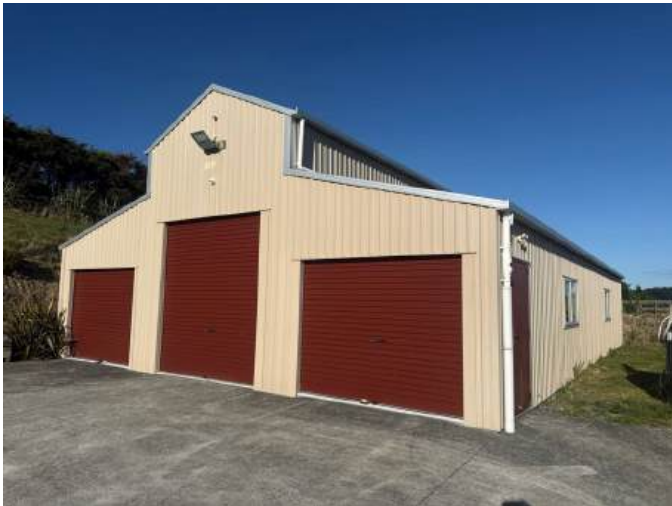
The surface condition of the garage doors is good

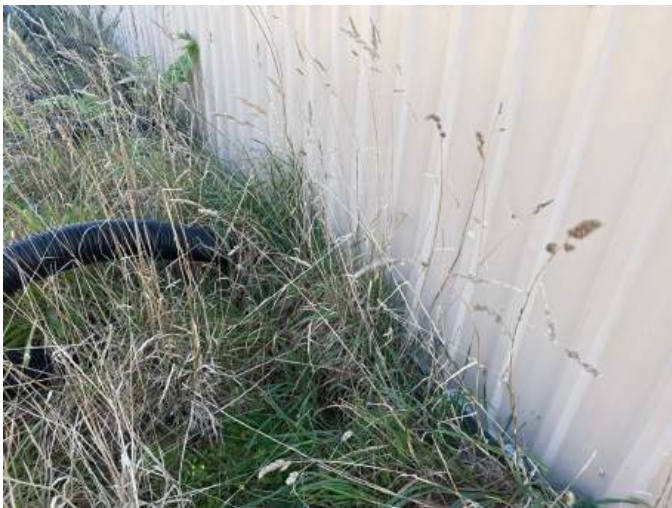
Vegetation should be removed and kept clear of the cladding as this will cause premature deterioration to the cladding over time. No current deterioration sighted.

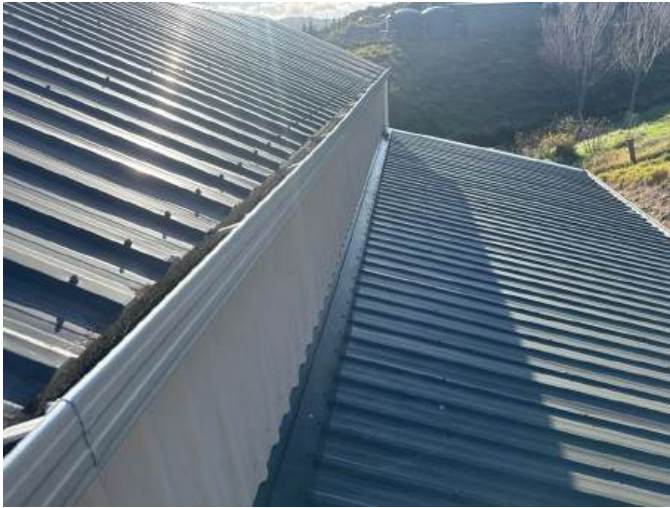
The lightweight metal trapezoidal roof is in good condition. Check the spouting regularly to prevent blockages.

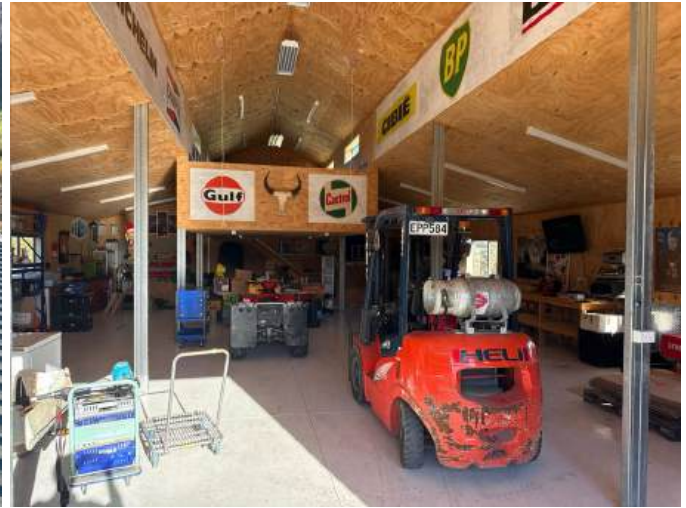
No visible concerns with the garage structure. The owner disclosed that the exterior walls are insulated.

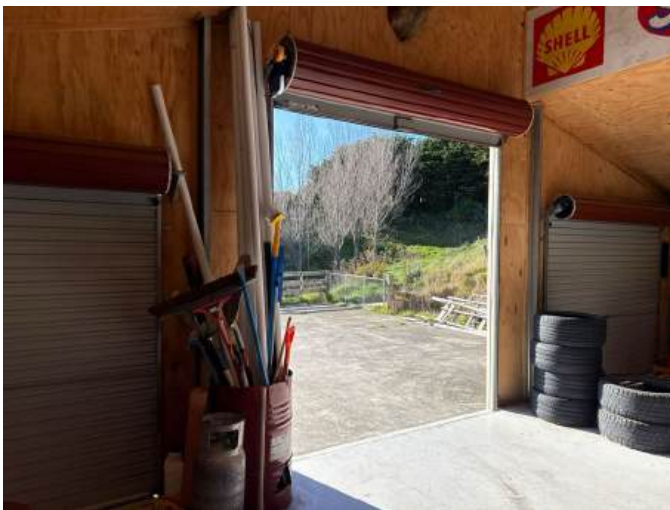
The main door is motorised and functional. The roller doors either side are manually operated and are functional.

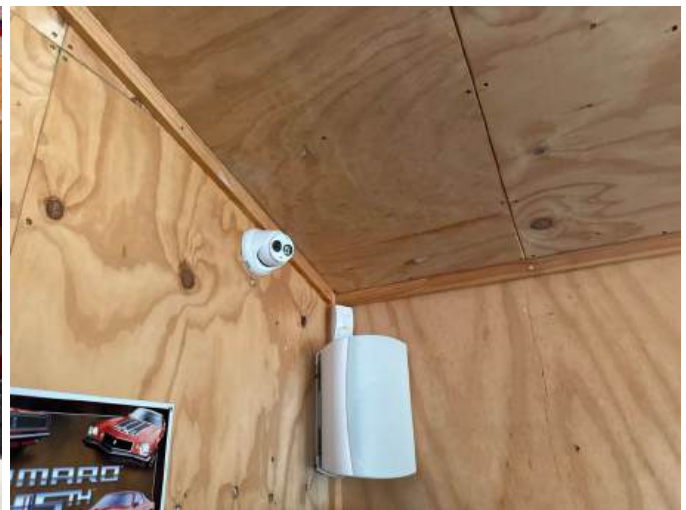
Security cameras installed around the outside and inside the garage

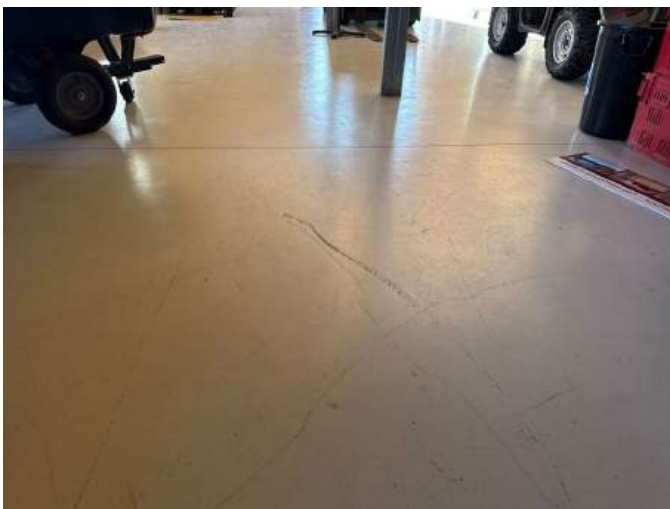
The concrete garage slab is in good condition

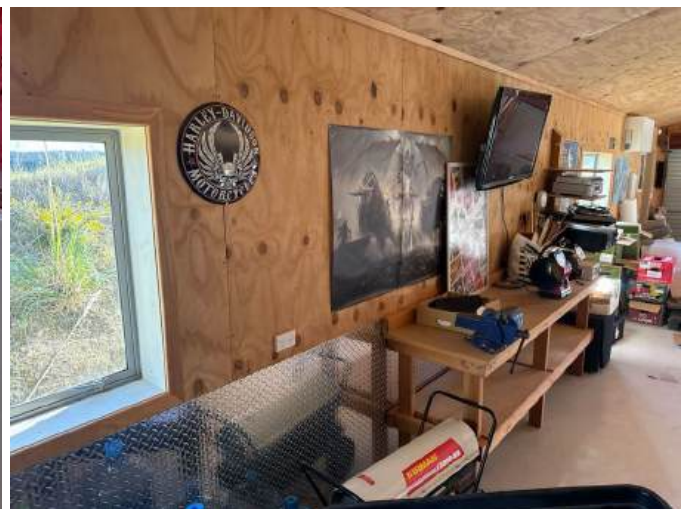
Internal plywood and metal sheet linings are in good condition

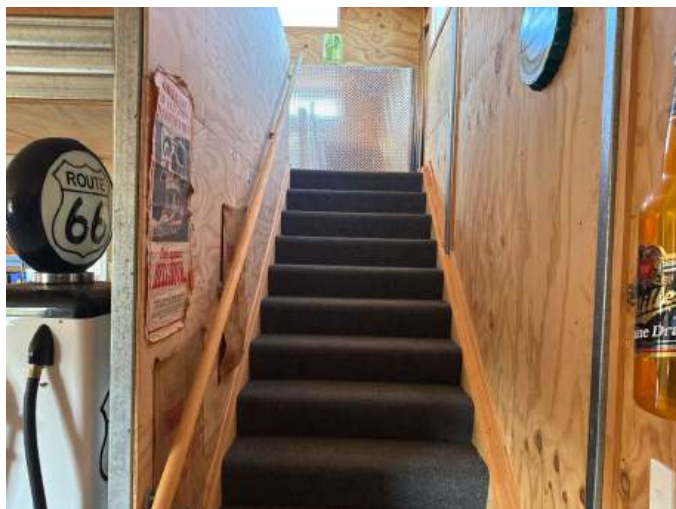
The timber stairs and handrail are solid and secure
