# Independent Builders Report

Total Home Inspection Services Porirua City Ltd

Thu 16 Jul 2026

**22 Pinewood Gr, Paraparaumu Beach, Paraparaumu,  
5032, New Zealand**

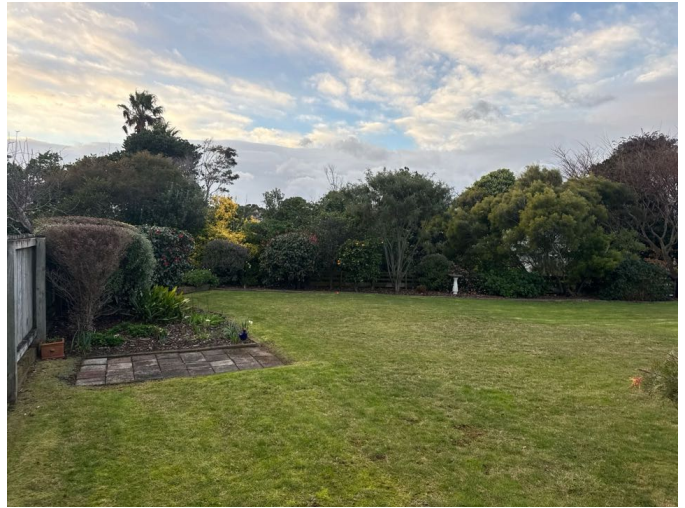
The section is very tidy

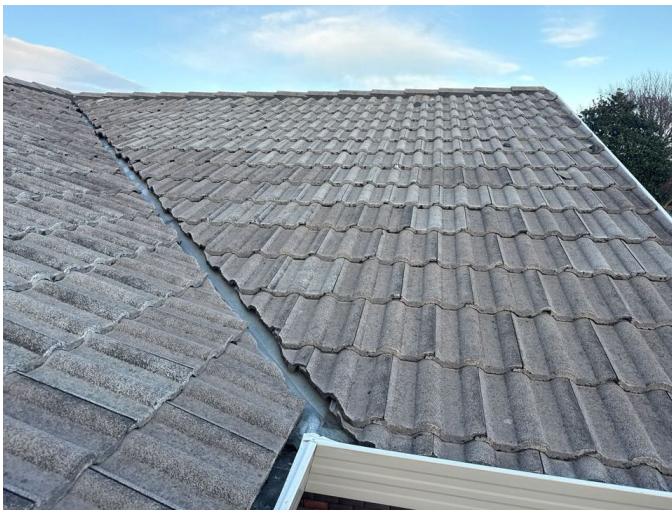
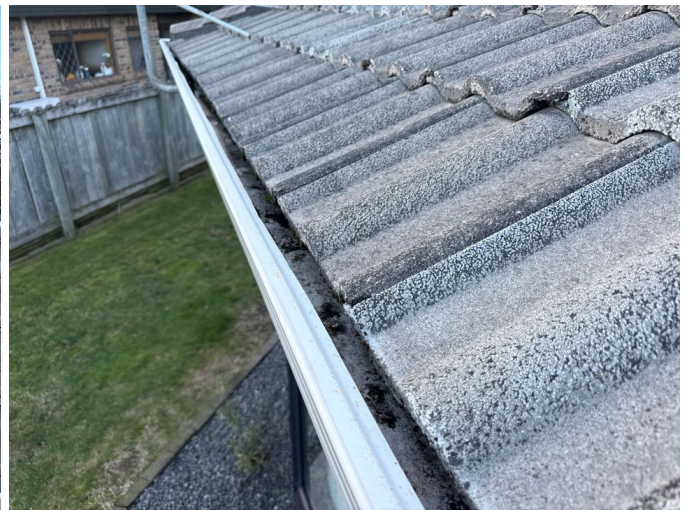
The internal (UPVC) gutter was clear at the time of the inspection.

The effectiveness of the gutter system will need to be checked during rainy periods. Due to the dry conditions that were evident on the day of our inspection we cannot comment on any leaks that maybe evident to the gutters or down pipes.

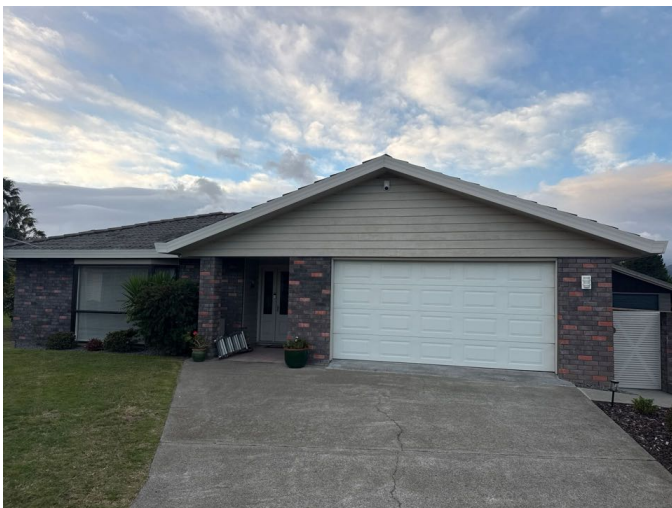
The front faces to the Northwest

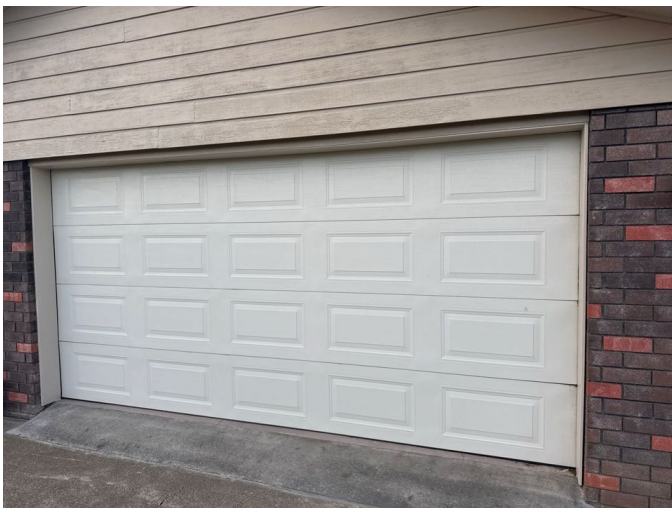
The surface condition of the garage door is good

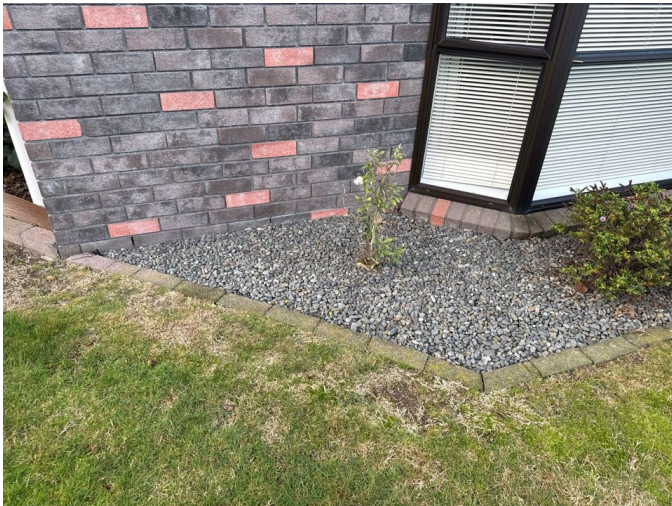
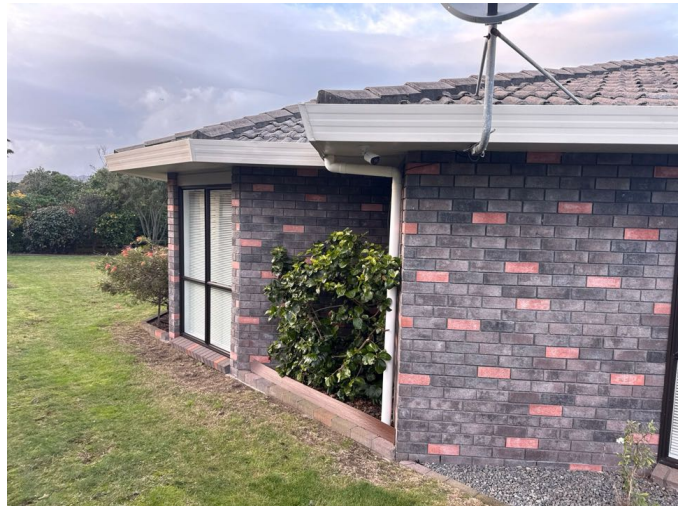
At the time of the inspection all non invasive moisture North/Northeast side tests completed to the bottom plate at these locations presented within the acceptable range.

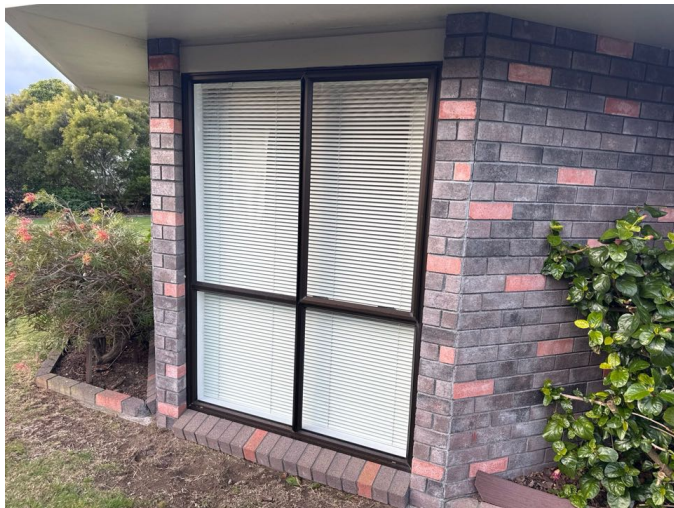
The typical double glazed aluminium window (brick detail) is recessed into the brick cladding with an overlapped weatherboard acting as a head flashing and brick sill.

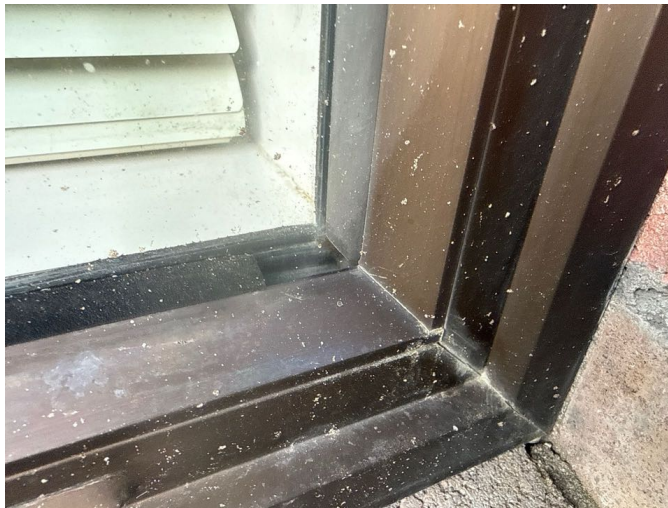
Some of the joinery seals have shrunk which is common for their age. The shrinking seals should not be a water tightness risk as long as the internal seal remains intact and effective. All internal moisture readings taken beneath the windows and doors were within the normal range.

The shrinking window seals should be checked by an aluminium joinery maintenance company and replaced if necessary.

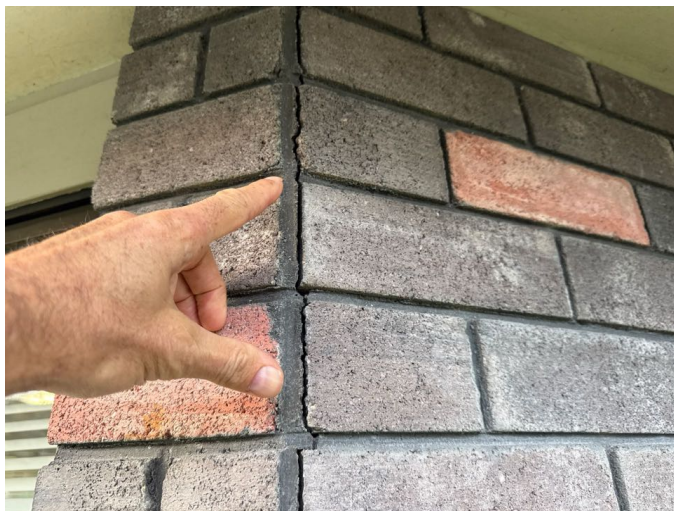
It is common for hairline cracks to develop over time which are generally superficial and non structural. Repointing of grout lines is required from time to time and is considered an expected part of ongoing maintenance.

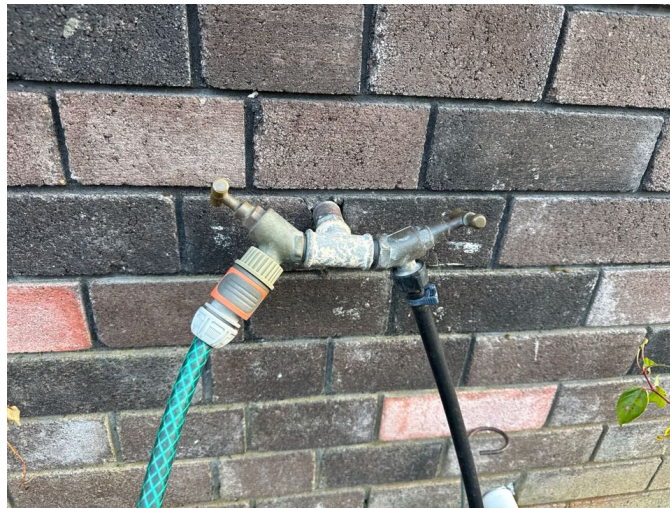
Cladding penetrations in general are a weather tightness risk area. Penetrations such as taps, screw fixings, gas or water pipes etc. A good seal must be maintained around all cladding penetrations over time to prevent issues.

No evidence of failure could be found.

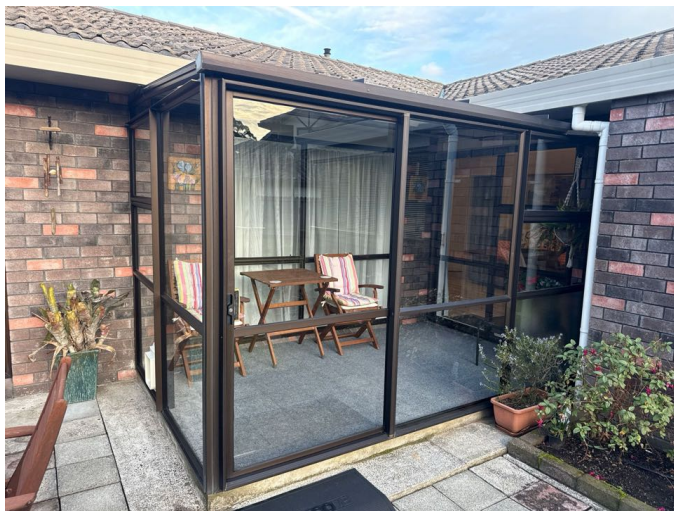
The small conservatory has a tidy overall appearance. Cat door installed.

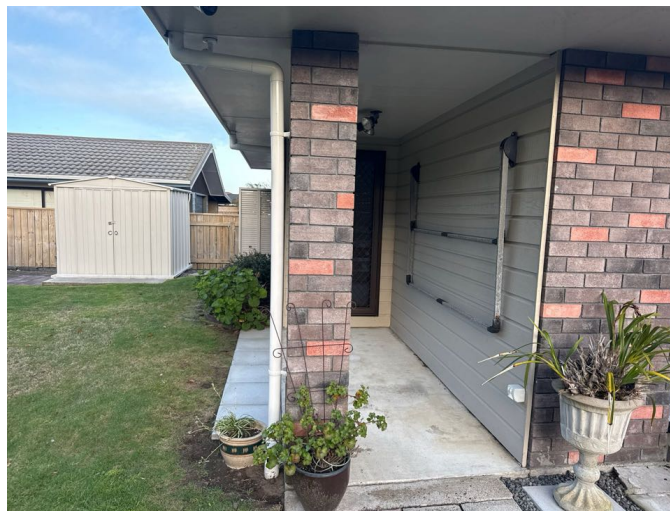
The brick columns are secure

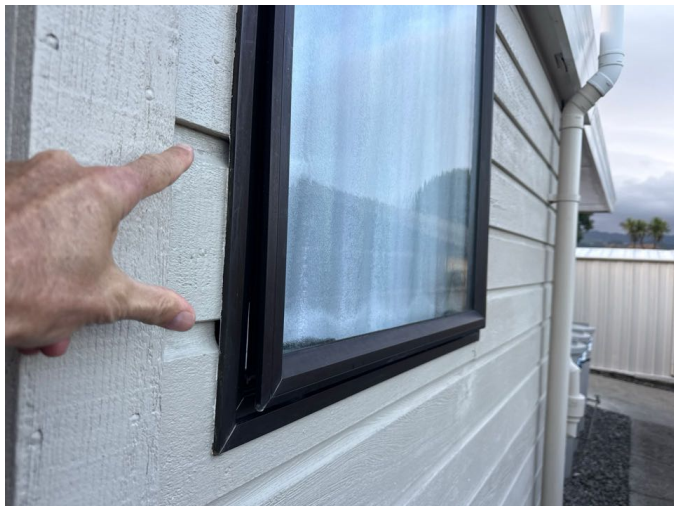
Rustic plugs are a timber plug that is used to seal the ends of this profile of weatherboard. They are a necessary water proofing component and must be replaced if they are missing to prevent water entering into the framing.

The rustic plugs should be replaced where missing, to prevent the risk of moisture ingress and potential damage.

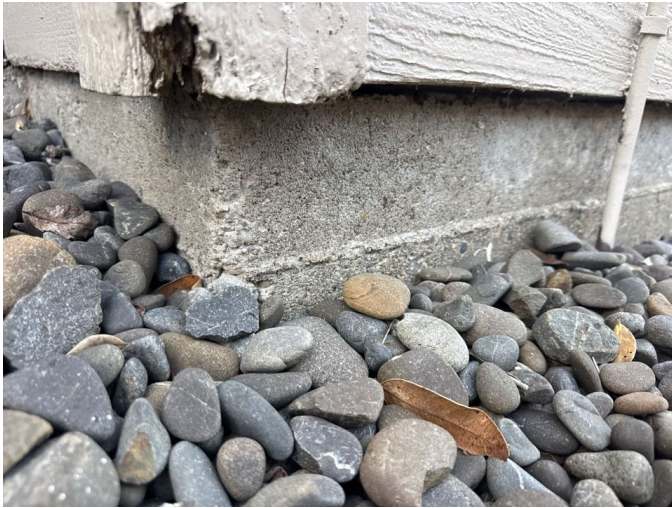
There is limited space to sight the concrete foundation but where visible it appears to be solid. No damage or deterioration could be found at the time of inspection.

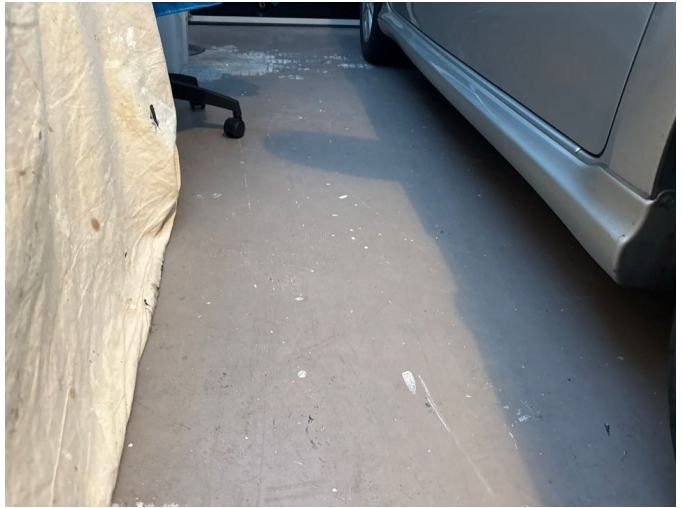
The painted garage floor was showing no evidence of damage

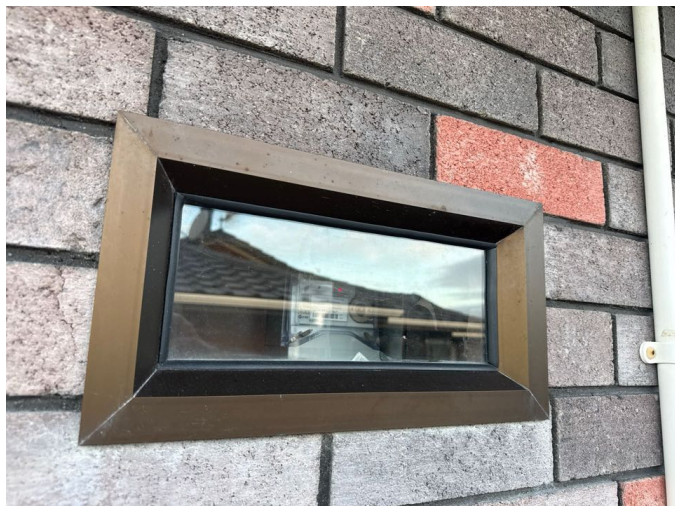
The meter board appears to be sufficiently sealed at the time of inspection. Smart meter installed, no obvious concerns sighted.

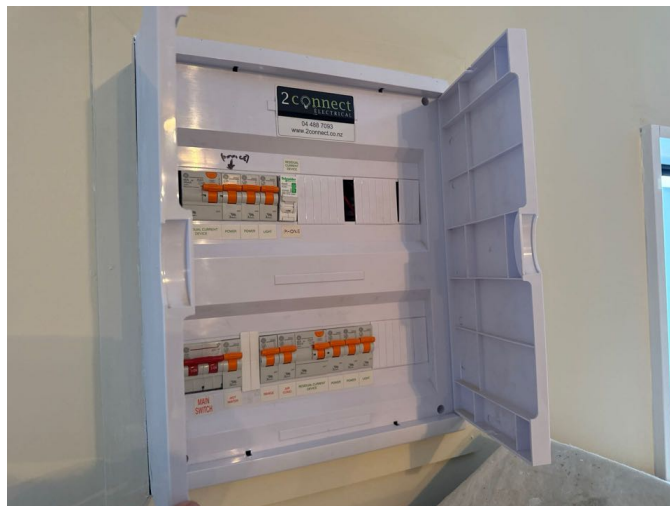
A visual inspection of the electrical system did not show any evidence of electrical overload to switches or power points. Cover plate(s) were not removed and the wiring behind the distribution board not inspected. This is beyond our scope of expertise. Please note. The assessor is not a registered electrician; no electrical safety tests or electrical component tests were undertaken. Power points, lights and switch testing therefore does not form part of this report.

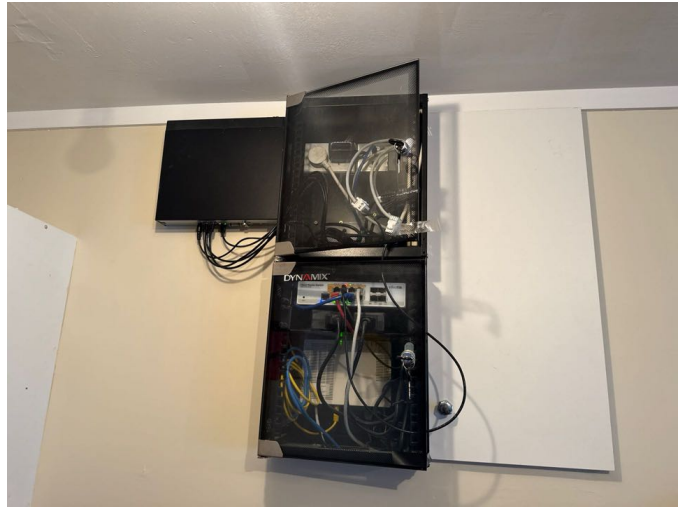
The optical network terminal and wiring for the internet is located in the garage (outside the scope of this inspection)

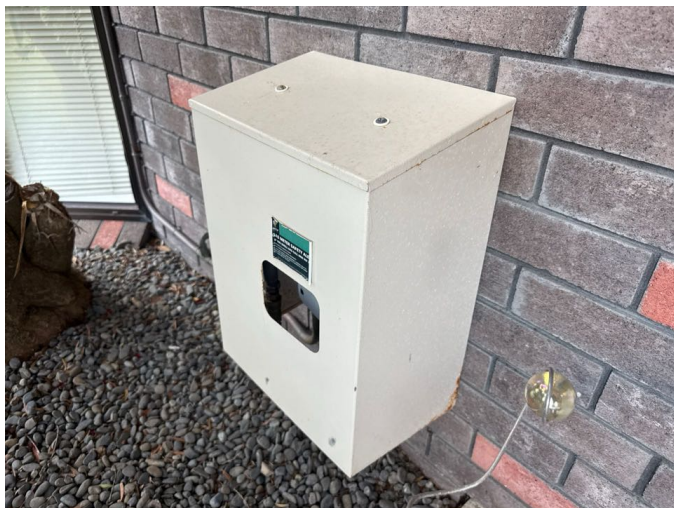
The gas system is not tested as part of this inspection. T.H.I.S recommends that gas appliances are serviced regularly to ensure correct combustion, maintaining optimum efficiency and correct performance of safety devices prior to use.

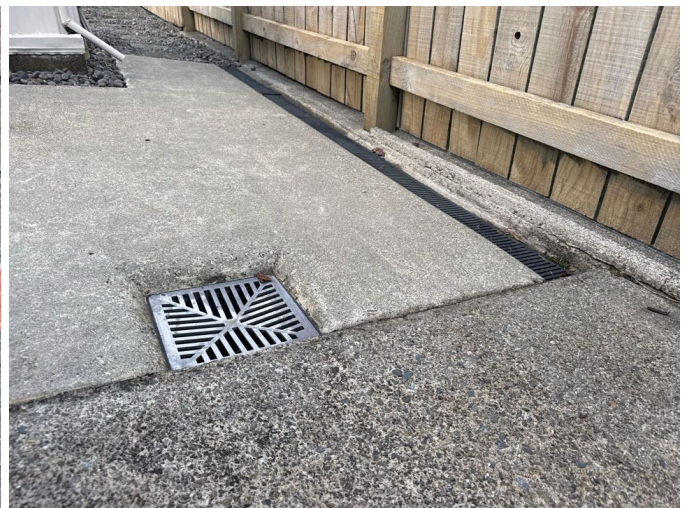
Channel drain and sump to the Southwest path by the shed. There was no sign of current blockages or recent overflows. The effectiveness of the drains will need to be monitored over time.

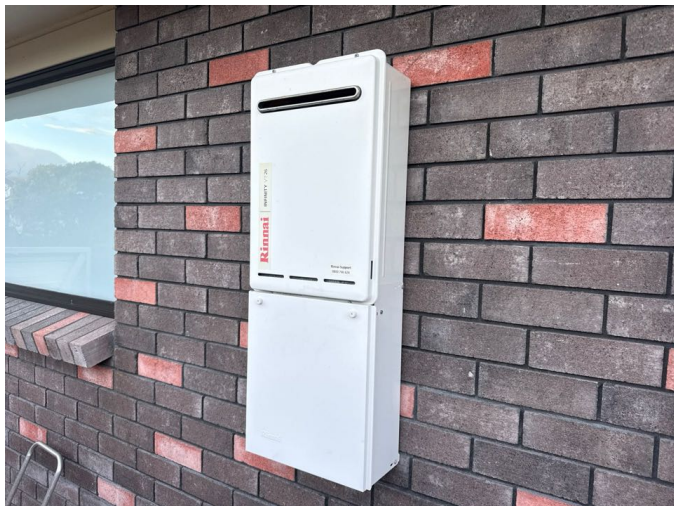
Southwest side.

For reliable operation Rinnai INFINITY water heaters in residential applications should be serviced every two years. Servicing and repair should only be carried out by authorised personnel. No visible signs of issues that may affect the performance of the gas water heater.

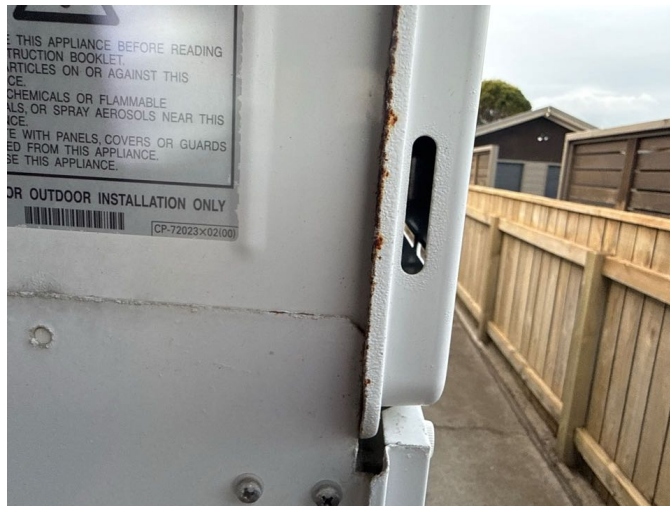
Surface rust to the outer cover should be treated with rust converter to slow the deterioration

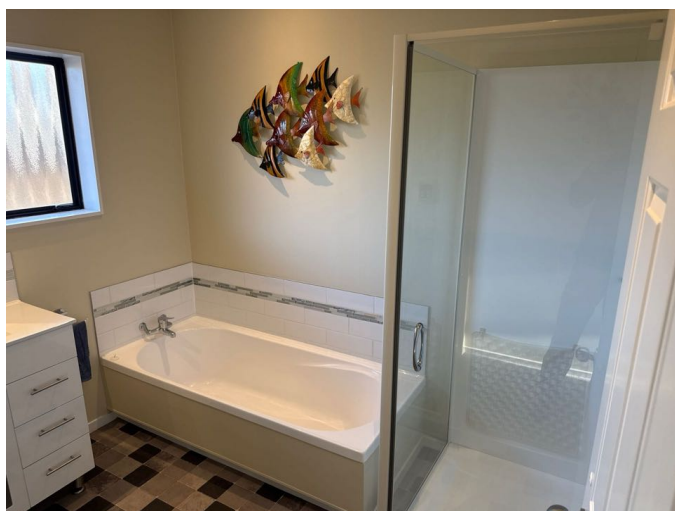
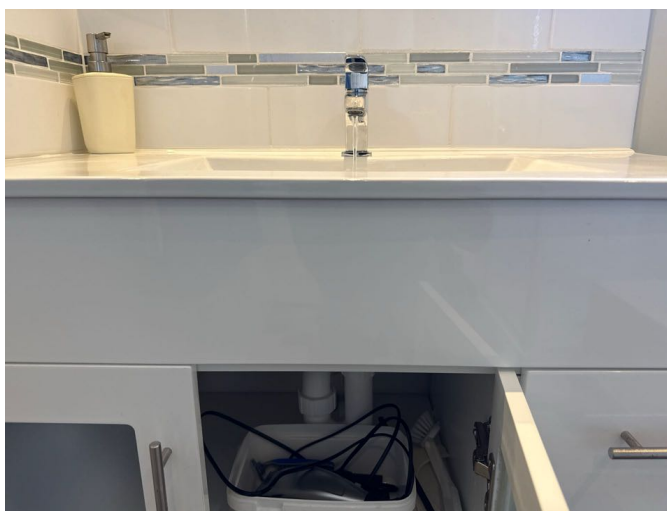
The rear edge of the vanity is well sealed. The tap is functioning well. No concerns with the water feeds or waste under the vanity

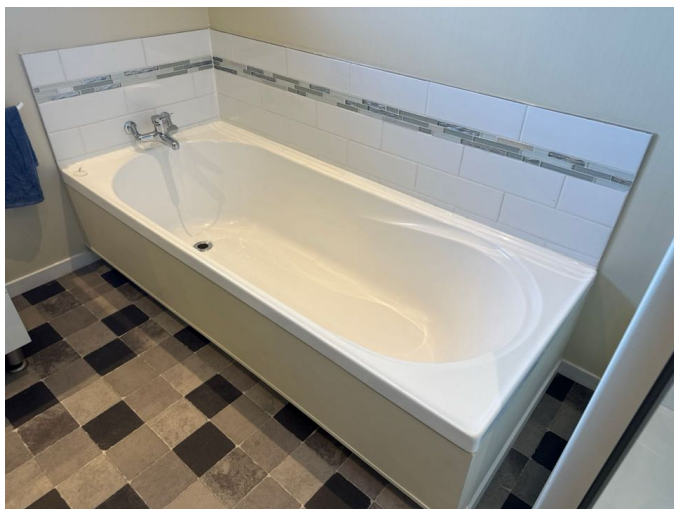
The perimeter of the bath is well sealed. The tap is functioning well.

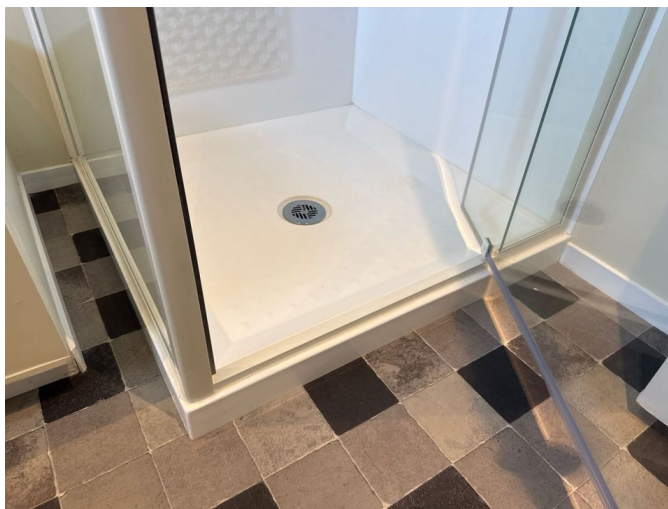
The base of the shower is well sealed. There was no evidence of damage to the shower base at the time of the inspection.

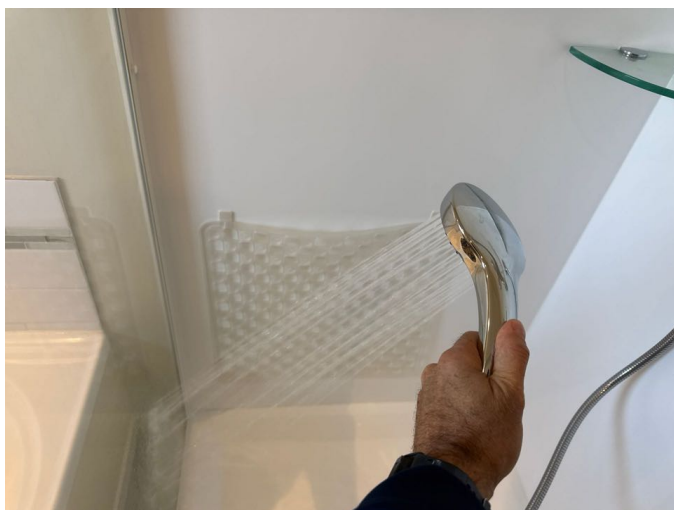
Good water pressure noted. No sign of current leaks from the shower frame during water testing.

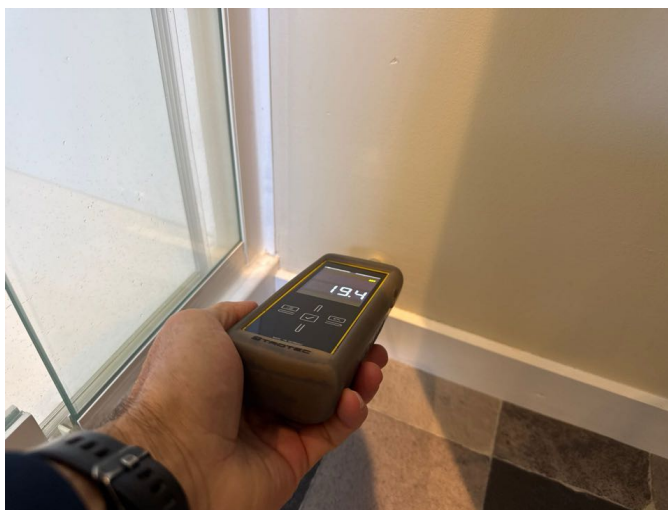
The common fail areas of the shower and plumbed areas were checked for elevated moisture. Moisture levels were within the normal range.

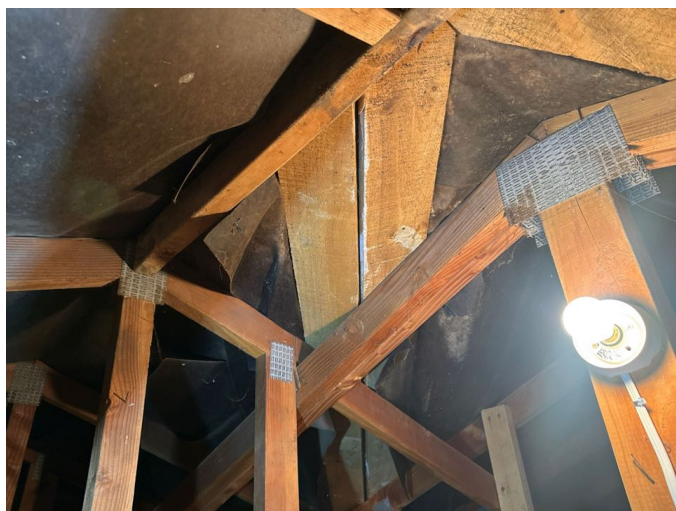
There was no evidence of current or past moisture ingress issues under the roof framing or linings (where accessible) at the time of inspection. The roof framing structure appears to be solid.

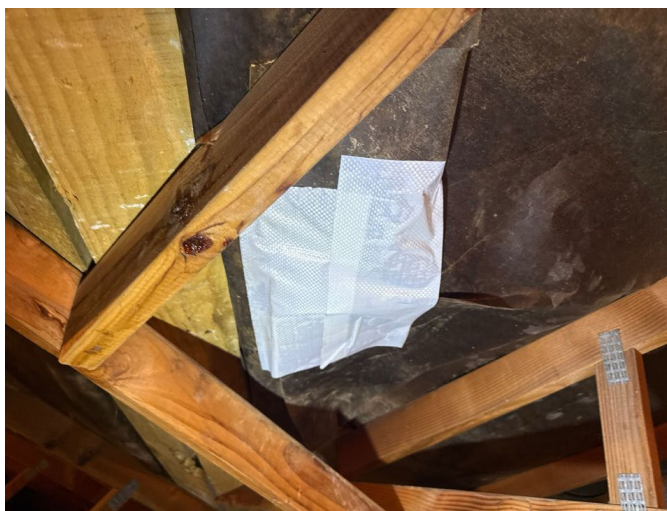
Patch repair to the underlay above the garage entrance point

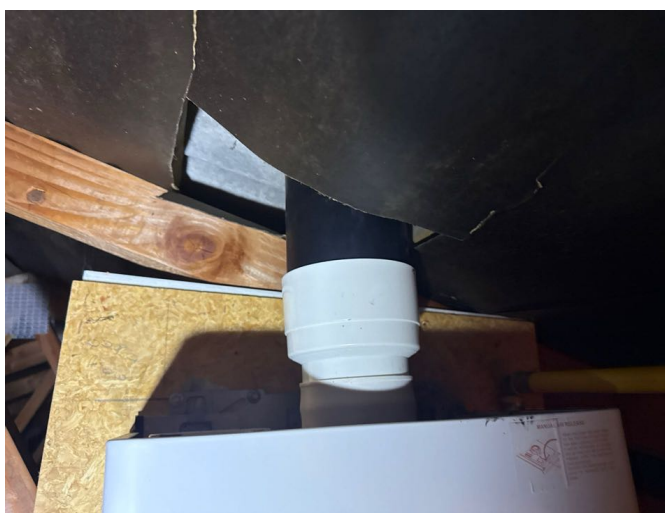
The roof penetrations were effectively sealed at the time of the inspection

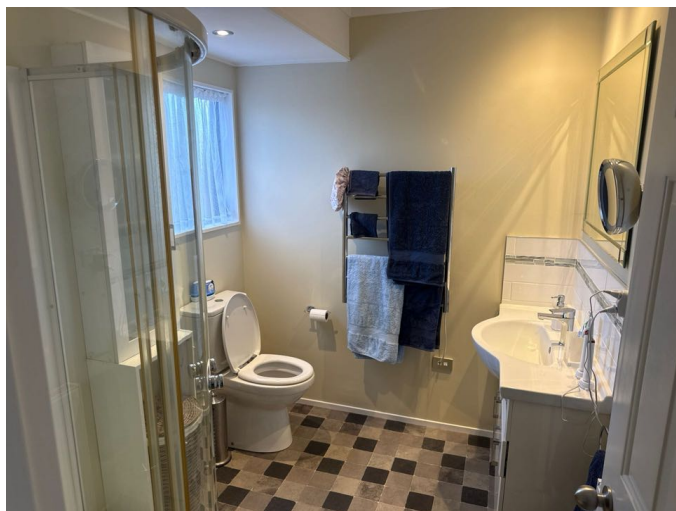
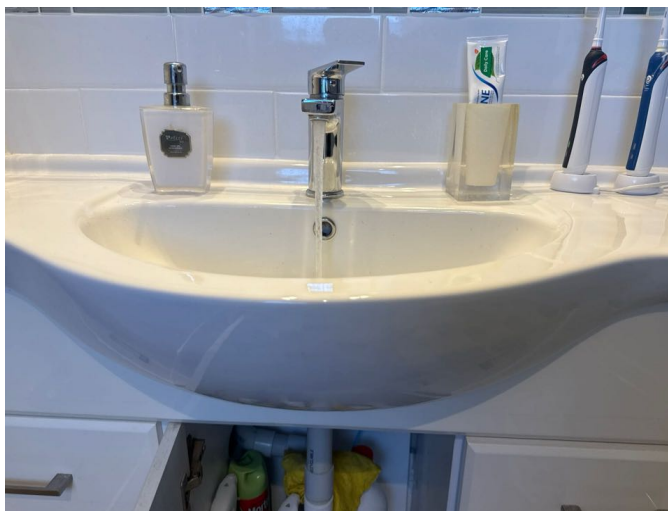
The rear edge of the vanity is well sealed. The tap is functioning well. No concerns with the water feeds or waste under the vanity

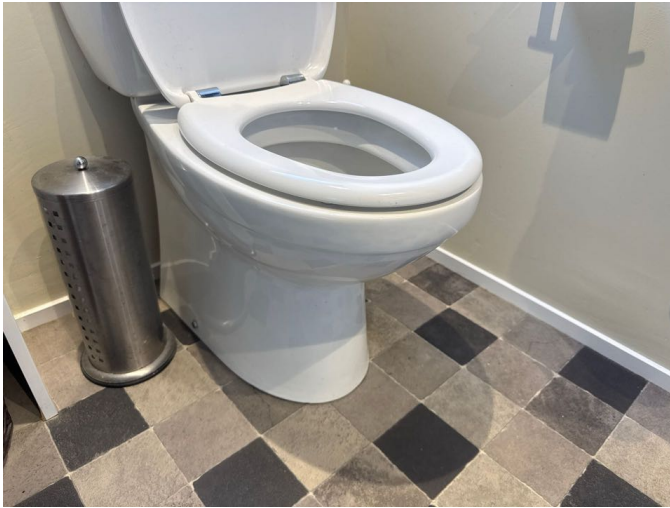
The base of the toilet is well sealed and secure. The toilet is in a functioning condition.

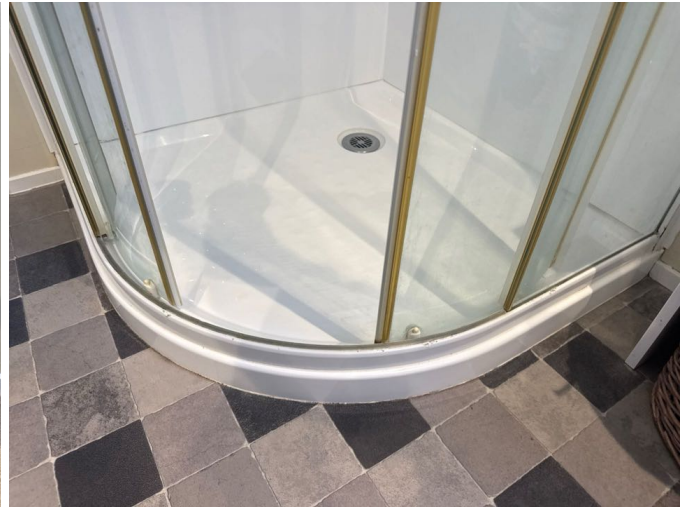
The base of the shower is well sealed. There was no evidence of damage to the shower base at the time of the inspection.

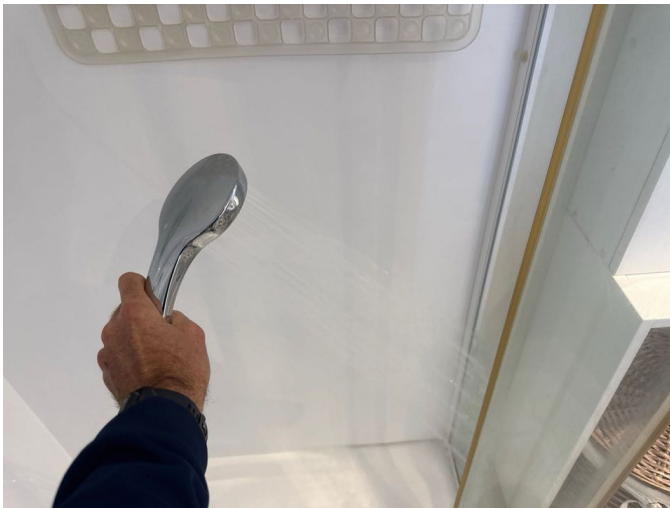
Good water pressure noted. No sign of current leaks from the shower frame during water testing.

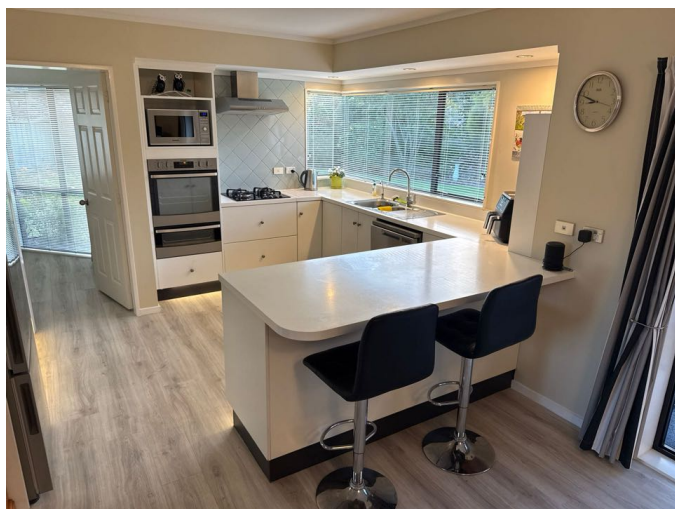
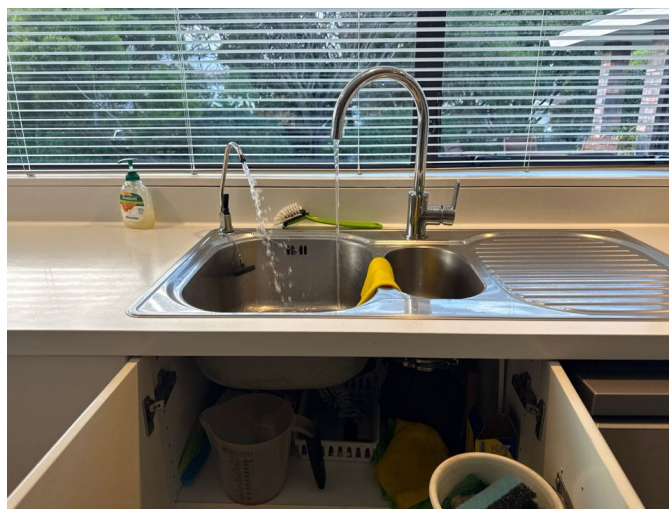
The rear edge of the bench top is well sealed. The taps are functioning well. No concerns with the water feeds or waste pipes under the sink.

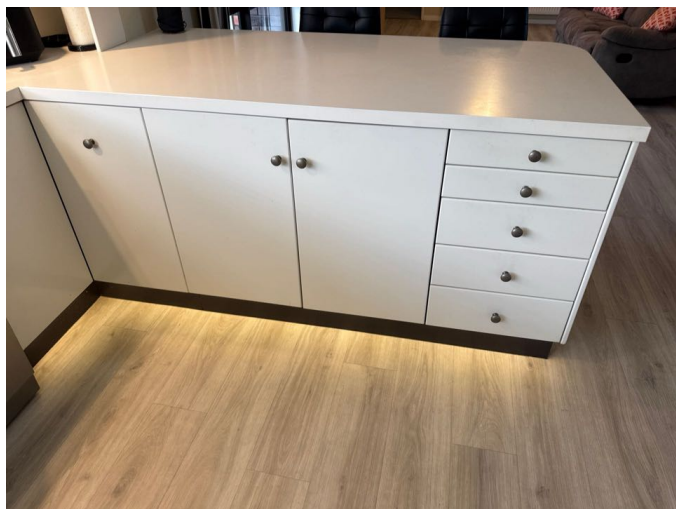
The kitchen cabinetry and vinyl floor are in good condition

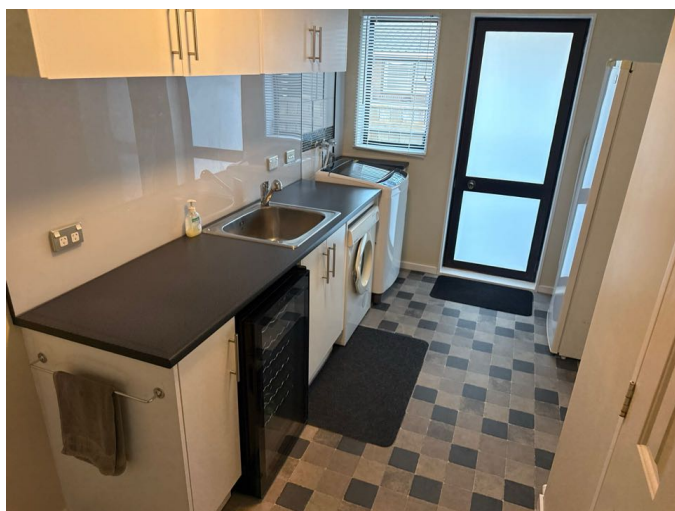
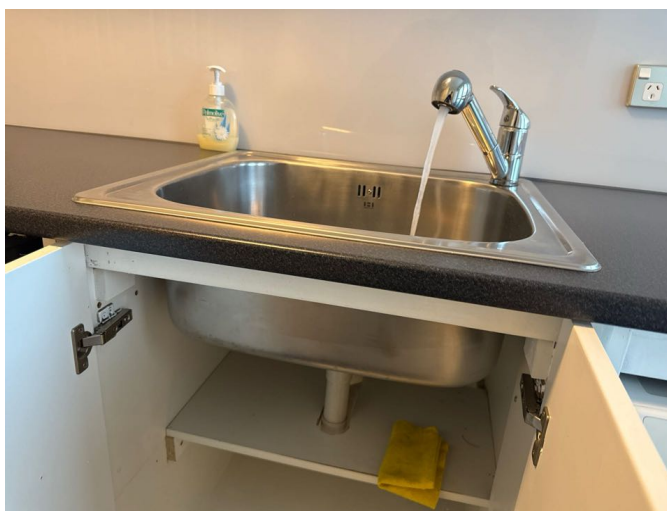
The bench is well sealed. The tap is functioning well. No visible concerns with the water feeds or waste under the tub.

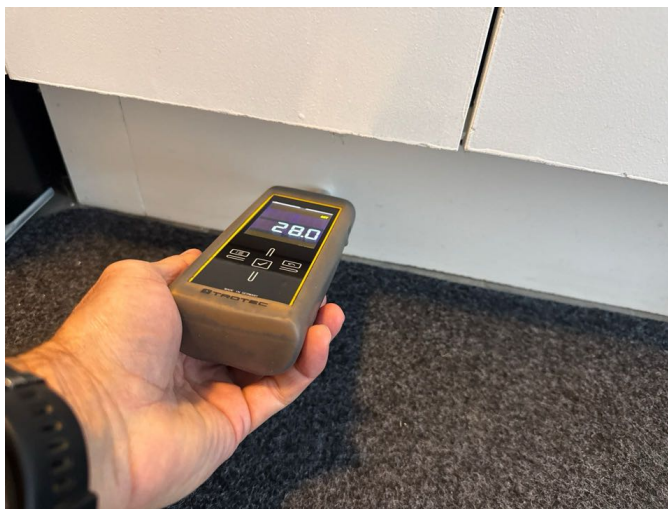
Moisture levels in the laundry were within the normal range at the time of inspection.

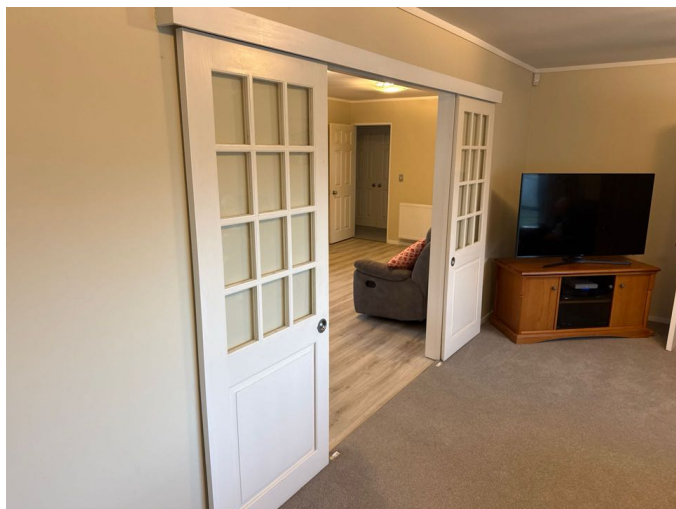
Internal doors are functional

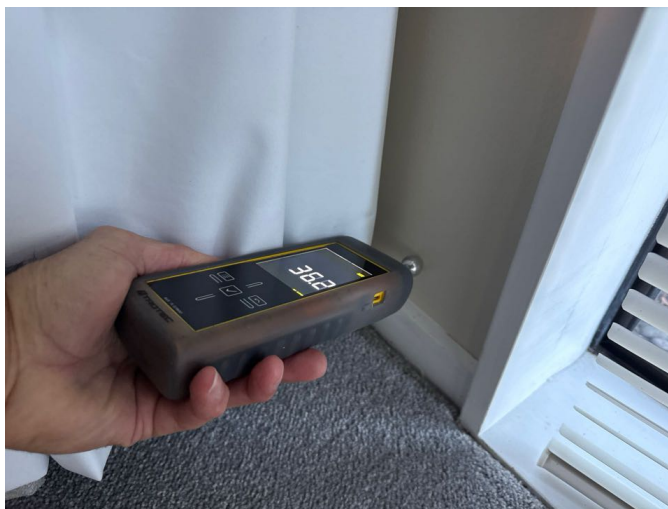
Moisture levels to the external walls were within the normal range at the time of inspection

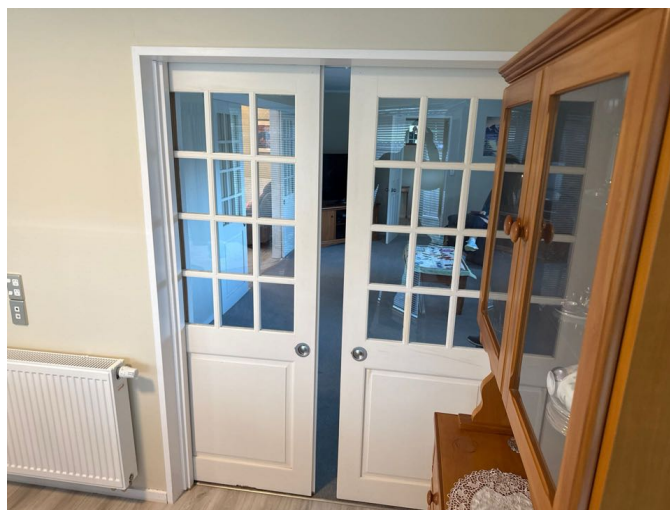
The doors are functioning well

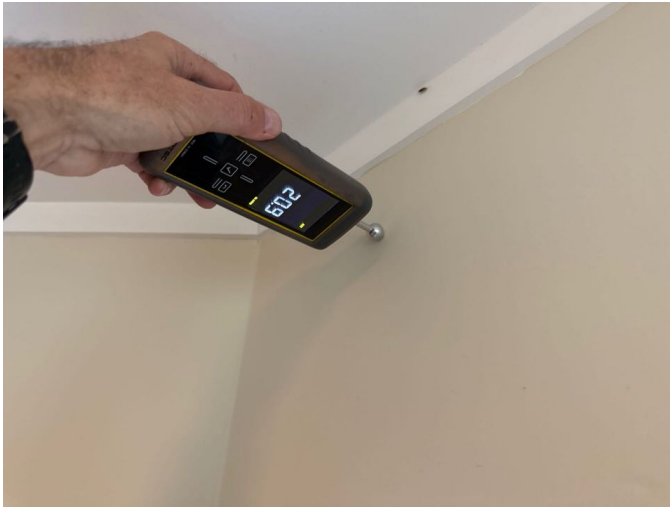
The moisture levels were thoroughly checked along the top of the wall. All areas were with the normal range.

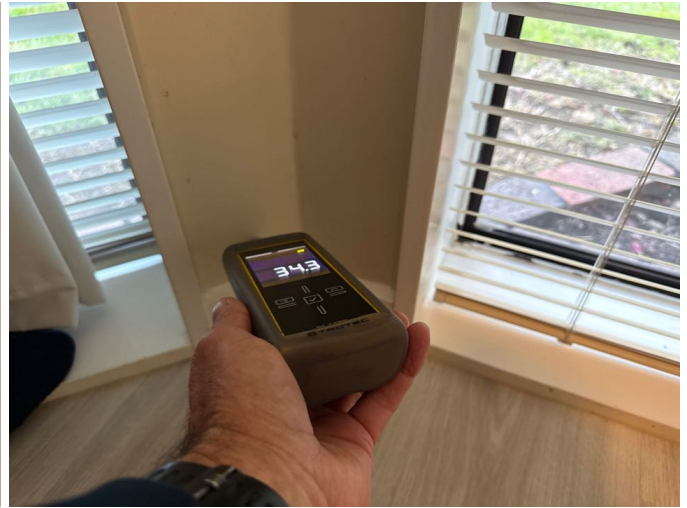
Moisture levels to the base of the external walls were within the normal range at the time of inspection

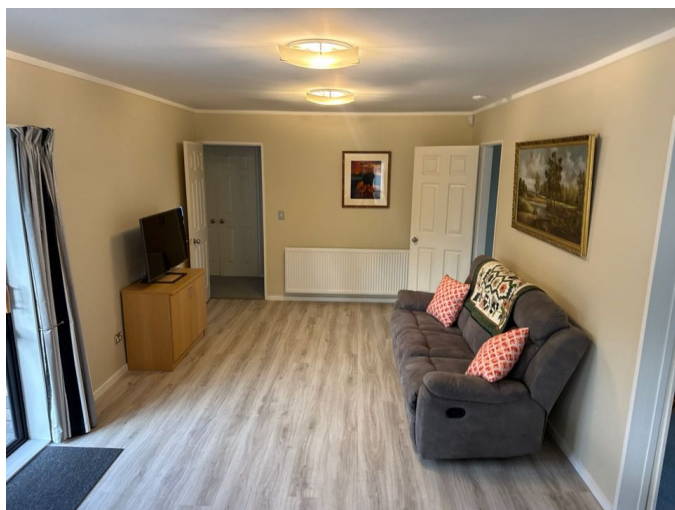
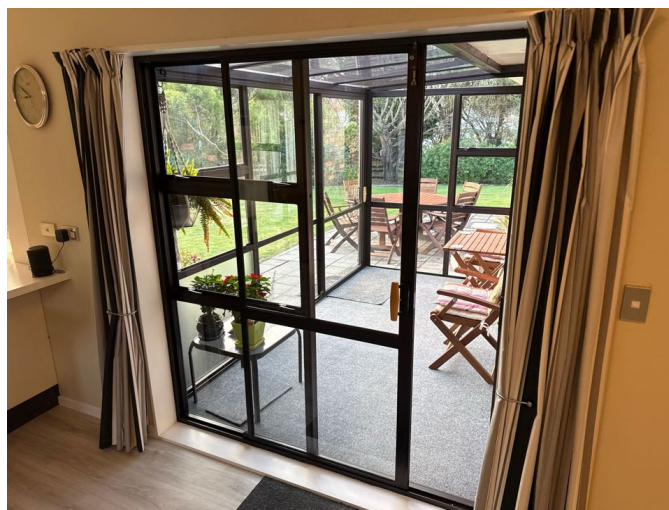
The sliding door is functioning well

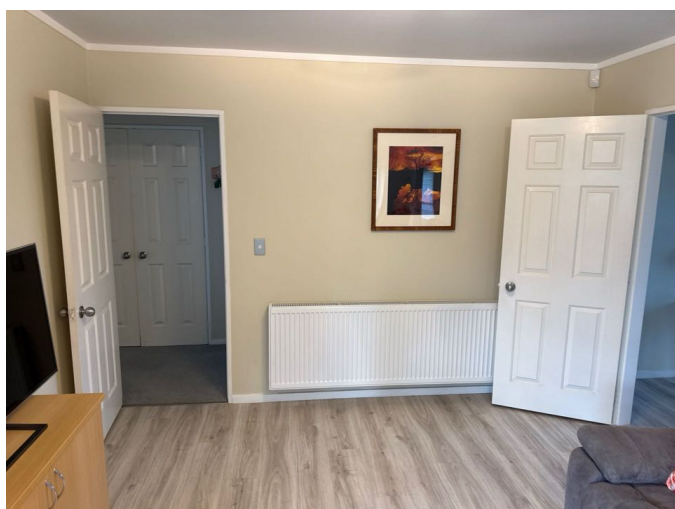
The internal doors are functioning well. Door stops installed behind the doors.

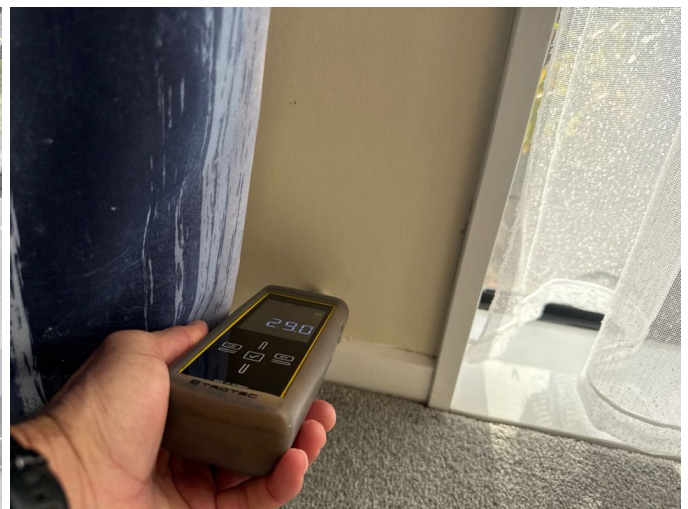
The windows are functioning in a typical condition for the age

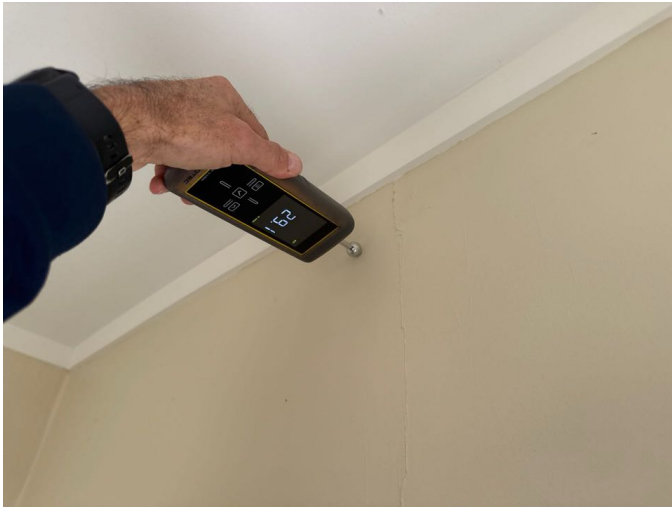
Moisture levels to the external walls were within the normal range at the time of inspection

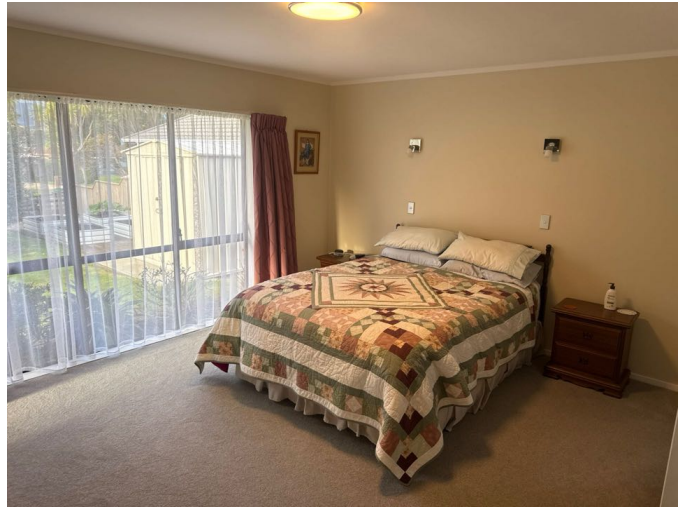
The moisture levels were thoroughly checked along the top of the walls, looking for internal spouting failure. All areas were within the normal range.

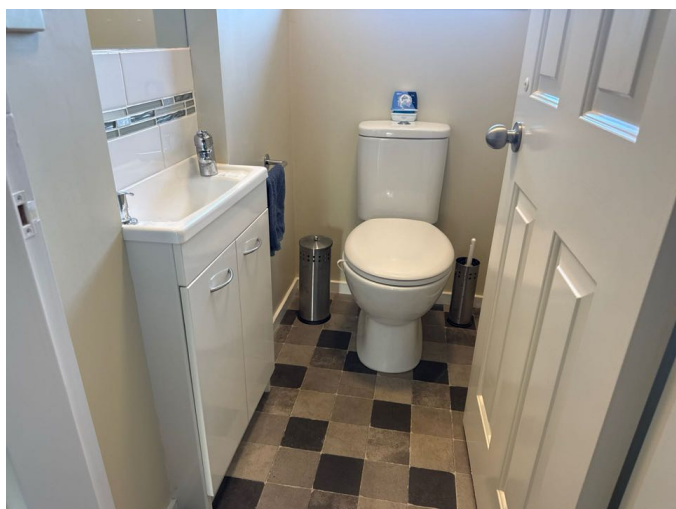
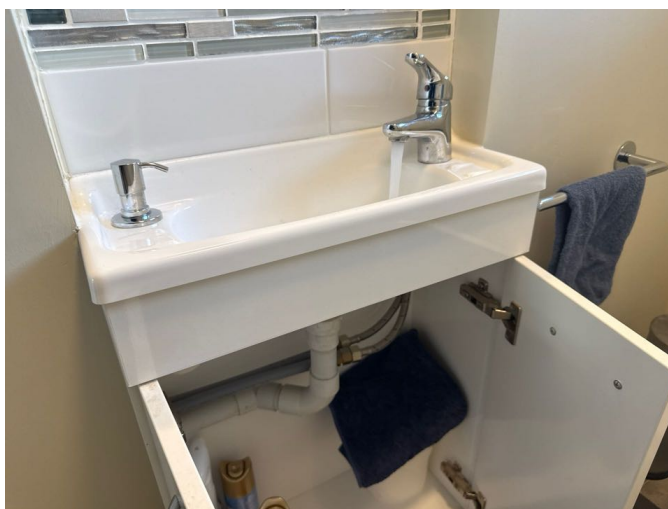
The toilet (room) is tidy and has been well maintained. The toilet and vanity are well sealed and functioning well.

Common failure areas examined. No unusual readings taken

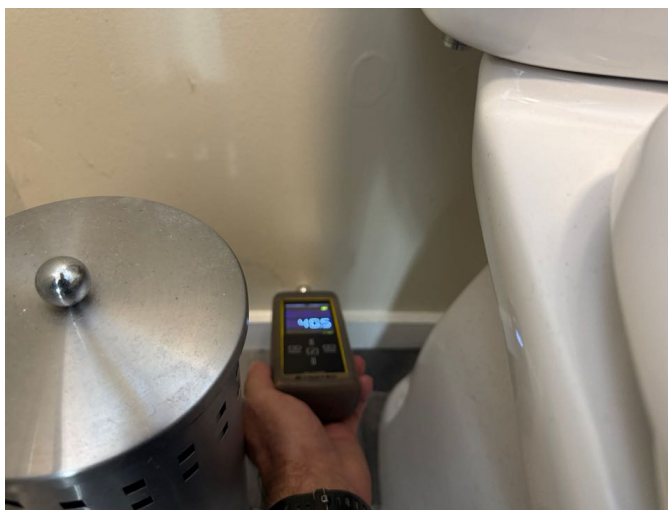
The base of the toilet is well sealed and is secure. The toilet is in a functioning condition.

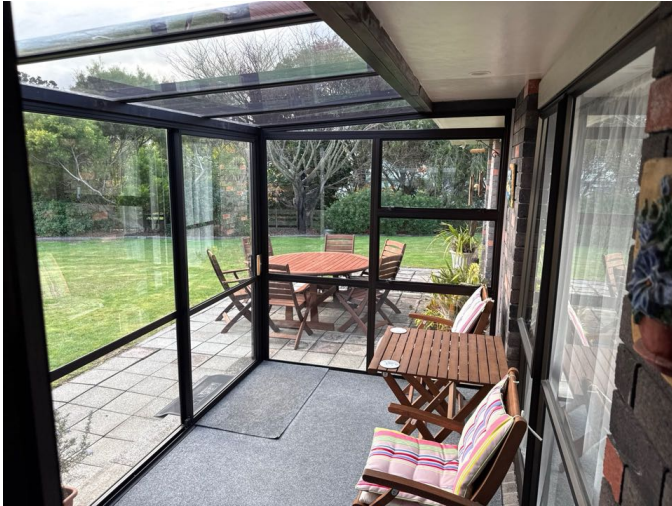
The conservatory is in good condition. There was no evidence of roofing failure found and there were no previous issues disclosed.

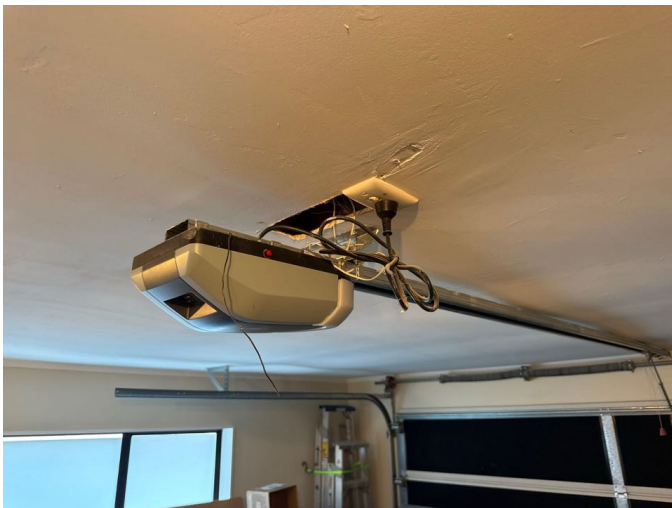
The electric garage door is functioning

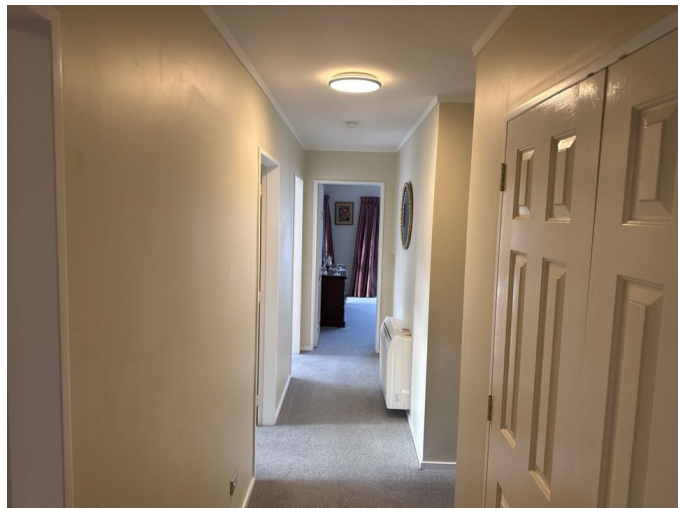
The hallway is tidy
