# Building inspection report here

## RED LBP PRE-PURCHASE REPORT

**Company:** JBC Builders Limited Ltd trading as RedLBP Christchurch North  
**Client:** Ana Paula da Silva & Luis Fernando da Silva  
**Date of Inspection:** 25th May 2026  
**Site Address:** 69 Marshland Road, Shirley, Christchurch 8061  
**Inspector:** Jamie Chapman  
**Qualifications:** National Certificate in Carpentry

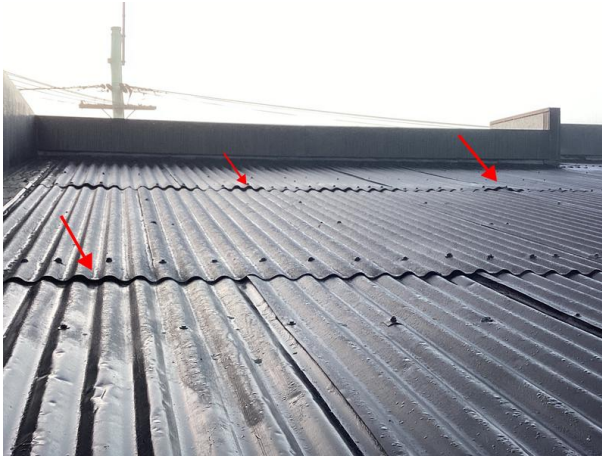
**Photo 4**

Lifting at the corrugated metal lap joints were noticed in a few locations on the roof system.

As viewed in the photos below, signs of tape repairs and silicone over some nail fixing holes were noticed around the roof system, as well as lifting lap joins. The tape repairs are more of a short-term, temporary fix, not a long-term solution. It is recommended to have a licensed roofer advise further on the roof system.

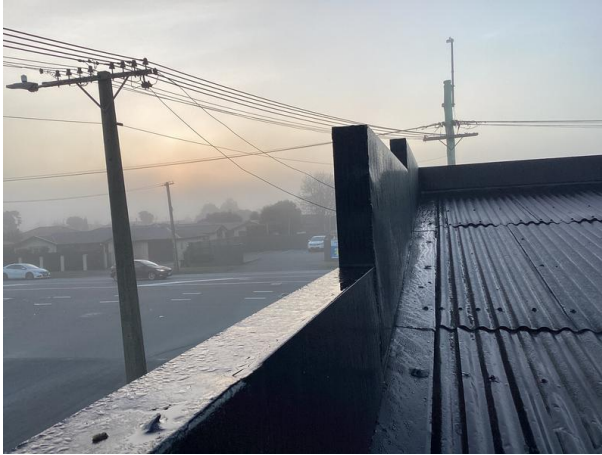
**Photo 8**  
Metal flashings installed over the  
parapet walls.

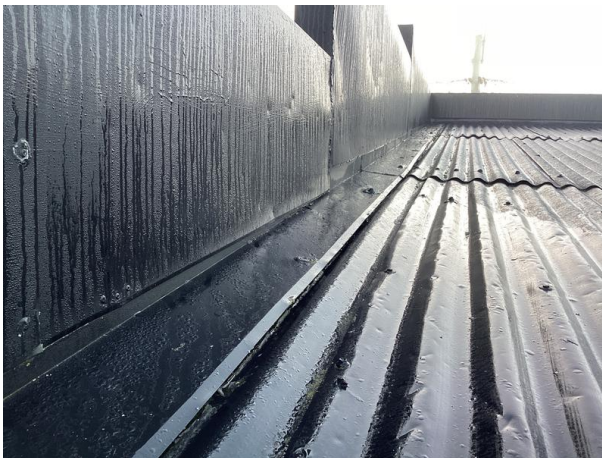
**Photo 9**  
Apron flashings located at the roof to  
wall junctions.

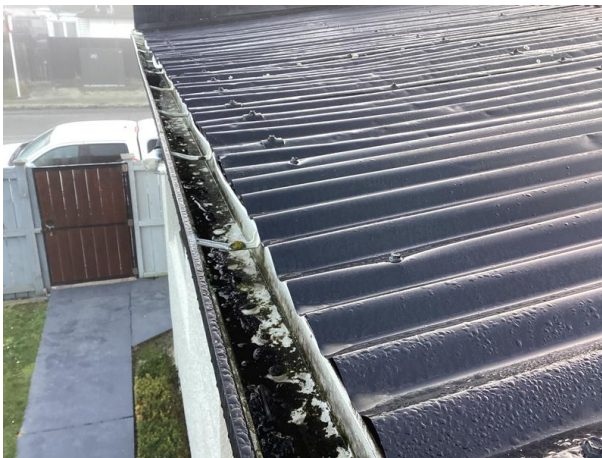
**Photo 13**  
The gutter system was clear of debris  
during the inspection.

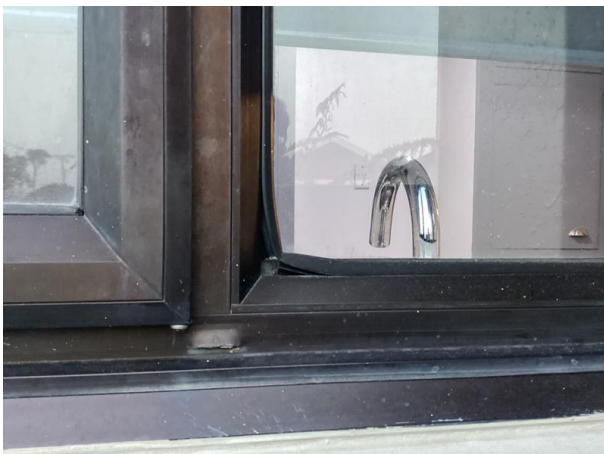
**Photo 23**

The window rubbers were noticed to be shrinking or pulling away from the corners.

To prevent water and draughts from entering, it is recommended to replace or properly re-seat the rubber seals on the exterior of the joinery. By doing so, you can ensure a tight seal that effectively safeguards against water and draught ingress.

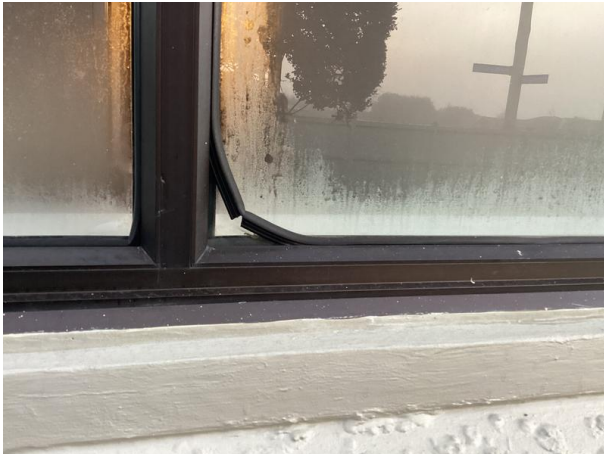
**Photo 24**

Example of a window rubber pulling away from the corners.

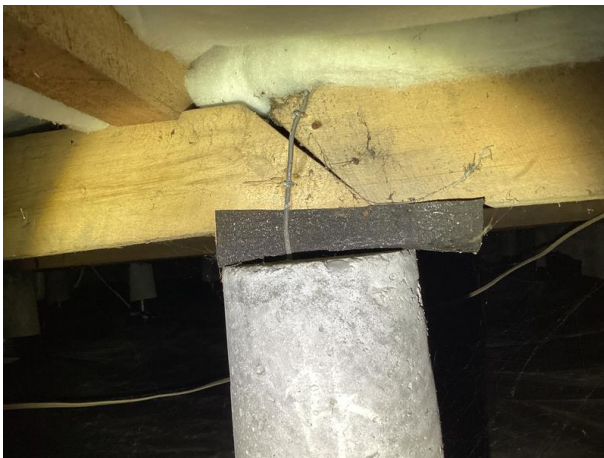
**Photo 36**  
Tie wire connections were visible between the concrete piles and timber bearers.

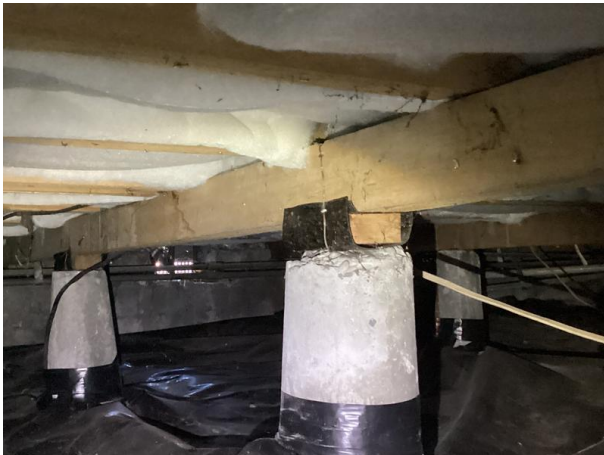
**Photo 37**  
A couple areas of floor relieving pile/packing were visible.

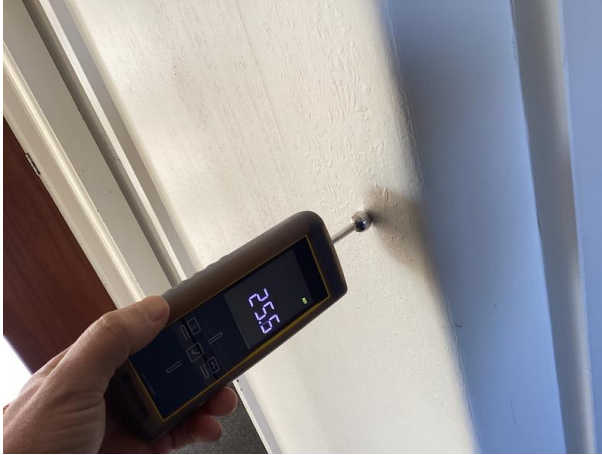
**Photo 49**

Example of a base reading that was taken on an internal wall. This was the average moisture reading for this dwelling during the inspection.

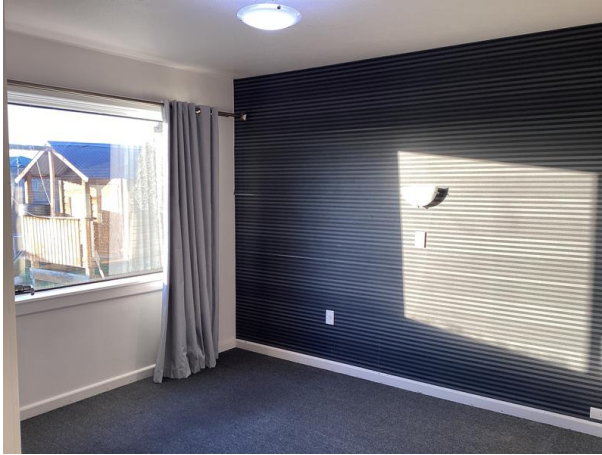
Defects - Ceiling defects and wall lining cracking was noted in bedroom one.

**Photo 60**  
Bedroom 1.

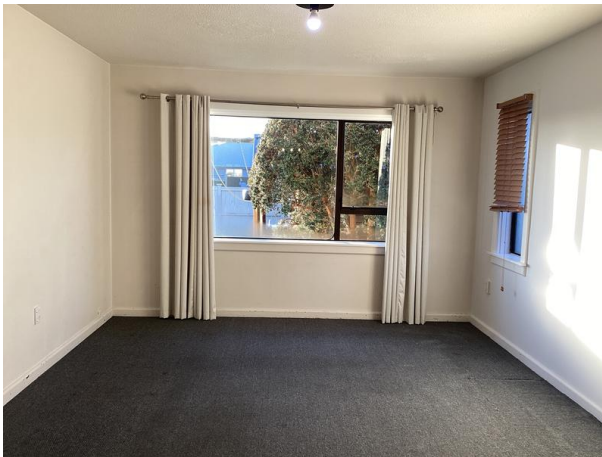
Defects - Ceiling defects and wall lining cracking was noted in the living room.

**Photo 61**  
Living room.

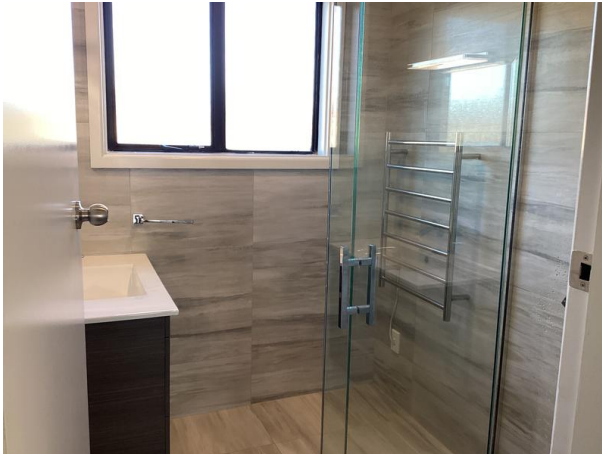
**Photo 69**  
Bathroom.

As viewed in the photos below, indications of elevated moisture readings were detected on the internal door reveal and architrave that is located directly next to the tile shower. Moisture readings were then done on the opposite side of the shower in the hallway and bedroom with no elevated moisture readings detected during the inspection. And as detailed in the foundation section of this report moisture staining was noted below the bathroom area in the subfloor. It is recommended to have a suitably qualified and licensed professional to advise further on this tile shower.

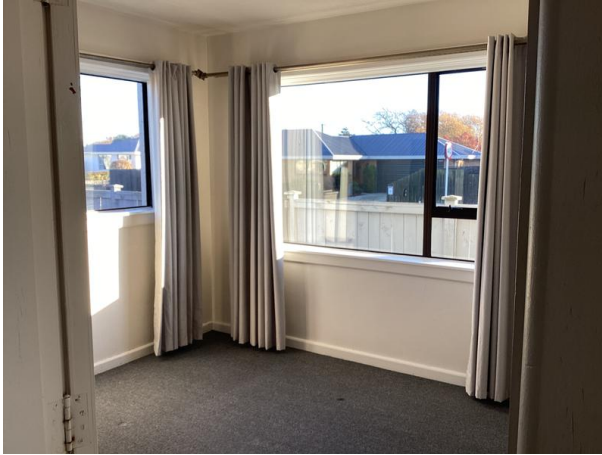
Defects - Wall and ceiling defects were noted in bedroom two.

**Photo 74**  
Bedroom 2.

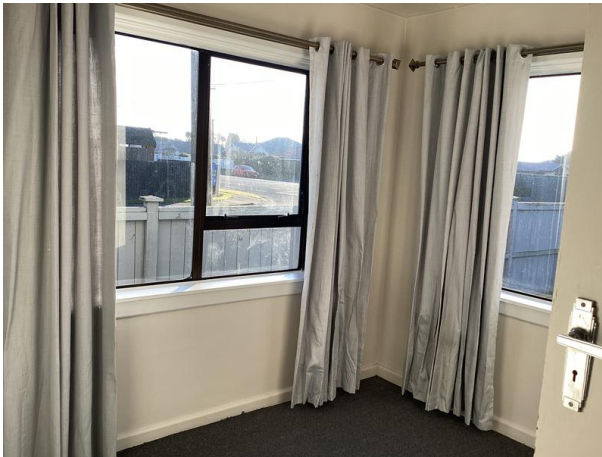
Defects - Wall and ceiling defects were noticed in bedroom three.

**Photo 75**  
Bedroom 3.

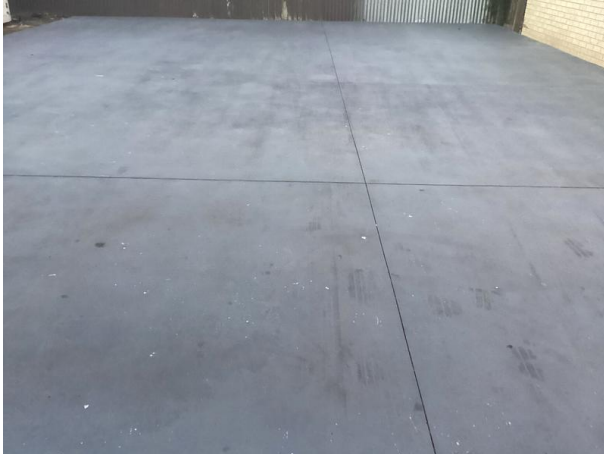
**Photo 76**  
Concrete driveway, no significant issues.

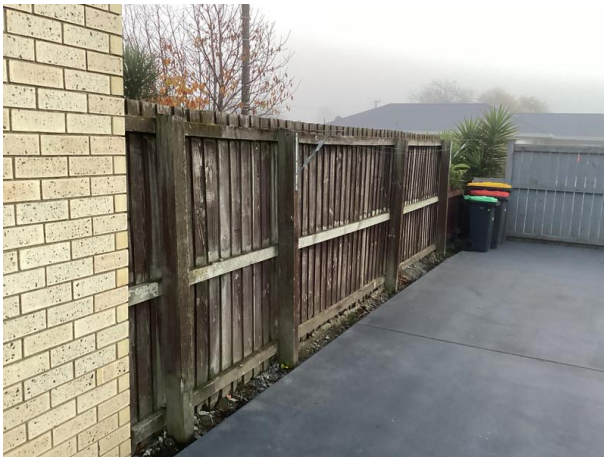
Painted timber palings fixed to timber rails with timber posts.  
Condition of cladding - In a condition expected for age.  
Alignment - No visible issues.  
Post and rail condition - No visible issues.  
Average height - 1.8 metres.

**Photo 77**  
Boundary fences, in a condition expected for age.

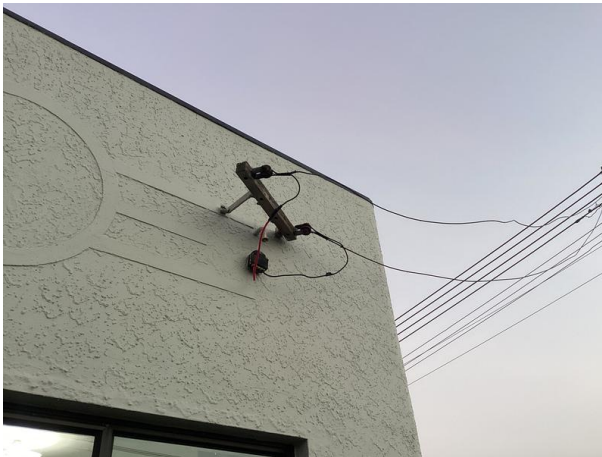
**Photo 79**  
Over head power supply.

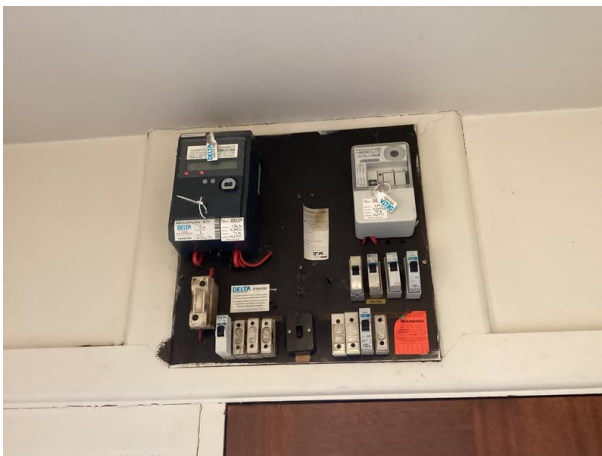
This type of distribution board is of an age where, if upgrades are required to the electrical system, replacement of the board may also be required.

**Photo 80**  
Meter box and switchboard located in the entrance.

It is recommended to have a registered electrician advise on the electrical system.

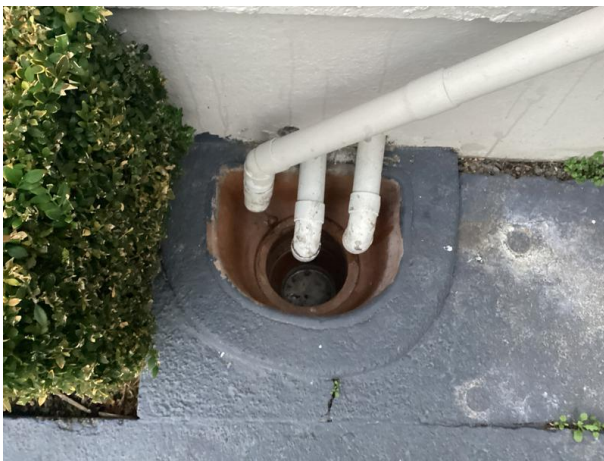
Condition - No observable issues.

**Photo 81**  
Kitchen gully trap.

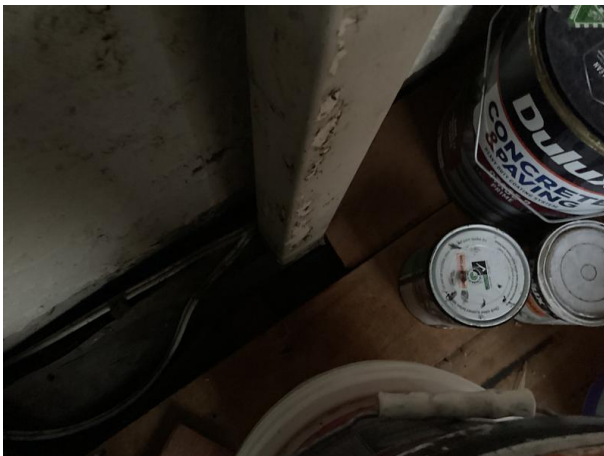
**Photo 82**  
The stormwater riser was not fully visible due to the shed timber flooring.

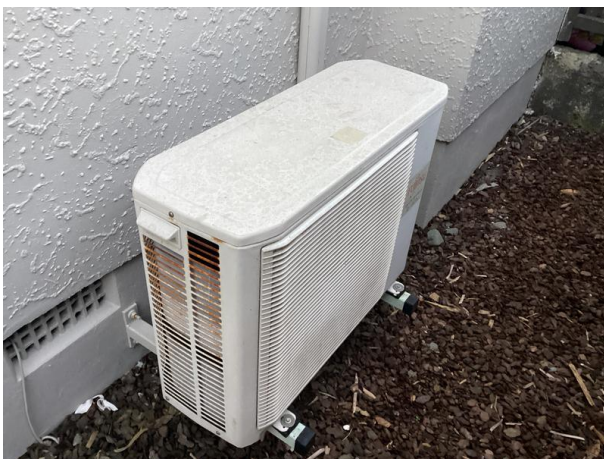
**Photo 83**

External Fujitsu heat pump system.

Follow the manufacturer's recommended servicing schedule to ensure the equipment operates efficiently and maintains optimal performance. Adhering to these guidelines helps identify and address potential issues early, reducing the risk of costly repairs and ensuring compliance with warranty requirements.

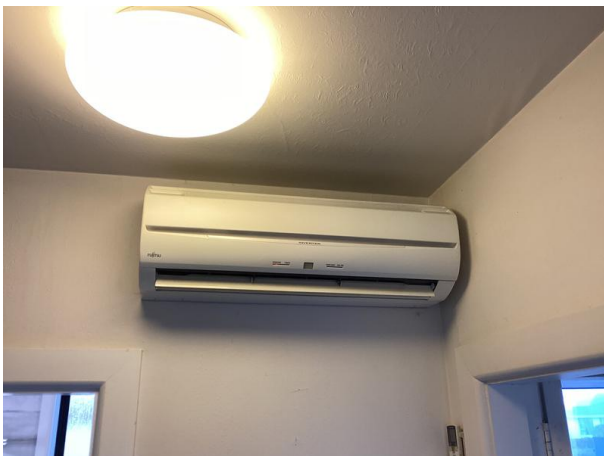
**Photo 84**

Fujitsu heat pump located in the hallway.

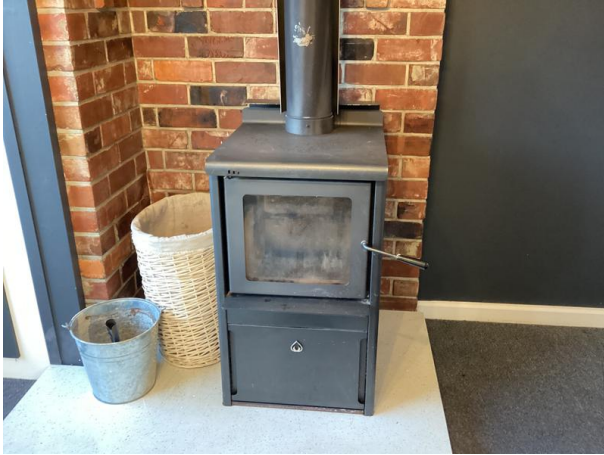
**Photo 85**  
Fireplace located in the living area.

Check with territorial authority for solid fuel burners compliance.

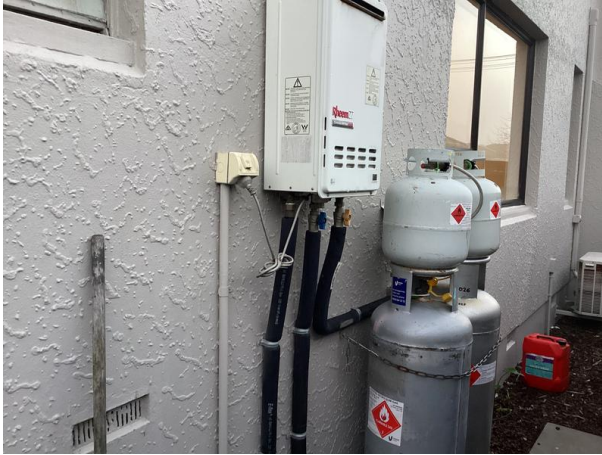
**Photo 86**  
South side gas bottle station and hot water Califont.

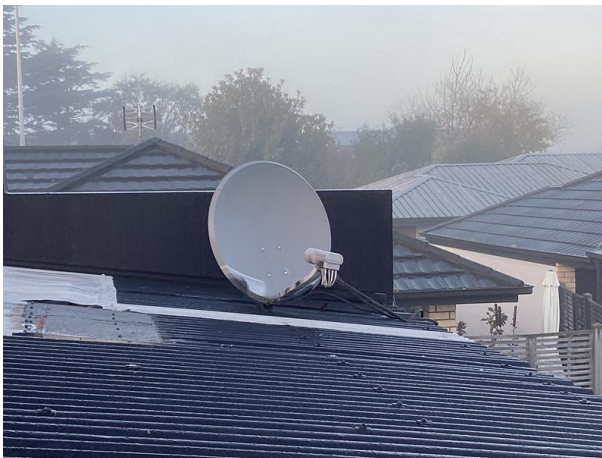
**Photo 87**  
Satellite aerial located on the roof system.

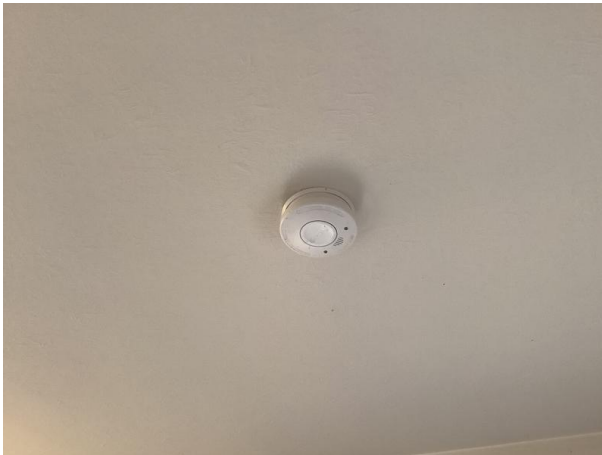
**Photo 88**  
Smoke alarm located in the hallway.

To ensure that your alarm system is functioning optimally, it is recommended to follow the manufacturer's maintenance advice. Additionally, on a monthly basis, you should check the alarm still works by pressing the test facility located on the outside of the device. Replace dead batteries immediately and gently vacuum the dust that gathers on the device. Do not take the alarm apart or off its mount to do this.
