## RED LBP PRE-PURCHASE REPORT

# CERTIFICATE OF INSPECTION IN ACCORDANCE WITH NZS 4306:2005

**Company:** JBC Builders Limited Ltd trading as RedLBP Christchurch North  
**Client:** [REDACTED]  
**Date of Inspection:** 2nd February 2026  
**Site Address:** 19 Tirangi Street, Hei Hei, Christchurch 8042  
**Inspector:** Jamie Chapman  
**Qualifications:** National Certificate in Carpentry

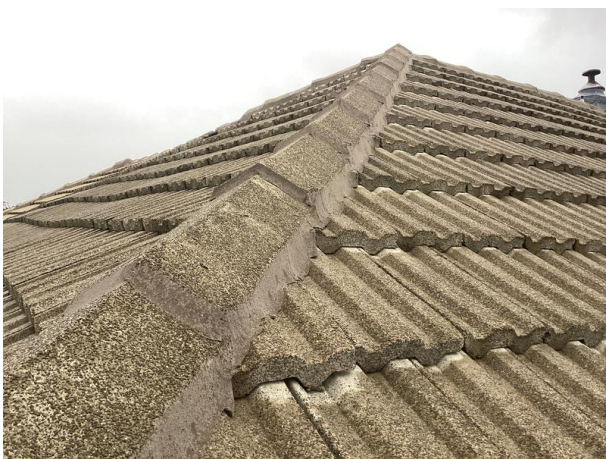
**Photo 9**

Masonry tiled hips and ridges are located around the roof system.

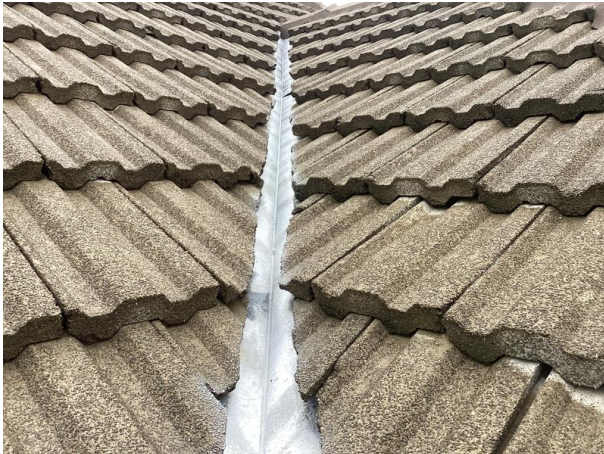
**Photo 10**  
Metal valleys located around the roof system.

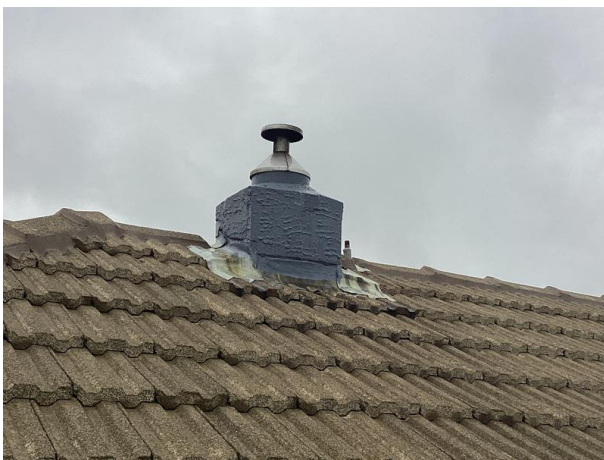
**Photo 11**  
Chimney penetration with lead flashings.

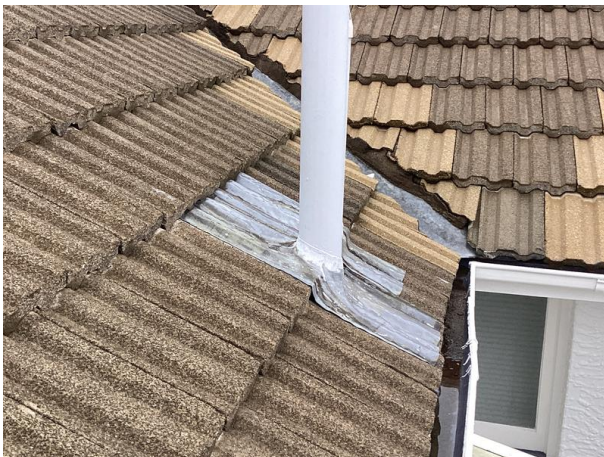
**Photo 12**  
Southside vent penetration with lead flashing.

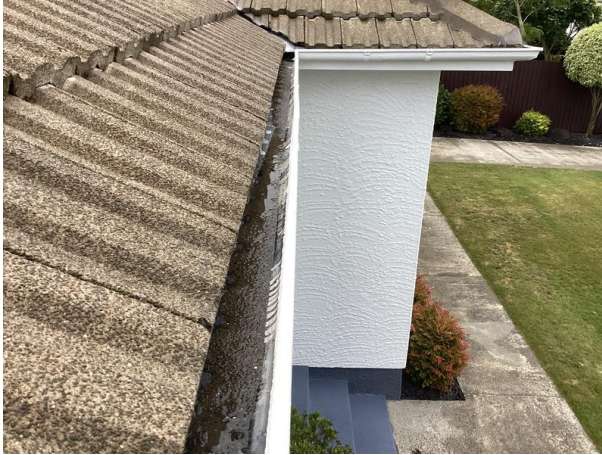
**Photo 13**

The metal gutter system was clean and clear at the time of the inspection.

At the time of the inspection, the gutters were found to be clear. To maintain proper drainage, it is crucial to ensure gutters remain free of debris. Blocked gutters can result in water overflowing and accumulating on the roof or other parts of the building, potentially causing water damage, leaks, and structural issues. Regular maintenance, such as removing leaves, twigs, and other debris, prevents blockages and ensures efficient water flow away from the roof, protecting the building's integrity.

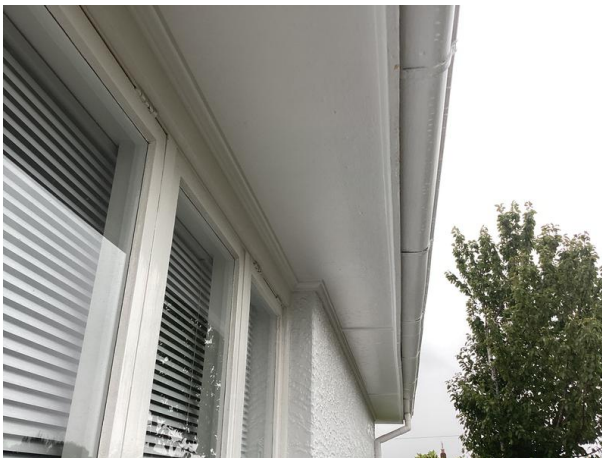
**Photo 14**

Painted fibre cement soffits located around the dwelling.

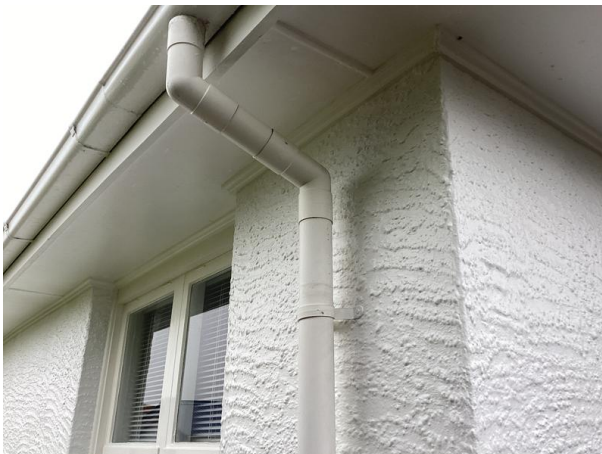
**Photo 15**

PVC downpipes installed around the dwelling.

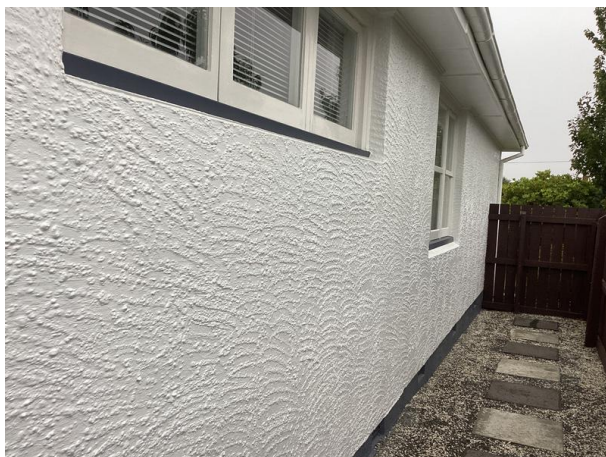
**Photo 16**

Stucco plaster over a masonry substrate is located around the dwelling.

Keep up regular maintenance and repainting/sealing.

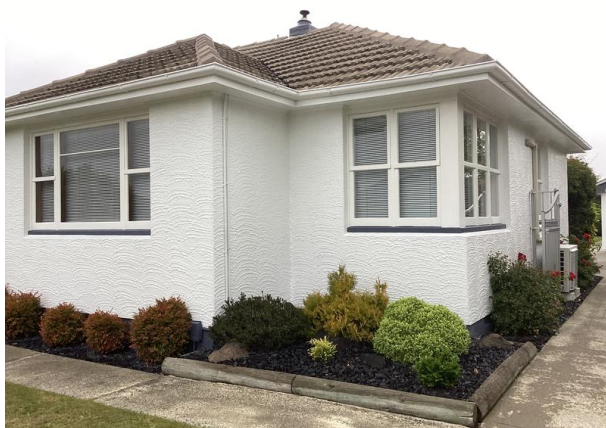
**Photo 17**

No significant defects identified with the stucco plaster at the time of the inspection.

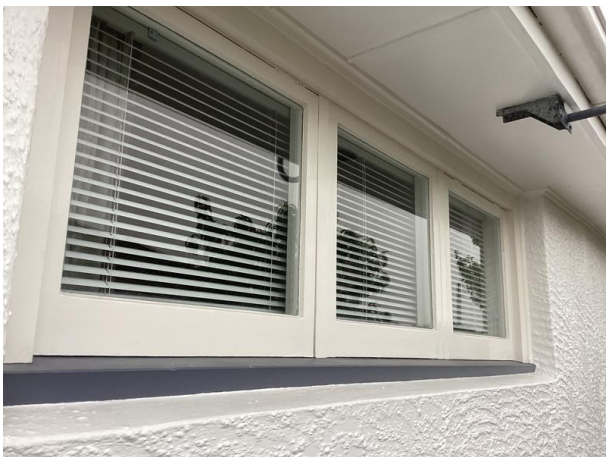
**Photo 18**

Single glazed timber windows are located around the dwelling.

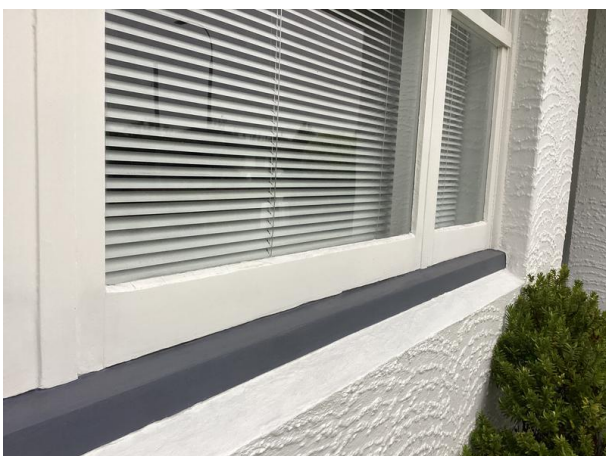
**Photo 19**

No significant issues identified with the timber windows on the exterior of the dwelling.

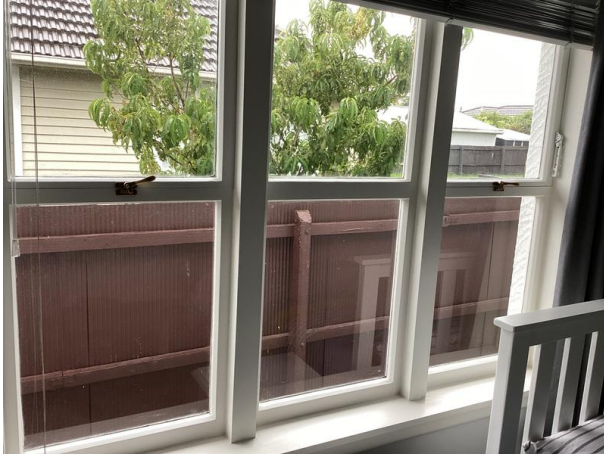
**Photo 20**

No significant issues with the timber windows viewed from inside the dwelling.

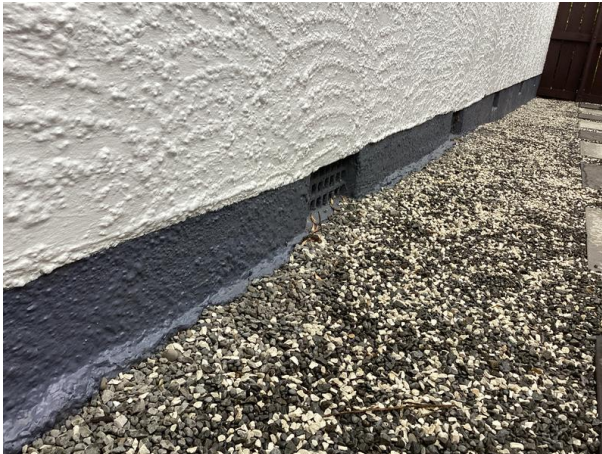
**Photo 21**

A concrete ring foundation with vent holes is located around the dwelling.

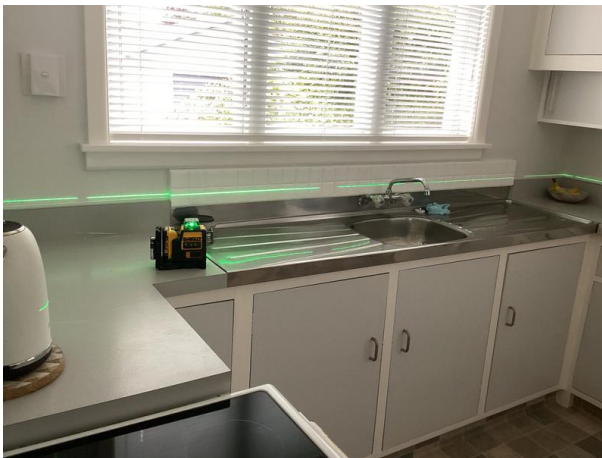
**Photo 25**

The kitchen Benchtops were also checked and were level.

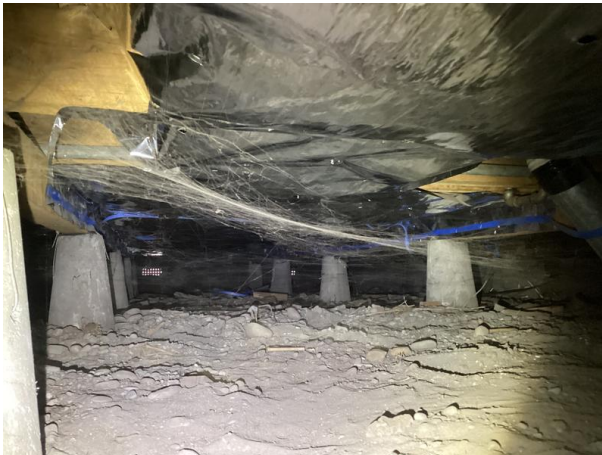
**Photo 26**

View of inside the subfloor.

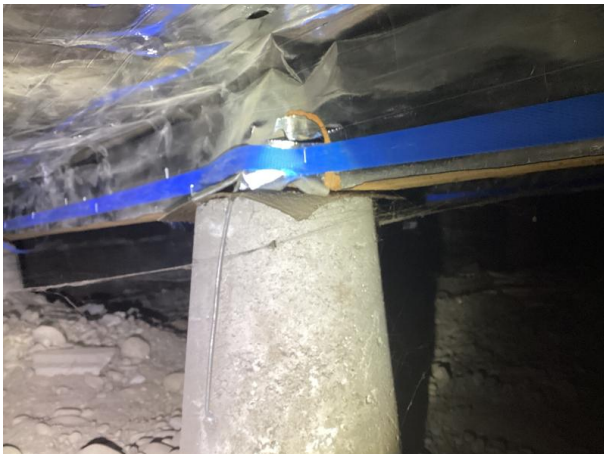
**Photo 27**

Tie wire connections were visible between the concrete piles and timber bearers.

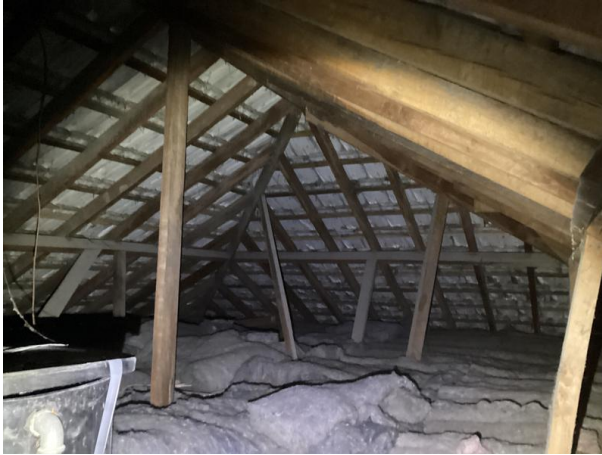
**Photo 32**

View of inside the roof space.

Regular maintenance of the property should include periodic visual inspections of the roof space through the manhole. These checks are essential to identify potential issues such as water leaks, signs of pest infestation, or other structural concerns. Conducting these inspections can help detect problems early, allowing for timely repairs and preventing more significant damage or costly remedial work in the future.

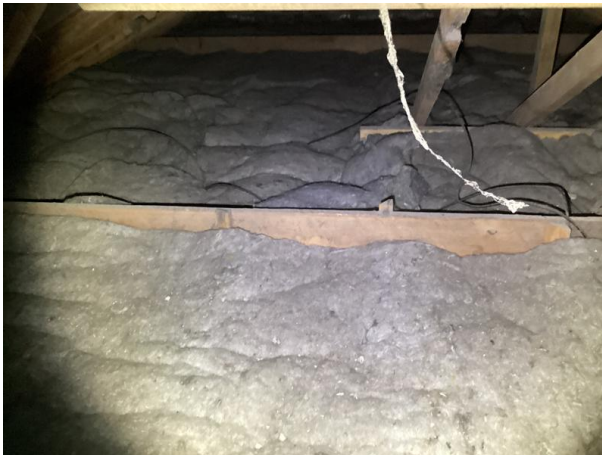
**Photo 34**

Acceptable coverage of insulation where visible.

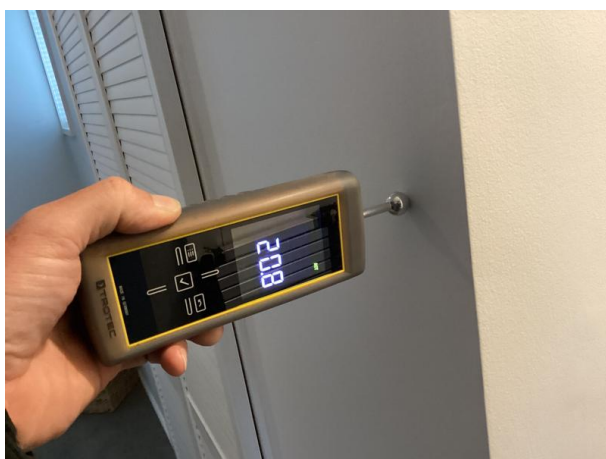
**Photo 37**

No indications of elevated moisture readings were detected. 'Supplementary' moisture testing photos are a representative sample of the comprehensive testing conducted.

Example of a base reading that was taken on an internal wall. This was the average moisture reading for this dwelling during the inspection.

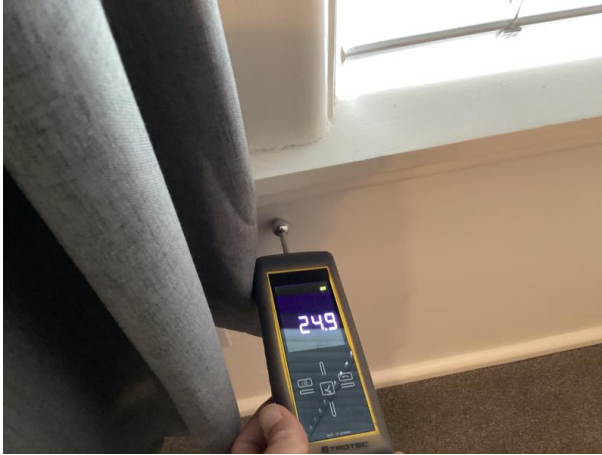
**Photo 39**

Moisture testing was done around the external window joinery.

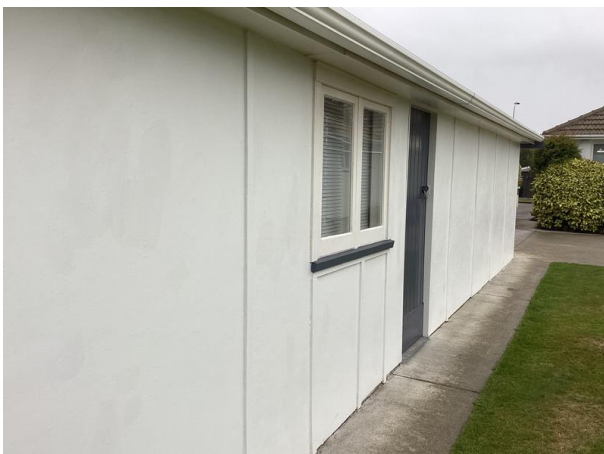
**Photo 52**  
No significant issues with the fibre cement sheeting on the garage.

Regular maintenance as per the main dwelling is required.

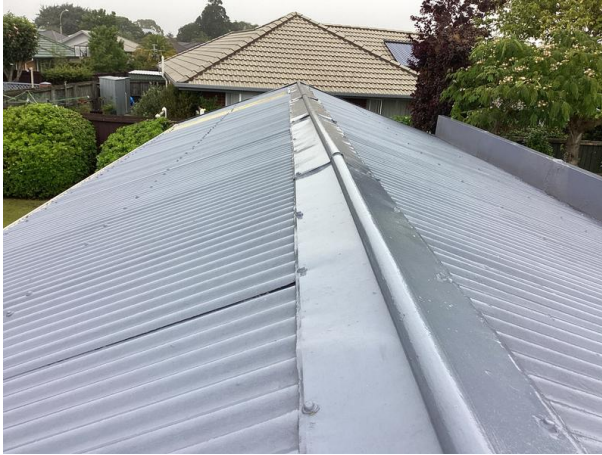
**Photo 53**  
Profiled metal roof located over the garage.

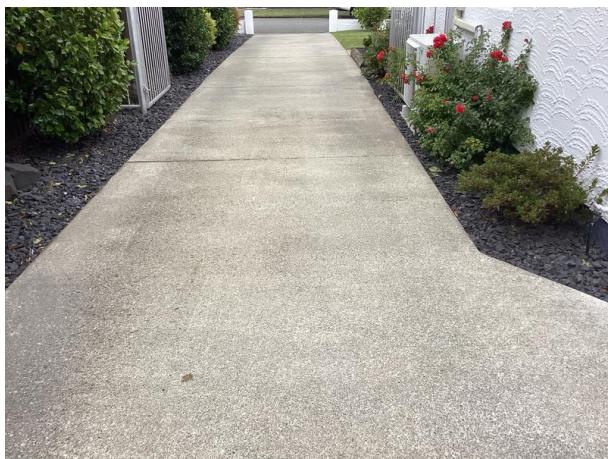
**Photo 55**  
Concrete driveway, no significant issues.

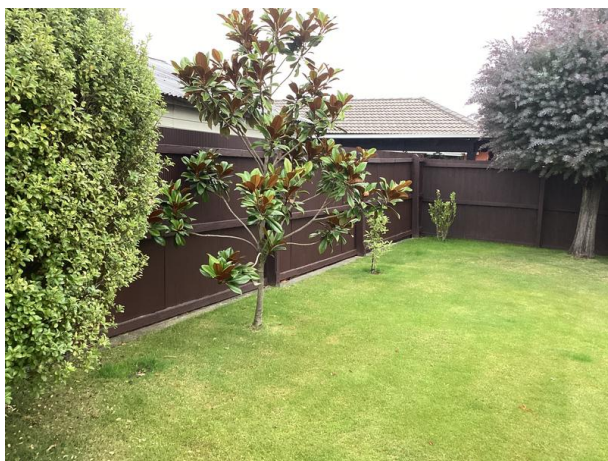
**Photo 56**  
No significant issues with the boundary fences.

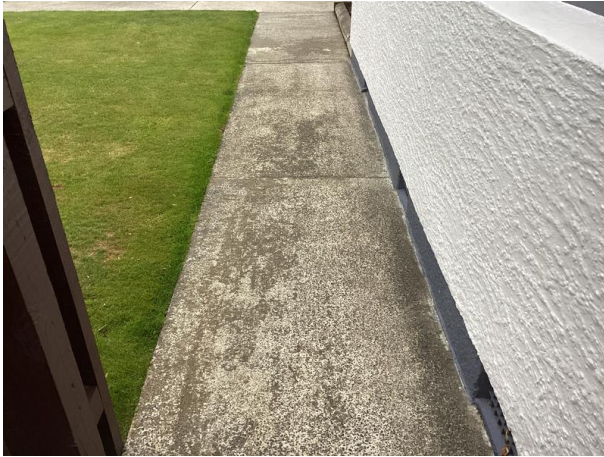
**Photo 57**

No significant issues with the concrete paths.

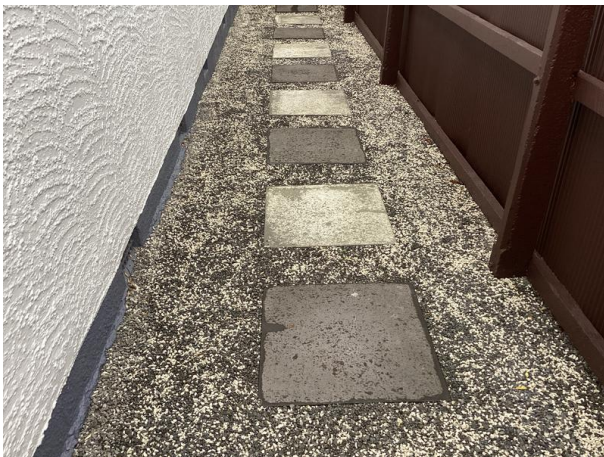
**Photo 58**

Concrete pavers, no significant issues.

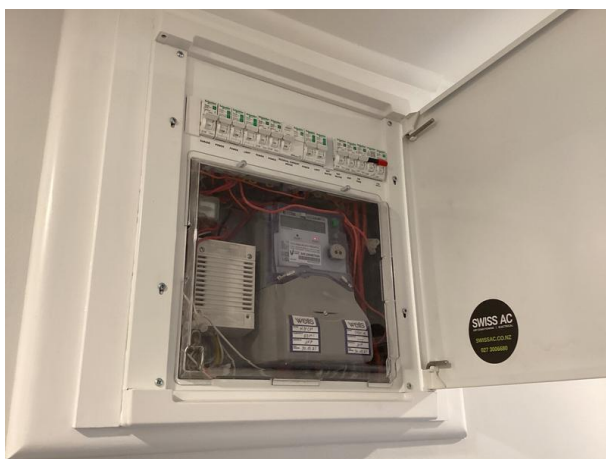
**Photo 59**

Switchboard and meter box located in the hallway.

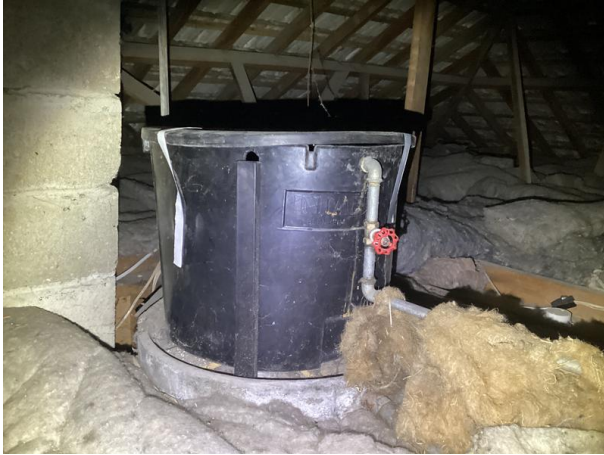
**Photo 65**

Header tank located in the roof space.
