## RESIDENTIAL HOUSE INSPECTION

12 Kirk Rd

03/08/2026

Kiwi House Inspections

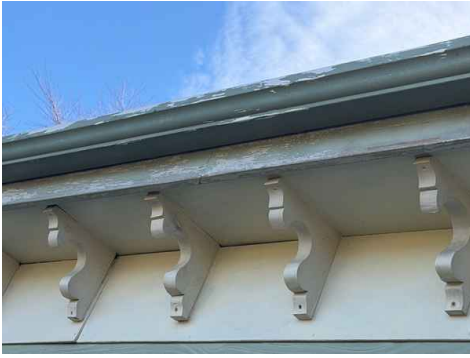
Deterioration of the painted surfaces is noted, general maintenance is recommended.

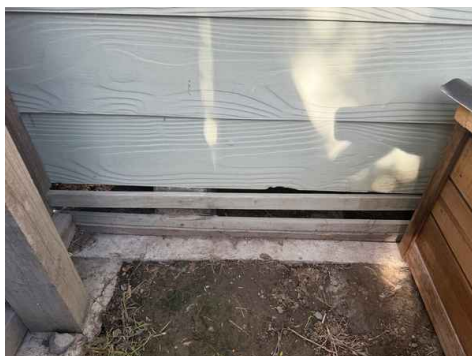
**MINOR CRACKING TO THE CLADDING NOTED**

Repairs and or replacement of damaged boards are recommended to prevent water ingress into the cladding system. The corner is missing the correct flashing.

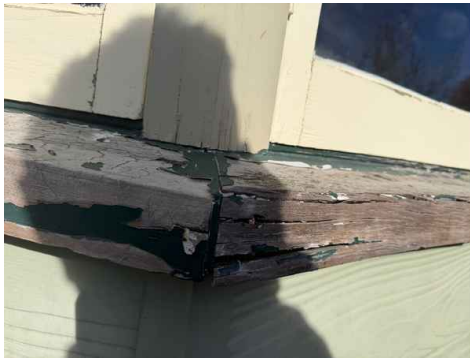
##### **DECAY TO TIMBER WINDOW FRAME**

Decay is noted to the timber window frame, maintenance to the damaged area should be completed.

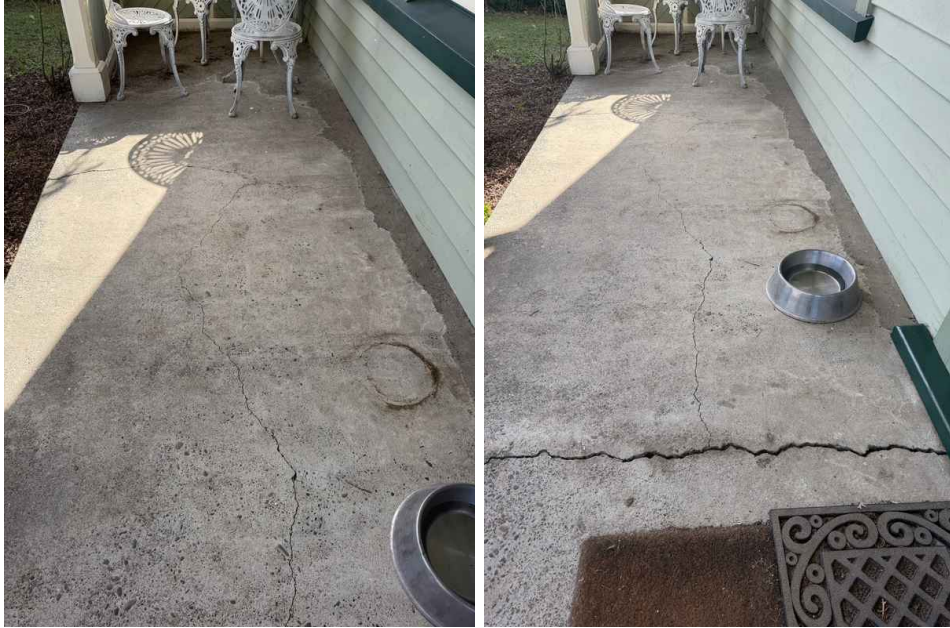
This is in conjunction of the house settlement to the north west and south west corners.

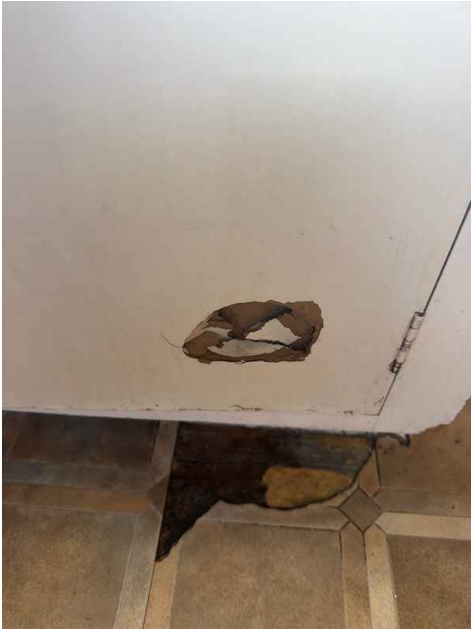
## 15.5.1 Kitchen

**WEAR TO CABINETS NOTED**

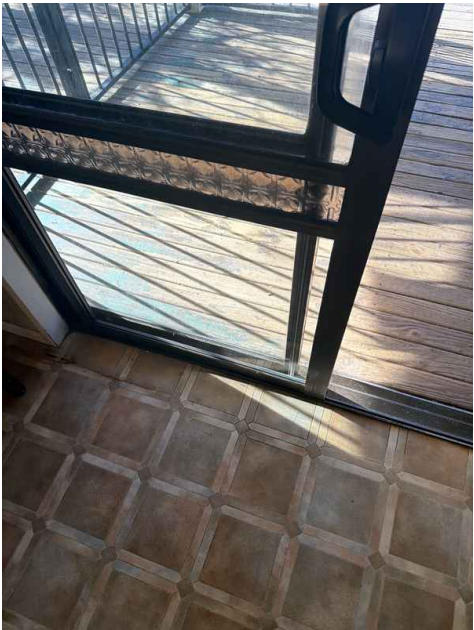
Maintenance Item

Adjust and complete maintenance as required to restore functionality.

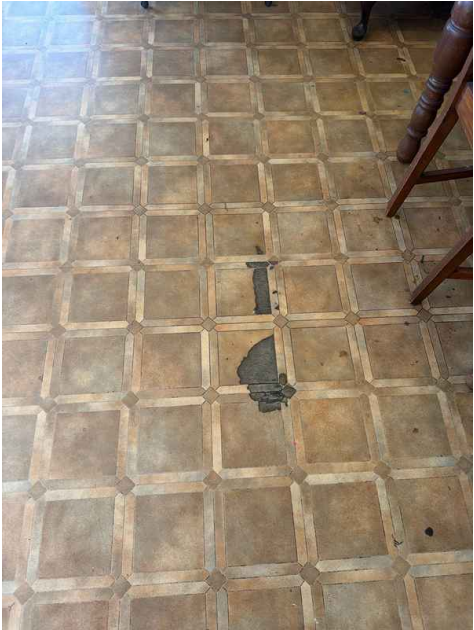
WEAR & TEAR NOTED TO THE FLOORING SYSTEM

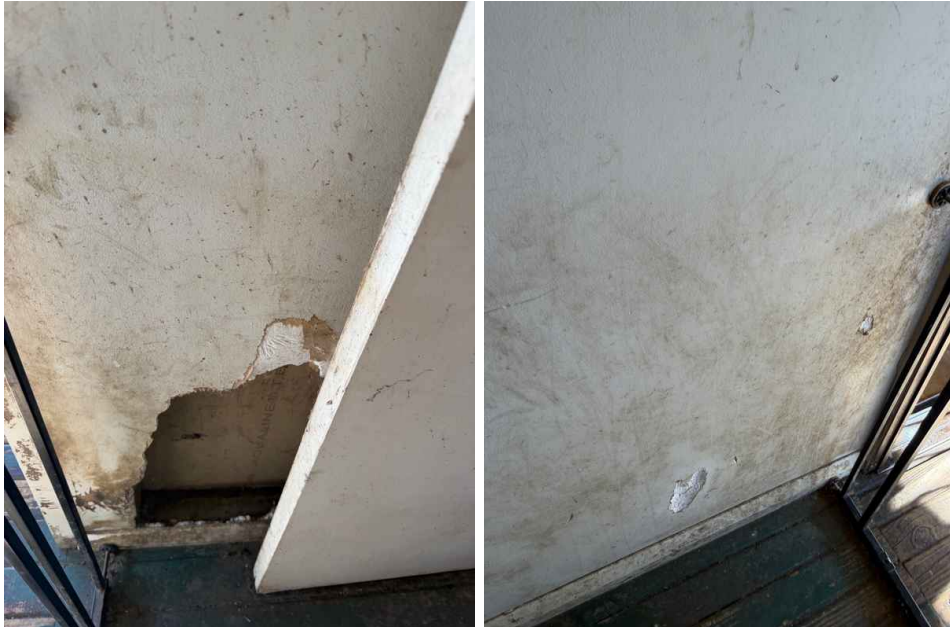
#### **IMPACT DAMAGE TO WALL NOTED**

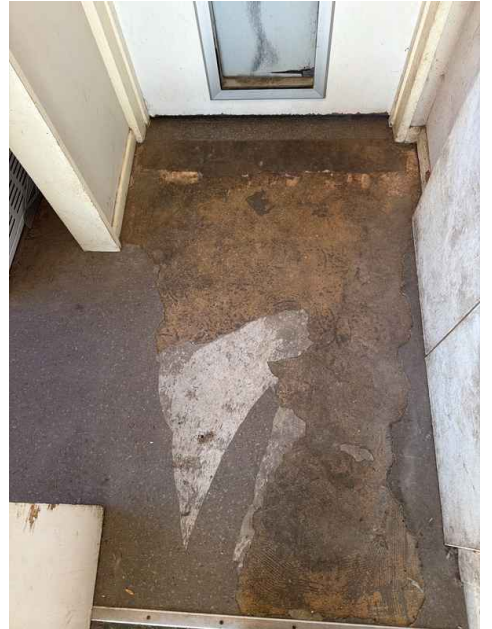
## 19.4.1 Floor Coverings

**WEAR & TEAR NOTED TO THE FLOORING SYSTEM**

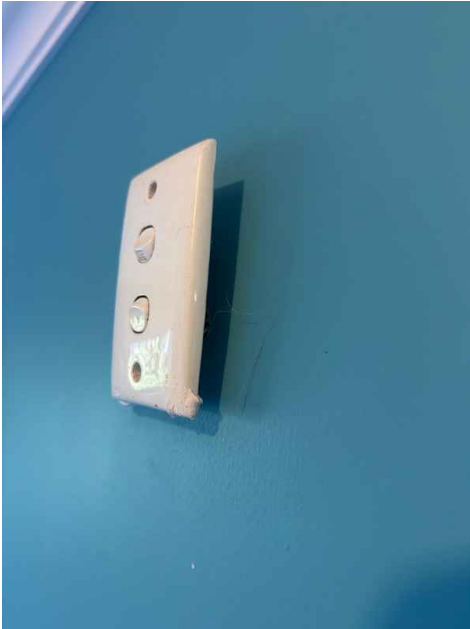
21.5.1 Electrical

### **LOOSE ELECTRICAL FITTING**

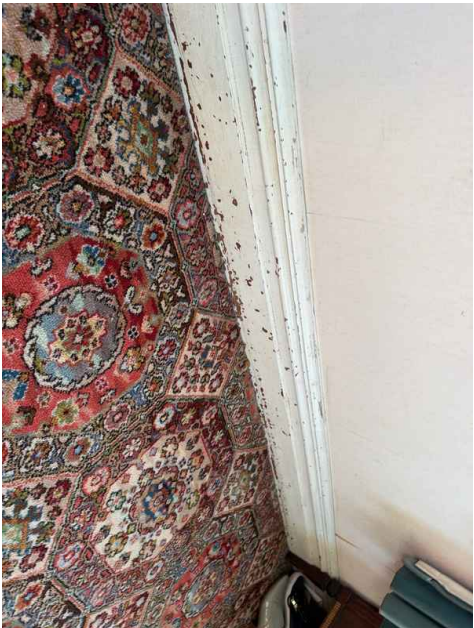
22.1.1 Internal Linings

**WEAR & TEAR TO WALLS NOTED**  
BEDROOM

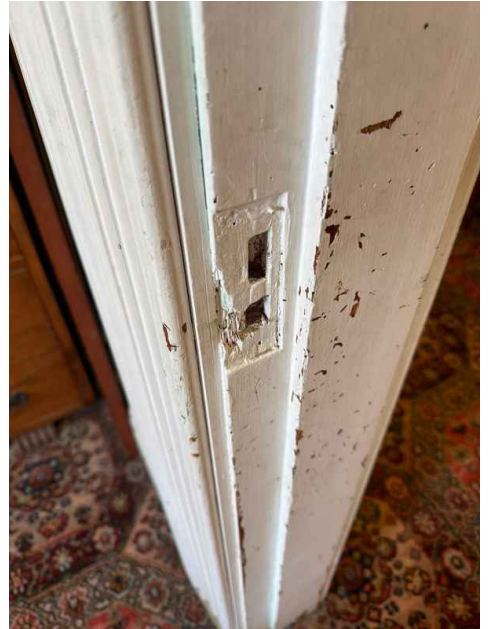
## 22.3.1 Internal Doors

**LATCH MISSING**

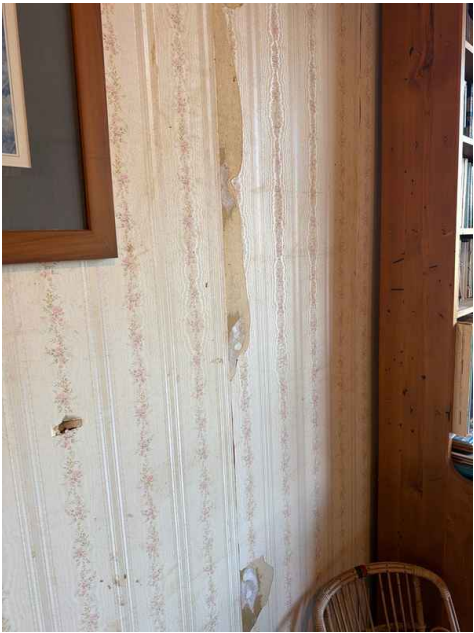
24.1.1 Internal Linings

**WEAR & TEAR TO WALLS NOTED**  
BEDROOM

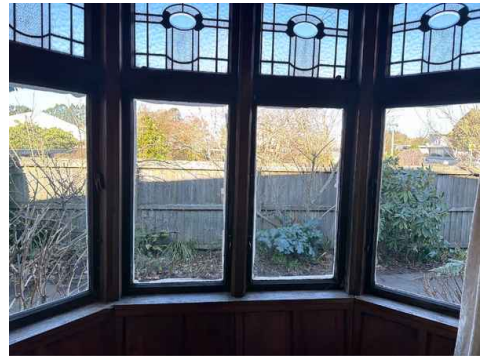
## 24.2.1 Exterior Joinery

**WINDOW FUNCTIONALITY IS LIMITED**

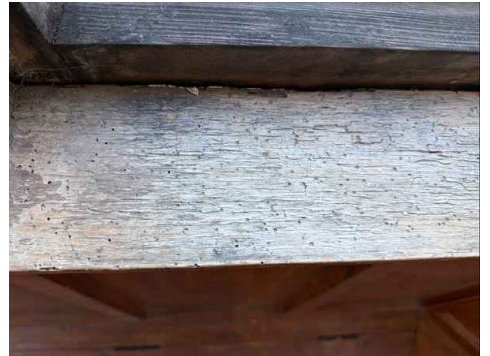
## 24.2.2 Exterior Joinery

**BORER NOTED TO WINDOW FRAME**

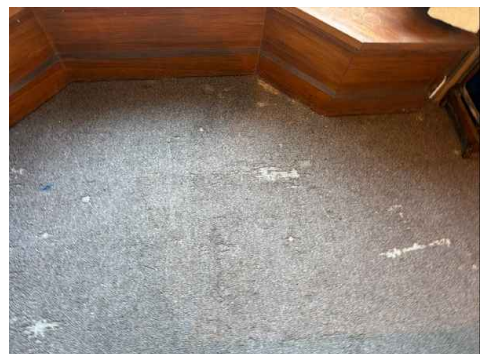
## 24.4.1 Floor Coverings

**WEAR & TEAR NOTED TO THE FLOORING SYSTEM**

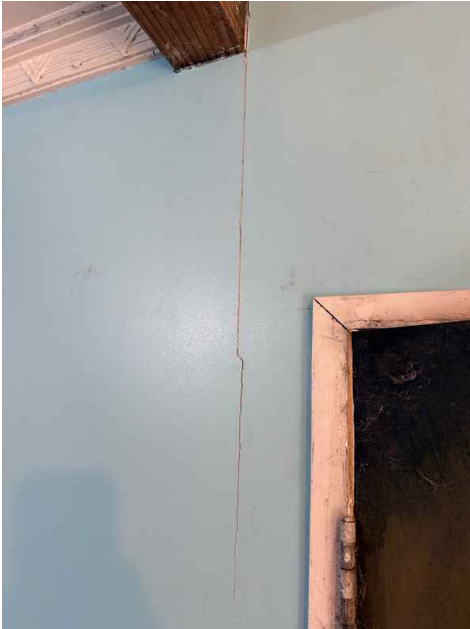
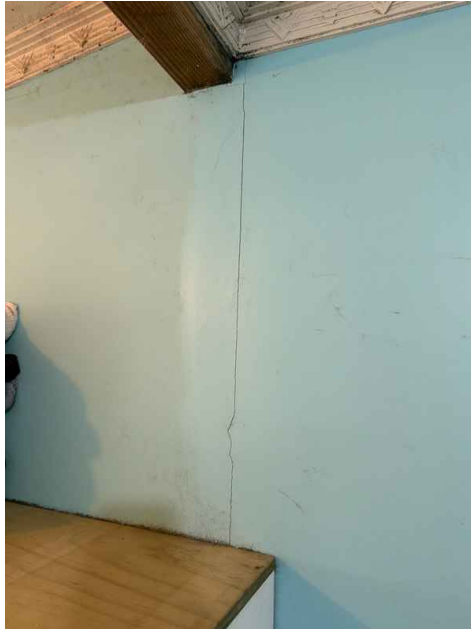
25.1.1 Internal Linings

**COSMETIC CRACKING TO WALLS NOTED**

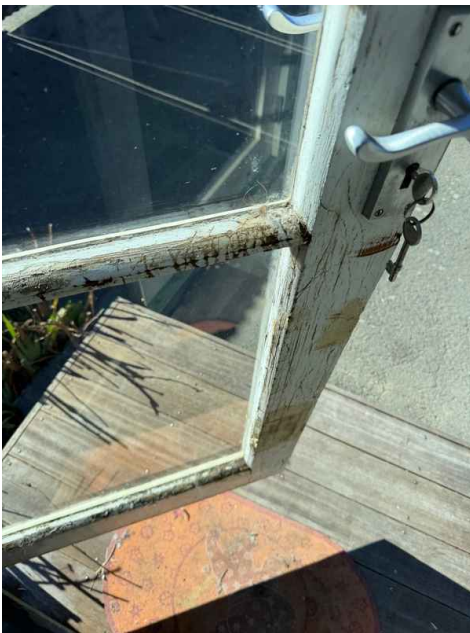
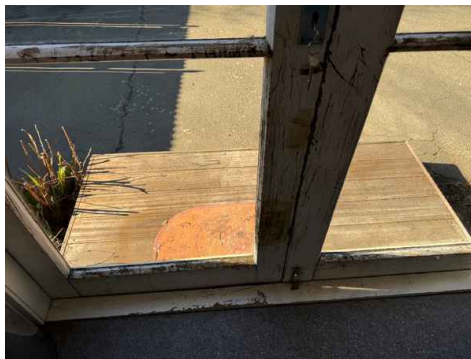
#### 25.2.1 Exterior Joinery

### **DETERIORATION WINDOWS PAINT SYSTEM NOTED**

Prepare and repaint as required to minimize deterioration of the timber

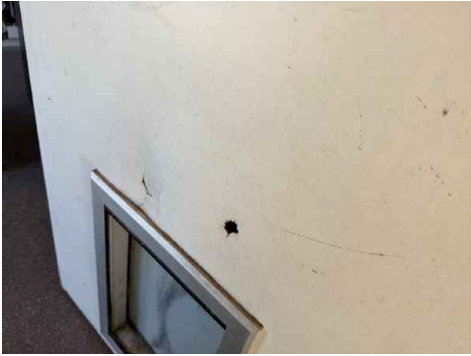
#### 25.3.1 Internal Doors

### **IMPACT DAMAGE TO DOOR NOTED**

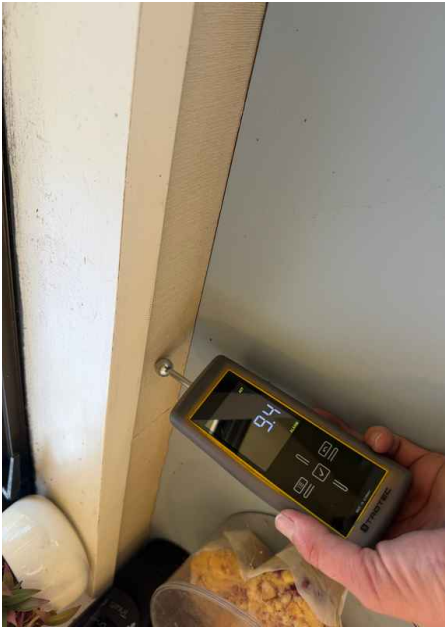
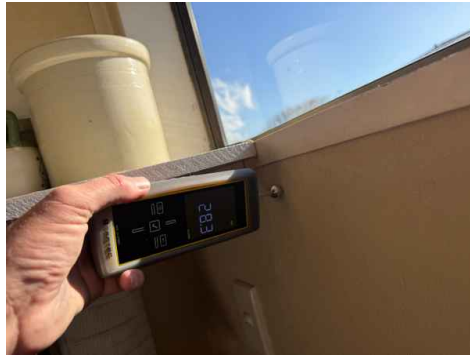
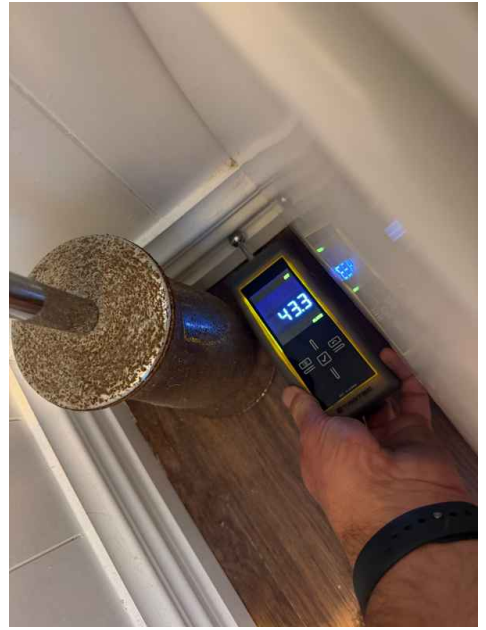
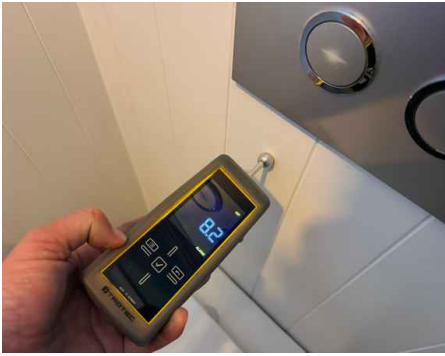
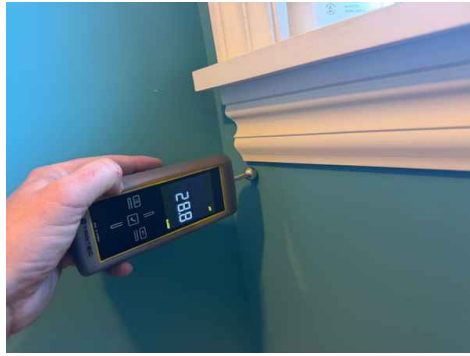
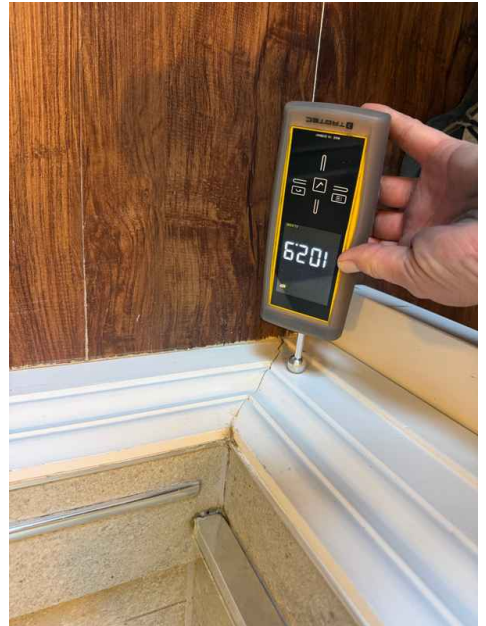
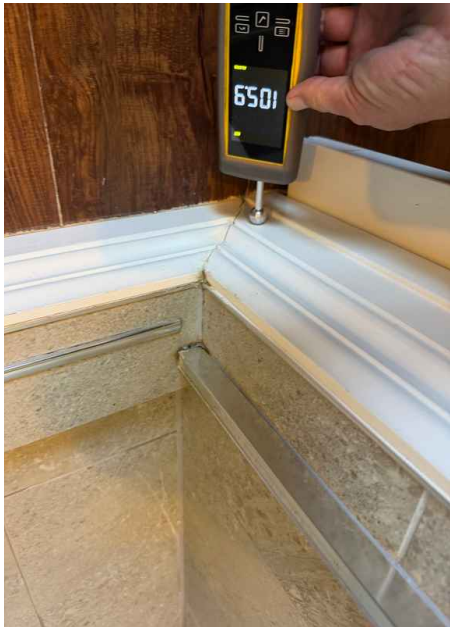
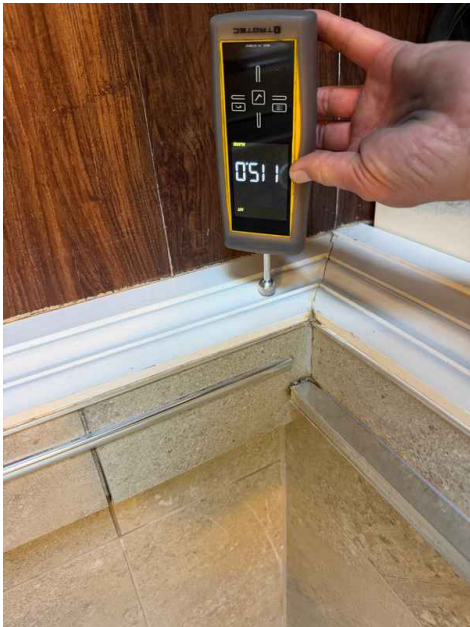
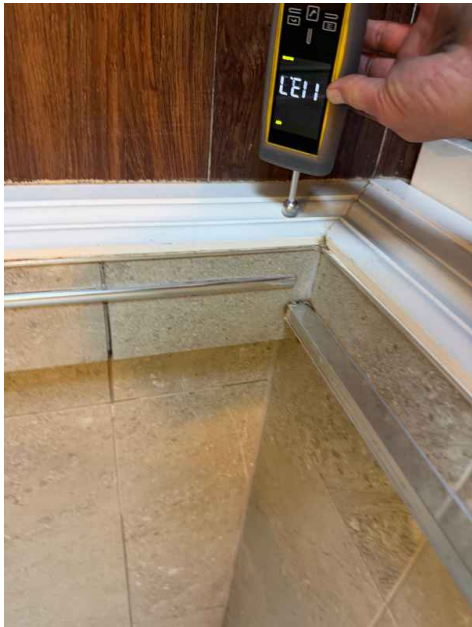
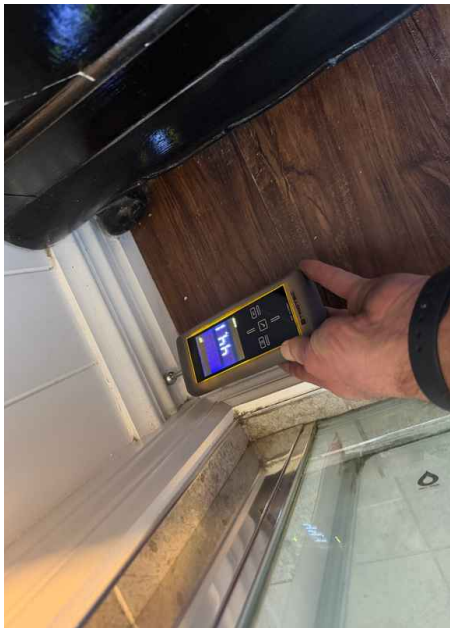
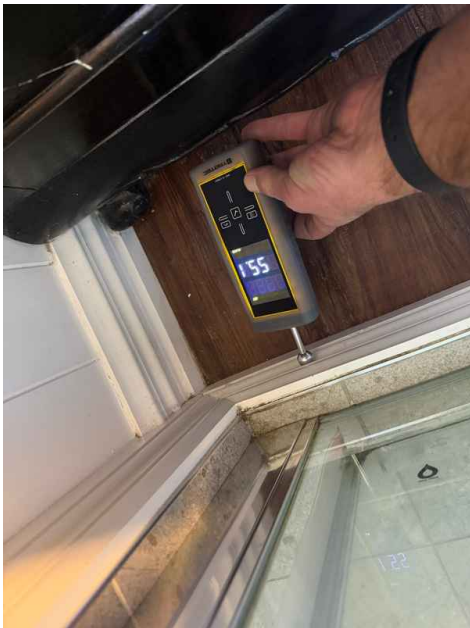
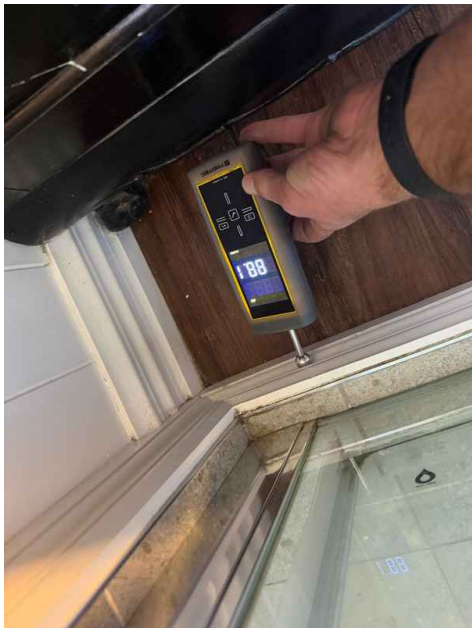
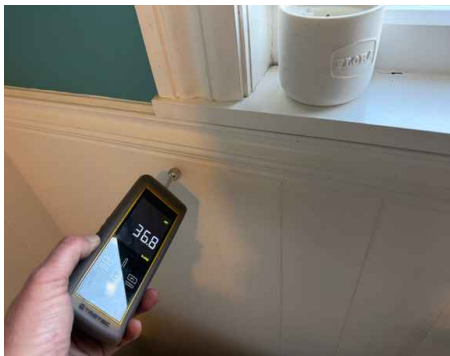
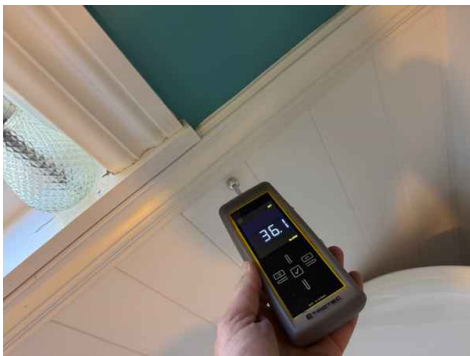
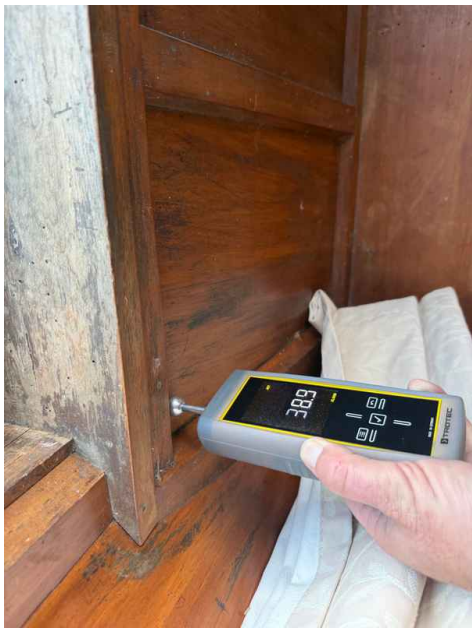
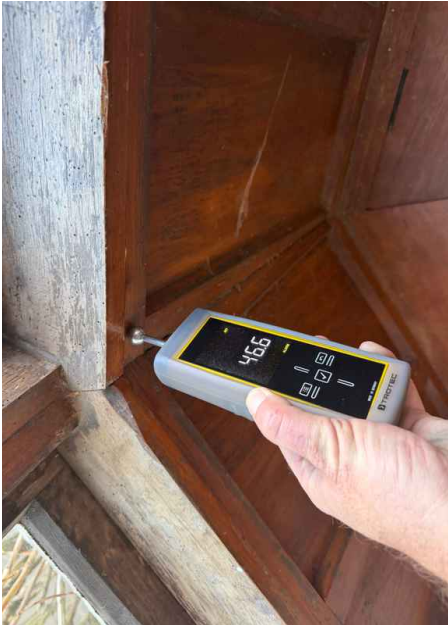
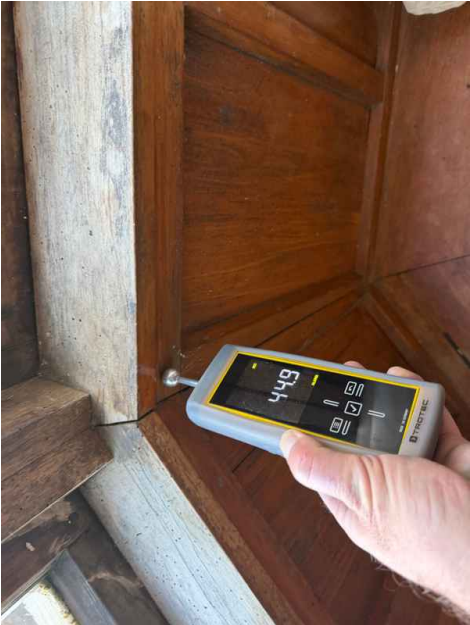
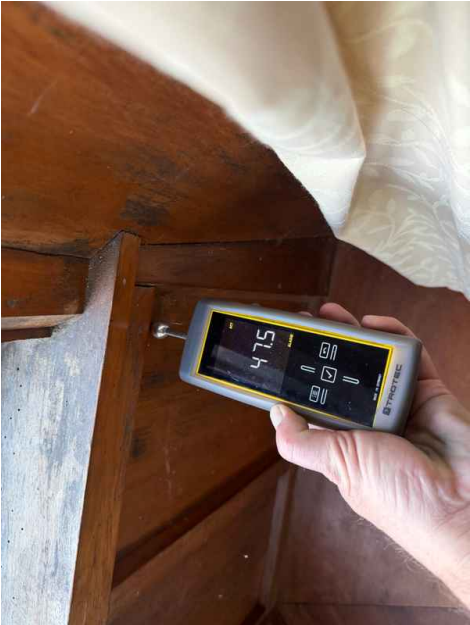
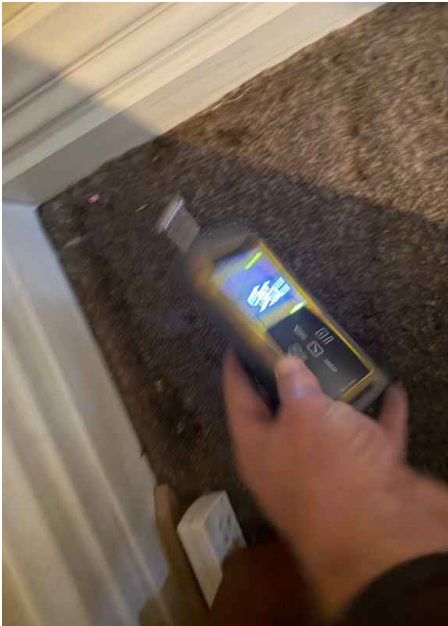
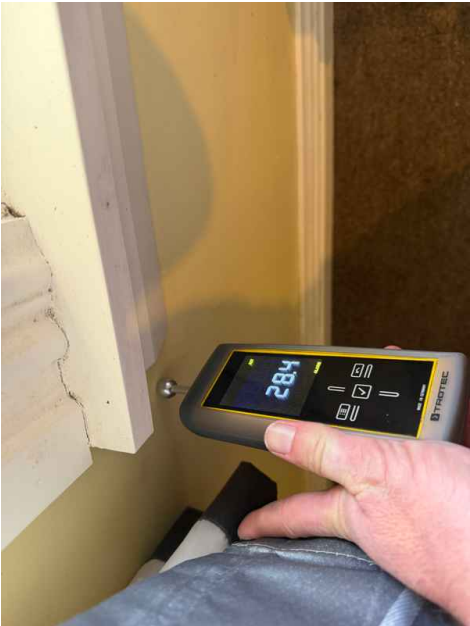
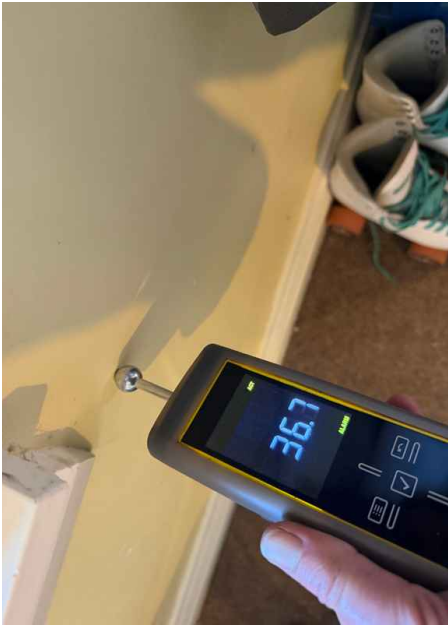
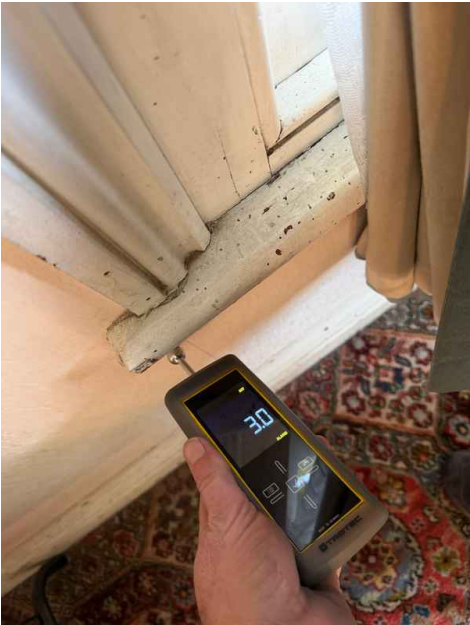
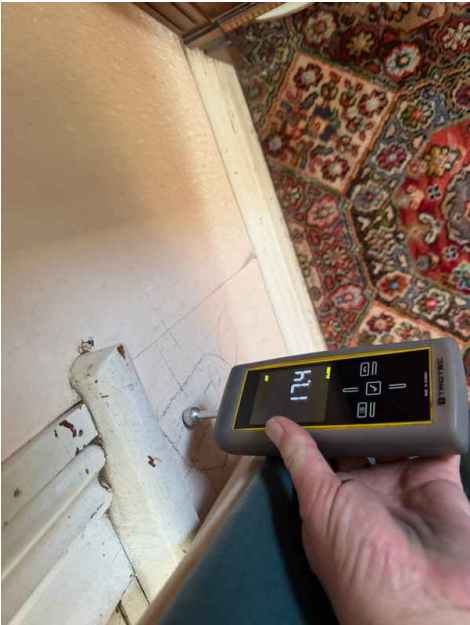
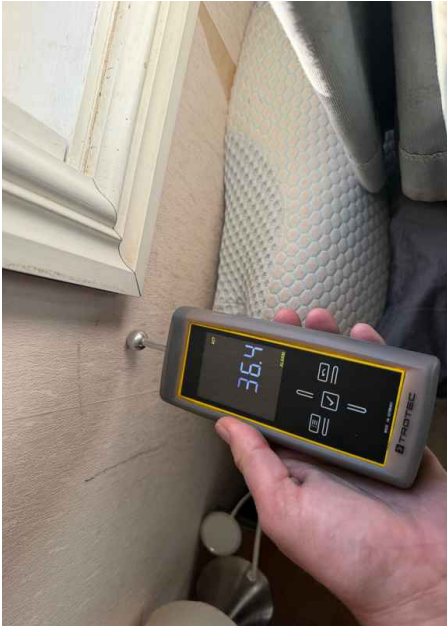
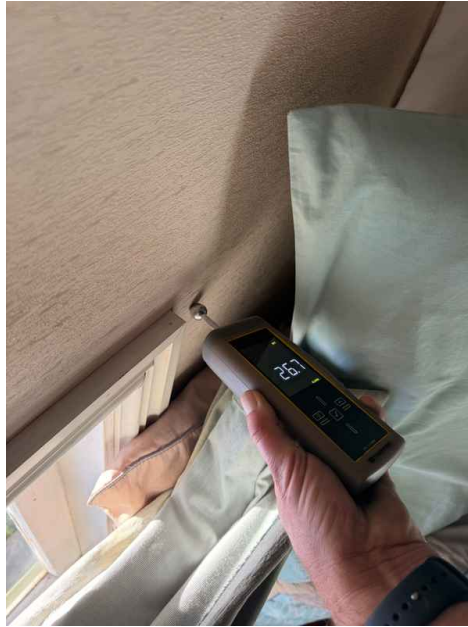
## Moisture : Sample Of Readings

Photos are samples of readings taking around the dwelling. Instrument may be tilted to allow image to be taken.

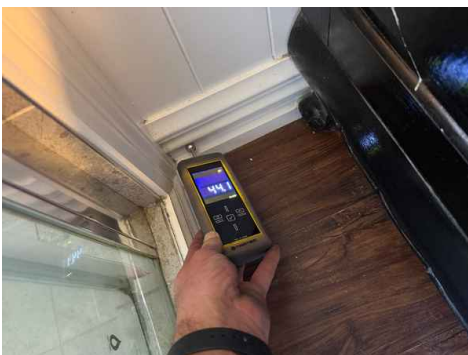
### 26.1.1 Moisture

#### **ELEVATED MOISTURE**

Elevated moisture was located to the shower area. Improvements to the area to prevent water escaping the enclosure are recommended.

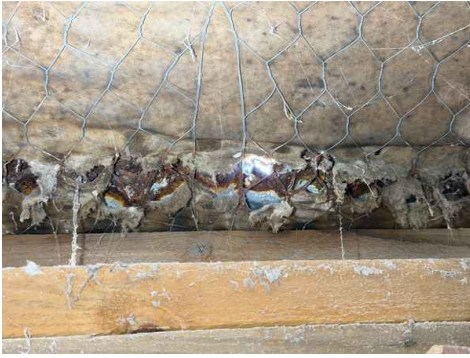
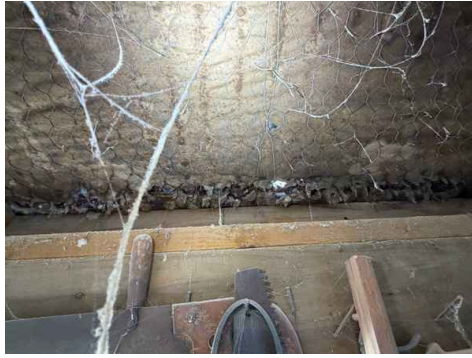
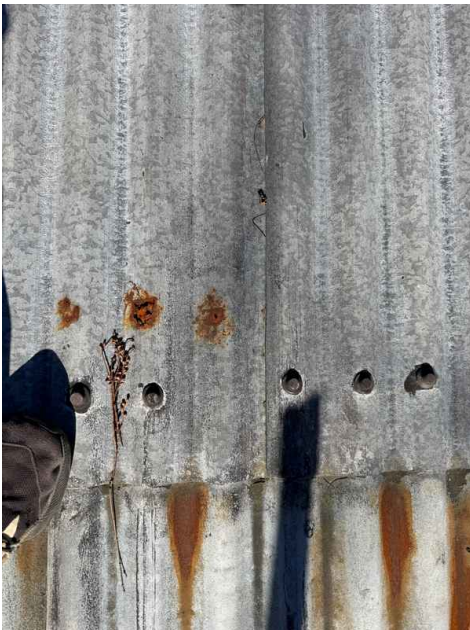
#### 27.3.1 Defects Roof System

##### ROOF CORROSION

corrosion to the roof system is noted, repairs and maintenance are required.
