# House Inspection at

29 Mamaku Street, Paraparaumu

## Summary of report

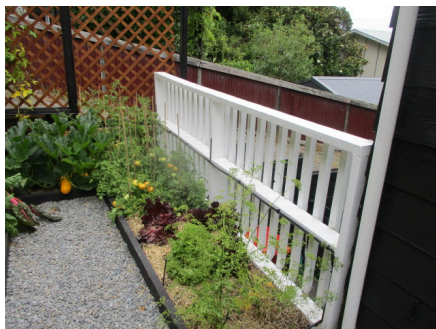
gardens replanted in places

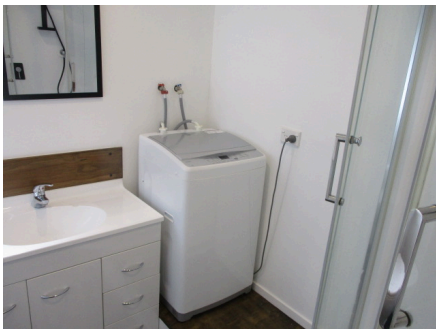
vanity and washing machine

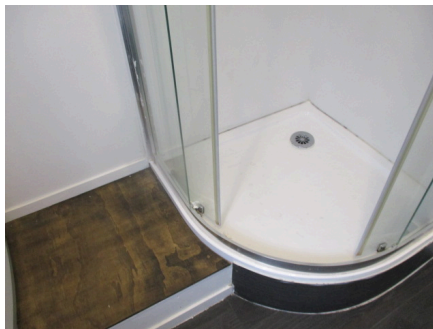
shower

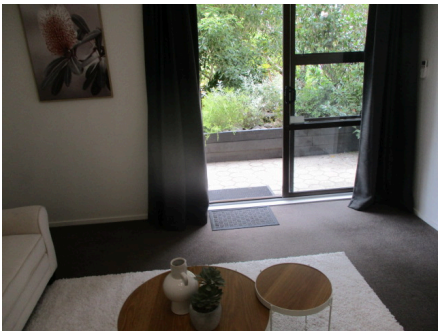
lounge area

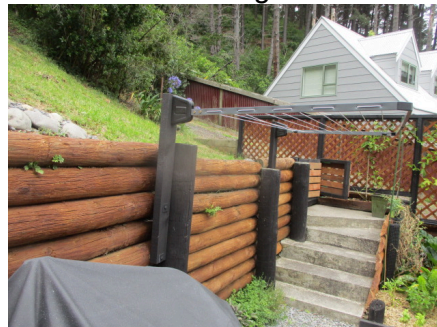
fold up clothes line
